Seismic Performance Assessment of Pre-1988 Steel Concentrically Braced Frames

PEER Internship Program – Summer 2013

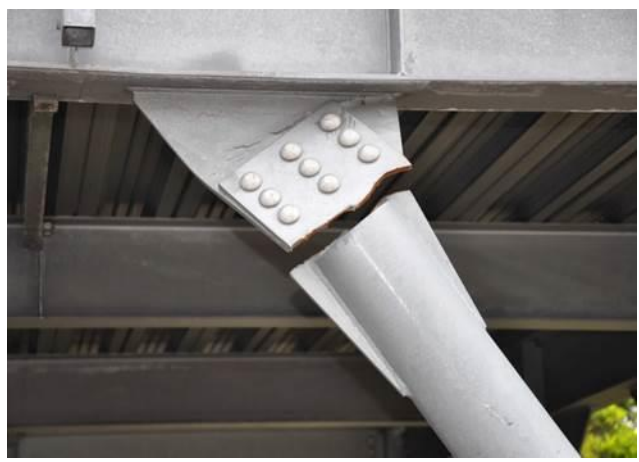
Figure 2: Complete fracture of gusset plate (Lignos, 2011)

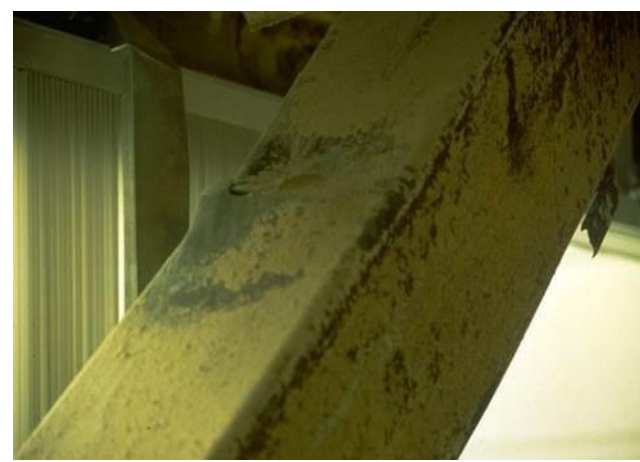
Figure 3: Local buckling of square HSS brace (NISEE, 1994)

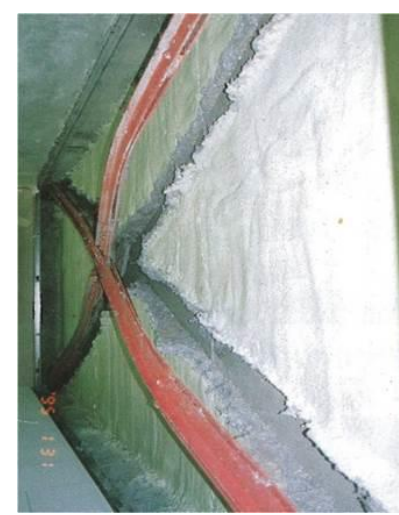
Figure 4: Global buckling of braces (AIJ, 1995)

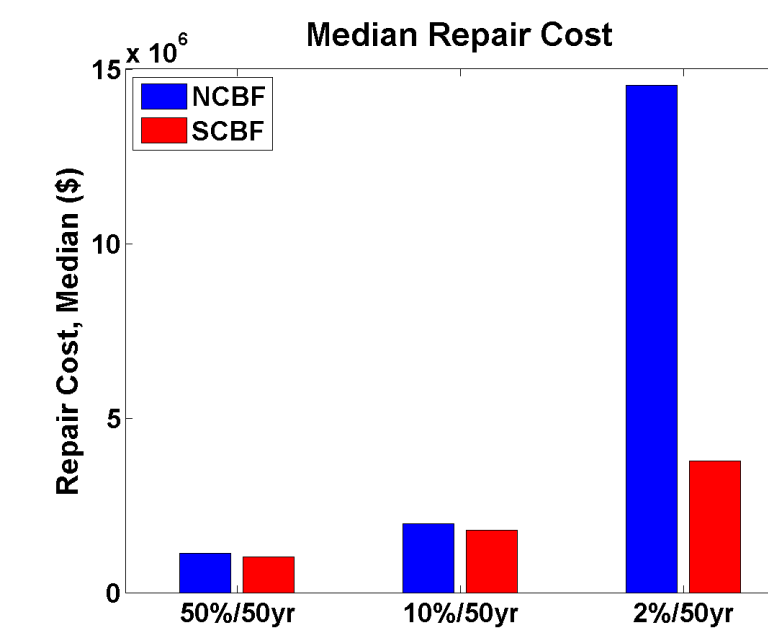
Figure 8: Comparison of repair costs

General trends in the PACT results indicate that an SCBF building would generally be expected to outperform an NCBF building in terms of:

- Repair cost
- Repair time
- The probability of unsafe placarding.

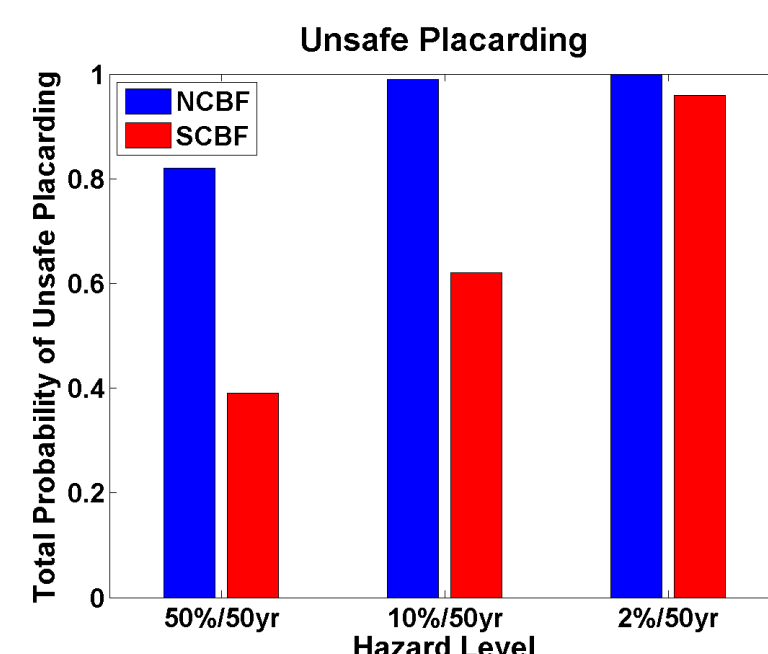
Figure 11: Comparison of probability of unsafe placarding

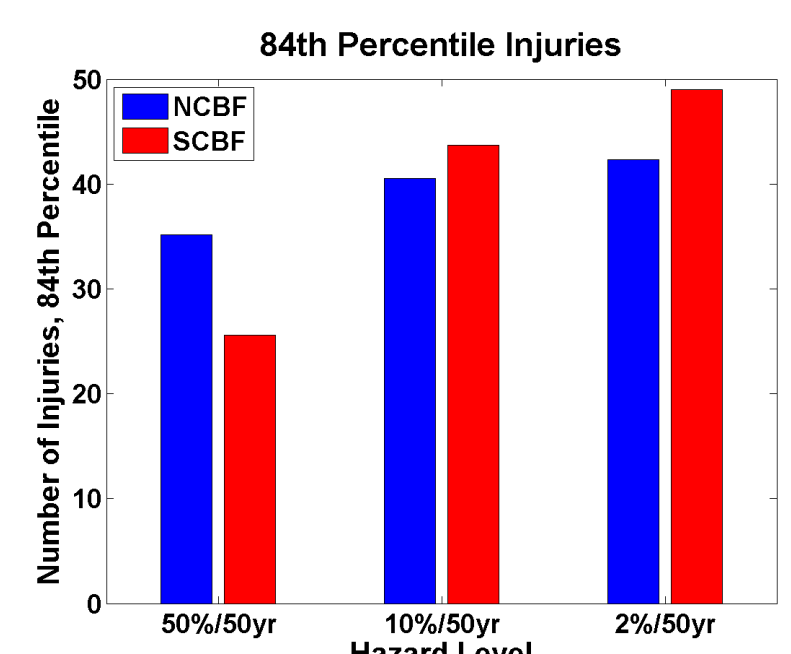
Figure 12: Comparison of injuries

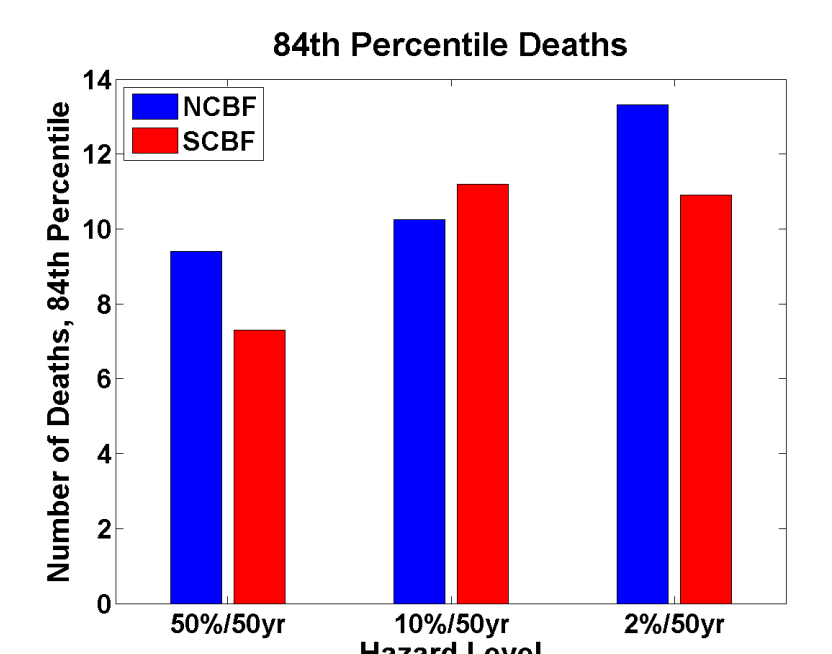
Figure 13: Comparison of deaths
