# PEER-CEA Wood-Frame Project: Numerical Simulations

# Outline

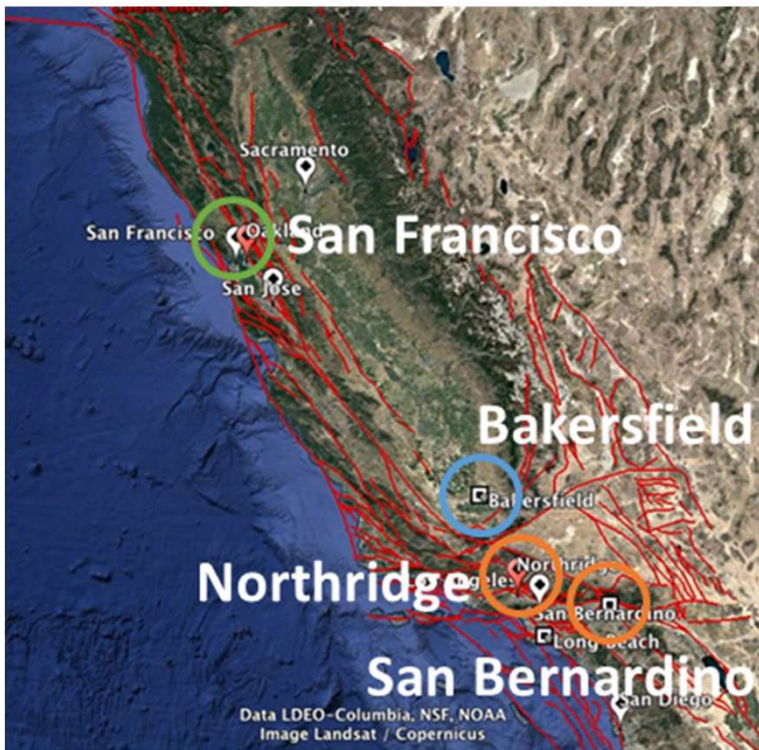
- 4 baseline sites adopted ( $V_{s,30}=270\text{m/s}$ )
- Covers seismicity range in FEMA P-1100

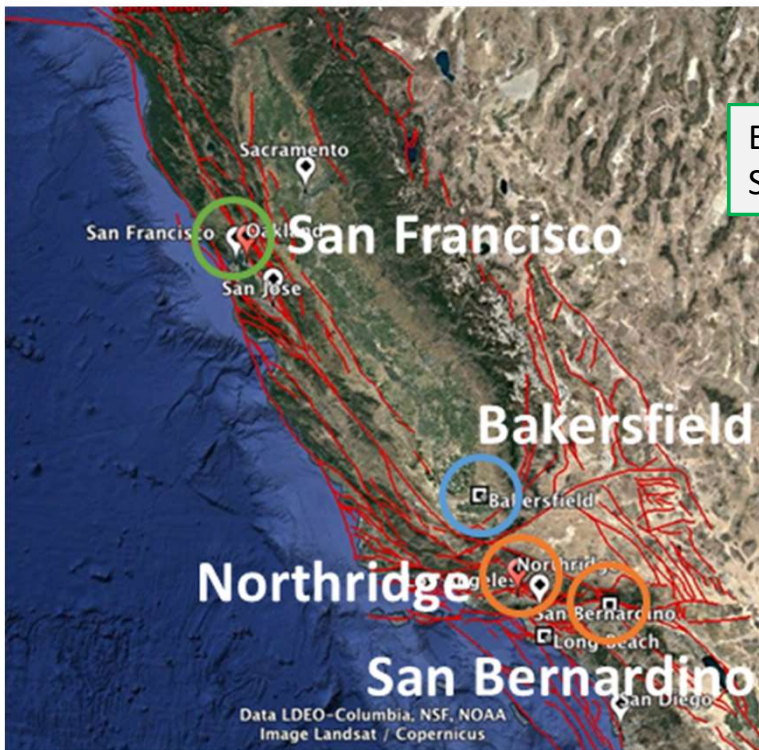
Example CMS:  
San Francisco 270 site

- 4 baseline sites adopted ( $V_{s,30}=270\text{m/s}$ )
- Covers seismicity range in FEMA P-1100
- 10 intensities per site (RP=15y to 2500y)
- 45 ground motion pairs per intensity selected to match target Conditional Mean Spectrum ( $T^*=0.25\text{s}$ )

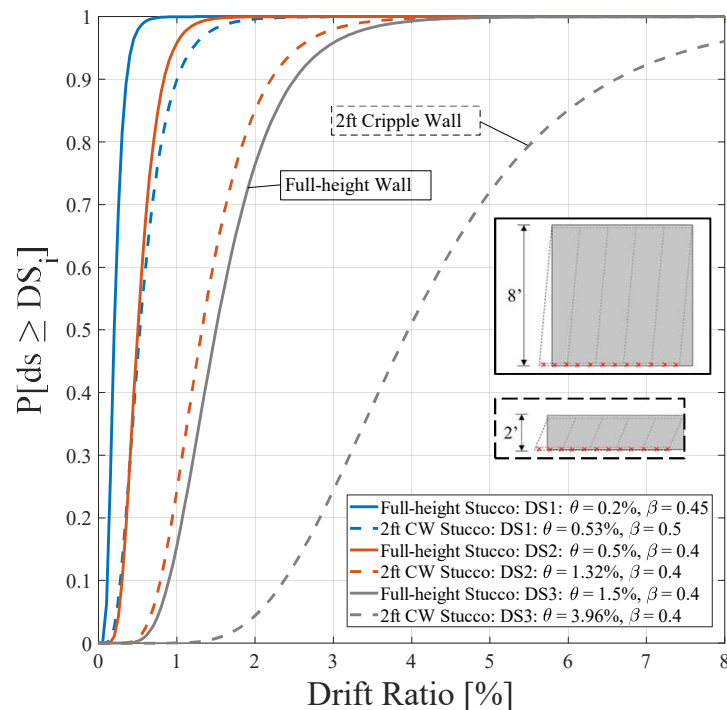
Median Drift Adjustment  
for Shorter Stucco Walls

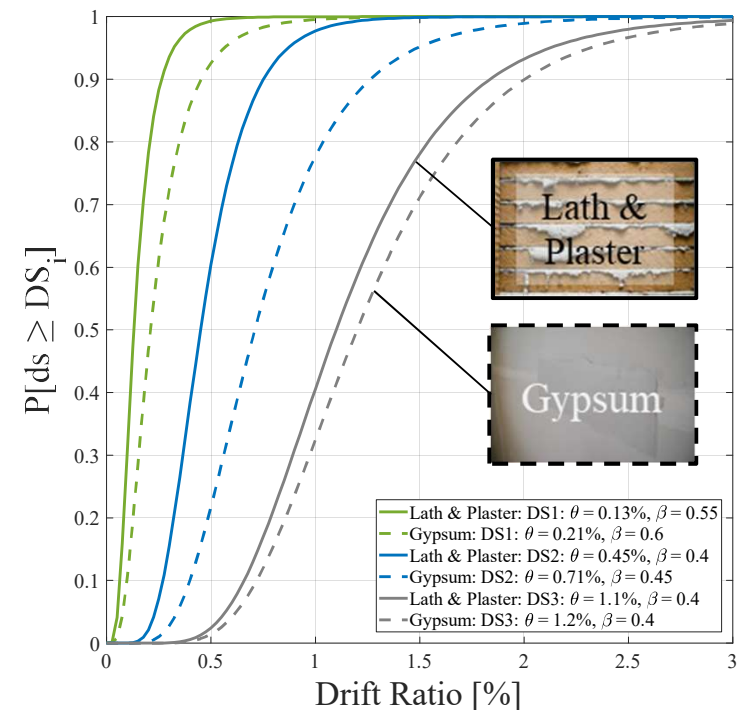
Gypsum vs. Lath and Plaster Fragility

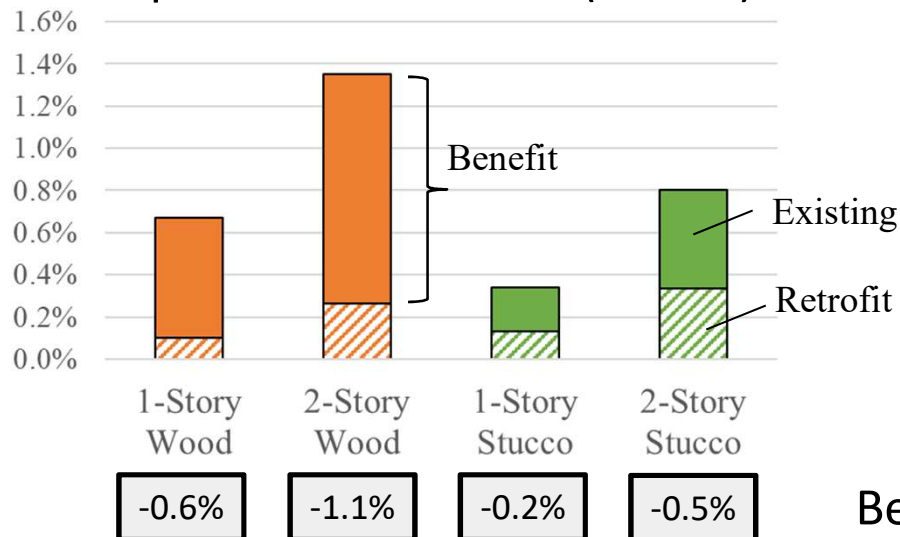
- Lower cripple wall strength increases observed retrofit benefit
- Two-story perform worse than one-story (existing and retrofit)
- Observed benefits due to retrofitting vary significantly depending on building variant and loss metric

Expected Annual Loss (SF Site)

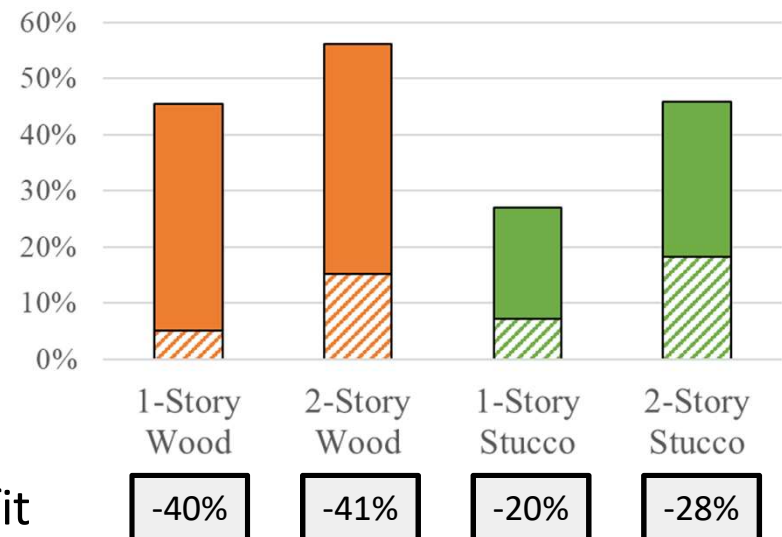
Loss at 250yr Hazard Intensity (SF Site)
