PACIFIC EARTHQUAKE ENGINEERING RESEARCH CENTER

Experimental Investigation of the Behavior of Vintage and Retrofit Concentrically Braced Steel Frames under Cyclic Loading

PEER Report No. 2017/12
Pacific Earthquake Engineering Research Center
Headquarters at the University of California, Berkeley

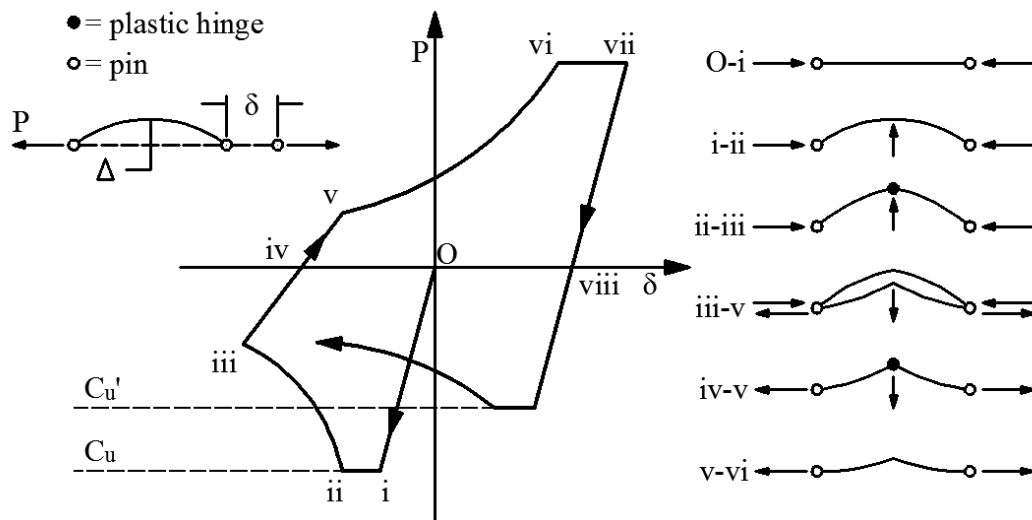
Figure 2.2 Idealized hysteretic behavior of a brace under cyclic axial loading (based on diagram found in Bruneau et al. [2011]).

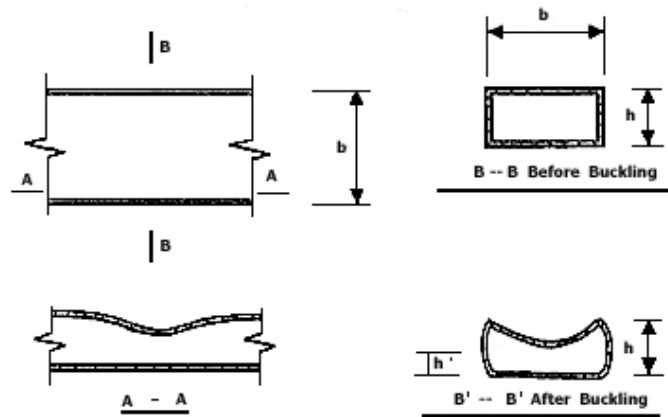
Figure 2.3 Local buckling in hollow cross sections [graphic courtesy of Liu and Goel 1988].

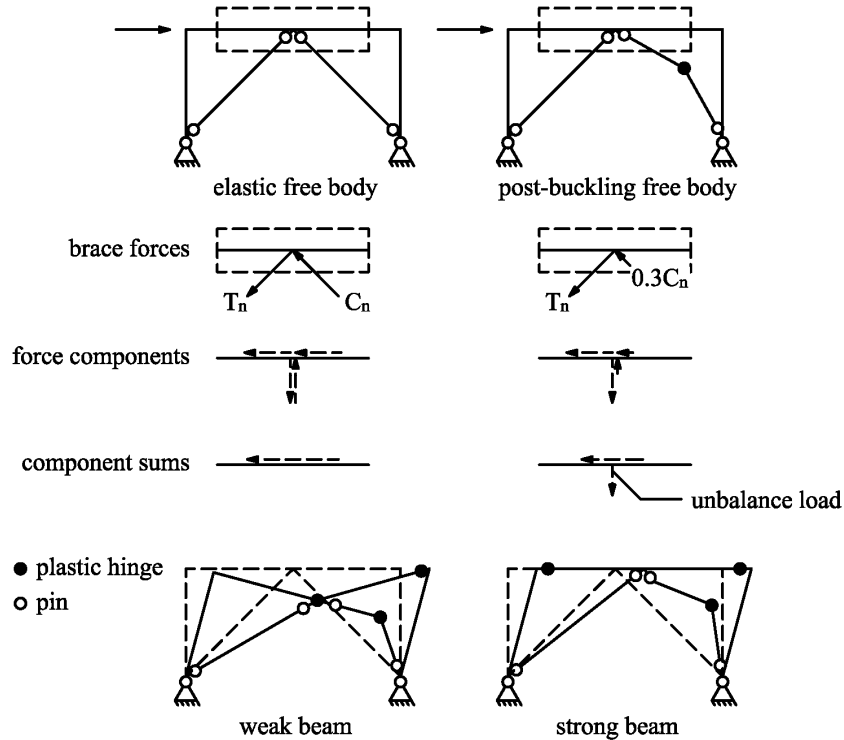
Figure 2.6 Diagram illustrating post-buckling strength degradation of the brace and the unbalanced load on the beam.

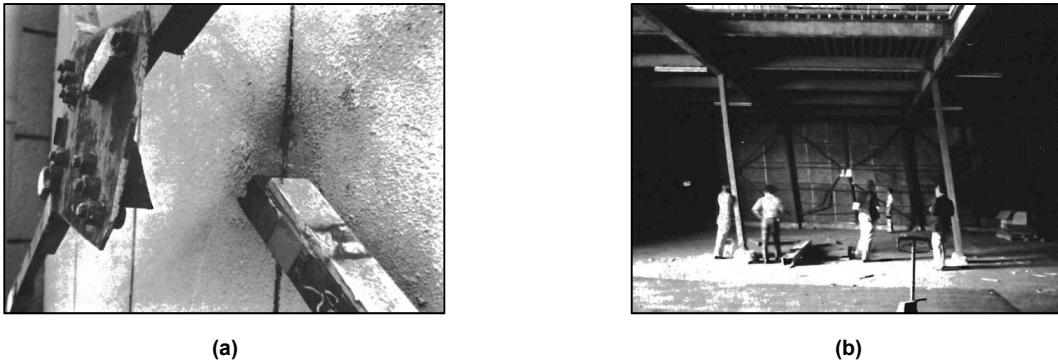
Figure 2.8 Photographed damage from the 1978 Miyagi-Ken Oki earthquake: (a) damaged steel frame furniture warehouse located on the outskirts of Sendai with rupture at bolt holes; and (b) Sendai Unyu Soko warehouse showing perimeter bracing with unbraced center bays [photographs courtesy of EERI 1978].

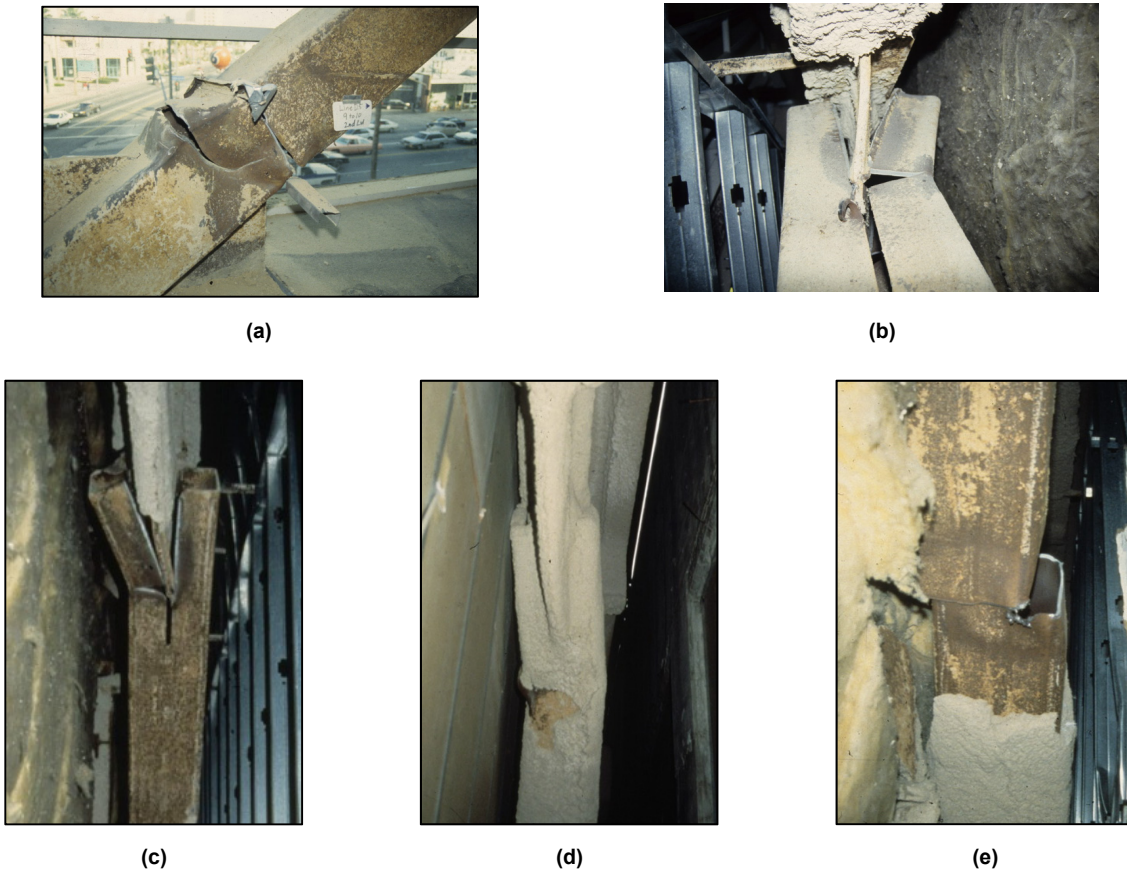
Figure 2.9 Photographs of a four-story commercial building damage after the 1994 Northridge earthquake: (a) fracture of brace near connection region; (b) and (c) failure of slotted brace to gusset weld; (d) local buckling of brace near connection region; and (e) fracture at midpoint of brace [photographs courtesy of Bonneville and Bartoletti 1996].

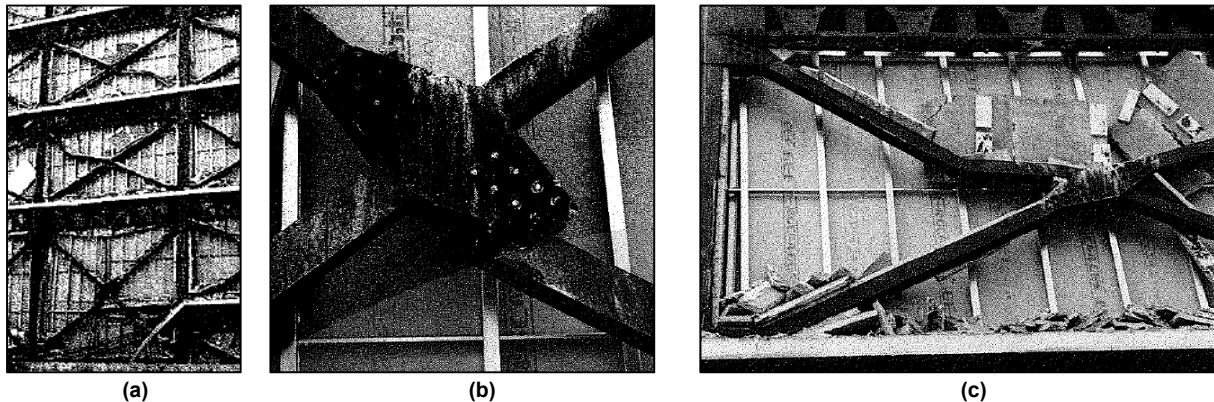
Figure 2.10 Photographs of damage to seven-story braced frame structure under the Hyogo-ken-Nanbu earthquake: (a) overall view; (b) brace fracture at net section area of bolted region; and (c) fracture of bracing member [photographs courtesy of Tremblay et al. 1996].

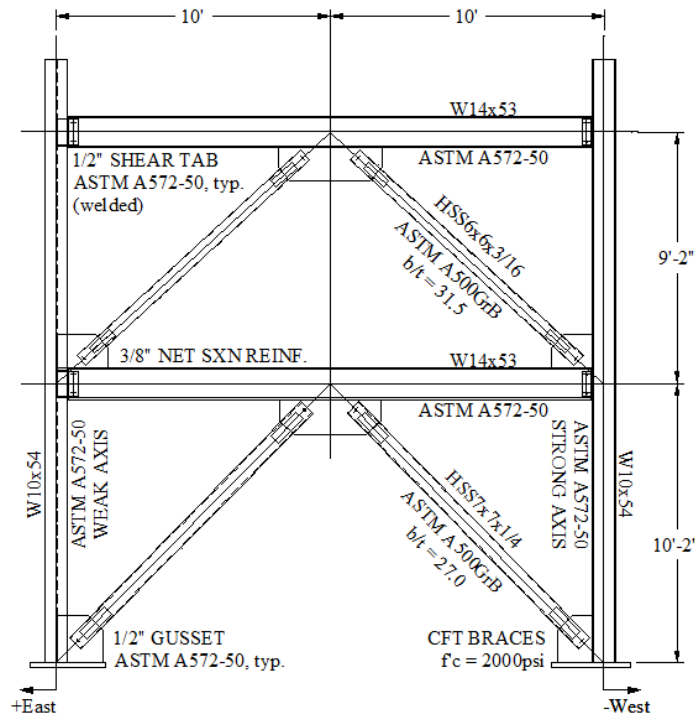
Figure 3.4 Test specimen schematic with dimensions, materials, and member sizes: NCBF-B-2.

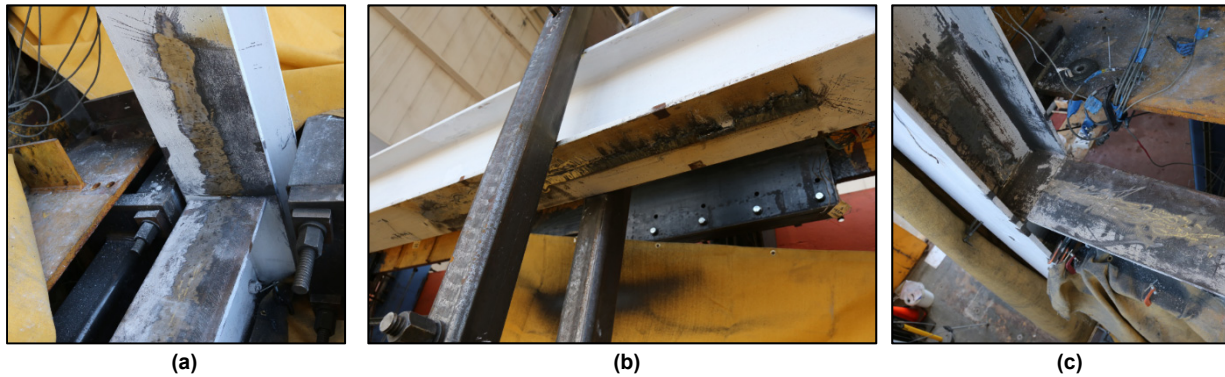
Figure 3.6 Final second-story demolition state: (a) west gusset plate removal; (b) middle gusset plate removal; and (c) east gusset plate removal.

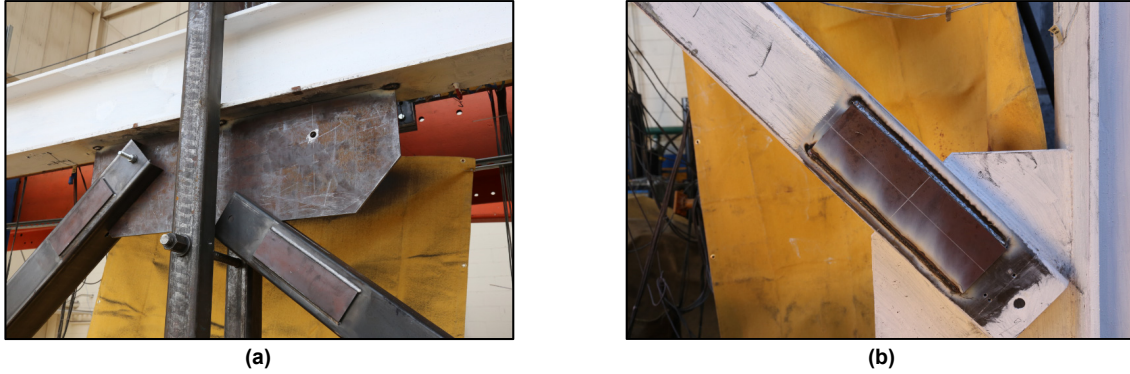
Figure 3.7 Repair of second story of NCBF-B-1: (a) erection of braces; and (b) added net-section reinforcement.

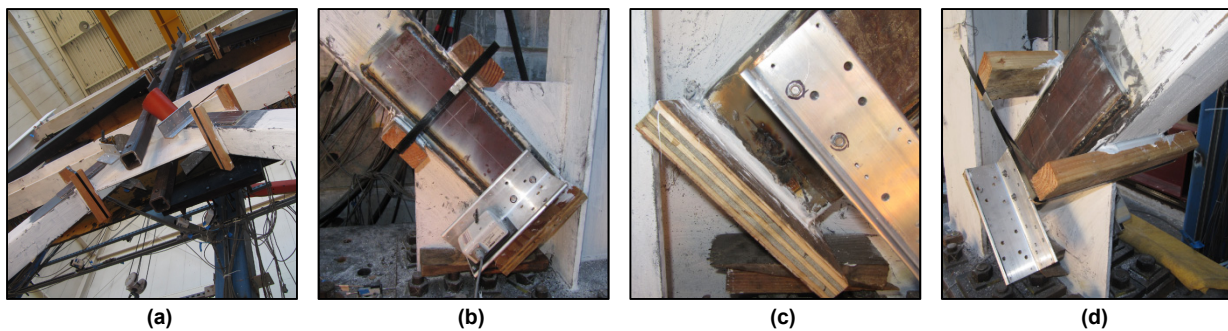
Figure 3.8 Formwork for concrete pour: (a) first-story middle formwork; (b) and (c) first-story east formwork; and (d) first-story west formwork.

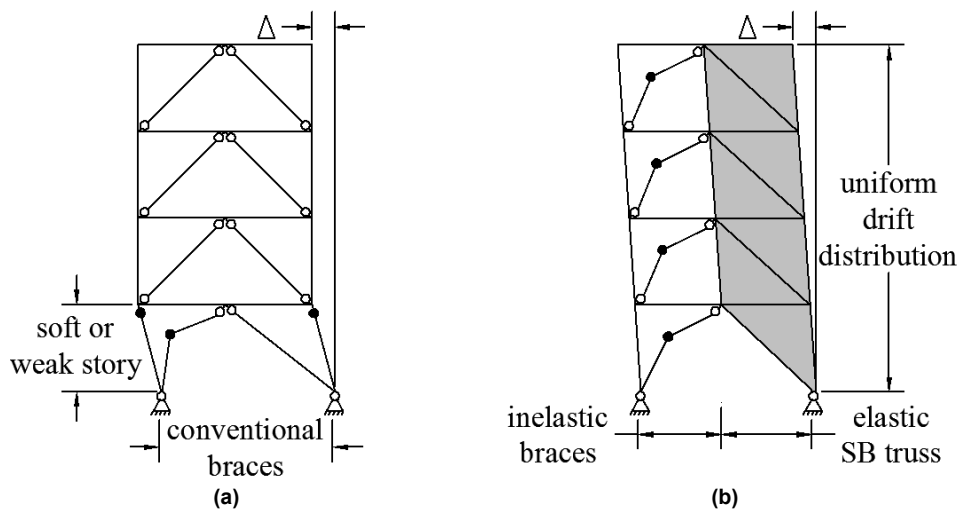
Figure 3.9 Examples of plastic mechanism: (a) conventional braced frame and (b) SB system.

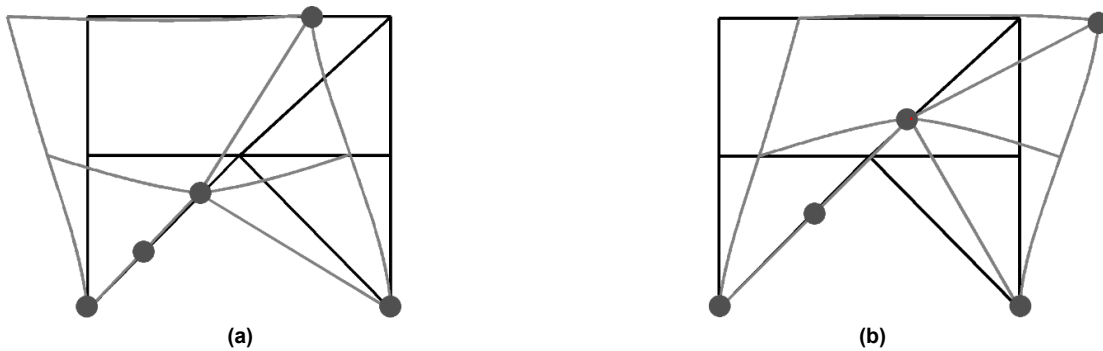
Figure 3.15 Deformed shape at incipient collapse under a triangular load distribution: (a) positive applied force; and (b) negative applied force.

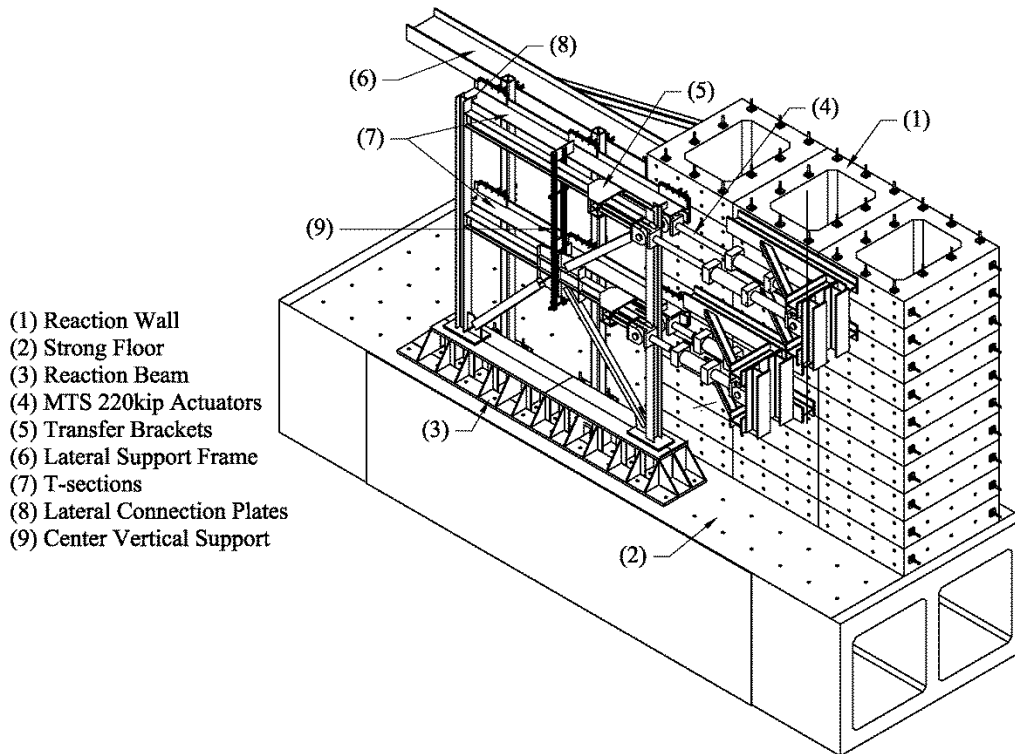
Figure 4.1 Test set-up: isometric drawing.

Lateral out-of-plane support was provided for the specimen by a stiff support frame (see “6”). The test specimen was attached to the support frame through heavy T-sections (see “7”) that were allowed to slide horizontally in a direction parallel to the intended lateral movement of the test specimen. The T-sections at each floor were attached to both columns through steel plates that acted like transverse shear tabs (see “8”), which allowed beam elongation and shortening through yielding of the plates. A center support (see “9”) running vertically along the frame centerline was also attached to the T-sections in the same fashion. This center support was connected to the T-sections and provided out-of-plane lateral stability to the beams while permitting vertical movement.

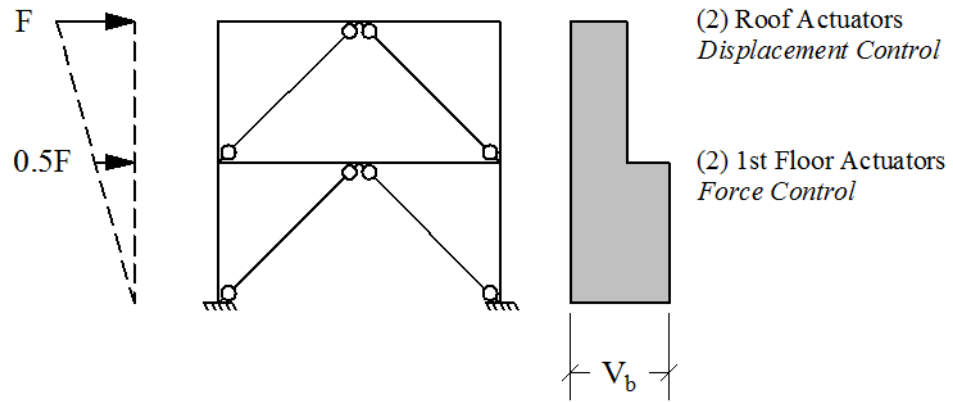
Figure 4.6 Lateral force distribution for loading protocol.

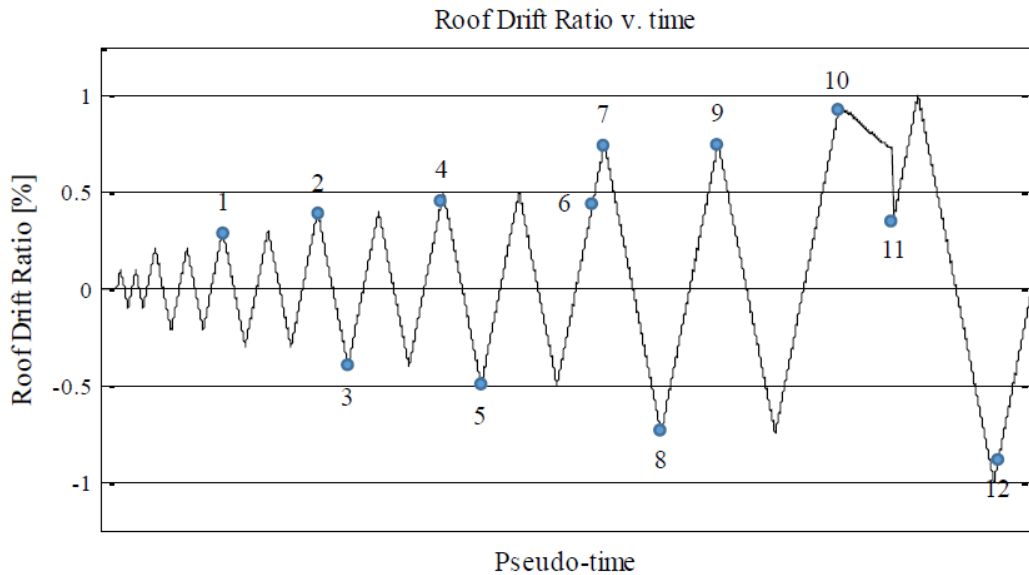
Figure 5.1 NCBF-B-1 applied roof drift ratio during the test.

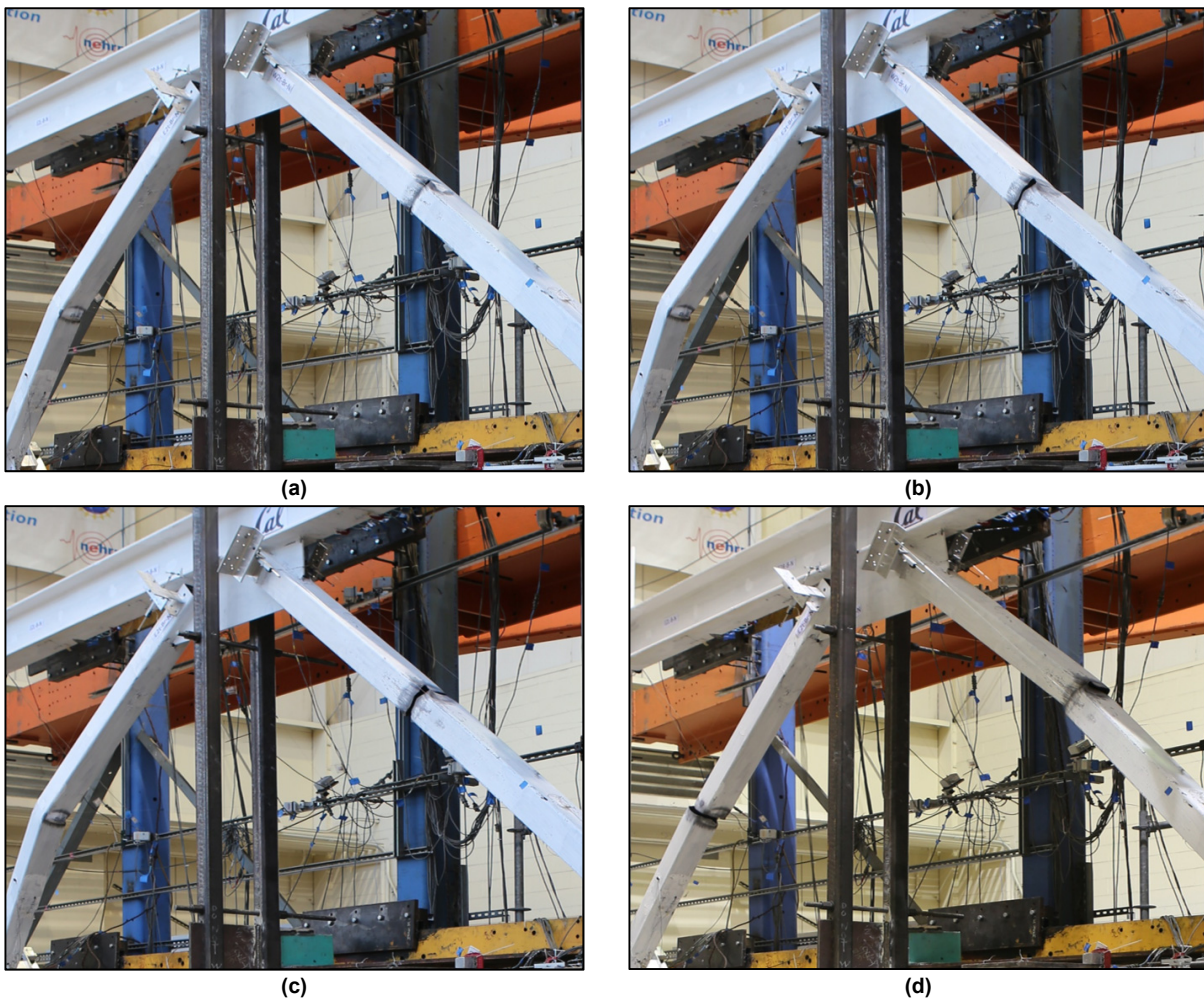
Figure 5.2 Sequence of brace behavior: (a) buckling of both braces with crack initiation in the west brace; (b) crack propagation in the west brace; (c) west-brace fracture; and (d) east-brace fracture

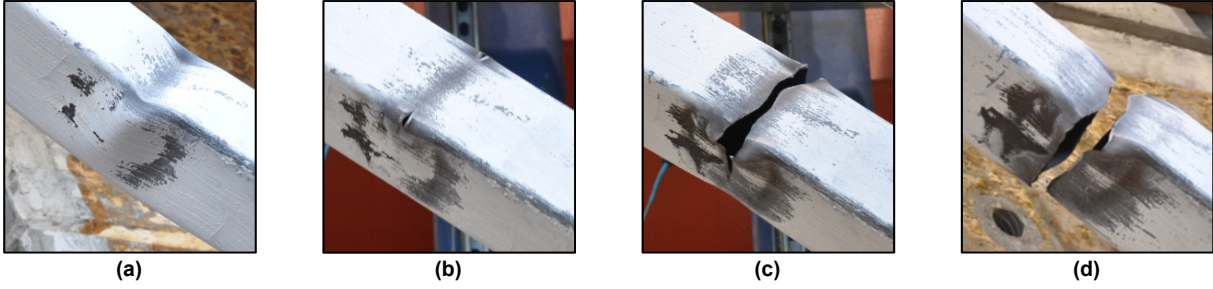
Figure 5.3 West brace behavior: (a) brace buckling; (b) crack initiation; (c) crack propagation; and (d) brace fracture.

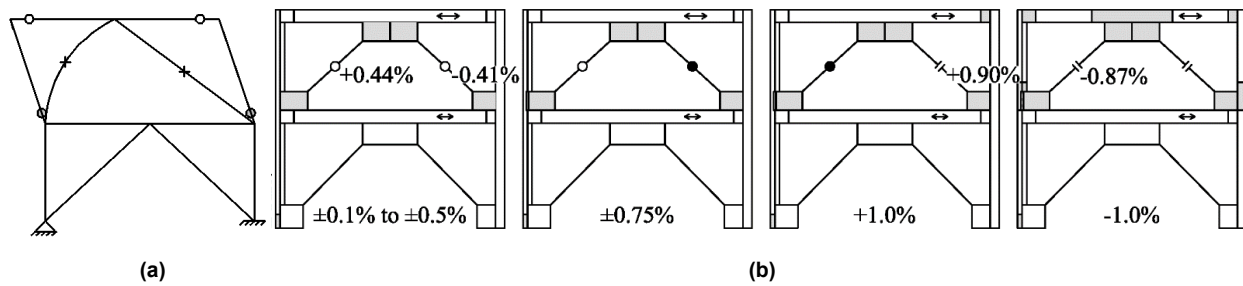
Figure 5.19 NCBF-B-1: (a) schematic of collapse mechanism and (b) hierarchy of damage.

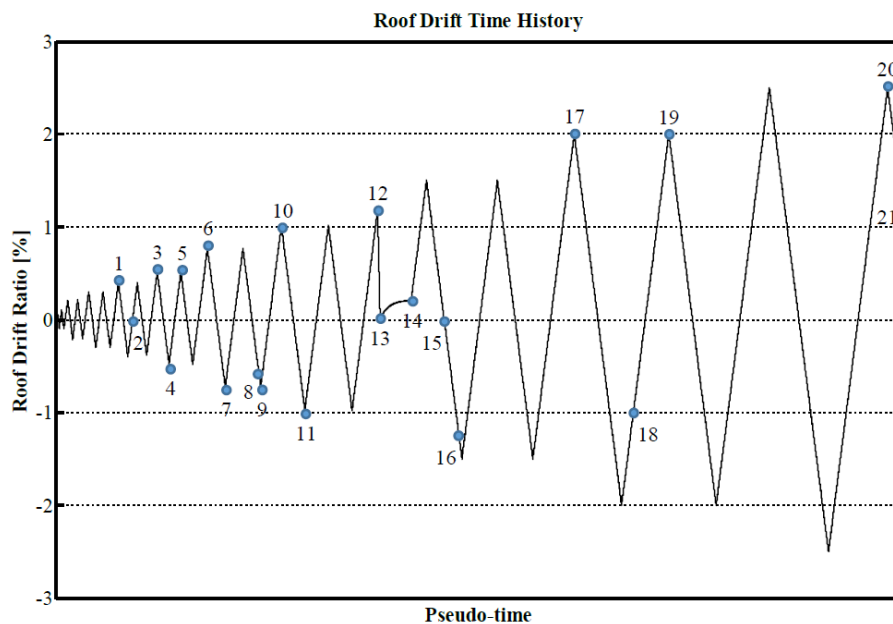
Figure 5.20 NCBF-B-2 applied roof drift ratio during the test.

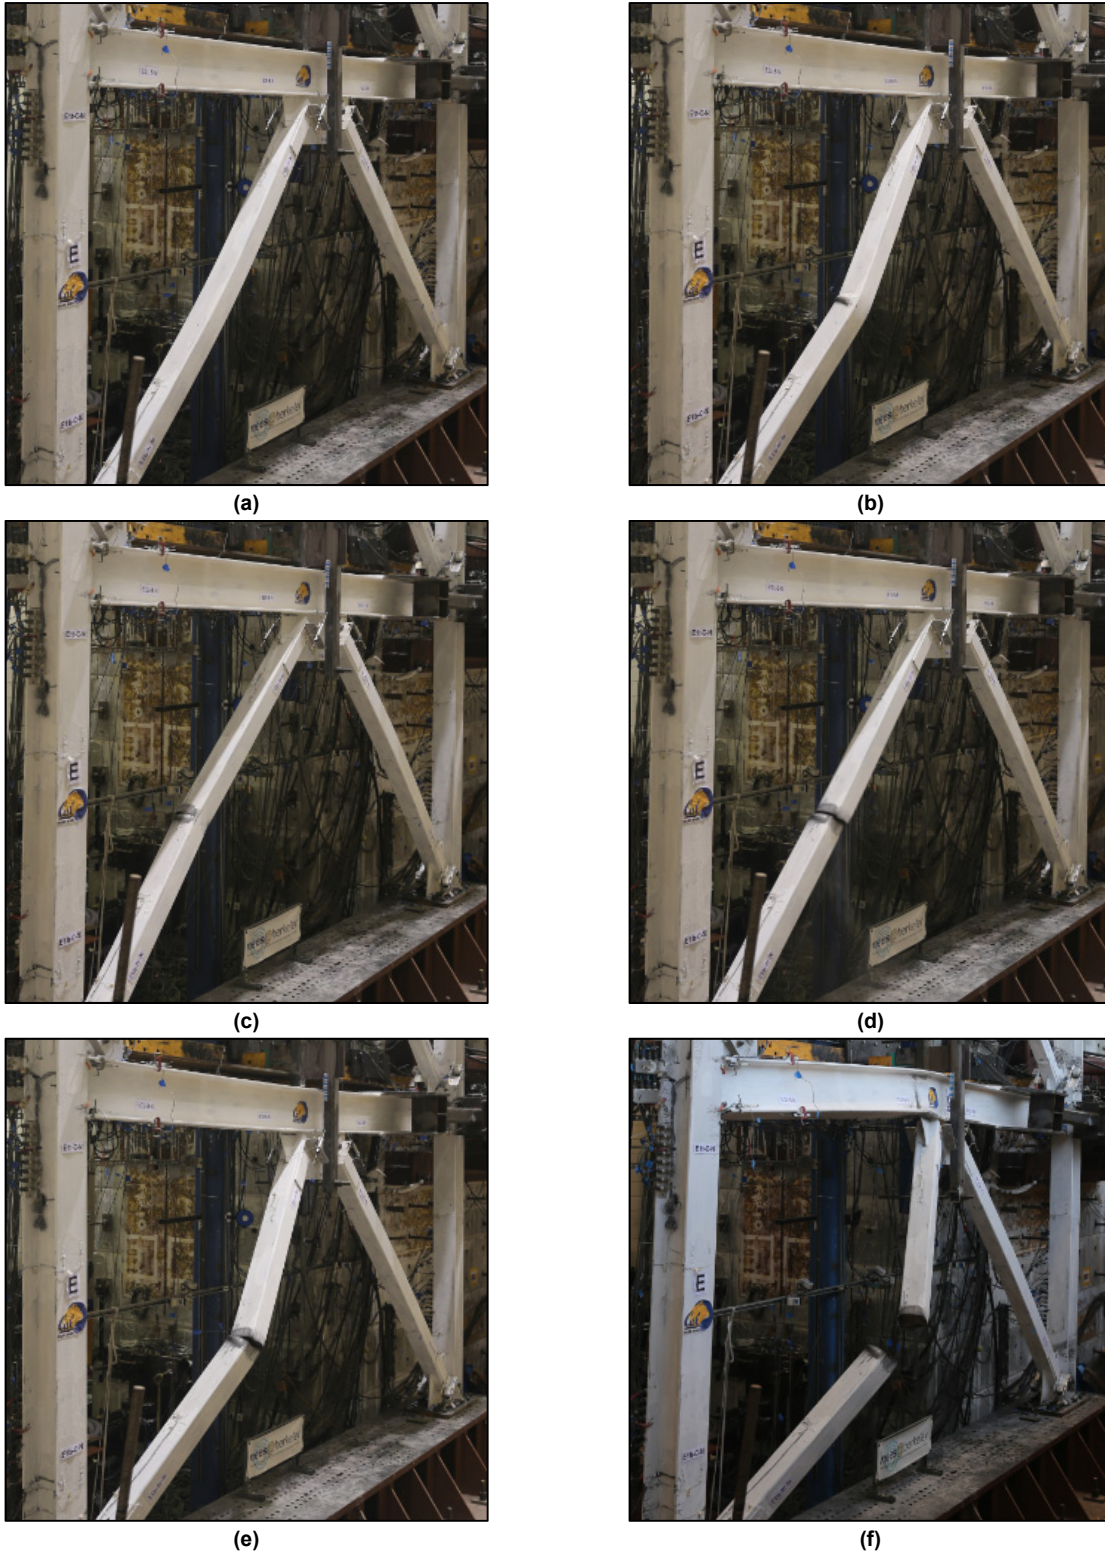
Figure 5.21 Sequence of first-story east-brace behavior: (a) east-brace global buckling; (b) east-brace local buckling; (c) east-brace crack initiation; (d) east-brace fracture; (e) meeting of east brace in compression (positive roof drift); and (f) separation of east brace in tension (negative roof drift).

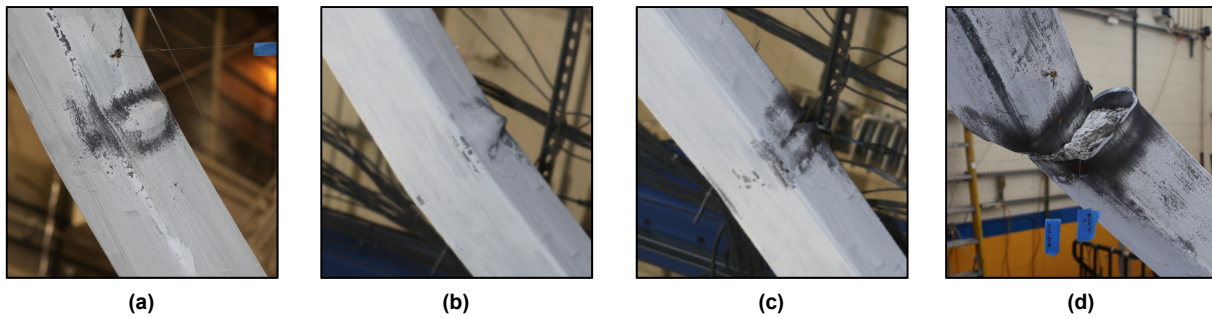
Figure 5.32 First-story east-brace behavior: (a) and (b) outward local buckling; (c) crack propagation; and (d) brace fracture.

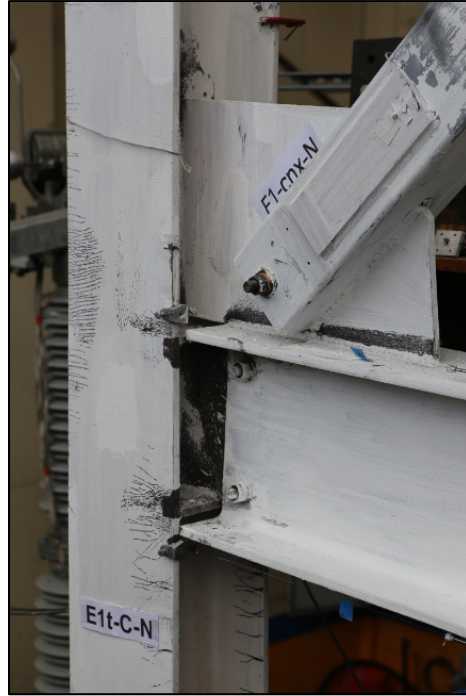
Figure 5.33 Second-story east connection.

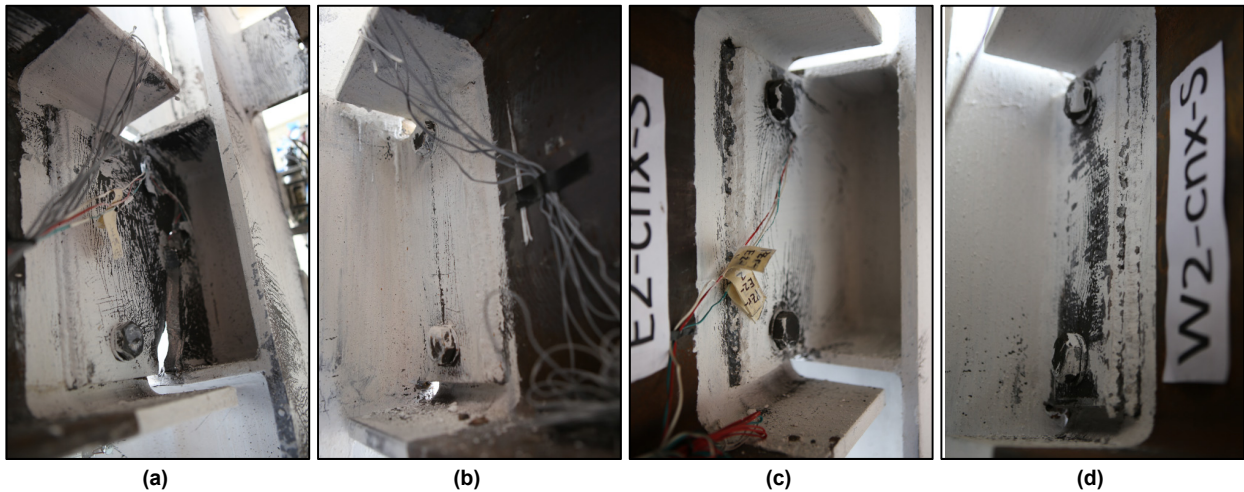
Figure 5.43 Damage to the first-floor shear tabs (south face) at: (a) the east gusset and (b) west gusset; and damage to second-floor shear tabs (south face) at (c) the east gusset and (d) west gusset.

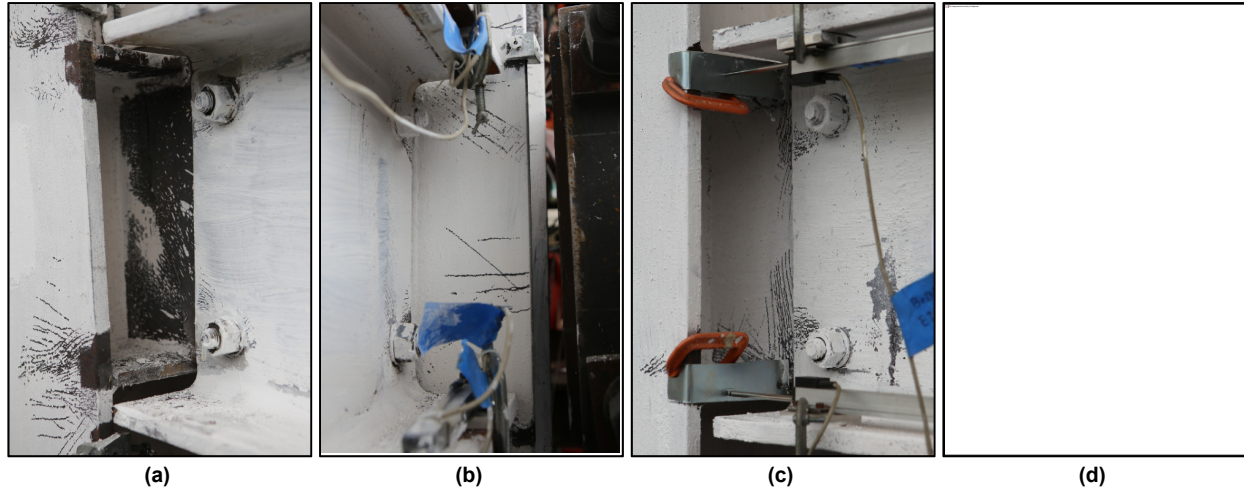
Figure 5.44 Damage to first-floor shear tabs (north face) at (a) the east gusset and (b) west gusset; and damage to second-floor shear tabs (north face) at (c) east gusset and (d) west gusset.

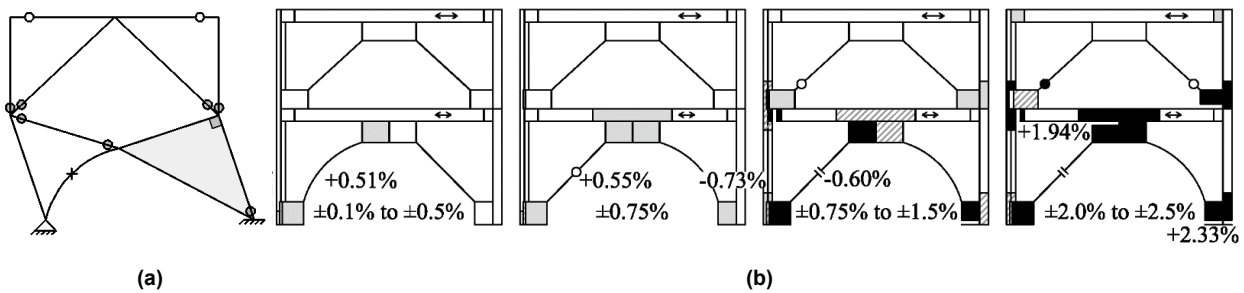
Figure 5.45 NCBF-B-2: (a) schematic of collapse mechanism and (b) hierarchy of damage.

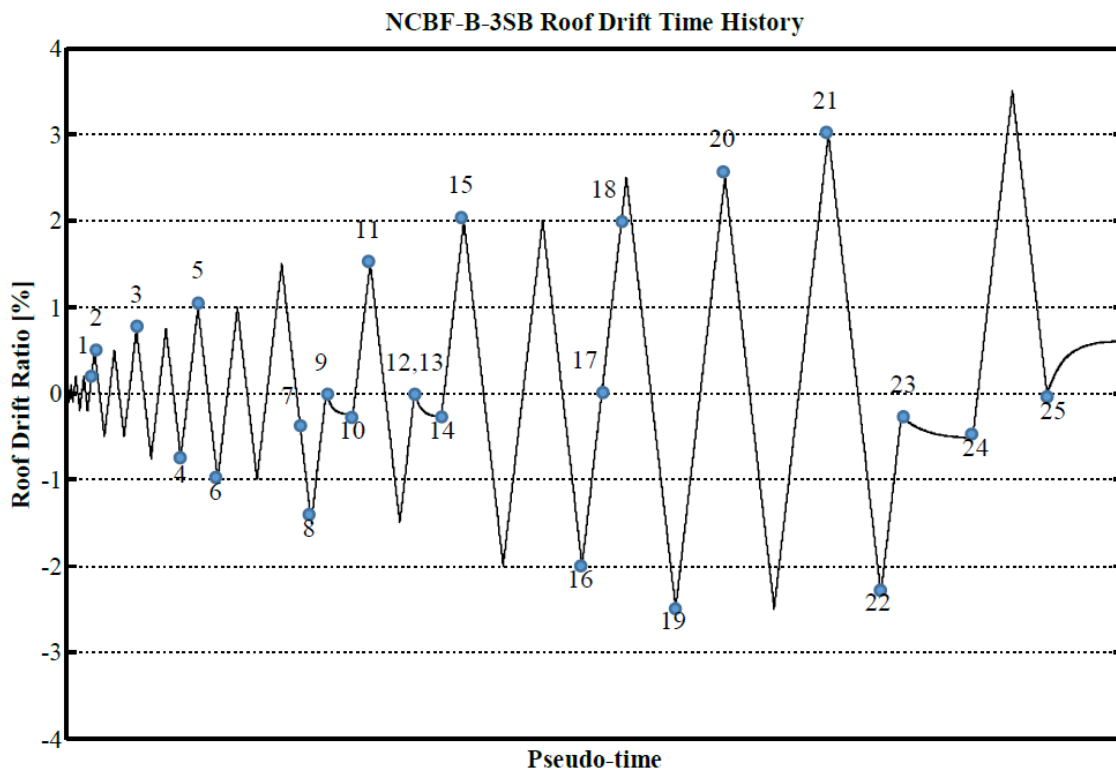
Figure 5.46 NCBF-B-3SB applied roof drift ratio during test.

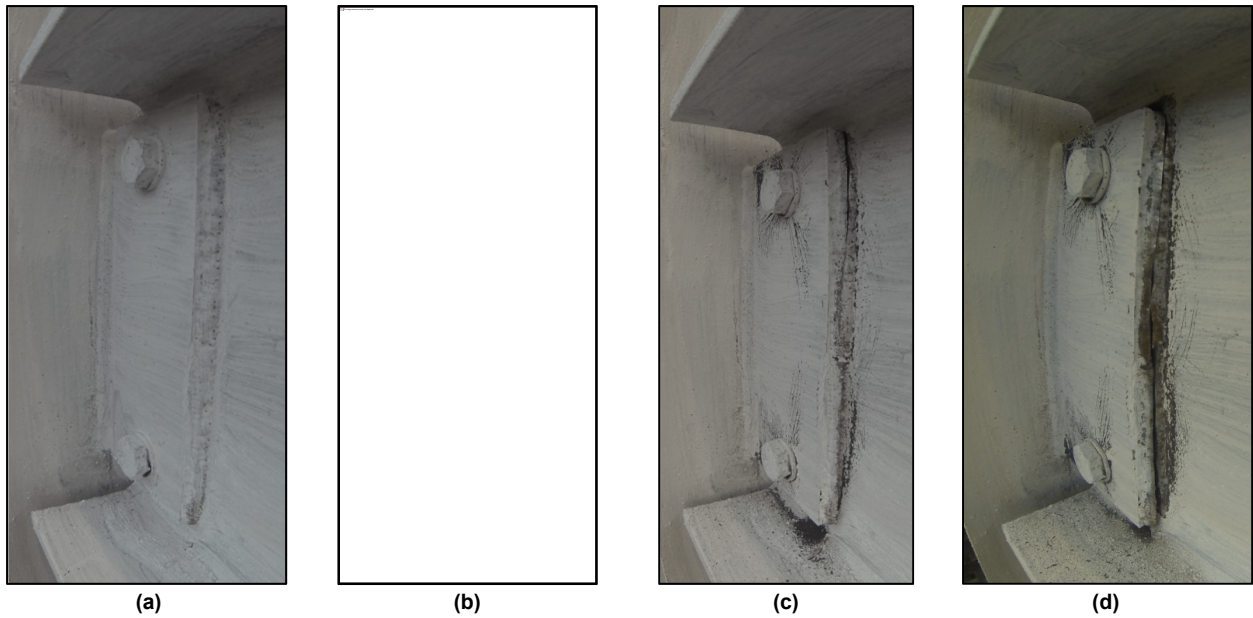
Figure 5.47 Damage sequence of first-floor east shear tab (welded): (a) initial state (0% drift ratio); (b) initial crack formation at bottom of weld (+1.5% drift ratio, first cycle); (c) crack propagation (+1.5% drift ratio, first cycle); and (d) full fracture of weld (-1.5% drift ratio, first cycle).

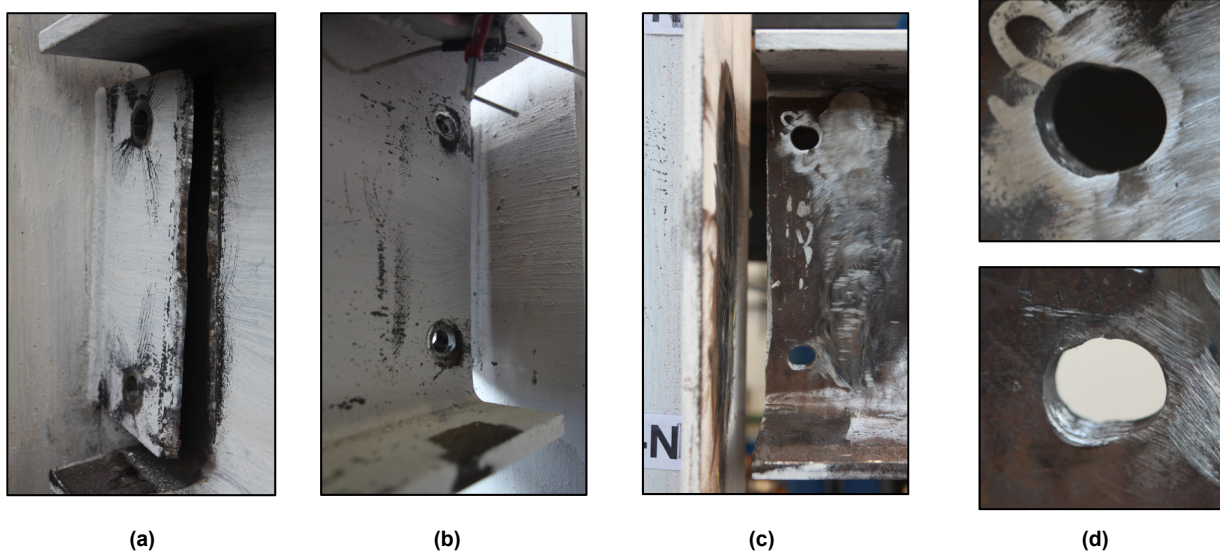
Figure 5.48 Final damage state of first-floor east shear tab (welded): (a) from north side; (b) from south side; (c) beam after removal of shear tab plate; and (d) erection bolt hole elongation.

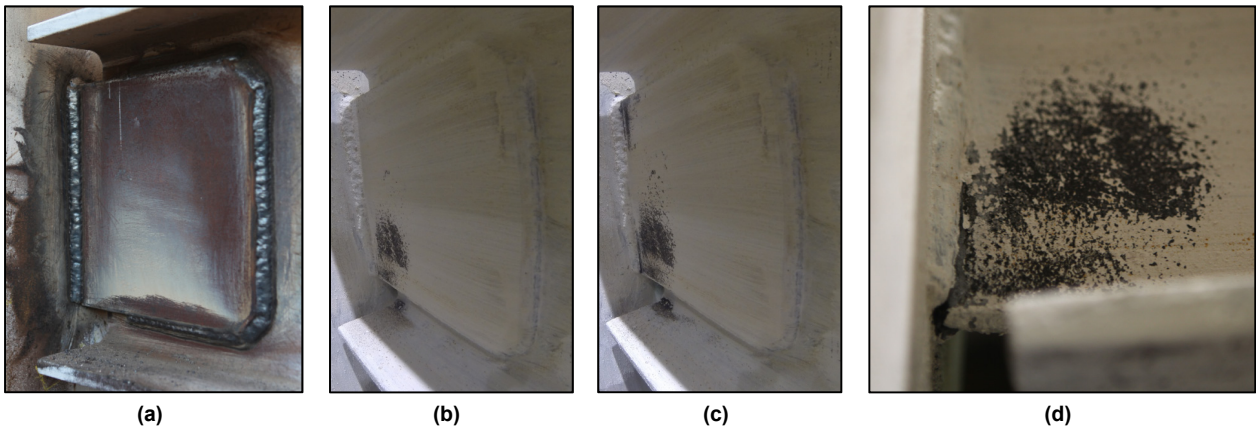
Figure 5.50 Damage sequence of first-floor east shear tab (welded repair): (a) after initial weld repair (part of 2014-10-25 repair); (b) gross section yielding of shear tab plate (+1.5% drift ratio, second cycle); (c) crack formation at top and bottom of shear tab near column weld line (-1.5% drift ratio, second cycle); and (d) close up of defective weld.

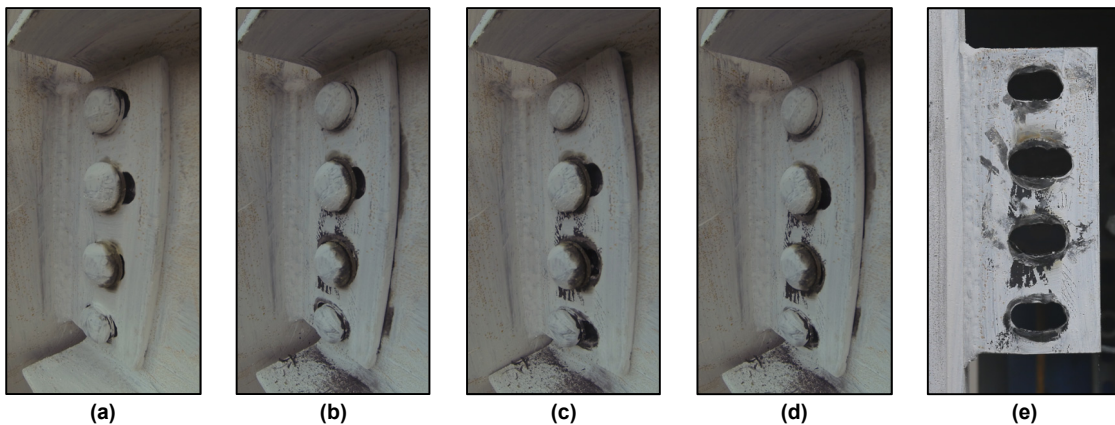
Figure 5.51 Damage sequence of first-floor east shear tab (with slotted holes): (a) initial state; (b) and (c) beam rotating through slotted holes (+3% and -3% drift ratio, respectively, first cycle); (d) final damage state; and (e) holes after demolition.

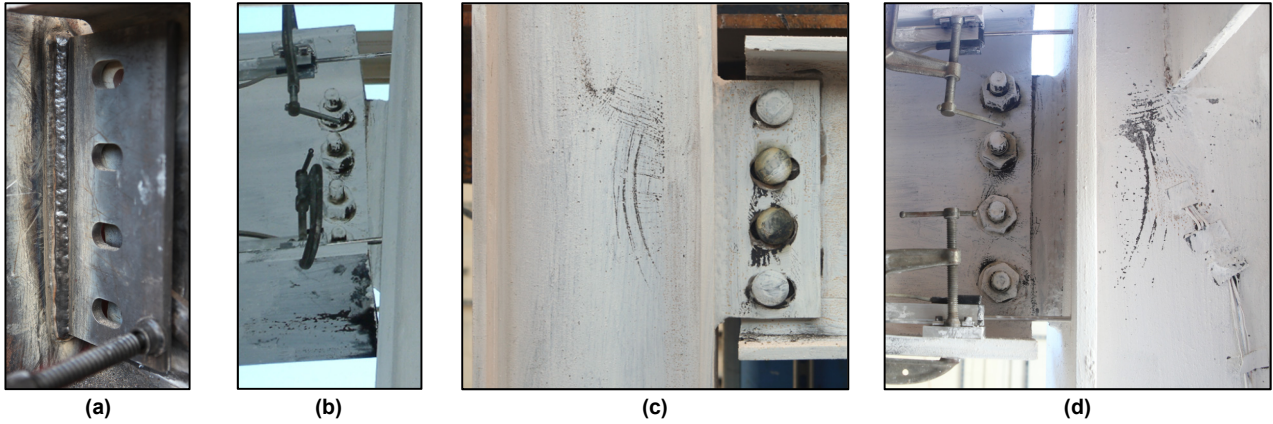
Figure 5.52 First-floor east shear tab (with slotted holes): (a) slotted plate repair (part of 2014-10-26 repair); original beam top and bottom holes in Figure 5.50; new middle standard size holes drilled in beam during repair; (b) rotation of beam through slotted holes (+3.5% drift ratio); and final damage state of slotted shear tab of (c) north face and (d) south face.

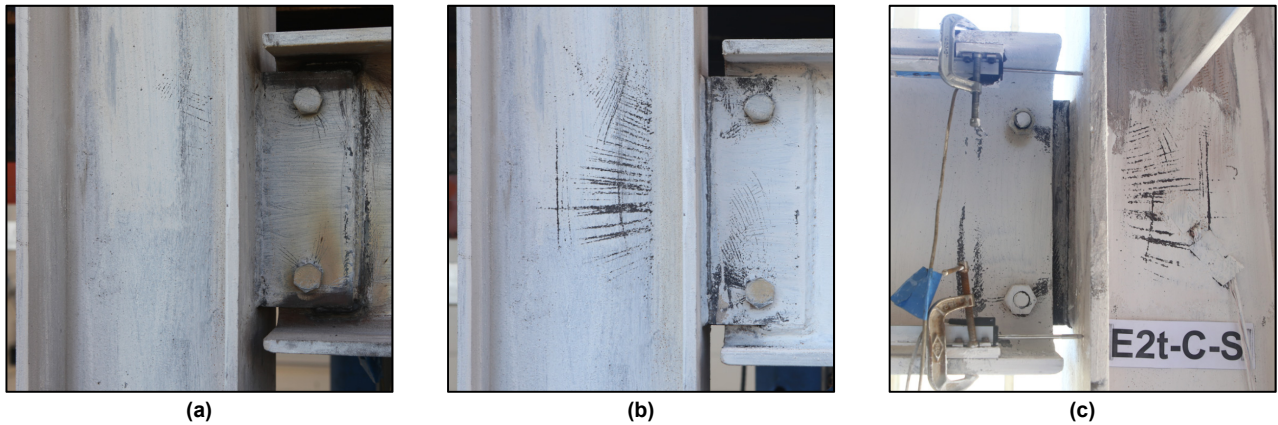
Figure 5.53 Second-floor east shear tab (welded): (a) additional welds added top and bottom of plate at plate-to-beam interface (part of 2014-10-25 repair); and final damage state of (b) north face and (c) south face.

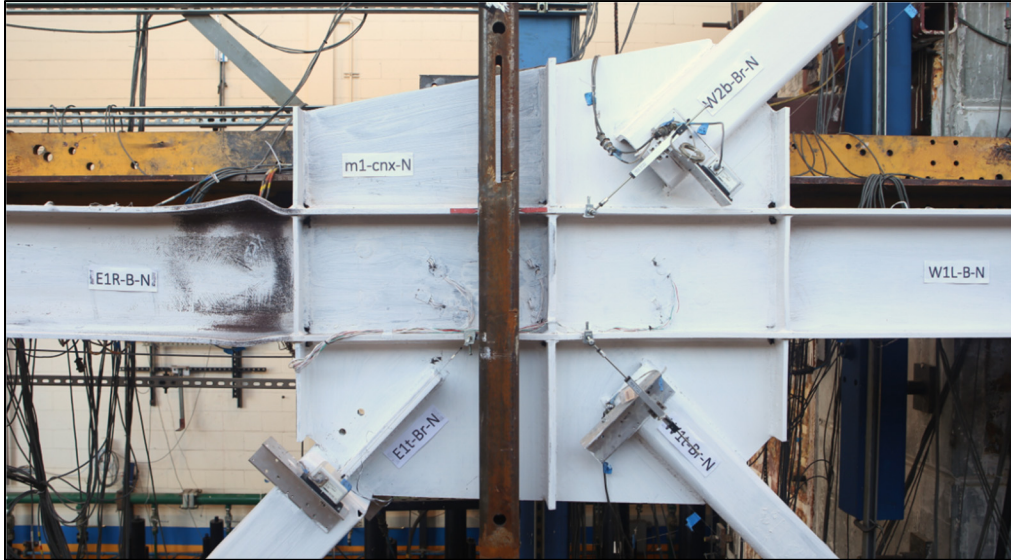
Figure 5.56 Final damage state of center connection and plastic hinging at first-floor east beam.

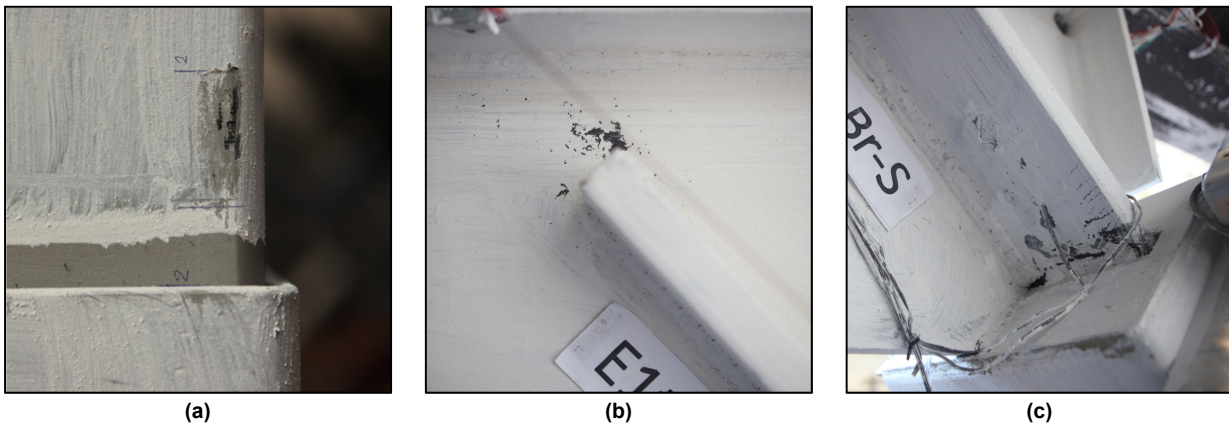
Figure 5.63 (a) Extension of BRB at 2% drift ratio; and (b) and (c) whitewash flaking at upper BRB gusset connection.

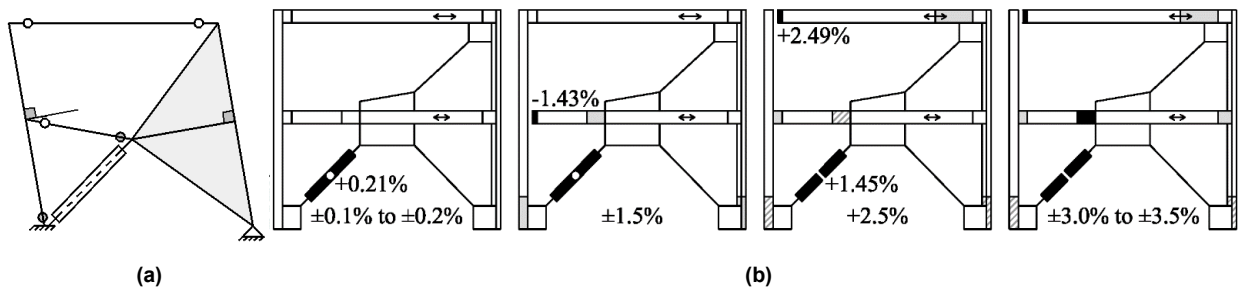
Figure 5.66 NCBF-B-3SB: (a) schematic of collapse mechanism and (b) hierarchy of damage.

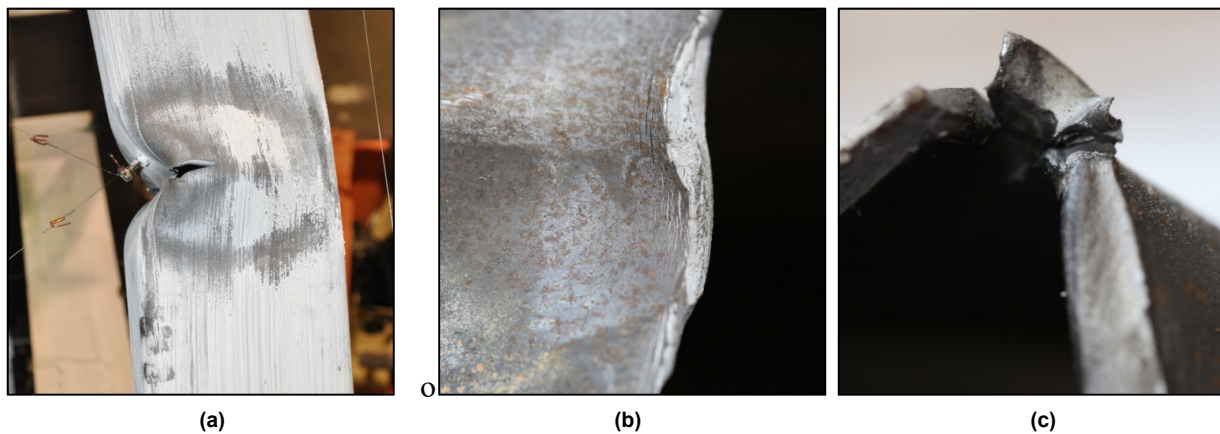
Figure 6.6 Second-story east brace: (a) crack propagation; (b) second-story west brace low-cycle fatigue striations; and (c) corner tear, possibly upon load reversal.

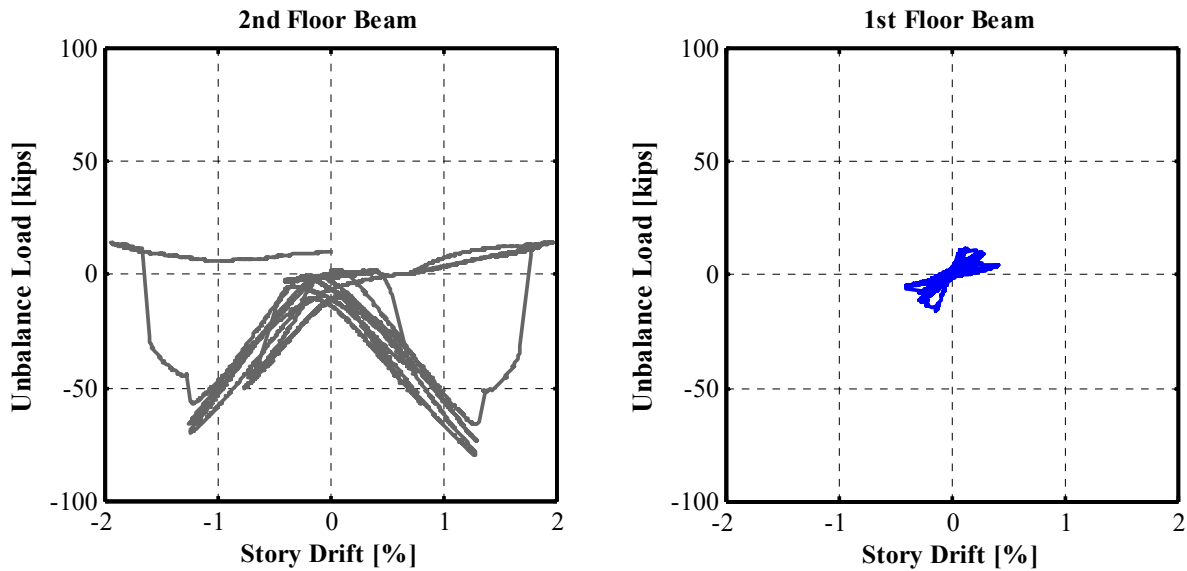
Figure 6.11 NCBF-B-1 beam estimated unbalanced load versus story drift.
