PACIFIC EARTHQUAKE ENGINEERING RESEARCH CENTER

Experimental Investigation of the Behavior of Vintage and Retrofit Concentrically Braced Steel Frames under Cyclic Loading

PEER Report No. 2017/12
Pacific Earthquake Engineering Research Center
Headquarters at the University of California, Berkeley

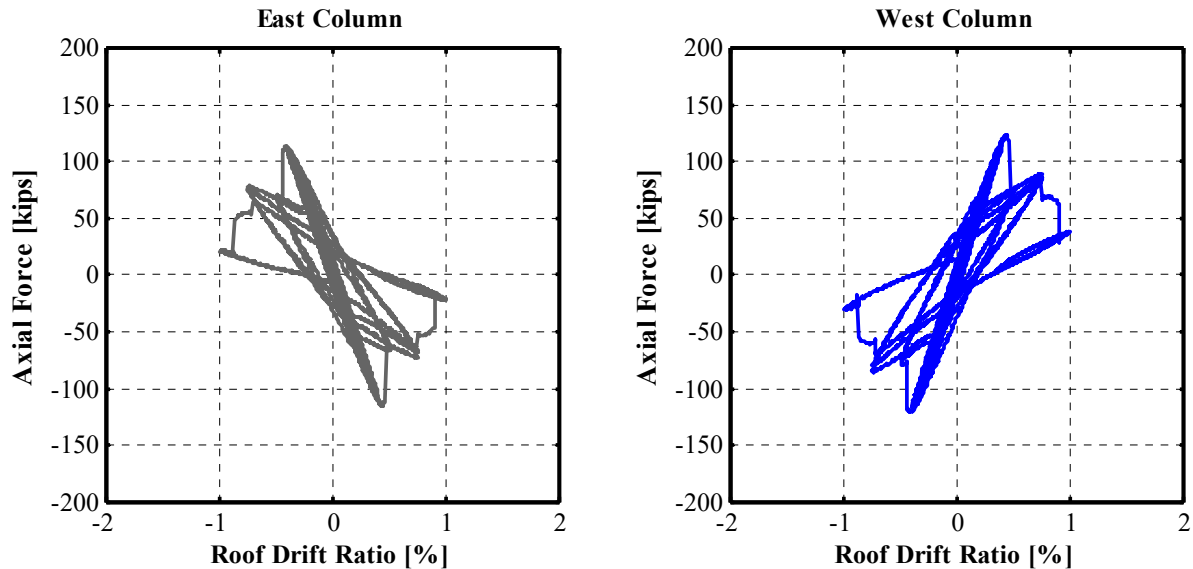
Figure 6.15 NCBF-B-1 column estimated axial force versus roof drift ratio.

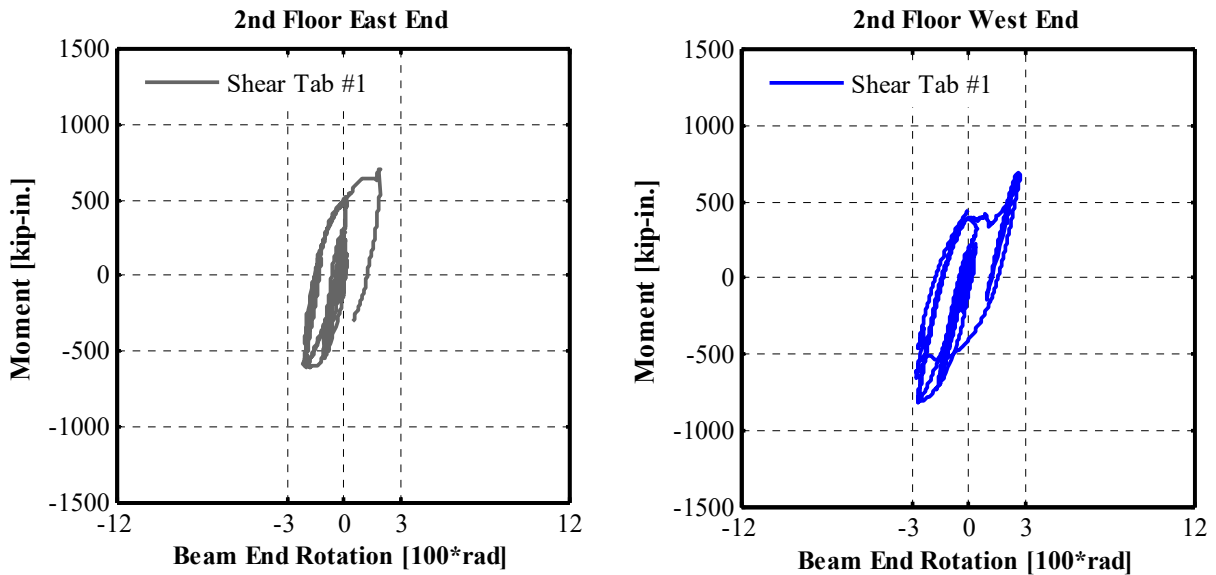
Figure 6.17 NCBF-B-1 second-floor beam estimated end moment versus end rotation.

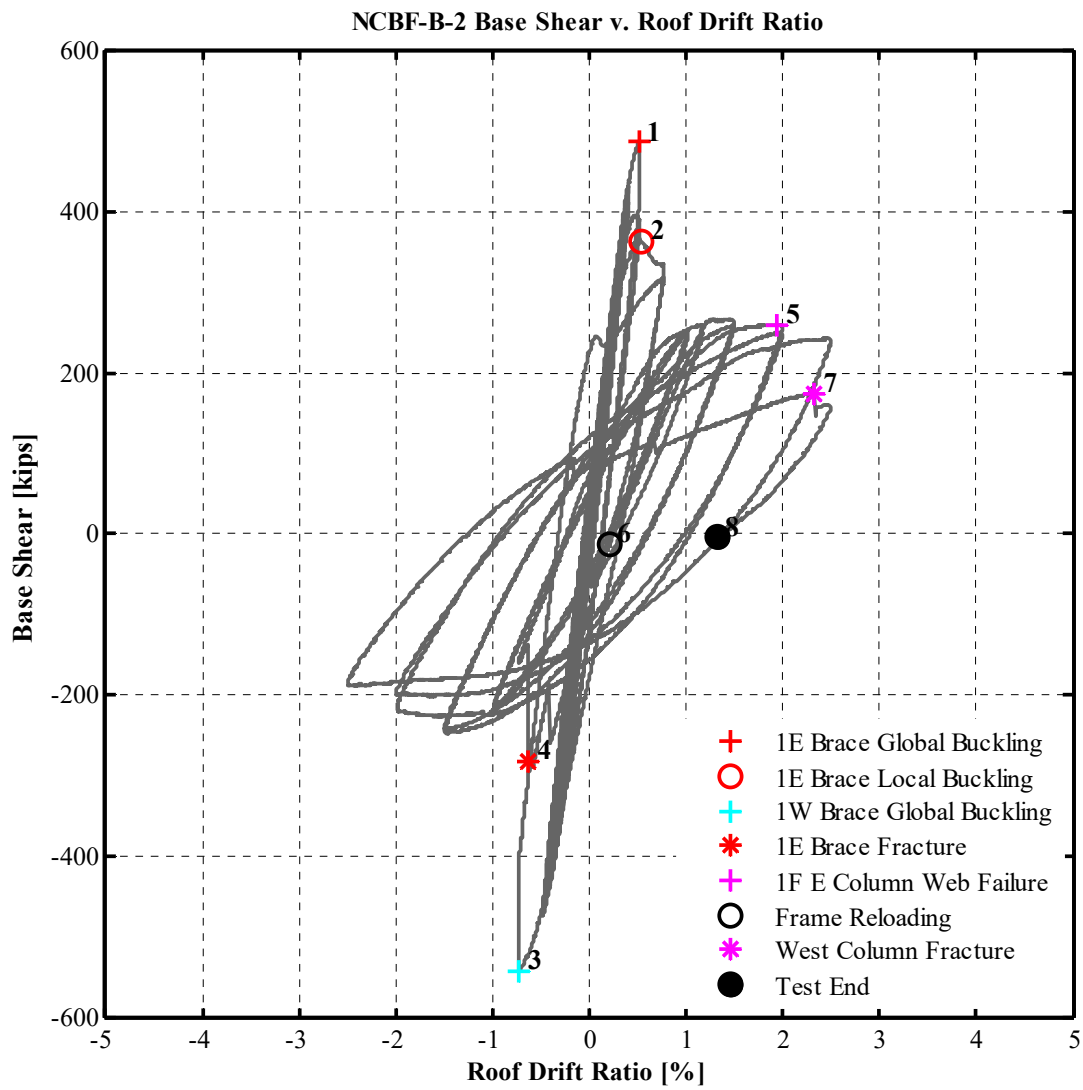
Figure 6.18 NCBF-B-2 base shear versus roof drift ratio.

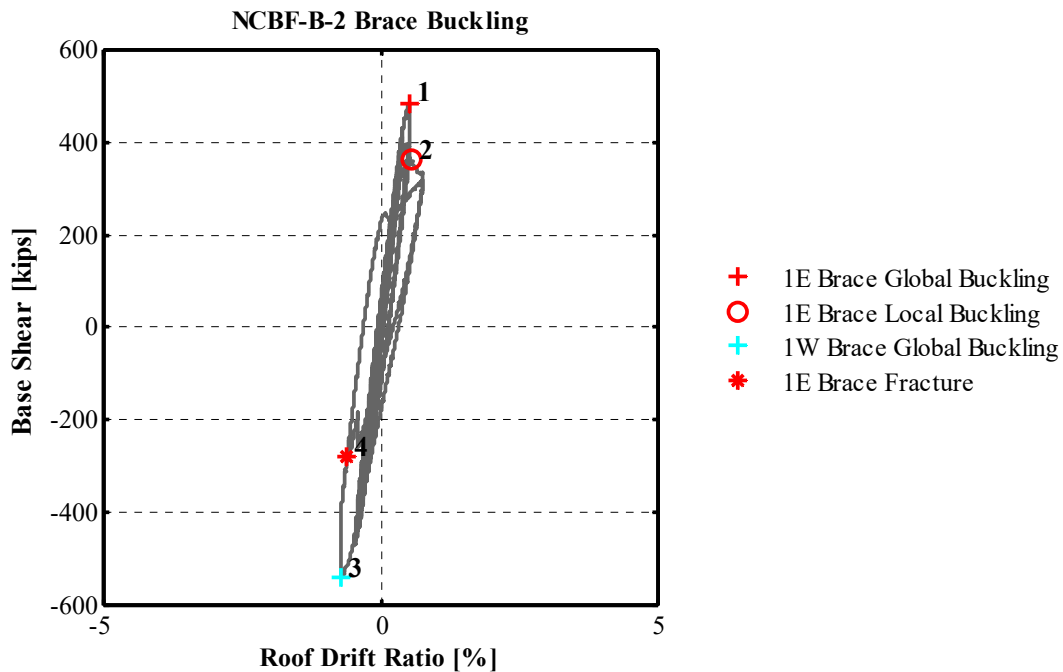
Figure 6.20 NCBF-B-2 base shear versus roof drift ratio up to first-story east brace fracture (at -0.60% on second cycle to -0.75%).

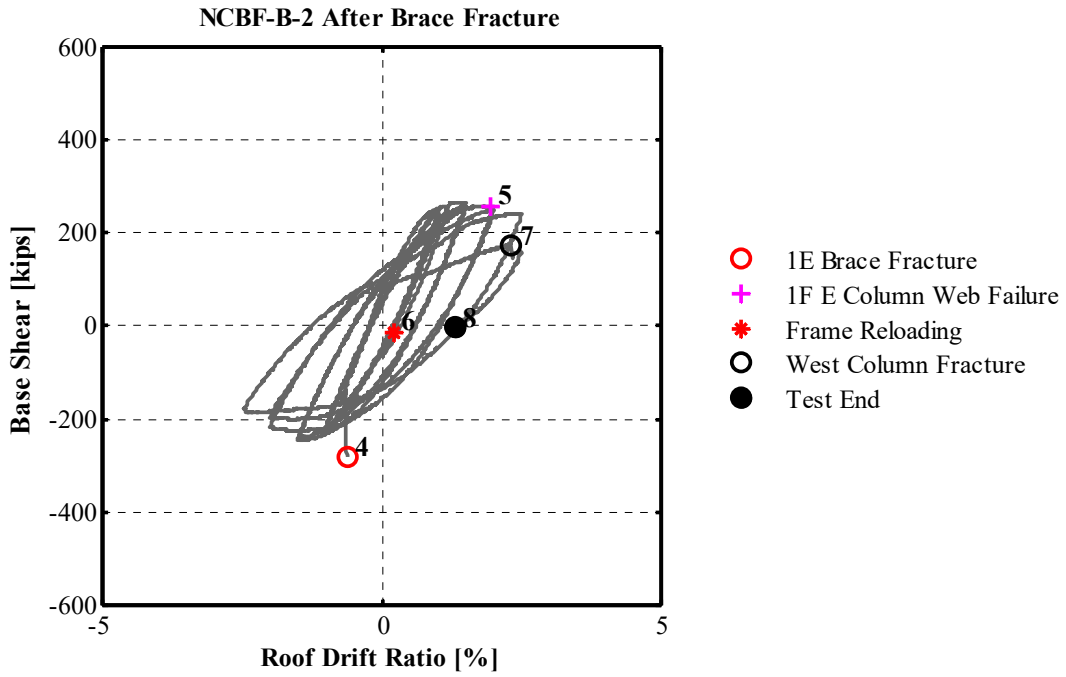
Figure 6.21 NCBF-B-2 base shear versus roof drift ratio after first-story east brace fracture (at -0.60% on second cycle to -0.75%).

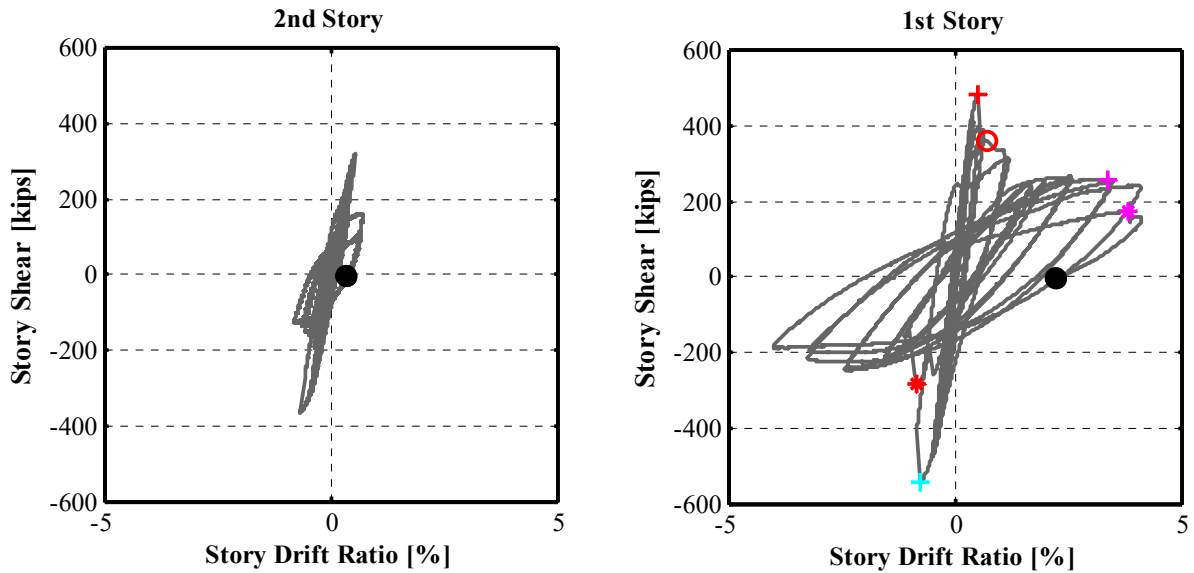
Figure 6.22 NCBF-B-2 story shear versus story drift ratio.

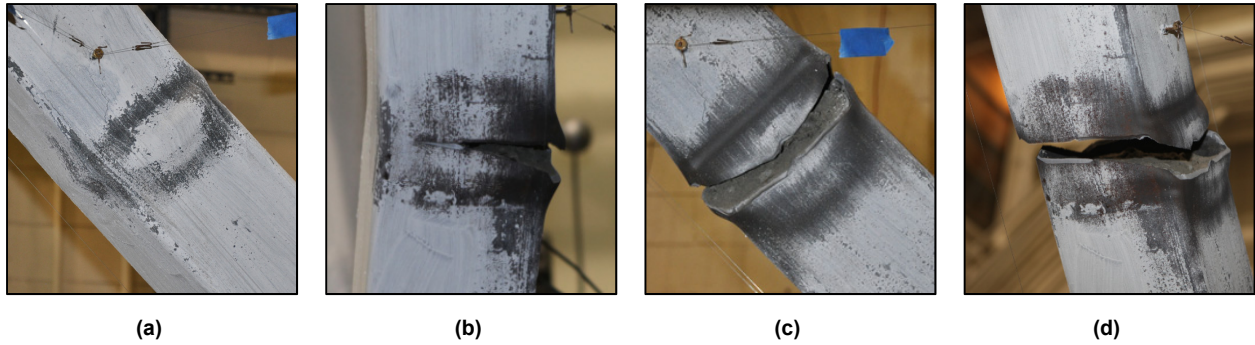
Figure 6.25 Local buckling of first-story east brace: (a) outward local buckling; crack propagation (b) west side and (c) south side; and (d) complete fracture.

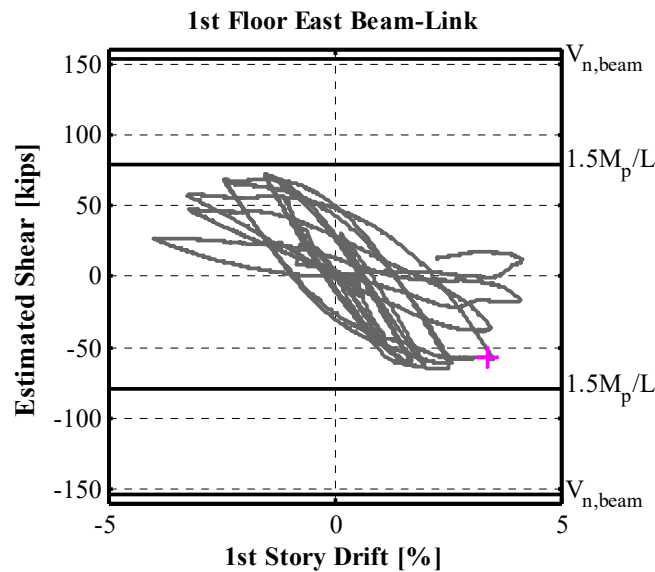
Figure 6.30 NCBF-B-2 first-floor east half-beam estimated shear versus story drift ratio (where L is the distance from the beam end to the edge of the middle connection).

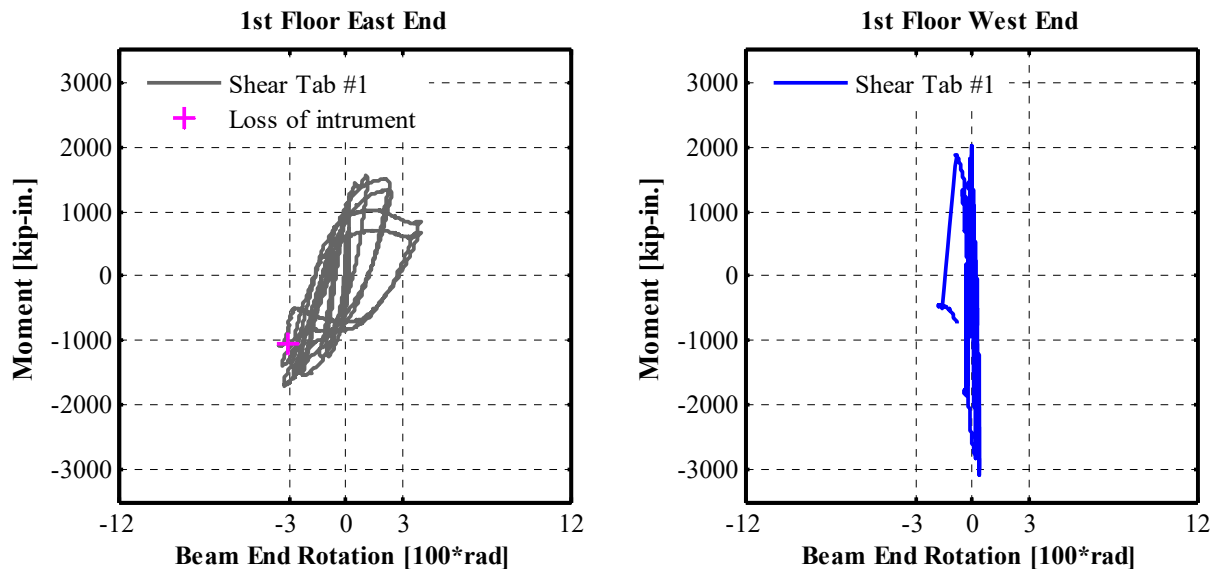
Figure 6.35 NCBF-B-2 first-floor beam estimated end moment versus end rotation.

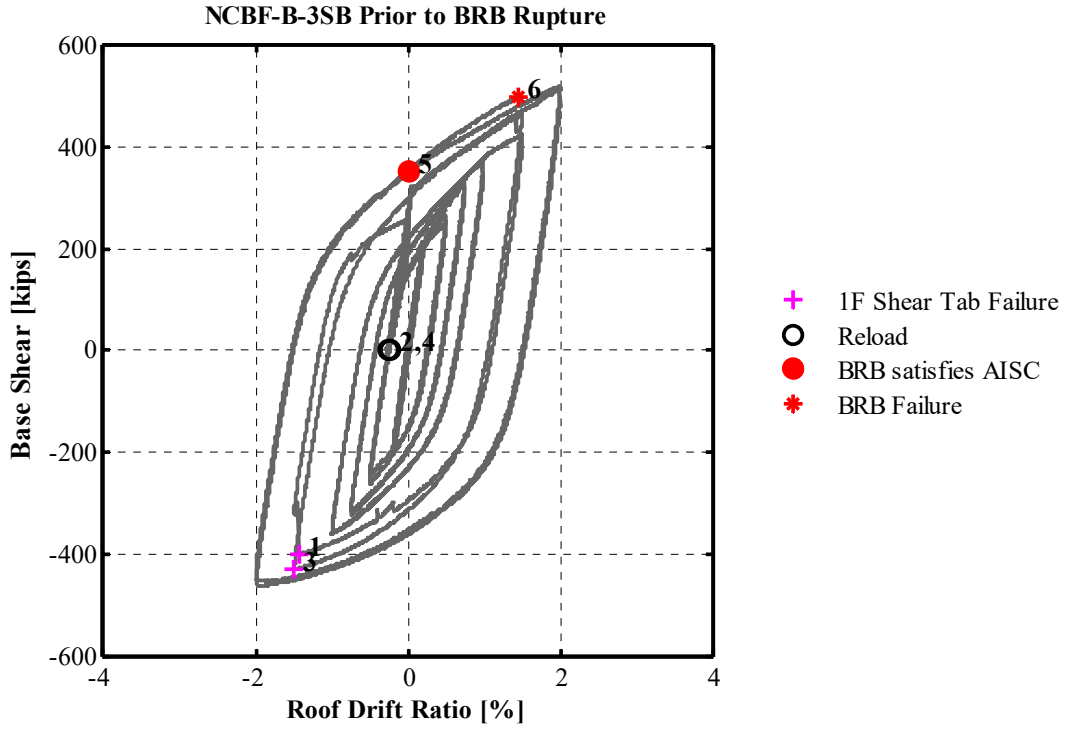
Figure 6.38 NCBF-B-3SB base shear versus roof drift ratio prior to rupture of BRB (@+1.45% on first cycle to +2.5%).

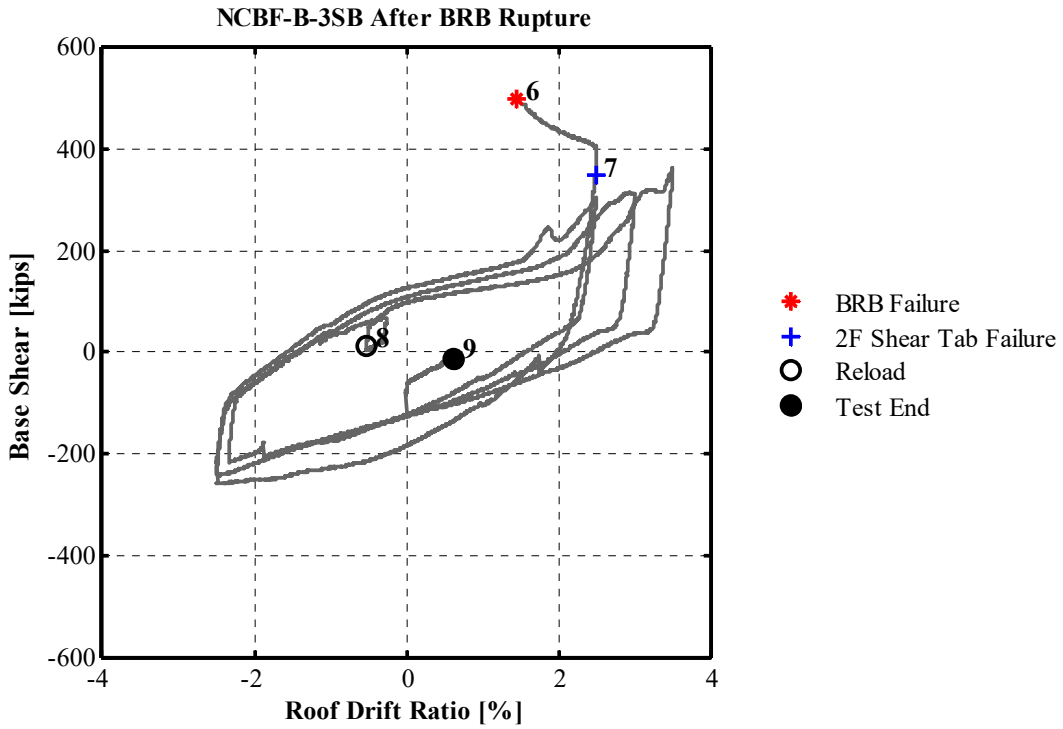
Figure 6.39 NCBF-B-3SB base shear versus roof drift ratio after rupture of BRB (@+1.45% on first cycle to +2.5%).

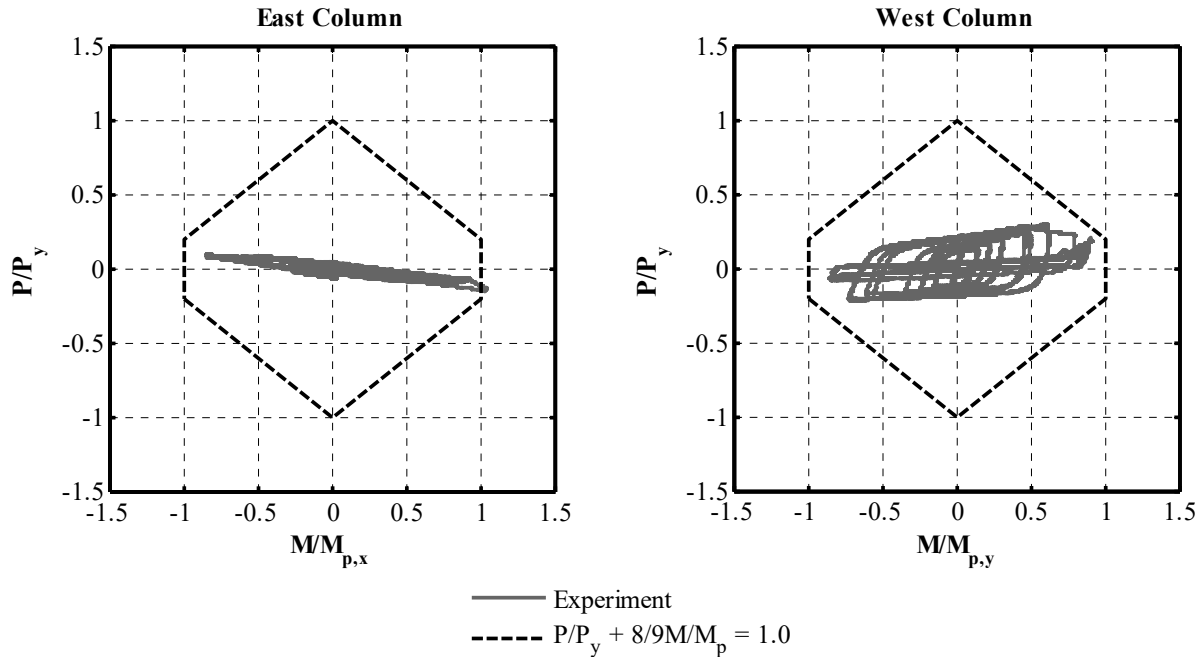
Figure 6.49 NCBF-B-3SB column normalized axial moment interaction (estimated at half the column depth above the second-story gusset plate connection). Here M_p is the plastic moment capacity of the column and P_y is the yield strength of the column equal to AF_y , where A is the cross-sectional area and F_y is the yield strength found from the coupon tests.

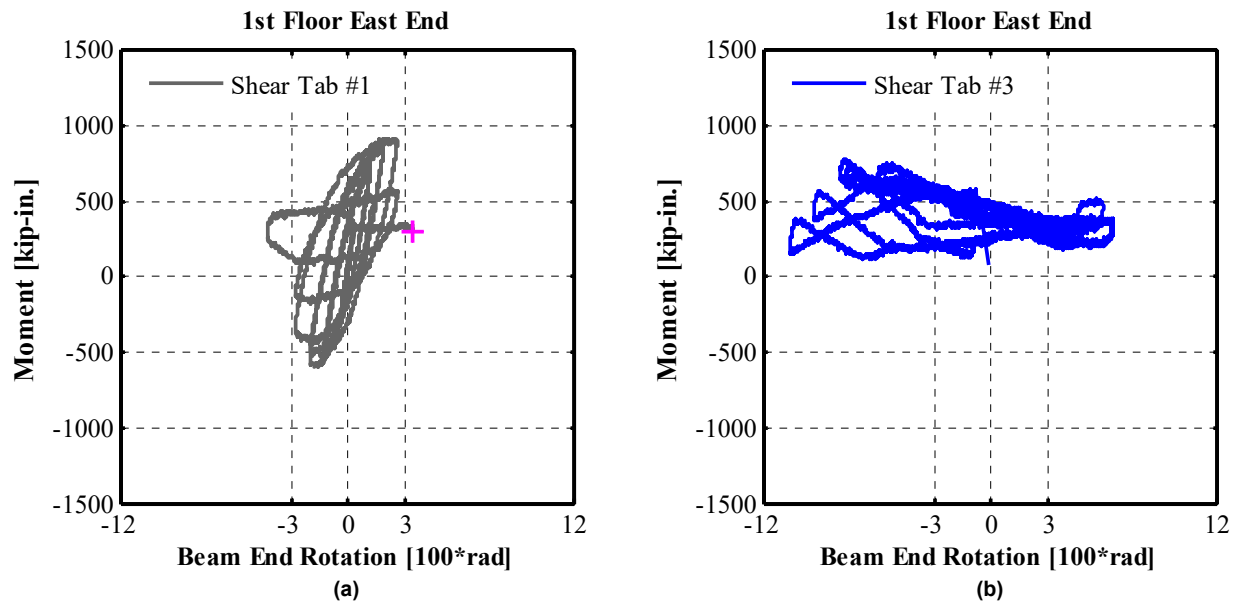
Figure 6.50 NCBF-B-3SB first-floor east beam estimated end moment versus end rotation: (a) welded shear tab and (b) slotted shear tab.

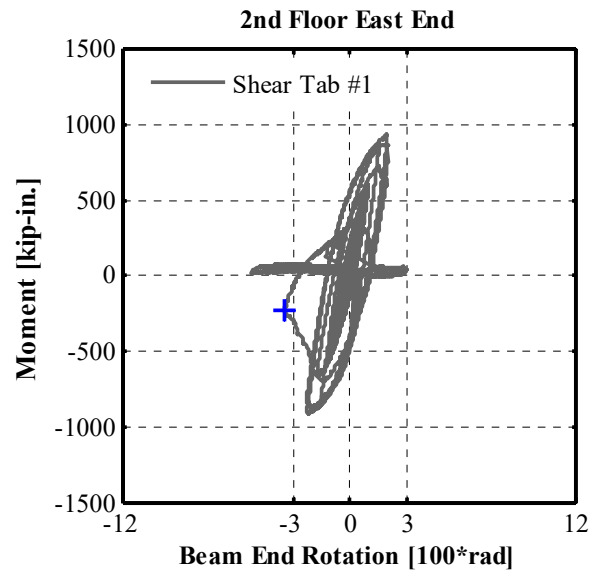
Figure 6.51 NCBF-B-3SB second-floor east welded shear tab estimated moment versus rotation at east end.

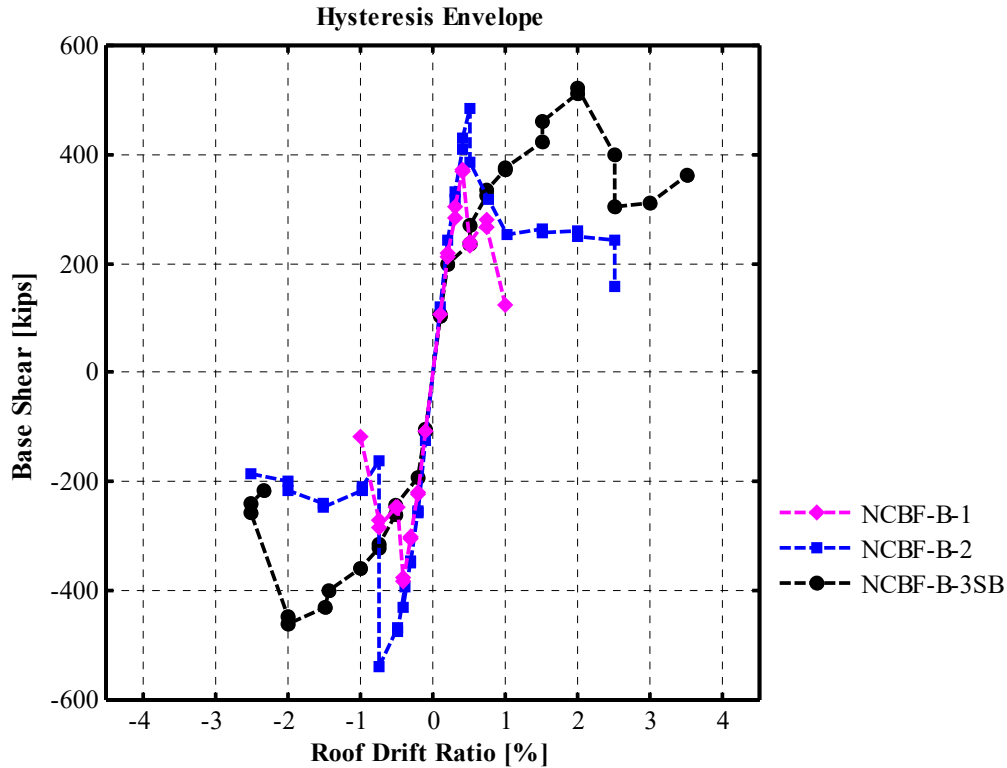
Figure 6.52 Base shear versus roof drift ratio envelopes for all three test specimens.

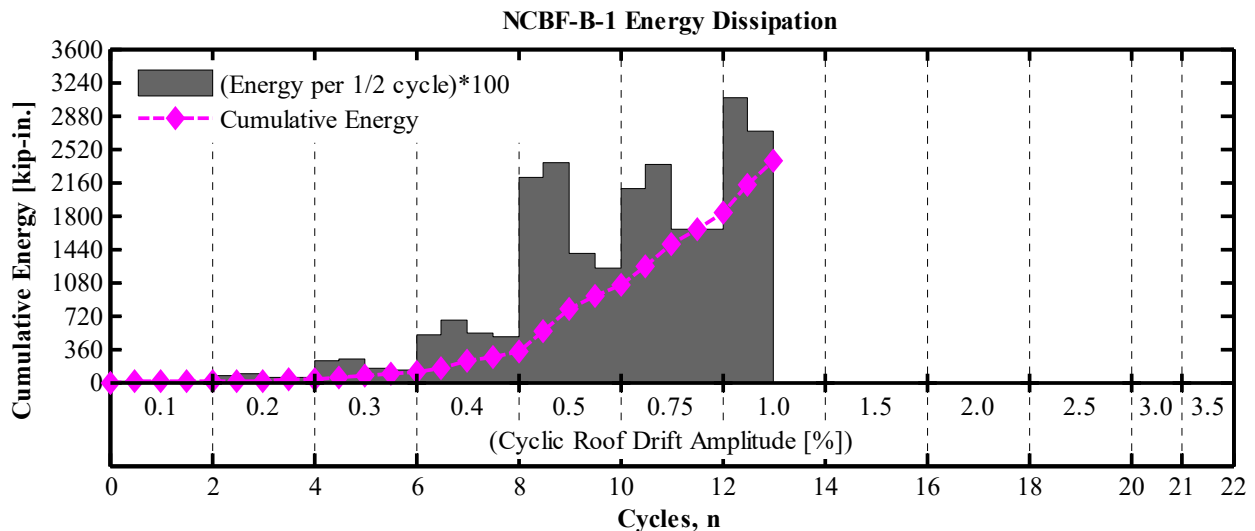
Figure 6.56 Energy dissipation in NCBF-B-1.

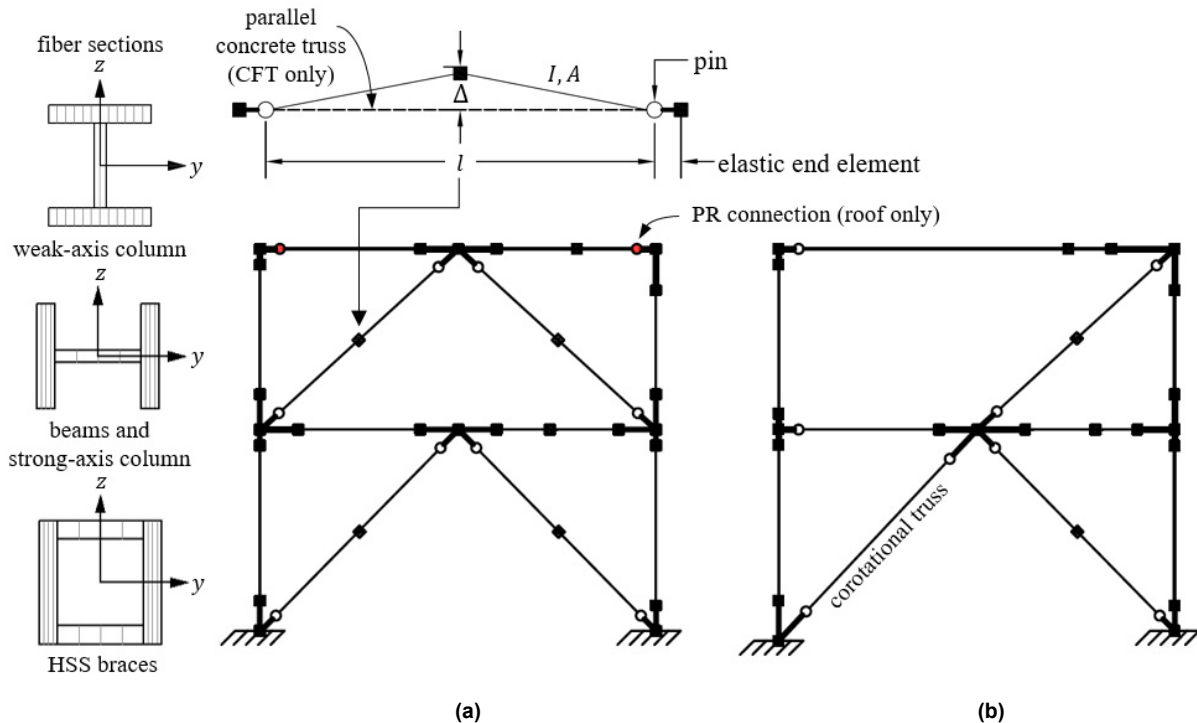
Figure 7.1 Schematic of simulations: (a) NCBF-B-1 & 2 and (b) NCBF-B-3SB.
