# APPROACHES TO MITIGATION OF CRIPPLE WALL FAILURE

## PEER Internship Program – Summer 2013

Undergraduate Intern: Jenny Taing, UC Berkeley  
Intern Mentors: Laurence Kornfield, Special Assistant to the city of San Francisco  
University of California Berkeley

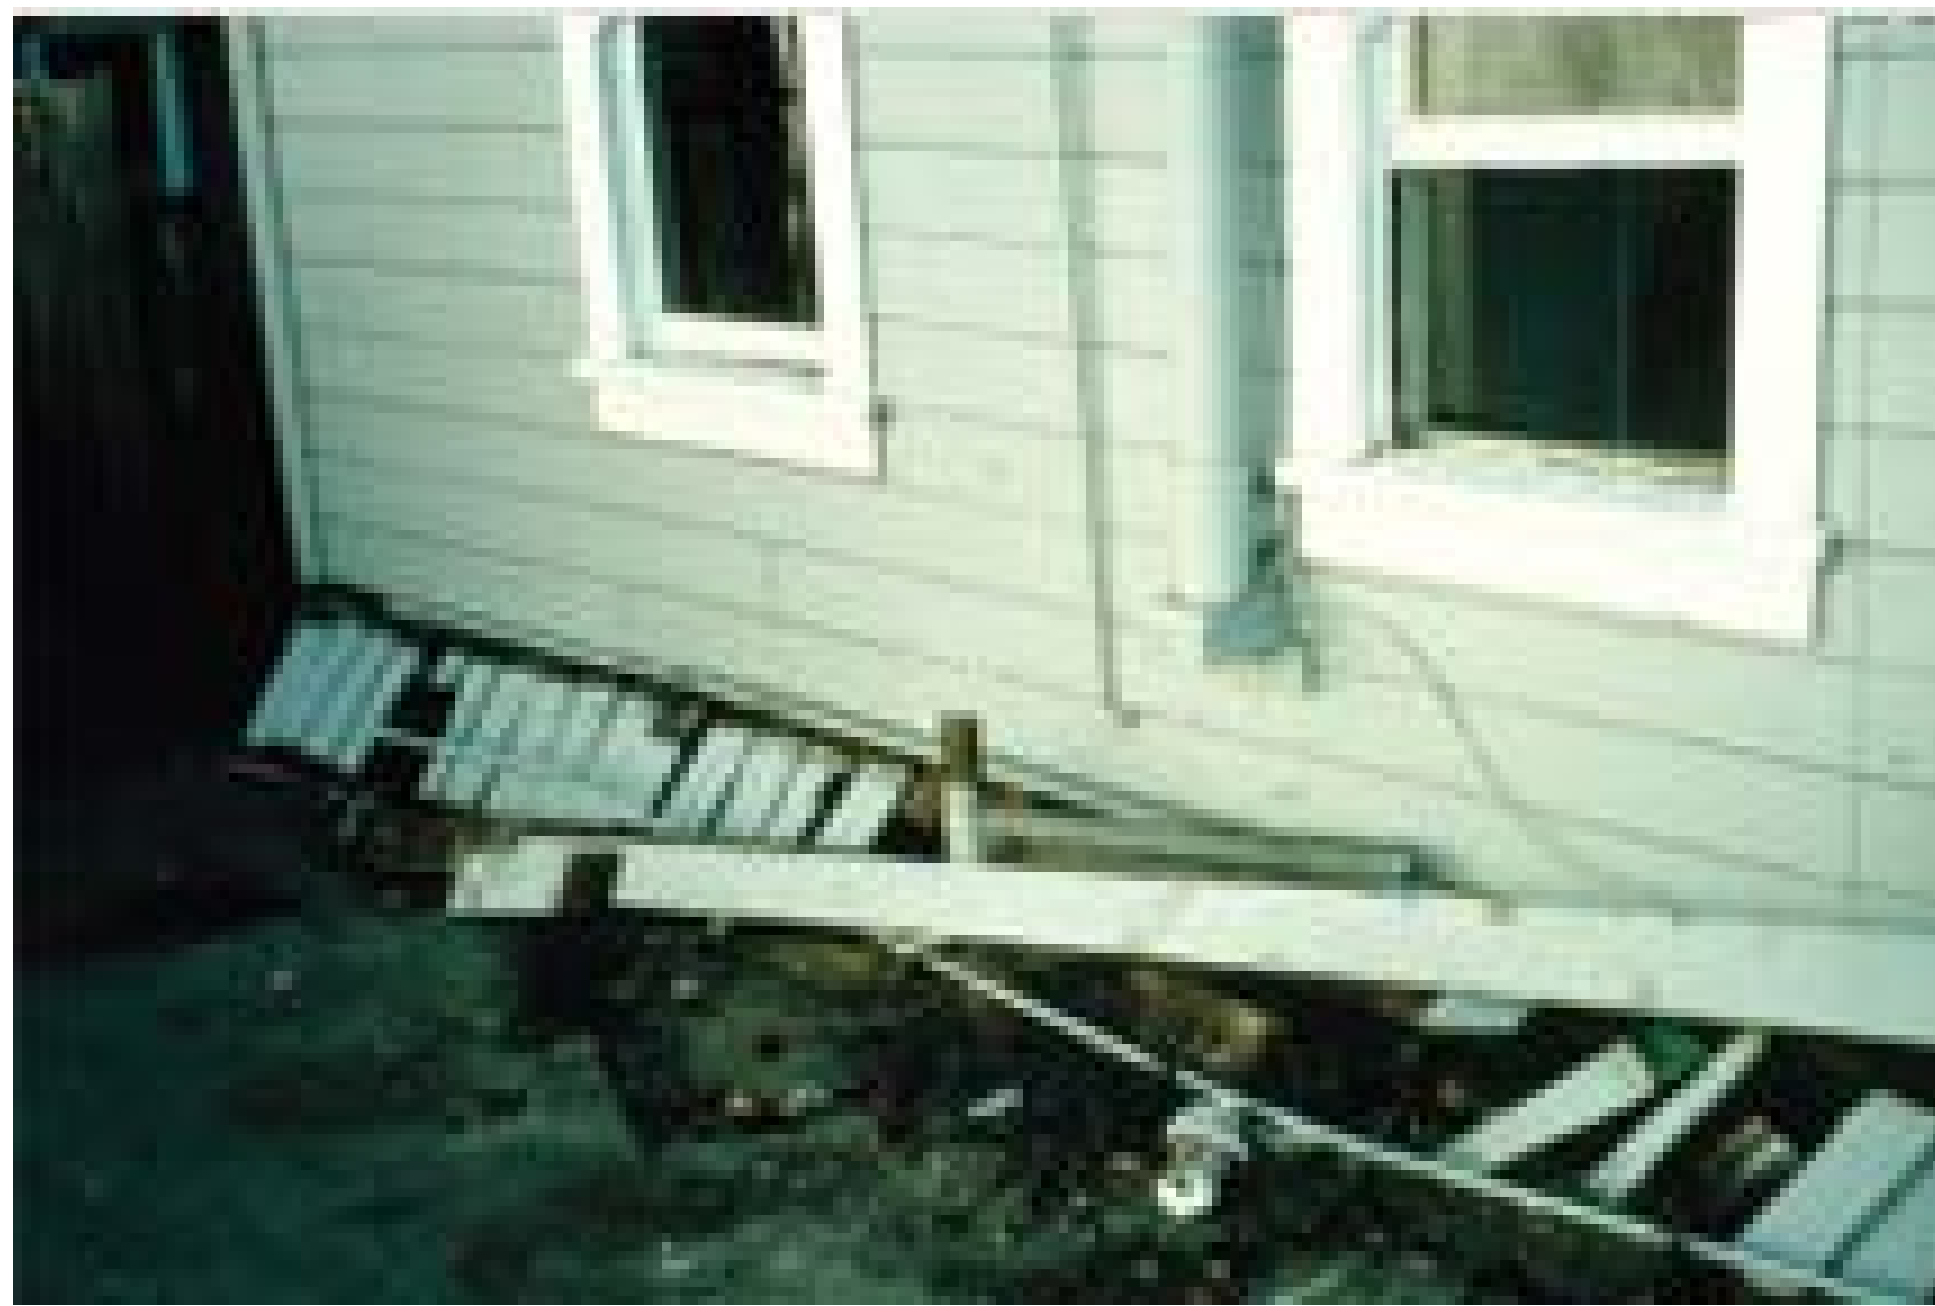
Figure 1. Typical cripple wall failure (SPUR, 2012)

- San Francisco has high earthquake hazard risk. Thus, made efforts to address buildings that are known to fare poorly during earthquakes.
- Weak structures: cripple walls, wood studs that run along the perimeter of a house's crawl space. Failures typically not life threatening but render a house uninhabitable (see figure 1).
- Plan Set A provides standard solutions for retrofit. Criteria to meet Plan Set A: cripple wall must be under 4 feet on at least 40% per side for a single story home
- This project explores approaches to mitigate cripple wall failures in San Francisco.

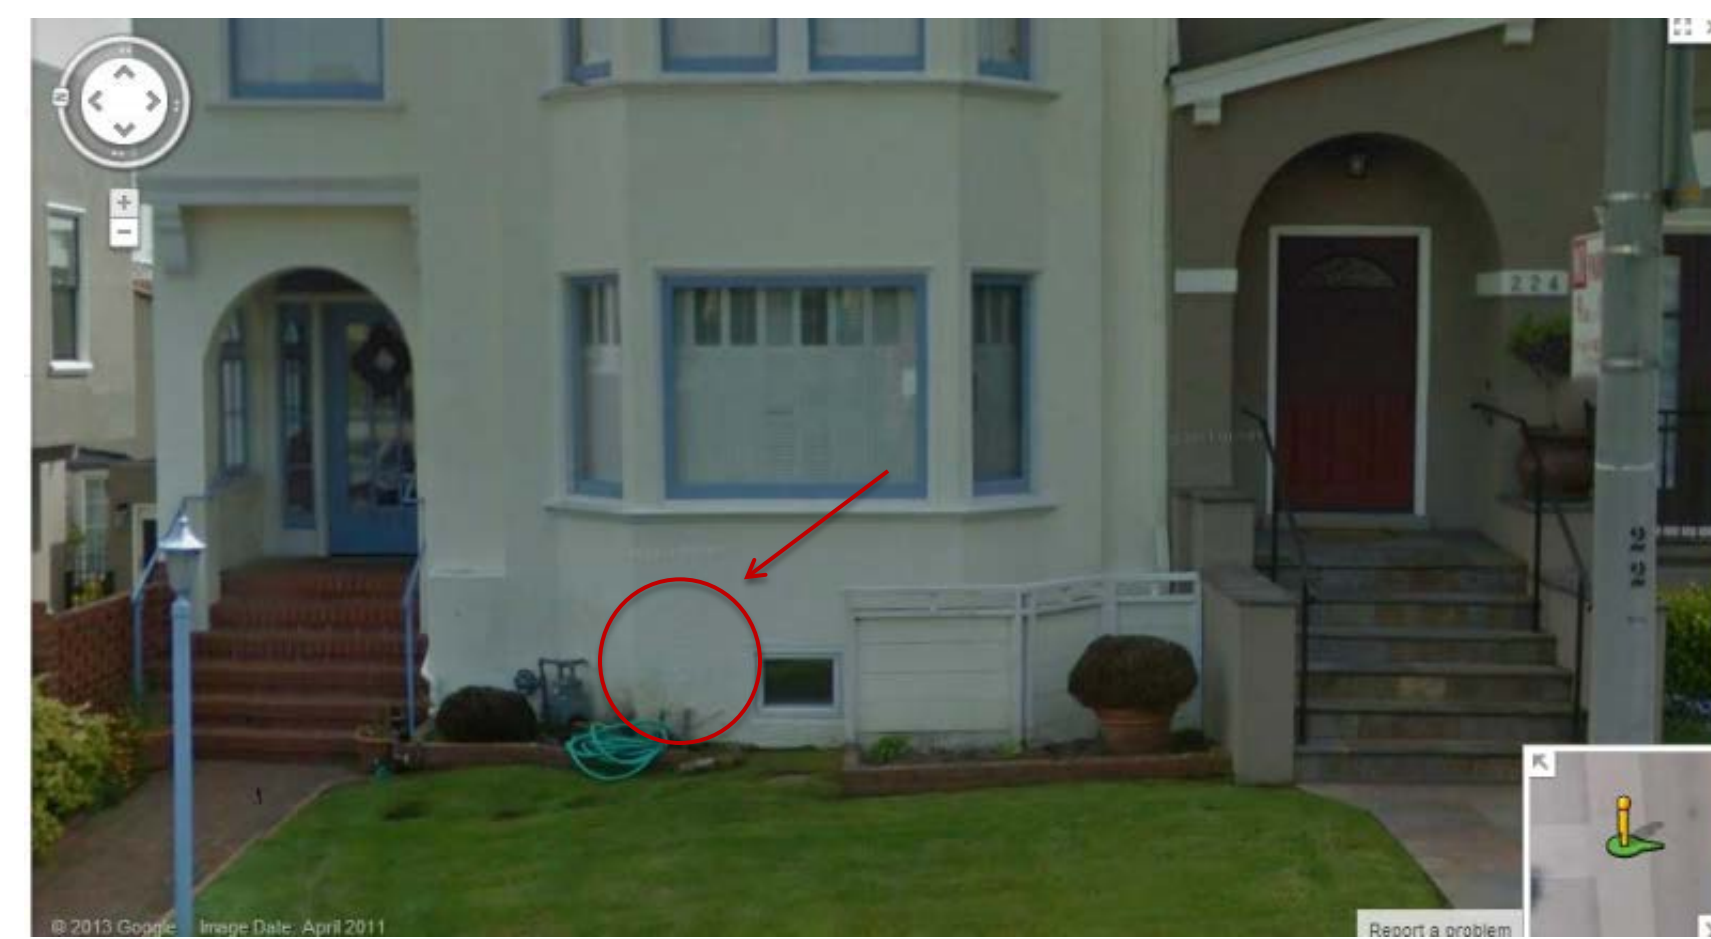
Figure 3. Front view of a home with cripple wall. Hints include vent and the number of steps (Google)

- By extrapolating from Google Earth (See Figure 3) and a slope map of San Francisco, the following estimate of cripple wall concentration in San Francisco was made:
