Structural Engineering Reconnaissance of the August 17, 1999, Kocaeli (Izmit), Turkey, Earthquake

Structural Engineering Reconnaissance of the August 17, 1999 Earthquake: Kocaeli (Izmit), Turkey

PEER Report 2000/09
Pacific Earthquake Engineering Research Center
College of Engineering
University of California, Berkeley
December 2000

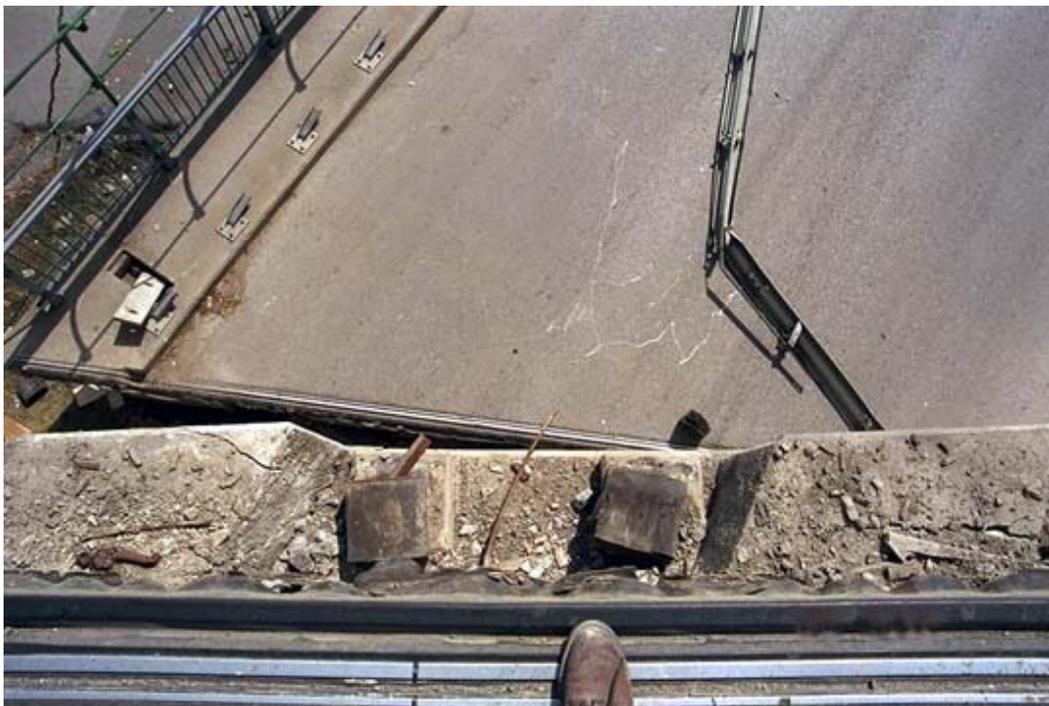
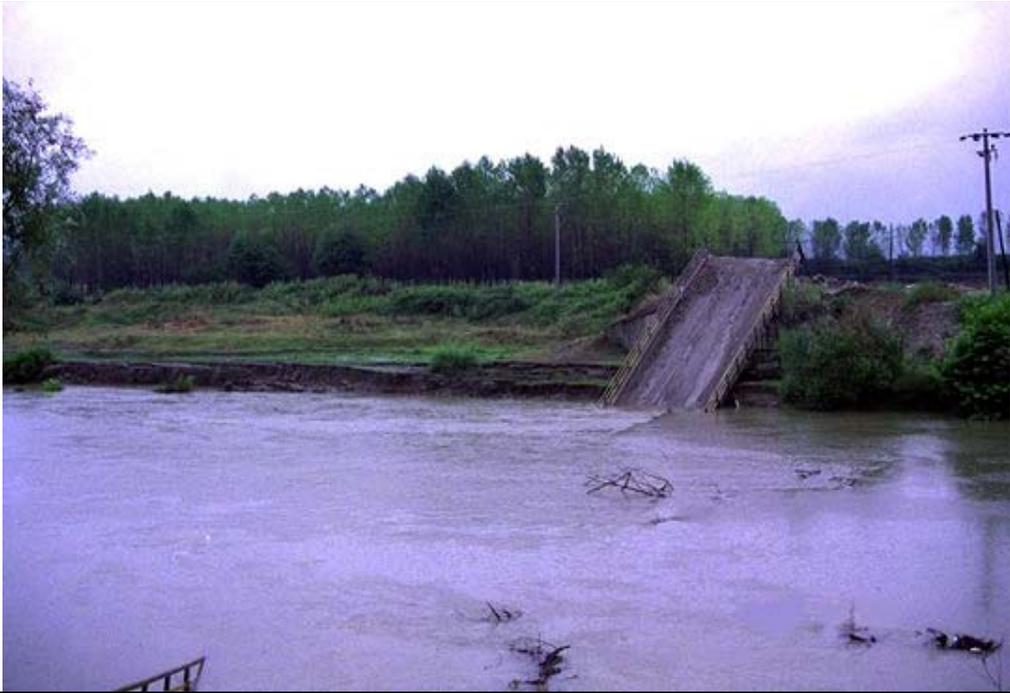
The reconnaissance team documented the collapse of two bridges. Each collapse was a result of fault rupture beneath the piers. Figure 1-5 shows the collapse of the bridge over the Trans-European Motorway. This bridge was composed of four 26-m-long simply supported spans. Each of the spans was positioned on elastomeric bridge bearings. Each span lost the support of at least one end. Figure 1-6 is a view of the bearings and an unseated span from one abutment. Another bridge near Akyazi collapsed (see Figure 1-7), reportedly due to movement of the supporting piers; much of the bridge is submerged in the photograph.

Figure 1-7 Collapsed and submerged bridge near Akyazi

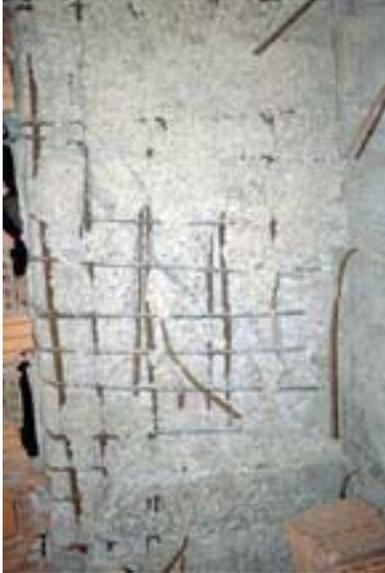
standards. Figure 3-2 shows a completed shear wall in a multistory apartment building in Yalova. The vertical and horizontal rebar in the shear wall can be seen on the exterior face of the wall. Although buildings in Yalova suffered damage in the earthquake, the apartment building was not damaged despite the poor quality of the concrete evident in the photograph.

Figure 3-2 Poor quality construction of a shear wall in an apartment building in Yalova

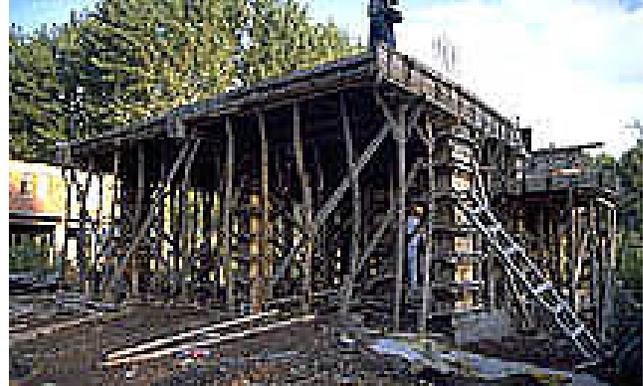
An example of residential apartment construction by a homeowner in a village outside of Gölcük is shown in Figure 3-3. The shoring is composed of cut and trimmed tree limbs. (In most instances, conventional steel and timber shoring is used for apartment construction over four stories.) Timber planks are used to form columns, beams, and slabs. Photographs of the second floor of the apartment building are presented in Figure 3-4. Slabs typically span in one-direction and are approximately 100 mm in thickness. Beams span 2 m to 4 m, range in depth up to 500 mm, and are typically 200 mm wide. Bent-up rebar can be seen in Figure 3-4. Transverse ties with 90° hooks are used. The beam rebar details are nonductile. Blade columns (long and narrow in plan) are routinely used in apartment buildings to

Figure 3-3 Homeowner apartment building construction

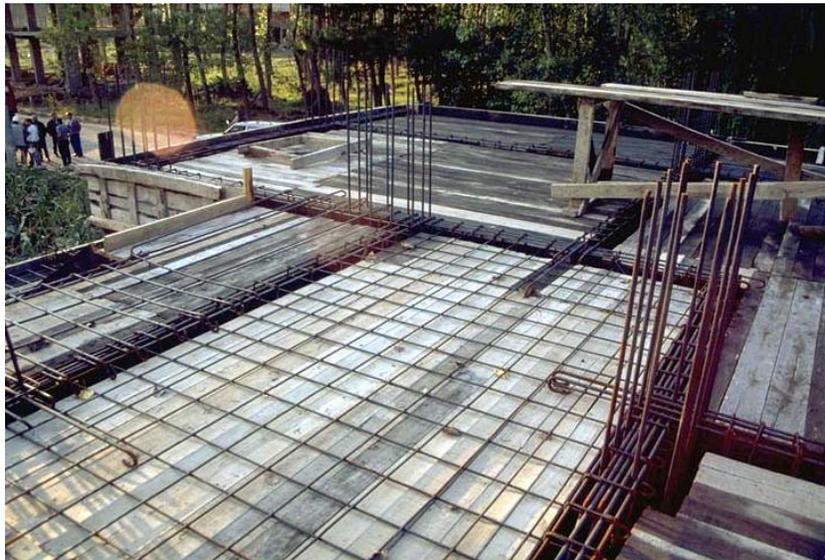
enable the builder to construct the columns within the thickness of the wall. Some column details can be seen in Figure 3-4. Vertical rebar are spliced at the floor level. Typical splice lengths are approximately 1 m and no additional ties are provided in the splice region. Transverse reinforcement with 90° degree hooks is typical. Joint shear reinforcement is not provided. The column rebar details are nonductile.

Figure 3-4 Typical gravity framing including beam and column details

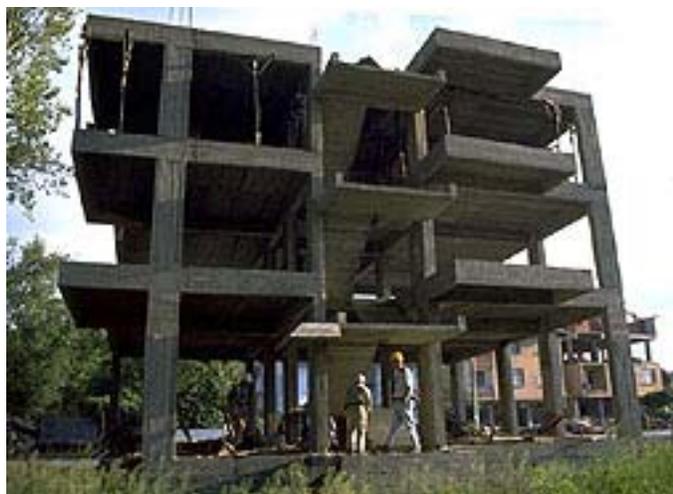
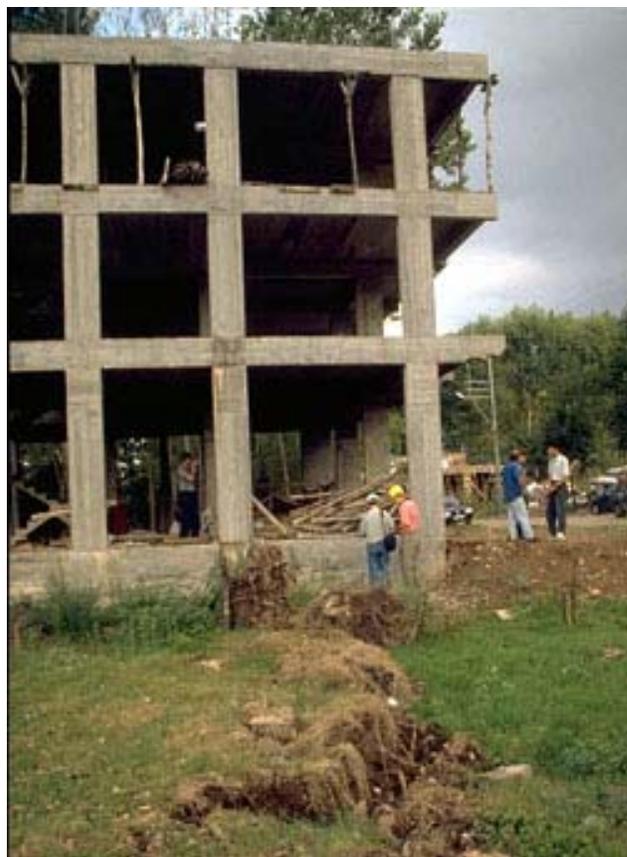
Figure 3-6 Three-story moment-resisting frame east of Gölcük

Figure 3-6 presents photographs of a three-story building that was under construction at the time of the earthquake. A plan of the second-floor framing is shown in Figure 3-7. The column and beam orientation shown in Figure 3-7 suggests that the framing system is much stiffer and stronger in the direction perpendicular to the street (parallel to the y -axis of Figure 3-7), assuming that similar rebar are used in all beams and columns in this building. The ratio of total column area to plan footprint in this building is 1.3%.

b. east-west elevation showing fault rupture

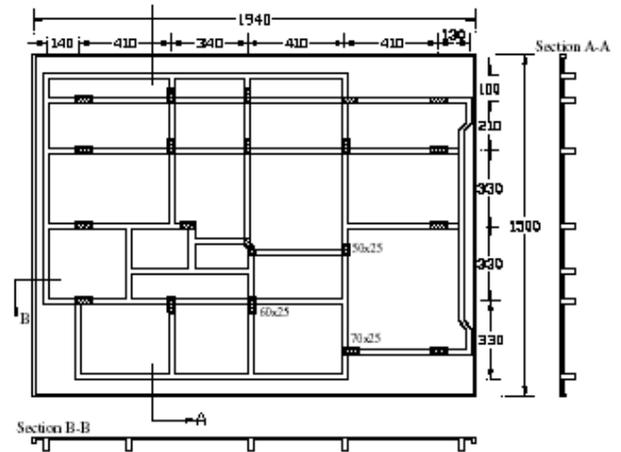
A plan of the roof framing of a five-story moment-resisting frame building is shown in Figure 3-8. The column orientations and locations are such that there are no moment-resisting frames of more than one bay in either direction of the building in the fifth story. Such framing likely possesses limited strength and stiffness that, if coupled with nonductile reinforcement details, results in a vulnerable building in the event of earthquake shaking.

Figure 3-8 Plan of roof framing for a five story apartment

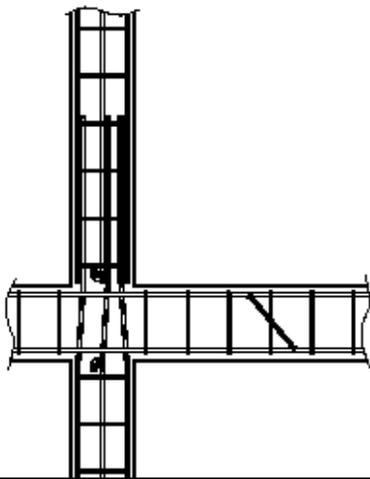
Figure 3-9 Typical modern beam and column rebar details

Information on column and beam rebar details is provided in Figure 3-9. Corner column rebar are spliced above the floor slab with lap lengths of 40 to 70 bar diameters. Side-face column rebar are either spliced per corner rebar or terminated above and below the joint with 180° hooks. No transverse reinforcement for the purpose of confinement is provided in the hinge, joint, or splice regions. Bent-up beam rebar is shown in the typical section.

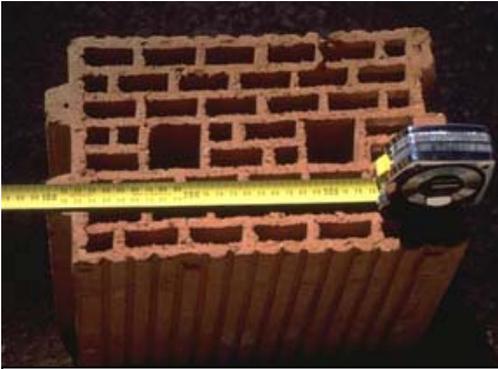
Figure 3-10 Hollow clay tile block used for infills

Interior and exterior infill walls are constructed of either *hollow clay tile* or lightweight gas-concrete blocks. The hollow clay tile block is more widely used than the gas-concrete block and is extremely brittle. The block infill is not reinforced nor is it anchored to the structural framing with masonry ties. Block infill walls are built in contact with the structural framing and add significant stiffness and strength to the framing system. Photographs of hollow clay tile block are shown in Figure 3-10.

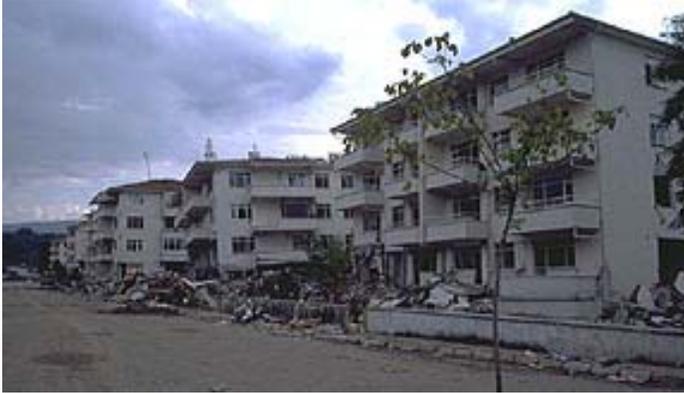
Figure 3-12 shows the collapse of six moment-resisting frame buildings in a village on the outskirts of Gölcük. Every moment-resisting frame building on this street collapsed, and 122 people died in these buildings. Nonductile details were observed in every (collapsed) moment-frame building on this street.

Figure 3-12 Collapse of moment frame buildings, Gölcük

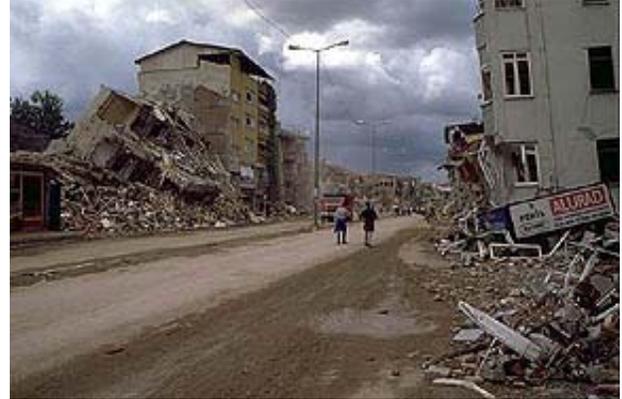
Figure 3-13 Collapse of moment-frame and wall buildings, Adapazari

Similar collapses were common in the epicentral region. Figure 3-13 shows the extent of the destruction in Adapazari, a major city approximately 10 km from the line of rupture. Many of these buildings were constructed with hollow clay tile infill in the frames perpendicular to the sidewalk. Because the buildings often housed shops and commercial space in the first-story, glass panels and not hollow clay tile infill walls were placed between the first story columns adjacent to the sidewalk, but tile infill was used in the upper stories. Such an arrangement of tile infill created stiffness discontinuities in these buildings, which may have contributed to their collapse.

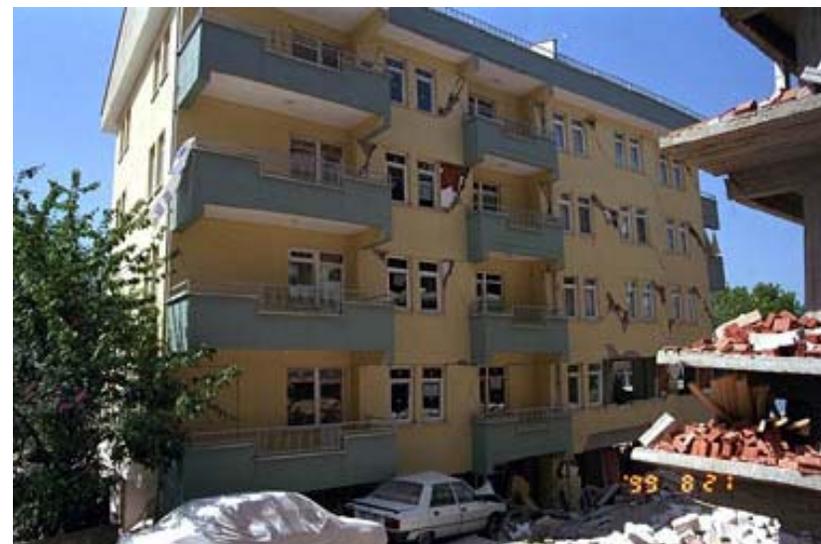
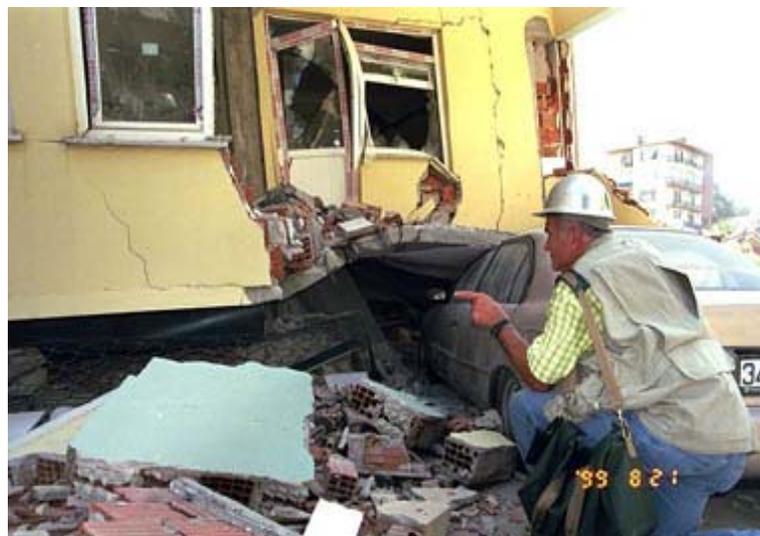
a. Collapsed building

b. View of failed first story

Figure 3-16 Collapsed building that straddled the line of rupture

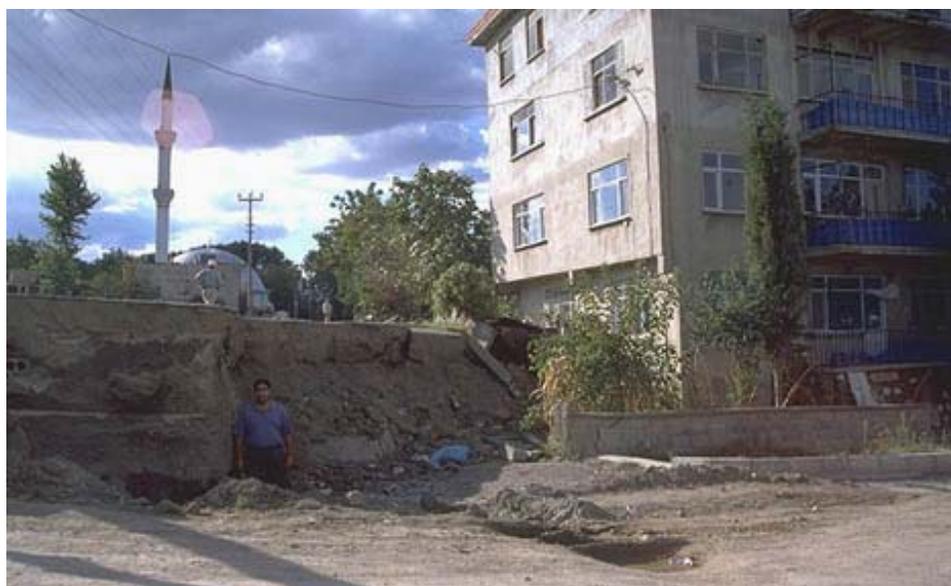
“Near-field” is the common term used to define the zone within 5 to 10 km of a major fault. Earthquake shaking in the near field is often severe, as illustrated by recorded ground motions obtained from the Northridge (1994) and Kobe (1995) earthquakes. Widespread collapse of older construction is to be expected in the near field due to the intensity of the earthquake shaking. Although many moment-frame buildings in the near field of the Izmit earthquake suffered gross damage or collapsed, some fared surprisingly well. Shown in Figure 3-17, the four-story moment-frame building is sited within 2 m of the line of rupture and yet suffered no visible damage despite 1.2 m of horizontal offset and 2.35 m of vertical offset on the fault. Figure 1-2 shows another view of the same building. The reasons for such good performance of this 10- to 30-year-old frame building with masonry infill are unknown.

Figure 3-17 Undamaged building located within 2 m of the line of rupture

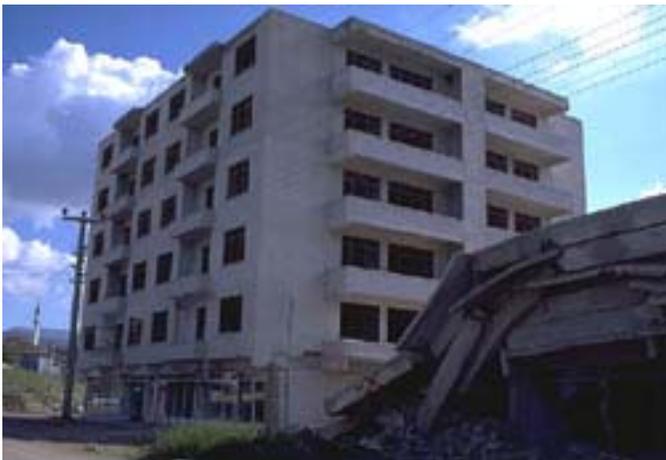
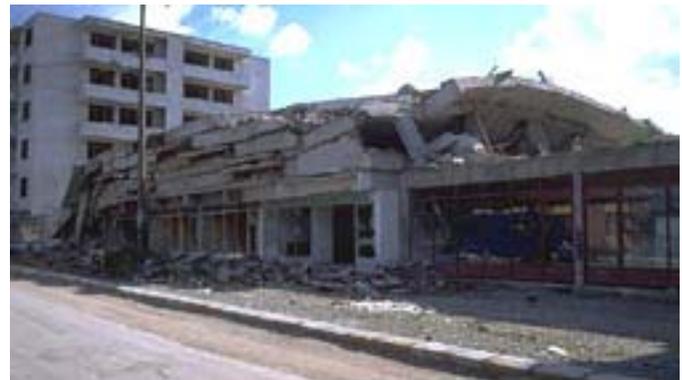
Figure 3-18 is a photograph of two six-story nonductile moment-frame buildings in Gölcük. One of the buildings collapsed completely, whereas the building immediately adjacent suffered only superficial damage in the form of minor cracking in the first-story columns. Much of the first story of the collapsed building was intact. Careful examination of the first stories in both buildings showed that the buildings had similar plan footprints and common construction details. It is likely that the two buildings were nearly identical and that the same contractor constructed both buildings. Both buildings were probably subjected to similar levels of earthquake shaking, yet one building remained in the elastic range and performed well, while the other collapsed. This raises many questions regarding limit states for nonductile moment-frames. Small differences in the strength of these nonductile buildings caused by the use of different construction materials and different construction practices and workmanship could account for the substantial difference in performance.

a. lightly damaged six-story building

b. collapsed six-story building

Figure 3-18 Variability of building response

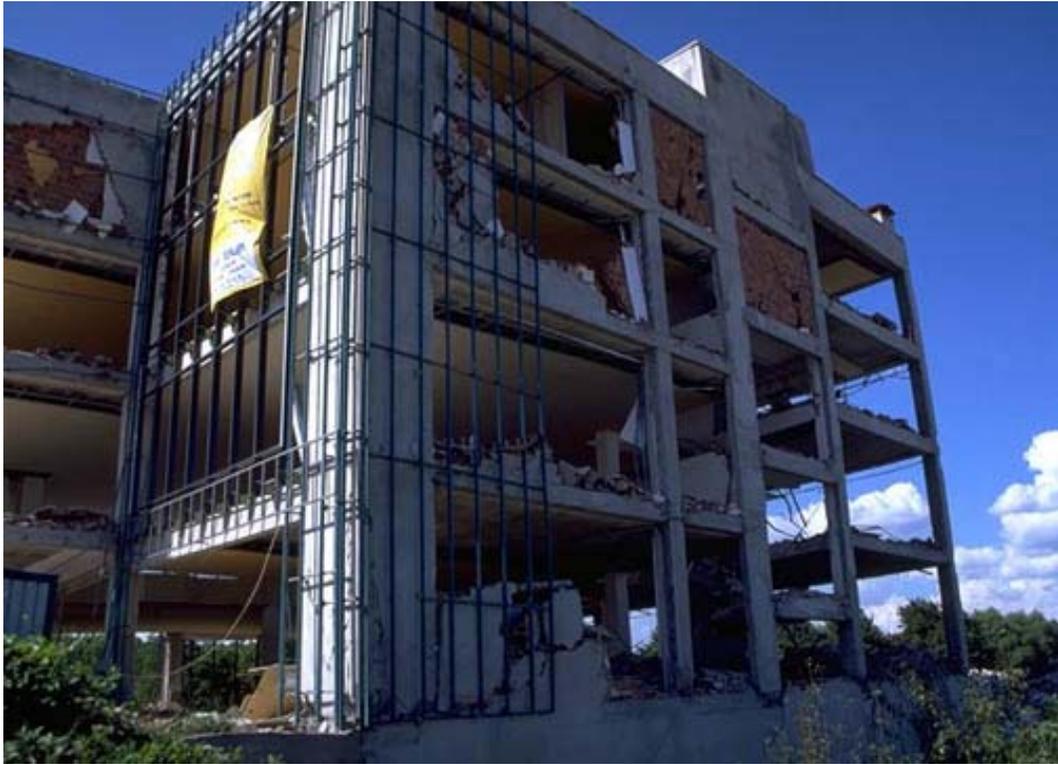
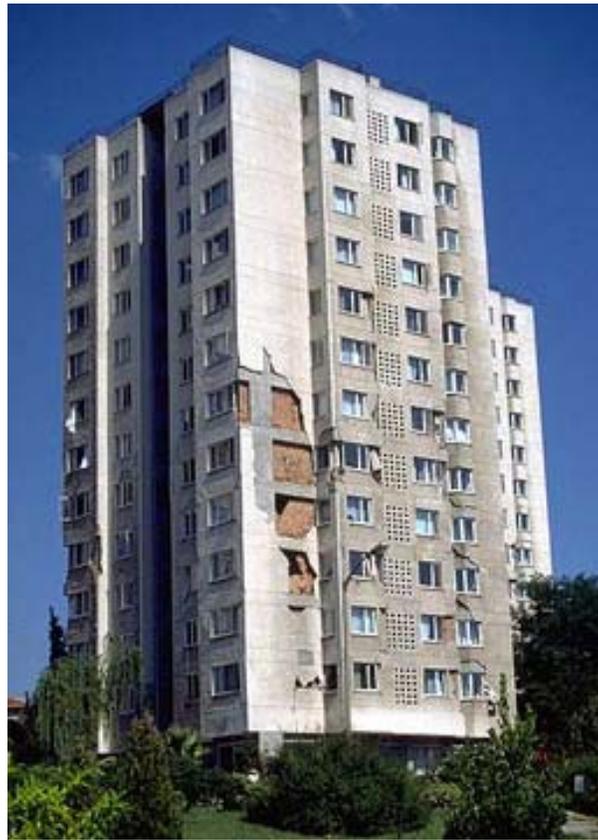
Hollow clay tile and gas-concrete masonry infill walls are widely used in the epicentral region. As noted in Section 3.3.2, these walls are unreinforced and nonductile. The walls abut the frame columns but are not tied to the frame. The high in-plane stiffness of the masonry infill that is developed by diagonal strut action can dictate the response of the more flexible moment-resisting frame. Figures 3-19a and 3-19b show complete and partial damage to hollow clay tile walls in four- and thirteen-story buildings, respectively. The four-story building was under construction at the time of the earthquake; the thirteen-story building was constructed in the early 1970s.

a. four-story building

b. thirteen-story building

Figure 3-19 Varying degrees of damage to infill masonry walls

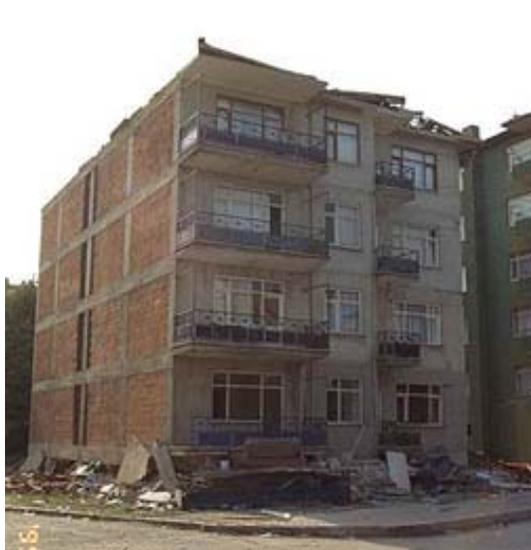
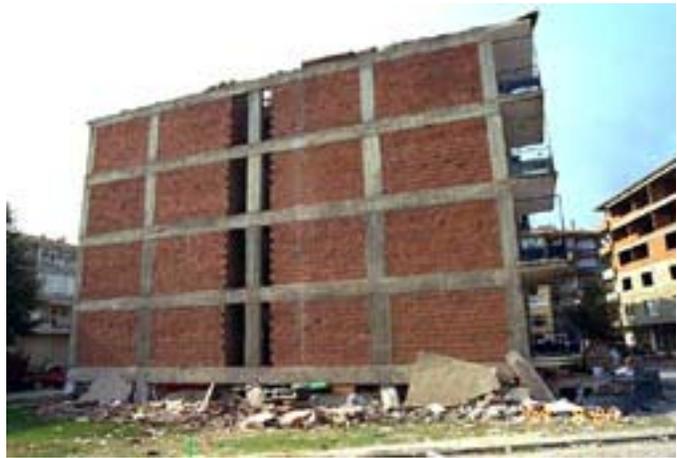
Figure 3-21 shows two views of a collapsed apartment building in Gölcük. The first two stories of this building failed completely but damage in the upper three stories was limited. The long infill walls in the upper three stories have significant elastic strength and stiffness—probably much greater stiffness and strength than the moment-resisting frame. If the infill walls in the upper three stories of the building are indicative of the infill in the failed stories, the first- and second-story infill walls likely played an important role in the collapse of the building. The brittle fracture of the first- and second-story infill masonry walls would have overloaded the nonductile first- and second-story frame columns, resulting in a complete failure.

a. view of front face of building

b. view of infill wall perpendicular to sidewalk

Figure 3-21 Collapsed apartment building in Gölcük

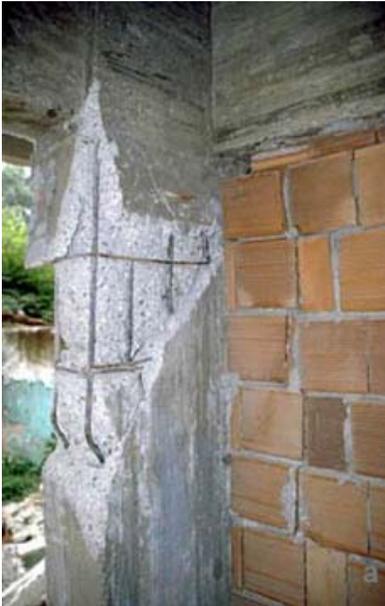
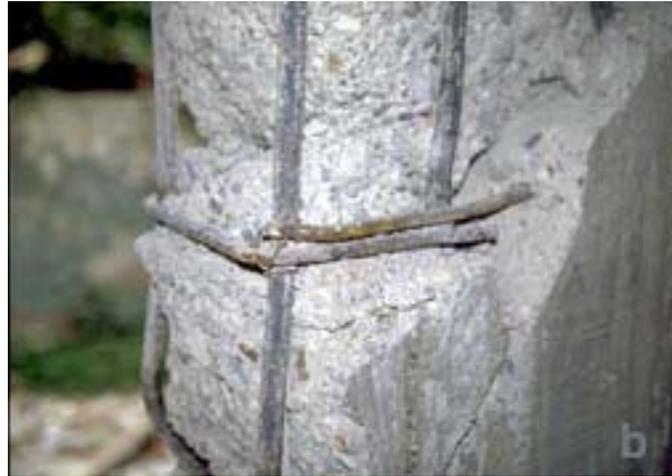
Figure 3 –26 Typical transverse reinforcement details in columns
a. view of damaged blade column
b. transverse tie details in blade column

Shear reinforcement was lacking in most damaged columns observed by the reconnaissance teams. The transverse tie details of Figures 3-26, 3-27, and 3-28 were common, namely smooth rebar, widely and often unequally spaced ties (200 to 250 mm), and 90° hooks. The wide spacing of the ties resulted in shear failures (Figure 3-26), buckling of longitudinal rebar (Figure 3-27), and poor confinement of the core concrete (Figure 3-28).

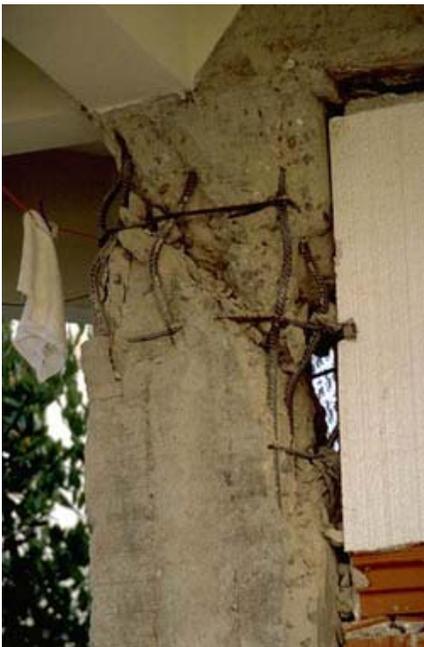
Figure 3-27 Shear failure of a moment-frame blade column

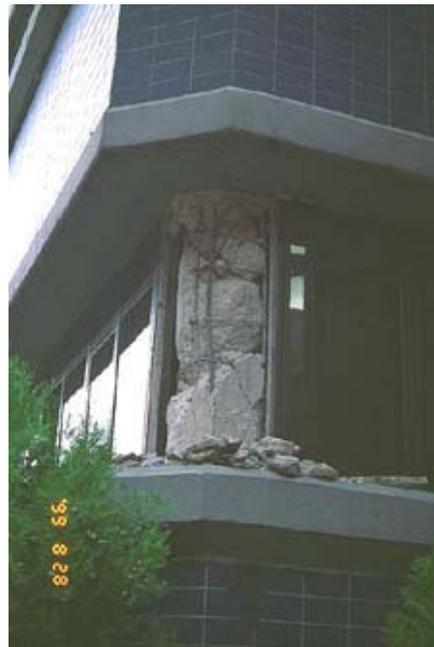
Figure 3-28 Lack of transverse reinforcement in moment-frame column

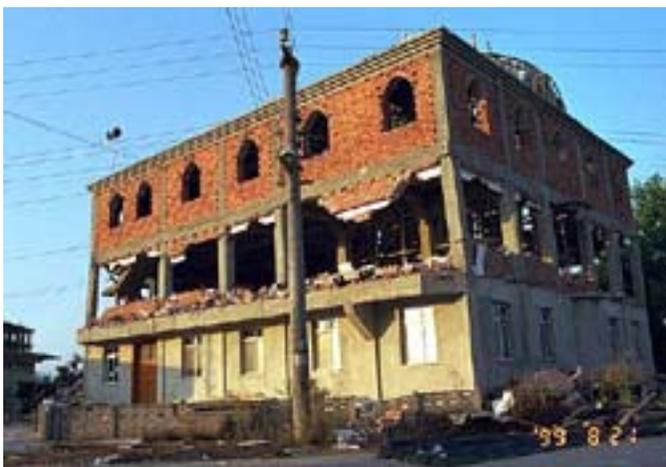
Column-infill masonry wall interaction resulted in severe damage to and failure of many moment-frame columns. Consider the building east of Gölcük that is shown in part in Figure 3-30. The infill hollow clay tile masonry on each side of the central column in this figure failed completely and the column hinged at each end. The column to the left of the central column was captured approximately 1 m above the floor by the residual hollow clay tile. The shear cracks that were observed in this captive column formed in the column at the top face of the remaining infill masonry.

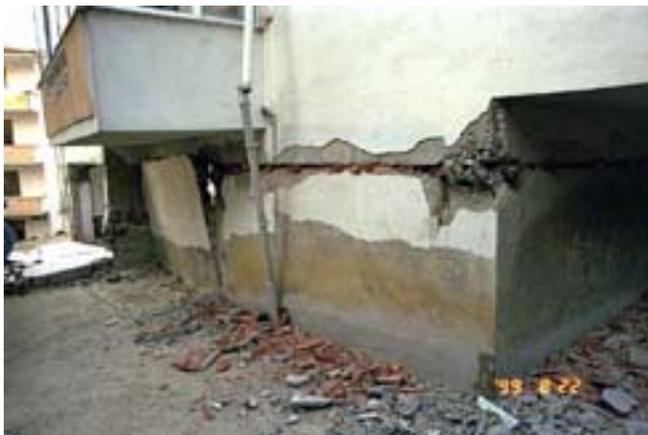
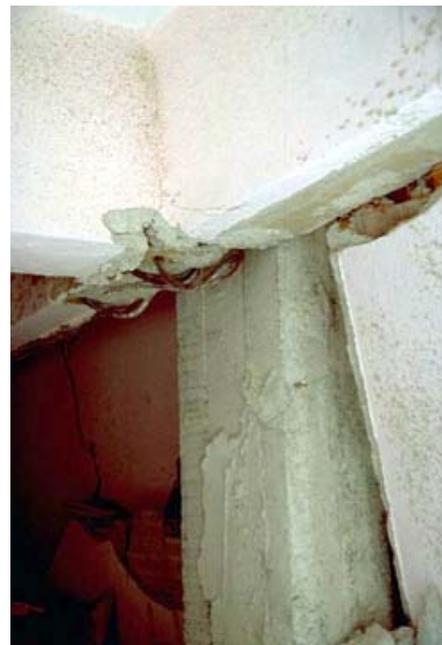
smooth rebar with 90° hooks. Such connection details have limited rotation capacity. The beam and slab framing (Figure 3-32b) lost seating on

a. damage from out-of-plane deformation

b. unseating of beam-slab system from column

Figure 3-32 Damage and failures at ends of moment-frame columns

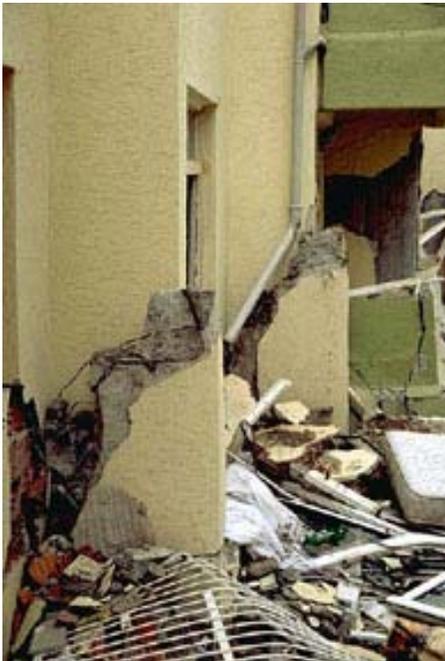
the column. The first-story columns of a collapsed building are shown in Figure 3-33; the second-story of the building is to the left of the columns. Note the smooth failure surface on the top right side of the columns.

Figure 3-33 Damage to moment-frame columns

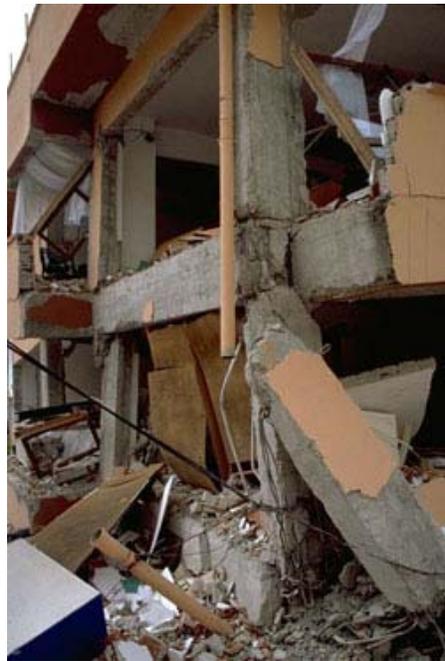
Typical damage to beam-column joints is shown in Figures 3-34, 3-35, and 3-36. The collapse of a building in Adapazari (Figure 3-35) was due to the failure of beam-column joints. Much of the framing (Figure 3-35a) is essentially intact but many of the beam-column joints are heavily damaged. One of the damaged joints is shown in Figure 3-35b. Beam rebar anchorage in the joint is inadequate and no transverse ties are present in the joint.

Figure 3-34 a. Damage to moment-frame beam-column joints

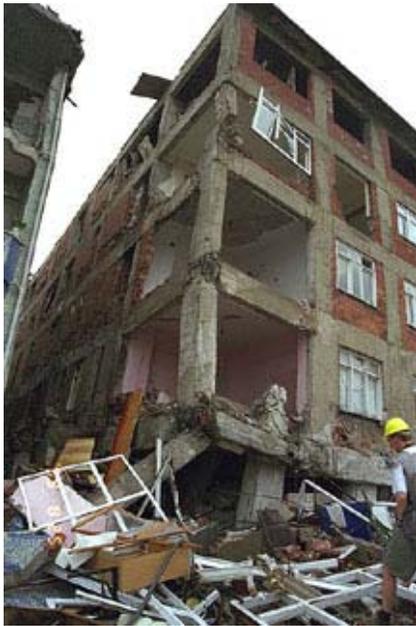
Figure 3-35 a. Building collapse due to failure of beam-column joints

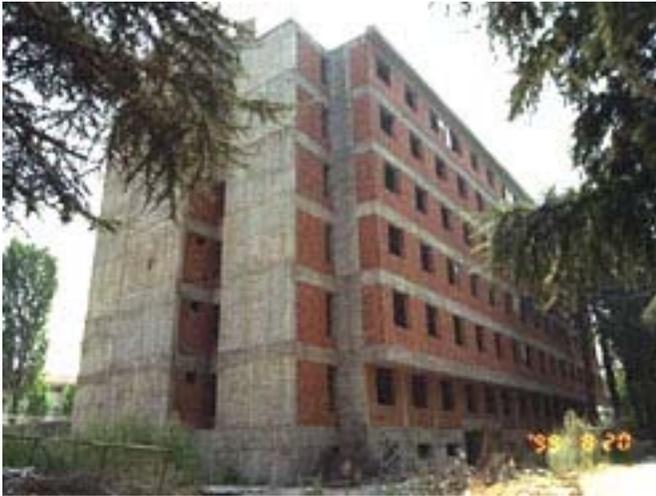
Outside Istanbul, few buildings in western Turkey are constructed with shear walls as the primary lateral load-resisting system. However, those wall buildings in the epicentral region, such as the building under construction in Figure 3-38 and the apartment buildings of Figure 3-39, performed well. Shear walls were used as the lateral load-resisting system in both the transverse and longitudinal directions of the building in Figure 3-38. This building suffered minor damage to the infill walls. The lateral force-resisting systems in the two apartment buildings shown in Figure 3-39 included moment-frames along the major axis of the buildings and shear walls along the minor axis. These buildings

Figure 3-38 Shear wall building under construction at the time of the earthquake

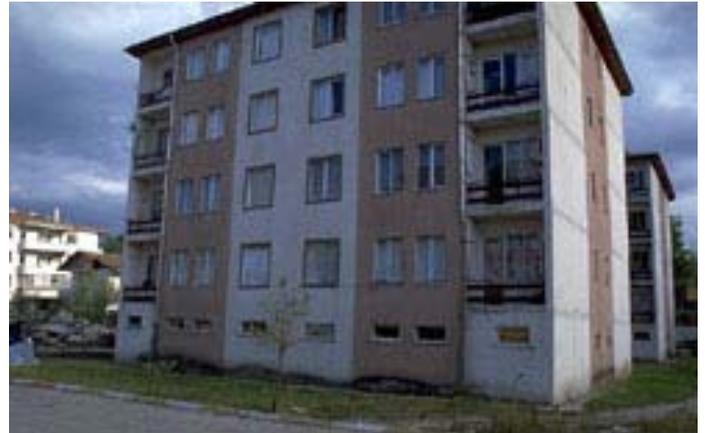
Figure 3-39 Undamaged apartment building in Gölcük

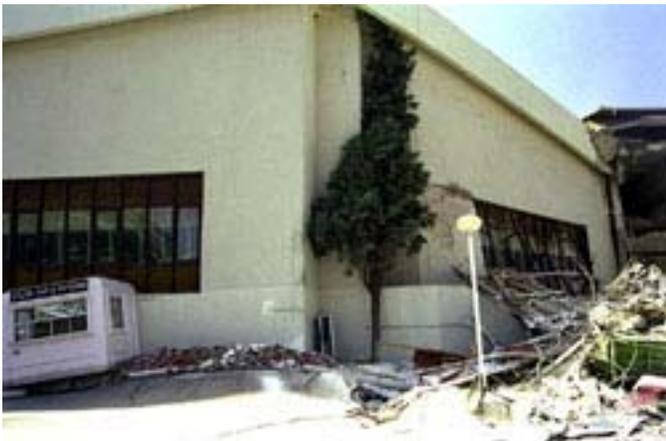
The building shown in Figure 3-40 experienced damage at the stiffness discontinuity in the shear wall. The fault ruptured directly beneath this building. The limited damage in this instance constitutes excellent performance.

Figure 3-40 a. Shear wall building damaged due to fault rupture

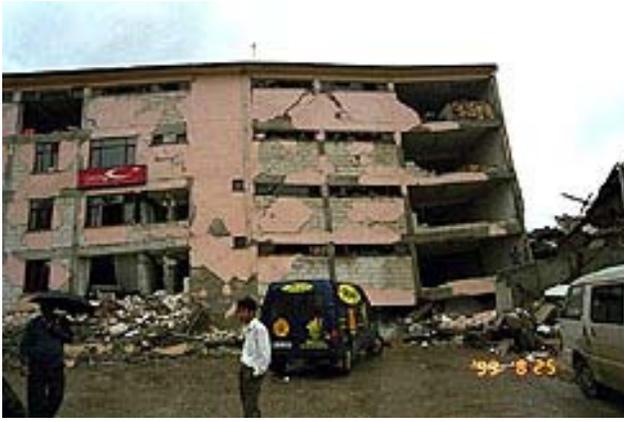
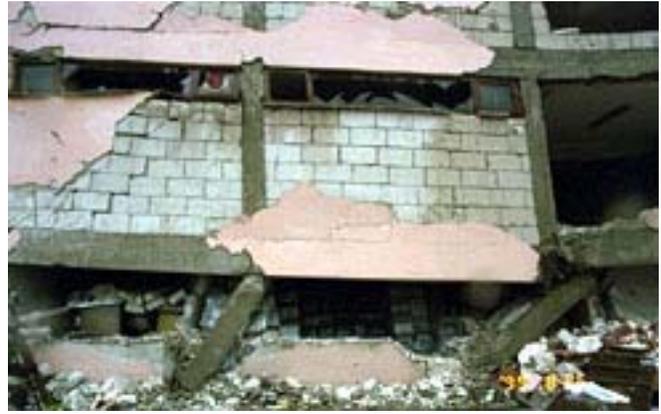
The reconnaissance team toured a number of buildings that would be classed as dual wall-frame systems in the United States. However, because design provisions for such systems did not exist in Turkey prior to 1997, these buildings would have been designed as either shear walls or moment-resisting frames. The most significant damage observed by the team in a dual wall-frame building is shown in Figure 3-41a. The wall and first-story exterior columns shown (Figure 3-41b) failed and shortened. These components displaced out of the plane of the wall, as seen in Figure 3-41b.

Figure 3-41 a. Collapse of dual wall-frame five story building, Adapazari

Figure 3-41 b. Close-up of failure of the shear wall and perimeter columns

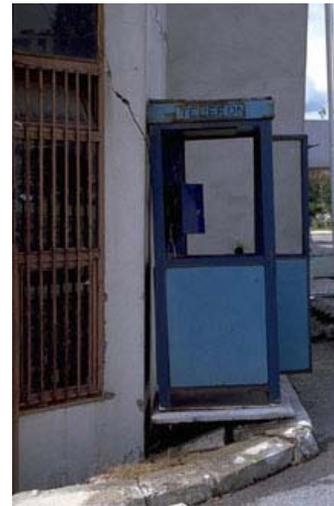
Figure 3-42 b. shear wall settlement

Another example of damage to beams and columns in a dual wall-frame building is shown in Figure 3-42. No cracks were observed in the shear wall, but the right end of the wall settled approximately 0.5 m (Figure 3-42b) due to bearing failure of the supporting soils. Although the shear wall was likely sufficiently stiff to protect the nonductile frame, the rotation at the base of the shear wall and settlement of the footings beneath the moment-frame columns contributed to the failure of the first-story columns.

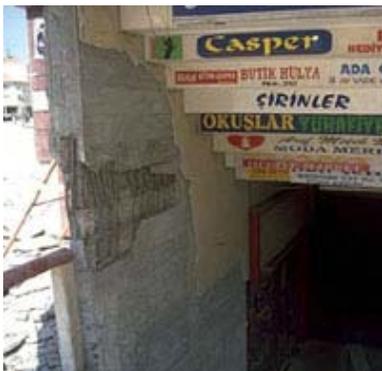
Blade columns or short shear walls were often constructed near stairwells (Figure 3-43). These walls or blade columns were detailed similarly to regular moment-frame columns with light transverse reinforcement with 90° hooks and no cross ties. The failures shown are similar to those observed in moment-frame columns.

Figure 3-43 Damage to short wall / blade column

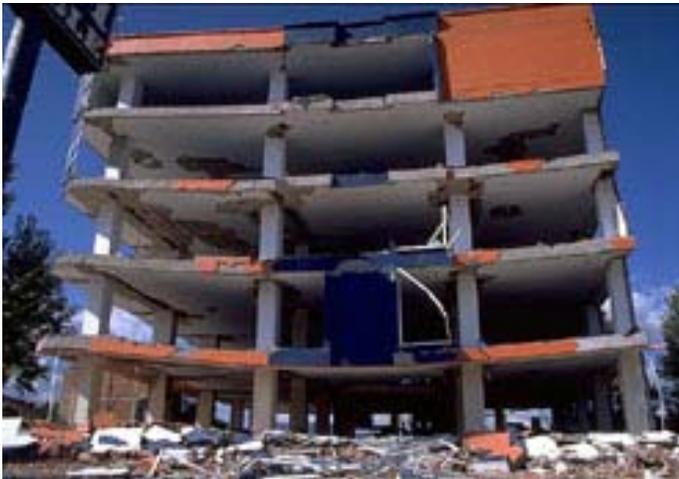
Figure 3-44 Front elevation of Building A

Building A, shown in Figures 3-44 and 3-45, was located at the eastern outskirts of Gölcük. Much of the first story of this moment-frame building (not seen in Figure 3-44) was located below grade. The grade level sloped down from the front to the back of the building. A sketch of the first-floor plan of the building is shown in Figure 3-46. Most of the hollow clay tile infill masonry failed during the earthquake but some remained intact at the rear of the building in the sixth story (see Figure 3-45).

After the columns in the first row failed in shear and shortened, the slab and beam framing deflected in the shape of a catenary (see the sag in the floor slabs in Figure 3-44) and gravity loads were carried to the adjacent undamaged columns by axial tension in the beams and slabs. Vierendeel truss action in the upper stories also likely transferred gravity loads to adjacent undamaged columns. Provision for such redundancy in framing systems would reduce the likelihood of building collapse and substantially uncouple system-level response from component-level response. The catenary and Vierendeel truss mechanisms may be very effective in stabilizing the structure when interior columns are lost. To ensure that beams and slabs are able to maintain catenary deflections, bottom reinforcement should be continuous through any columns that may fail under lateral loads.

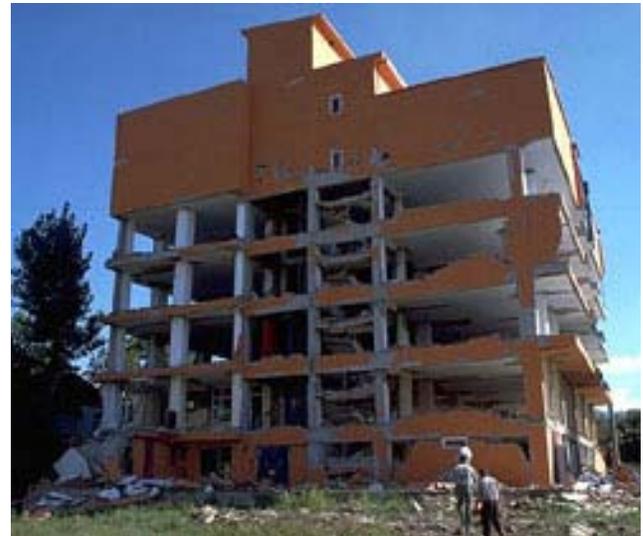
Figure 3-45 Rear elevation of Building A showing intact infill masonry walls

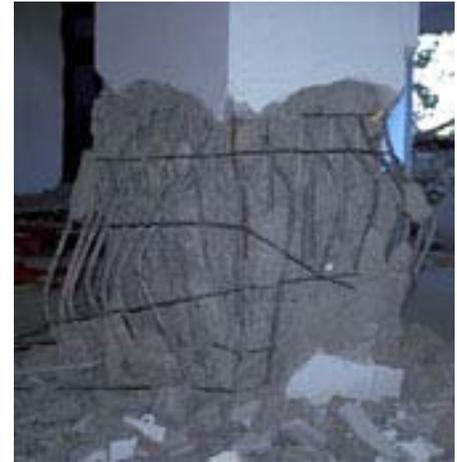
The distribution of damage to columns in the first story is shown in Figure 3-46. Figures 3-49, 3-50, and 3-51 show column failures. Nonductile detailing is evident, including widely spaced perimeter transverse ties with 90° hooks and no cross ties, and lap splices located at the floor level with no confining transverse reinforcement.

Figure 3-51 Axial failure at lap splice in Column C (See Figure 3-46)

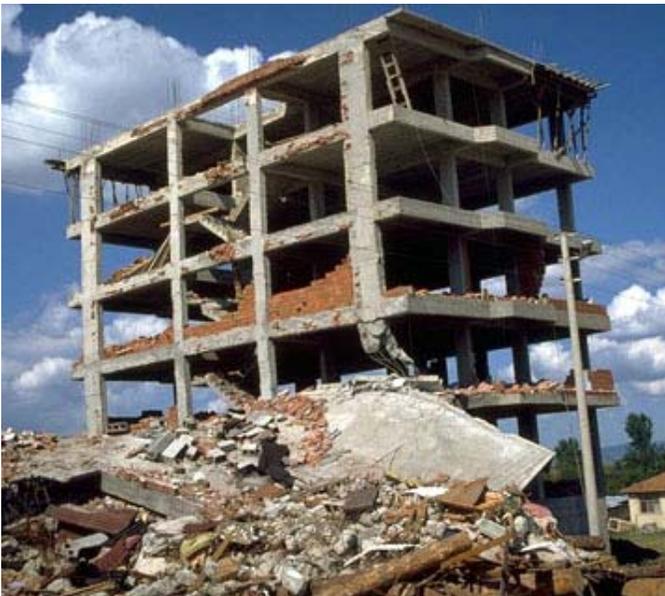
Figure 3-52 Elevation of Building B

A corner column in the third story of Building B failed during the earthquake, as seen in Figure 3-52. Part of the roof framing of the adjacent building can be seen immediately below the failed column, indicating that the third-story column failed due to the impact of the adjacent building. Figure 3-53 shows more details of the failed column and the roof slab of the adjacent building.

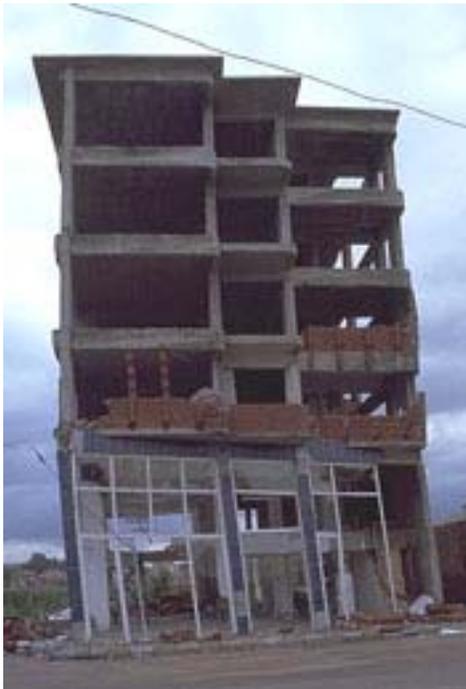
Building C, shown in Figure 3-54, was located near the Adapazari city center. The five-story reinforced concrete frame building included a high retail space in the first story. The retail space shown in Figure 3-55 included a mezzanine level on the west side of the building. The building was not occupied at the time of the earthquake.

Figure 3-54 Elevation of Building C

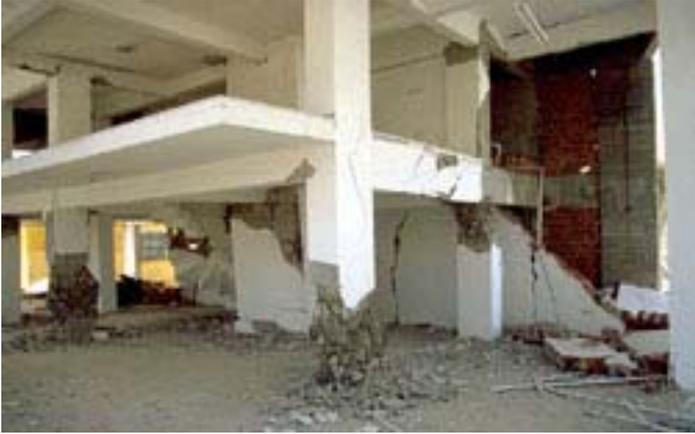
Most of the first-story columns connected to the mezzanine level failed in shear (Figure 3-55). The mezzanine level reduced the clear length of the columns, resulting in shear failures before the moment capacities of the columns could be developed. Damage to the stair framing and short shear wall connected to the mezzanine level can also be seen.

Figure 3-55 View of retail space in the first story of the Building C

damaged or failed components is needed. The severely damaged interior columns of Figure 3-55 could support little or no gravity load. This observation suggests that much of the gravity load in the building must have been distributed to the perimeter first-story columns by Vierendeel truss action in the upper stories. Many of these perimeter columns suffered damage to their beam-column joints, but the use of transverse reinforcement prevented joint failure and gravity load resistance was maintained.

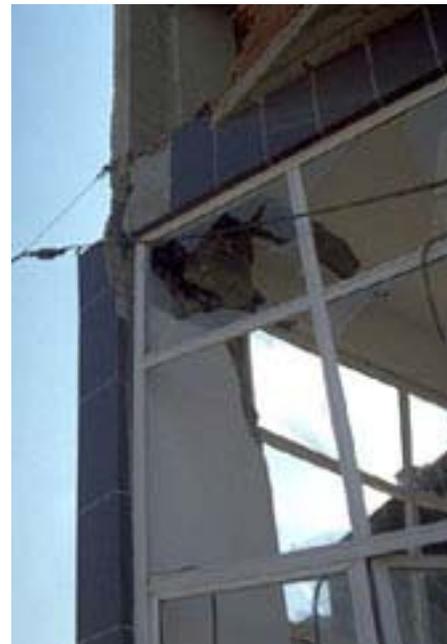
Figure 3-58 Damaged beam-column joint at top of first-story corner column, Building C.

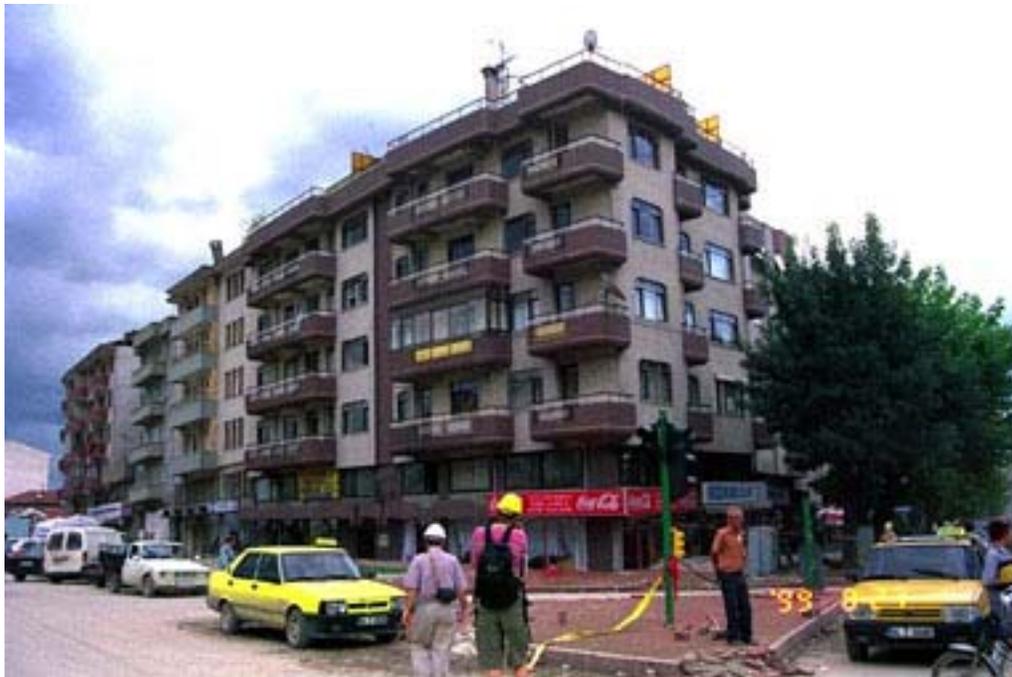
Figure 3-59 Elevation of Building D

Building D is an example of poor system performance that was not accompanied by component damage or failure. This building suffered little damage as a result of the earthquake shaking but could not be occupied because it settled more than 1 m due to liquefaction and bearing failure of the supporting soils (see Figure 3-60). It is likely that this failure of the supporting soils limited the shaking experienced by the building. Services and utilities to the building were destroyed and ingress and egress were most difficult. The poor performance of this building underscores the need to

explicitly account for soil and foundation behavior in performance-based earthquake engineering. Although the building would have satisfied the performance level of collapse prevention (as defined in FEMA 273 [FEMA 1997] and Vision 2000 [SEAOC 1995]), it would not have satisfied the egress requirements of the life-safety performance level. To achieve performance beyond collapse prevention, site improvements to avoid liquefaction would have been required.

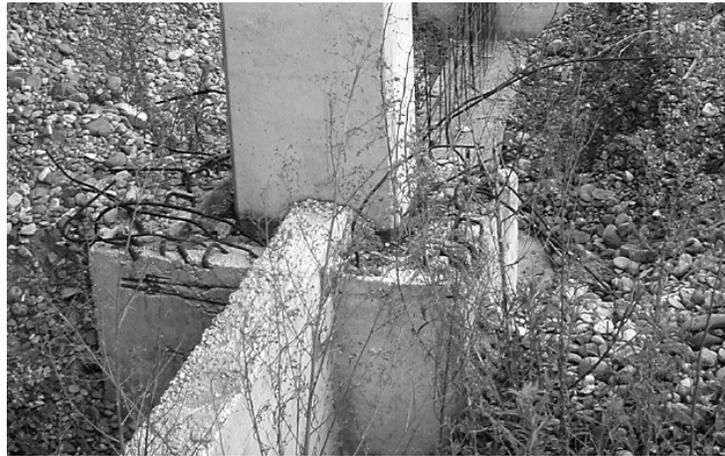
a. interior foundation socket connection

b. exterior foundation socket connection

Figure 4-5 Foundation connection for prefabricated reinforced concrete facilities

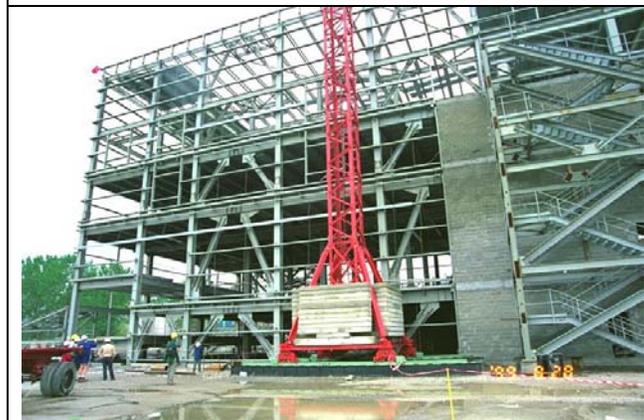
Braced and moment-resisting steel frames are used for some single-story and many multistory industrial facilities. One such facility, under construction at the time of the earthquake for DuSA, is shown in Figure 4-7. The framing system in this five-story building suffered no damage but much of the reactive weight in the form of the concrete-on-metal deck floors and masonry perimeter walls was not present at the time of the earthquake. The building was designed and detailed in the United States using U.S. standards for such facilities. The seismic moment-resisting frame in the elevation of (Figure 4-7a) used bolted end-plate connections. On the perpendicular elevation (Figure 4-7b), eccentrically braced steel frames were used to resist seismic loads. On this elevation, part of a three-story masonry wall peeled off the exterior steel framing and collapsed; the remaining part of the wall can be seen to the right of the crane base.

a. elevation showing steel moment frames

b. elevation showing steel eccentrically braced frames

Figure 4-7 Five-story steel-framed industrial facility under construction

A new steel-frame building was under construction at the time of the earthquake. Photographs of the framing were presented earlier in Figure 4-7. The structural frame suffered no damage. No damage was observed to nonstructural components in (ductwork and process equipment) and around (unanchored tanks and piping) of the new building.
