Structural Engineering Reconnaissance of the August 17, 1999, Kocaeli (Izmit), Turkey, Earthquake

Structural Engineering Reconnaissance of the August 17, 1999 Earthquake: Kocaeli (Izmit), Turkey

PEER Report 2000/09
Pacific Earthquake Engineering Research Center
College of Engineering
University of California, Berkeley
December 2000

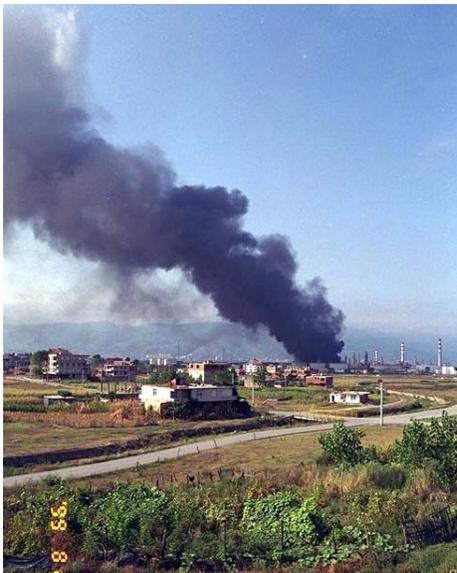
The most spectacular damage to an industrial facility was observed at the state owned and managed Tüpras oil refinery near Körfez (see Figure 4-8: a photograph taken shortly after the earthquake by an unknown photographer). Prior to the earthquake, the Tüpras refinery produced more than 200,000 barrels of oil-related product per day, approximately one-third of Turkey's total output. The Tüpras product was primarily for domestic consumption, much of which was local to industry in the Körfez region. The Tüpras refinery was designed and constructed in the early 1960s by U.S. contracts and according to U.S. standards of practice at that time (Danis 1999). As such, the damage observed to the Tüpras refinery would not be unexpected at refineries of a similar age that are located on the West Coast of the U.S. The plant was expanded in size and production in 1974 and 1983.

Figure 4-8. Tank farm fires at Tüpras refinery

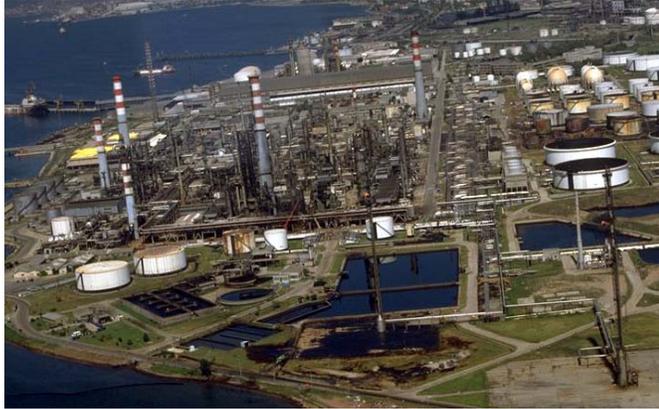
Figure 4-9. Tüpras refinery showing part of the tank farm

Figure 4-10. Tupras refinery

Figures 4-9, 4-10, and 4-11 are aerial photographs of the refinery taken by members of the reconnaissance team two weeks after the earthquake. Figure 4-9 shows the main processing facility and part of the tank farm (in the foreground). The jetty that serviced the refinery is not shown but is located at the left-hand edge of the figure. Another view of the main processing facility shows the failed heater stack (see the circled section in Figure 4-10). Some of the burned fuel-oil tanks can be seen in the upper right middle of the figure. The remains of the timber cooling tower that burned following the earthquake can be seen in the middle right of the photograph between the burned tanks and the northern perimeter of the main processing facility. Substantial pollution can be seen (Figures 4-9 and 4-10), which resulted from the failure and breaching of fuel-oil tanks, much of which was successfully contained by the earthen berms that surrounded the tanks. According to refinery staff, some oil spilled into Izmit Bay due to fractured pipes and from an oil tanker that pulled away from the loading jetty immediately following the earthquake.

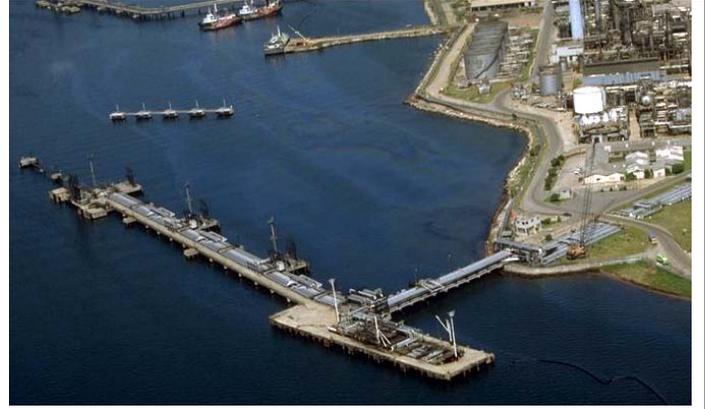
Figure 4-11. Loading and unloading jetty at Tupras refinery

The loading and unloading jetty shown in the aerial photograph (Figure 4-11) serviced the refinery only. Failure of this jetty prevented the loading and unloading of all fuel-oil products at the refinery. Ships tied up to the long arm of the T-shaped jetty (oriented north-west to south-east in the figure, where the top of the page is north). The jetty was composed of a reinforced concrete deck that was supported on steel piles. Modest ground failure was observed around the approach to the jetty. The support to the crude-oil pipeline (Figure 4-12) that ran along the seawall near the jetty was lost. Figure 4-13 is a photograph of the damaged jetty from point A of Figure 4-11. Gross damage to the jetty and the elevated pipeway and pipes is evident to the left of the tug. These pipes transferred fuel oil and other products between the refinery and ships tied to the jetty. Figure 4-14 is a photograph of the damaged jetty, from point B of Figure 4-11, that resulted from the failure of some of these piles. The loading and unloading jetty was separated from the vertical leg of the jetty. Refinery staff told members of the reconnaissance team that the heavy steel grating joining the two components of the jetty dropped into the water, indicating that the two components moved independently during the earthquake. The reconnaissance team observed steady leaks from one of the pipes at ground level, which was filled with volatile gasoline, more than ten days after the earthquake.

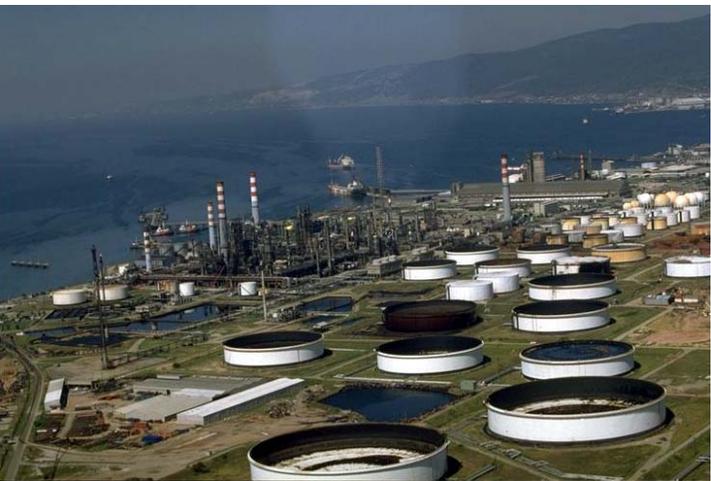
Figure 4-18. Partial view of Tupras tank farm showing Tank 211 and two burn zones

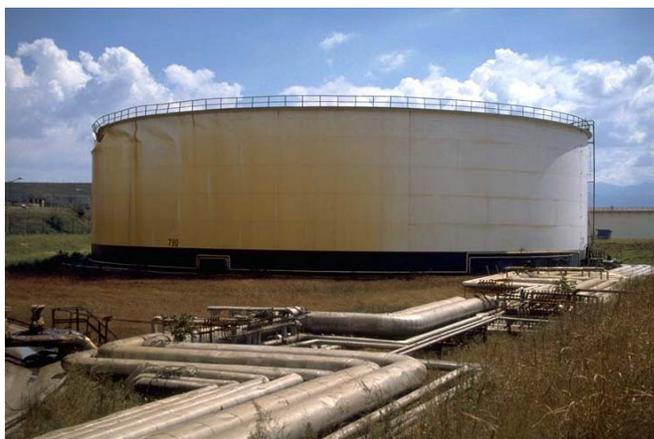
Sloshing of fluid produced overtopping in several tanks (see Figure 4-19) and gross damage to the tank wall near the tops of walls in other tanks (see Figure 4-20). The oil lost from these tanks was contained within the earthen berms surrounding the tanks.

Figure 4-20. View of tank wall damage

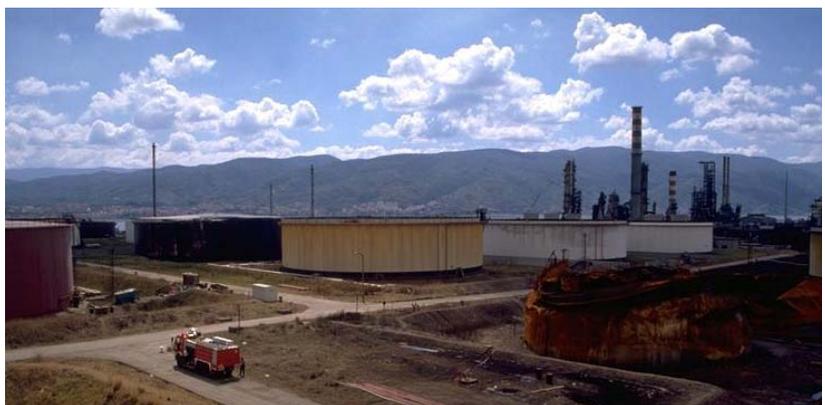
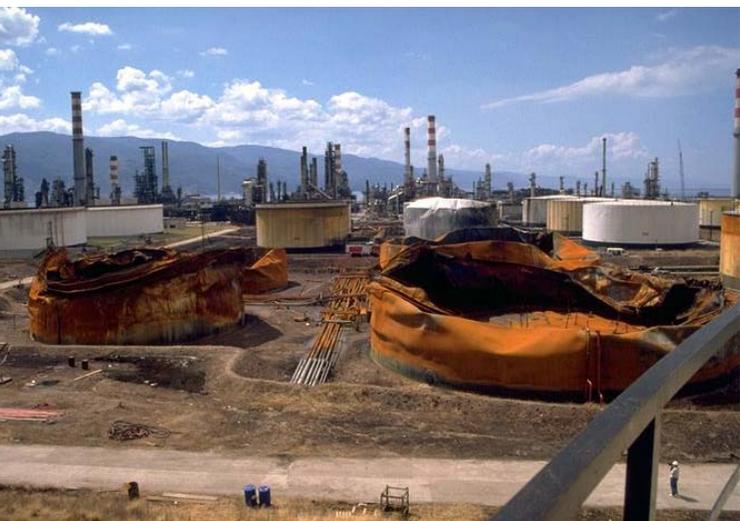
Figure 4-21. Photograph from top of Tank 211 facing south

Figure 4-22. Photograph from top of Tank 211 looking approximately south

Considered write-offs by the management (Danis 1999), approximately 20 tanks in the Tüpras refinery farm were damaged or destroyed by fire. Figures 4-21 and 4-22 are overlapping left-to-right photographs of burned tanks taken from the top of Tank 211 looking south toward the main processing facility. For reference, the mountains in the background of these photographs are located on the other side of Izmit Bay, to the south of the cities of Gölcük and Degirmendere. An overtopped tank can be seen to the left of the middle of Figure 4-21. Figures 4-23 and 4-24 are photographs of two tanks destroyed by fire. The tank in Figure 4-23 is located in tank burn zone 1 of Figure 4-18. The tank of Figure 4-24 is located in tank burn zone 2 of Figure 4-18. Twisted wreckage of the walls, walkways, and floating roof of the tank in Figure 4-24 can be seen in Figure 4-25. Figure 4-26 is a photograph of one tank, located immediately adjacent the burned tank of Figure 4-25 and linked to this tank by hard piping. Gross expansion of this fixed roof tank due to intense heating from the burning tank is evident. This tank can be seen to the right of the middle of Figure 4-22.

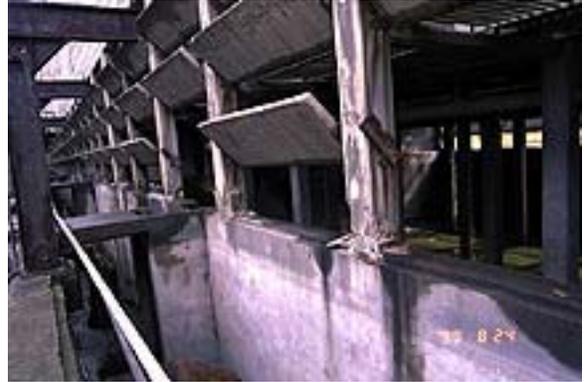
Figure 4-32. Damage to nonductile reinforced concrete in Petkim cooling tower

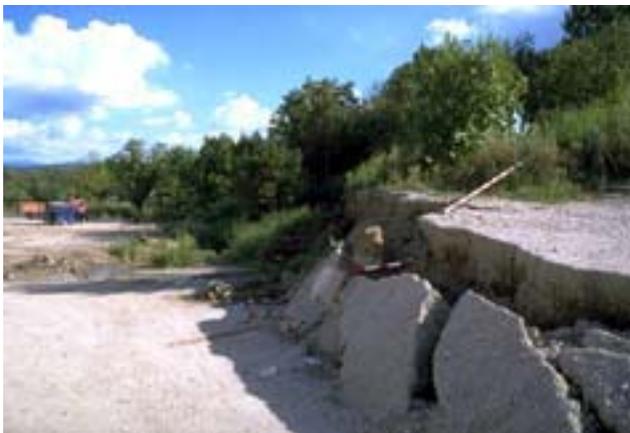
Figure 4-37. Ground movement near Ford plant, Gölcük

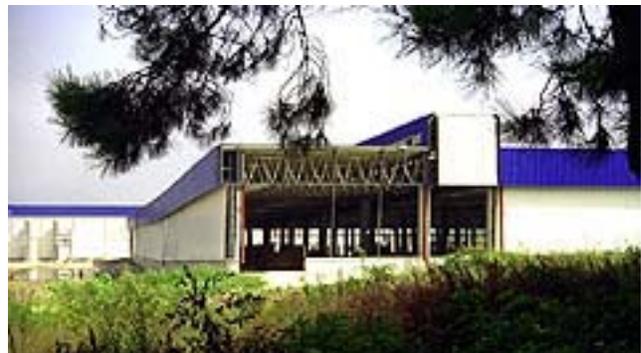
Figure 4-38. Exterior view of damaged Ford body shop

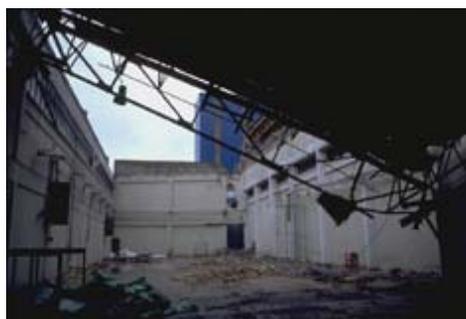
A product storage area was added to the main plant after the original construction. The light steel-framed roof of this storage area collapsed (Figure 4-43), likely due to the differential movement of two parallel walls, also visible. A number of the *short* columns in the wall to the right failed in shear. The masonry infill above these short columns fell through the roof of the storage area.

Figure 4-43. Roof collapse in storage area of KordSA plant

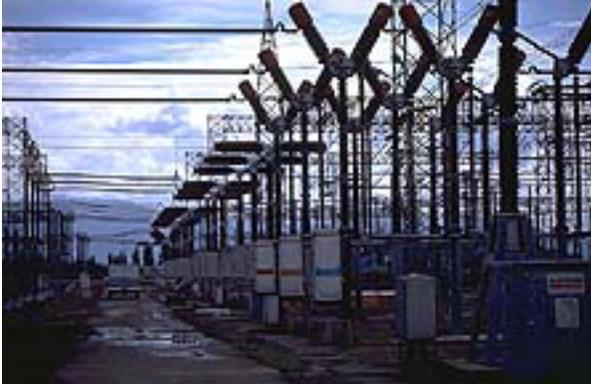
Figure 4-51a. View along service road showing pre- and post- earthquake circuit breakers

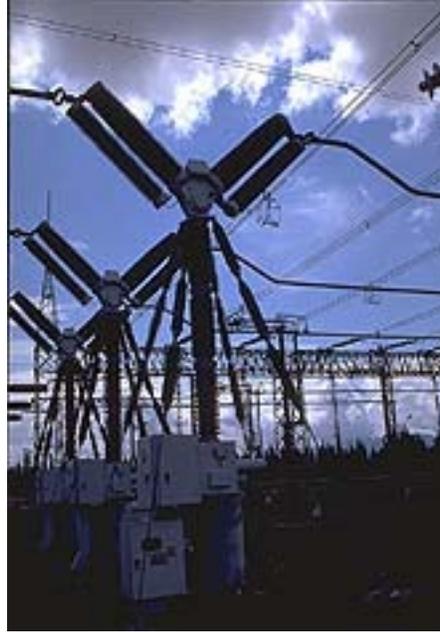
V-headed gas circuit breakers from a number of manufacturers were in service at the time of the earthquake. Many of the cantilever ABB circuit breakers failed during the earthquake. None of the braced Hitachi circuit breakers of Figure 4-52 were damaged.

Figure 4-52. Braced Hitachi gas circuit breaker, Adapazari substation

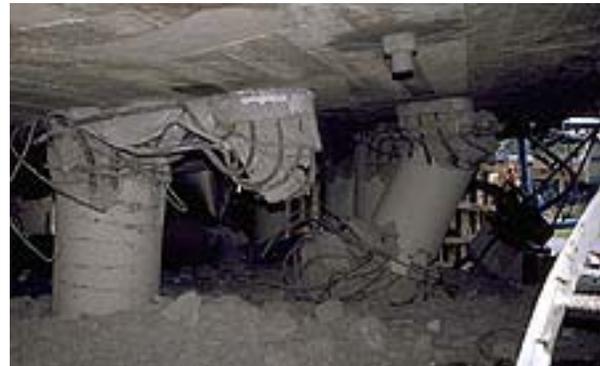
The two tanks containing liquid oxygen collapsed as seen in Figure 4-57. The tank and supporting structure containing liquid nitrogen was undamaged except for some hairline cracks in the columns. Habas representatives reported that the liquid oxygen tanks were 85% full, and the liquid nitrogen tank was 25% full at the time of the earthquake. The outer shells of the collapsed tanks buckled (Figure 4-58). Photographs of some of the failed columns beneath one of the liquid nitrogen tanks are presented in Figure 4-59.

Figure 4-59b. View of failed columns beneath liquid oxygen tank, Habas facility

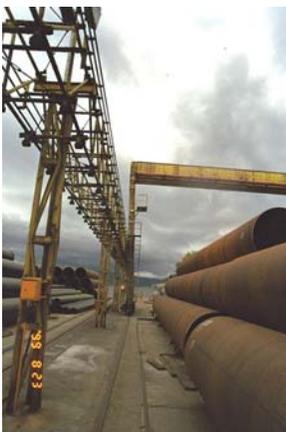
Figure 4-60a. Undamaged crane at

Damage was observed in reinforced concrete and steel buildings. In two buildings, shear cracking was prevalent in nonductile columns with short shear spans due to the presence of infill masonry walls. In one of the large-pipe production buildings, the anchor bolts of a steel moment-resisting frame elongated and fractured. In the storage yard at the large-pipe area, two cranes that were constructed in the early 1970s suffered identical failures of the box sections supporting one leg of the crane. Figure 4-60a is a photograph of an undamaged crane in the yard. Figure 4-60b shows the failed leg of another crane in the yard.

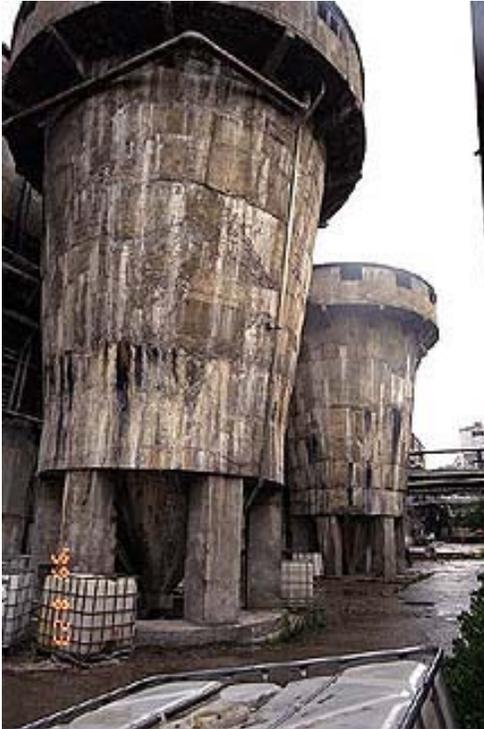
Figure 0-14-62a. Undamaged silo at SEKA paper mill

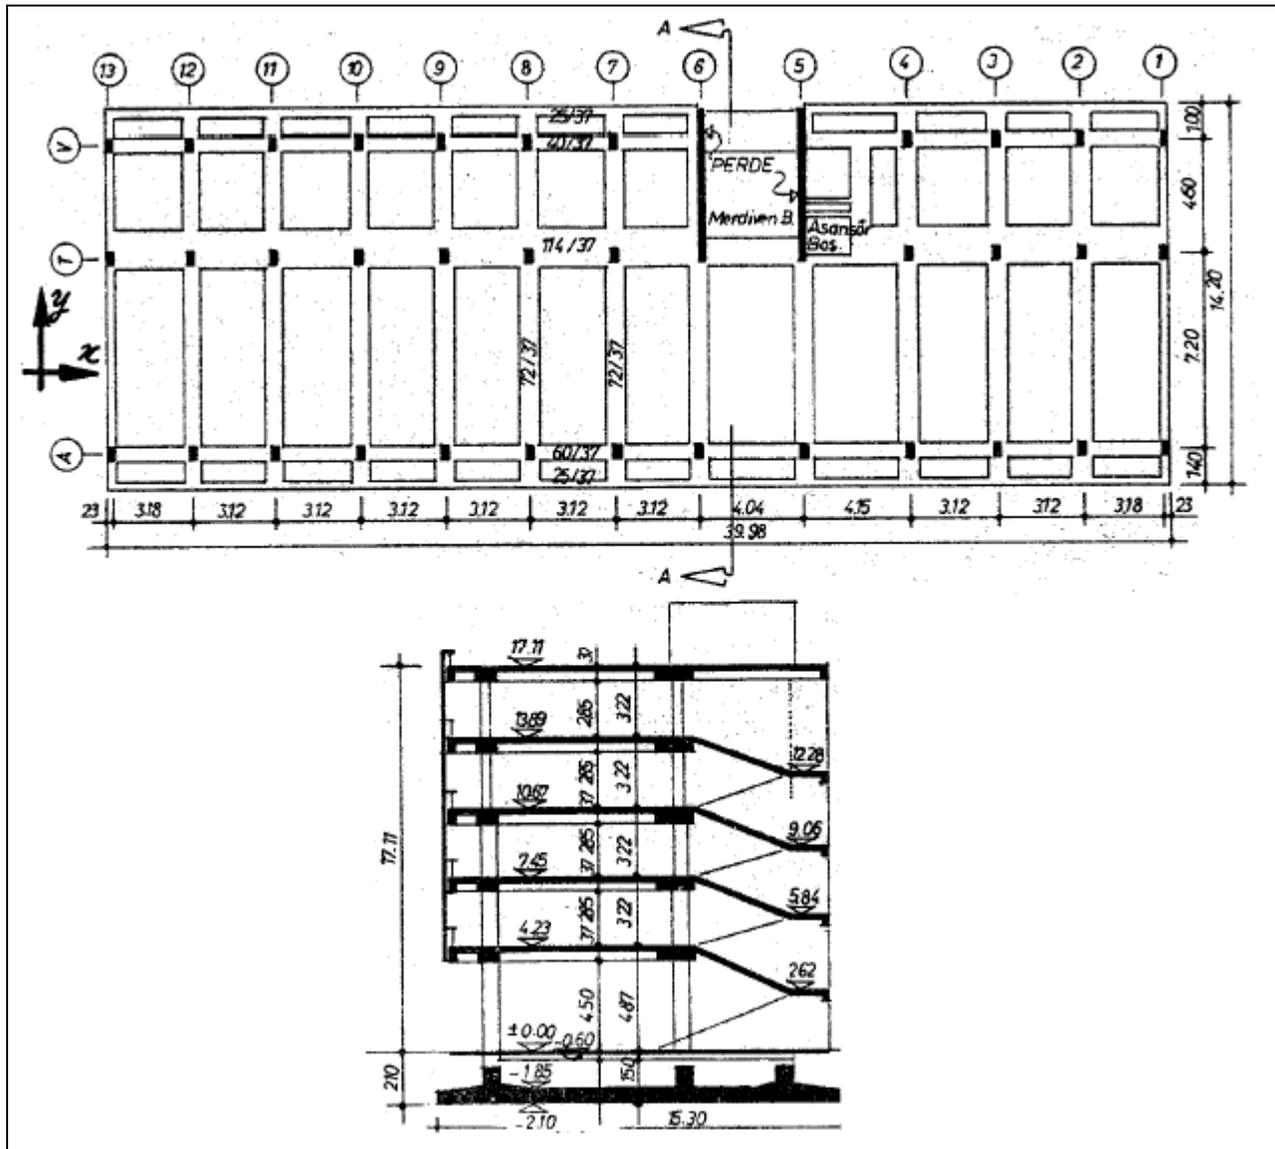
Figure A-1 Typical plan and elevation of the original building (Anadol et al. 1972)

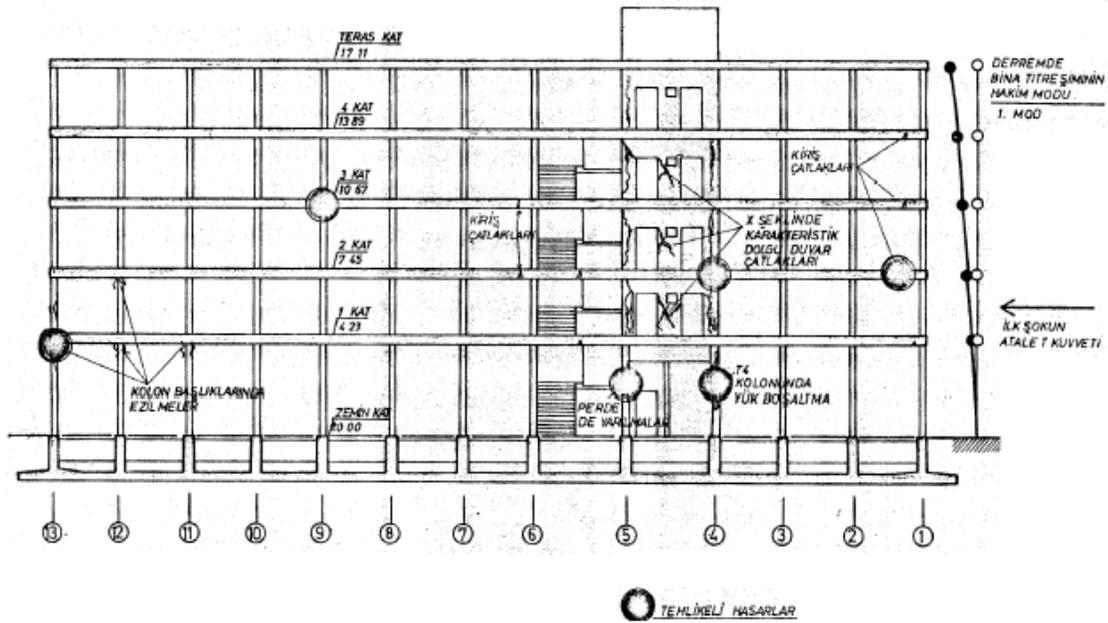
Construction of Adapazari City Hall was started in 1959 and completed in 1964. This five-story reinforced concrete frame building was heavily damaged during the July 22, 1967, Akyazi M7.1 earthquake and retrofitted using conventional methods in the eight-month period after that earthquake. Adapazari was 36 km east of the epicenter of the 1967 earthquake. The estimated intensity in Adapazari was MMI 7.

Figure A-2 Building damage after the 1967 Akyazi earthquake

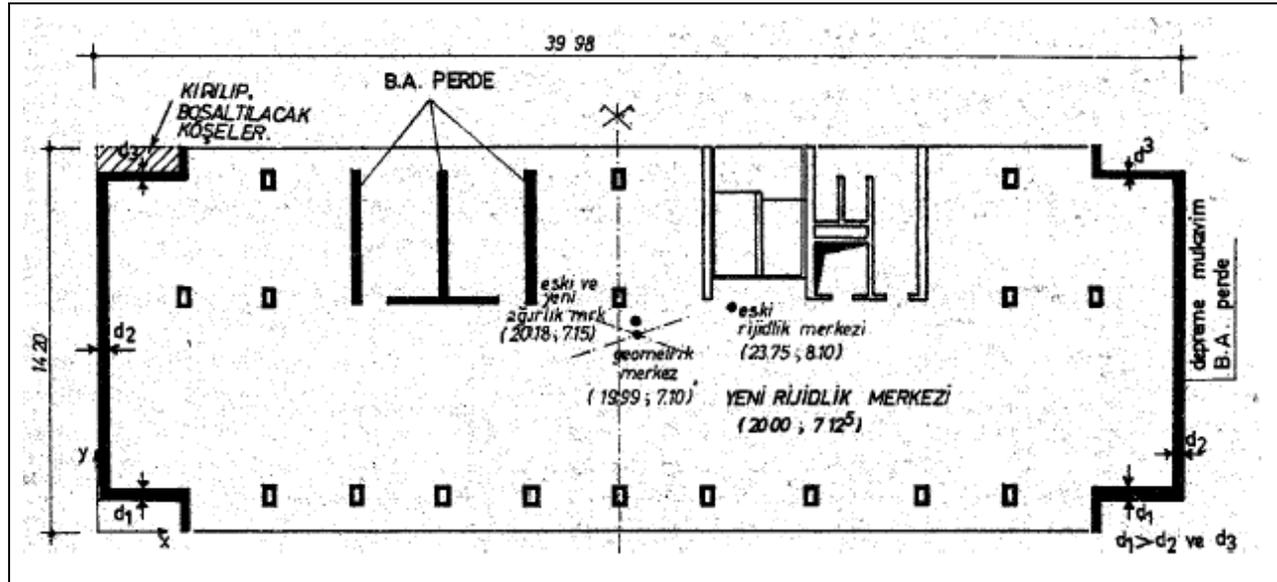
Figure A-4 Typical floor plan after retrofit showing the location of new shear walls (Anadol et al. 1972)

and substantially improve the performance of the building. Such conventional methods of retrofitting are the most promising and cost effective means of reducing the vulnerability of the large inventory of nonductile moment-frame buildings in Turkey.

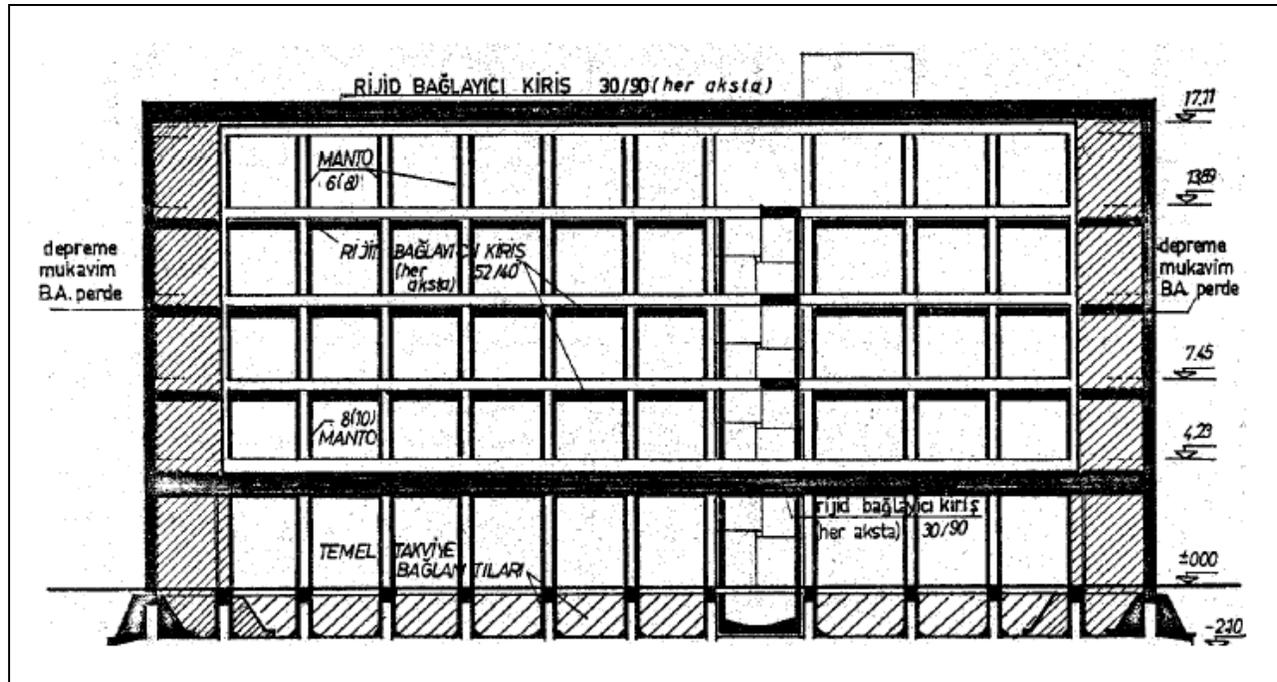
Figure A-5 Front elevation after the retrofit in 1968 (Anadol et al. 1972)

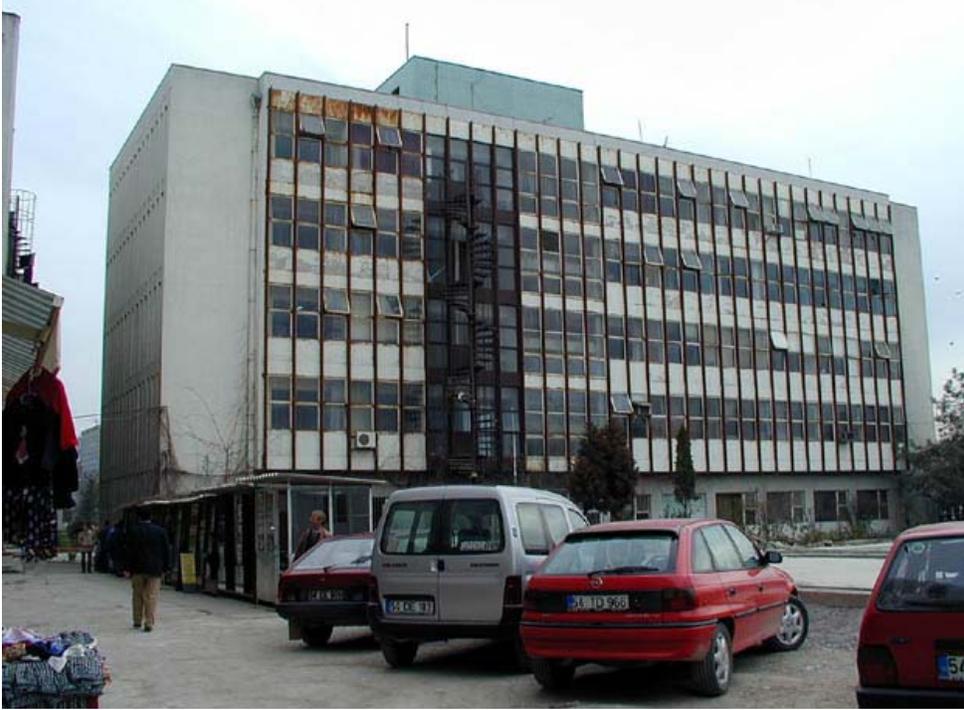
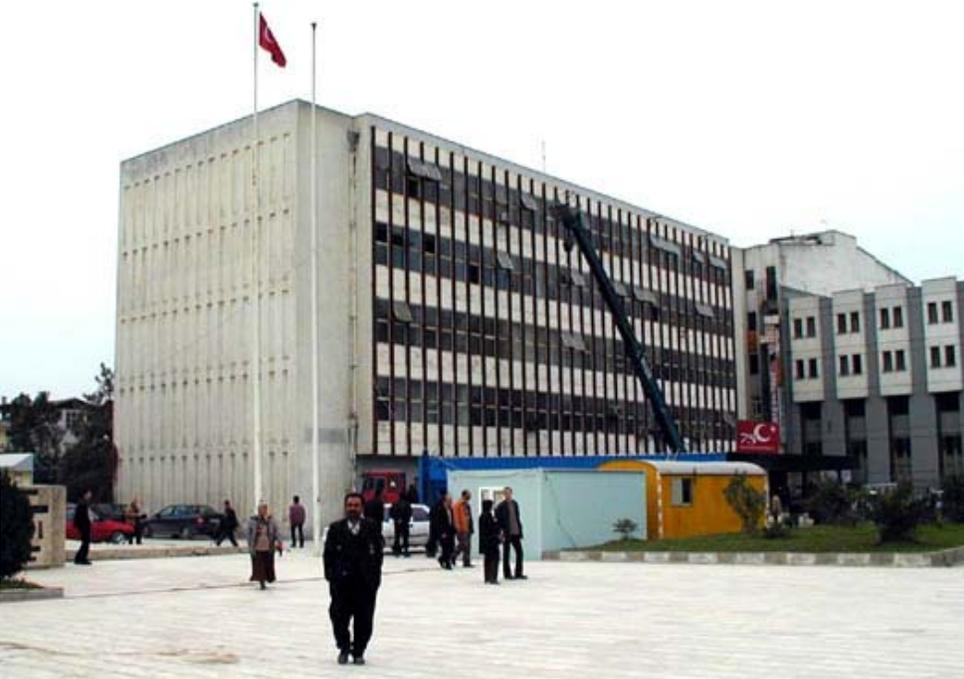
Figure A-6 City Hall after the November 12, 1999, Duzce earthquake

The excellent performance of the retrofitted Adapazari City Hall in the August 17, 1999, main shock and the November 11, 1999, aftershock is, by comparison with the poor performance of most reinforced concrete moment-frame buildings in the immediate vicinity of the City Hall, a clear endorsement for retrofitting using reinforced concrete shear walls. The introduction of a modest number of strategically placed ductile structural walls into an existing nonductile reinforced concrete moment-frame building will protect the vulnerable nonductile components

a. back view (V and 1 axes on plan, Fig. A-1)

b. front view (A and 13 axes on plan, Fig. A-1)
