PACIFIC EARTHQUAKE ENGINEERING RESEARCH CENTER

Damage to Bridges during the 2001 Nisqually Earthquake

PEER Report 2001/15

November 2001

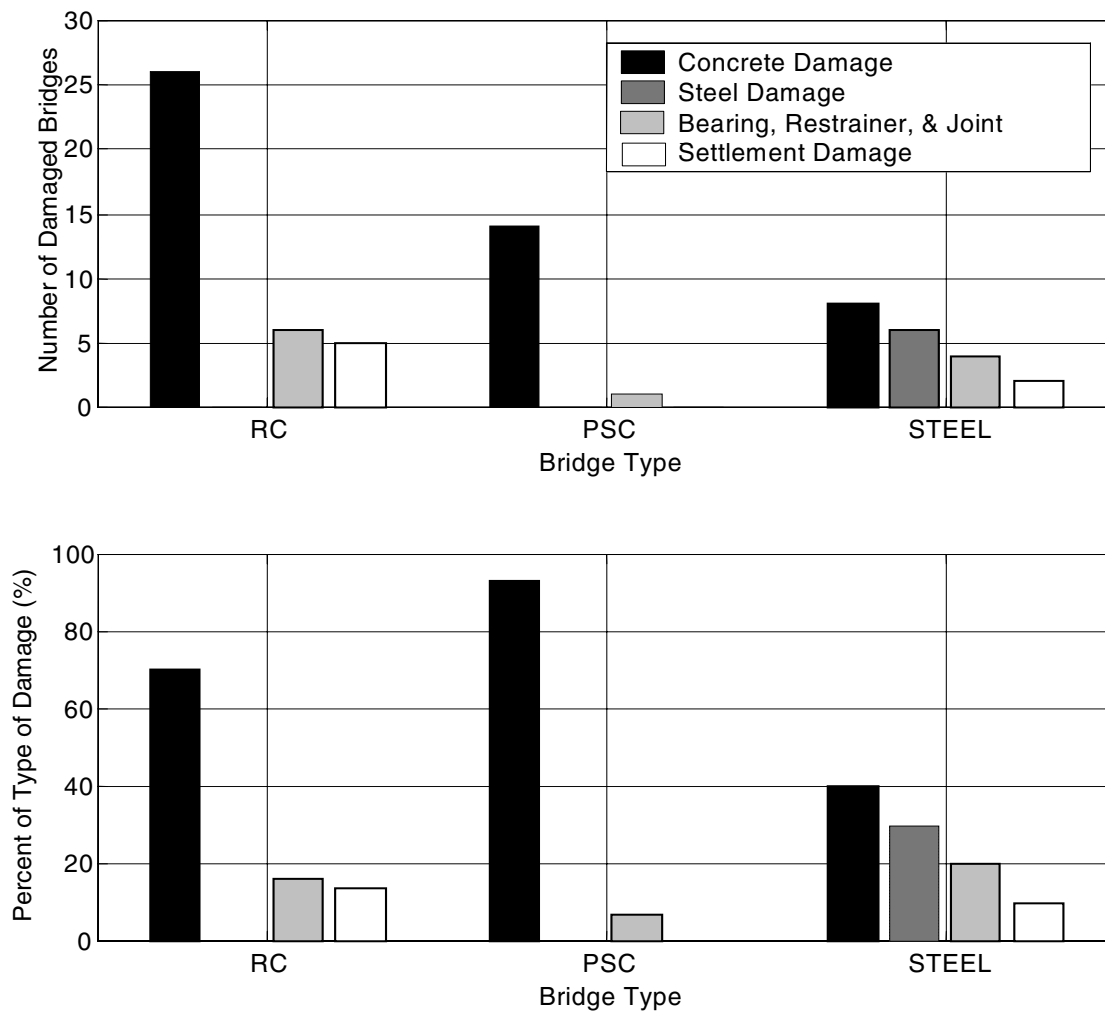
Fig. 2-1: Distribution of types of damage for each type of bridge

The distribution of damage type, sorted primarily by the type of bridge, is shown in Fig. 2-1. For each type of bridge, Fig. 2-1 displays the type of damage as a percentage of the total amount of damage for that type of bridge. For example, of the 36 reinforced concrete bridges that were damaged, 26 sustained damage to the reinforced concrete elements, resulting in a damage percentage of 72%.

According to the figure, concrete damage was the most prevalent type of damage for each of the three types of bridges. It had been expected that concrete damage would predominate in reinforced concrete and prestressed concrete bridges. More surprising is that damage to steel components represented only 30% of the damage to steel bridges. In comparison, 40% of damaged steel bridges were reported to have damage primarily to the reinforced concrete substructure. Most of the concrete damage to the steel bridges consisted of minor spalling of the concrete columns.

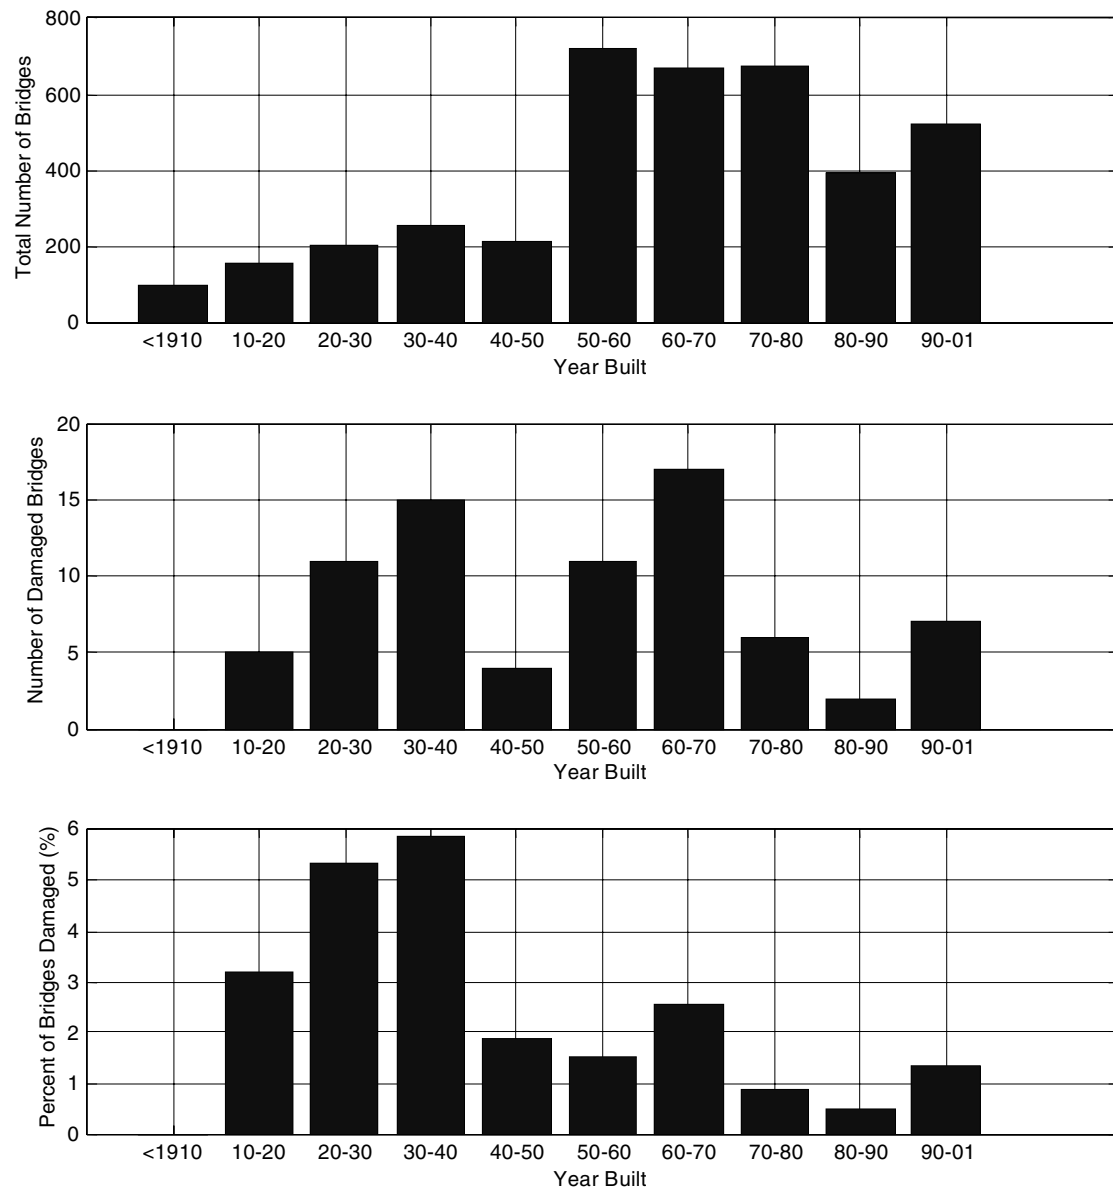
Fig. 3-1: Effect of year of construction, separated into decades

According to Fig. 3-1, the number of bridges constructed increased dramatically at the beginning of the 1950s, and then decreased at the beginning of the 1980s. This range of time coincides with the construction of the interstate highway system. The figure also shows that the percentage of the bridges that were damaged was largest for bridges constructed before 1940, averaging approximately 4.5%. Between 1940 and 1970, the percentage of bridges that were damaged were half that value, averaging approximately 2%. After 1970, this percentage was again reduced in half, averaging approximately 1%. Although the causes of the decline at the beginning of the 1940s are unclear, the drop at the beginning of the 1970s was expected. The San Fernando Earthquake occurred on February 9, 1971, and during the next few years, codes and practices were changed to reduce damage to structures (Moehle and Eberhard 1999).

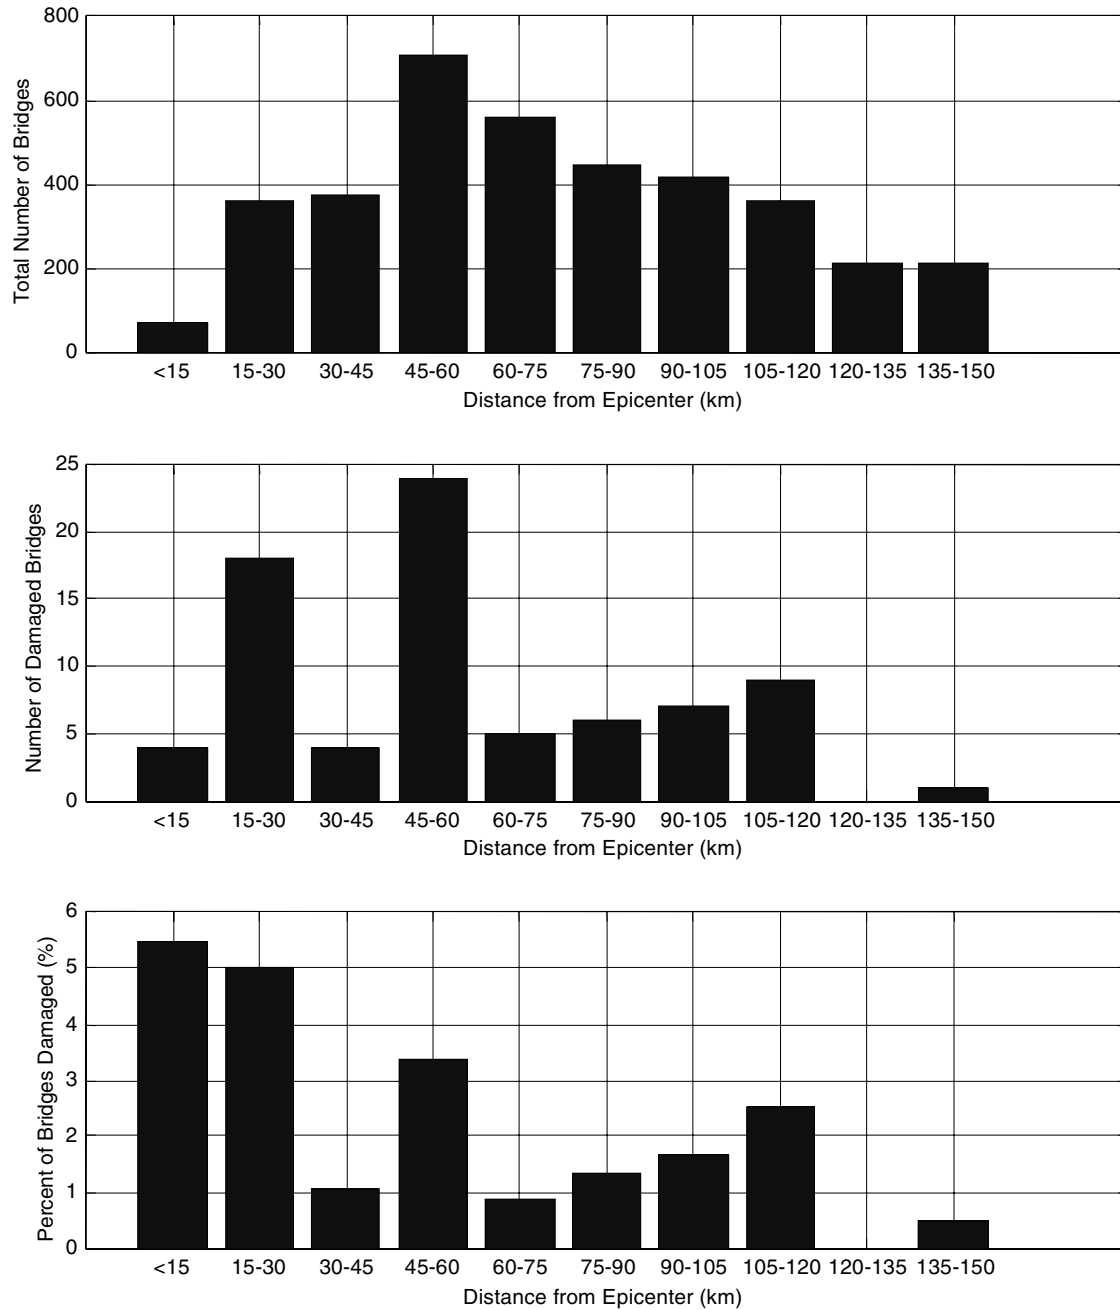
Fig. 3-2: Effect of distance to epicenter

As shown in Fig. 3-2, many bridges were damaged within the ranges of 15–30 km and 45–60 km. The range of 15–30 km corresponds to the distance to the City of Olympia, while the range of 45–60 km corresponds to the distance to the City of Seattle. As expected, the percentage of bridges that were damaged was largest near the epicenter. However, as the distance to the epicenter increased, the damage percentage did not decrease consistently. If the

intensity of the earthquake had depended only on the distance from the epicenter, the trend would have been more consistent. The correlation between damage and epicentral distance was weak, because epicentral distance does not account for the local geology. For example, the City of Seattle has a large number of bridges situated on soft soils.

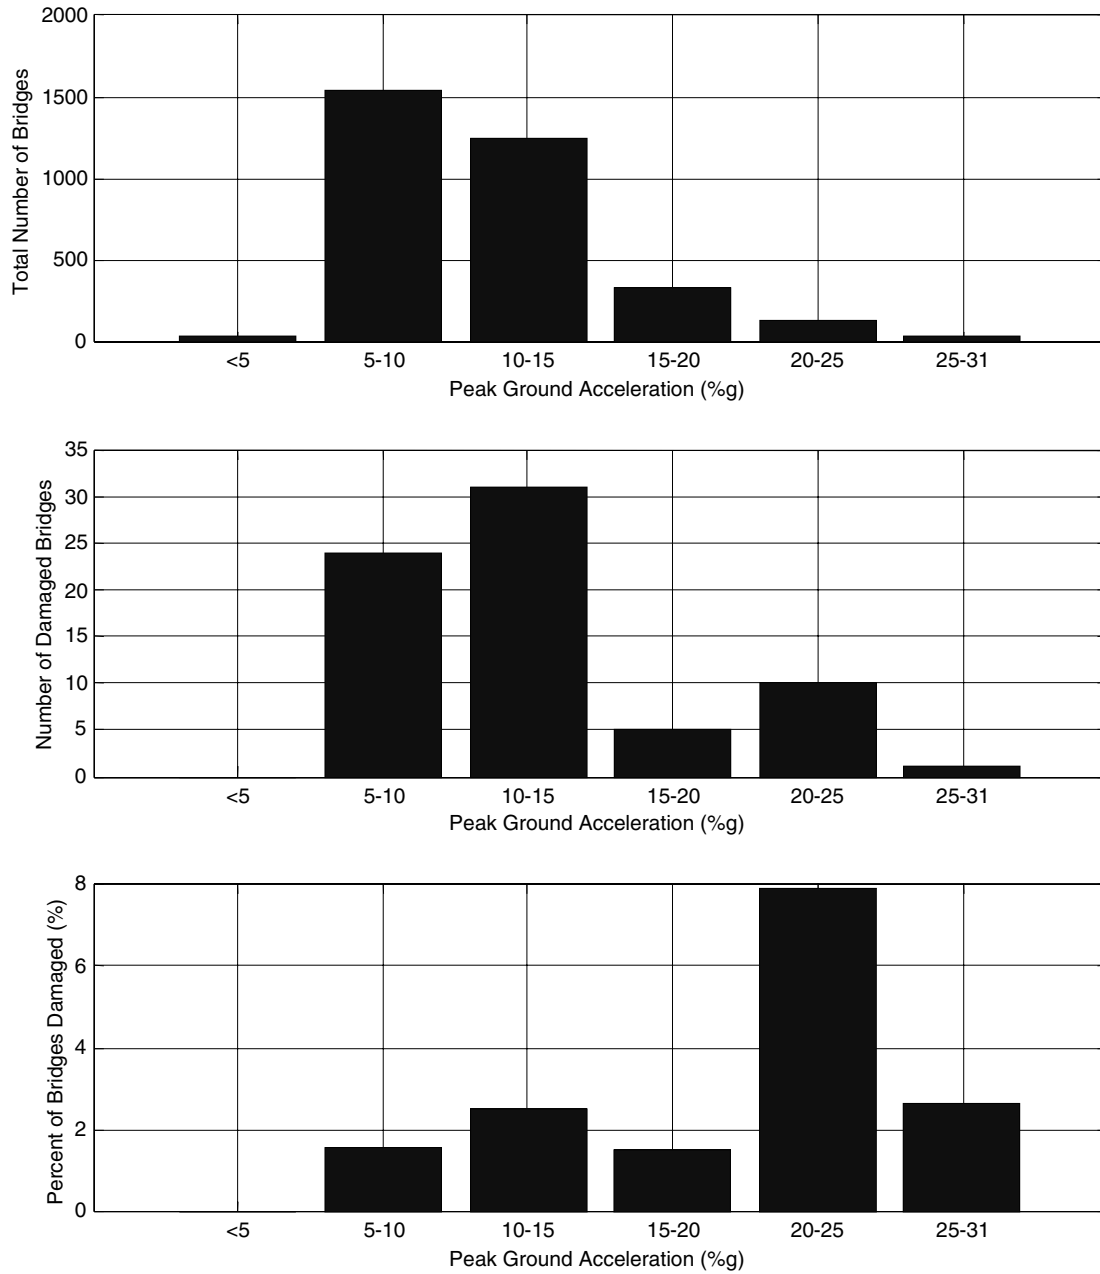
Fig. 3-3: Effect of peak ground acceleration

To investigate the effect of the estimated peak ground acceleration (PGA), the PGA at every bridge location was estimated from ShakeMaps, as described in Section 1.2. The ground-motion characteristics for seven of the damaged bridges could not be estimated from the ShakeMap, because they were located outside of the boundaries of the map (Section 1.2). Overall, 3,312 bridges (of which 71 were damaged) were located within the range of the ShakeMap, which corresponds to an average damage percentage of 2.1%. The analysis of the percentage of bridges damaged as a function of the PGA is shown in Fig. 3-3. As shown in Fig. 3-4, there is only a weak correlation between the level of the estimated peak ground acceleration and the percentage of bridges that were damaged. From this figure, one can only conclude that bridges with peak ground accelerations above 0.2g were more likely to be damaged than bridges subjected to lower peak accelerations.

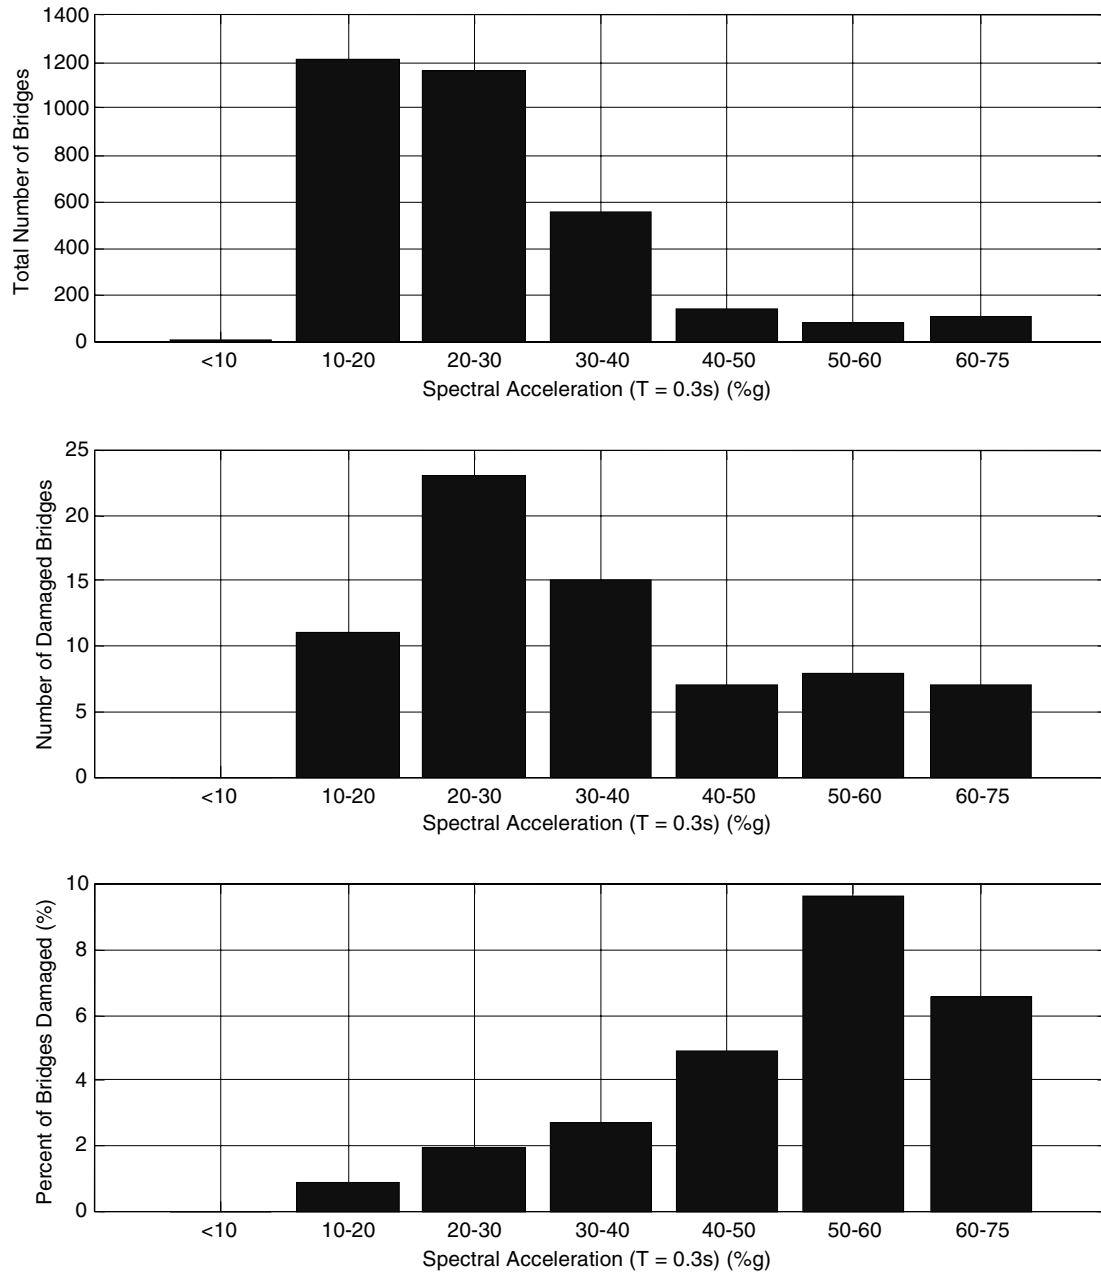
Fig. 3-4: Effect of spectral acceleration at a period of 0.3 s

The percentage of the bridges that were damaged correlated well with the magnitude of the spectral acceleration at 0.3 s, as shown in Fig. 3-4. An exception to this trend was the decrease at the highest range of the spectral acceleration. This anomaly is most likely attributable to the small number of bridges in each category.

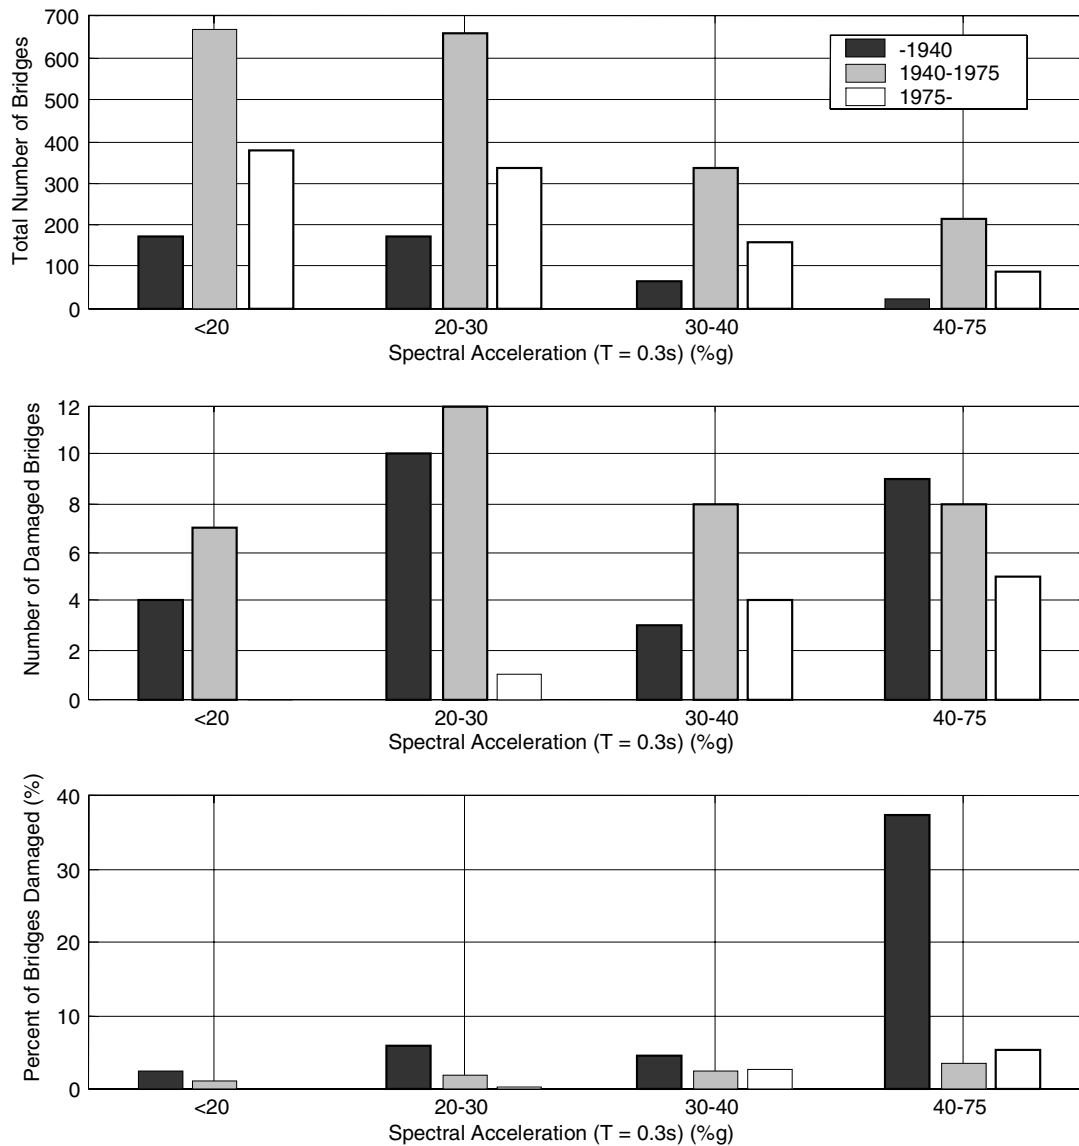
Fig. 3-5: Combined effect of spectral acceleration and year of construction

As noted before, the bridges with high spectral accelerations were more likely to be damaged. Moreover, at each level of spectral acceleration, the bridges that were built before 1940 had the highest percentage of damaged bridges, and in general, those built after 1975 were the least likely to be damaged.

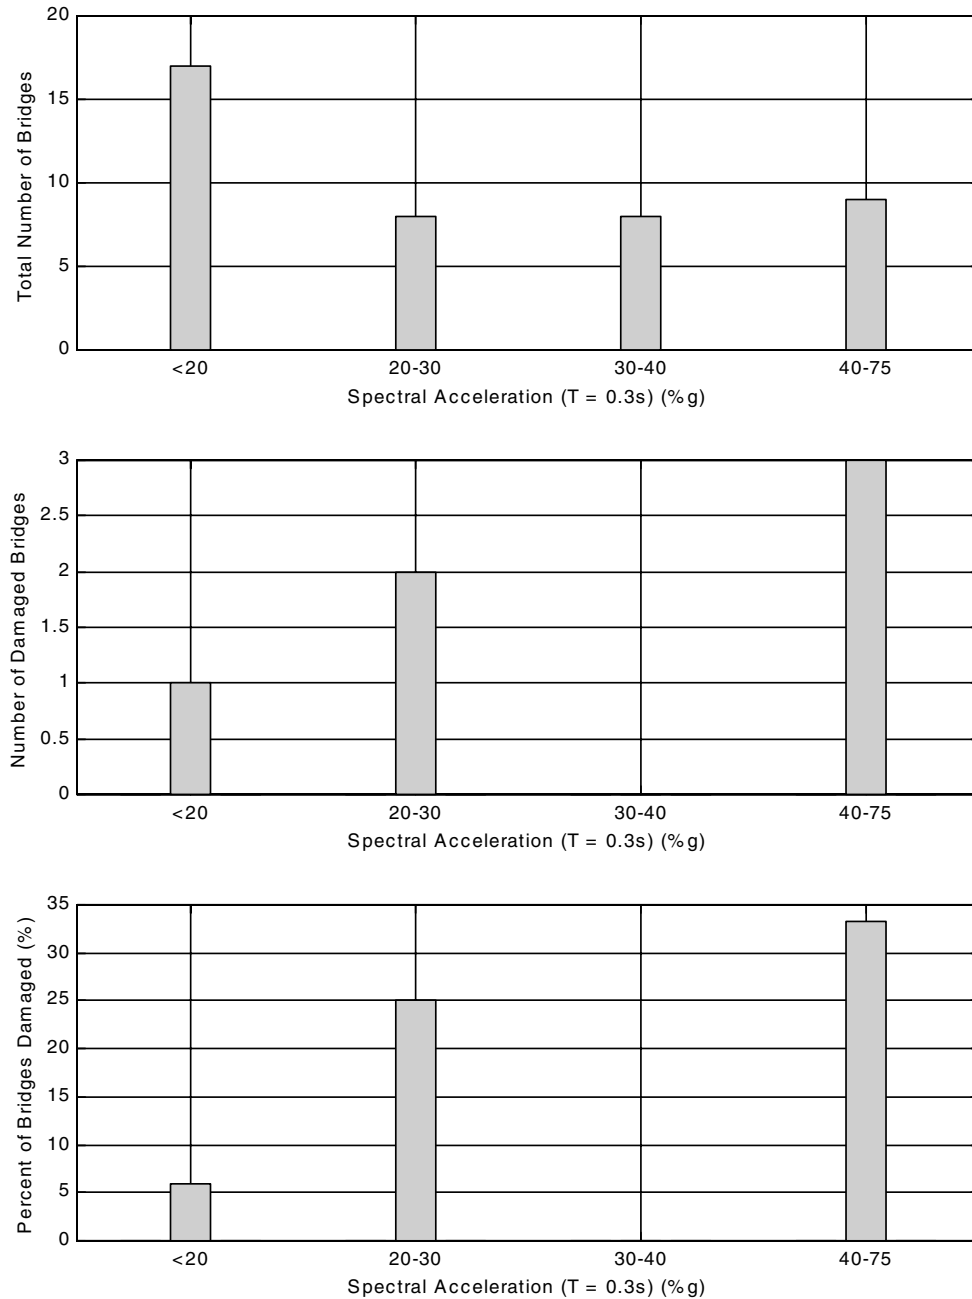
Fig. 3-6: Effect of spectral acceleration on movable bridges

The movable bridges were the most vulnerable type of bridge. Of the 42 movable bridges within the boundaries of the ShakeMap, six were damaged, resulting in an average damage percentage of 14%. Fig. 3-6 shows that the percentage of damaged movable bridges tended to increase with spectral acceleration. For example, of the nine bridges with estimated spectral accelerations above 0.4g, three (33%) were reported to have suffered damage. There was a notable exception to this trend. None of the eight movable bridges with estimated spectral accelerations in the range 0.30g to 0.40g were reported to suffer any damage. Such exceptions should be expected for small data sets.

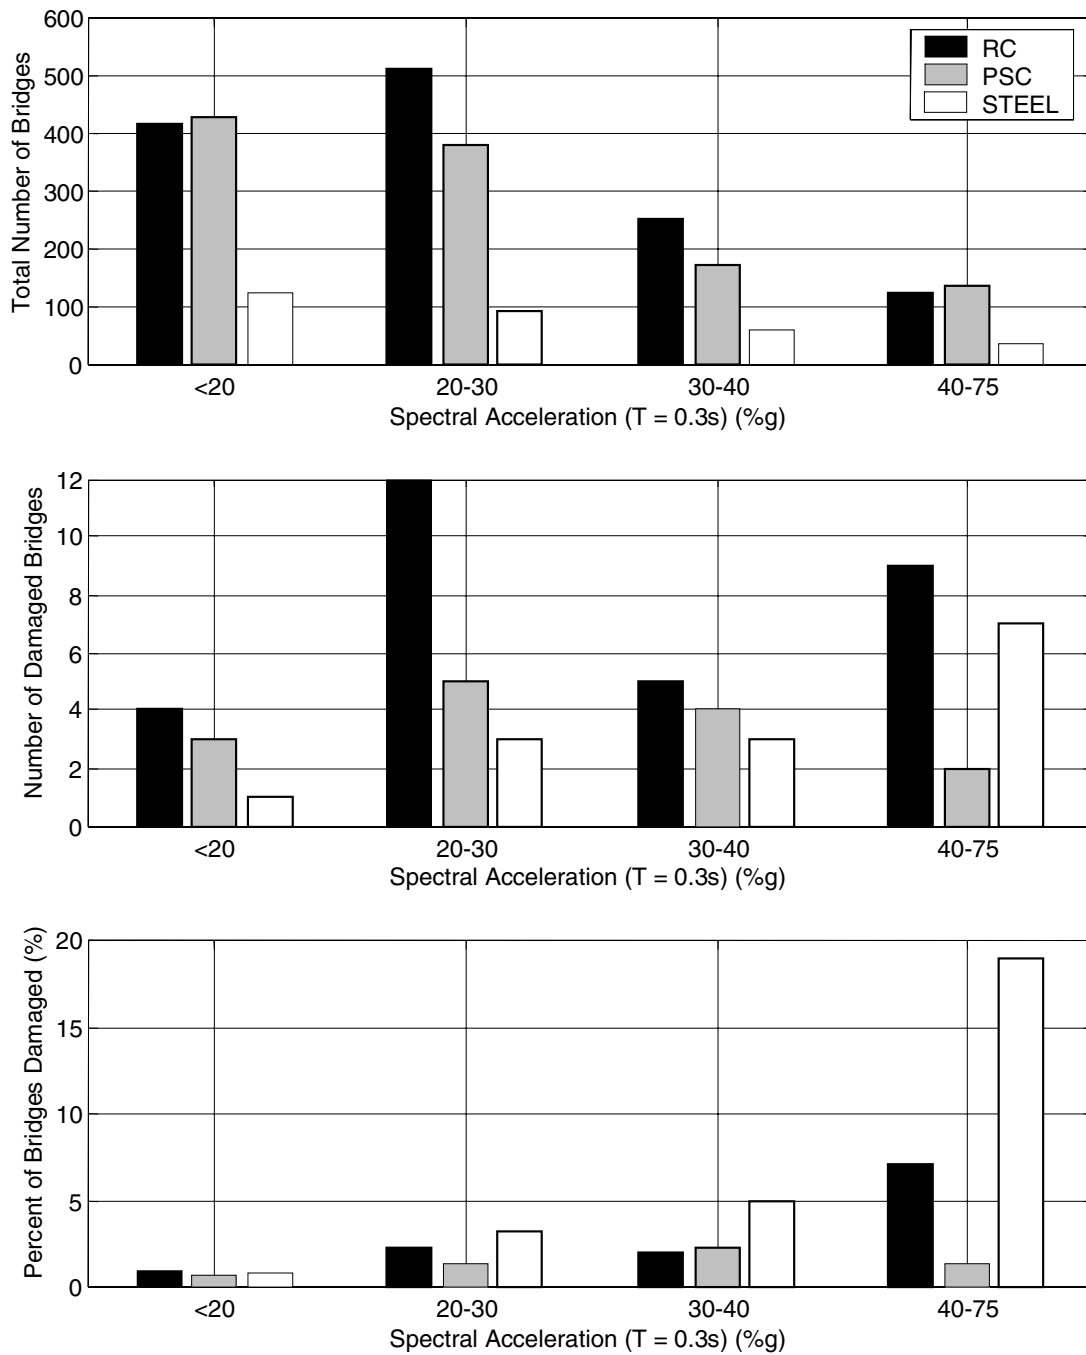
Fig. 3-7: Combined effect of spectral acceleration and bridge type

Despite the small number of damaged bridges in each category, Fig. 3-7 shows a clear correlation between the percentage of bridges that were damaged and the level of spectral acceleration. Based on this breakdown, it appears that the steel bridges were more vulnerable

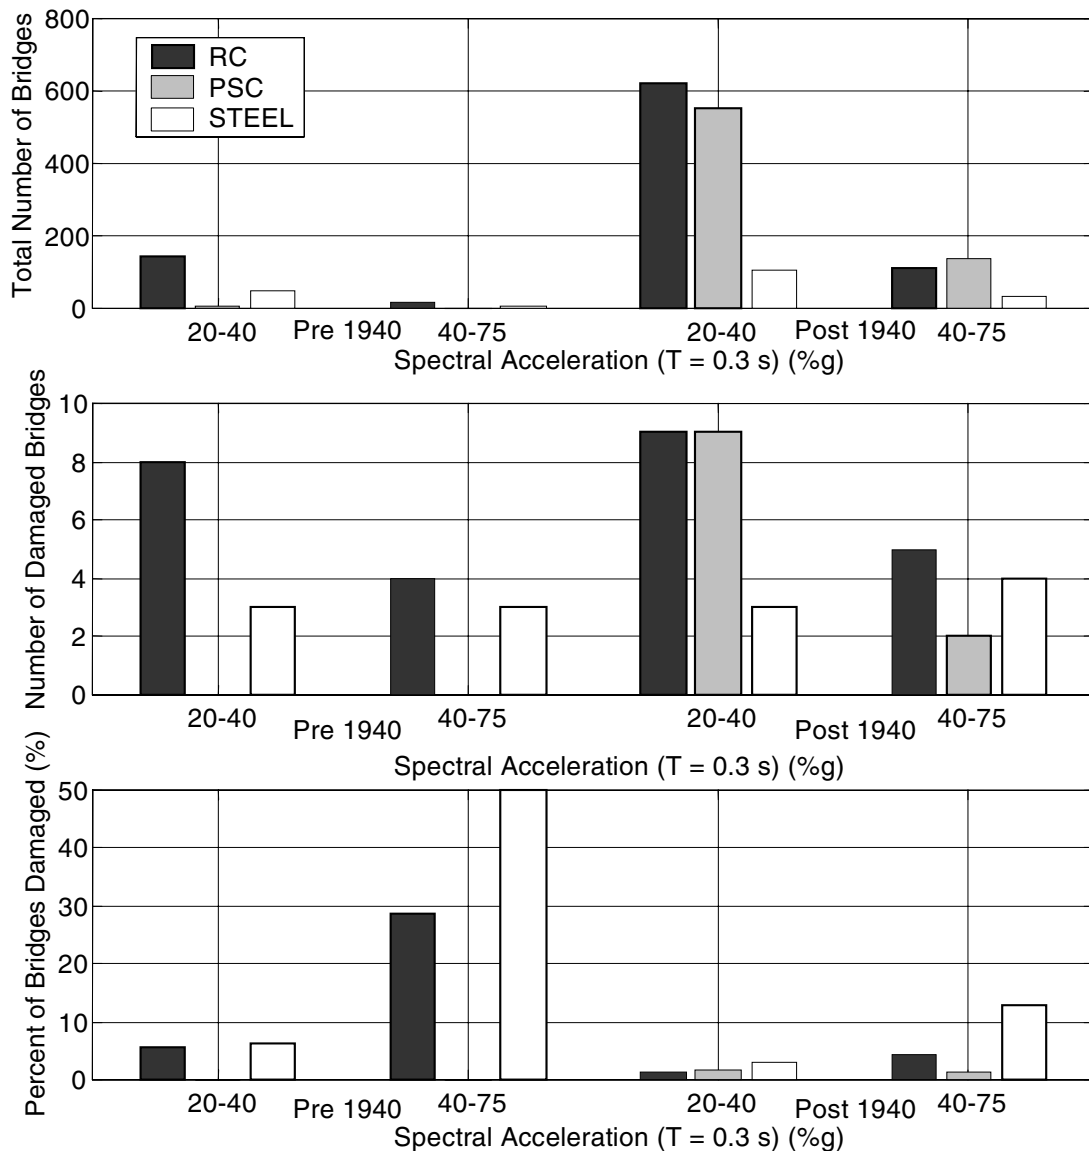
Fig. 3-8: Combined effects of spectral acceleration, year of construction, and bridge type

than those constructed of reinforced or prestressed concrete. However, this observation is not attributable solely to the type of bridge, but to the year that the bridges were constructed, as shown in Fig. 3.8. As shown in this figure, both reinforced concrete and steel bridges that were constructed before 1940 were much vulnerable than bridges constructed later. In addition, 40% of the damage to steel bridges consisted of damage to the reinforced concrete substructure (Fig. 2-1).
