Cripple Wall Small-Component Test Program: Wet Specimens I

**A Report for the “Quantifying the Performance of
Retrofit of Cripple Walls and Sill Anchorage in Single-
Family Wood-Frame Buildings” Project**

PEER Report 2020/16

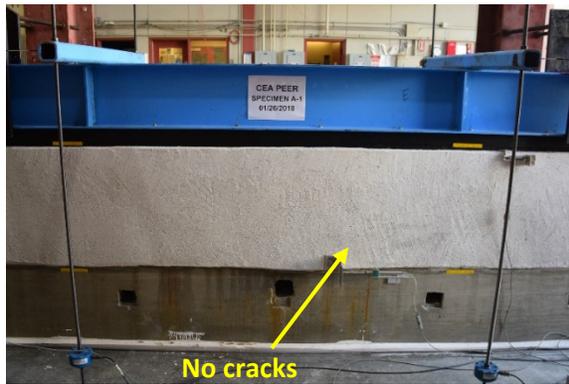
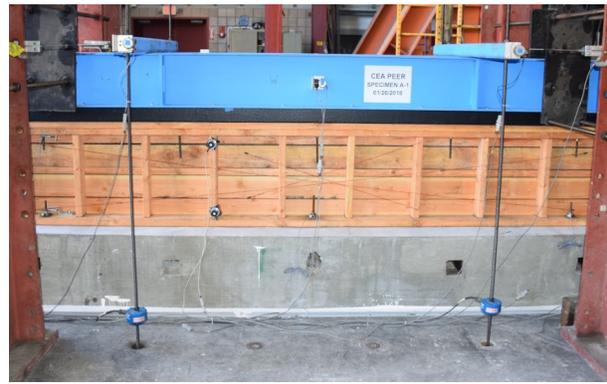
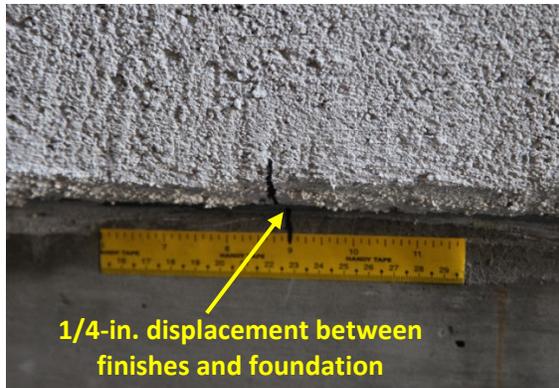
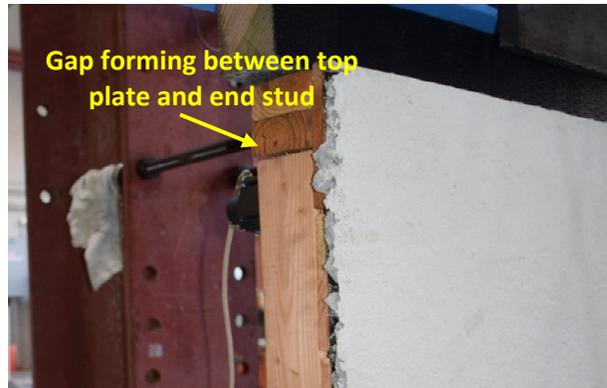
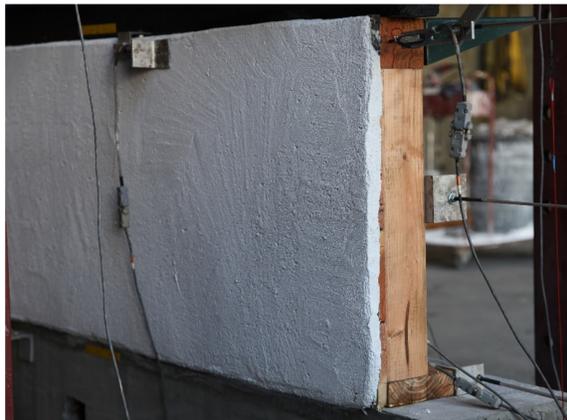
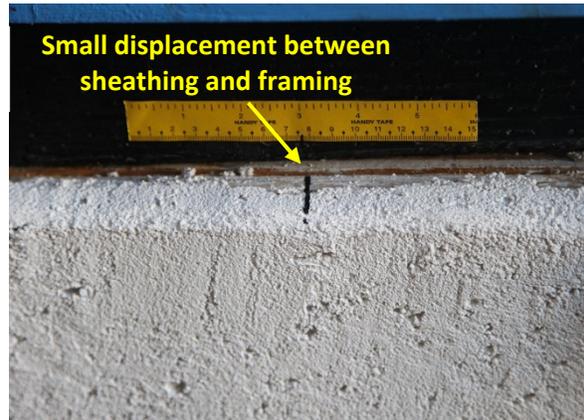
Figure 5.2(a) to (f) show the damage state of Specimen A-1 at 1.4% drift amplitude. At this low-level amplitude, no cracks had yet formed on the stucco face. On the interior of the wall, the studs began to uplift and exhibit slight rotation. This uplift and rotation can be seen in the connection of the studs to the sill plate as well as the connection to the top plates. The most noticeable damage characteristics are as follows: the 1/4 in. of relative slip between stucco and foundation face at the base of the cripple wall and the 1/8 in. of relative slip between the stucco and framing at the top of the cripple wall. From an exterior view, the lack of cracking on the specimen would indicate that at this point there was minimal-to-no structural damage to the wall.

Figure 5.2 Specimen A-1 damage state at -1.4% drift @ $\Delta = -0.336$ in.: (a) exterior elevation; (b) interior elevation; (c) bottom of exterior wall displacement; (d) south top exterior and corner view; (e) north exterior and corner view; and (f) top of wall displacement.

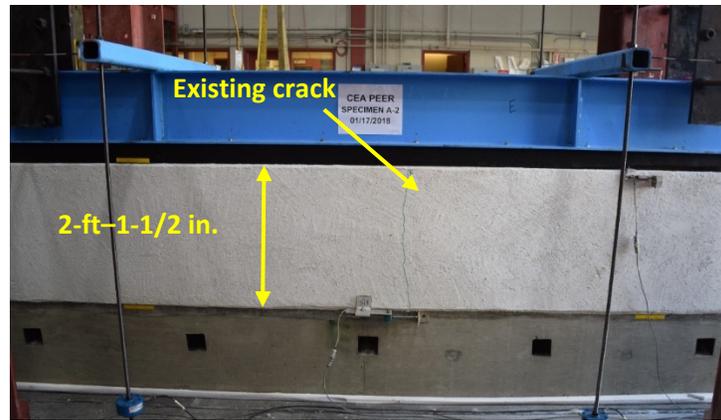
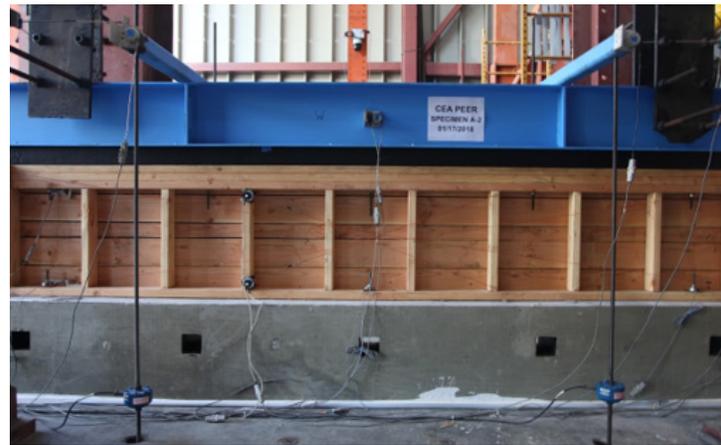
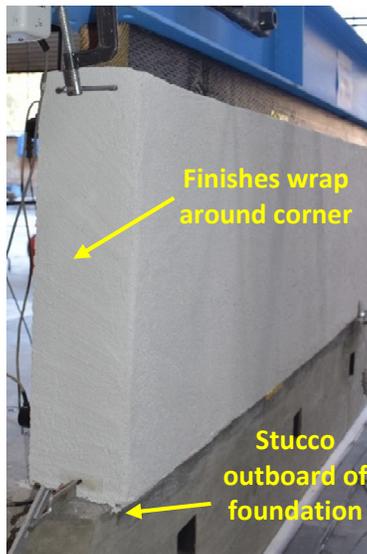
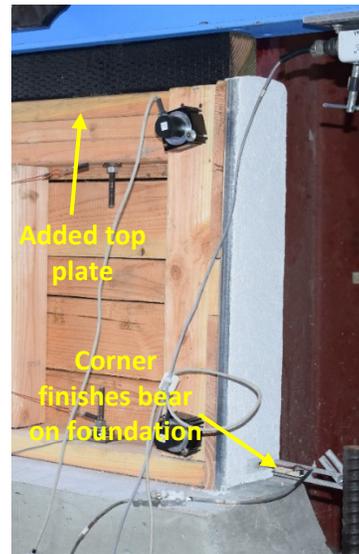
Figure 5.3 shows the initial state of Specimen A-2 prior to testing. The primary difference between Specimen A-1 versus Specimen A-2 is the change in the boundary conditions. Specimen A-2 utilized an extra top plate to allow for two rows of a denser furring nail arrangement. This provides the extra 1-1/2 in. of wall height compared with Specimen A-1, which contained only a double top plate. In addition, Specimen A-2 incorporated built-up corners, featuring two 2 × 4 corner studs and a 2 × 4 flat stud. In addition, the finishes wrapped 6 in. around the corner; see Figure 5.3(c). The stucco finish was outboard of the foundation, while the face of the horizontal sheathing boards was flush with the foundation face. Specimen A-2 had top boundary condition B and bottom boundary condition “c”; see Figure 5.3(a); note that a crack had already formed on the face of the stucco prior to testing.

Figure 5.3 Specimen A-2 pre-test photographs with existing top boundary condition B, bottom boundary condition "a": (a) exterior elevation of cripple wall; (b) interior elevation of cripple wall; (c) north-end exterior and corner view; and (d) north-end interior and corner view.

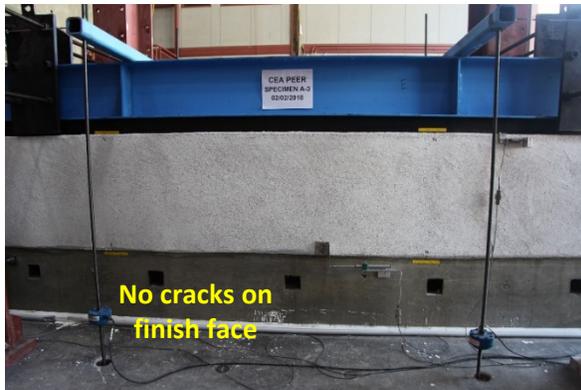
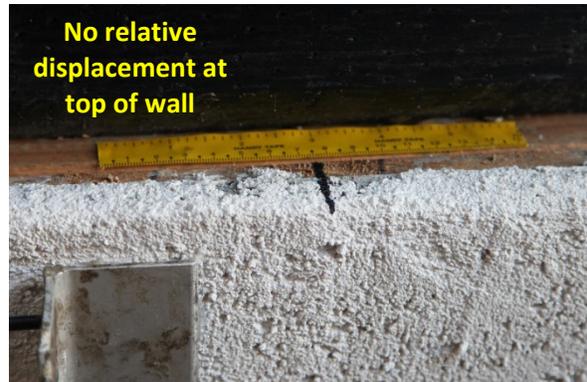
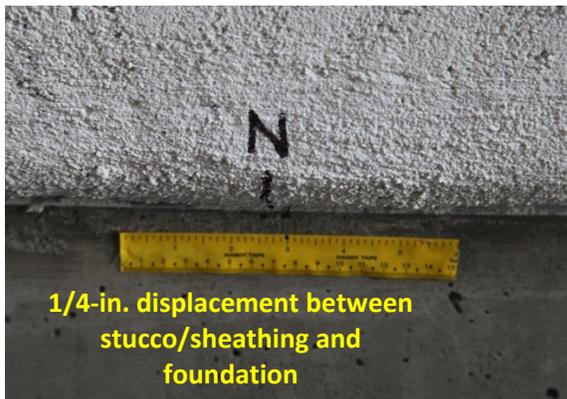
Figure 5.6(a) to (f) show the damage state of Specimen A-3 at 1.4% drift amplitude. At this drift level, no cracks had yet formed on the exterior face of the stucco besides a small crack running diagonally from the top of the cripple wall to the corner on the north. Many cracks started propagating vertically at the corners; see Figure 5.6(d) and (e). Similar to the previous specimen, these cracks started at the 0.2% drift amplitude and continued to extend in subsequent cycles of increased drift amplitude. Note: no cracks appeared on the face of either return walls. Figure 5.6(c) shows that stucco-to-foundation slip of 3/8 in. occurred, which is higher than the previous test; however, unlike the previous test, the slip of the sheathing relative to the framing did not occur. The continued reduction of relative displacement between the sheathing and framing is attributed to the presence of extended corners (end return walls), which offered additional resistance. This is demonstrated by the 50% reduction in slip. The return walls showed significant uplift and slight rotation in the studs; see Figure 5.6(d).

Figure 5.6 Specimen A-3 damage state at -1.4% drift @ $\Delta = -0.336$ in.: (a) exterior elevation; (b) top of the exterior wall; (c) bottom of exterior wall; (d) bottom of interior wall; (e) north-end of exterior corner; and (f) south-end of exterior corner.

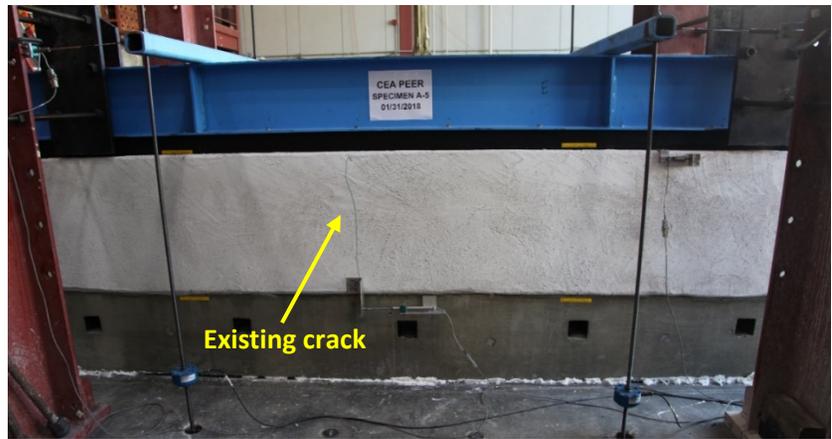
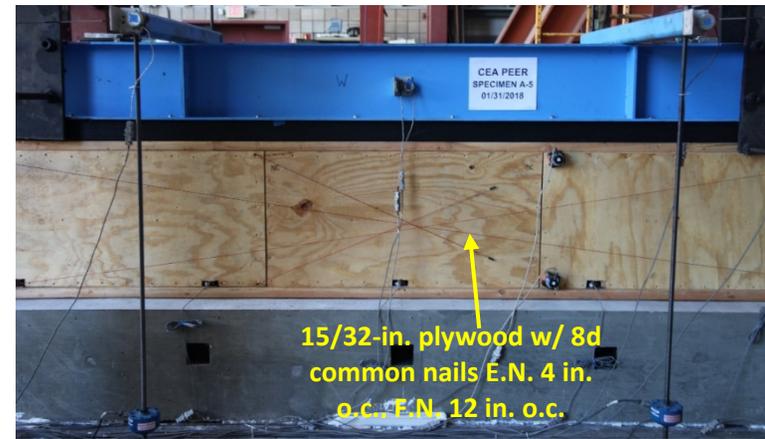
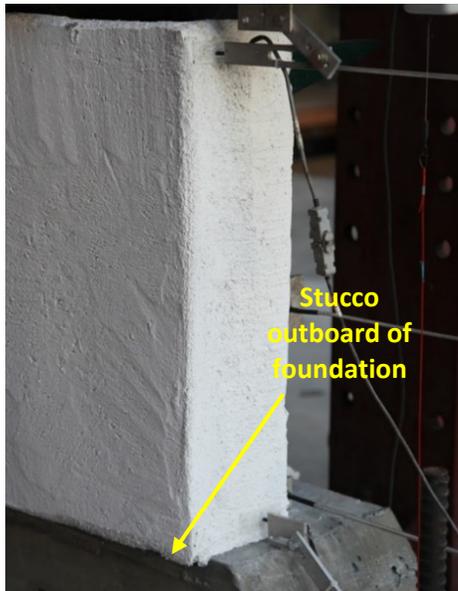
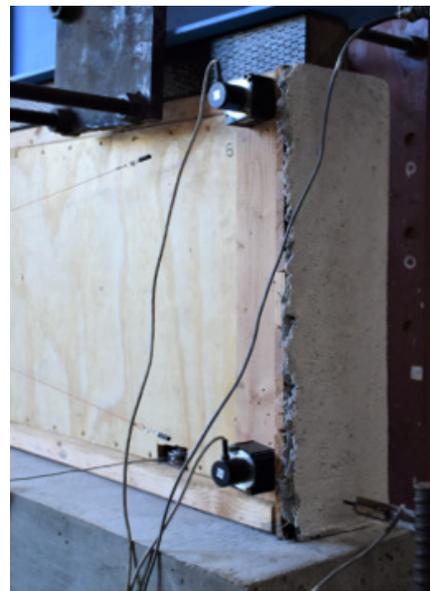
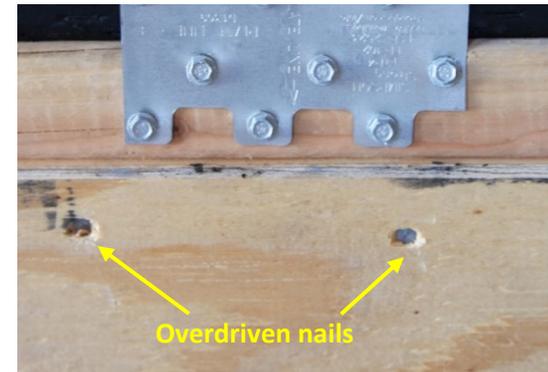
Photographs in Figure 5.9 show the initial state of Specimen A-5 prior to testing. Specimen A-5 has the same boundary conditions as the Specimen A-2 but was retrofitted. The retrofit consisted of 100% bracing of 15/32-in. plywood panels. Each panel was 4 ft long and ran from the sill plate to the top of the middle top plate. As described in Chapter 3, additional studs and blocking were placed on the interior of the cripple wall to allow for connection of the plywood panels. The plywood was connected with 8d common hot-dipped galvanized nails at 4 in. on center over the edge and 12 in. on center over the field. In addition, two anchor bolts were added to decrease the spacing from the typical 64 in. on center, as is with the previous cripple walls, to 32 in. on center. The retrofit detail conforms to the ATC-110 design guidelines. As shown in Figure 5.9(a), a vertical crack had formed along the face of the stucco prior to testing, and that ~one-fourth of the nails were slightly overdriven between 1/16 and 1/8 in.; see Figure 5.9(e).

Figure 5.9 Specimen A-5 (retrofitted) pre-test photographs with top boundary condition B and bottom boundary condition "a": (a) exterior elevation; (b) interior elevation; (c) exterior north-end corner view; (d) interior north-end corner view; and (e) close-up of plywood nailing at top of wall.

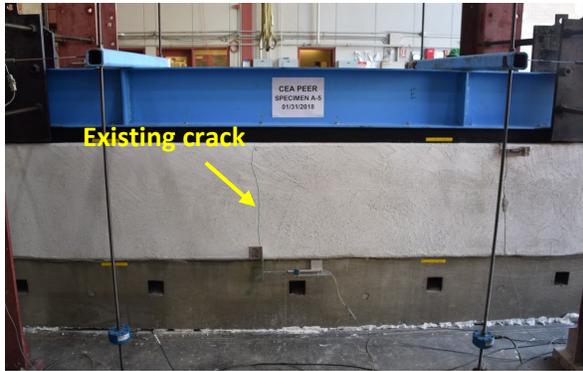
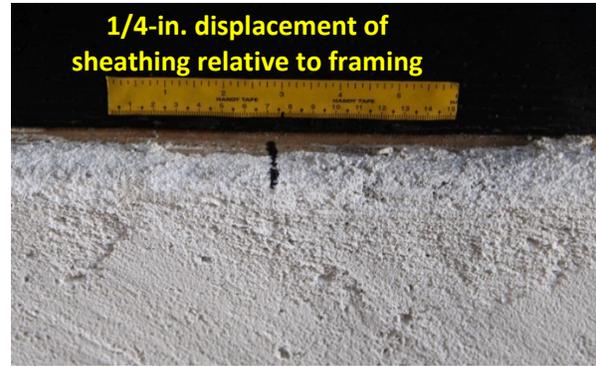
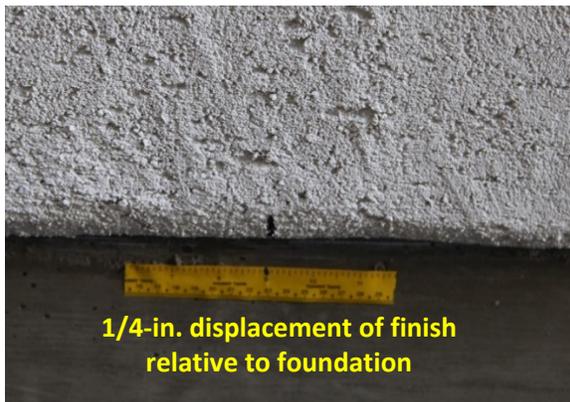
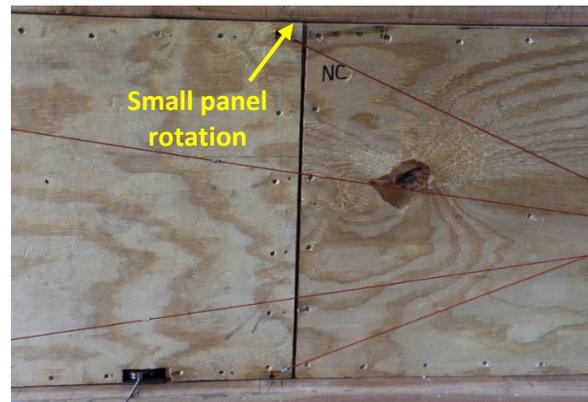
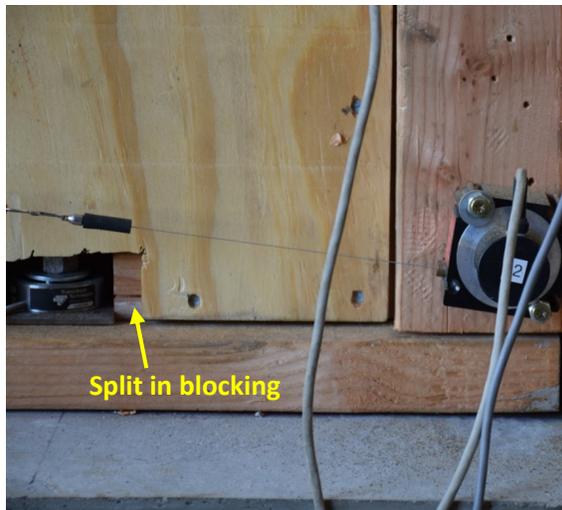
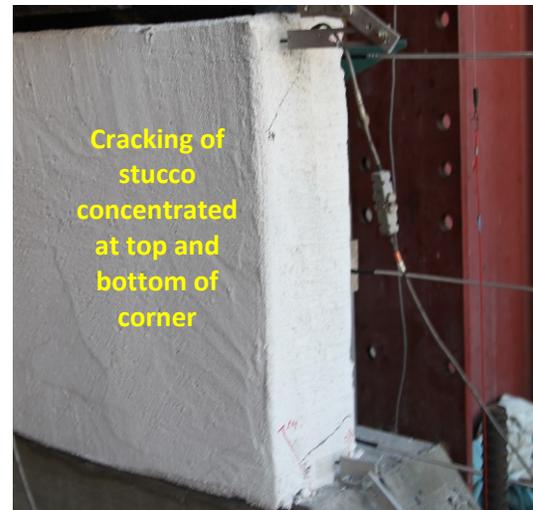
Figure 5.10(a) to (f) shows the damage state of Specimen A-5 at 1.4% drift amplitude. At this drift level, no additional cracks formed on the face of stucco. There was a large reduction in the amount of cracking at the corners of the cripple wall compared to Specimens A-2 through A-4; see Figure 5.10(f). This could be because much of the work resisting displacement was due to the retrofit strategy instead of the finish materials bearing on the foundation at both ends of the specimen, as was the case with Specimen A-2. As with Specimen A-2, there was a 1/4-in. slip between the stucco and the foundation, as well as disconnect between the stucco and the foundation at the base of the cripple wall. At the top of the cripple wall, a 3/16-in. displacement between the sheathing and framing formed, which is the largest seen in any of the previous tests. This is due to the framing members being significantly stiffened by the attachment of the plywood panels on the interior face. On the interior face, small slips between the plywood panels had started to form as the plywood panels began to rotate. The 1/8-in. gap between abutting plywood panels remained; therefore, the wood structural panels had not yet begun to bear down on each other. Figure 5.10(e) shows that some of the nails were slightly overdriven and had started to pull through the plywood. For the other nails that attached the plywood to framing, minimal rotation or pulling through was visible at this drift level.

Figure 5.10 Specimen A-5 damage state at +1.4% drift @ $\Delta = +0.336$ in.: (a) exterior elevation; (b) top of exterior wall; (c) bottom of exterior wall; (d) plywood panel joint; (e) close-up of top of the south-end interior wall; and (f) north-end exterior corner.

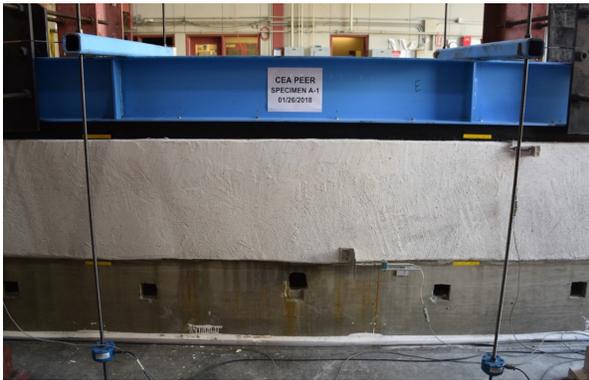
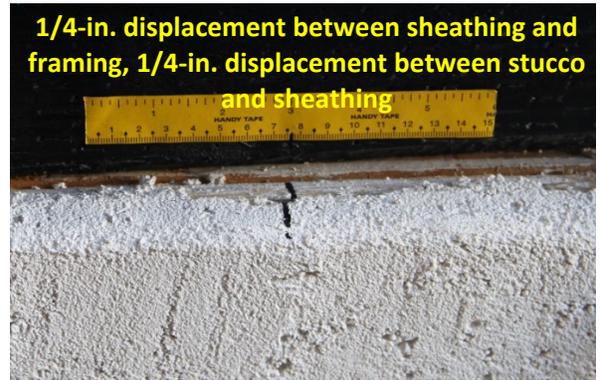
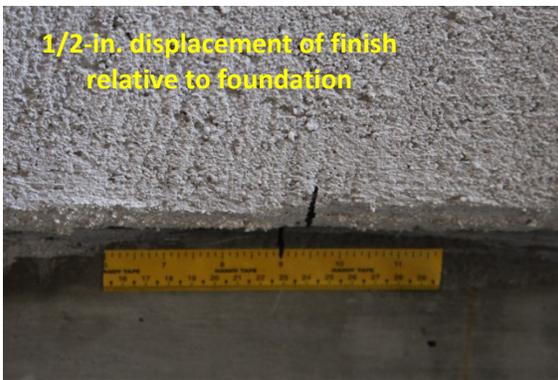
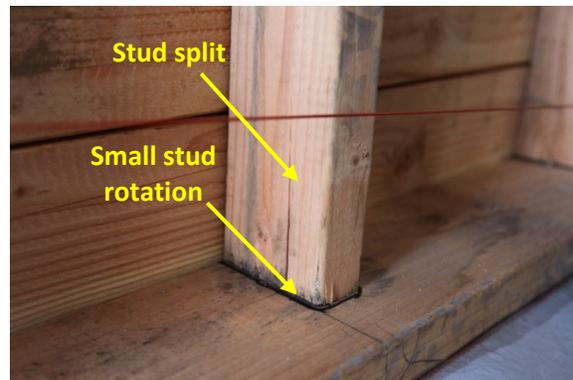
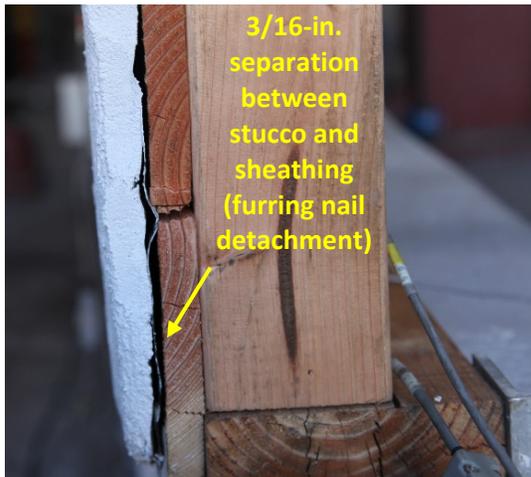
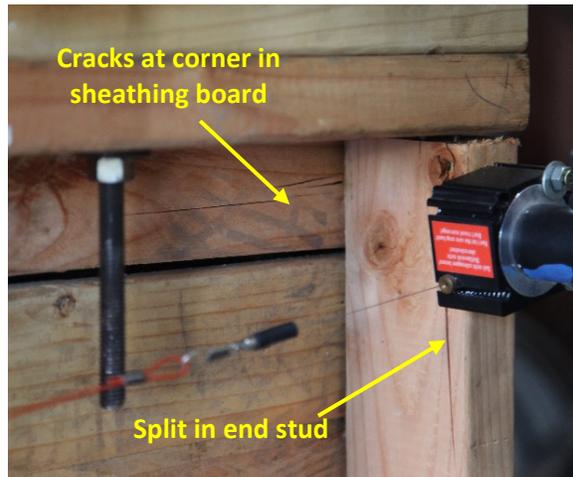
Figure 5.13(a) to (f) show the damage state of Specimen A-1 at lateral strength, which occurred at 3% global and relative drift in both the push and pull directions. Due to its lower capacity, Specimen A-1 did not experience any sill slip relative to the foundation. At strength, there were still no visible cracks on the face of the stucco. Figure 5.13(e) shows a 3/16-in. separation between the stucco and sheathing. This occurred as the furring nails (a) began to detach from the framing and work their way out of the sheathing (nail withdrawal) and/or (b) the furring nails had detached from the stucco (nail head pullout). Nail withdrawal or nail head pullout is dependent on how well the furring nails were fastened to the metal reinforcement mesh and how well they were fastened to the sheathing. Whichever condition has the least capacity will occur first. Note: only 1/8 in. of the 1-1/2-in. furring nails would be driven into the framing; the nails are furred out 1/4 in. and penetrate through the 7/8 in.-thick horizontal sheathing. The slip between the base of the stucco and the foundation increased to 1/2 in., and a gap between the stucco and foundation face became more pronounced. Figure 5.13(f) shows that at the top of the cripple wall there was a 1/4-in. relative displacement between the stucco finish and the sheathing, as well as a 1/4-in. relative displacement between the sheathing and framing. In addition, a small gap opened up between the sheathing and framing, indicating that the small amount of embedment of the furring nails into the framing was gone. On the interior of the cripple walls, the uplift of the studs was more pronounced, while the rotation of the studs was similar to that experienced at the service-level drift. Some of the studs began splitting at both the connection to the sill plate and top plate. Lastly, cracks had begun to form on the ends of the sheathing boards and were concentrated near the location where the boards were nailed to the studs.

Figure 5.13 Specimen A-1 damage state at lateral strength @ +3% drift, $\Delta = +0.72$ in.: (a) exterior elevation; (b) top of the exterior wall; (c) bottom of exterior wall; (d) close-up of stud; (e) north-end corner of wall; and (f) close-up of top of south-end interior corner.

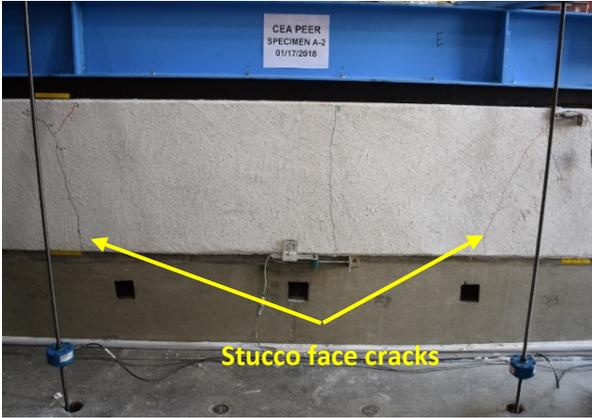
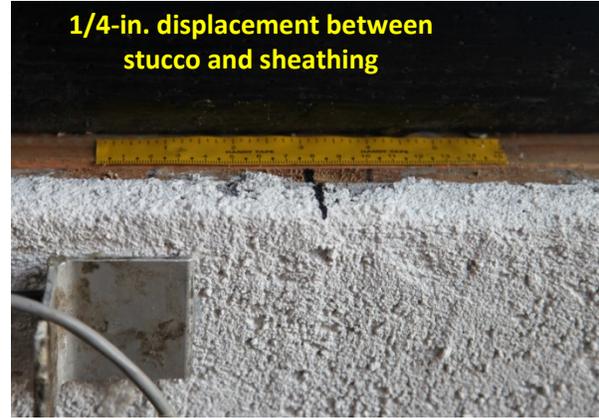
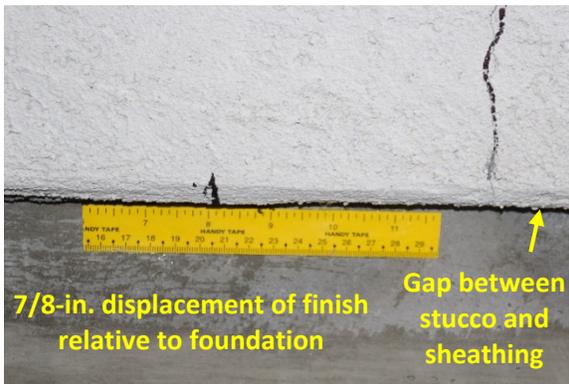
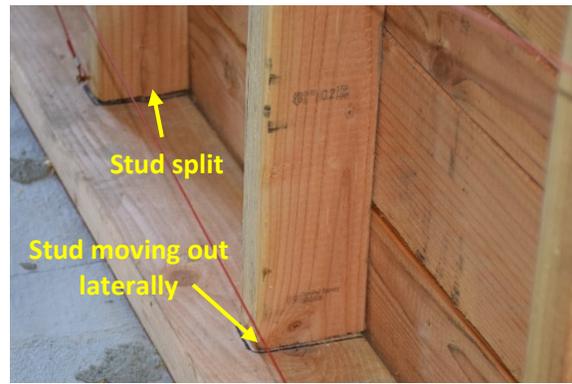
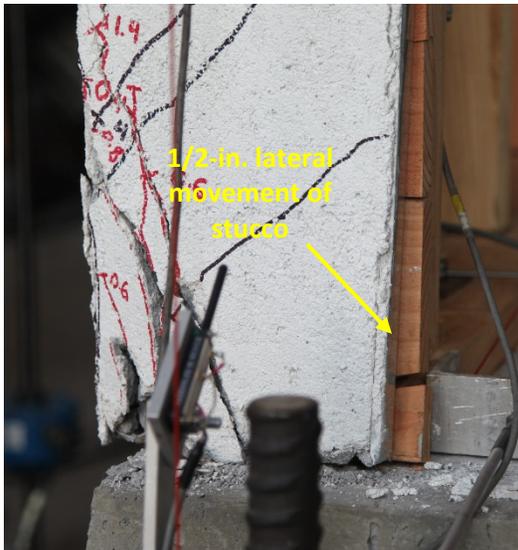
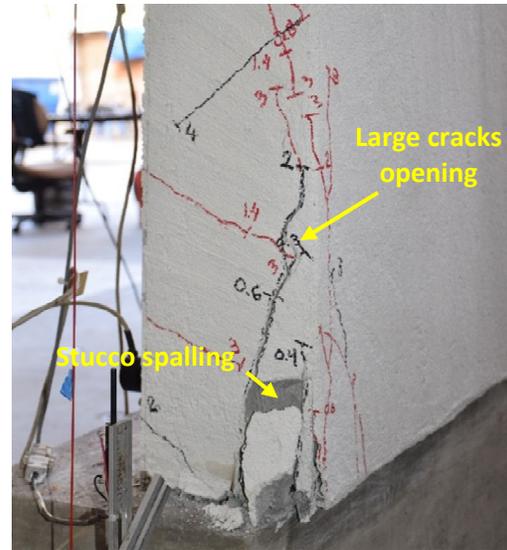
Figure 5.14(a) to (f) show the damage state of Specimen A-2 at lateral strength. The lateral strength occurred at 5% global drift in the push loading direction and 4% in the pull loading direction. The subsequent relative drift was 4.3% in the push direction and 3.1% in the pull direction. At peak strength, additional vertical cracks began propagating along the face of the stucco. The formation of a 1/2-in. gap formed at the base of the stucco; see Figure 3.14(c) and (e). At this point, although the stucco had detached from the furring nails at the base, in some cases the furring nails remained attached to the stucco, but as expected they had pulled out significantly from the sheathing. This same gap is not evident at the top of the cripple wall because of the increased pullout resistance due to the significantly denser furring nail arrangement on the upper top plates. The displacement of the stucco at the base and the foundation increased to 7/8 in., while the only apparent relative displacement at the top of the cripple wall was 1/4-in. displacement between the stucco and sheathing; see Figure 5.14(d). This is due to the rotation of the furring nails at the top of the wall. At the exterior corners, major cracking ran in all directions and was heavily concentrated at the corner edge. Crushing and spalling of the stucco was extensive at the corner faces due to the heavy bearing sown of the stucco finish on the foundation. On the interior face, some of the studs split at the connection to the sill plate. In addition, a slight lateral movement occurred on the studs. This lateral movement can be attributed to the horizontal sheathing and stucco finish moving out laterally. The cause of this lateral movement is due to the nails being pulled out as they rotate back and forward during each cycle.

Figure 5.14 Specimen A-2 damage state at lateral strength @-4% drift, $\Delta = -0.96$ in.: (a) exterior elevation; (b) top of exterior wall; (c) bottom of exterior wall; (d) close-up of studs; (e) close-up of north-end corner; and (f) close-up of bottom south-end exterior corner.

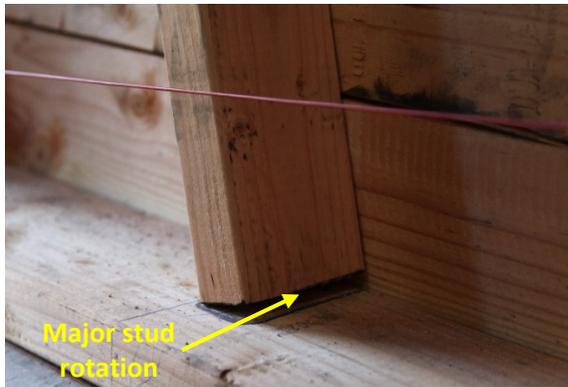
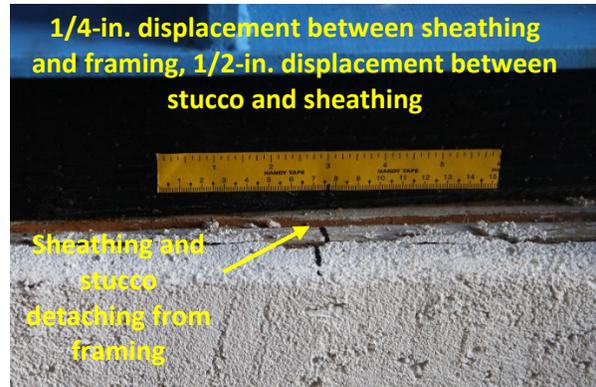
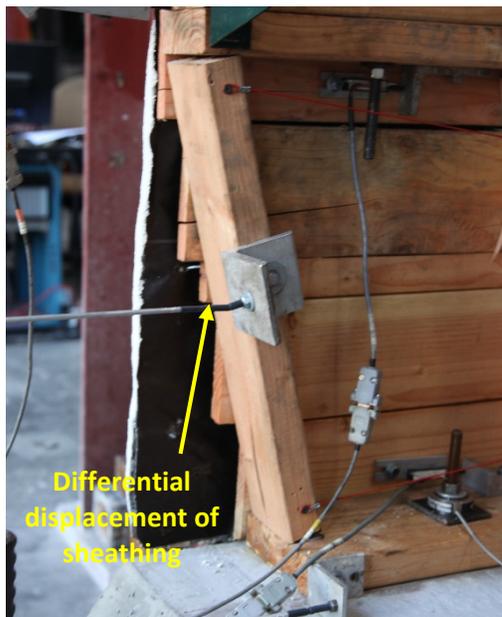
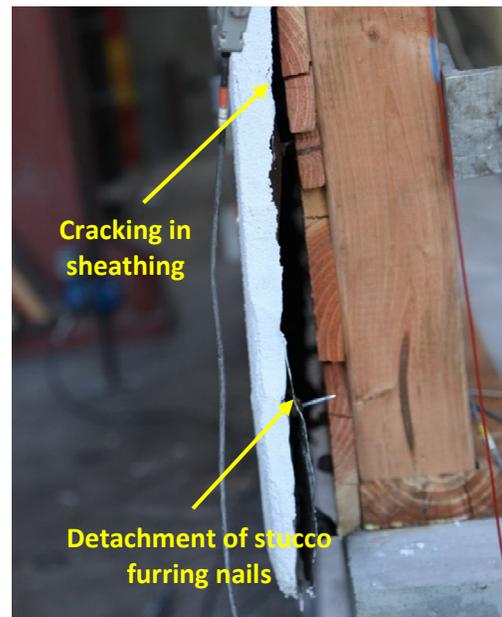
Figure 5.19(a) to (d) shows the damage state of Specimen A-1 at +12% drift. The damage state at 12% correlates closer to a 60% drop in peak strength as opposed to an 80% drop in lateral strength. At this stage, the stucco was only connected to the top plate and top row of furring nails on the studs. From Figure 5.19(c) and (d), it is evident that almost all of the furring nails remained attached to the sheathing and pulled away the metal reinforcement in the stucco. The displacement between the stucco and sheathing at the top of the cripple wall was 1/4 in., and a 1/4-in. displacement between the sheathing and the framing occurred as well. In addition, pronounced gaps occurred at the interface of the stucco and sheathing, as well as sheathing and framing. At this point, the stucco provided negligible lateral resistance. The source of capacity was due to the stacking of the horizontal sheathing boards bearing on the foundation. As shown in Figure 5.19(c), the gaps between all but the top sheathing board had closed. Cracks formed on the corners of the sheathing boards where the nails were located. Figure 5.20 shows the cripple wall in its residual state at the end of testing after a 5.0-in. monotonic push. There was a residual displacement of 4.90 in. once the load was removed.

Figure 5.19 Specimen A-1 damage state at 60% post-peak reduction of lateral strength @ +12% drift, $\Delta = +2.88$ in.: (a) close-up of studs and sill plate; (b) exterior top of the wall; (c) north-end interior corner; and (d) north-end bottom of corner.

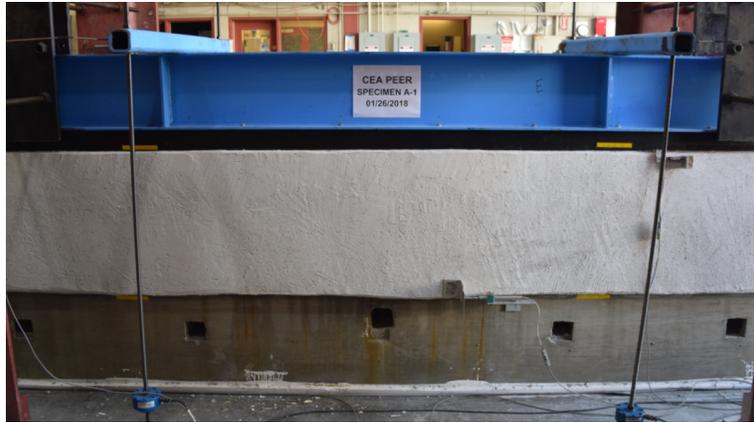
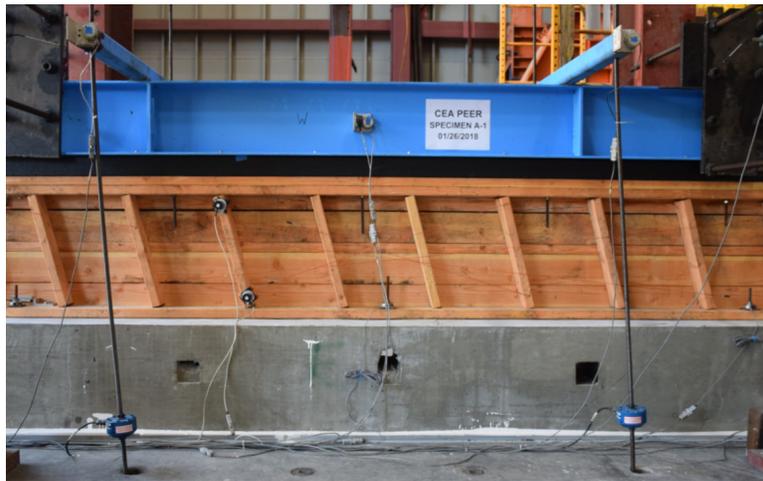
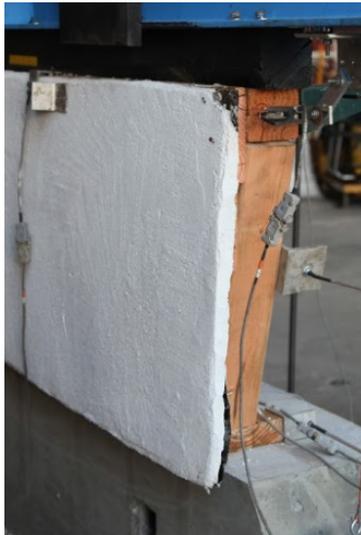
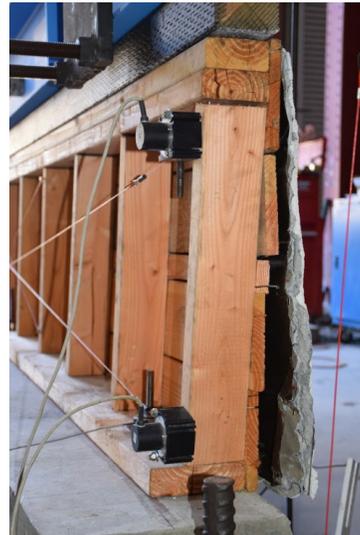
Figure 5.20 Specimen A-1 post-test photographs at lateral load = 0 kips, residual displacement = +4.90 in. @ +20.4% drift: (a) exterior elevation of cripple wall; (b) interior elevation of cripple wall; (c) north-end exterior corner view: and (d) south-end interior corner view.

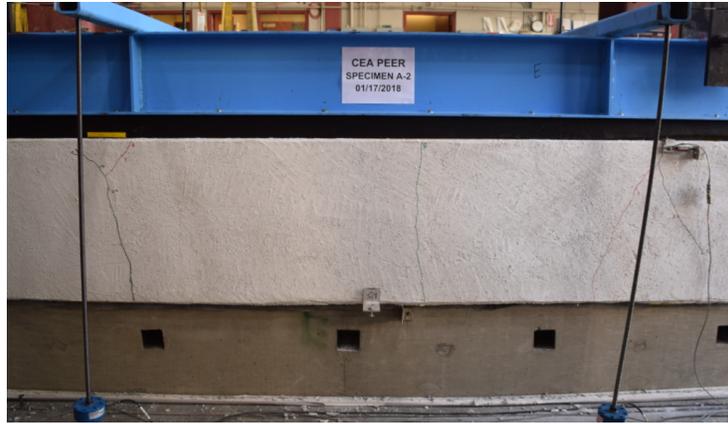
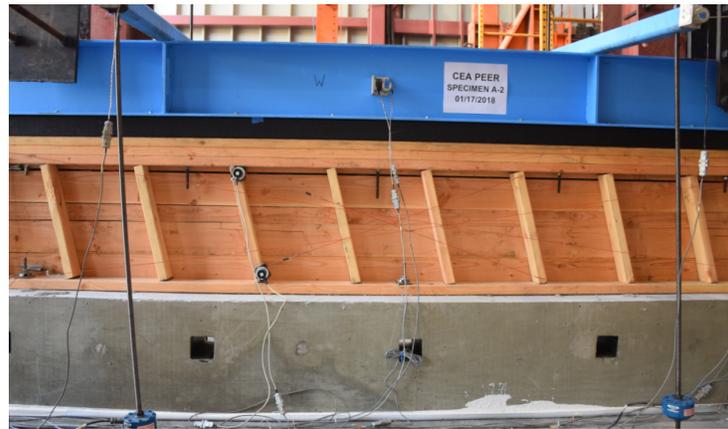
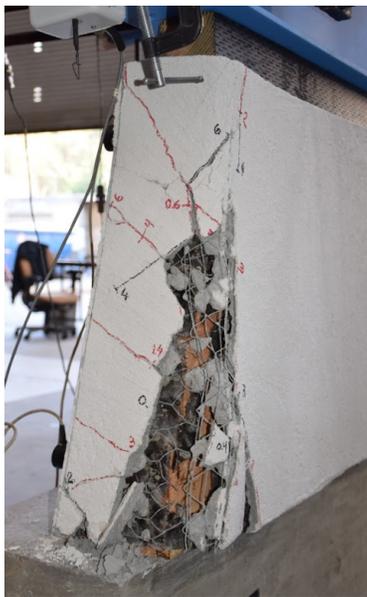
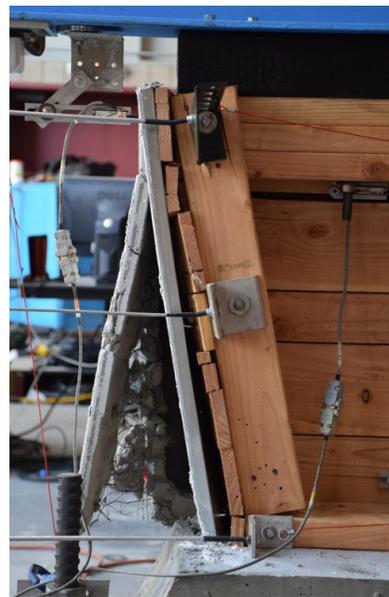
Figure 5.21(a) to (d) shows the damage state of Specimen A-2 at +12% drift. Specimen A-2 never exhibited an 80% drop in lateral strength. The damage state at 12% correlates closer to a 70% drop in peak strength. The stucco detached completely over the majority of the wall. The only attachment was at the dense furring nail arrangement at top. Figure 5.21(d) shows extensive movement of the stucco away from the sheathing at the base, as well as around a 1/4 in. of movement of the sheathing board away from the framing. Much of the stucco had spalled off of the corners, coming off in large chunks. Most of the sheathing boards on the corners split. A 3/8-in. gap formed between the top two sheathing boards, which was due to the top sheathing board being fastened to the top plates, while the other sheathing boards were attached to the studs. Like the other specimens, the capacity of the wall is attributed the sheathing boards stacking on each other and bearing on the foundation. Figure 5.22 shows the cripple wall in its residual state at the end of testing after a 4.5-in. monotonic push. There was a residual displacement of 3.45 in. once the load was removed.

Figure 5.22 Specimen A-2 post-test photographs at lateral load = 0 kips, residual displacement = +3.45 in @ +14.4% drift: (a) exterior elevation of cripple wall; (b) interior elevation of cripple wall; (c) south-end exterior corner view; and (d) north-end interior view.

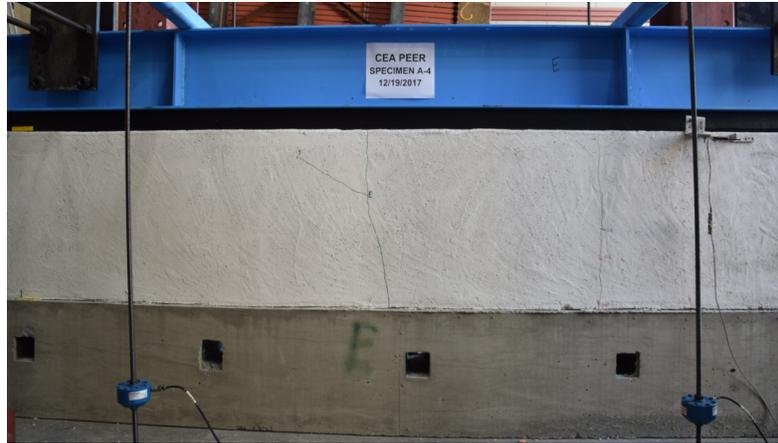
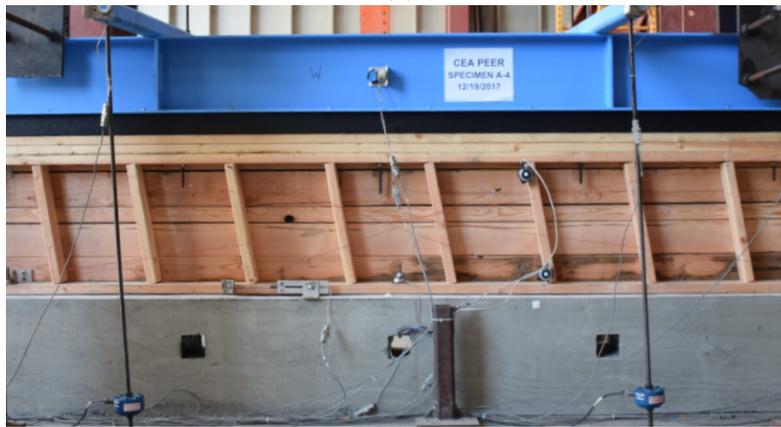
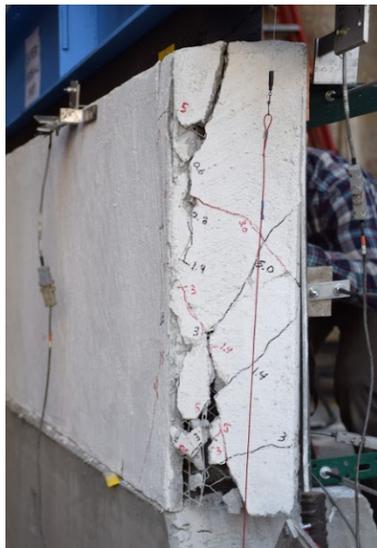
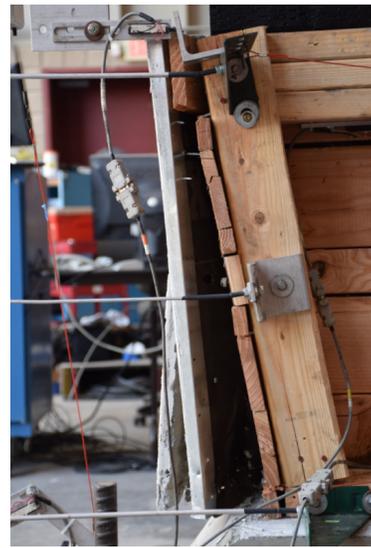
Figure 5.25(a) to (d) shows the damage state of Specimen A-4 at -12% drift. Specimen A-4 achieved an 80% loss of strength before the monotonic push was implemented. Because of the stucco-bearing condition, the stucco detached from both the bottom and top of the wall (unlike the previous three specimens); see Figure 5.25(c) and (d). At this point, the stucco provided almost no lateral resistance. In addition, there was a complete detachment of the stucco at the corners and splitting of many of the sheathing boards; see Figure 5.25(b). Like the previous three tests, the majority of the lateral resistance can be attributed to the bearing of the sheathing boards on the foundation. Figure 5.26 shows the cripple wall in its residual state at the end of testing after a 4.7-in. monotonic push. There was a residual displacement of 3.43 in. once the load was removed.

Figure 5.26 Specimen A-4 post-test photographs at lateral load = 0 kips, residual displacement = +3.43 in. @ +14.3% drift: (a) exterior elevation of cripple wall; (b) interior elevation of cripple wall; (c) north-end exterior corner view; and (d) north-end interior view.

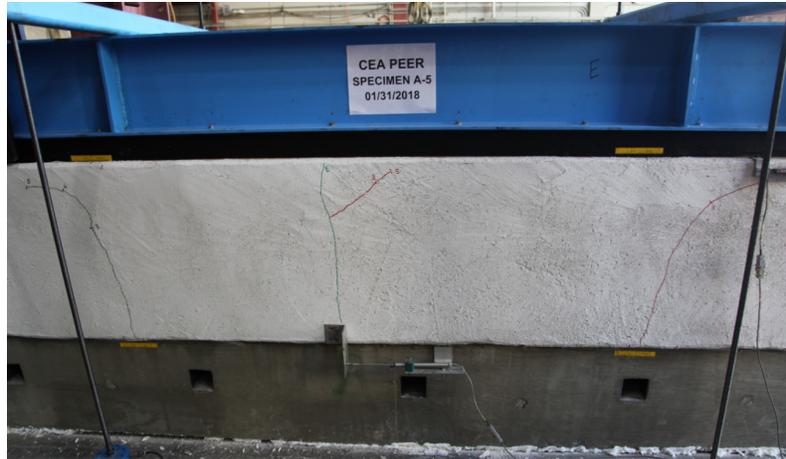
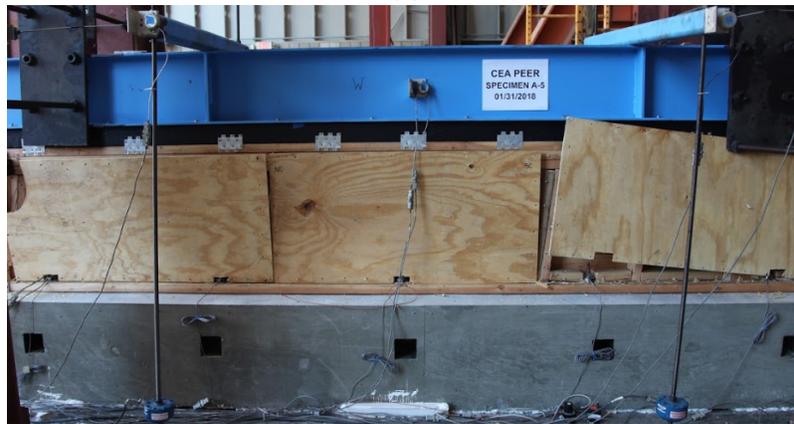
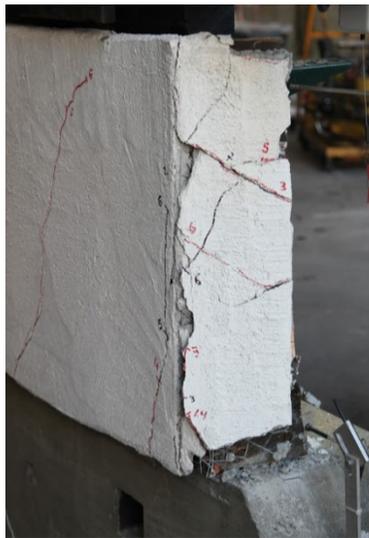
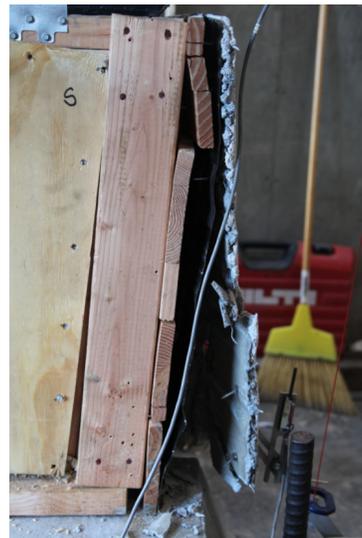
Figure 5.27(a) to (d) shows the damage state of Specimen A-5 at -11% drift. The data for this test stopped being accurately recorded at 7% drift amplitude due to the loss of the control displacement potentiometer; however, higher amplitudes were imposed to obtain a visual of the damage state of the failed wall. All plywood panels almost completely detached (only two to three nails remained attached) on the top, bottom, and one side, providing no lateral resistance. The south-end plywood panel remained attached by only two nails; see Figure 5.27(a). Most of the nails at the top had ripped through or pulled through the plywood. At the bottom of the plywood panels, many of the nails pulled out of the block, and much of the blocking was either uplifted out of the sill plate or split where the plywood was nailed. The corner flat studs split due to the abutment of the plywood. The damage to the stucco had the same characteristics as Specimen A-2, the existing condition replica. Figure 5.28 shows the cripple wall in its residual state at the end of testing after the end of the 11% drift cycle group. After the wall was unloaded at -11% drift (-2.64 in.), a residual displacement of -1.74 in. remained.

Figure 5.28 Specimen A-5 post-test photographs at lateral load = 0 kips, residual displacement = -1.74 in. @ -7.3% drift: (a) exterior elevation of cripple wall; (b) interior elevation of cripple wall; (c) north-end exterior corner view; and (d) south-end interior corner view.

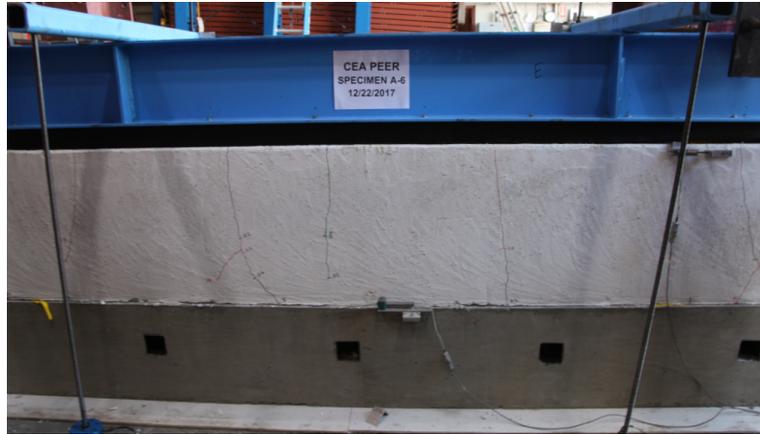
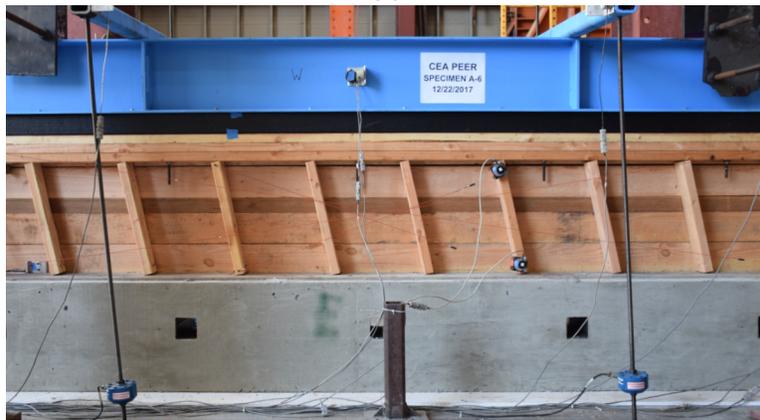
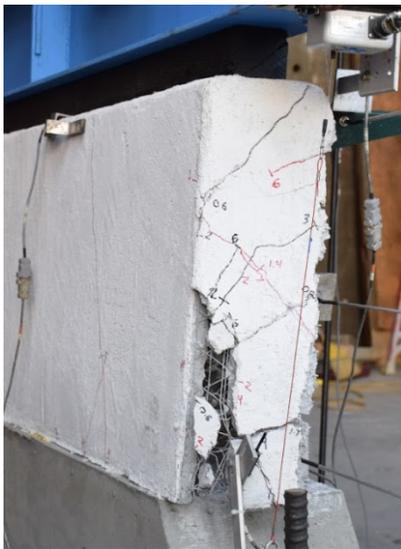
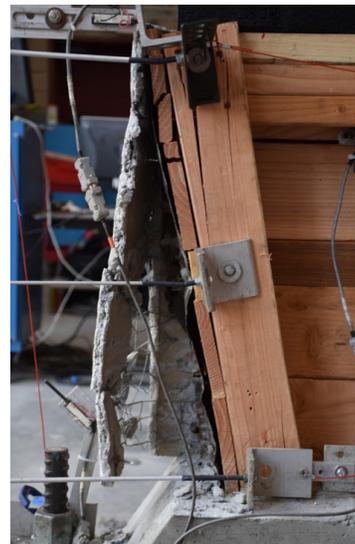
Figure 5.29(a) to (d) shows the damage state of Specimen A-6 at +13% drift. This wet set sill specimen never dropped under half of its peak capacity. This is due to the sheathing boards bearing on the foundation, which at large displacements closed up the gaps between the bottom sheathing boards, causing the sheathing boards to work as a unit and provide increased lateral resistance; see Figure 5.29(d). Due to the top sheathing board being nailed to the top plates instead of the studs, a 3/16-in. gap formed between the upper two sheathing boards. At the corners, the stucco spalled off in large chunks, and the entire stucco face detached from the cripple wall along the sill plate and studs; see Figure 5.24(c). Partial attachment of the stucco remained at the top plates. The studs exhibited large rotations as well as uplifting. Figure 5.30 shows the cripple wall in its residual state at the end of testing after a 4.32-in. monotonic push. There was a residual displacement of 4.22 in. once the load was removed.

Figure 5.30 Specimen A-6 post-test photographs at lateral load = 0 kips and residual displacement = +4.22 in. @+17.6% drift: (a) exterior elevation of cripple wall; (b) interior elevation of cripple wall; (c) exterior north-end corner view; and (d) interior north-end view.
