PACIFIC EARTHQUAKE ENGINEERING RESEARCH CENTER

Fire-Induced Structural Collapse on Pier 45 at Fisherman's Wharf, San Francisco, California, May 23, 2020

PEER Report No. 2021/01

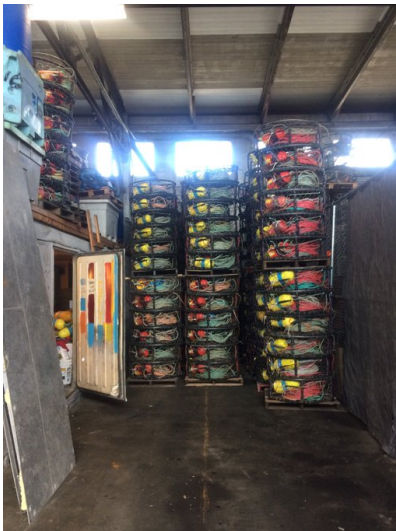
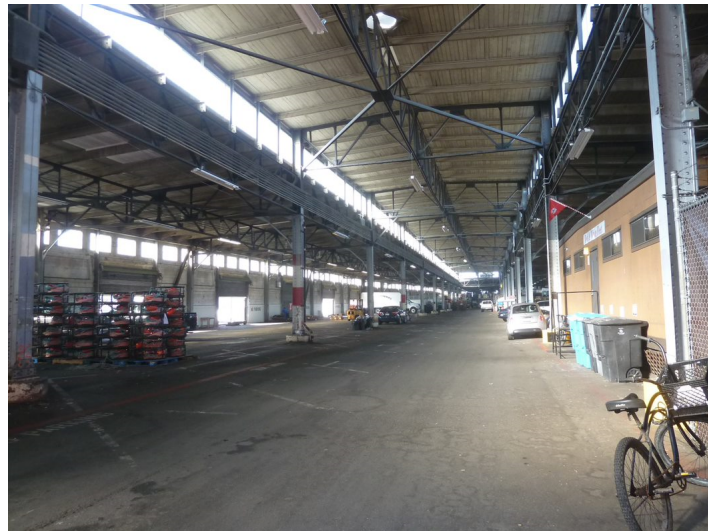
Figure 2.5 shows fishing equipment piled outside of Shed C. Note: large amounts of fishing equipment similar to what is shown in Figure 2.5 may have served as fuel for the fire. Figure 2.6 shows the type of equipment being housed in Shed A, which is identical equipment that had been stored in Shed C. The historic SS Jeremiah O'Brien ship was spared from the fire, and it was towed to Pier 35 the Tuesday afternoon after the fire.

Figure 2.6: Passageway in Shed A: (a) fishing equipment; and (b) Shed A is identical in construction to Shed C.

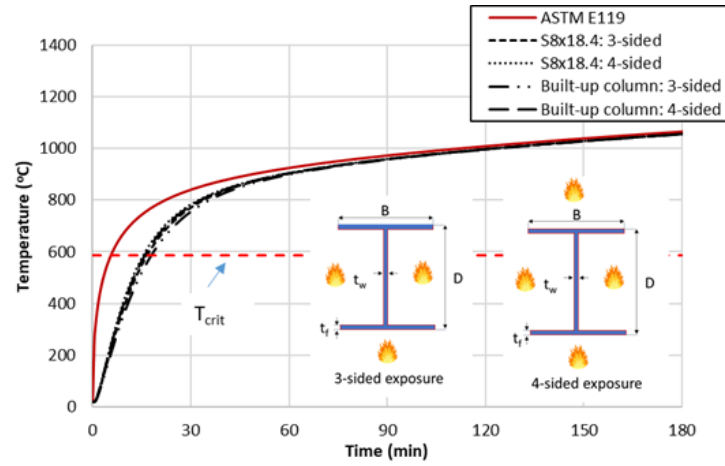
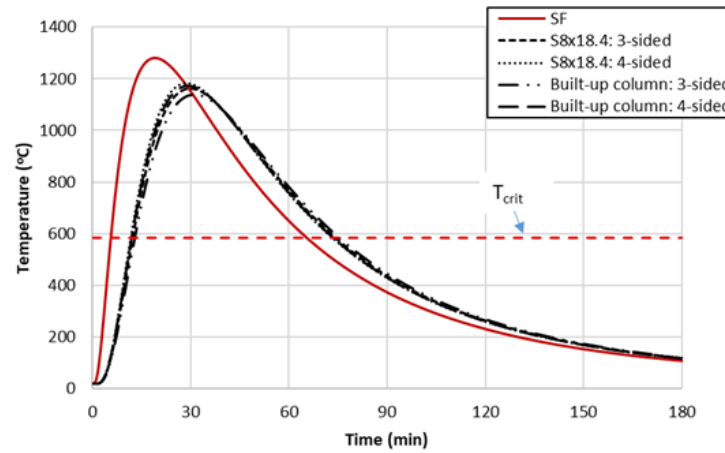
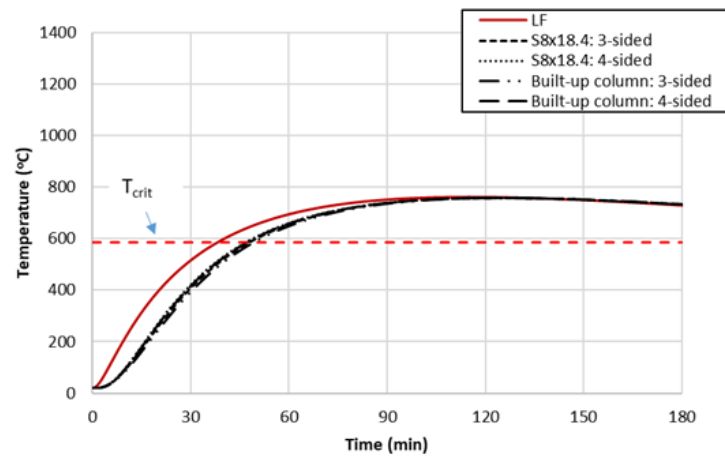
Figure 5.1 plots the calculated temperature–time histories for the assumed fire scenarios along with temperature progression within the steel member cross sections for the first 180 minutes (or three hours) of fire exposure. The critical temperature calculated to be 585°C corresponding to a load ratio of 0.5 is also plotted to determine expected failure time based on the temperature criteria discussed in Section 5.3.

Clearly, the temperature progression in the cross sections follow the calculated gas temperatures for the respective fire scenarios. Moreover, variation in cross-sectional dimensions or exposure conditions seems to have negligible effect on the temperatures experienced within the member. In case of ASTM E119 fire exposure, temperatures increased monotonically, and the critical temperature was reached within 16–18 minutes into fire exposure. The time to reach critical temperature in the case of fire scenario SF with a greater rate of increase in temperature compared to ASTM E119 exposure occurred between 12 to 13 minutes for the considered cross sections. Finally, in the case of fire scenario LF, both the peak gas temperature and rate of temperature was significantly lower, and critical temperature was exceeded almost 47 to 50 minutes into fire exposure.

Therefore, it is postulated that the non-fire-rated steel members (the frame) failed during early phases of fire exposure once flash-over occurred. However, a more detailed analysis is needed to substantiate the complex sequence of interrelated events that led to fire-induced progressive collapse. As shown, results can vary significantly depending on assumptions regarding the fire scenario (gas temperature–time history). Further studies are needed to accurately represent the thermal environment that existed during fire exposure.

Figure 5.1: Calculated temperatures for different fire scenarios and exposure conditions: (a) temperature progression with time for ASTM E119 fire exposure; (b) temperature progression with time for SF fire exposure; and (c) temperature progression with time for LF fire exposure.

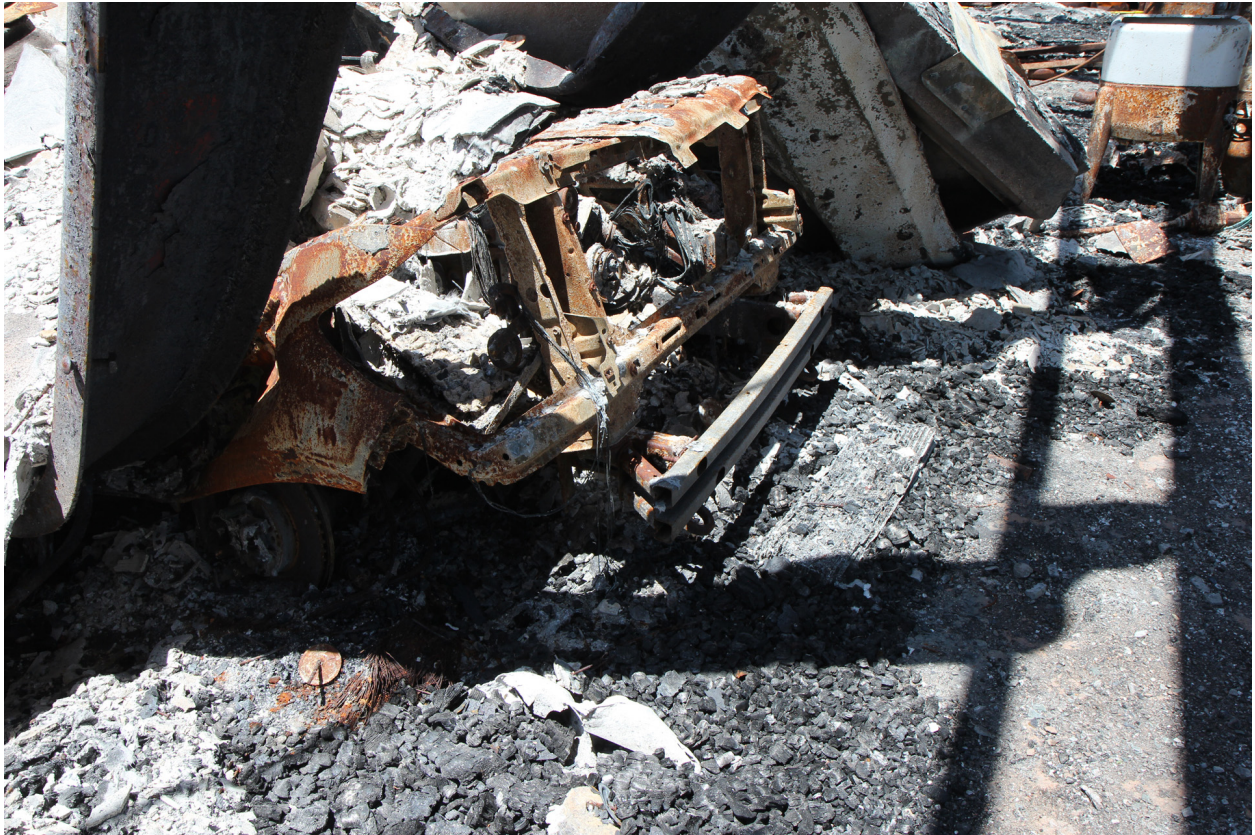
Figure A.22: Remnant of an automobile.
