PEER Preliminary Notes and Observations on the August 24, 2014, South Napa Earthquake

2014 South Napa Field Notes
Oregon State University Team

Report No. 2014/13

A 2014 South Napa Field Notes—Oregon State University Team⁺

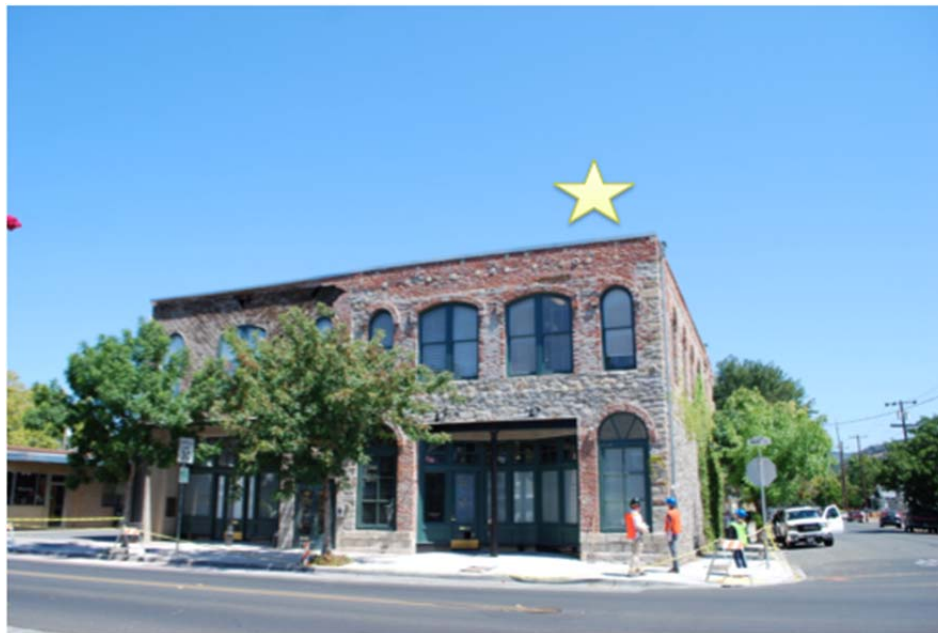
Figure 12 Evaluated Structure No. 3: Star indicates buildings on 1606 Main St.

No.	Address	Building Name	Photo Comments
3	1606/1610 Main St.	Law Offices	1606 Main St. is a URM building that had been retrofitted. Interior brace frame in front. No apparent steel brace frame on the back or side walls.

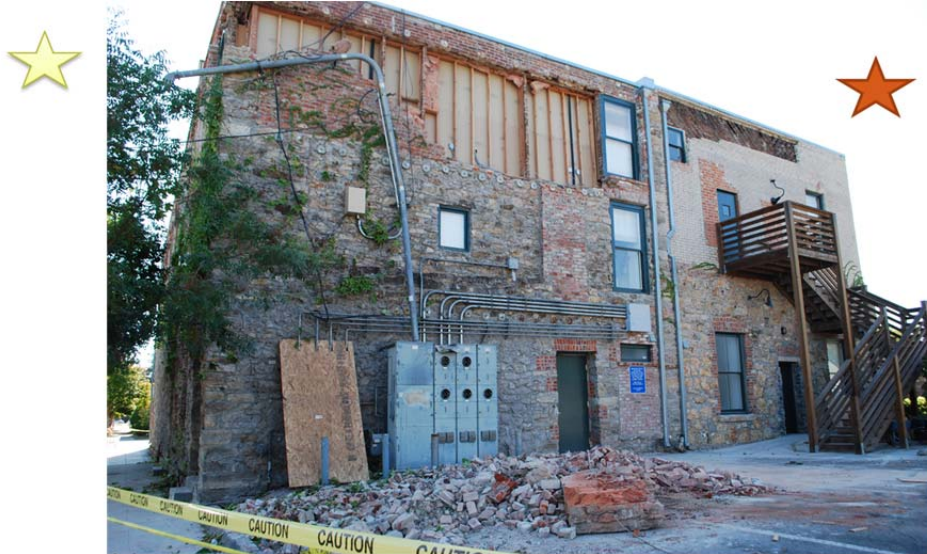
Figure 16 Evaluated Structure No. 3.

No.	Address	Building Name	Photo Comments
3	1606/1610 Main St.	Law Offices	Back wall collapse (out-of-plane) between two levels of wall-to-floor ties.

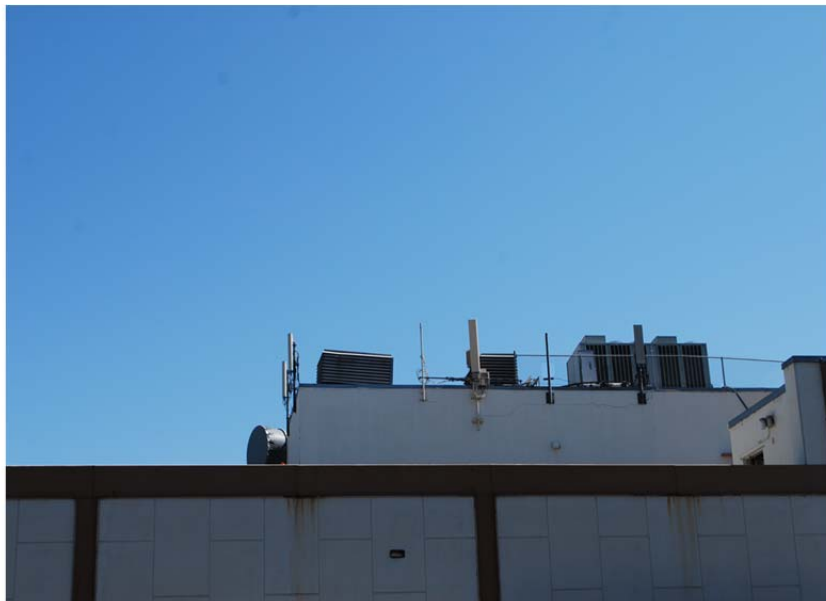
Figure 44 Evaluated Structure No. 14.

No.	Address	Building Name	Photo Comments
14	1300 Clay St.	AT&T Building	A/C units had shifter off supports.

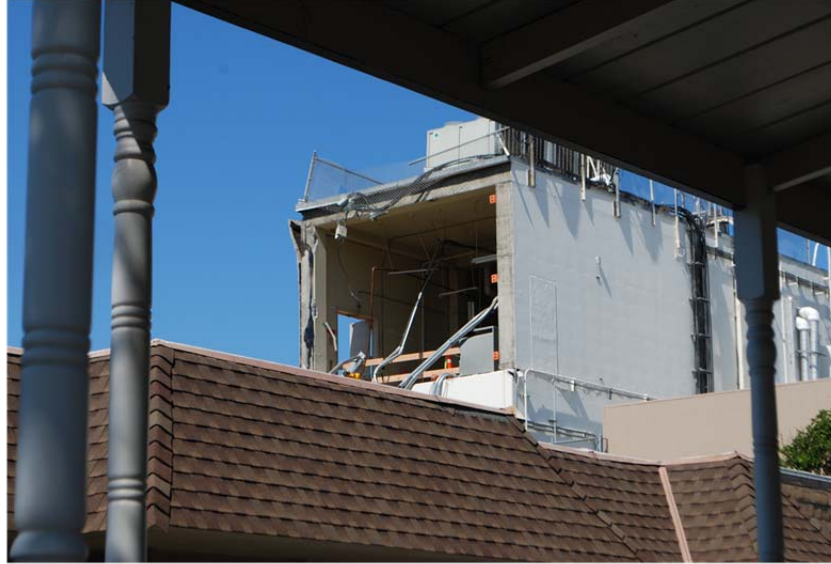
Figure 45 Evaluated Structure No. 14.

No.	Address	Building Name	Photo Comments
14	1300 Clay St.	AT&T Building	Non-structural pre-fabricated concrete wall panel sheared off from supporting angles.

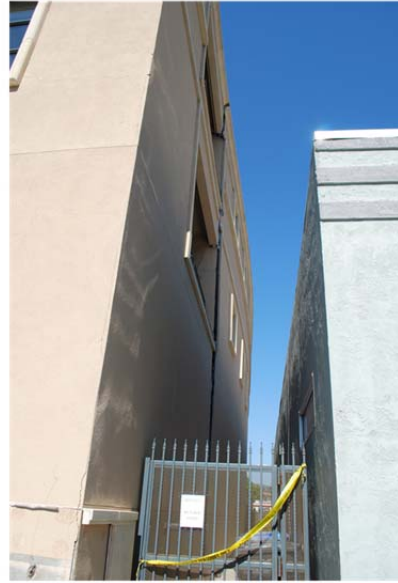
Figure 55 Evaluated Structure No. 18.

No.	Address	Building Name	Photo Comments
18	935 Franklin St.	Charles Schwab Building	Failed wall-to-diaphragm connections.

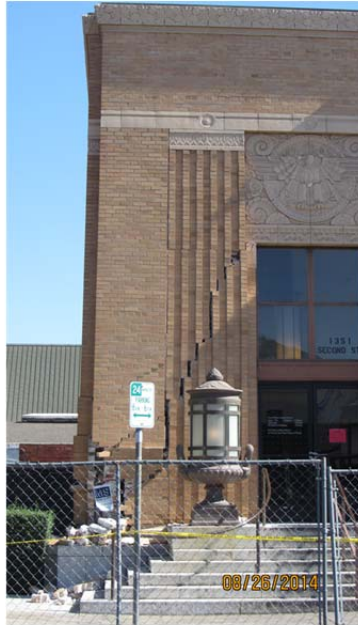
Figure 59 Evaluated Structure No. 19.

No.	Address	Building Name	Photo Comments
19	820 Randolph St.	Post Office	Stepped shear/diagonal cracks.

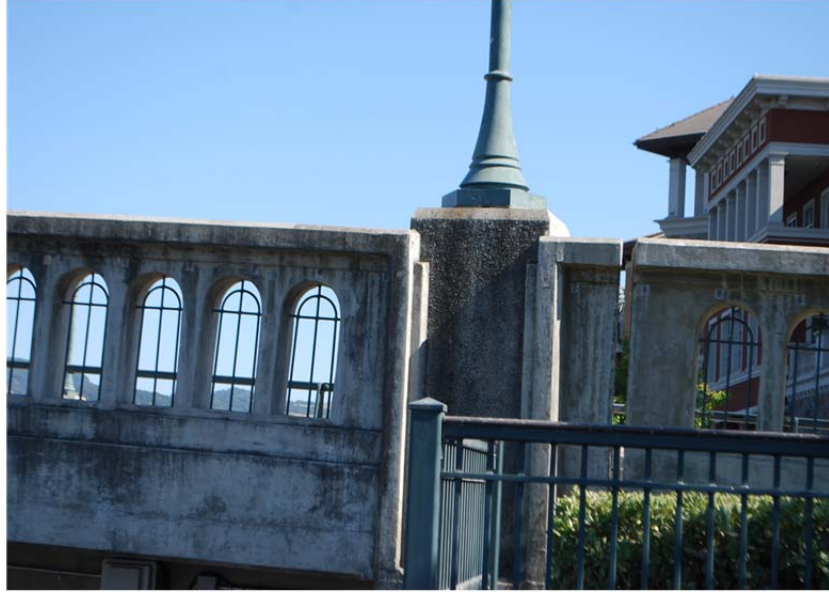
Figure 69 Evaluated Structure No. 24.

No.	Address	Building Name	Photo Comments
24	3 rd St. Bridge	--	Retaining wall under bridge with 1/2 to 1 inch permanent gap.

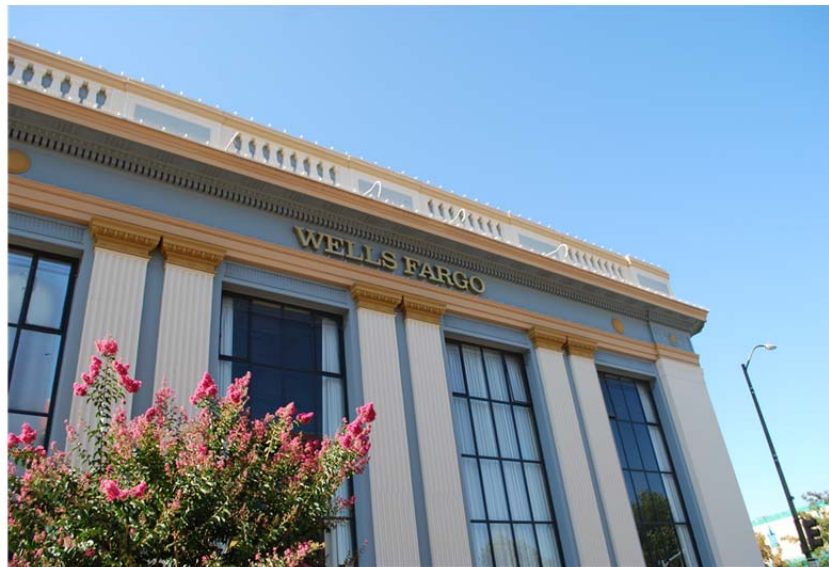
Figure 70 Evaluated Structure No. 25.

No.	Address	Building Name	Photo Comments
25	901 Main St.	Wells Fargo Building	Tall 1 story building that appears to be RC framing with infill or RC frame. Need conformation.

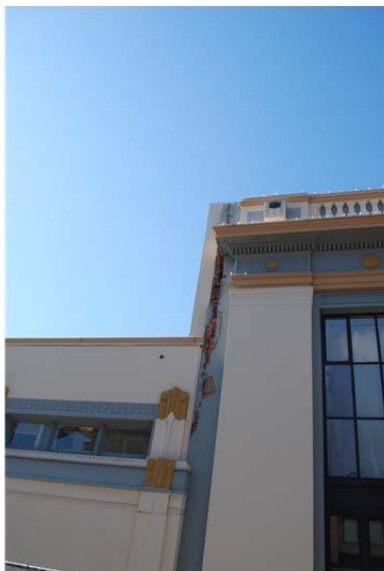
Figure 71 Evaluated Structure No. 25.

No.	Address	Building Name	Photo Comments
25	901 Main St.	Wells Fargo Building	Crack at end walls possibly enhanced by significant height between adjacent buildings.

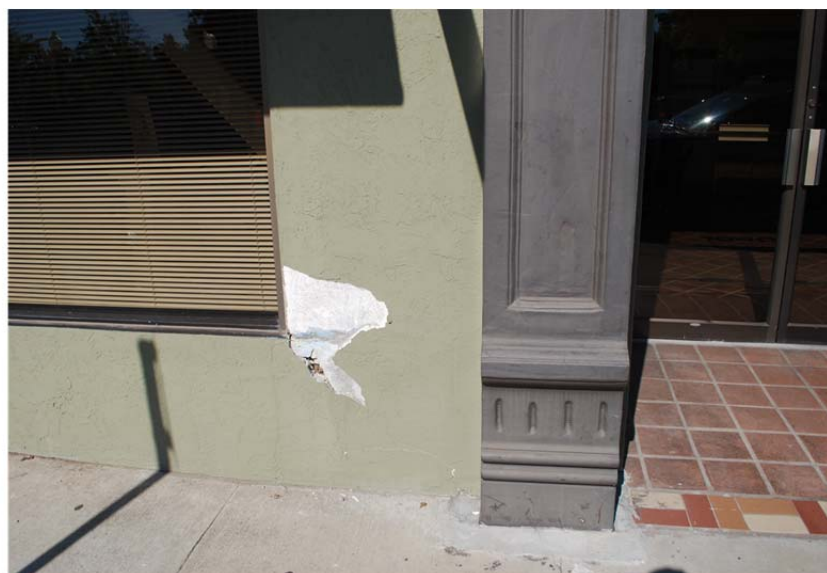
Figure 76 Evaluated Structure No. 28.

No.	Address	Building Name	Photo Comments
28	1040 Main St.	--	Retrofitted URM building with interior braced frames.

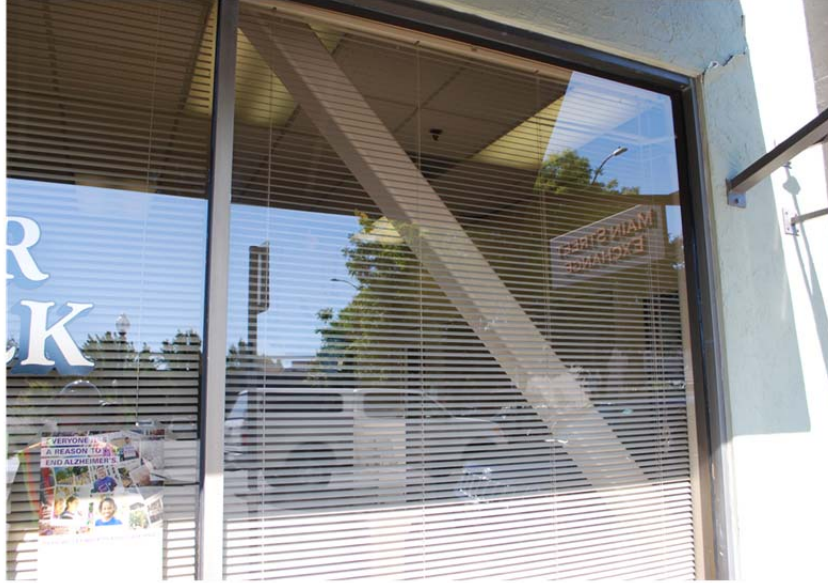
Figure 77 Evaluated Structure No. 28.

No.	Address	Building Name	Photo Comments
28	1040 Main St.	--	Retrofitted URM building with interior braced frames.
