Damage of Transportation Facility due to 2010 Chile Earthquake

April 5, 2010

Kawashima, K., Unjoh, S.,
Hoshikuma, J. and Kosa, K.

Bridge Team Dispatched by
Japan Society of Civil Engineers

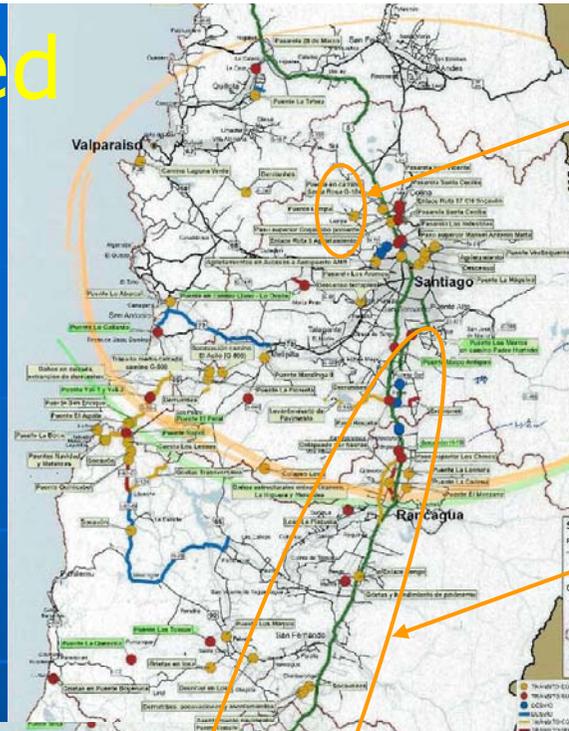
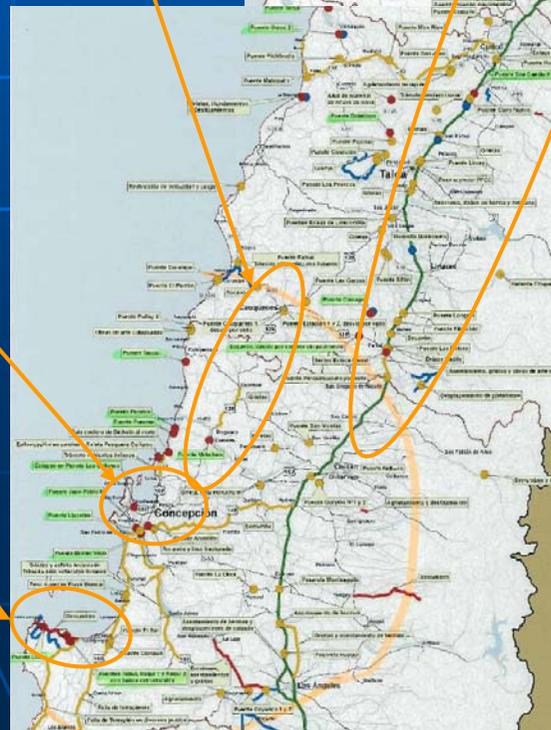
45 bridges located at 30 sites were investigated

Suburbs of Concepcion

Concepcion

Arauko

Santiago

Route 5

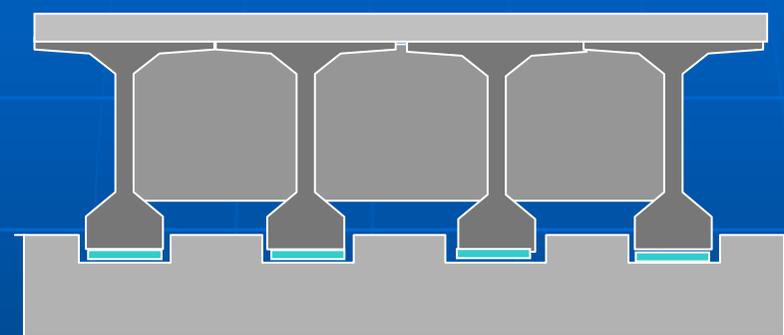
Pre Mid-1990s Typical Chile Bridges

Pre-tension
PC girders

Diaphragm

Cap beam

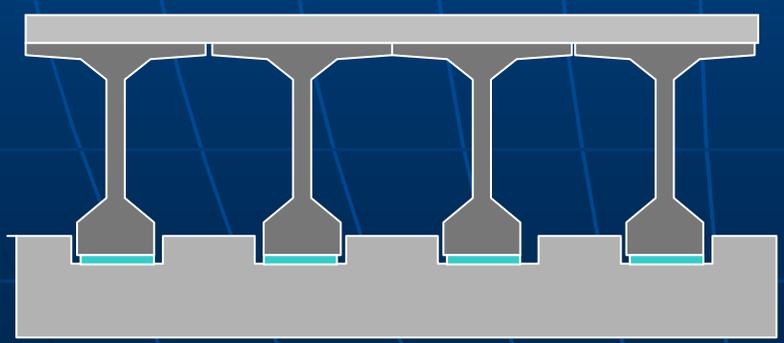
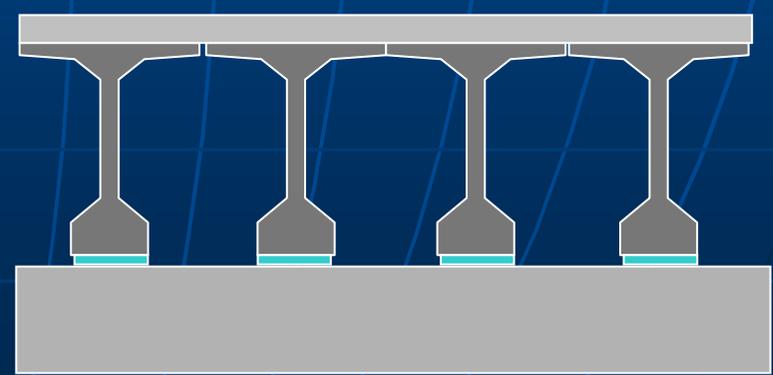
After the Mid 1990s influenced by Spanish practice

Why was damage extensive in bridges built in recent years?

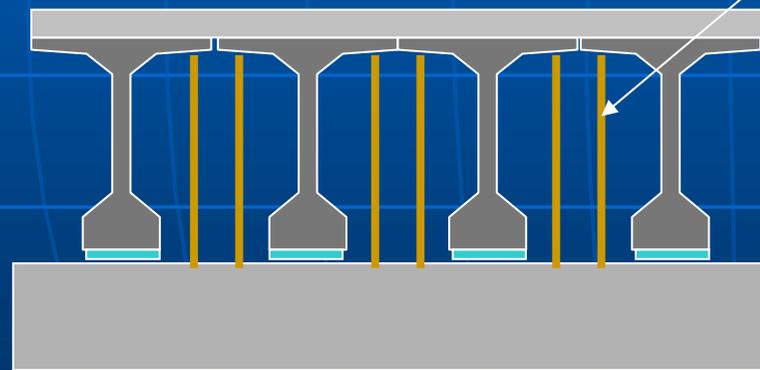
What happened if side stoppers on the top of pier cap were removed in addition to removal of diaphragms?

Vertical restrainers?

- Resist Uplift?
- Insufficient to constrain offset of a bridge in the transverse direction

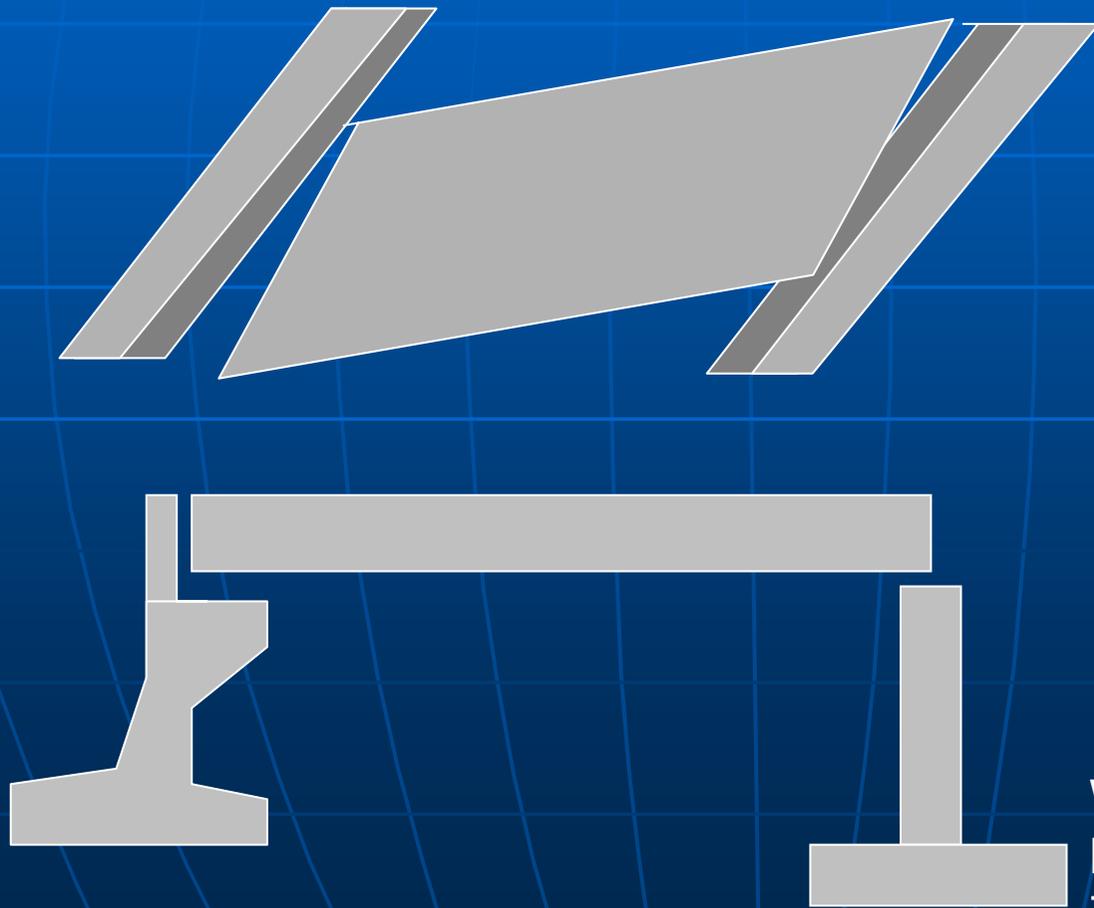
Lack of constraint to rotation of skewed bridges

Skewed bridges tend to rotation under seismic excitation

Skewed bridges which lacked diaphragms and effective side stoppers suffered extensive damage
