Damage of Bridges Resulted from March 11, 2011 East-Japan Earthquake

April 15, 2011

Kazuhiko Kawashima Department of Civil Engineering Tokyo Institute of Technology

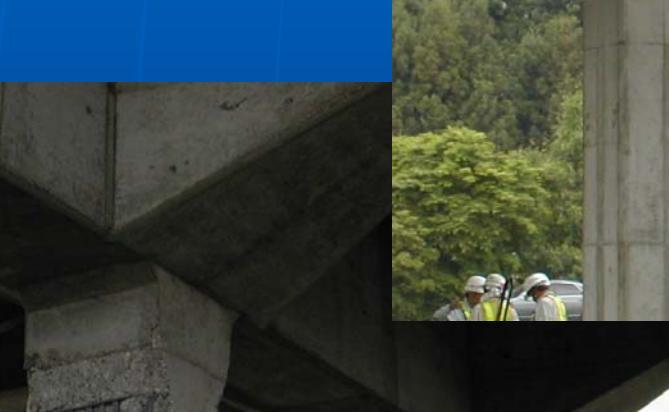
Extensive Damage of Shinkansen Viaduct during 2003 Miyagi-ken-oki

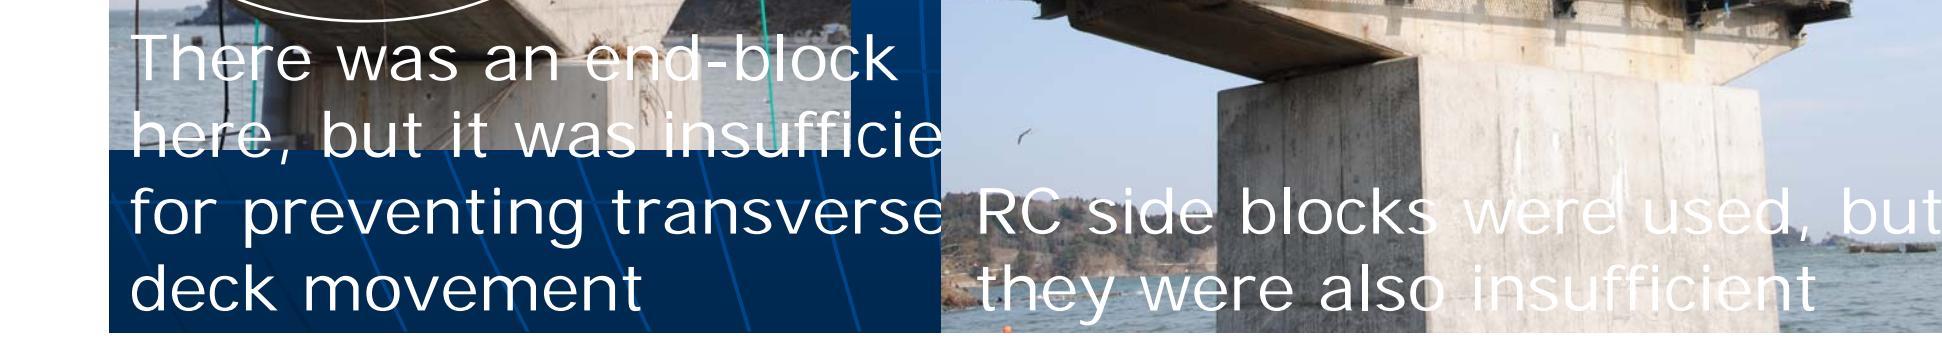
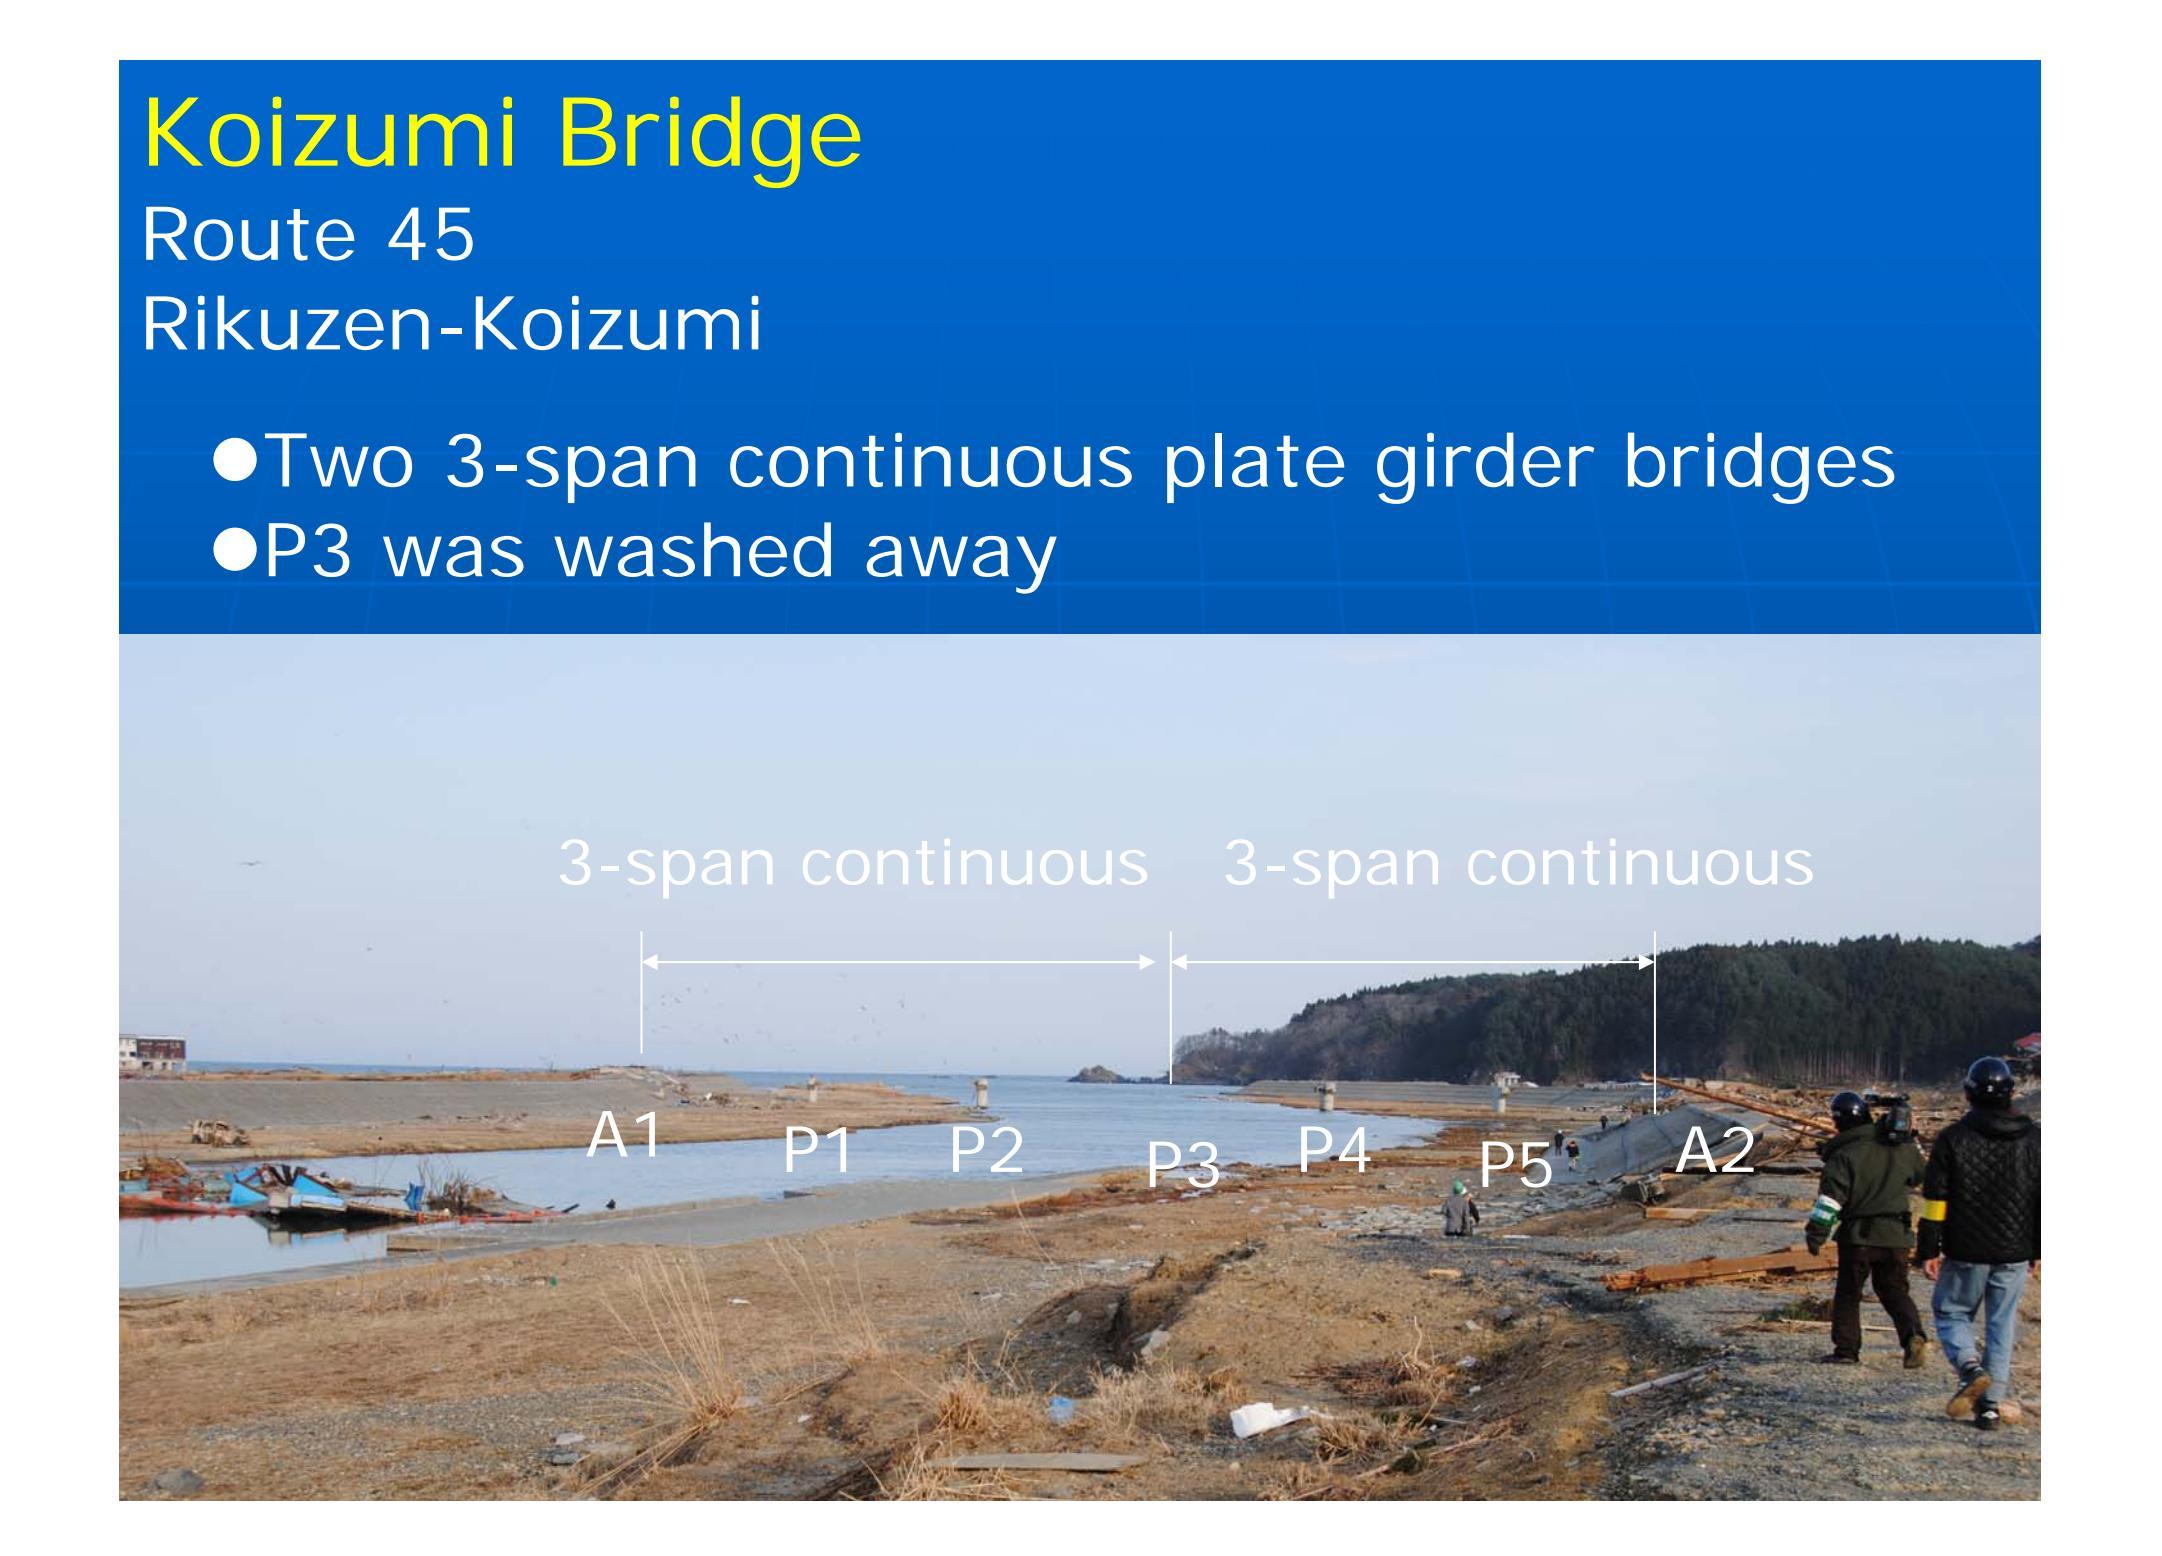
Steel stoppers were provided, but they were ineffective for preventing transverse deck movement & uplift by tsubamine

Two 3-span continuous superstructures were washed away upstream

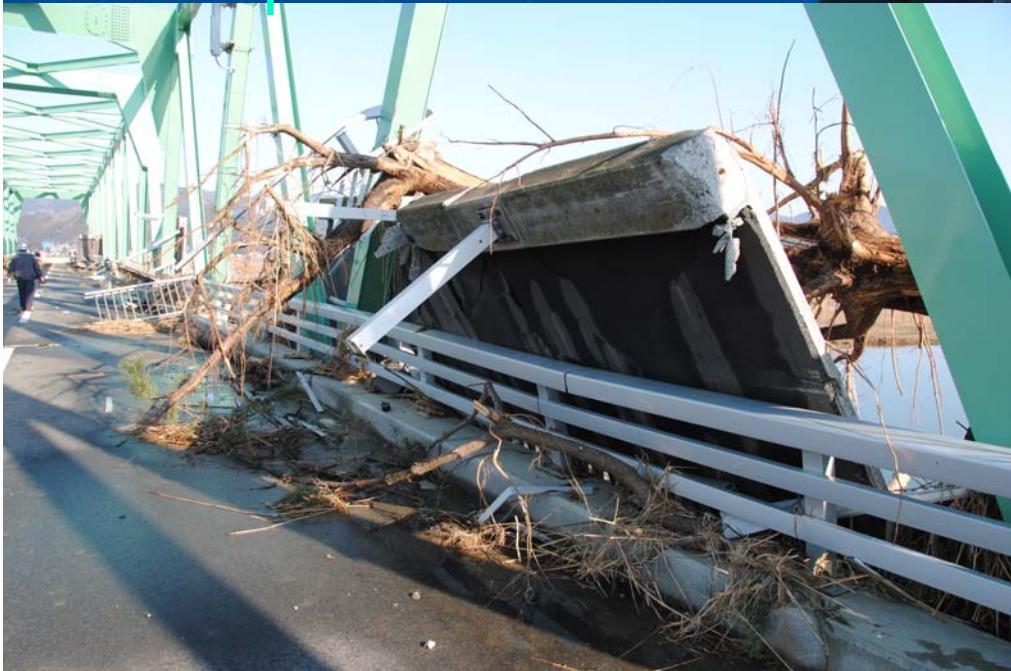
Deck floors of a side pedestrian bridge (upstream side) uplifted to rotate by 90 degree from the ginders of the side of the si

They contributed to increasing of water pressure

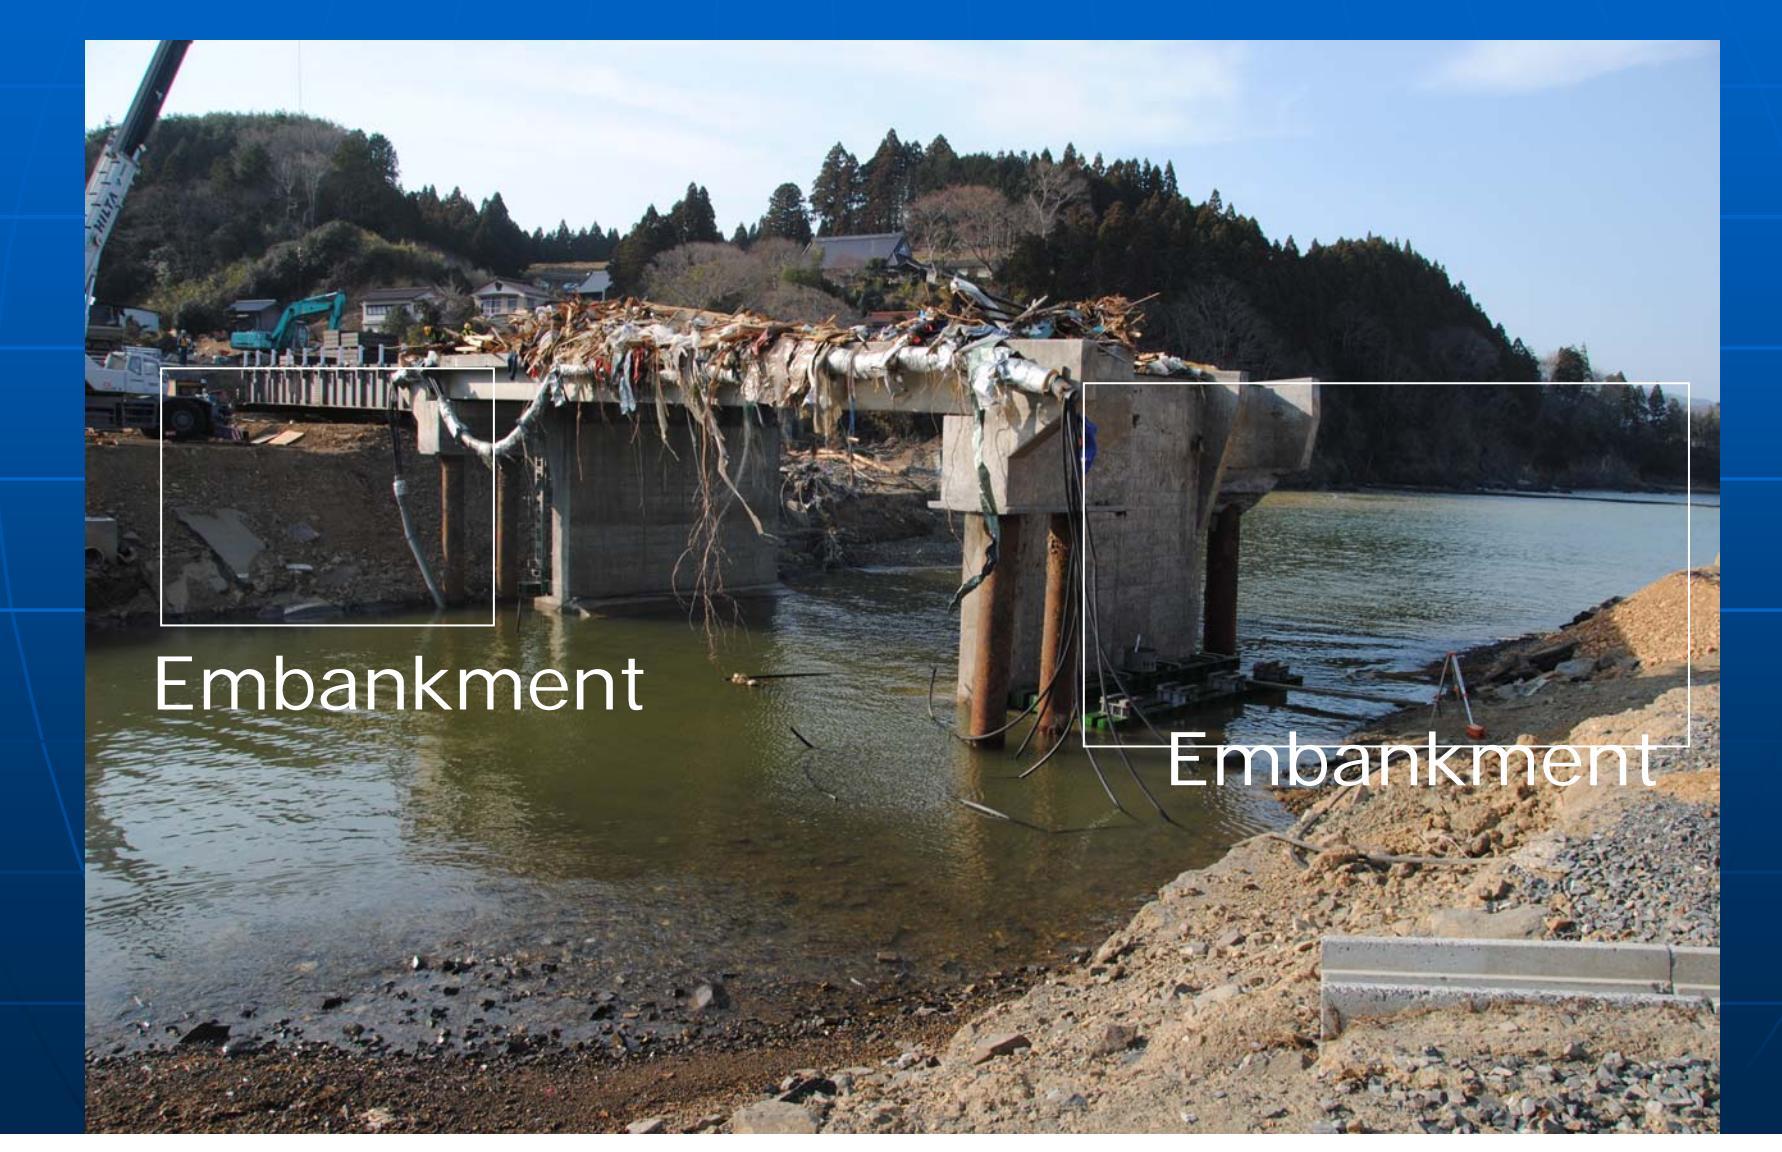
Nijyu-ichi Hama Bridge Route 45 Kesen-numa City

Many short bridges survived tsunami

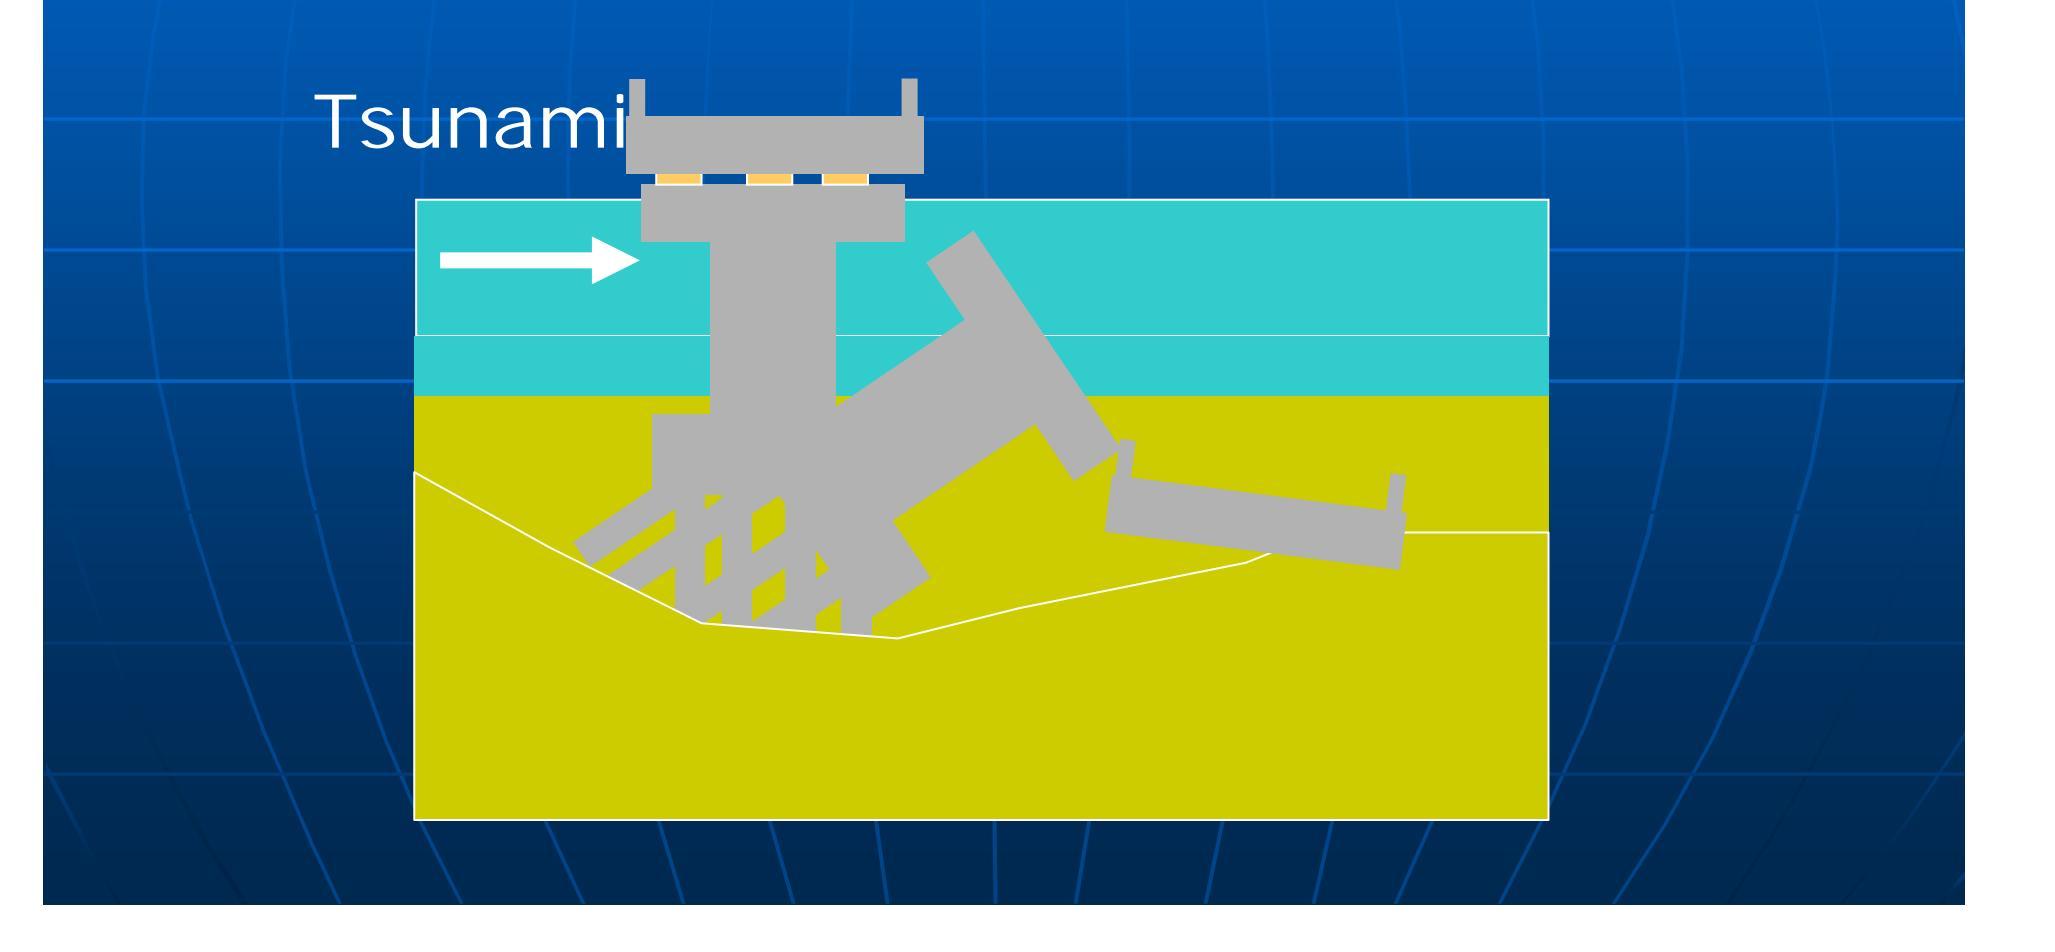
Failure Bridges due to Scouring

This failure mode was not observed during the East-Japan earthquake since foundations were deep and well constructed

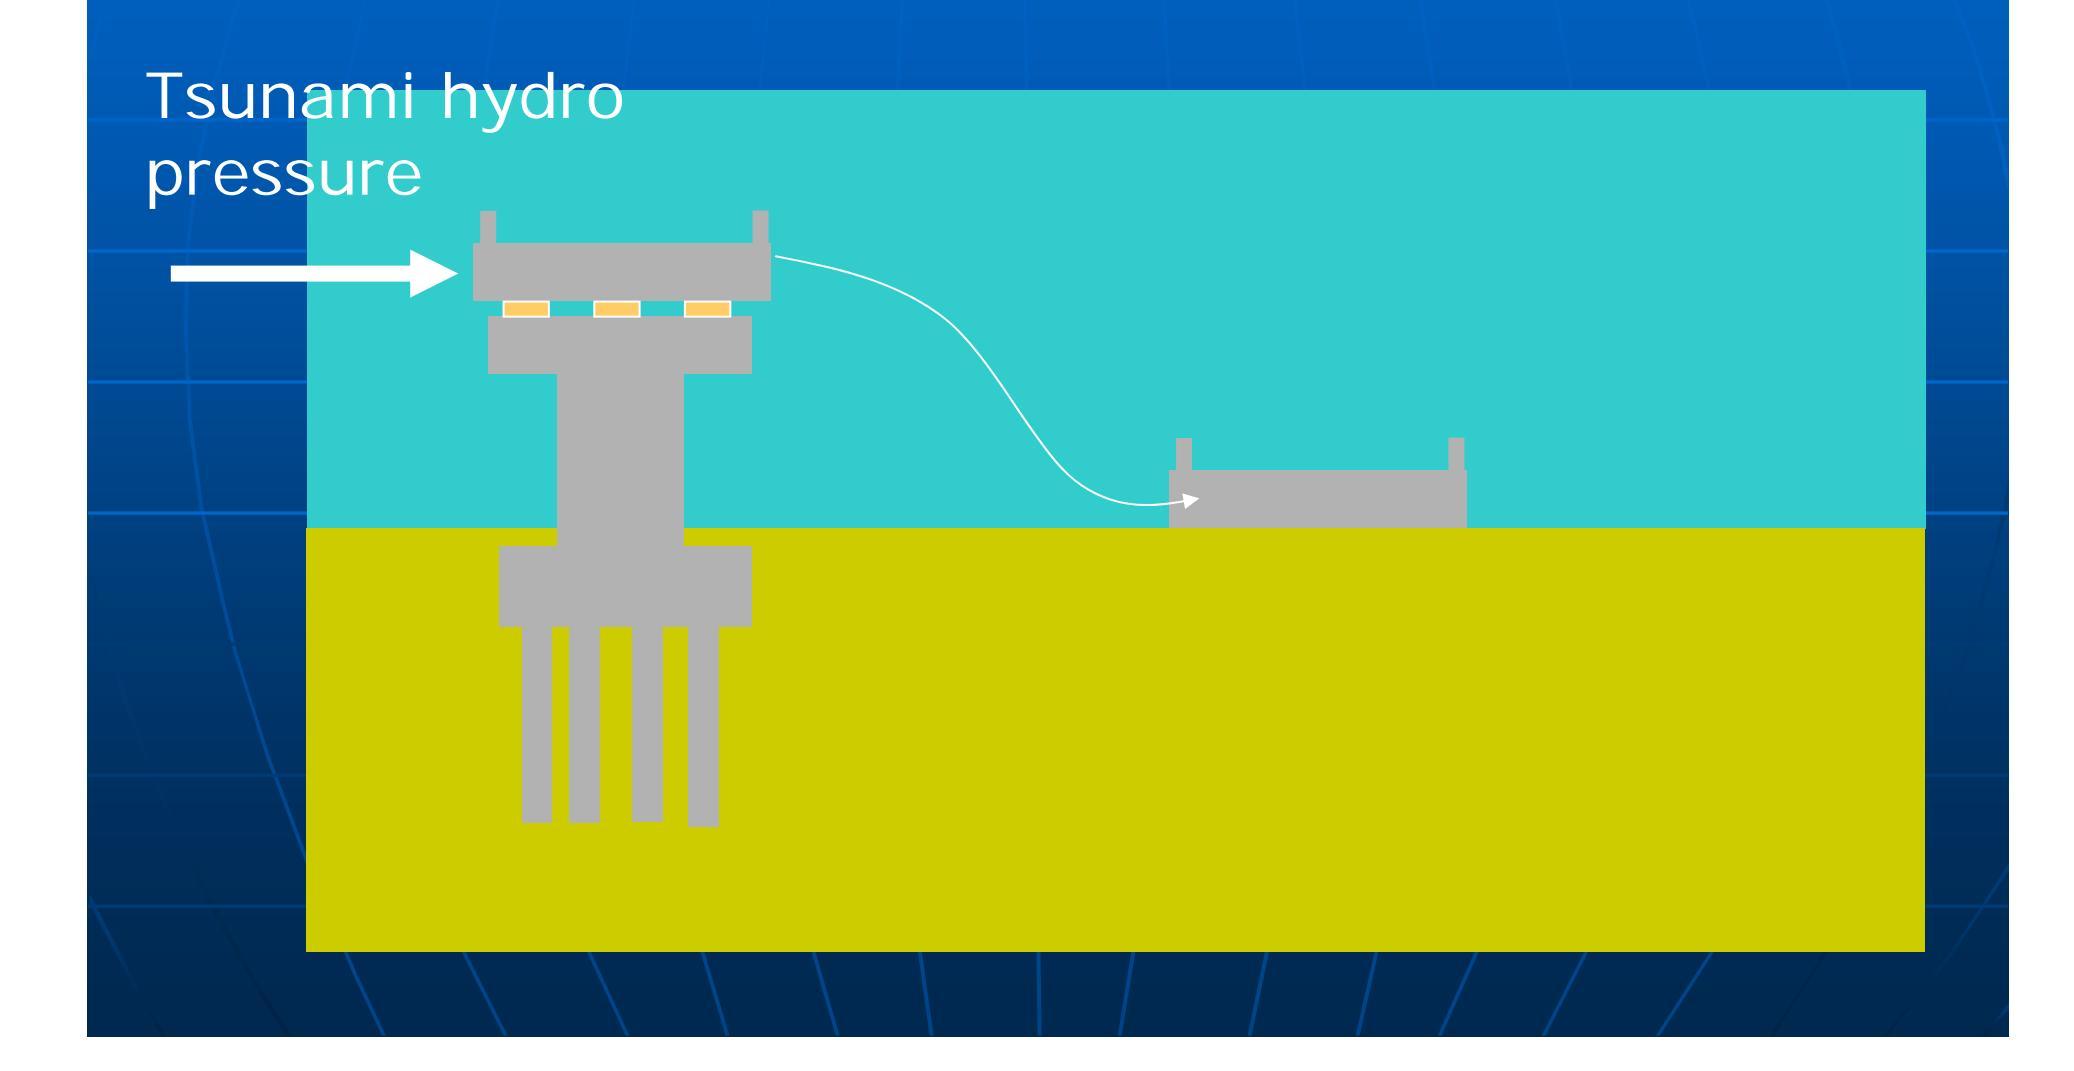
A possible Failure Mechanism of Bridges due to Tsunami

•A number of bridges suffered damage by tsunami. Damage was possibly developed by deck rotation toward upstream side, resulted from uplifting force. If failure of bearings (particularly downstream side bearings) due to uplifting force can be prevented, damage of tsunami may be mitigated.

It is recommended to install "unseating prevention device for tsunami." Restrainers which are widely used for unseating prevention device for earthquake may be effective if they are set in the vertical direction.
