5 	Steer STRUCTURAL EXTREME EVENTS RECONNAISSANCE	EVENT BRIEFING	
			Event:	26 November, 2019 Albania, Mw 6.4 Earthquake
		Region:	Europe	
Authors:	Alicia Tsai, Fan Hu, Selim Günay and Khalid M. Mosalam University of California, Berkeley			
Editors:	Ian Robertson, University of Hawaii at Manoa David O. Prevatt, University of Florida Tracy Kijewski-Correa, University of Notre Dame			
DesignSafe Project # PRJ-2654		Release Date:	December 14, 2019

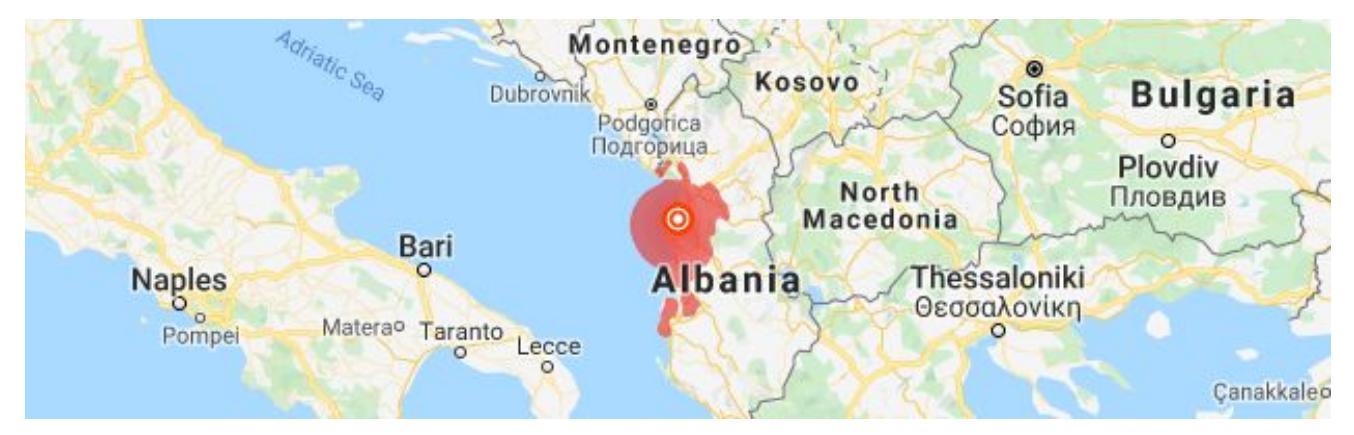
Figure 1. Epicenter of the Mw 6.4 Albania earthquake (USGS, 2019)

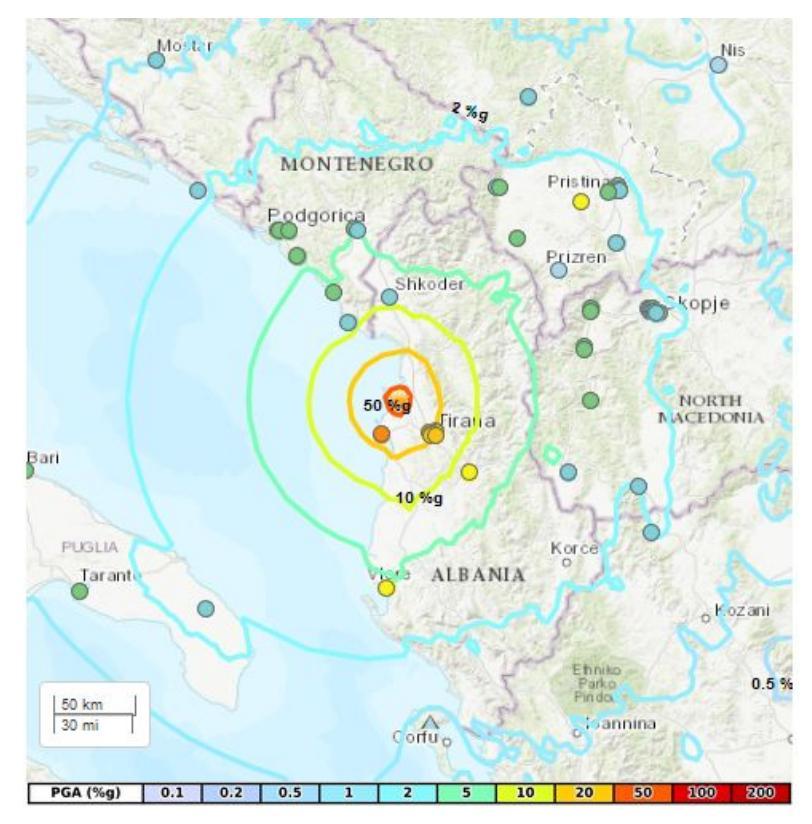
According to the USGS ShakeMap in Figure 2, significant levels of ground shaking, with as large as 0.5g peak ground acceleration (PGA), are estimated (USGS, 2019).

Figure 2. PGA contours estimated from ShakeMap (USGS, 2019)

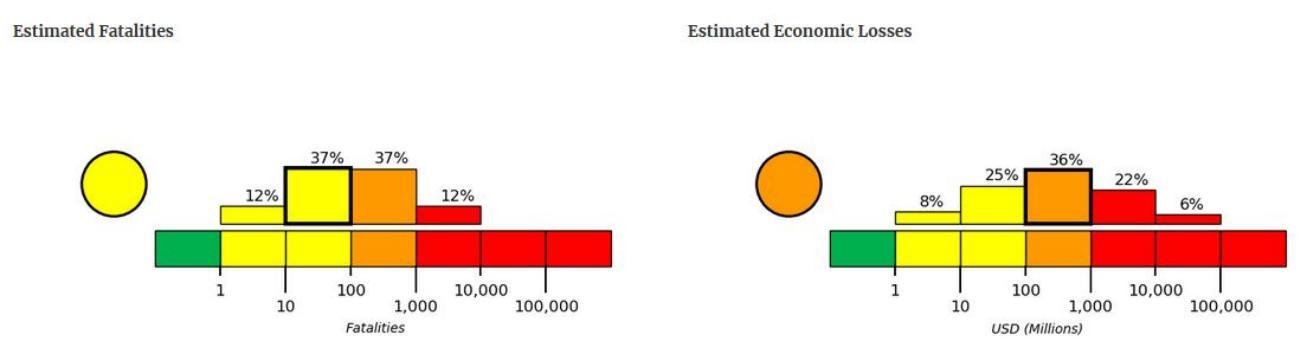
USGS PAGER tool estimated the fatalities to be between 1 and 10 with a probability of 12%, between 10 and 100 with a probability of 37%, between 100 and 1,000 with a probability of 37% and between 1,000 and 10,000 with a probability of 12% (Fig. 10). At the time this briefing was authored, the number of deaths as a consequence of the earthquake was reported as 51 and there were approximately 2,000 injuries. Damages were expected to be between \$1 million and \$10 million, between \$10 million and \$100 million, and between \$100 million and \$1,000 million with probabilities of 8%, 25% and 36%, respectively. Furthermore, there were probabilities of 22% and 6% of the economic loss to be between \$1,000 million and \$10,000 mi

Figure 10. USGS PAGER loss estimates (USGS, 2019)
