February 2023 Earthquakes in Türkiye and Syria: Observations from the Field and the Structural Engineering Office

Ayşe Hortaçsu
Applied Technology Council

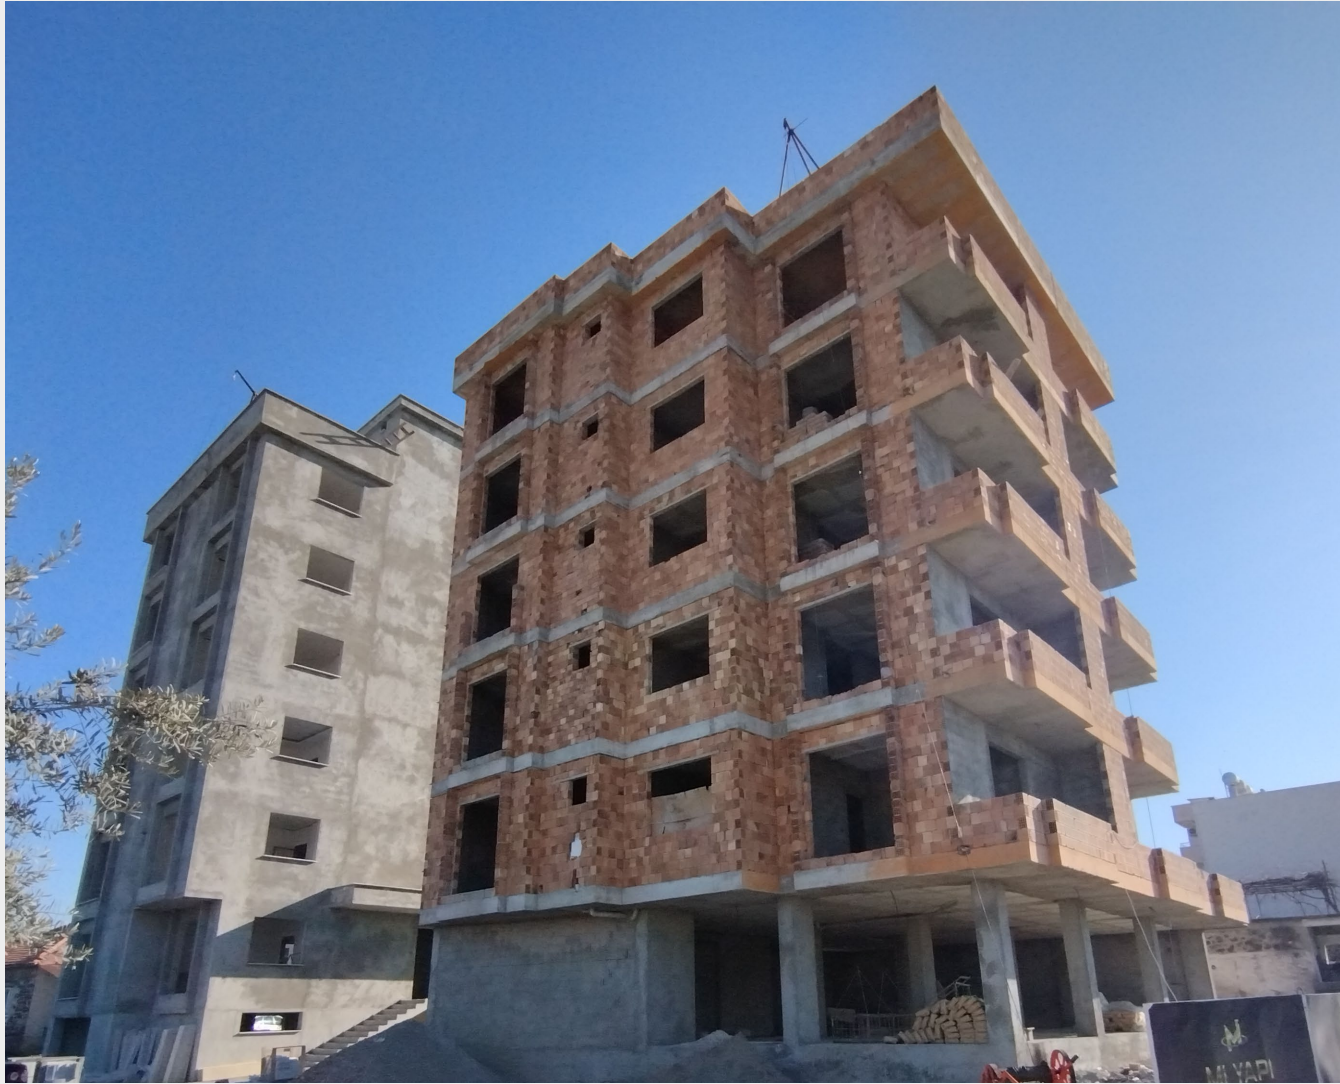
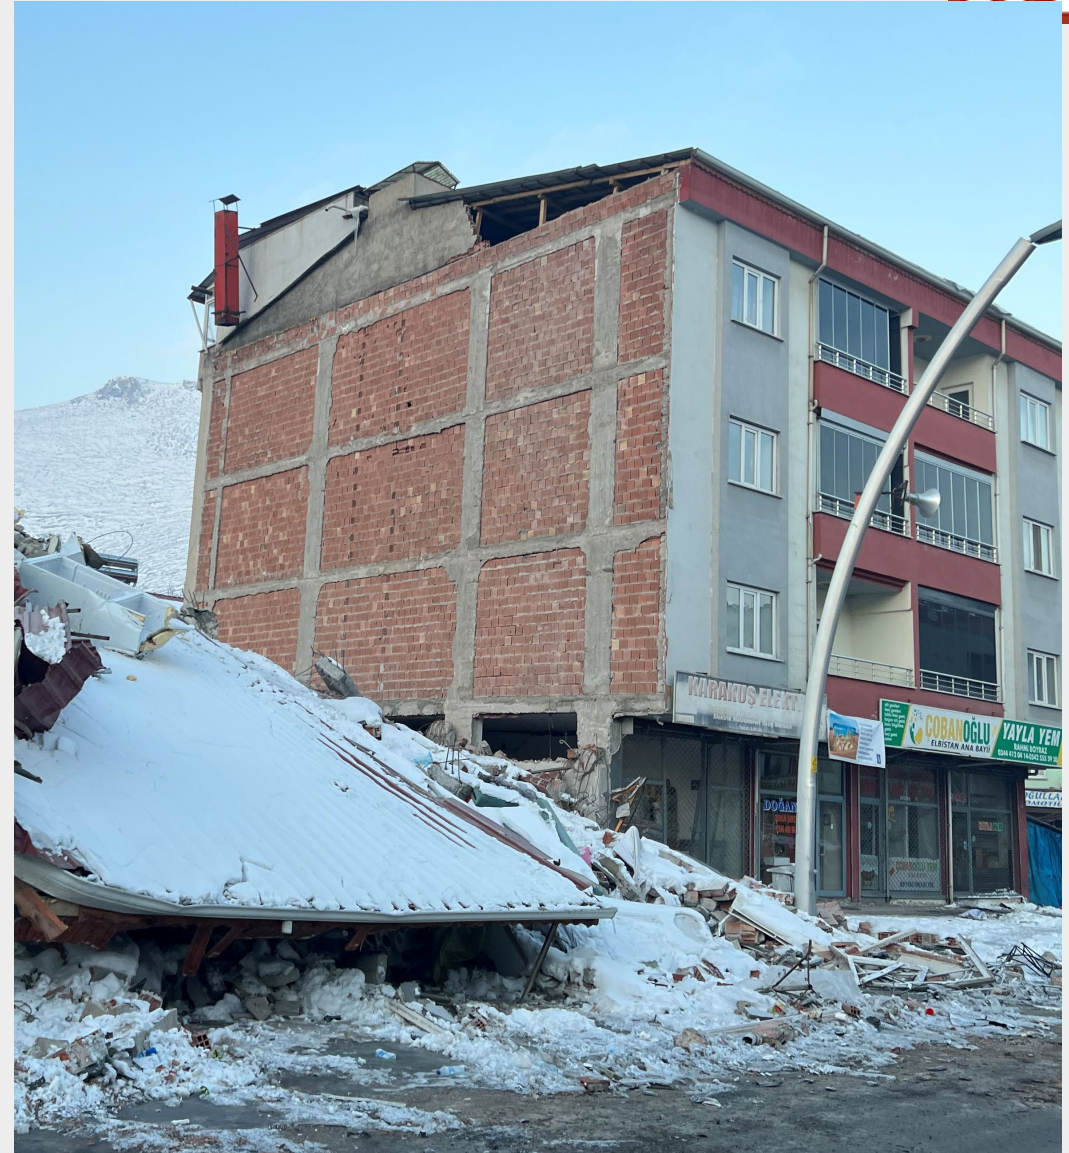
Typical construction
Typical damage

91 residential buildings
all post-2000
58% heavy damage

Figure 5.10. Types of damage observed in the residential buildings visited by the EERI Buildings team.

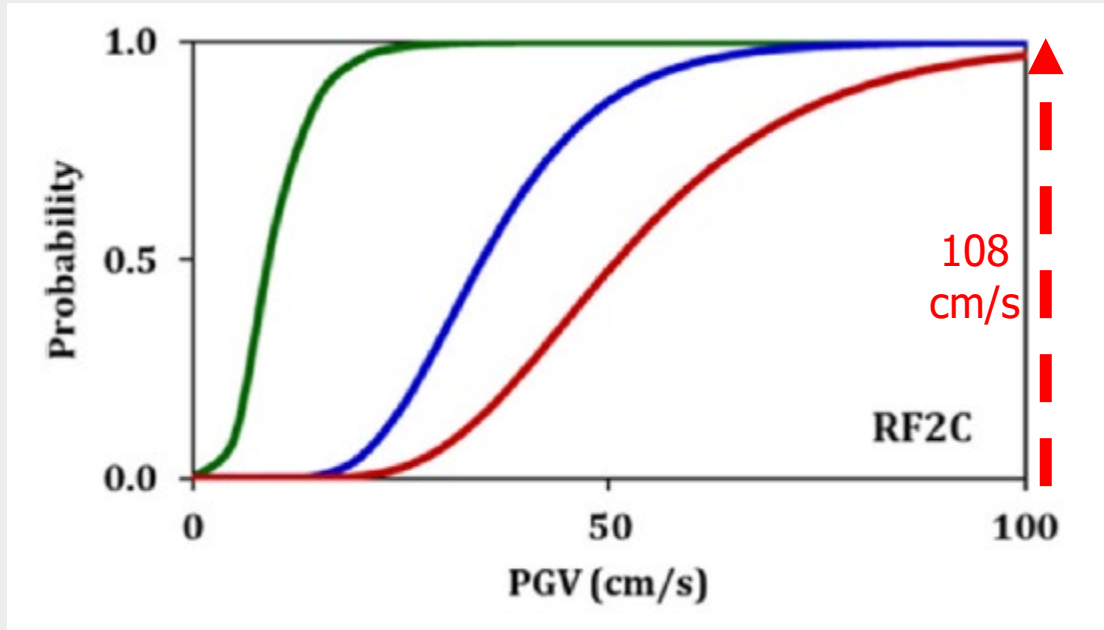
4-8 story reinforced concrete (RC) frames with no code compliance (Kelam et al., 2022)

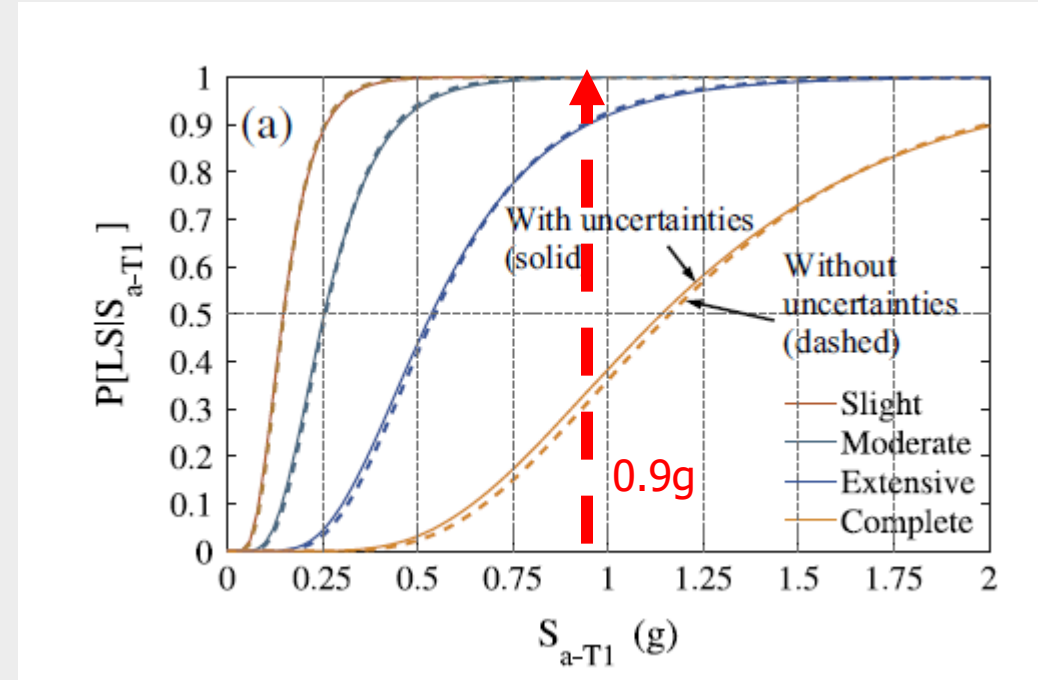
Non-code compliant nonductile RC frame in California (Jeon et al., 2015)

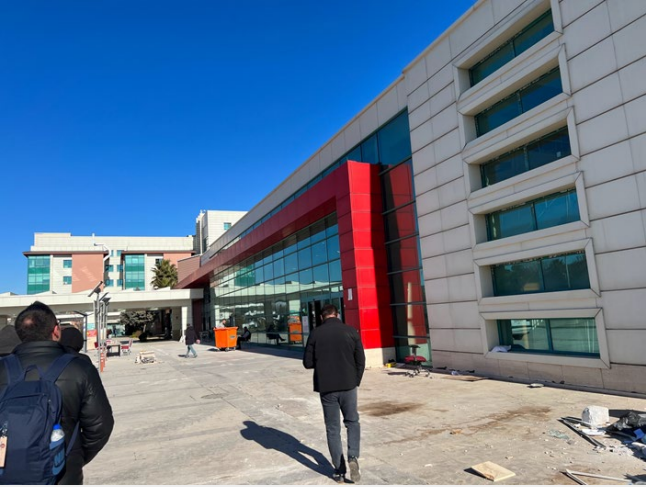
New Hospital (under construction)

- 361 base isolators
- 9-story wing to be added
- 18cm movement

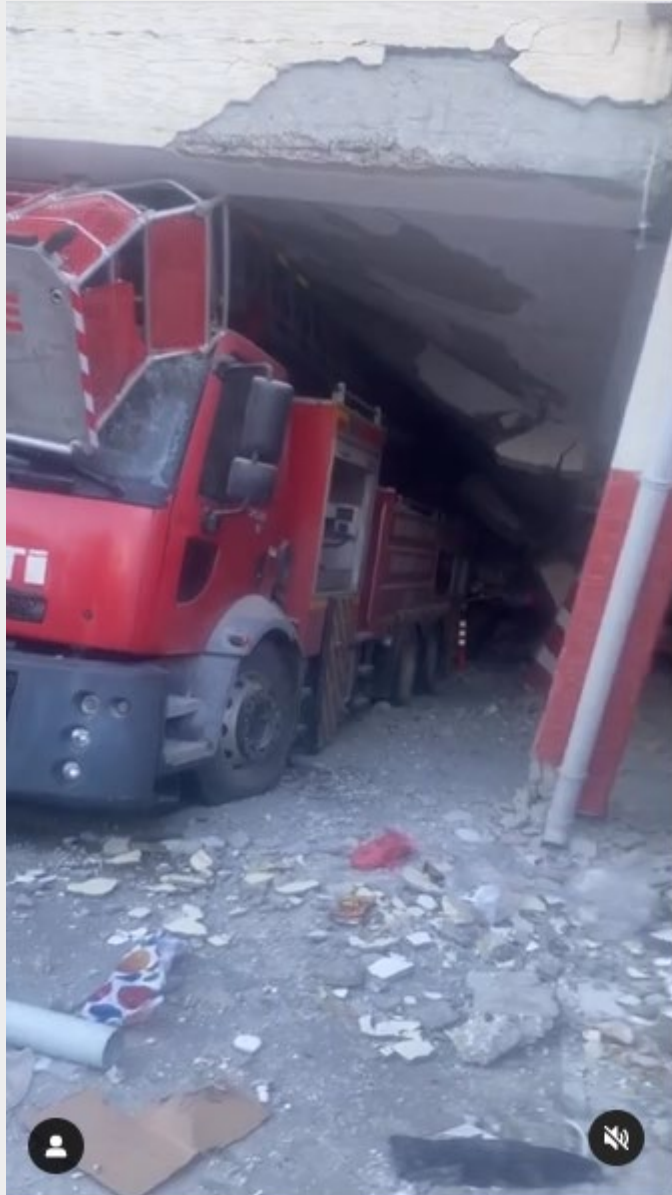
Fire Station in Antakya

“The main fire station in Antakya collapsed on top of three fire engines and one Search&Rescue vehicle. Fortunately all of it's 25 strong shift miraculously survived as the trucks below stopped the failing slab. The crew didn't have any time to recover from the shock as they needed to immediately start suppressing numerous earthquake induced fires in addition to Search&Rescue operations.” – Anton Andonov (EEFIT Team)
