OBSERVATIONS AFTER 5/12/2008 WENCHUAN EARTHQUAKE BASED ON FIELD RECONNAISSANCE FROM 7/4/2008 TO 7/7/2008

Khalid M. Mosalam, PhD, PE mosalam@ce.berkeley.edu
Professor and Vice Chair for Research and Technical Services
Structural Engineering, Mechanics and Materials
Department of Civil and Environmental Engineering

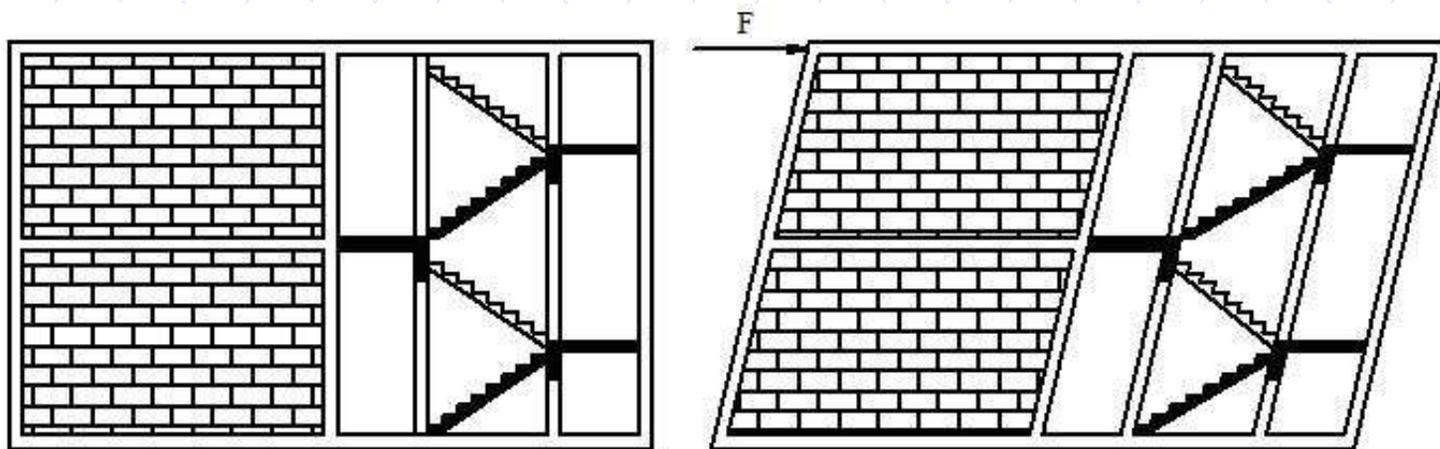
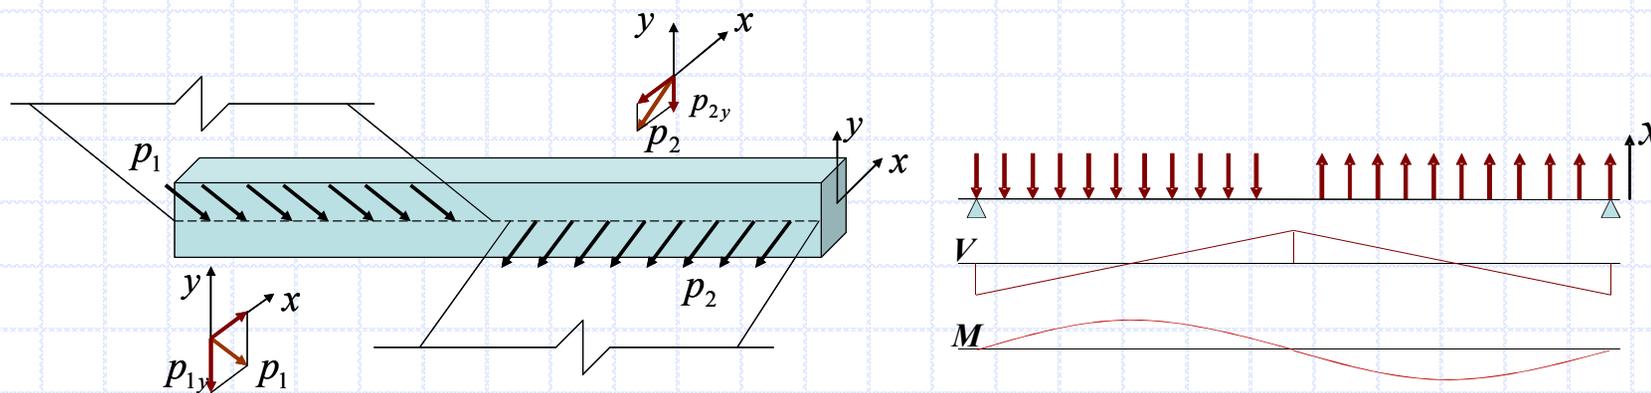
Seismic Performance of Stair Wells

1. Poor construction practice and inadequate seismic design levels† are the main reasons for most of the building collapses.
2. Short columns, strong-beam/weak-column, use of inconsistent masonry walls, disregard of infill walls in design are main reasons for the widespread damage in the epicenter region.
3. Types of stairwell damage when a building is shaken in the transverse direction (parallel to tread depth) are:
 - I. flexural damage in staircase treads,
 - II. shear damage at construction interface of staircase treads,
 - III. shear failure in landing beams
 - IV. crushing in staircase treads/landing beams joints
