Reconnaissance Report on the China Wenchuan Earthquake May 12, 2008

*Chu-Chieh J. Lin, Associate Research Fellow of NCREE
Juin-Fu Chai, Research Fellow of NCREE*

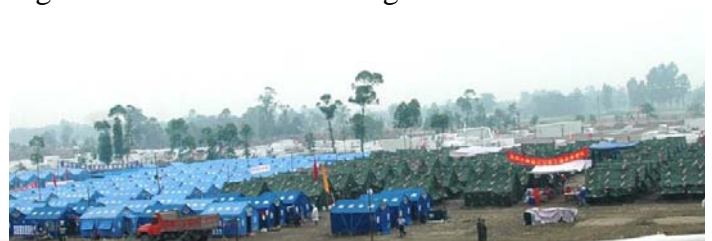
Fig.75

Immediately after earthquake, more than 100,000 China Army, police and fire fighters from other provinces come to Sichuan to help. Three days later, rescue teams from overseas join the missions and save thousands of lives together. Central government allocates billions for rescue and relief efforts in quake-hit regions. Loads of materials and people sent to help the massive recovery. The damaged roads to the mountainous region were made accessible for emergency transportation. Figure 73 shows the people line up waiting for reliefs and figure 74 shows the farmers working on the rice field in disaster zone. Figure 75 shows enormous emergency tents at refuge area.
