ASCE-41 Evaluation of a Reinforced-Concrete Building Damaged in the 2016 Meinong Earthquake

Andrew D. Sen, Jakob Sumearll, Dawn E. Lehman, and Laura N. Lowes

University of Washington – ATC-134 Project

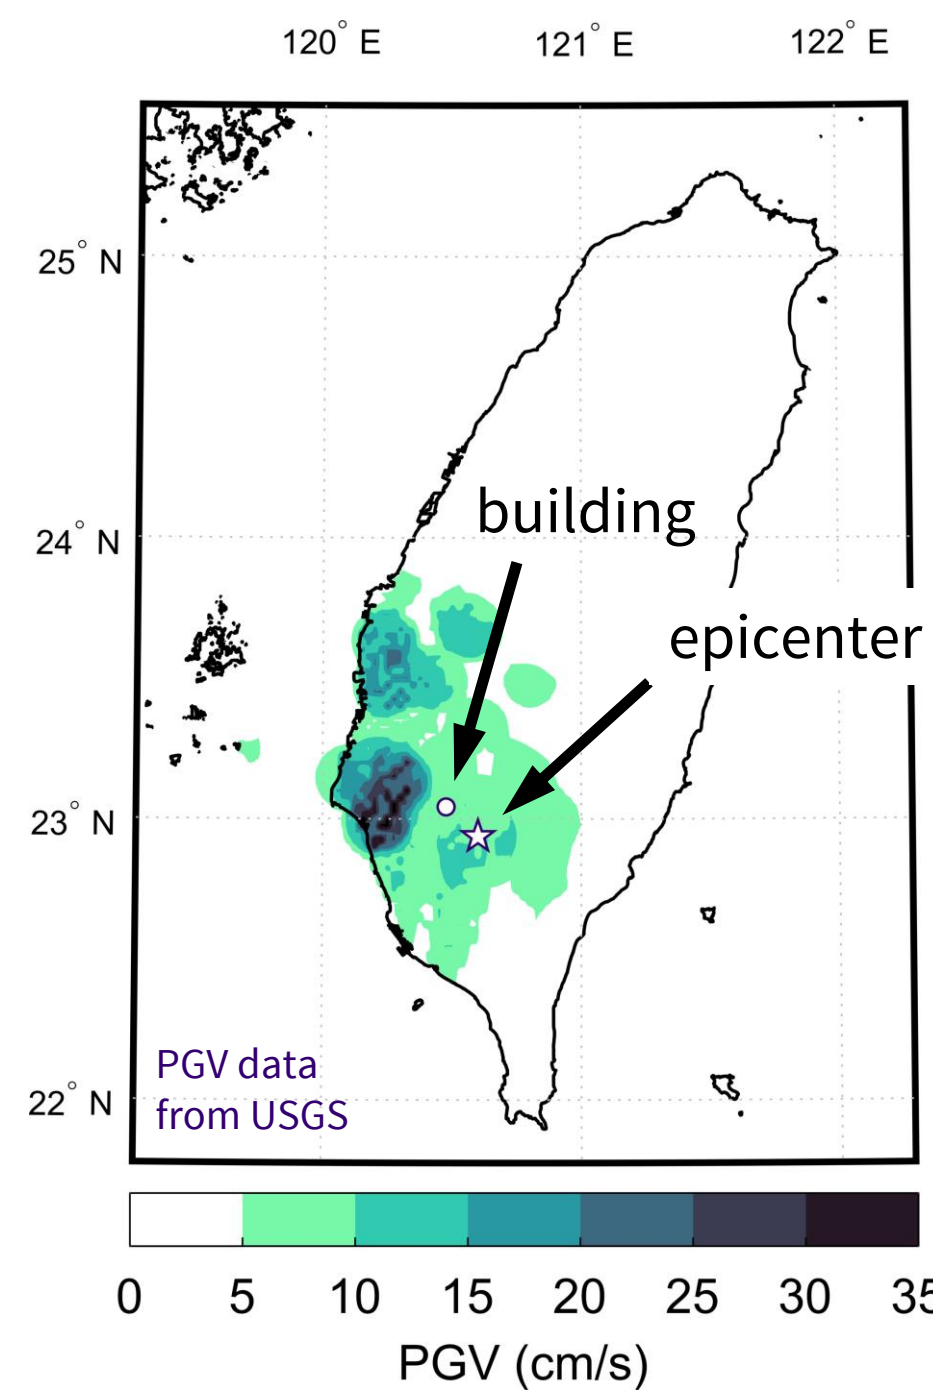
- > M6.4 earthquake occurred in southern Taiwan near the city of Tainan on February 6, 2016
- > Significant damage to reinforced-concrete buildings, particularly moment-resisting frames with masonry infill
 - > Several major collapses
 - > 3 district offices damaged, including Nanhua District Office (1967):

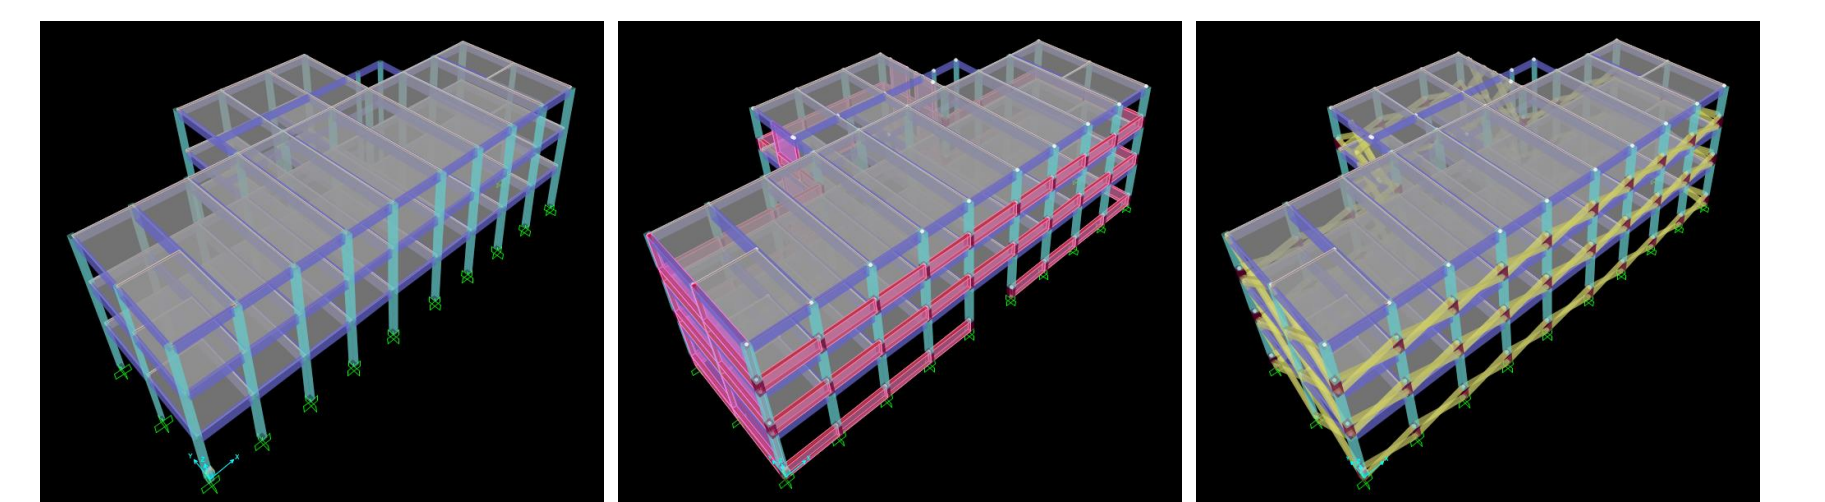
(1) Bare frame (2) Infill offsets (3) Infill Shell elements (4) Infill diagonal struts

- > Analyses performed in SAP2000 using four model variations
- > Ground motion is closest to building and captures forward-directivity effects
- > Results:
 - > Variation in response of models is not significant
 - > Predicted damage modes inconsistent with observations

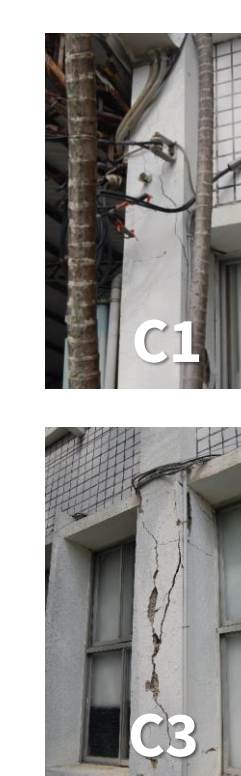
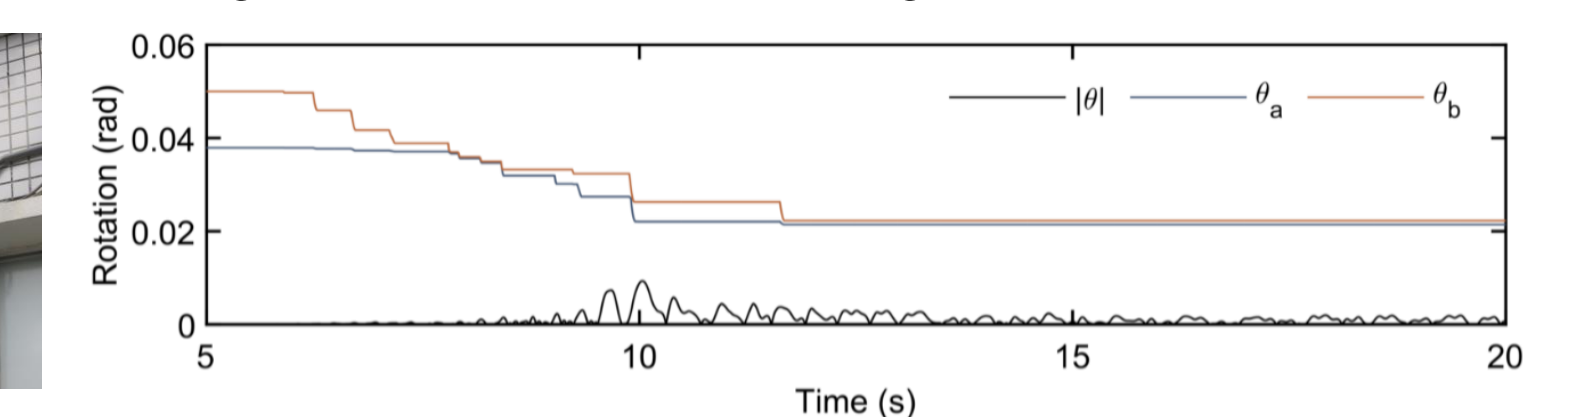
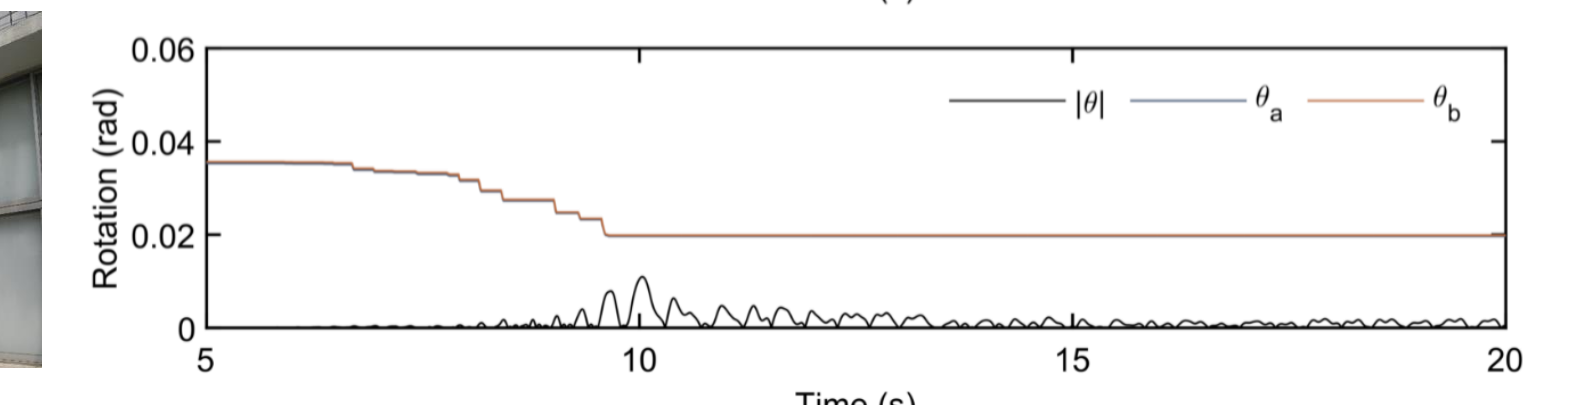
Hinge Rotation and Modeling Parameter Evolution

- > Columns yield but do not sustain shear or flexure-shear degradation
- > Acceptance criteria for life safety exceeded in several cases
- > In contrast to linear analysis but in concert with post-earthquake reconnaissance, predicted damage only in longitudinal (X) direction of building
