24 August 2014 South Napa M_w 6 Earthquake Reconnaissance Report

26 September 2014

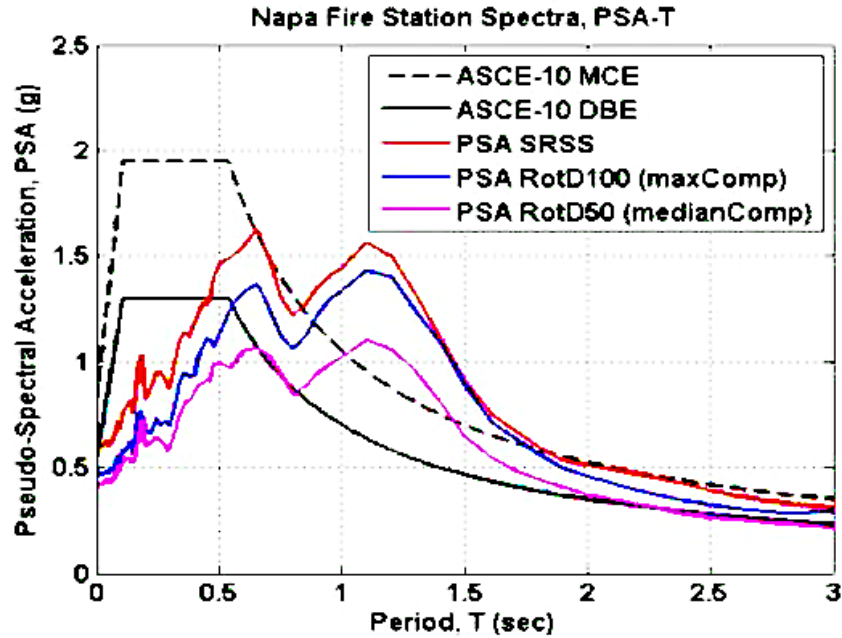
(Bray et al. 2014) compared recorded ground motions to code-based design spectra, Figure 6, finding that the pseudo-spectral accelerations recorded there (and at some other locations) exceeded the maximum considered earthquake (MCE) and 2/3·MCE (design) spectra at a period around 1.5 s near the fault, observing that “this observation is related to near-fault velocity pulses.”

To explain: the black lines in Figure 6 are what engineers design for. A shorter building (less than 5 stories or so) is designed for accelerations near the flat part of the solid black line. A taller building is designed for downward-curving solid black line. The dashed black line corresponds to very rare (MCE) motion, with somewhat higher than 2% probability of being exceeded in 50 years, or in other words somewhat higher than shaking that is only expected to occur once in 2,500 years. The three jagged lines show shaking at Napa Fire Station 3 measured in two different directions and a geometric mean, which approximates the strongest motion a building would have experienced. Different x-values in the plot correspond to the motions that buildings of different heights would have experienced or would be designed for. The plot shows that motions in not-very-rare earthquakes can produce very rare shaking in some locations, reaching or substantially exceeding life-safety and even collapse-prevention motions.

Figure 6 Spectra comparison for Napa; Fire Station No. 3
(Bray et al. 2014)

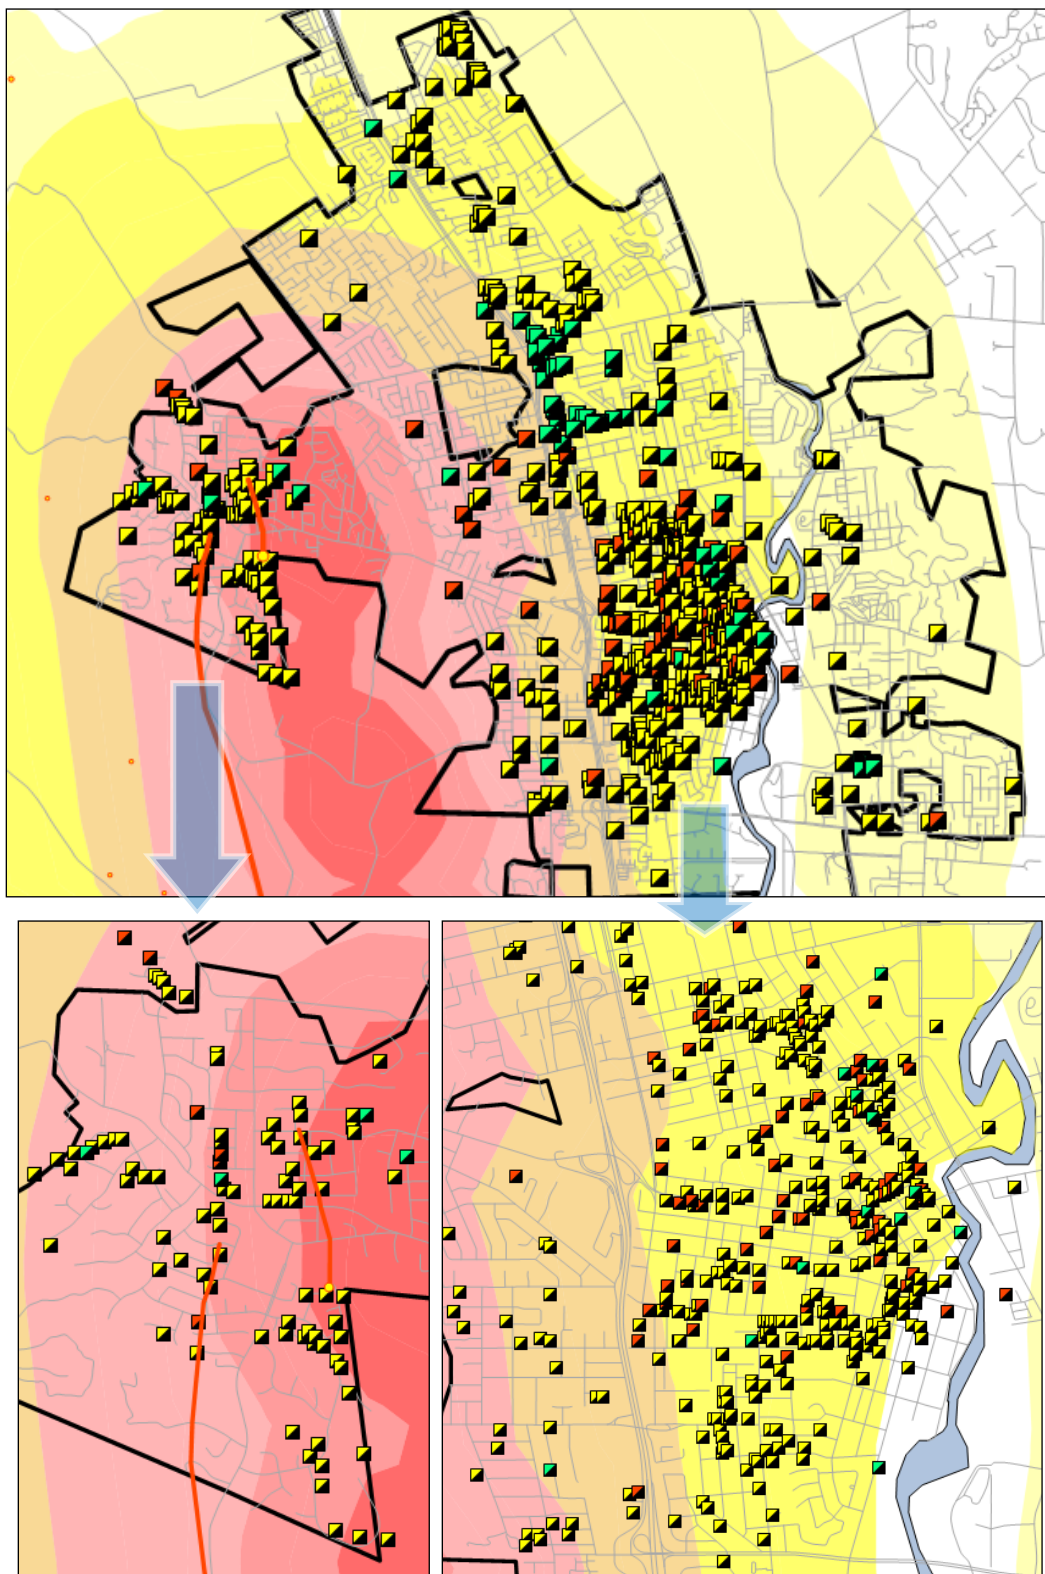
A total of 752 buildings in the City of Napa were tagged red, yellow or green according to the ATC-20 process, as of 1 pm on 27 August 2014. Of these, 116 (15%) were red (unsafe to enter or occupy), 515 (68%) were yellow (limited entry, such as safe enough to remove property or

safe enough only in a portion of the building), and 121 (16%) were green (inspected, and deemed safe for normal, pre-earthquake use). These are shown in Figure 9.

Figure 9 ATC-20 Tags, City of Napa (t) entire city;
(b) detail for Brown's Valley on left, for downtown on right

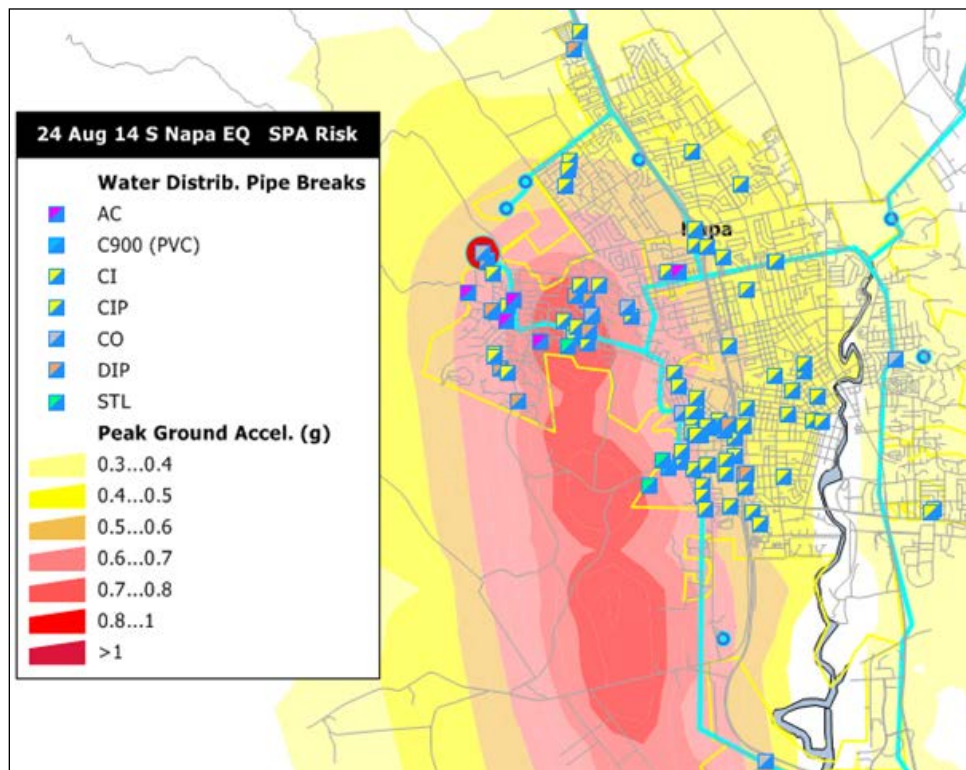
The distribution system includes 12 tanks and 337 miles of distribution pipe, which is made up of several types and vintages of pipe as shown in Table 4. Table 5 and Figure 26 show the breakdown and locations of breaks in the system caused by the 24 Aug. event – there were a total of 163 breaks, 75% of which were in cast iron pipe.

Figure 26 City of Napa water system overlaid on PGA and showing locations of breaks and Montana “B” tank.

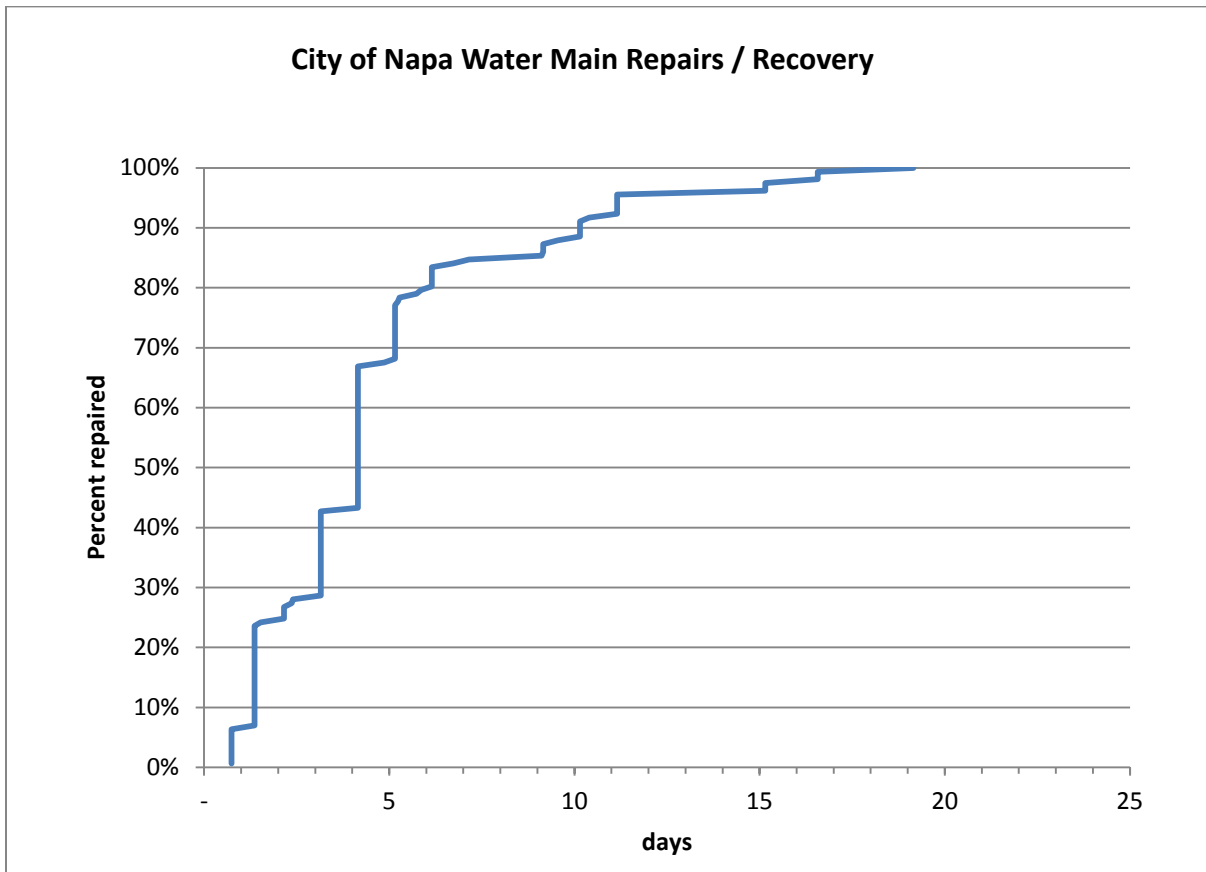
Pipe breaks were repaired relatively quickly, with half completed in less than five days, Figure 30. The City of Napa was aided in making repairs by regional utilities through the CalWARN (www.calwarn.org) system, as follows:

Figure 30 Water distribution pipe break repairs (%) vs. number of days following the earthquake.

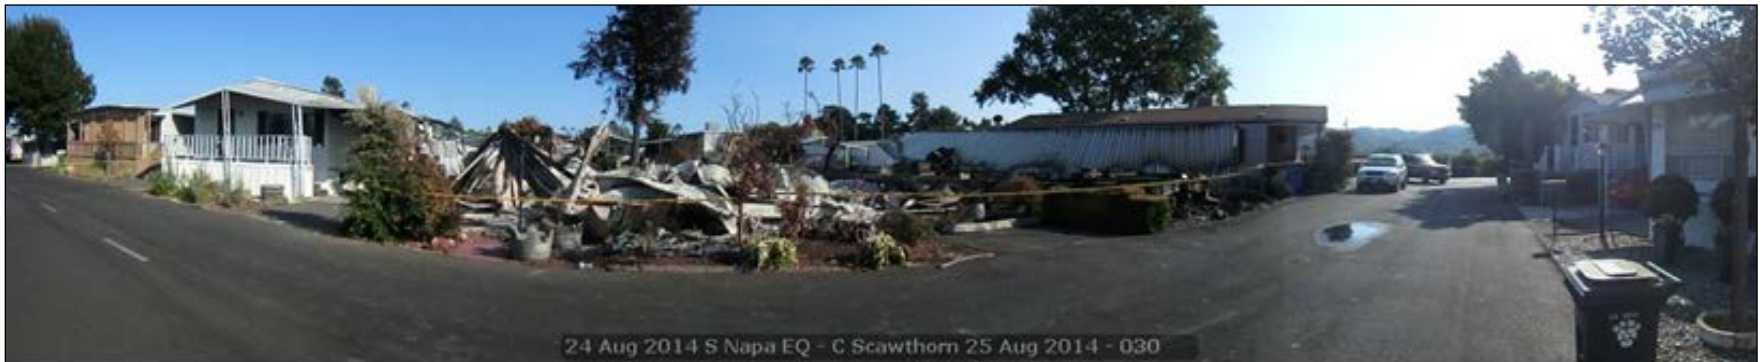
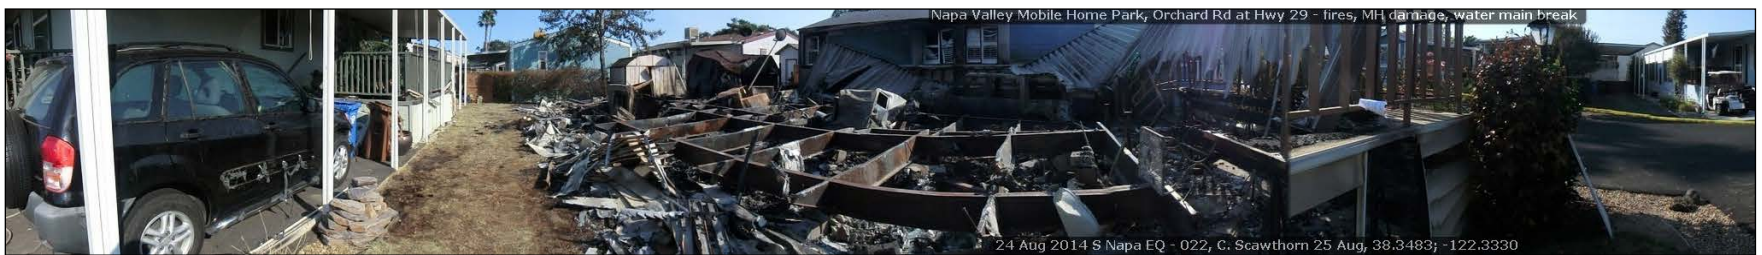
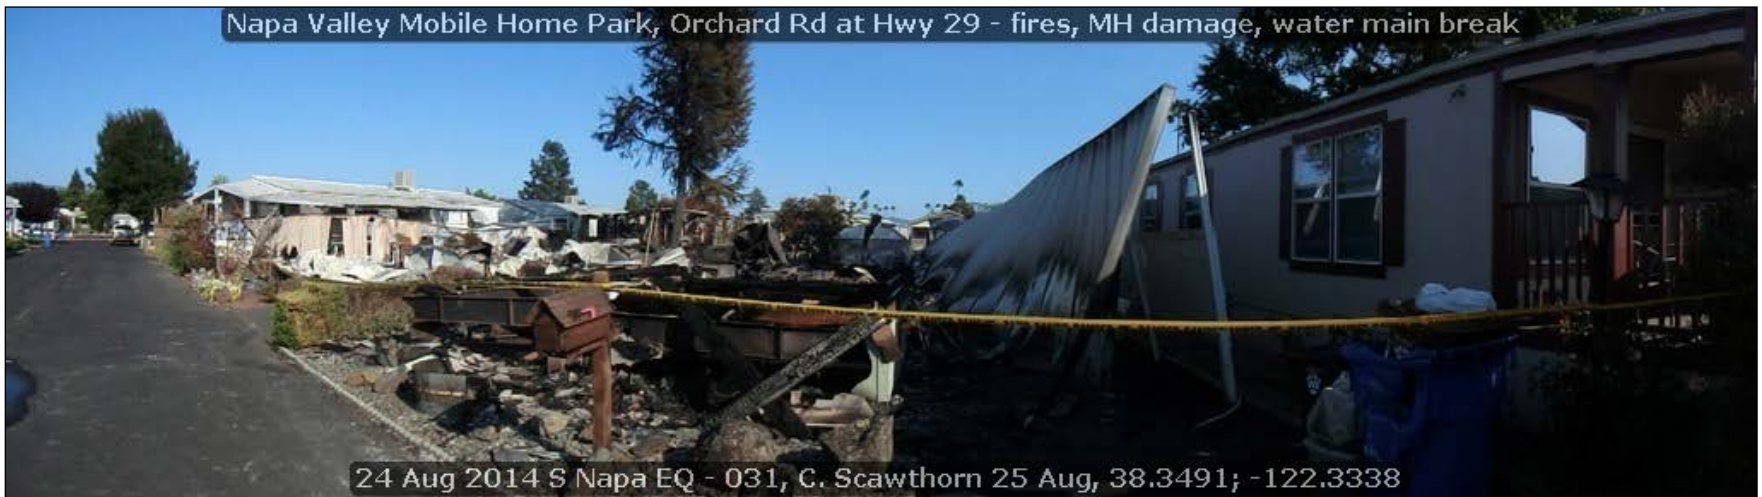
Figure 48 Fireground 317 Patty Way, NVMHP Park, 24 Aug 2014 S. Napa M_w 6.0 Earthquake

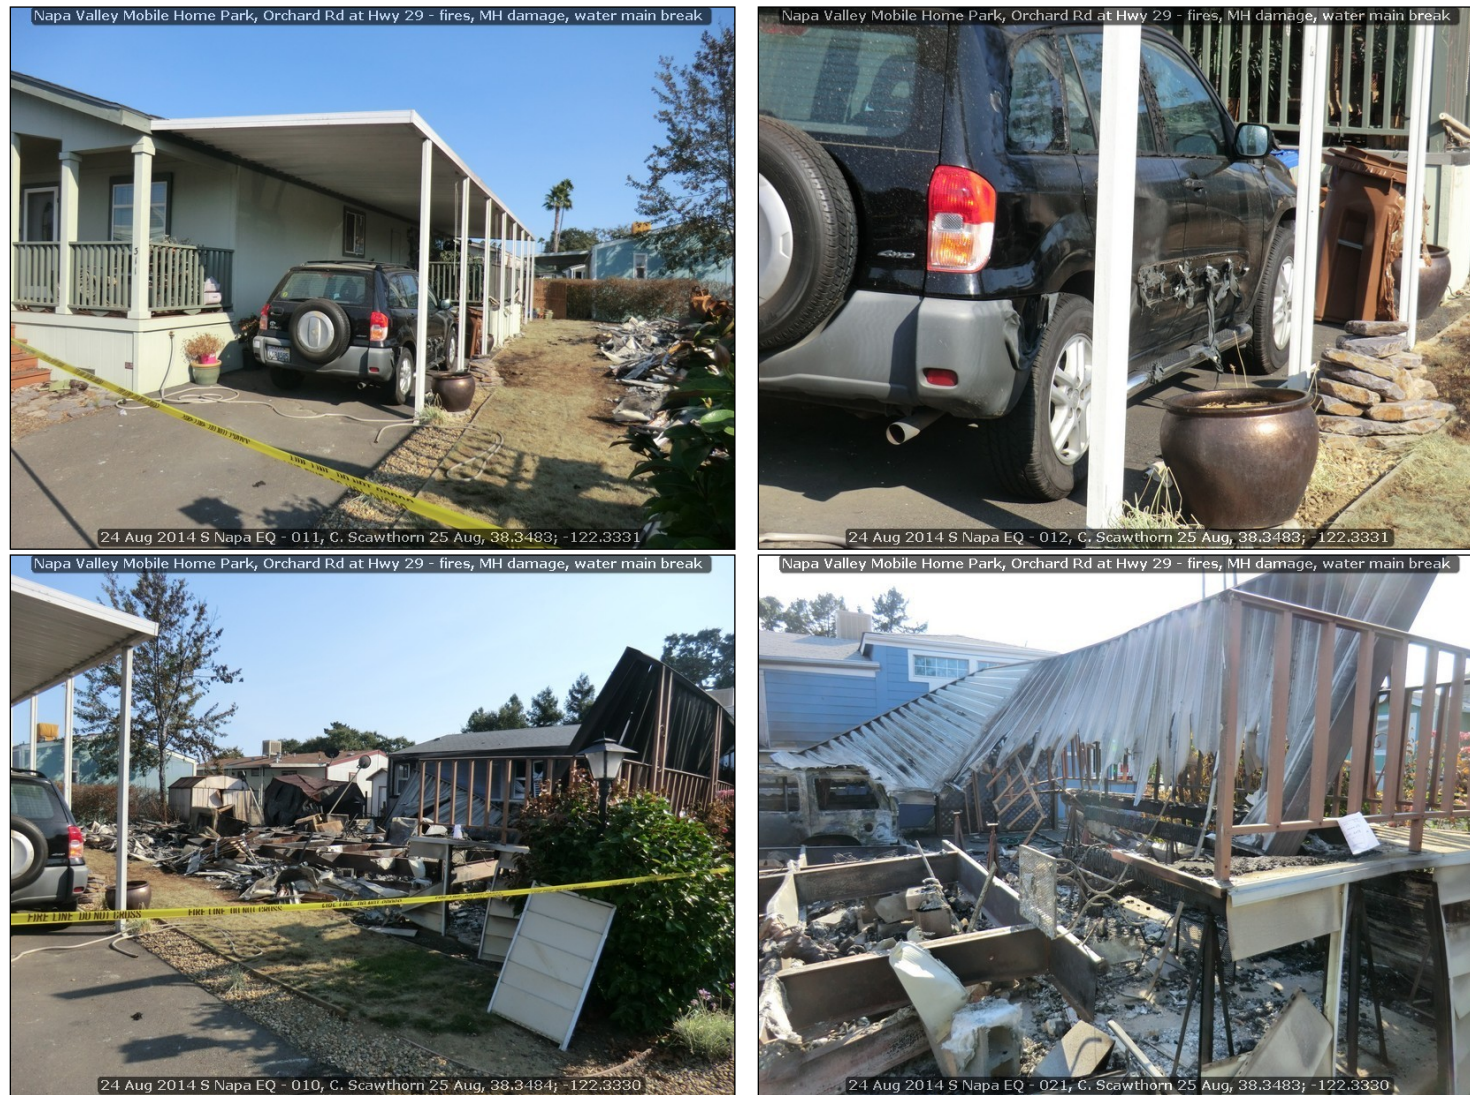
Figure 49 Views from NE, Fireground 317 Patty Way, NVMHP Park, 24 Aug 2014 S. Napa M_w 6.0 Earthquake

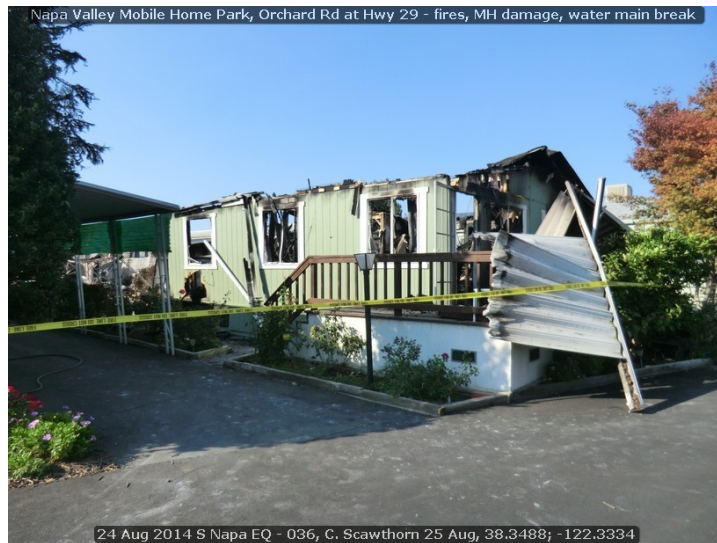
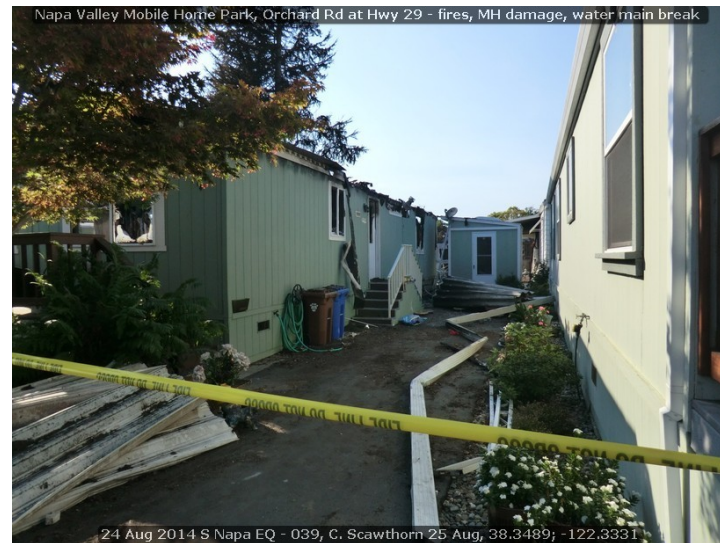
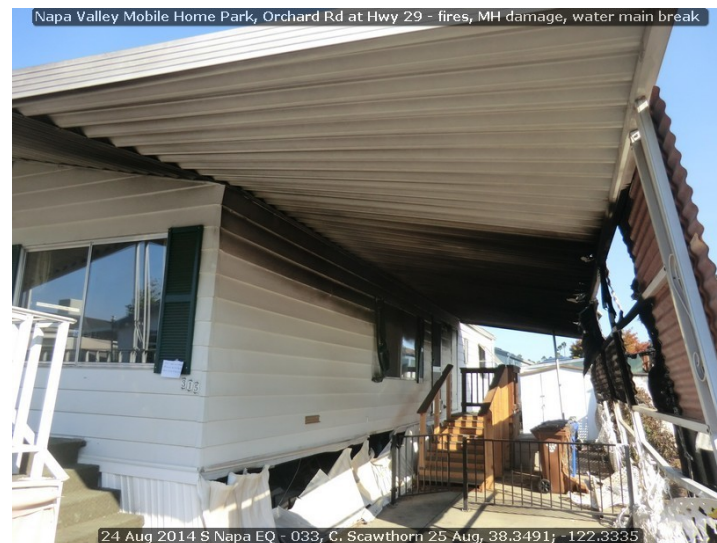
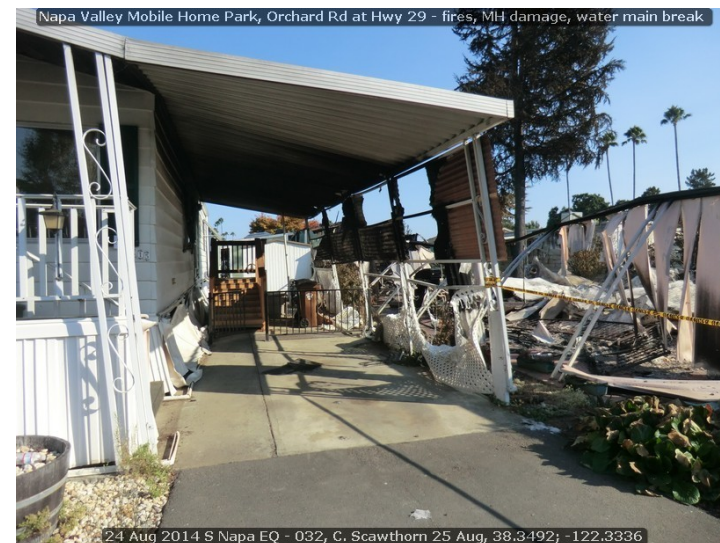
Figure 50 Views looking N from Stacey Way, Fireground 317 Patty Way, NVMHP Park, 24 Aug 2014 S. Napa M_w 6.0 Earthquake

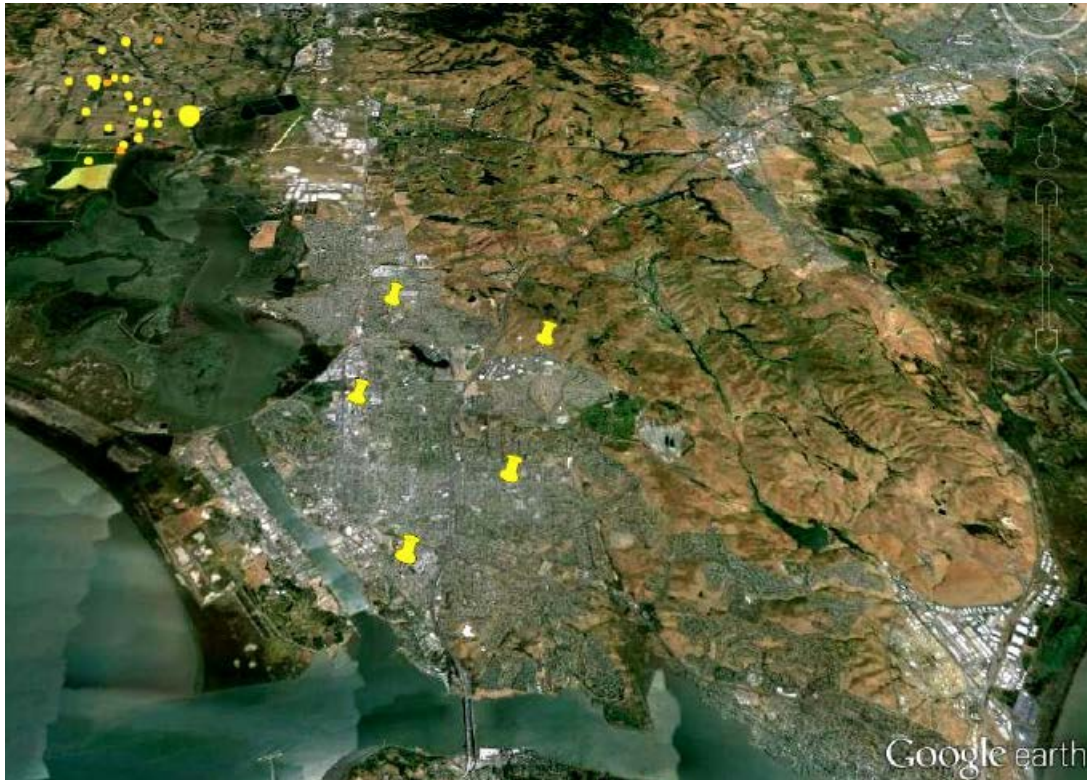
The operational system is a relatively small system operated by the private sector firm of Seismic Warning Systems (SWS). SWS has five operational stations in Vallejo (in fire stations), Figure 52, one in an Albany fire station, and one at the Lawrence Berkeley National Laboratory. SWS reported their performance as follows⁶:

Figure 52 SWS stations in Vallejo (yellow pins). Yellow dots are mainshock and aftershocks of 24 Aug. 2014 South Napa Earthquake

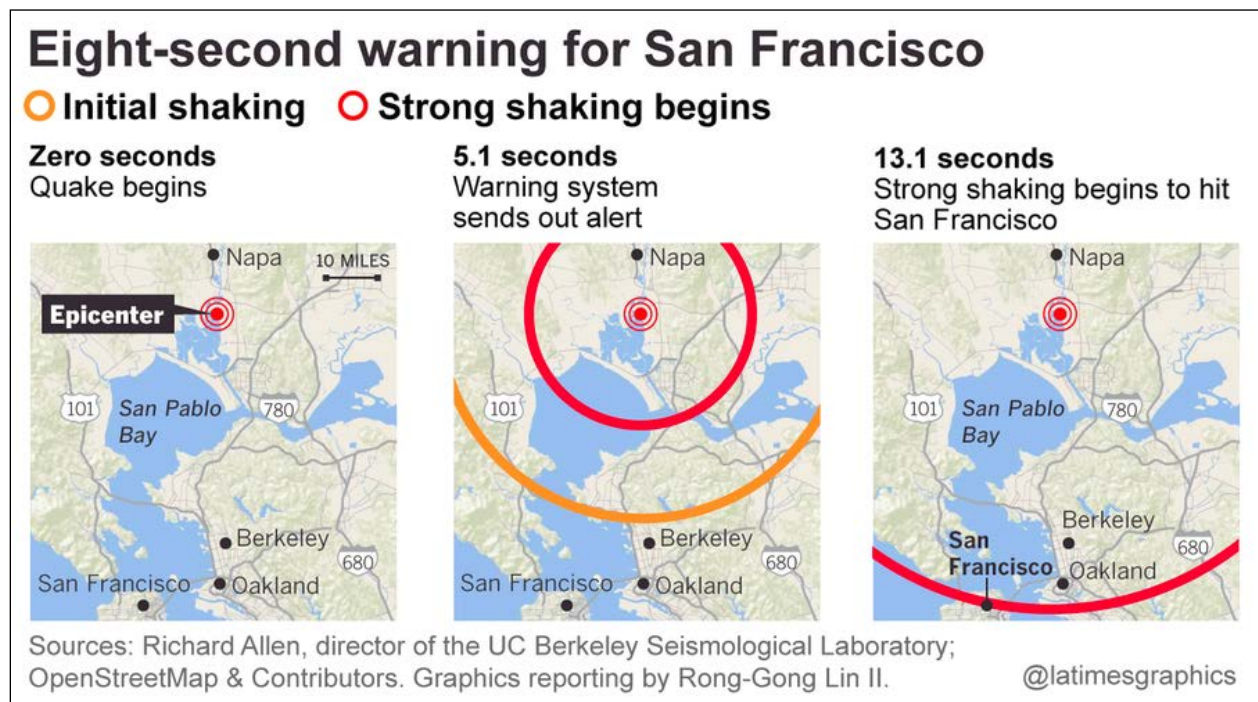
system functioned well in the South Napa event, providing about two seconds warning for recipients in the strongly shaken epicentral area – in Berkeley, which was not heavily shaken, the warning was about eight seconds, Figure 53.

Figure 53 ShakeAlert Early Earthquake Warning, 24 Aug. 2014 South Napa Earthquake
