## **Development of an Electrical Substation Equipment Performance Database for Evaluation of Equipment Fragilities**

**Thalia Anagnos**

Final Report  
April 1, 1999

PEER Report 2001/06  
Pacific Earthquake Engineering Research Center  
College of Engineering  
University of California, Berkeley  
April 1999

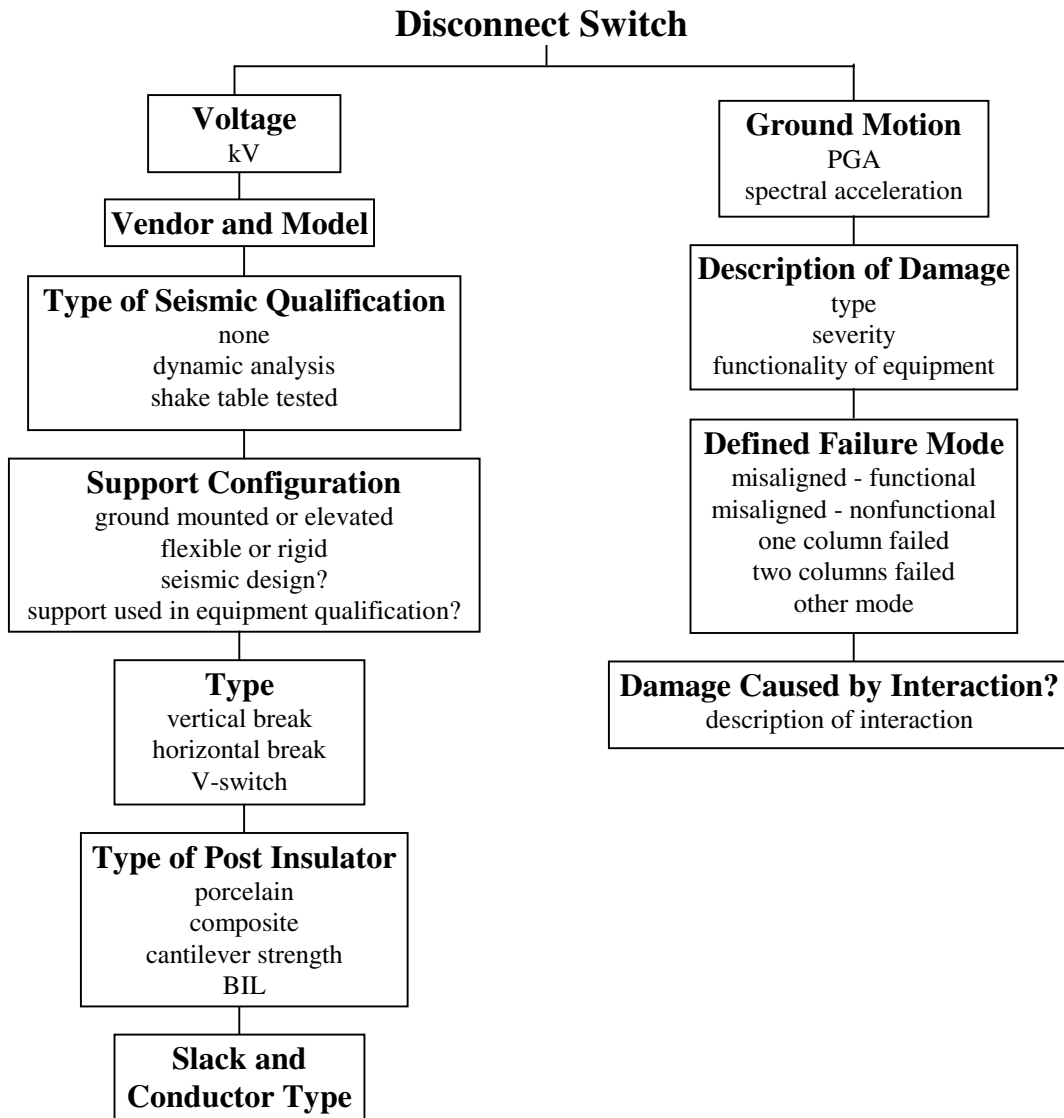
Figure 3.1 Key parameters for defining seismic damage to a disconnect switch

Figures 3.1 through 3.8 summarize the key parameters needed to define equipment fragilities from earthquake damage data. It is recommended that these data be collected for all equipment on future earthquake reconnaissance visits. The items in solid boxes are essential for a complete definition of the fragilities. The items in dashed boxes are less critical.

Each figure has two branches. The left branch describes attributes, specific to a particular type of equipment, which can be collected and cataloged before an earthquake. These attributes affect how the equipment will respond to a certain level of ground motion. For example, a composite insulator will be more rugged than a porcelain insulator; a well-braced radiator will perform better than one with no bracing. To some extent these parameters were used to develop the equipment classification system described in Section 4. The right branch describes the seismic input and the type of damage. These data can only be collected after the earthquake has occurred.

Comparison of equipment damage data with fragilities requires a standardized approach for reporting damage. As indicated in Figures 3.1 through 3.8, well-defined standardized failure modes are an essential element of the fragility curve definition. Failure modes that have been defined by the UWG are summarized in Table 5.1. In all cases where a number is used it should be read “at least.” For example, for TR2 or TR4, the third failure mode should read “At least 3 Main Porcelain Gasket Leaks.” These failure modes could be further refined by indicating whether the damaged equipment is functional or nonfunctional immediately after the earthquake.

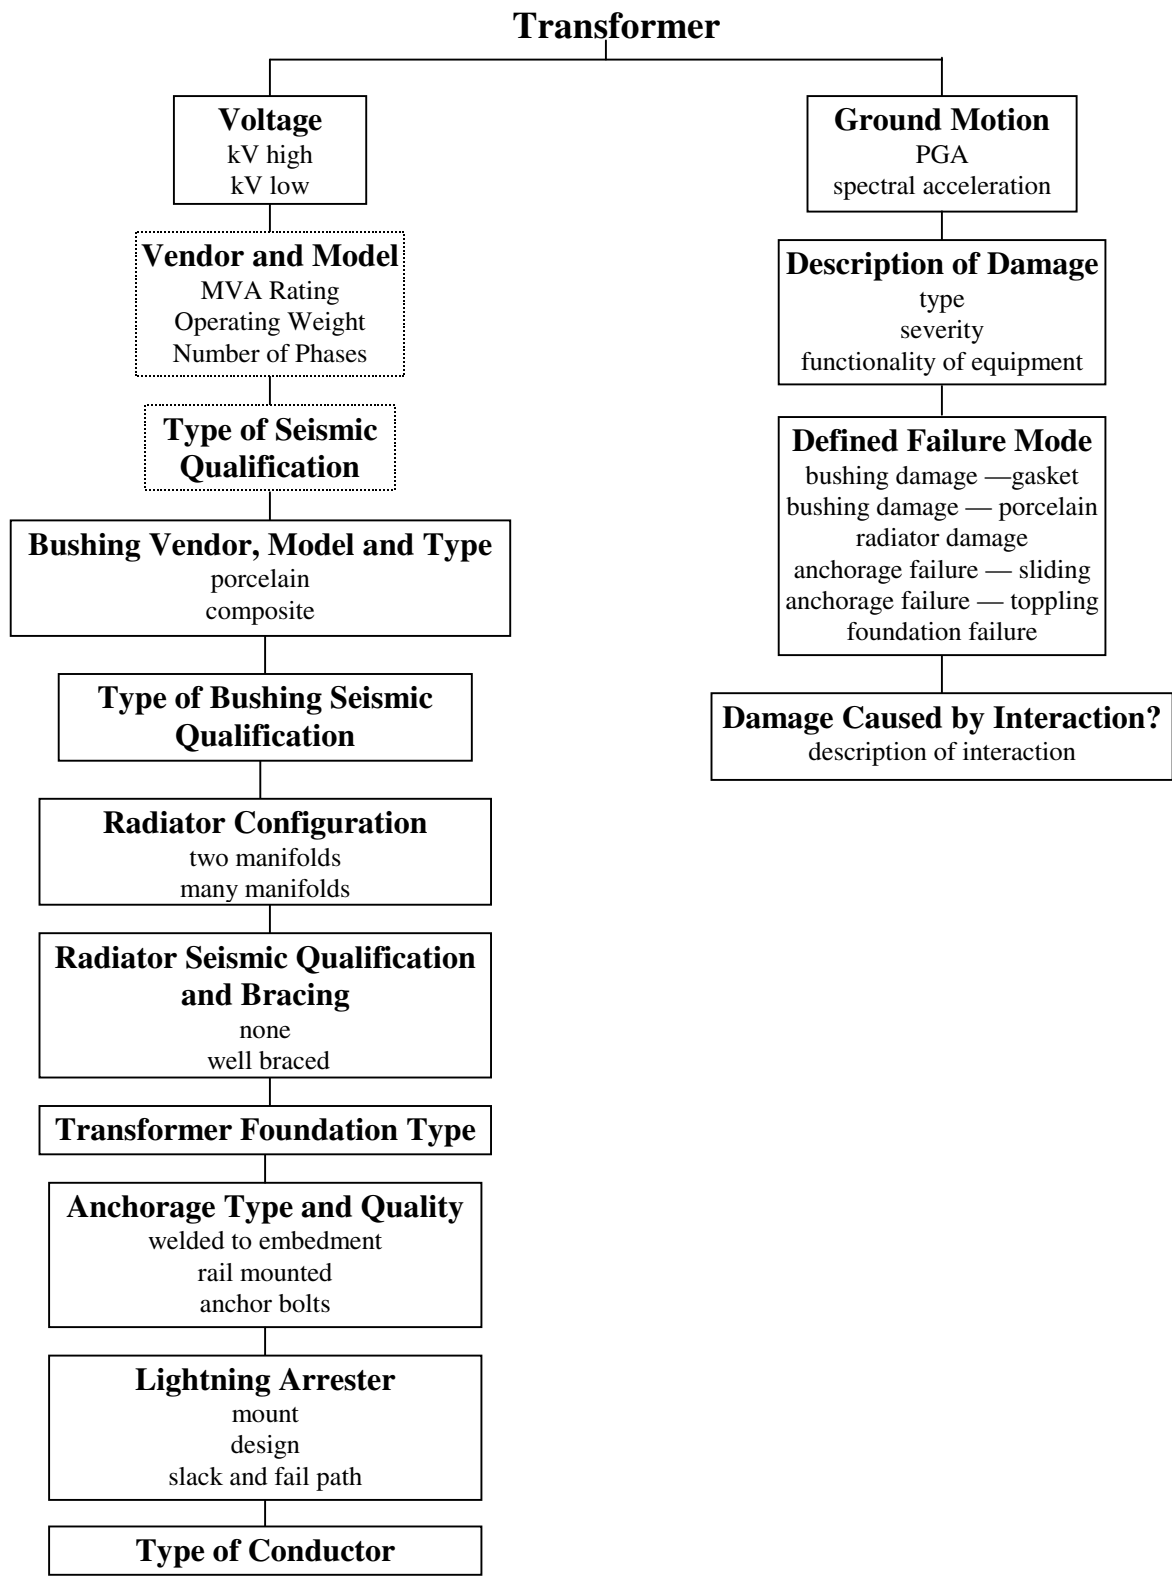
Figure 3.2 Key parameters for defining seismic damage to a transformer

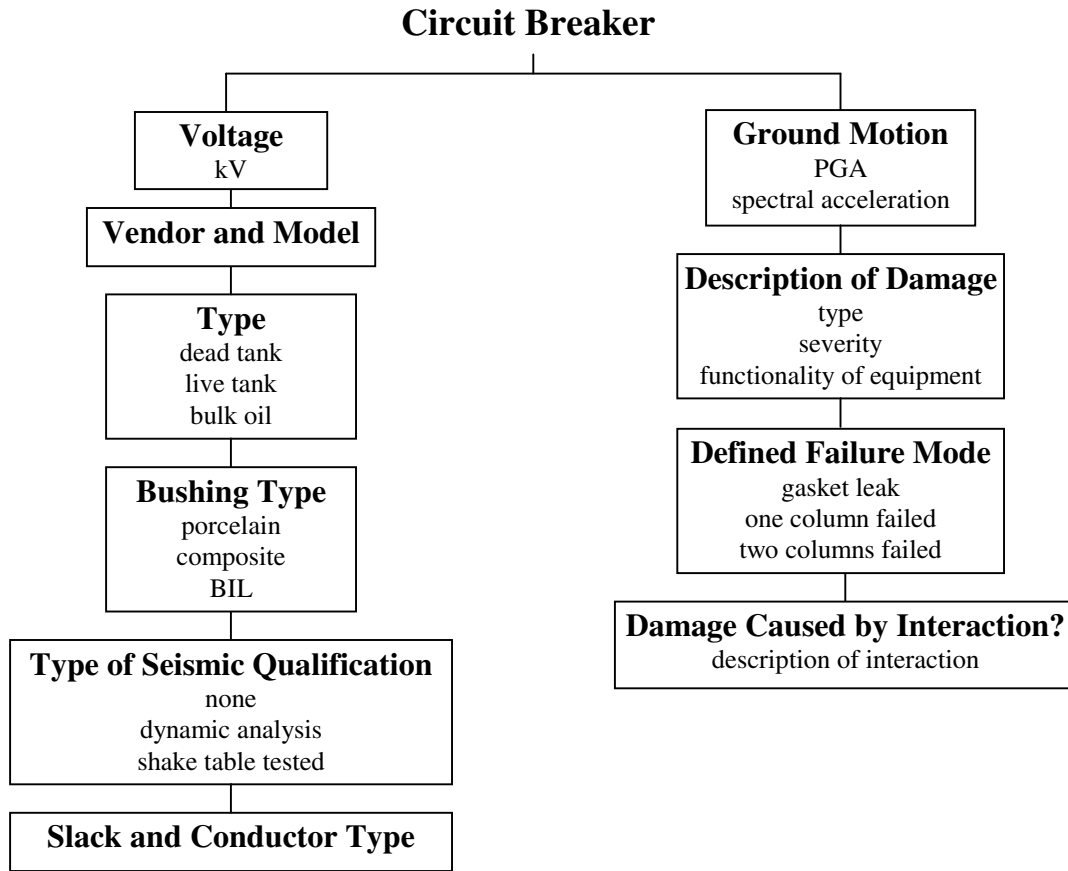
Figure 3.3 Key parameters for defining seismic damage to a circuit breaker

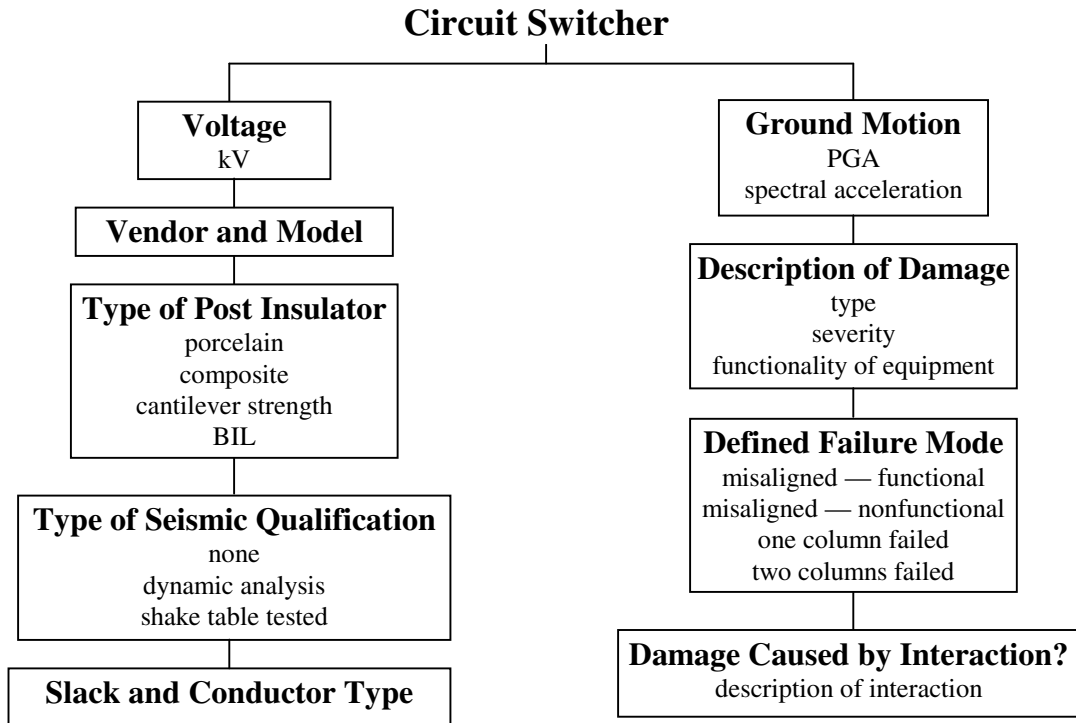
Figure 3.4 Key parameters for defining seismic damage to a circuit switcher

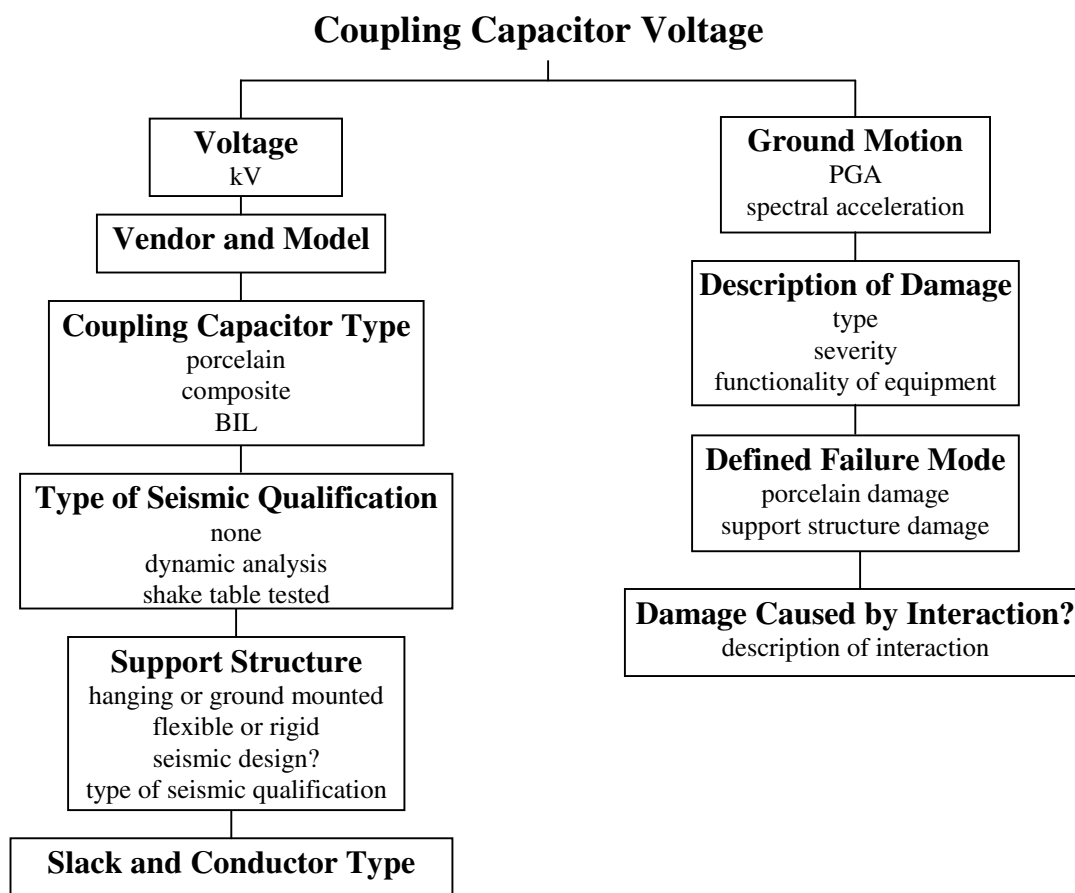
Figure 3.5 Key parameters for defining seismic damage to a coupling capacitor voltage transformer

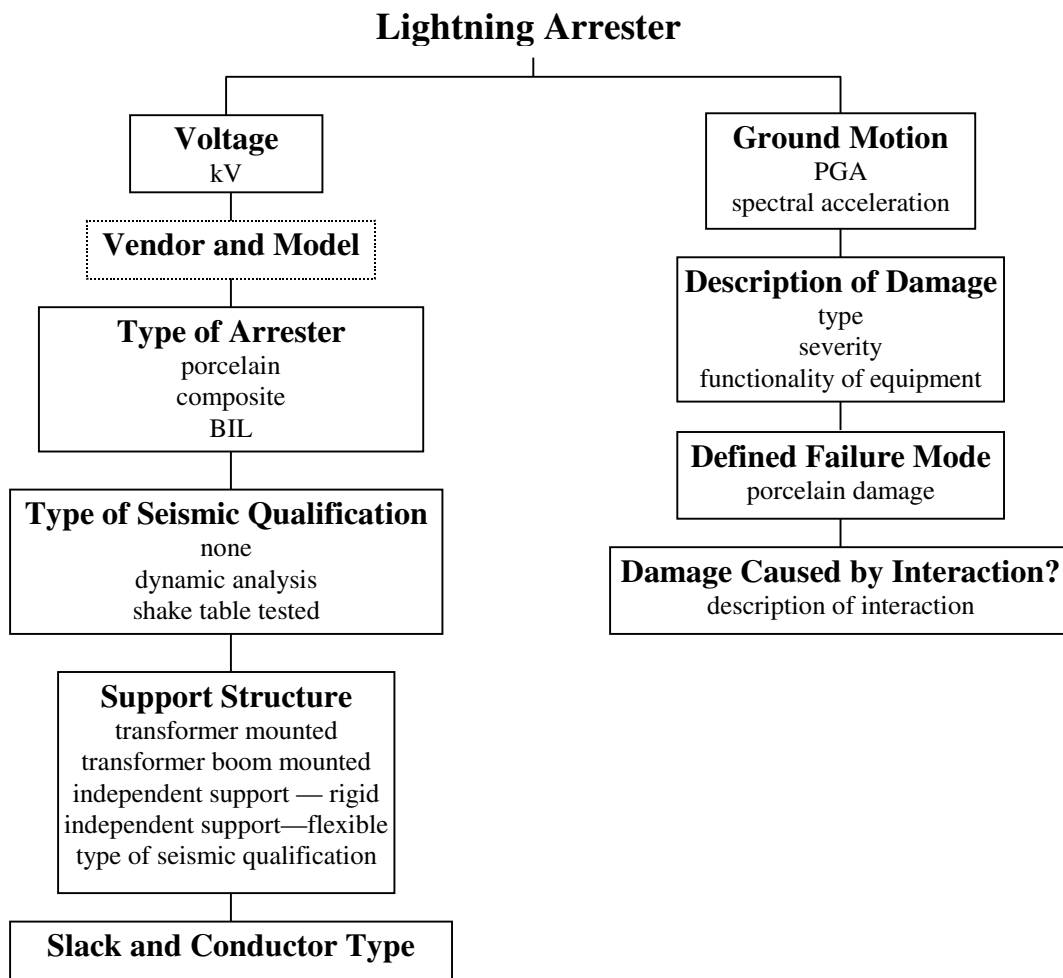
Figure 3.6 Key parameters for defining seismic damage to a lightning arrester

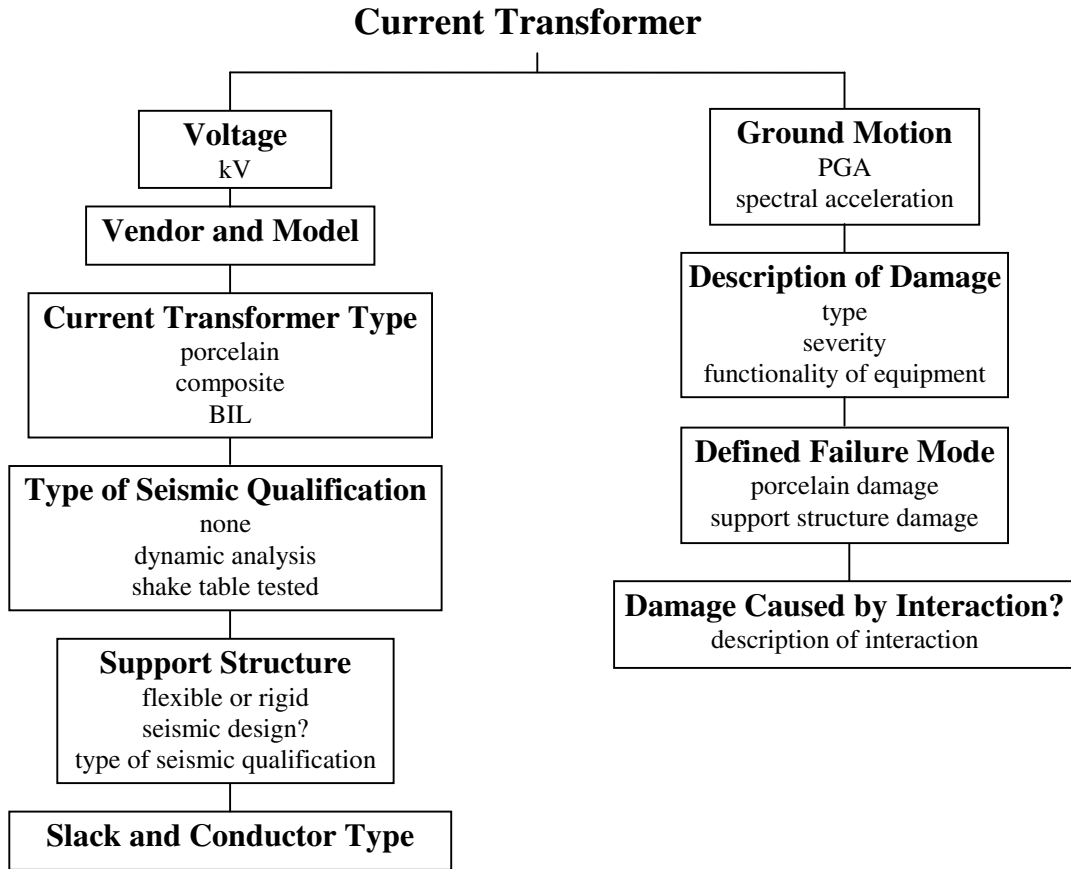
Figure 3.7 Key parameters for defining seismic damage to a current transformer
