# PACIFIC EARTHQUAKE ENGINEERING RESEARCH CENTER

Development of an Electrical Substation Equipment Performance Database for Evaluation of Equipment Fragilities

PEER Report 2001/06
Pacific Earthquake Engineering Research Center
College of Engineering
University of California, Berkeley
April 1999

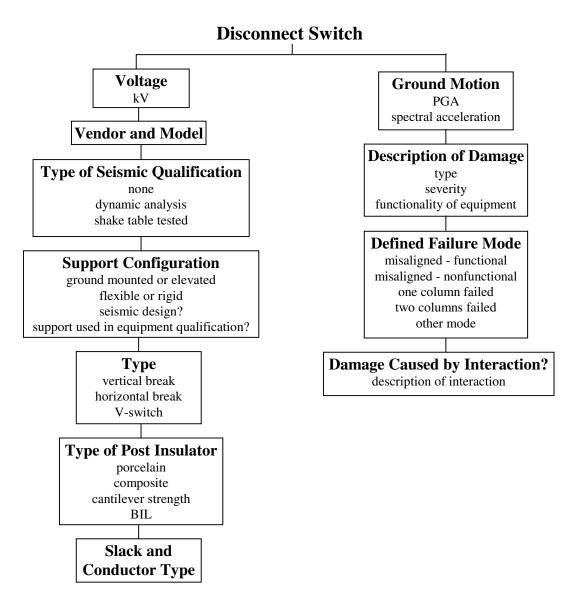
Figure 3.1 Key parameters for defining seismic damage to a disconnect switch

Figures 3.1 through 3.8 summarize the key parameters needed to define equipment fragilities from earthquake damage data. It is recommended that these data be collected for all equipment on future earthquake reconnaissance visits. The items in solid boxes are essential for a complete definition of the fragilities. The items in dashed boxes are less critical.

Each figure has two branches. The left branch describes attributes, specific to a particular type of equipment, which can be collected and cataloged before an earthquake. These attributes affect how the equipment will respond to a certain level of ground motion. For example, a composite insulator will be more rugged than a porcelain insulator; a well-braced radiator will perform better than one with no bracing. To some extent these parameters were used to develop the equipment classification system described in Section 4. The right branch describes the seismic input and the type of damage. These data can only be collected after the earthquake has occurred.

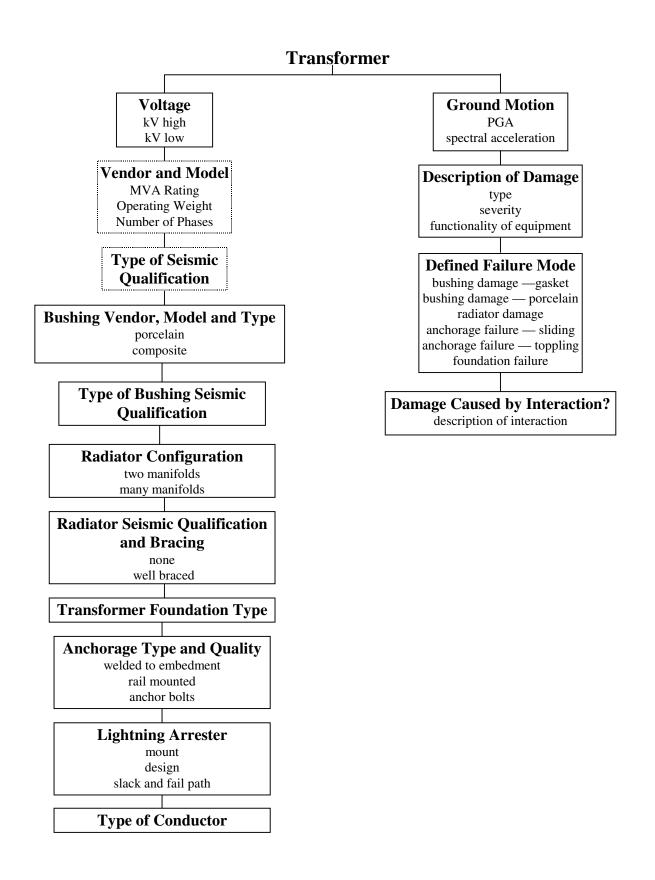
Figure 3.2 Key parameters for defining seismic damage to a transformer

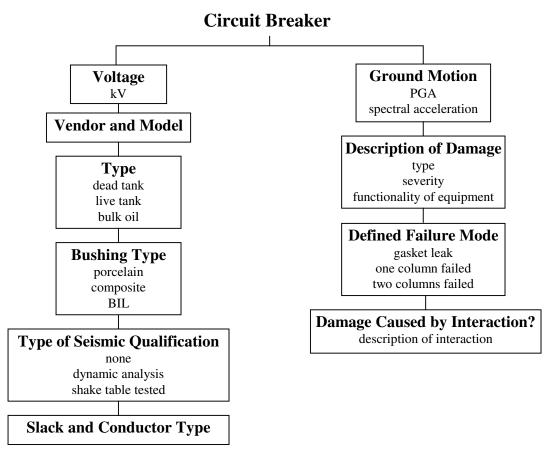
Figure 3.3 Key parameters for defining seismic damage to a circuit breaker

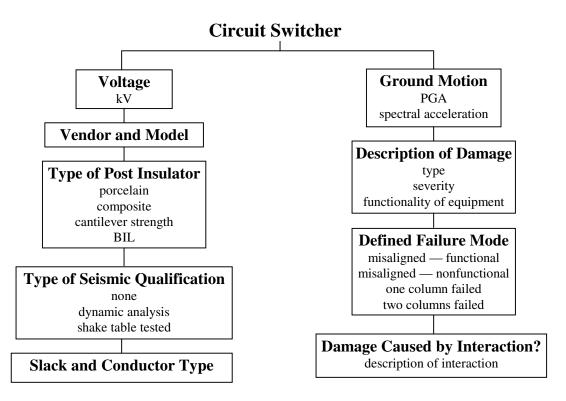
Figure 3.4 Key parameters for defining seismic damage to a circuit switcher

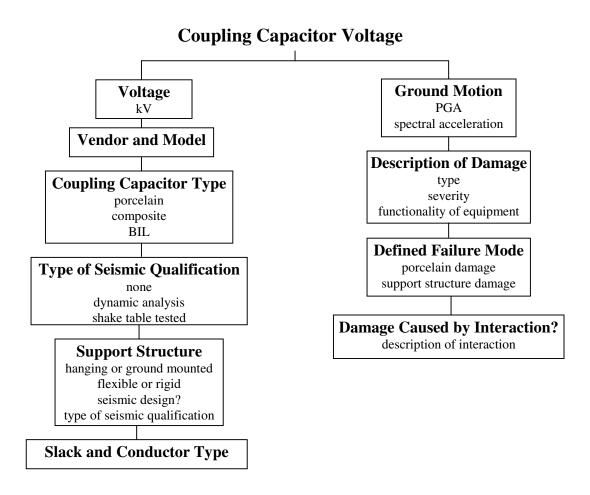
Figure 3.5 Key parameters for defining seismic damage to a coupling capacitor voltage transformer

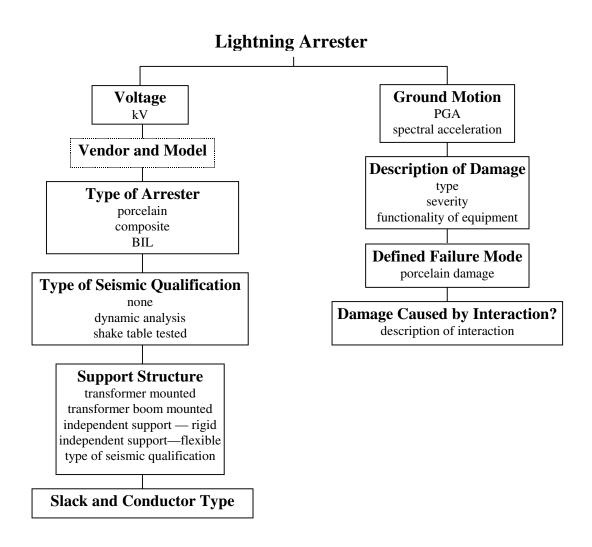
Figure 3.6 Key parameters for defining seismic damage to a lightning arrester

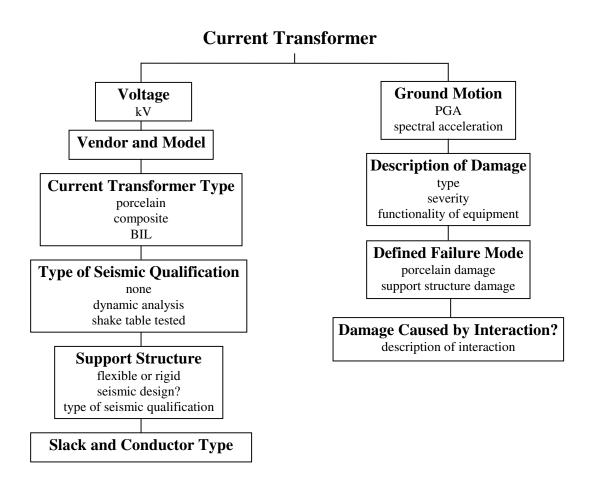
Figure 3.7 Key parameters for defining seismic damage to a current transformer

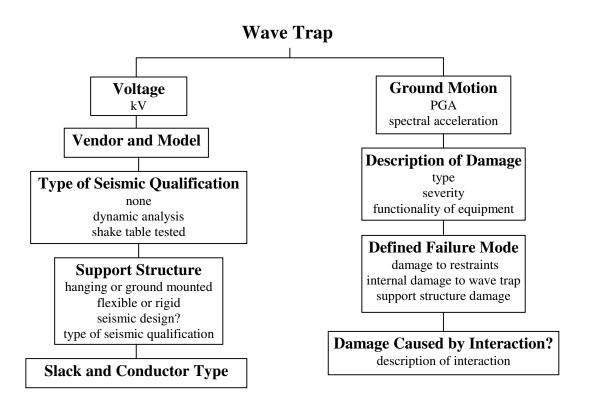
Figure 3.8 Key parameters for defining seismic damage to a wave trap

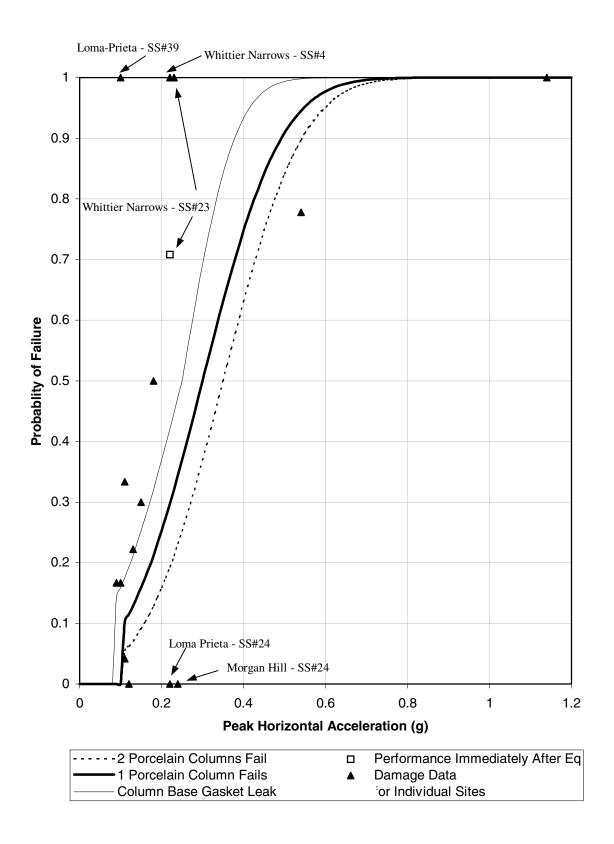
Figure 5.1 Comparison of UWG fragility curves with damage data for 230 kV live tank General Electric ATB4 - ATB6 circuit breakers (CB9). Damage data are plotted for each site.

Figure 5.1 shows the damage data for General Electric 230 kV live tank ATB4, ATB5, and ATB6 (CB9) plotted for each site along with the UWG fragility curves. The damage probabilities, plotted as solid triangles and an open square, are determined by dividing the number of damaged items by total number of items at a site. The plotted data do not include information about failure modes. In this figure, data from each site was plotted separately even though in some cases different sites experienced nearly identical peak ground accelerations. Data for sites with similar ground motion are combined in Figure 5.2.

Plotting data for each site is useful for identifying data that deviate significantly from the trend. These deviations may be due to site-specific factors such as soil conditions, ground motion duration, or installation procedures that can affect the amount of damage at a particular site. For example, it is possible that the soft soil at the SS#39 substation may account for the longer duration of shaking, or there may have been some other effect such as equipment interaction that caused the circuit breakers to fail at a lower PGA than would be expected. Another factor that may result in the high failure probability for SS#39 is that there was only one CB9 circuit breaker (Three Phases) at the site. A larger sample may have yielded a failure probability that was in better agreement with the data trend. In another case, the circuit breakers at SS#24 in both the Loma Prieta and Morgan Hill earthquakes seemed to have performed better than would be expected at that level of ground motion. It would be worth investigating why these circuit breakers performed so well. Also, it should be noted that ground motion is only reported for one location at a substation. Often this is at the control house. The site conditions at the control house may not be representative of the entire site. In particular, it is possible that the equipment under investigation is founded on a particularly good or bad soil.

Two different points represent the damage data for the SS#23 substation during the Whittier Narrows earthquake. This is because the performance of the circuit breakers immediately after the earthquake differs dramatically from the longer-term performance. The square shows that about 30% of the CB9's were functional immediately after the earthquake. Ultimately all the CB9's failed due to leaking gas (shown by the triangle).

Figures 5.1 and 5.2 suggest that the UWG fragility curves underestimate damage probabilities for ATB4, ATB5, and ATB6 circuit breakers. Among the limitations to this analysis is that a large number of the peak ground accelerations used to plot the data are based on attenuation relationships rather than on actual recordings. In addition, PGA is most likely not the best indicator of equipment performance. The fundamental period of this type of circuit breaker is about 0.2 seconds and spectral acceleration may be a better predictor of performance. As stated earlier, spectral acceleration also has limitations in predicting performance in that the support structure may significantly alter the period of the circuit breaker assembly. For comparison, the same damage data for ATB breakers are plotted versus 0.2-second spectral acceleration in Figure 5.3.

Clearly, in Figures 5.1 through 5.3, there are data that deviate significantly from the trend and from the expert-based curves. However additional data would be needed to provide recommendations about how the curves should be altered.

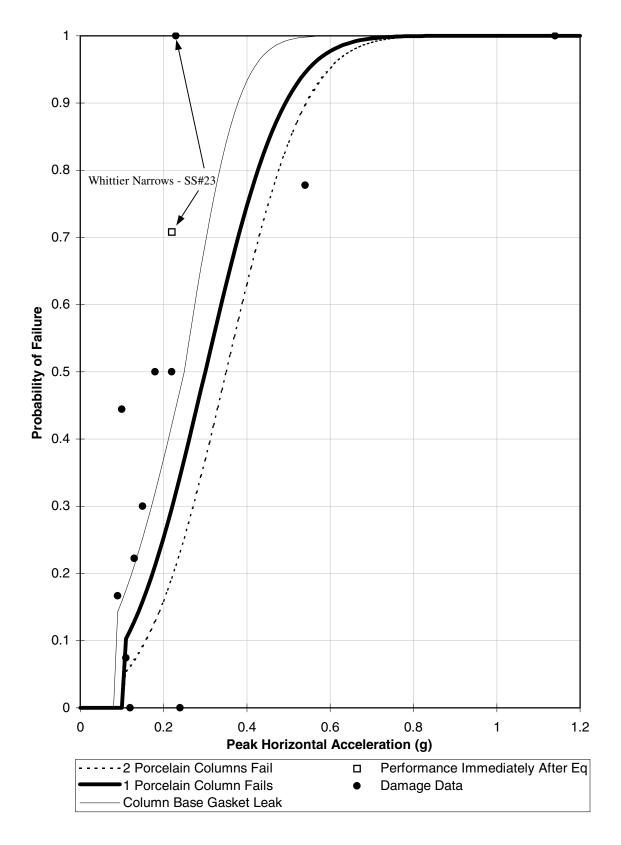
Figure 5.2 Comparison of UWG fragility curves with damage data for 230 kV live tank General Electric ATB4 - ATB6 circuit breakers (CB9). Data for sites with the same PGA are combined and plotted as a single point.

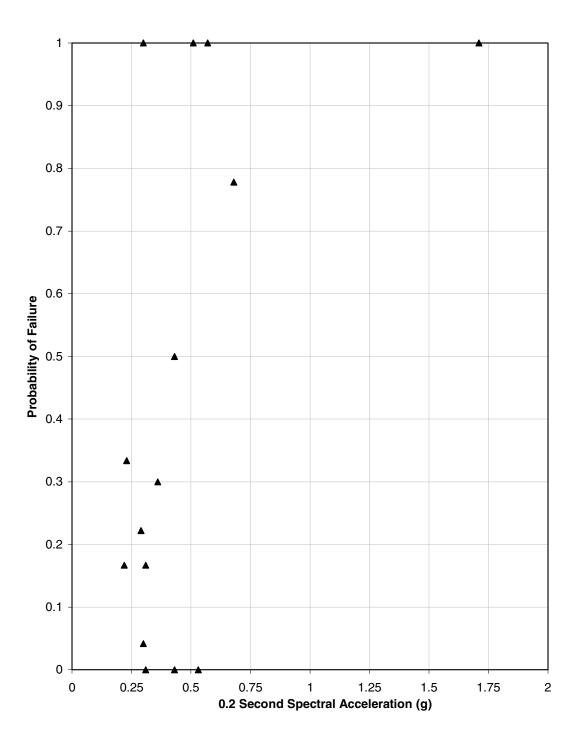
Figure 5.3 Damage data for 230 kV live tank General Electric ATB4 - ATB6 circuit breakers (CB9) for individual sites plotted against 0.2-second spectral acceleration.

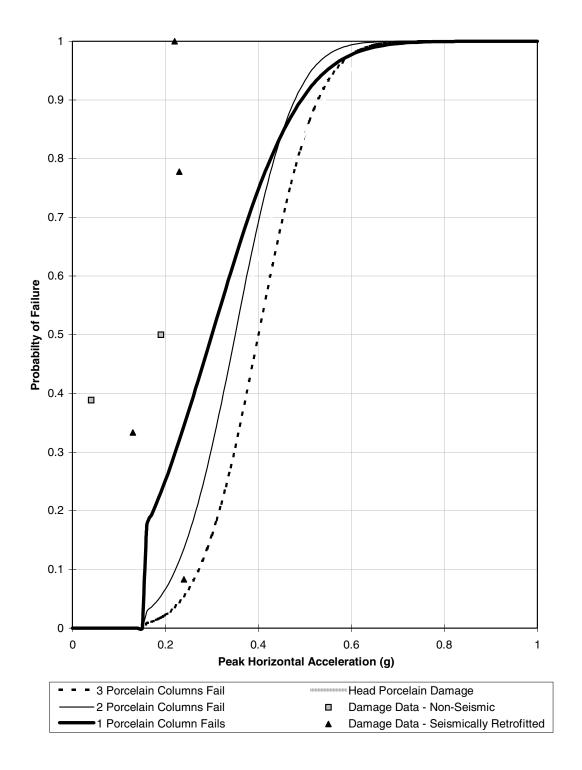
Figure 5.4 Comparison of UWG fragility curves with damage data for 500 kV Westinghouse live tank SF6 circuit breakers (CB72)

Figure 5.4 compares damage data and UWG fragility curves for Westinghouse 500 kV live tank SF6 circuit breakers (CB72). These types of circuit breakers proved to be very vulnerable in the San Fernando earthquake. In an effort to improve performance, CB72 breakers at certain sites were seismically retrofitted using internal prestressing tendons. As can be seen in Figure 5.4, the seismic retrofitting did not always improve the quality of the performance.

In general, the damage data indicate that the UWG fragility curves underestimate the failure rate for this type of equipment. The UWG fragility curves should be adjusted upward to reflect the poor performance of this circuit breaker. In addition, the parameters of the curves should be modified so that the curve representing at least one column failing does not cross over the curves for at least two columns failing.

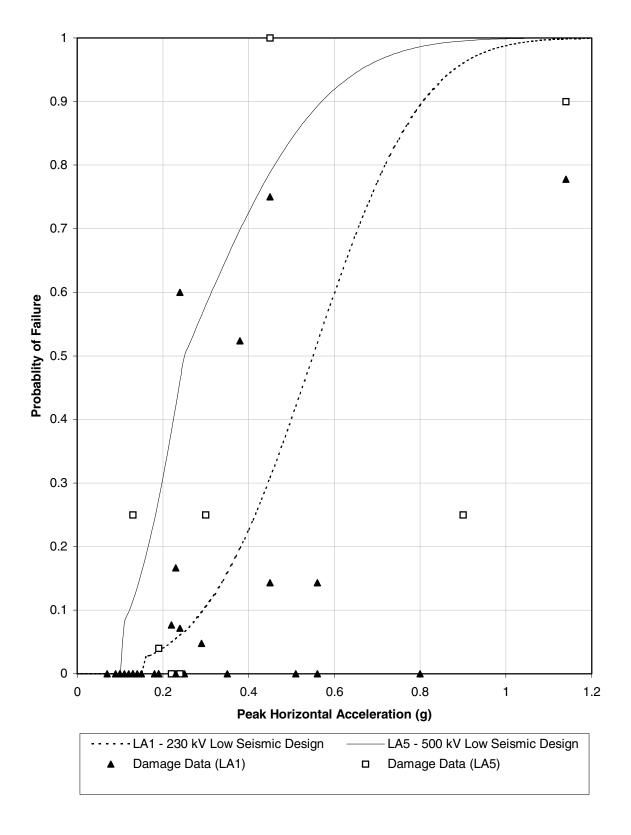
Figure 5.5 Comparison of UWG fragility curves with damage data for 230 kV and 500 kV lightning arresters with low seismic design (LA1 and LA5)

Figure 5.5 compares damage data with UWG fragility curves for 230 kV and 500 kV lightning arresters. The damage data does not show a clear trend of increased damage probability with increasing PGA. Lightning arresters can be mounted at the top of a transformer, on a boom that is attached to a transformer or on a stand-alone post. Each of these mounts would filter the ground motion differently. The amount of slack on bus drops also affects performance. It is possible that the scatter of the data is a result of not accounting for different mount types and slack. Figure 5.5 does suggest that the minimum level of ground motion needed to trigger damage to a 230 kV lightning arrester is 0.2g rather than the 0.15g defined by the UWG.

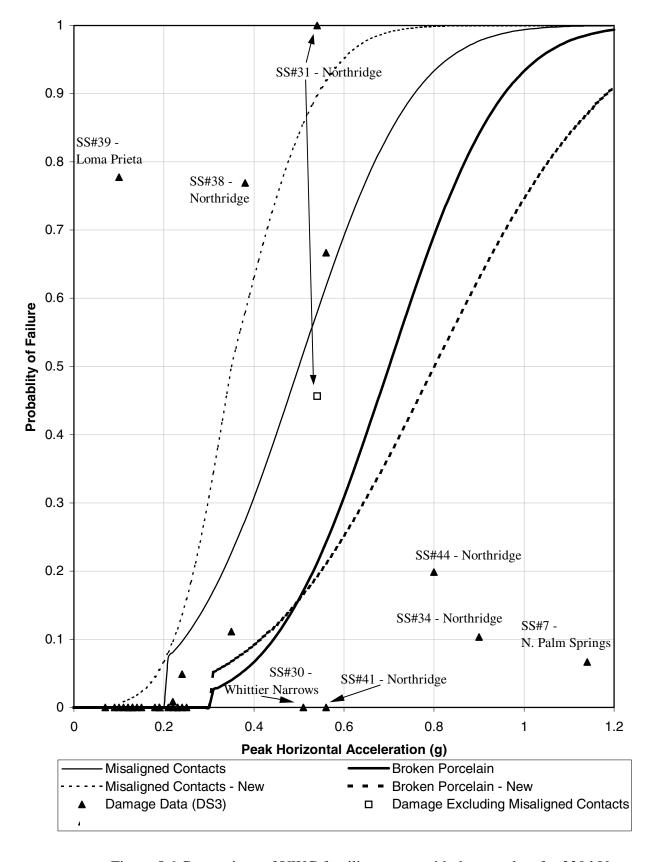
Figure 5.6 Comparison of UWG fragility curves with damage data for 230 kV horizontal disconnect switches (DS3).

Figure 5.6 compares damage data with UWG fragility curves for 230 kV horizontal disconnect switches (DS3). Disconnect switches are difficult to compare because they can be mounted on different types of frames and different types of post insulators, which can have a significant affect on performance.

severely damaged are counted. The damage probability calculated from SS#39 data is based on incomplete information, since there were an unknown number of disconnect switches at the site. This damage probability is unrealistically high, since it does not include all of the undamaged disconnect switches in the ratio of damaged to total switches. Aside from these few anomalous points, the data indicate that for accelerations less than 0.25g this type of equipment has performed well.

Disconnect switches at several substations in the Northridge earthquake, as well as at SS#7 in the North Palm Springs and SS#30 in the Whittier Narrows earthquakes performed particularly well. At SS#44, 24 phases were mounted on heavily braced frames. These had been sine beat tested indicating that they were more modern switches. On average, these performed less well (6 damaged, 18 undamaged) than the phases on less stiff support structures (12 damaged, 120 undamaged). At SS#34, the database indicates that some of the units were seismically qualified. The database provides little insight for the other substations.

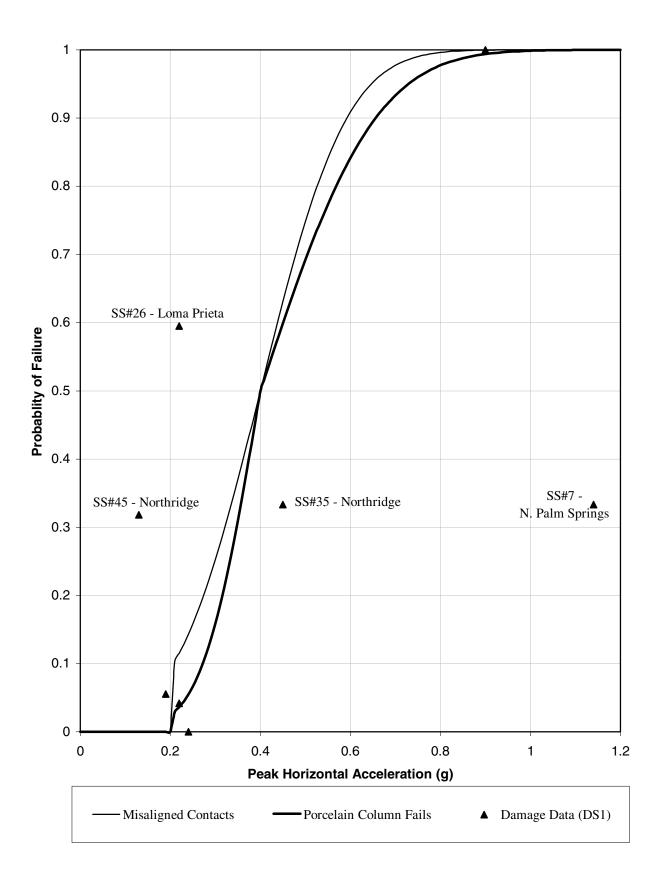
Figure 5.7 Comparison of UWG fragility curves with damage data for 500 Kv disconnect switches (DS1)

Figure 5.7 compares UWG fragility curves with damage data for 500 kV disconnect switches (DS1). There are very few data for this equipment class and no clear trends are evident. At SS#26, the database indicates one of the failures may have been due to equipment interaction. Another failure appears to have been a misalignment in which it is not clear if the equipment remained functional. If both of these failures are removed, the failure probability at SS#26 reduces from 0.60 to 0.55. It remains high with respect to the UWG fragility curves.

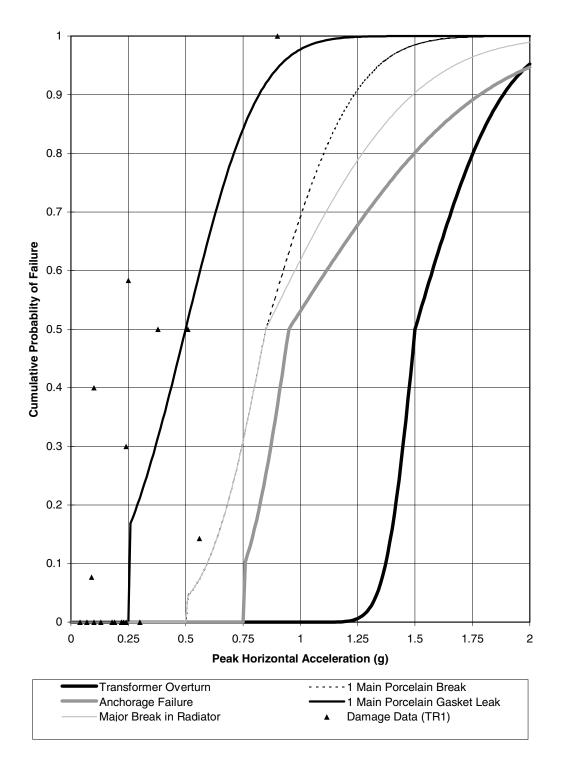
Figure 5.8 Comparison of UWG fragility curves with damage data for single-phase 230 kV transformers (TR1)

Figure 5.8 compares UWG fragility curves with damage data for single-phase 230 kV transformers (TR1). Transformers can have many different configurations and the data in Figure 5.8 do not discriminate between different configurations. Most of the damaged transformers experienced oil leaks due to gasket damage. The data indicate that gasket leaks are occurring at lower PGA's than would be predicted by the UWG fragility curves.
