Cripple Wall Small-Component Test Program: Comparisons

**A Report for the “Quantifying the Performance of
Retrofit of Cripple Walls and Sill Anchorage in Single-
Family Wood-Frame Buildings” Project**

PEER Report 2020/19

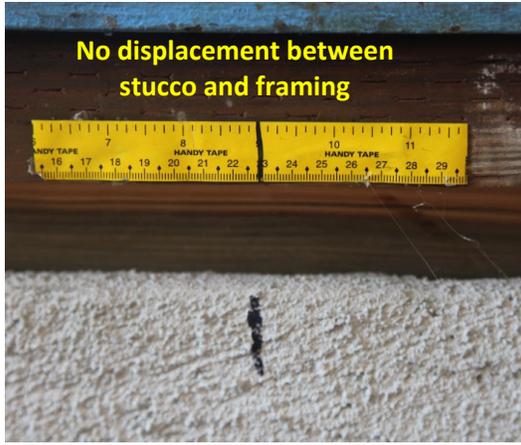
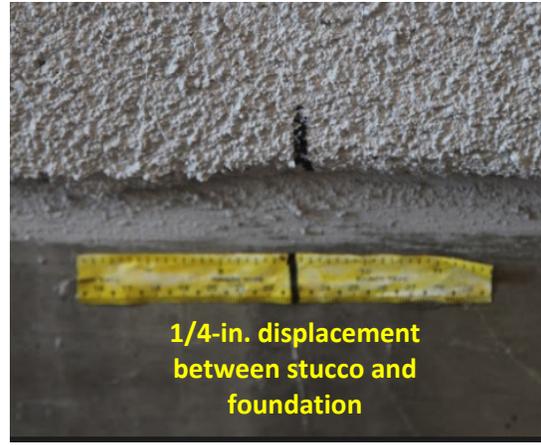
Figure 4.1 Damage to the wet finished existing 2-ft-tall specimens at 1.4% drift ratio, positive and negative drift values are noted: (a) south exterior end of Specimen A-17 at -1.4% drift ratio; (b) middle exterior of Specimen A-17 at -1.4% drift ratio; (c) bottom of north-end exterior corner of Specimen A-22 at -1.4% drift ratio; (d) bottom of middle interior of Specimen A-22 at -1.4% drift ratio; (e) top of middle exterior of Specimen A-15 at +1.4% drift ratio; and (f) bottom of middle exterior of Specimen A-15 at +1.4% drift ratio.

The photographs in Figure 4.1 show the state of the wet finished retrofitted 2-ft-tall cripple walls at $\pm 1.4\%$ drift ratio, while photographs in Figure 4.2 show the same for dry finished existing 2-ft-tall specimens. It is noted that these photographs were taken while the specimen was held at the prescribed drift amplitude; positive and negative signs are included in the captions to differentiate between push and pull directions of loading. The specimen that each photograph is taken from is included in the caption. A comparison of all wet finished cripple walls indicates that by 1.4% drift, cracking in the stucco had concentrated at the bottom of both corners of the cripple wall in its end wall regions; see Figure 4.1(a). This cracking concentration was due to the bearing of the stucco on the foundation at the ends. In addition, due to the bearing of the stucco on the foundation, spalling of the stucco occurred at the base of the corners, as shown in Figure 4.1(c). In many cases, vertical cracks had propagated on the exterior face of the stucco; see Figure 4.1(b). In general, vertical cracks along the face of the wet finished specimen were minimal. Small displacements of the finish materials relative to the foundation occurred, which was due to both the sill plate displacing relative to the foundation as well as the stucco displacing relative to the foundation. These displacements were typically between 1/8 in. and 1/4 in. for all wet finished specimens; see Figure 4.1(f). At the top of the cripple walls, no displacement of the stucco and finish materials relative to the framing occurred; see Figure 4.1(e).

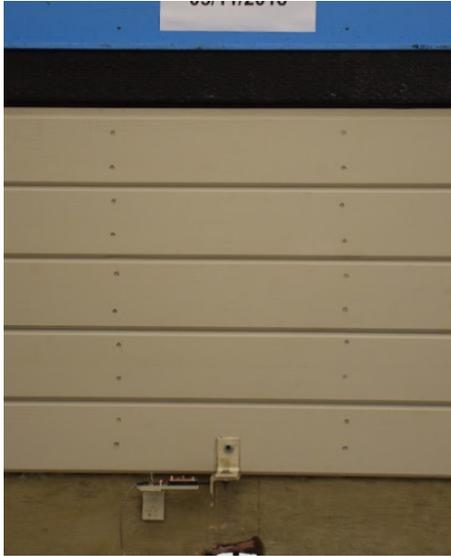
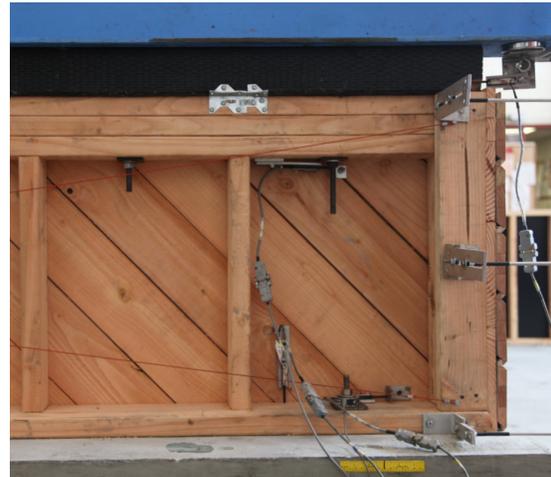
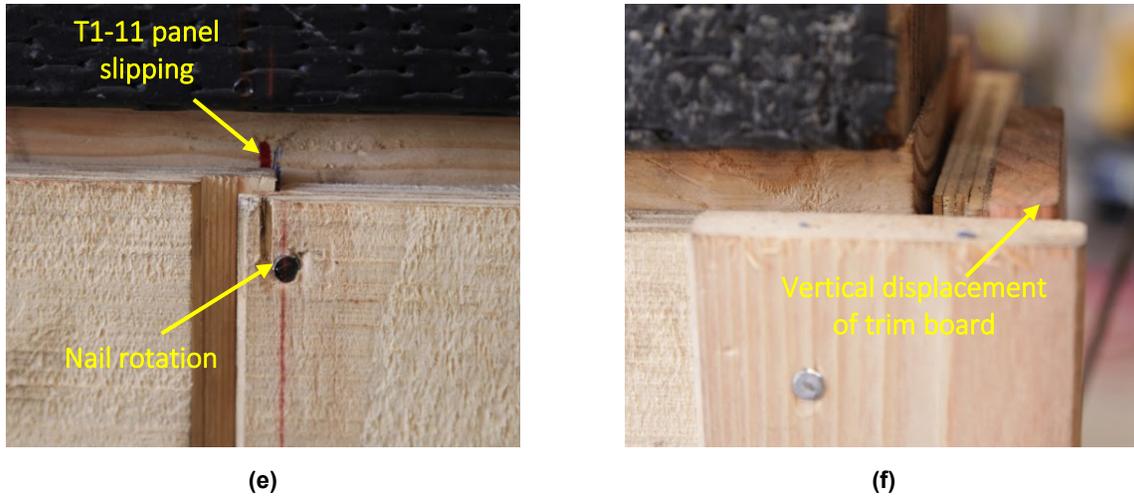
Figure 4.2 Damage to the dry finished existing 2-ft-tall specimens at 1.4% drift ratio, positive and negative drift values are noted: (a) middle exterior of Specimen A-7 at -1.4% drift ratio; (b) south end interior of Specimen A-7 at -1.4% drift ratio; (c) bottom of middle interior of Specimen A-9 at +1.4% drift ratio; (d) south-end of interior of Specimen A-9 at +1.4% drift ratio; (e) top of middle exterior of Specimen A-11 at +1.4% drift ratio; and (f) top of north exterior corner of Specimen A-9 at +1.4% drift ratio.

For the dry finished specimens at 1.4% drift ratio, the cripple walls containing horizontal siding had little to no observable damage; see Figure 4.2(a)-(d). Common observations included wrinkling of the building paper and small rotations of the studs; see Figure 4.2(b) and Figure 4.2(c), respectively. The horizontal siding boards and diagonal sheathing boards had little visible displacement and no visible cracking. For the T1-11 finished cripple walls, observable rotation of the panels [see Figure 4.2(e)] and displacement of the trim boards occurred; see Figure 4.2(f). At the panel overlaps of the T1-11 finished cripple walls, only the overlying panels were fastened to the framing while the underlying panels were sandwiched between the overlying panel and the framing. Therefore, even at small displacement amplitudes, panel rotation was observed. Overall, the extent of visible damage for the dry finished specimens was minor in contrast to that of the wet finished specimens at similar drift levels.

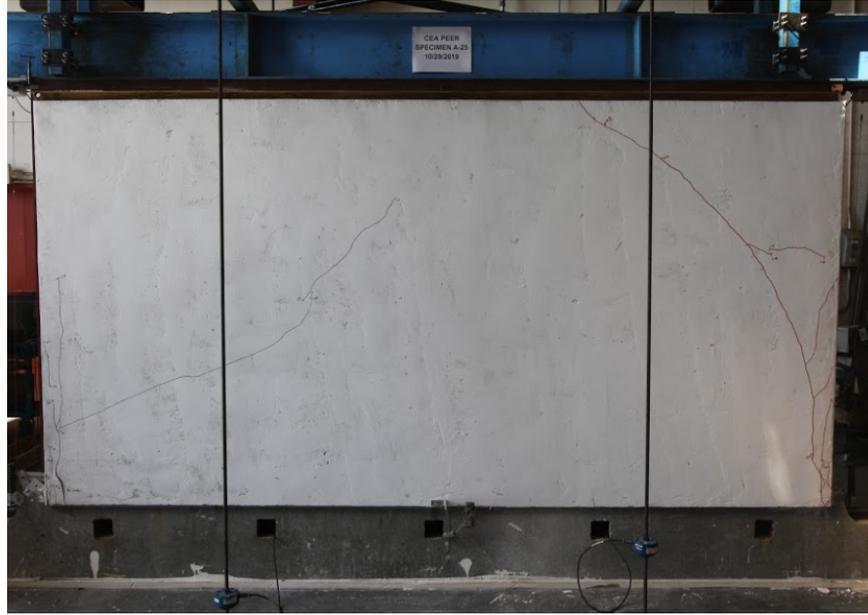
Figure 4.3 Damage to the wet finished existing 6-ft-tall specimens at 1.4% drift ratio, positive and negative drift values are noted: (a) exterior elevation of Specimen A-25 at -1.4% drift ratio; (b) north-end exterior corner of Specimen A-25 at -1.4% drift ratio; (c) south-end exterior corner of Specimen A-25 at -1.4% drift ratio; (d) bottom of south-end exterior corner of Specimen A-25 at -1.4% drift ratio; and (e) bottom of middle interior of Specimen A-25 at -1.4% drift ratio.

The photographs in Figure 4.3 show the state of the wet finished existing 6-ft-tall cripple walls at $\pm 1.4\%$ drift ratio, and photographs in Figure show the dry finished existing 6-ft-tall specimens at the same drift ratio. Only one wet finished existing 6-ft-tall cripple wall with stucco over framing was tested (Specimen A-25). There was much more extensive damage to the wet finished retrofitted 6-ft-tall specimen compared to the wet finished existing 2-ft-tall specimens. This was primarily due to the imposed displacement on the 6-ft-tall wall being three times as much compared to the 2-ft-tall walls.

In Figure 4.3(a), several cracks had propagated along the face of the stucco. There was a heavy concentration of vertical cracks at both ends of the stucco face, which propagated from the bottom and extended over half of the height of the specimen: see Figure 4.3(b) and (c). These cracks were a result of the stucco detaching from the framing at the sill plate and bottom of the studs. In addition, diagonal cracks formed at both ends of the cripple wall that extended to the middle of the specimen, which was not observed with the 2-ft-tall specimens. As with the 2-ft-tall specimens, a dense concentration of cracking and some spalling of the stucco at the bottom of the corners on both sides of the specimen was visible, which was due to the bearing of the stucco on the foundation at these locations; see Figure 4.3(d). Along the interior, the studs had not only rotated but displaced as much as 1/4 in.; see Figure 4.3(e). It should be noted that Specimen A-23 reached strength at 1.4% drift ratio.

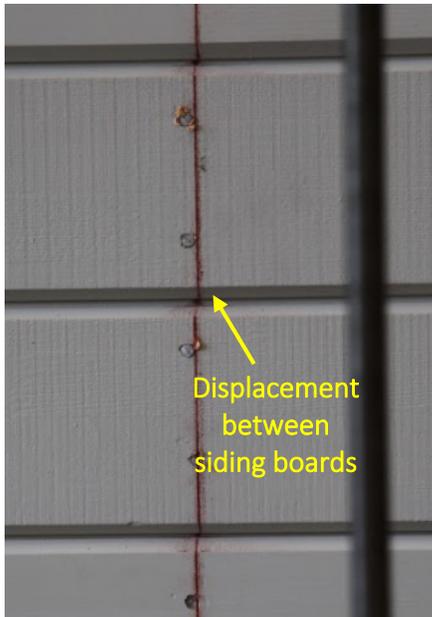
Figure 4.4 Damage to the dry finished existing 6-ft-tall specimens at 1.4% drift ratio, positive and negative drift values are noted: (a) bottom middle interior of Specimen A-13 at +1.4% drift ratio; (b) bottom middle exterior of Specimen A-23 (south and middle panels) at -1.4% drift ratio; (c) middle exterior of Specimen A-13 at +1.4% drift ratio; (d) north-end exterior of Specimen A-13 at +1.4% drift ratio; (e) bottom of south-end interior of Specimen A-23 corner view at +1.4% drift ratio; and (f) top middle exterior of Specimen A-23 (south and middle panels) at +1.4% drift ratio.

Two dry finished existing 6-ft-tall specimens were tested; one was finished with horizontal siding over framing (Specimen A-13), and the other was finished with T1-11 wood structural panels (Specimen A-23). As with the horizontal siding finished 2-ft-tall specimen, there was little observable damage; see Figure 4.4(d). Small displacements of the siding boards relative to each other occurred [see Figure 4.4(c)] as well as small rotations of the studs; see Figure 4.4(a). The displacement and rotation of the studs was much less pronounced for the horizontal siding finished specimen compared to the wet finished specimen, which was primarily due to the decreased load being carried by the horizontal siding finished specimen. The damage characteristics of the T1-11 finished cripple wall were similar regardless of cripple wall height, but they were more pronounced with the taller specimen due to the increased imposed displacement. Most notably was the

increased rotation of the T1-11 panels and rotation of the fasteners at the top and bottom of the specimen; see Figure 4.4(b) and (f). Uplift of the corner studs and the finish at the corners occurred at the ends of the T1-11 finished specimen; see Figure 4.4(e). The amount of uplift observed for the T1-11 finished specimen corner studs was similar to that of the stucco finished specimens, around 1/4 in.; see Figure 4.4(e).

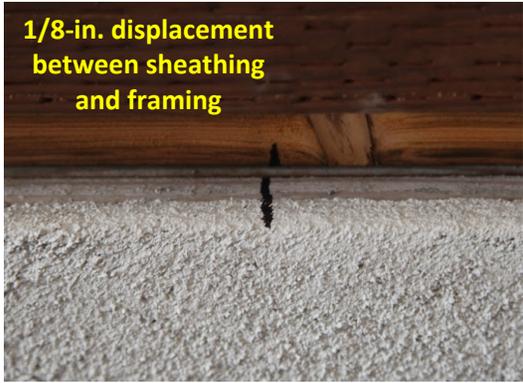
Figure 4.5 Damage to the wet finished retrofitted 2-ft-tall specimens at 1.4% drift ratio, positive and negative drift values are noted: (a) bottom interior (north and middle panels) of Specimen A-18 at -1.4% drift ratio; (b) top interior (north and middle panels) of Specimen A-18 at -1.4% drift ratio; (c) middle exterior of Specimen A-18 at -1.4% drift ratio; (d) south-end exterior corner of Specimen A-19 at -1.4% drift ratio; (e) top of south-end exterior of Specimen A-19 at -1.4% drift ratio; and (f) bottom of south-end exterior of Specimen A-19 at -1.4% drift ratio.

The photographs in Figure 4.5 show the state of wet finished retrofitted 2-ft-tall cripple walls at $\pm 1.4\%$ drift ratio, and Figure 4.6 shows the dry finished retrofitted 2-ft-tall specimens at the same drift ratio. A comparison of these photographs indicates that the damage characteristics of the retrofitted components of cripple walls were similar for both wet and dry specimens (i.e., the plywood panelling and its nailing). The damage at 1.4% drift can be characterized by small rotations and uplift of the plywood panels and insipient nail withdrawal/pull through; see Figure 4.5(a) and (b). The cracking patterns in the stucco along the face of the retrofitted wet specimens were more pronounced compared to the existing wet specimens; see Figure 4.5(c). The concentration of cracking at the corners due to the bearing of the stucco on the foundation was similar [see Figure 4.5(d)], but in general there was no spalling of the stucco at this displacement amplitude that was observed with the existing specimens. As with the existing wet finish specimens, displacements of the finish materials relative to the foundation occurred, which was due to both the sill plate and the stucco displacing relative to the foundation. These displacements were typically around 1/4 in. for all wet finished specimens, which was similar to that experienced by the existing specimens; see Figure 4.5(f). Unlike the existing specimens, there was around 1/8-in. displacement of the stucco and finish materials at the top of the cripple walls relative to the framing; see Figure 4.5(e).

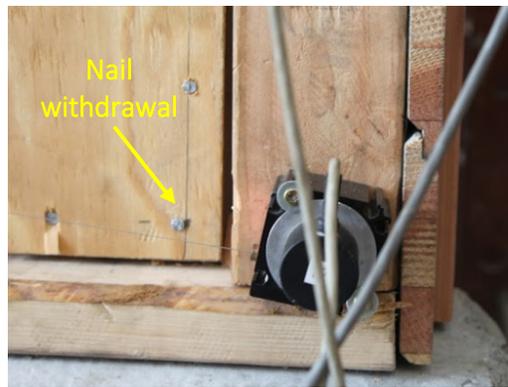
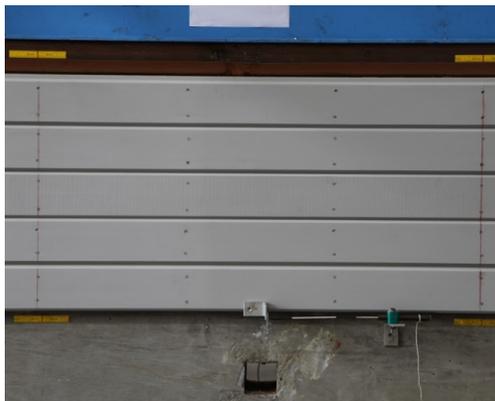
Figure 4.6 Damage to the dry finished retrofitted 2-ft-tall specimens at 1.4% drift ratio, positive and negative drift values are noted: (a) bottom of north interior corner of Specimen A-8 at -1.4% drift ratio; (b) bottom interior (middle and south panels) of Specimen A-8 at -1.4% drift ratio; (c) middle exterior of Specimen A-10 at -1.4% drift ratio; (d) bottom of north-end interior of Specimen A-10 at -1.4% drift ratio; (e) top middle interior of Specimen A-12 (north and middle panels) at +1.4% drift ratio; and (f) top middle interior of Specimen A-12 (south and middle panels) at +1.4% drift ratio.

For the dry finished 2-ft-tall specimens with horizontal siding, there was no visible damage to the exterior of the specimens; see Figure 4.6(c). This was the same as with the existing specimens. The retrofitted components displayed similar damage characteristics compared to the wet specimens, namely, small rotations of the plywood panels as well as insipient nail withdrawal/pull through; see Figure 4.6(a) and (b). The T1-11 finished cripple walls experienced similar amounts of rotations of T1-11 panels as with the plywood panels used in all other retrofits. The rotations were considerably less than the existing T1-11 finished specimens due to the decreased edge nail spacing and an extra row of nails being added to the underlying panels at the overlaps; see Figure 4.6(e) and (f). Overall, at this displacement amplitude, there was little damage

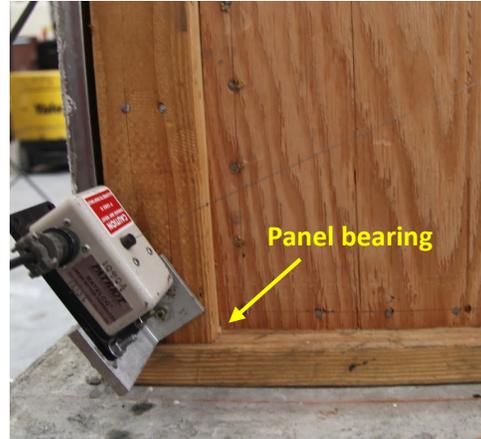
Figure 4.7 Damage to the wet finished retrofitted 6-ft-tall specimens at 1.4% drift ratio, positive and negative drift values are noted: (a) bottom of south-end exterior corner of Specimen A-26 at -1.4% drift ratio; (b) bottom of north-end exterior corner of Specimen A-26 at -1.4% drift ratio; (c) bottom interior of Specimen A-26 (south and middle panels) at -1.4% drift ratio; (d) bottom of south-end interior of Specimen A-26 at -1.4% drift ratio; (e) top interior of Specimen A-26 (north and middle panels); and (f) bottom of north-end corner of Specimen A-26 at -1.4% drift rate.

The photographs in Figure show the state of the wet finished retrofitted 6-ft-tall cripple walls at $\pm 1.4\%$ drift ratio, and photographs in Figure show the same for dry finished retrofitted 6-ft-tall specimens. As with the wet finished existing 6-ft-tall specimens, only one 6-ft-tall cripple wall was tested (Specimen A-26). At both corners, vertical cracks had propagated at the base due to the bearing of the stucco on the foundation. This also caused some of the stucco to spall off at these locations; see Figure (a) and (b). The same diagonal cracking pattern at the corners occurred as with the existing specimen. In Figure (b), a vertical crack had begun to open, indicating that the stucco had partially detached from the furring nails at the sill plate and the bottom of the studs. It was evident that the stucco had partially detached due to the out-of-plane displacement of the bottom of the stucco, which is shown by the gap forming between the face of the foundation and the stucco; see Figure 4.7(a). On the interior, the panels had begun to rotate; see Figure 4.7(c)–(e). The fasteners had rotated in many locations, especially at the base of the cripple wall; see Figure 4.7(d). At the top of the cripple wall, fasteners tended to withdraw from the framing; see Figure 4.7(e). Unlike the retrofitted 2-ft-tall specimens, a more definitive pattern was observed as to whether the nails would withdraw from the framing or pull through the plywood. At the top, the nails would withdraw, and at the bottom the nails would pull through. At the bottom corners, the plywood was bearing on the sill plate and end studs, showing incipient crushing of the panels; see Figure 4.7(f).

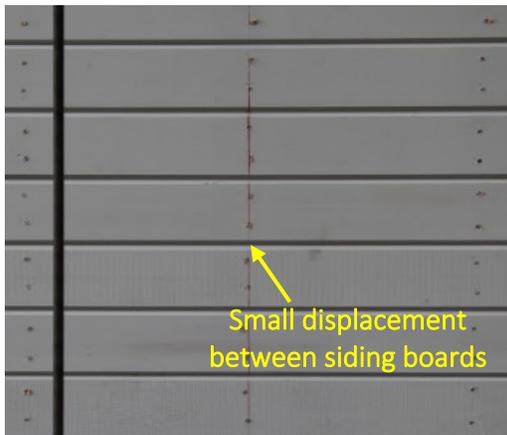
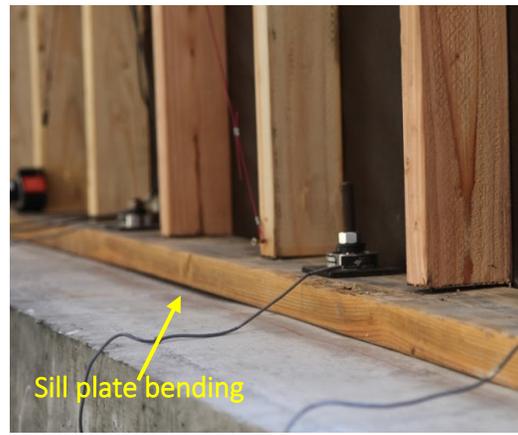
Figure 4.8 Damage to the dry finished retrofitted 6-ft-tall specimens at 1.4% drift ratio, positive and negative drift values are noted: (a) bottom middle interior Specimen A-14 (north and middle panels) at -1.4% drift ratio; (b) bottom of north-end interior of Specimen A-14 at -1.4% drift ratio; (c) middle exterior of Specimen A-14 at -1.4% drift ratio; (d) bottom of interior of Specimen A-24 at 1.4% drift ratio; (e) bottom of interior of Specimen A-24 at -1.4% drift ratio; and (f) bottom of middle exterior Specimen A-24 (south and middle panels) at -1.4% drift ratio.

As with all of other cripple walls with horizontal siding, there was no observable damage to the siding boards at 1.4% drift ratio. Most notable were the small displacements of the siding boards relative to each other, which was around the same magnitude as the existing specimen; see Figure 4.8(c). The damage characteristics of the retrofit materials were similar for both the wet and dry finished specimens, namely, small rotation of the plywood panels and insipient nail withdrawal/pull through of the fasteners attaching the plywood to the framing; see Figure 4.8(a) and 4.8(b). Splitting of blocking was observed for the horizontal siding finished specimen, which was a common occurrence for all retrofitted specimens, regardless of height or finish materials; see Figure 4.8(b).

For the retrofitted 6-ft-tall cripple wall finished with T1-11 wood structural panels, there was observable bending of the sill plate in the middle of the span [Figure 4.8(d)] as well as around 1/4-in. uplift of the studs; see Figure 4.8(e). The uplift was more pronounced for the T1-11 finished specimen than all other retrofitted 6-ft-tall specimens because it was the only specimen that was not retrofitted with hold-downs at both ends of the wall. Along the exterior face, the rotation of the T1-11 panels was more significant compared to the T1-11 finished retrofitted 2-ft-tall specimen but significantly less compared to the existing 6-ft-tall specimen; see Figure 4.8(f). This was due to the increased imposed displacement on the 6-ft-tall specimens (which increased the panel rotation) and the denser nailing arrangement of the retrofit (which decreased the panel rotation).

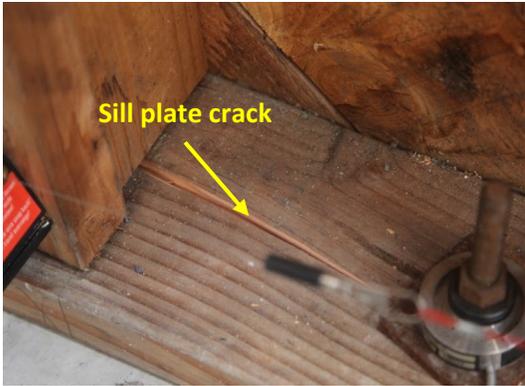
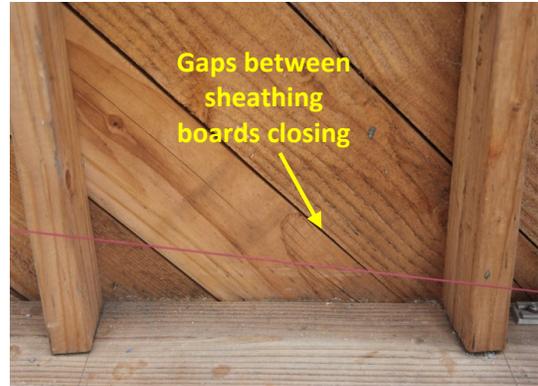
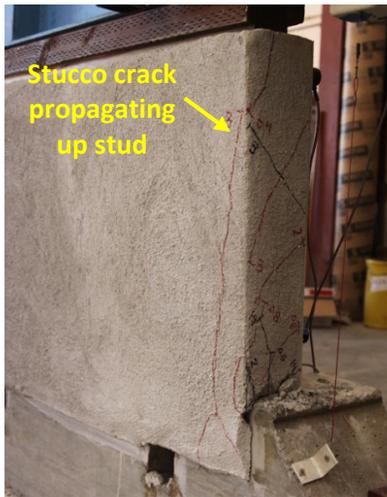
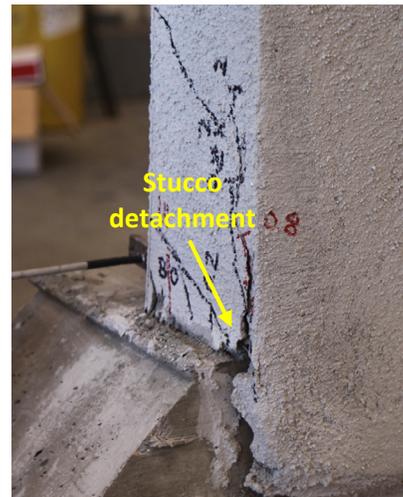
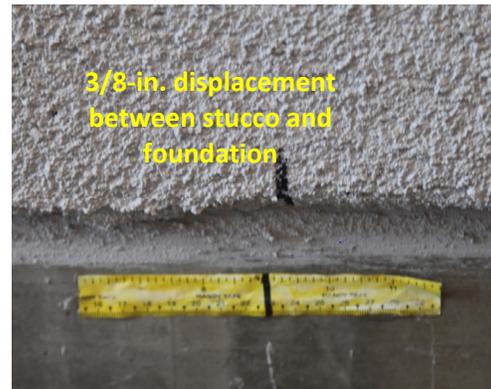
Figure 4.9 Damage to the wet finished existing 2-ft-tall specimens at lateral strength. Drift values are noted: (a) bottom of north-end interior of Specimen A-15 at +5% drift ratio; (b) bottom of middle interior of Specimen A-15 at -4% drift ratio; (c) north-end exterior corner of Specimen A-17 at -3% drift ratio; (d) bottom of south-end corner of Specimen A-17 at -3% drift ratio; (e) bottom middle interior of Specimen A-22 at -2% drift ratio; and (f) bottom of north-end exterior of Specimen A-22 at -2% drift ratio.

Figure 4.9 shows observable damage at lateral strength for the wet finished existing 2-ft-tall cripple walls, and Figure 4.10 shows the observable damage for the dry finished existing 2-ft-tall cripple walls. The drift ratio values and specimen names for each of the photographs are given in the captions. For all wet finished specimens, the stucco detached from the sill plate and the bottom of the studs at strength, leading to a loss in strength in subsequent drift cycles; see Figure 4.9(d) and (e). Cracking on the face of the stucco and end walls propagated up the wall height for all wet specimens as the stucco detached from the furring nails progressed; see Figure 4.9(c). The cracks at the ends of the specimens propagated along the entire height of the cripple wall. Typically, the cracks were vertical at the base where the stucco was bearing on the foundation and diagonal along the rest of the height due to the imposed displacement. For the stucco over diagonal sheathing specimen, cross-grain sill plate cracks formed at both ends of the wall; see Figure 4.9(a). The cracking of the sill plate occurred due to the uplift of the diagonal sheathing boards when the cripple wall was being loaded in the push direction. In the pull loading direction, the gaps between the diagonal sheathing boards had nearly all closed at strength for both specimens; see Figure 4.9(b). At the bottom of the specimens, increased displacement of the finish materials relative to the foundation occurred, which was due to both the displacement of the sill plate relative to the foundation and the finish materials relative to the sill plate. This displacement was between 3/8 and 1/2 in. for all wet finished existing 2-ft-tall specimens.

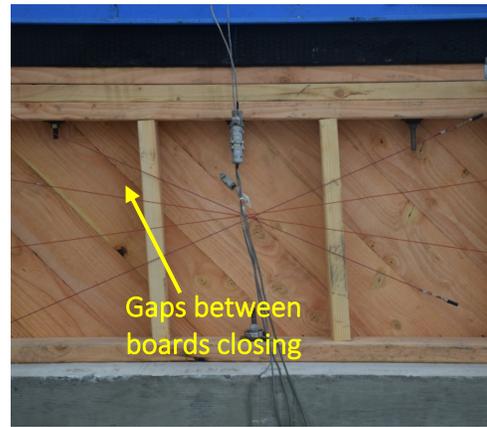
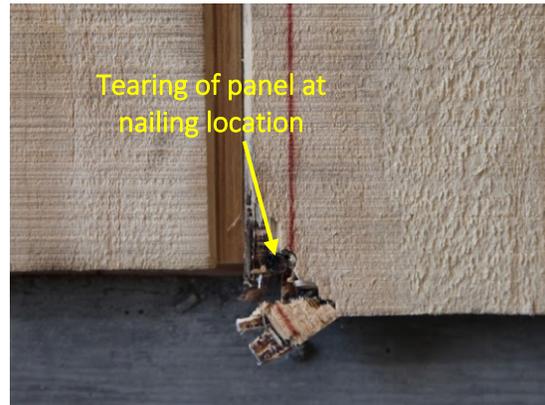
Cross-grain sill plate cracking

Gaps between boards closing

Panel rotation

Tearing of panel at nailing location

Figure 4.10 Damage to the dry finished existing 2-ft-tall specimens at lateral strength. Drift values are noted: (a) bottom of south-end interior of Specimen A-9 at -10% drift ratio; (b) middle interior of Specimen A-9 at -10% drift ratio; (c) middle exterior of Specimen A-11 at -5% drift ratio; (d) bottom of middle exterior (south and middle panel) of Specimen A-11 at -5% drift ratio; (e) south-end exterior of Specimen A-7 at -4% drift ratio; and (f) north-end interior of Specimen A-7 at -4% drift ratio.

For the dry specimens at strength, there was little visible damage to the horizontal siding finished specimens. The most notable observation was the development of a ~1/4-in. displacement between the siding boards; see Figure 4.10(e). In addition, tearing of the building paper at the location of the studs occurred along the interior of the specimen; see Figure 4.10(f). The damage characteristics along the interior for the horizontal siding over diagonal sheathing specimen was similar to that which occurred for the stucco over diagonal sheathing specimen. Cross-grain sill plate cracks developed at both ends of the wall [see Figure 4.10(a)], and the gaps between the sheathing boards closed; see Figure 4.10(b). Compared to the wet finished specimen, smaller gaps between the sheathing boards of the dry finished specimen occurred, which was a result of the dry finished specimen reaching strength at a later displacement amplitude than the wet finished

specimen. For the T1-11 finished cripple walls, the panel had rotated significantly [see Figure 4.10(c)], and some of the nails had torn through the edges of the panels; see Figure 4.10(d).

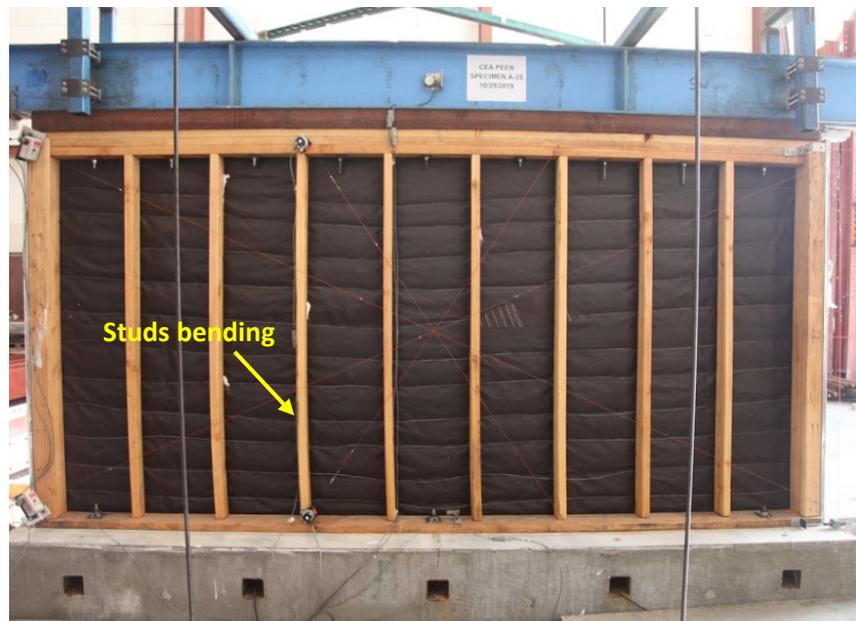
Figure 4.11 Damage to the wet finished existing 6-ft-tall specimens at lateral strength. Drift values are noted: (a) exterior elevation of Specimen A-23 at -1.4% drift ratio; (b) interior elevation of Specimen A-23 at -1.4% drift ratio; (c) bottom of middle interior of Specimen A-25 at -1.4% drift ratio; and (d) bottom of south-end corner of Specimen A-25 at -1.4% drift ratio.

Figure 4.11 shows that damage at lateral strength for the existing 6-ft-tall wet finished cripple walls, and Figure 4.12 shows the damage at lateral strength for the existing 6-ft-tall dry finished cripple walls. Only one existing 6-ft-tall wet finished specimen with stucco over framing was tested (Specimen A-25). At strength, large diagonal cracks extended across the exterior face of the specimen; see Figure 4.11(a). The crack openings were largest where the vertical cracks had formed at the bottom of the wall and then propagated upward at both ends of the specimen. These crack openings indicated the stucco had detached from the furring nails at the sill plate and bottom of the studs. The detachment of the stucco from the sill plate can be seen from the interior in Figure 4.11(c). Heavy spalling of the stucco occurred at both corners, which was primarily due to the corners bearing on the foundation; see Figure 4.11(d). Visible bending of the studs along the interior of the wall occurred, which had not occurred with any of the 2-ft-tall cripple walls [Figure 4.11(b)].

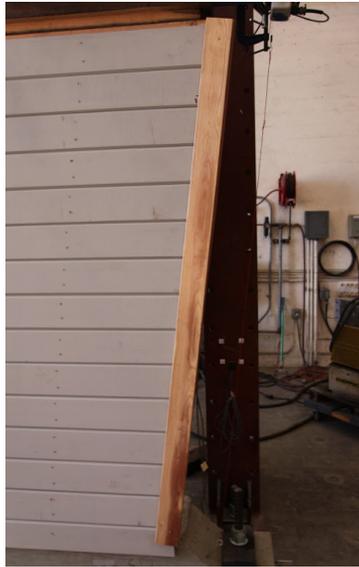
Figure 4.12 Damage to the dry finished existing 6-ft-tall specimens at lateral strength. Drift values are noted: (a) north-end exterior of Specimen A-13 at +11% drift ratio; (b) bottom of middle interior of Specimen A-13 at +12% drift ratio; (c) middle exterior of Specimen A-13 at -12% drift ratio; (d) bottom of north-end exterior of Specimen A-23 corner at -2% drift ratio; (e) middle exterior of Specimen A-23 at +3% drift ratio; and (f) bottom of north-end interior of Specimen A-23 at +3% drift.

Lateral strength for the existing 6-ft-tall cripple wall finished with horizontal siding was achieved at -11% and +12% drift ratio, which was by far the largest drift amplitude achieved compared to any of the cripple walls tested. By comparison, the existing 6-ft-tall cripple wall finished with T1-11 achieved strength at -2% and +3% drift ratio. In addition, Specimen A-13 had the lowest peak load of any of the cripple walls tested. There was little damage to both the interior and exterior face of the cripple wall at strength. Figure 4.12(a) shows the north-end corner of the exterior of Specimen A-13. No cracking of the siding boards or trim boards occurred, although. There was around 1/2 in. of displacement between each of the siding boards; see Figure 4.12(c). Significant rotation of the studs along the interior occurred; see Figure 4.12(b). Due to the low strength of the cripple wall, little uplift occurred.

The horizontal siding specimen exhibited the least amount of damage at strength of any of the specimens tested. The T1-11 finished existing 6-ft-tall cripple wall accumulated significant damage. Figure 4.12(d) shows the panels pulling away from the sill plate, with the largest gap formed at the panel overlap where the underlying panel did not have any nails on that edge. The sill plate shows less uplift and rotation than in previous displacement cycles due to the reduced amount of nailing attaching the sill plate to panels, i.e., the nails pulling through the panel at the sill plate. At the corners, the studs uplifted 1/4 in. from the sill plate, which had not experienced any increase compared with the state of the specimen at 1.4% drift ratio; see Figure 4.12(f). This is more uplift compared to that experienced by the horizontal siding finished specimen, and the mechanism is similar that experienced by the stucco finished specimen. Along the overlap joints of the T1-11 panels, the underlying panel displaced relative to the overlying panel due to the confinement of the overlying panel on the underlying panel being primary source of resistance to displacement of the underlying panel. Thus, significant rotations of the panels occurred, and the mechanism was similar to that of the existing 2-ft-tall specimen at strength; see Figure 4.12(e).

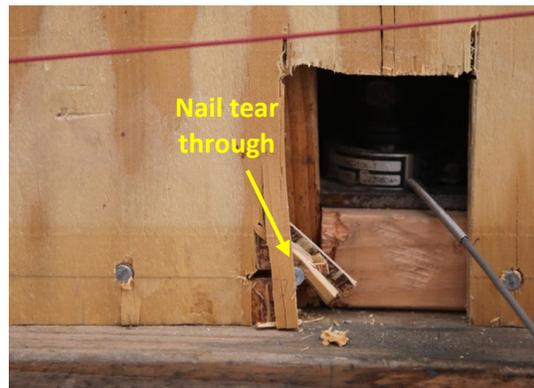
Figure 4.13 Damage to the wet finished retrofitted 2-ft-tall specimens at lateral strength. Drift values are noted: (a) south-end exterior corner of Specimen A-19 at +8% drift ratio; (b) north-end exterior of Specimen A-19 at +8% drift ratio; (c) bottom interior (south and middle panels) of Specimen A-16 at -5% drift ratio; (d) bottom of south-end interior of Specimen A-16 at -5% drift ratio; (e) bottom of south-end interior Specimen A-19 at +8% drift ratio; and (f) bottom of north-end interior Specimen A-19 at +8% drift ratio.

Figure 4.13 shows damage incurred at lateral strength for the wet finished retrofitted 2-ft-tall cripple walls, and Figure 4.14 shows the same for the dry finished retrofitted 2-ft-tall cripple walls. Near the corners of the exterior face of the specimen, vertical cracks propagated up the entire height of the wall; see Figure 4.13(a). In addition, the vertical cracks at the bottom of the wall had opened up significantly; see Figure 4.13(b). This response was like that experienced by the retrofitted specimens, indicating that the stucco had detached from the sill plate and bottom of the studs. The observed damage along the interior was manifested by plywood uplift and rotation; see Figure 4.13(c), (d), and (e). Many of the nails fastening the panels to the framing had rotated, and some had torn through the plywood panel; see Figure 4.13(f). In addition, splitting of some of the blocking attaching the plywood to the framing occurred; see Figure 4.13(e). The location of the split blocks was concentrated towards the ends of the specimens for all retrofitted cripple wall tested. The corner studs had uplifted roughly around 1/4 in. at the ends, which was a common occurrence for all retrofitted 2-ft-tall cripple walls.

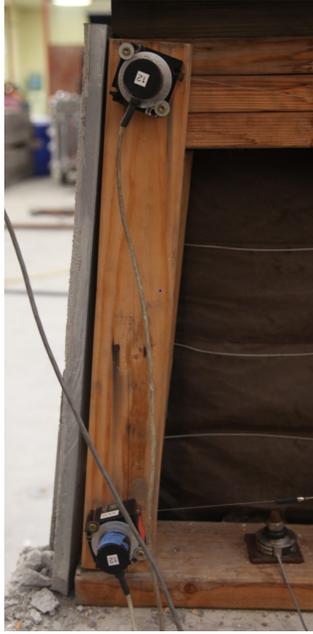
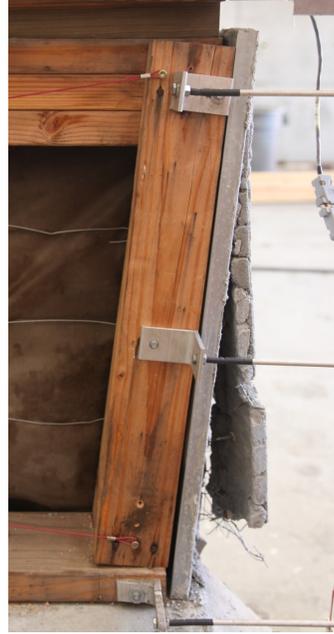
Figure 4.17 (continued).

Figure 4.17 Damage to the wet finished retrofitted 2-ft-tall specimens at lateral strength. Drift values are noted: (a) bottom of south-end exterior corner of Specimen A-15 at -13% drift ratio (70% post-strength reduction); (b) bottom of south-end interior of Specimen A-15 at +13% drift ratio (70% post-strength reduction); (c) top of south-end interior of Specimen A-20 at -14% drift ratio (80% post-strength reduction); (d) south-end exterior corner of Specimen A-20 at -14% drift ratio (80% post-strength reduction); (e) north-end interior of Specimen A-17 at +8% drift ratio (80% post-strength reduction); and (f) south-end interior of Specimen A-17 at +8% drift ratio (80% post-strength reduction).

Figure 4.17 provides photographs of the post-strength wet finished retrofitted 2-ft-tall specimens at various drift amplitudes. Figure 4.18 provides the same photographs for the dry finished retrofitted 2-ft-tall specimens. The drift amplitudes, percent of post-strength, and specimen name are given in the caption. For all wet finished specimens, the stucco had detached from the framing up most of the height of the stud. In many instances, the only attachment remaining between the stucco and the framing was at the top plates. This can be seen by the large crack formed at the corner of the stucco over horizontal sheathing specimen shown in Figure 4.17(d). At these large displacement amplitudes, the corner finishes had detached from the framing around the same distance as the stucco on the exterior face; see Figure 4.17(c), (d), and (f). For the stucco over framing finished cripple wall, there was little visible damage along the interior of the specimens; see Figure 4.17(e).

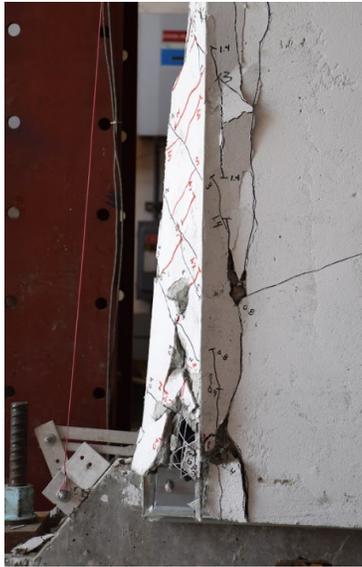
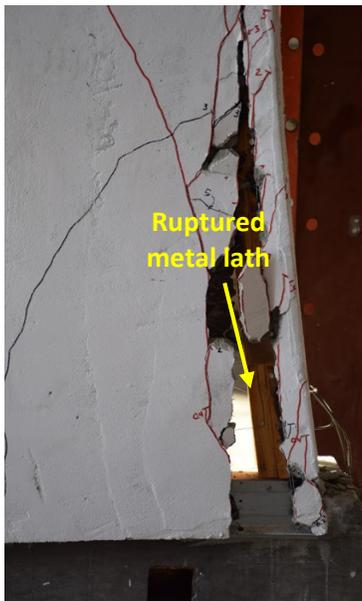
Figure 4.19 Damage to the wet finished existing 6-ft-tall specimens at lateral strength. Drift values are noted: (a) bottom of south-end exterior corner of Specimen A-23 at -7% drift ratio (80% post-peak strength reduction); (b) bottom of north-end corner of Specimen A-23 at -7% drift ratio (80% post-peak strength reduction); (c) bottom of north-end exterior of Specimen A-23 at -7% drift ratio (80% post-peak strength reduction); and (d) middle interior of Specimen A-23 at +7% drift ratio (80% post-peak strength reduction).

Figure 4.19 provides photographs of the existing wet finished 6-ft-tall specimens at various drift amplitudes, post-strength. Figure 4.20 provides the same photographs for the dry finished existing 6-ft-tall specimens. The drop in strength for the existing 6-ft-tall specimen with stucco over framing finish occurred slightly earlier than the existing 2-ft-tall cripple walls with stucco; see Specimen A-17 and A-22. The damage characteristics were similar in many respects to the shorter cripple walls. The stucco finish had detached from most of the furring nails on the studs and remained only attached to the furring nails at the top plates and the top third of the studs. The large crack openings in the stucco at the corners are shown in Figure 4.19(a), (b), and (c). The stucco had fully detached from the bottom two-thirds of the corners at both ends of the specimen. Along the interior, the studs were bent, and one of the studs had fractured; see Figure 4.19(d). For the 6-ft-tall specimen finished with T1-11 wood structural panels, the panels detached from the sill plate and then continued to detach up the studs. Eventually the detachment of the panels on the studs was extensive enough that the studs underlying panel had almost no contact with the overlying panel; see Figure 4.20(d). Most of the nails at the sill plate and near the base of the studs pulled through or torn through the edges of the T1-11 panels. Higher up on the wall, more nails remained attached to the panels and had pulled out from the framing. The rotation of the studs at the interface with both the top plates and the sill plates were heavily rotated, both in and out of plane. The trim boards at the finish face of the corner had almost fully detached from the framing and only remained partially fastened to the T1-11 panels; see Figure 4.20(f). Along the exterior face, multiple edges of the panels had partially or completely lost attachment to the framing; see Figure 4.20(e).

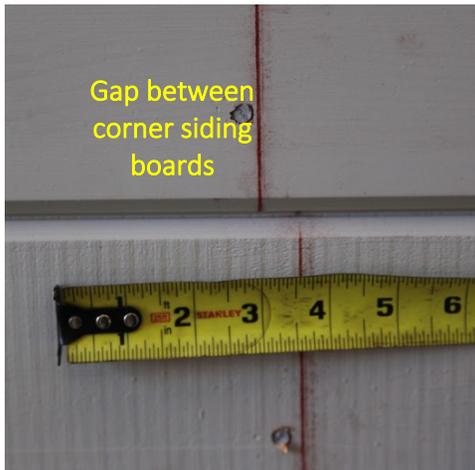
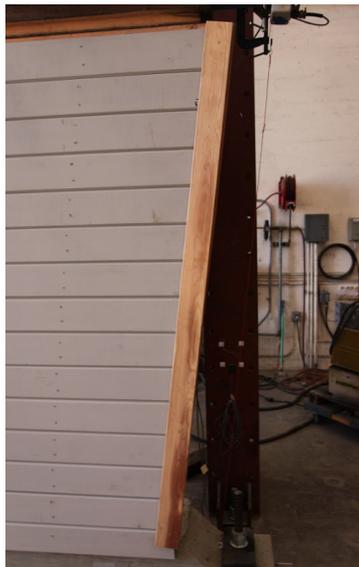
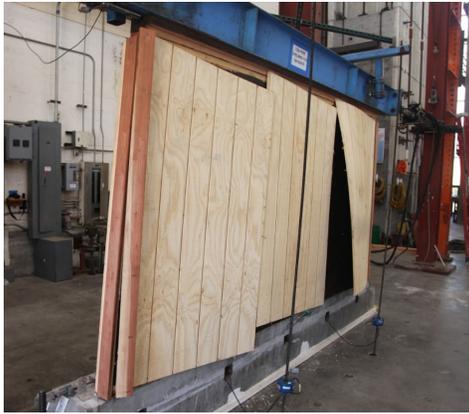
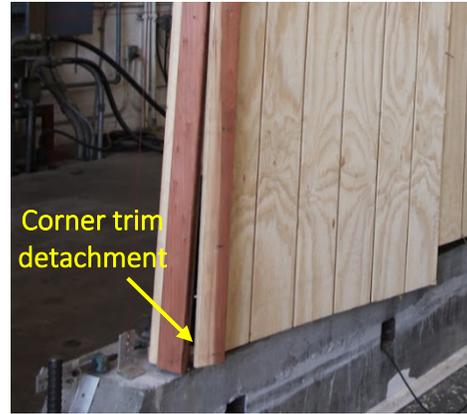
Figure 4.20 (continued).

Figure 4.20 Damage to the dry finished existing 6-ft-tall specimens at lateral strength. Drift values are noted: (a) middle exterior of Specimen A-13 at -12% drift ratio (10% post-peak strength reduction); (b) bottom of south-end corner Specimen A-13 at -12% drift ratio (10% post-peak strength reduction); (c) north-end exterior of Specimen A-13 at +11% drift ratio (10% post-peak strength reduction); (d) bottom interior of Specimen A-23 at +10% drift (south and middle panels) (80% post-peak strength reduction); (e) exterior isometric view of Specimen A-23 at -10% drift (80% post-peak strength reduction); and (f) bottom of south-end of Specimen A-23 at -10% drift (80% post-peak strength reduction).

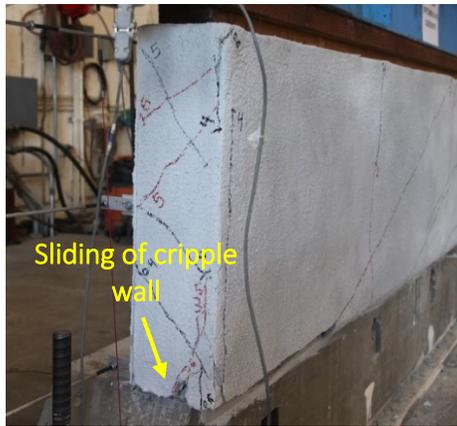
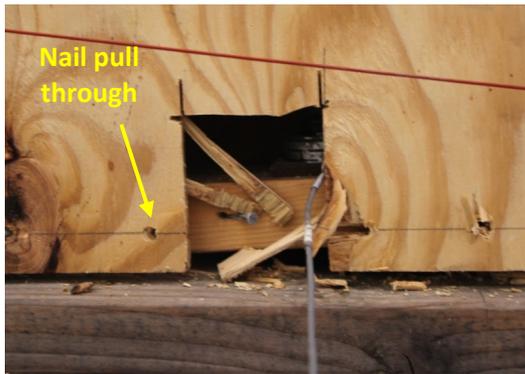
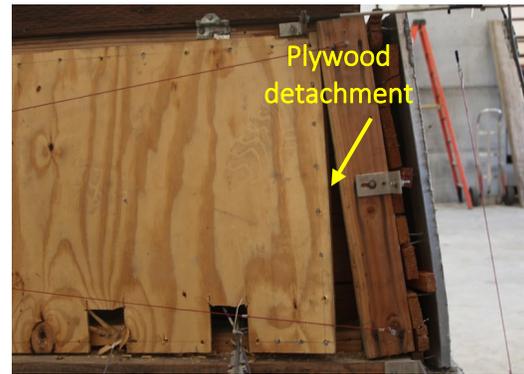
Figure 4.21 Damage to wet finished retrofitted 2-ft-tall specimens at lateral strength. Drift values are noted: (a) south-end exterior corner of Specimen A-16 at -9% drift ratio (80% post-peak strength); (b) bottom of north-end interior of Specimen A-16 at -9% drift ratio (80% post-peak strength); (c) south-end interior of Specimen A-19 at -12% drift ratio (80% post-peak strength); and (d) bottom interior of Specimen A-19 at -12% drift ratio (80% post-peak strength).

Figure 4.21 provides photographs of the wet finished retrofitted 2-ft-tall specimens at various drift amplitudes, post-strength. Figure provides the same photographs for the dry finished retrofitted 2-ft-tall specimens. The damage to the retrofitted specimen was similar for most specimens. The T1-11 finished cripple walls had different observable damage due to there being no additional plywood with the retrofit. The corners of the plywood crushed against the sill plate and flat studs. Often this resulted in the flat stud being push out laterally or twisting; see Figure 4.22(b). The residual state of the specimen was a result of the plywood partially or fully detaching from the framing on multiple sides; see Figure 4.21(c) and (d). Along the edges of the panels, many of the nails had torn through, especially at the locations where the plywood panels were crushed; see Figure 4.21(a) and (b) There was significantly less damage to both the wet and dry finished specimens with diagonal sheathing; see Figure 4.21(b) and Figure 4.22(c). This was a result of the anchor bolt fracturing, so the residual strength was provided by the frictional resistance of the sill plate sliding along the foundation, a similar mechanism experienced by the existing specimens with diagonal sheathing. For the cripple walls finished with T1-11 wood structural panels, the panels detached along multiple edges; see Figure 4.22(e). The stucco on the wet finished specimens showed the same damage characteristics as the existing wet finished specimens, including large crack openings at the corners where the stucco had detached from the studs up most of the height of the studs. In addition, the finish materials had detached at the corners in a similar fashion, as shown in Figure 4.21(d).

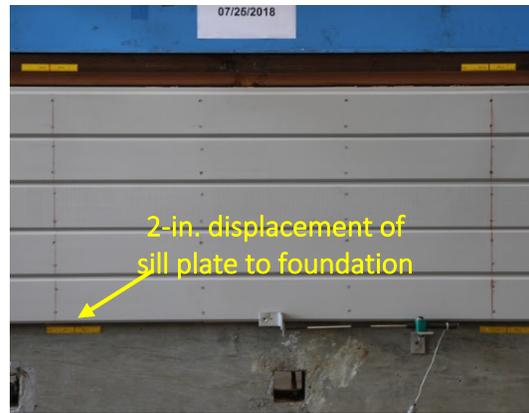
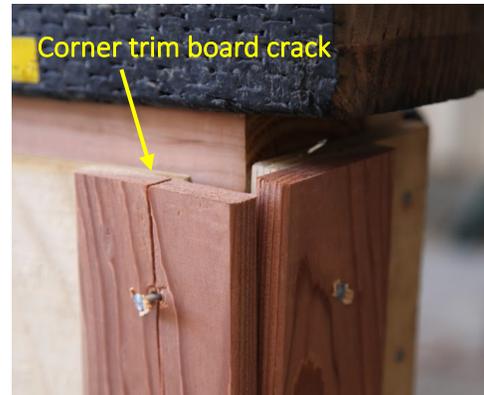
Figure 4.22 Damage to the dry finished retrofitted 2-ft-tall specimens at lateral strength. Drift values are noted: (a) bottom of south-end interior of Specimen A-8 at -11% drift ratio (80% post-peak strength); (b) bottom of south-end interior of Specimen A-8 at +12% drift ratio (80% post-peak strength); (c) bottom north-end exterior of Specimen A-10 at +9% drift ratio (80% post-peak strength); (d) middle exterior of Specimen A-10 at +9% drift ratio (80% post-peak strength); (e) top of north-end exterior corner of Specimen A-12 at -9% drift (south and middle panels) (80% post-peak strength); and (f) top of middle exterior of Specimen A-12 at -9% drift (south and middle panels) (80% post-peak strength).

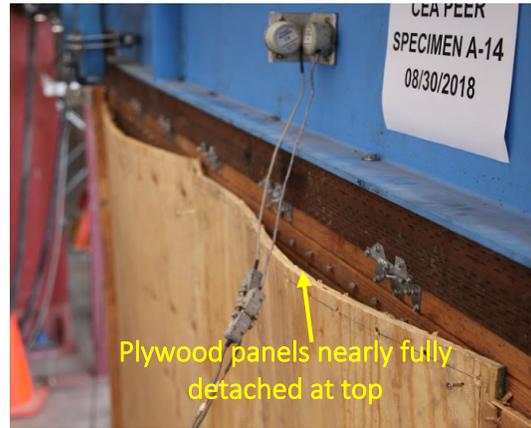
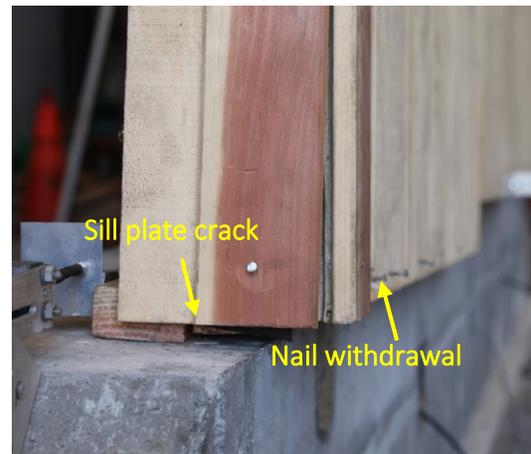
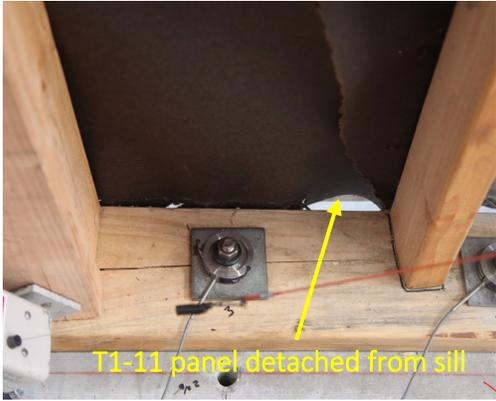
Figure 4.24 Damage to the dry finished retrofitted 6-ft-tall specimens at lateral strength. Drift values are noted: (a) bottom of south-end interior of Specimen A-14 at -10% drift (80% post-peak strength reduction); (b) top of interior of Specimen A-14 at -10% drift (80% post-peak strength reduction) (north and middle panels); (c) bottom of south-end interior Specimen A-14 at +10% drift (80% post-peak strength reduction); (d) bottom of south-end exterior corner of Specimen A-24 at -6% drift (80% post-peak strength reduction); (e) bottom of south-end interior of Specimen A-24 at +6% drift ratio (80% post-peak strength reduction); and (f) bottom of middle interior of Specimen A-24 at -6% drift ratio (80% post-peak strength reduction).

Figure 4.23 provides photographs of the wet finished retrofitted 6-ft-tall specimens at various drift amplitudes, post-strength. Figure 4.24 provides the same photographs for the dry finished retrofitted 6-ft-tall specimens. For the retrofitted 6-ft-tall cripple wall with stucco exterior finish, the stucco finish had detached from most of the furring nails on the studs and remained only attached to the furring nails at the top plates and the top third of the studs, similar to Specimen A-25. The stucco had fully detached from the bottom two-thirds of the corners at both ends of the specimen. The detachment at the bottom of the corners can be seen in Figure 4.23(a). Along the interior, the plywood was heavily damaged. At the ends, the plywood crushed against the flat studs and caused the flat studs to laterally displace; see Figure 4.23(b). At the bottom of the panels, the fasteners either pulled through the panels or tore through the edges of the panels [Figure 4.23(d)], and at the top of the walls, there was assortment of nails withdrawing from the framing, pulling through the plywood, or tearing through the plywood edges; see Figure 4.23(c).

For the retrofitted 6-ft-tall cripple wall with horizontal siding, the detachment of the plywood occurred when the nails pulled through the plywood and remained attached to the framing. At the bottom of the cripple wall, the opposite occurred. The plywood panels remained attached to the nails. Significant uplift of the panels occurred as the blocking either split or was uplifted with the panels; see Figure 4.24(a). Along the studs, there was a combination of nails pulling through the plywood and nails pulling out of the framing, leading to detachment of the plywood panels; see Figure 4.24(b). The large amount of uplift forces was carried in tension by the hold-downs on both ends. Eventually, this caused the stud attaching the hold-down to the framing to split; see Figure 4.24(c). For the retrofitted 6-ft-tall cripple wall with T1-11 wood structural panels, cracking of the sill plate extended nearly two studs bays on both ends of the wall; see Figure 4.24(e). In these photographs, the separation of T1-11 panels from the sill plate can be observed. The nails attached through the 5/8-in. sections of the panels generally pulled out from the framing, while the nails attached through the 5/16 in. sections generally pulled through the panels or tore through the edges of the panels. At the panel overlaps, sections of the T1-11 panels are thin, and the fasteners had pulled through or torn through the panels in most instances, especially near the bottom of the wall. The withdrawal of the fasteners at the sill plate can be seen in Figure 4.24(d). Splitting of one of the studs occurred at 6% drift and led to a large displacement

of the stud; see Figure 4.24(f). Previously, there had been visible bending of the studs, leading to the splitting of the stud. The damage characteristics of the 6-ft-tall specimen were similar to the 2-ft-tall specimen, but more pronounced.
