# PACIFIC EARTHQUAKE ENGINEERING RESEARCH CENTER

## **Comparison of the Response of Small- and Large-Component Cripple Wall Specimens Tested under Simulated Seismic Loading**

**A Report for the “Quantifying the Performance of  
Retrofit of Cripple Walls and Sill Anchorage in Single-  
Family Wood-Frame Buildings” Project**

PEER Report 2020/21

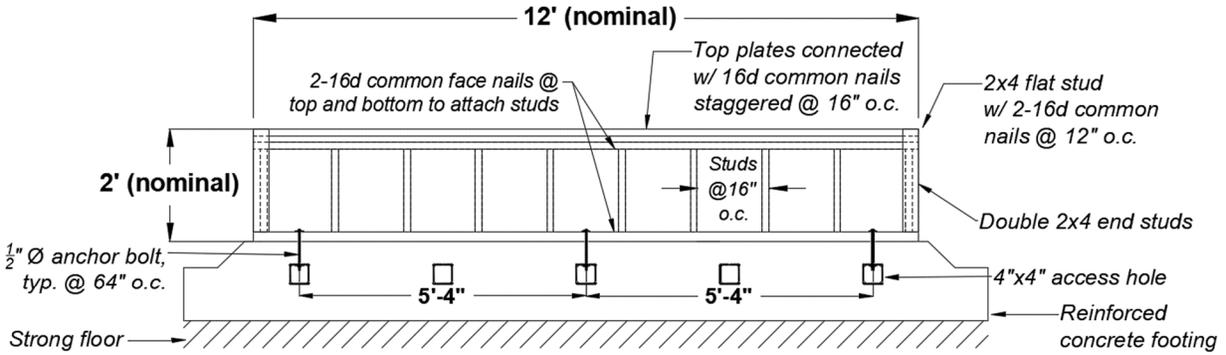
The listed small-component test specimens were 2-ft-high, 12-ft-long cripple walls. They had an exterior finish of stucco applied over horizontal lumber sheathing. All specimens were tested using the same displacement-controlled loading protocol. All specimens were tested with a superimposed dead load of 450 lbs per linear foot (plf); see Figure 2.1 for a diagram of the typical small-component test specimen.

1. Sill plates are 2x6 and top-plates are 2x4.
2. Anchor bolts are  $\frac{1}{2}$ "  $\varnothing$  with  $2\frac{1}{2}$ " (min.) x  $\frac{3}{16}$ " square washer (to receive load cell on top).

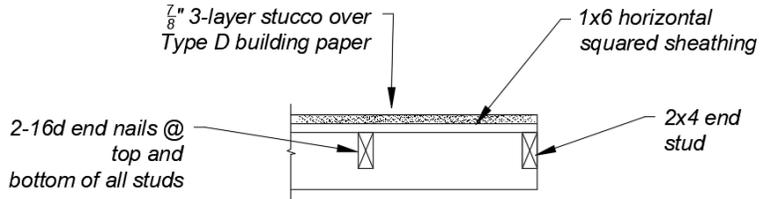
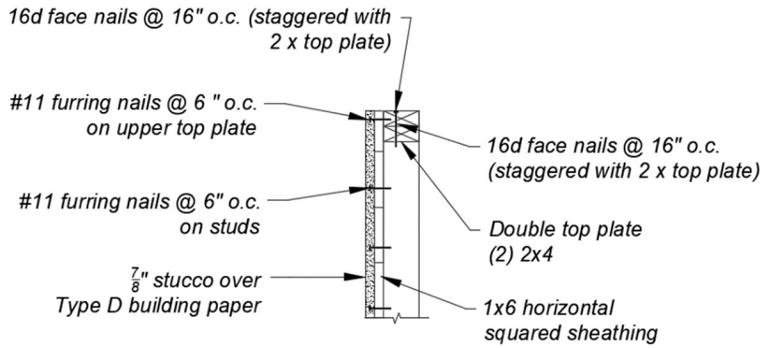
**Figure 2.2** Illustration of top boundary condition A: (top) plan view detail; and (bottom) top of wall detail.

**Plan View Detail**  
**Stucco Over Horizontal Sheathing**  
**Top Boundary Condition A**

**Top of Wall Detail**  
**Stucco Over Horizontal Sheathing**  
**Top Boundary Condition A**

Small-component Specimen A-1 included top boundary condition A and bottom boundary condition a. Top boundary condition A represents a lower bound of stucco continuity, with the stucco ending at the panel ends and top without any wrapping around corners or supplemental fasteners; see Figure 2.2. Bottom boundary condition a has the stucco outboard of the face of the concrete foundation, while the horizontal wood sheathing is seated on the foundation; see Figure 2.3. Photographs of the specimen taken prior to testing are shown in Figure 2.4.

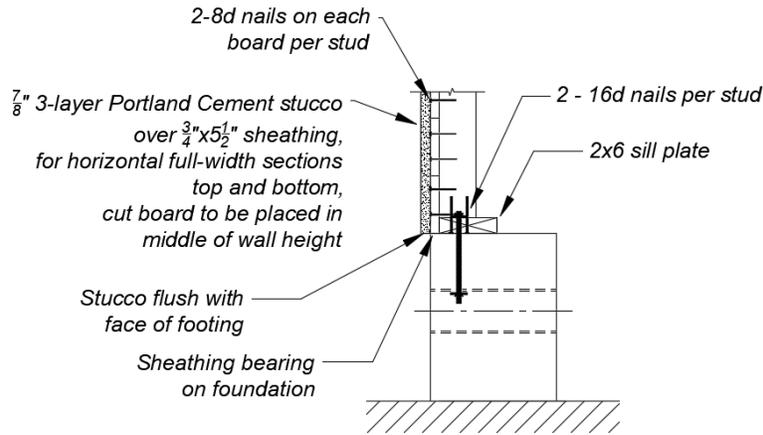
**Figure 2.3** Illustration of bottom boundary condition a.

**Bottom of Wall Detail**  
**Stucco Over Horizontal Sheathing**  
**Bottom Boundary Condition a**

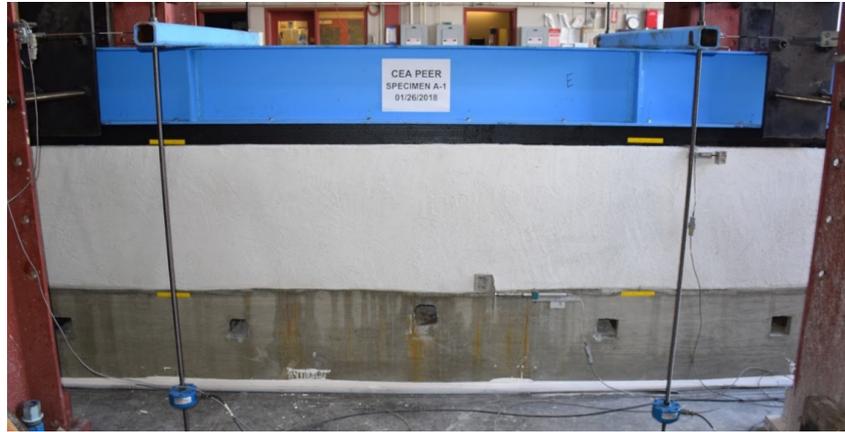
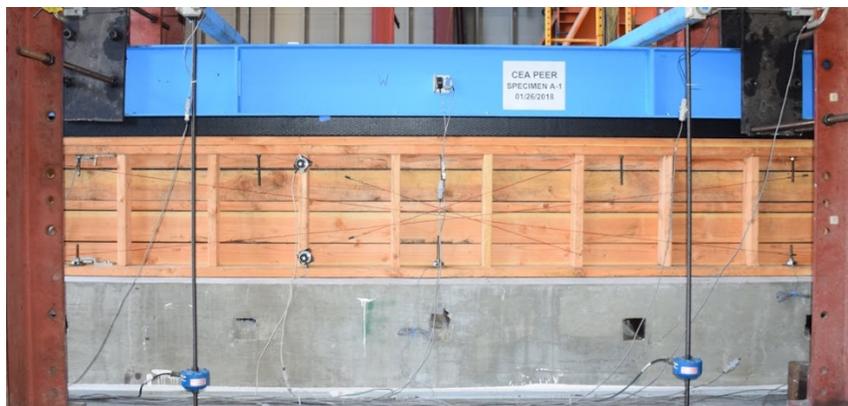
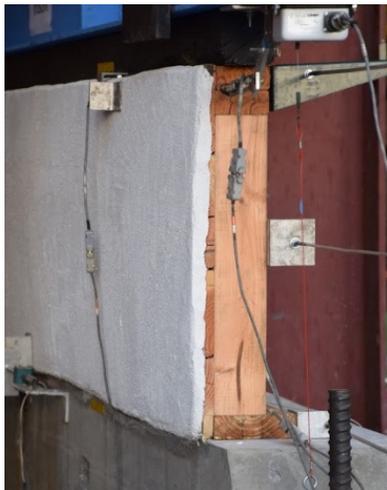
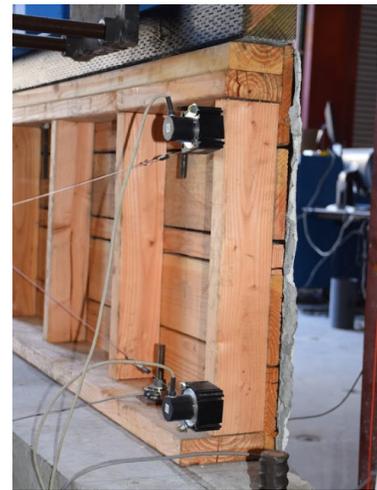
**Figure 2.4** Specimen A-1 pre-test photographs of top boundary condition A and bottom boundary condition a: (a) exterior elevation; (b) interior elevation; (c) north exterior corner; and (d) south interior corner.

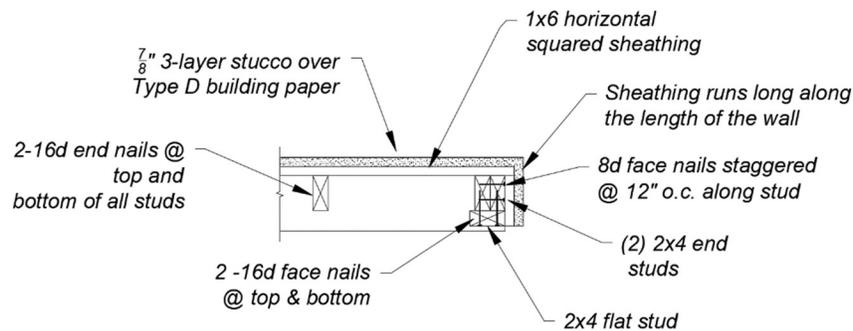
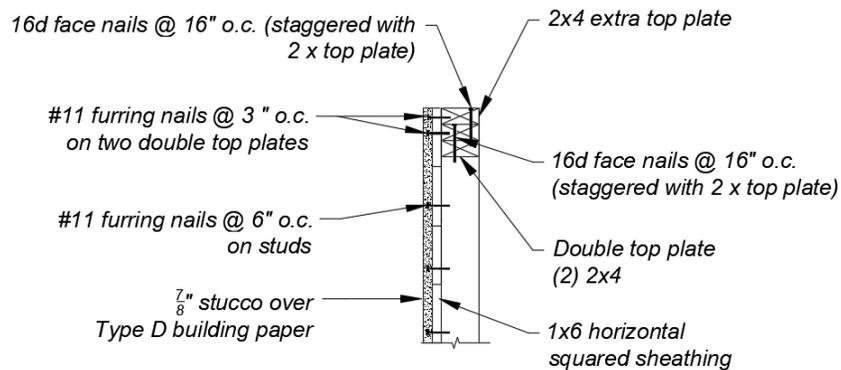
**Figure 2.5 Illustration of top boundary condition B: (top) plan view detail and (bottom) top of wall detail.**

**Plan View Detail  
Stucco Over Horizontal Sheathing  
Top Boundary Condition B**

**Top of Wall Detail  
Stucco Over Horizontal Sheathing  
Top Boundary Condition B & C**

Small-component Specimen A-2 included top boundary condition B and bottom boundary condition a. Top boundary condition B included additional fastening between the stucco and the cripple wall top plates to emulate additional transfer of load into the stucco that might occur in the superstructure portion of a complete house. Top boundary condition B also included wrapping of the stucco around the end of the wall specimen. Both of these detail changes were intended to provide further continuity of the stucco, moving toward the continuity found in a complete house. Top boundary condition B is illustrated in Figure 2.5. Photographs of the specimen taken prior to testing are shown in Figure 2.6.

Small-component Specimen A-4 included top boundary condition B and bottom boundary condition b. With bottom boundary condition b, both the stucco and the horizontal lumber sheathing were seated on the foundation. This is illustrated in Figure 2.9, while top boundary condition B is illustrated in Figure 2.5. Photographs of Specimen A-4 are provided in Figure 2.10.

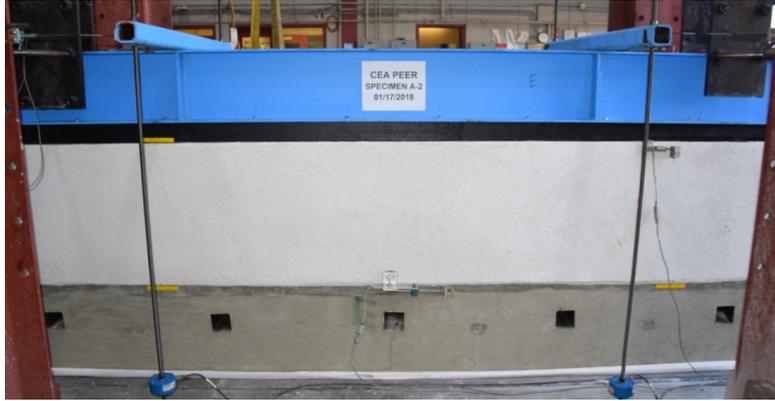
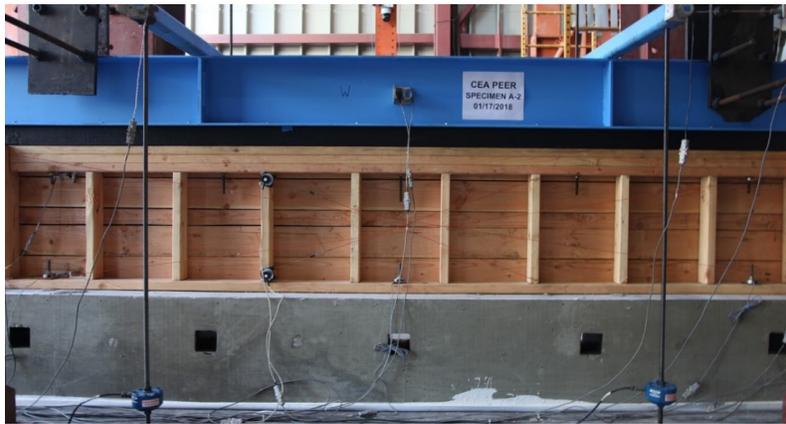
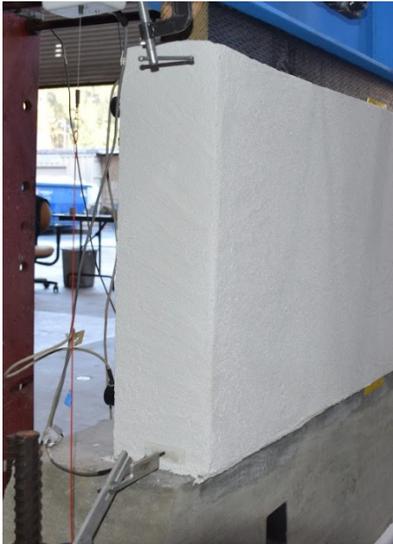
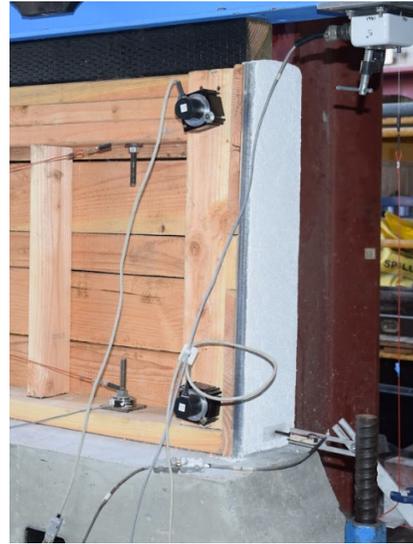
**Figure 2.6** Specimen A-2 pre-test photographs with top boundary condition B and bottom boundary condition a: (a) exterior elevation; (b) interior elevation; (c) south exterior corner; and (d) south interior corner.

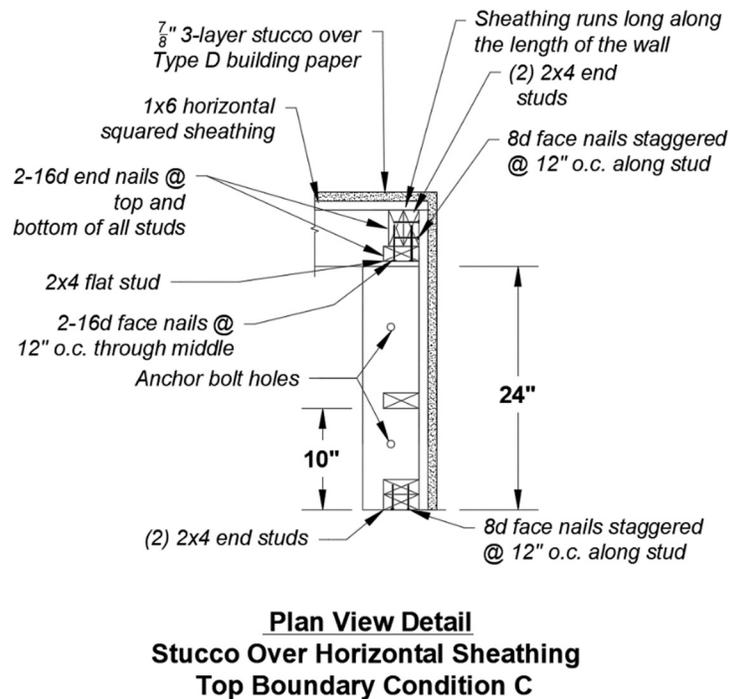
Figure 2.7 Illustration of top boundary condition C.

Small-component Specimen A-3 included top boundary condition C and bottom boundary condition a. Top boundary condition C had the same fastening along the top of the wall as top boundary condition B. In addition, this boundary condition incorporated a return wall at each end, effectively resulting in a C-shaped wall specimen. The return walls were 2 ft long on both ends of the specimen. The first stud bay was 16 in. on center and the second was 8 in. on center. The return wall corners were framed with two 2 × 4 studs, and the return wall was tied down with two anchor bolts, one within each stud bay; see Figure 2.7. Photographs of the specimen taken prior to the test are shown in Figure 2.8.

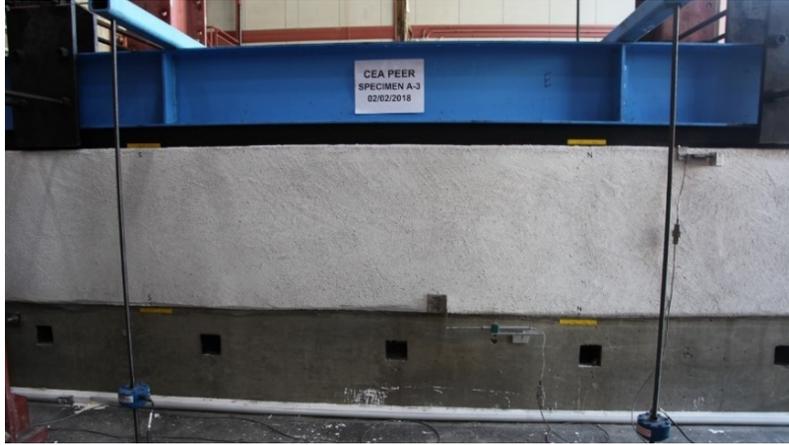
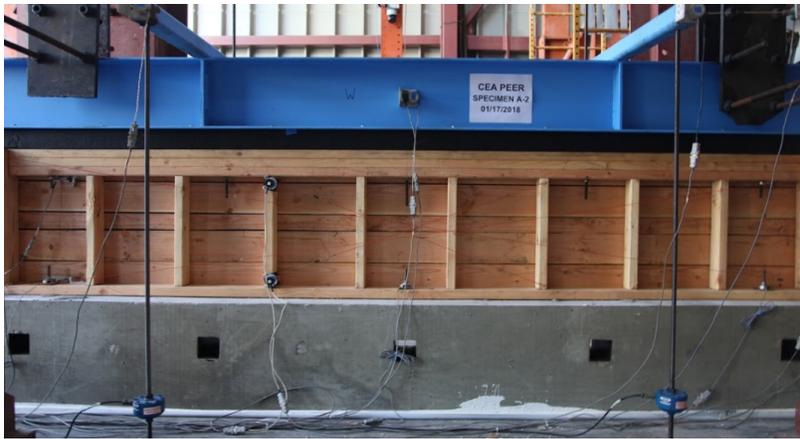
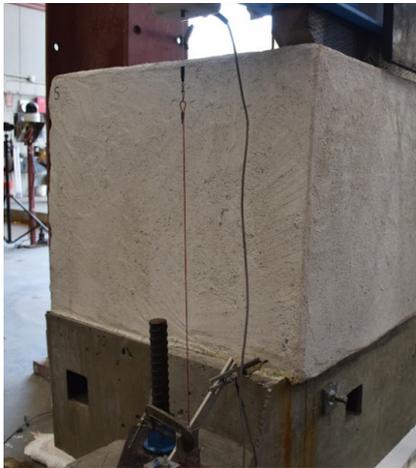
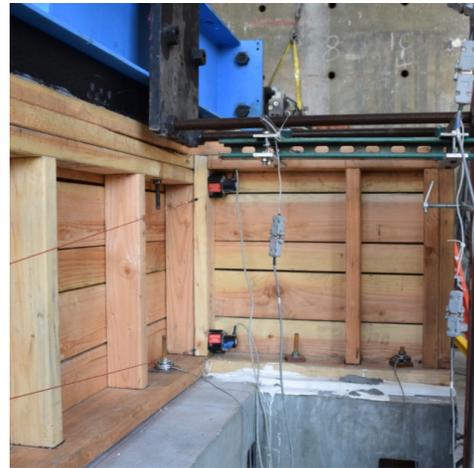
**Figure 2.8** Specimen A-3 pre-test photographs of top boundary condition C and bottom boundary condition a: (a) exterior elevation; (b) interior elevation; (c) south exterior corner; and (d) south interior corner.

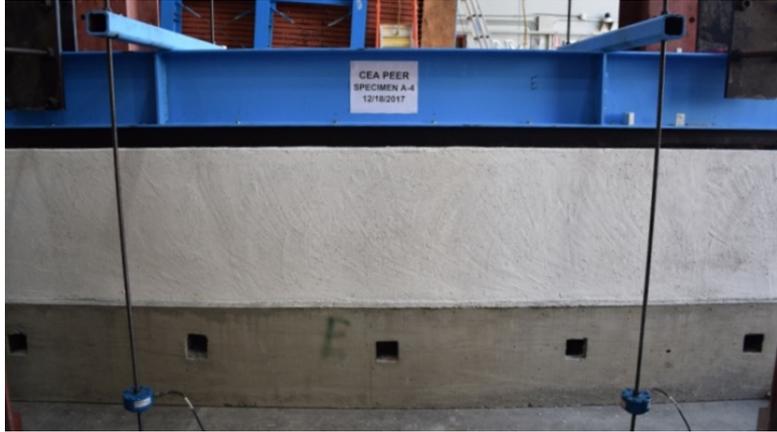
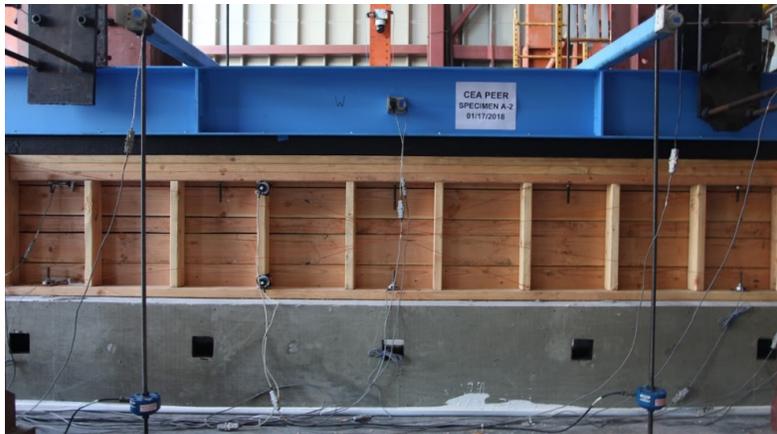
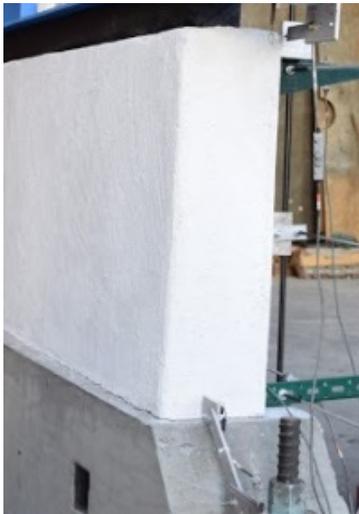
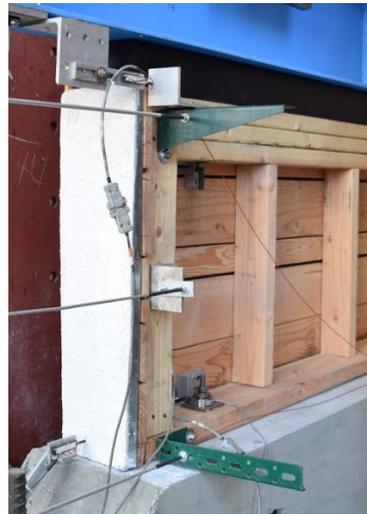
**Figure 2.10** Specimen A-4 pre-test photographs with top boundary condition B and bottom boundary condition b: (a) exterior elevation; (b) interior elevation; (c) south exterior corner; and (d) south interior corner.

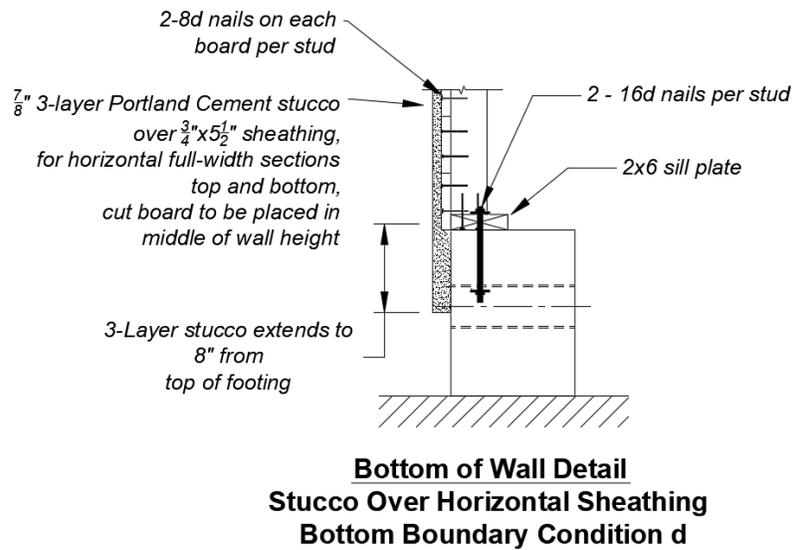
**Figure 2.11** Illustration of return wall for bottom boundary condition d.

Small-component Specimen A-20 included top boundary condition B and bottom boundary condition d. With bottom boundary condition d, both finish materials (the stucco and horizontal lumber sheathing) were outboard of the foundation. In addition, the stucco extended 8 in. down the face of the footing. This is illustrated in Figure 2.11, while top boundary condition B is illustrated in Figure 2.5. These boundary conditions are the same as large-component Specimen AL-1. Photographs of Specimen A-20 are provided in Figure 2.12.

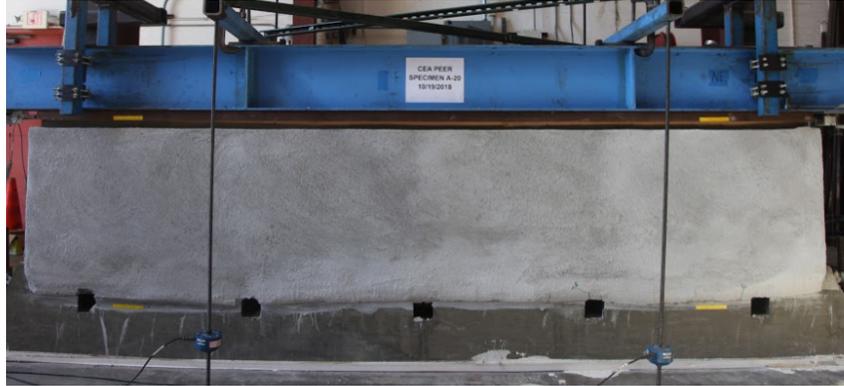
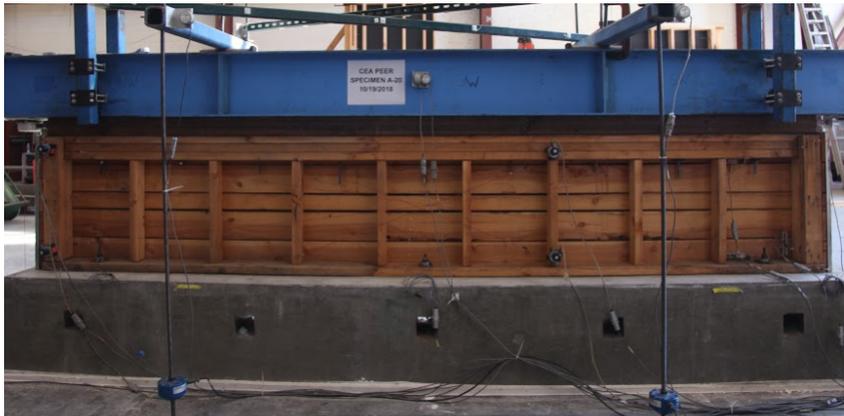
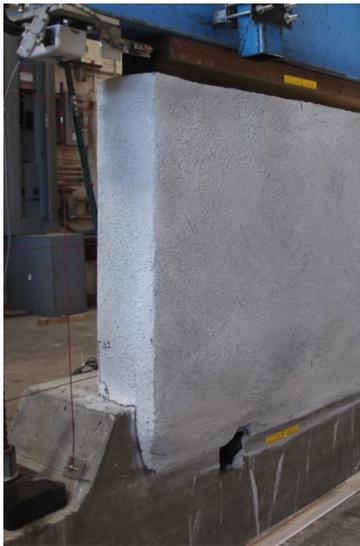
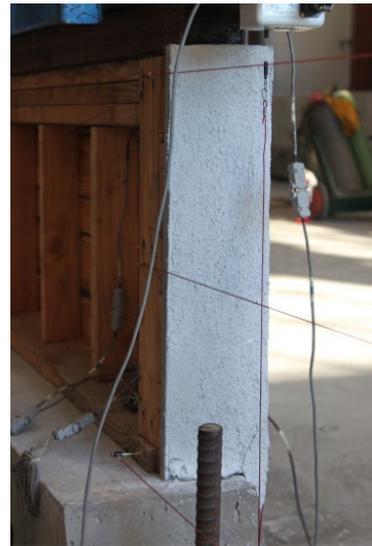
**Figure 2.12** Specimen A-20 pre-test photographs of existing 2-ft-tall cripple wall with stucco over horizontal sheathing exterior finish and bottom boundary condition d: (a) exterior elevation; (b) interior elevation; (c) south exterior corner; and (d) south interior corner.

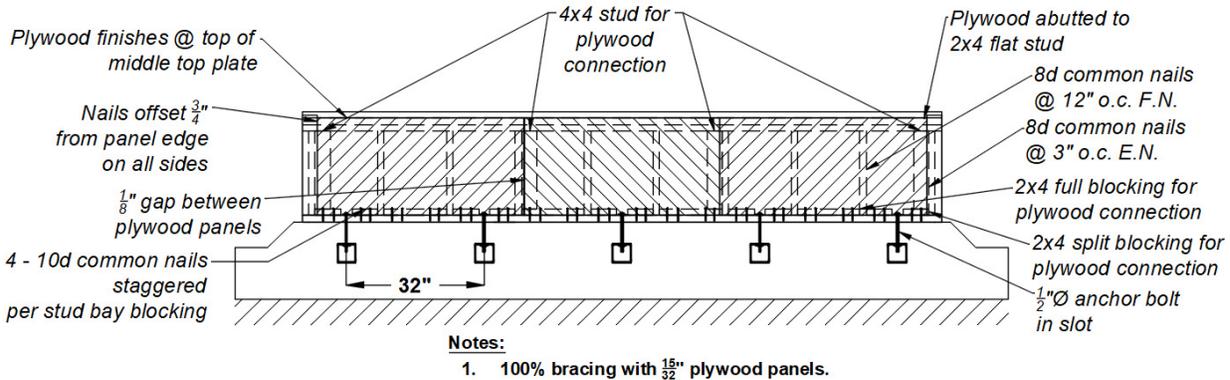
**Elevation**  
**Retrofit Framing Details (Interior Face)**  
**2' Tall Cripple Wall**  
**5 Anchor Bolt Configuration**

**Figure 2.13** Diagram of FEMA P-1100 retrofit [2018] (applied to Specimen A-5).

Small-component Specimen A-5 included the seismic retrofit of the cripple wall. The retrofit was installed on a test specimen with top boundary condition B and bottom boundary condition a, which matched the configuration of Specimen A-2. The retrofit was designed based on guidance from the in-progress ATC-110 design guidelines [FEMA 2018]. An engineered retrofit was designed based on materials and weights consistent with 1940s-era construction, using an  $R$  factor of 4. The retrofit involved fully sheathing the interior face of the cripple wall with 15/32-in. plywood. Prior to installation of the sheathing, 2 × 4 blocking was attached to the sill plate with 4-10d common nails per stud bay. Added blocking was split into two sections for stud bays that had anchor bolts so that the anchor bolts were seated on the sill plate. Additional 2 × 4 studs were toe-nailed in with 2-8d common nails top and bottom at each end of the wall, and two 4 × 4 studs were toe-nailed in with 2-8d common nails top and bottom in the interior of the cripple wall at each interior third.

The addition of studs and blocking plates were used so that the plywood panels could be nailed to the cripple wall. Details of the framing are shown in Figure 2.13. The interior of the framing before the application of plywood can be seen in Figures 2.14 (a) and (b). The plywood was placed in three 4-ft sections, fully sheathing the interior face of the wall. Panels were attached with 8d common nails at 4 in. on center along the edges and 12 in. on center in the field. An 1/8-in. gap was provided between panels to allow for expansion; the nails were placed 3/4 in. from the panel edge to prevent nails from tearing through the panel edges. Details of the plywood panel attachment for Specimen A-5 can be seen in Figure 2.15, and pre-test photos of the overall specimen are provided in Figure 2.16. For the 12-ft section of wall tested, five 1/2-in.-diameter anchor bolts were used. Five anchor bolts were installed in the pre-existing anchor bolt sleeves on the foundation, spaced at 32 in. on center; see Figure 2.13.

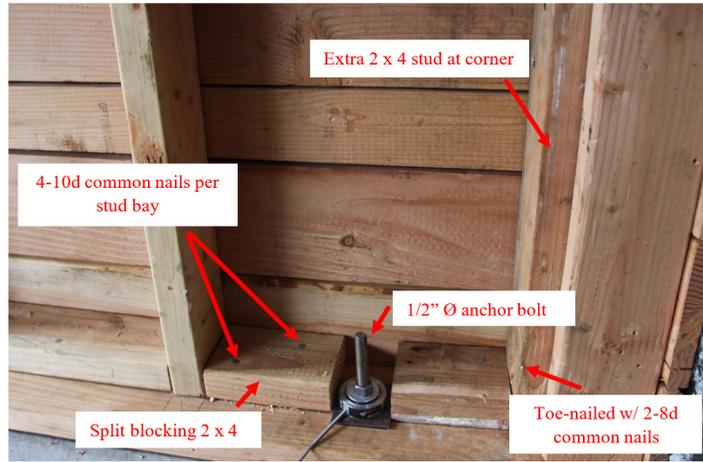
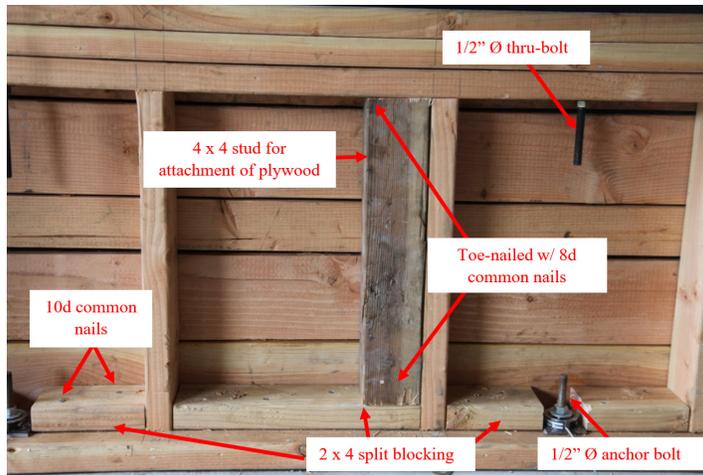
Figure 2.14 Specimen A-5 anchor bolt retrofit: (a) framing face corner retrofit detail; and (b) framing face retrofit detail.

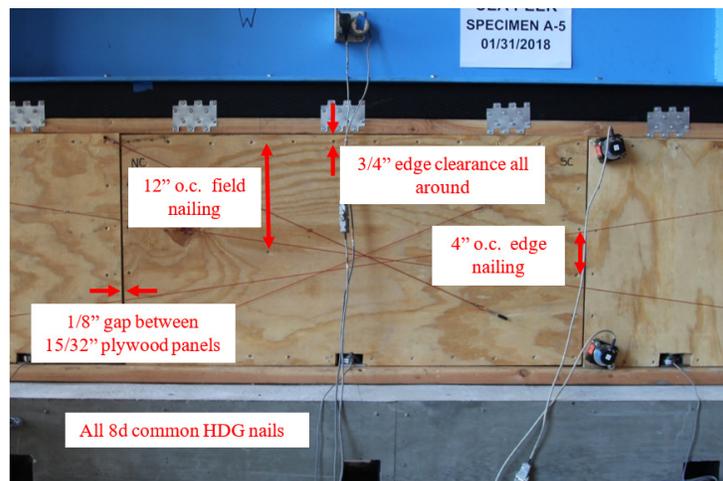
Figure 2.15 Specimen A-5 retrofit with plywood sheathing.

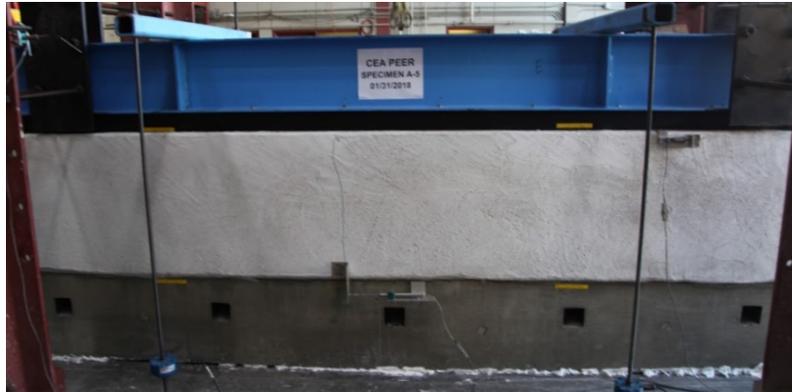
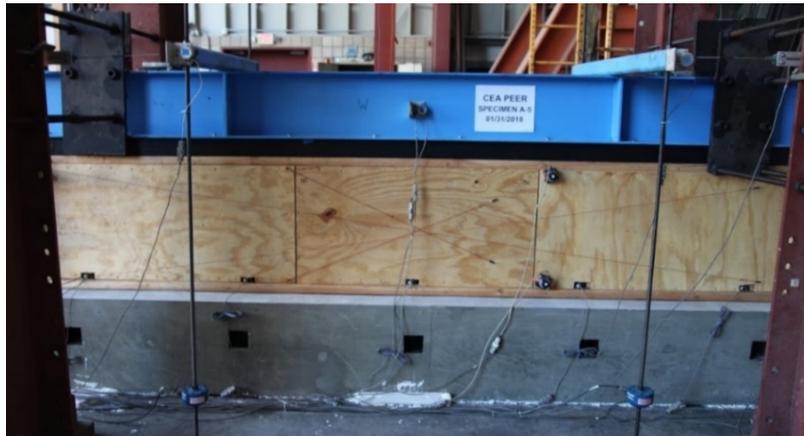
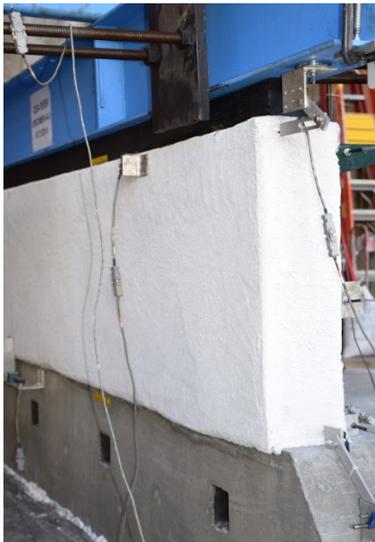
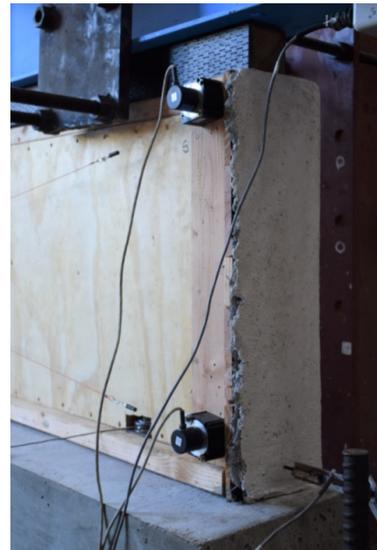
**Figure 2.16** Retrofitted Specimen A-5 pre-test photographs with top boundary condition B and bottom boundary condition a: (a) exterior elevation; (b) interior elevation; (c) north exterior corner; and (d) south interior corner.

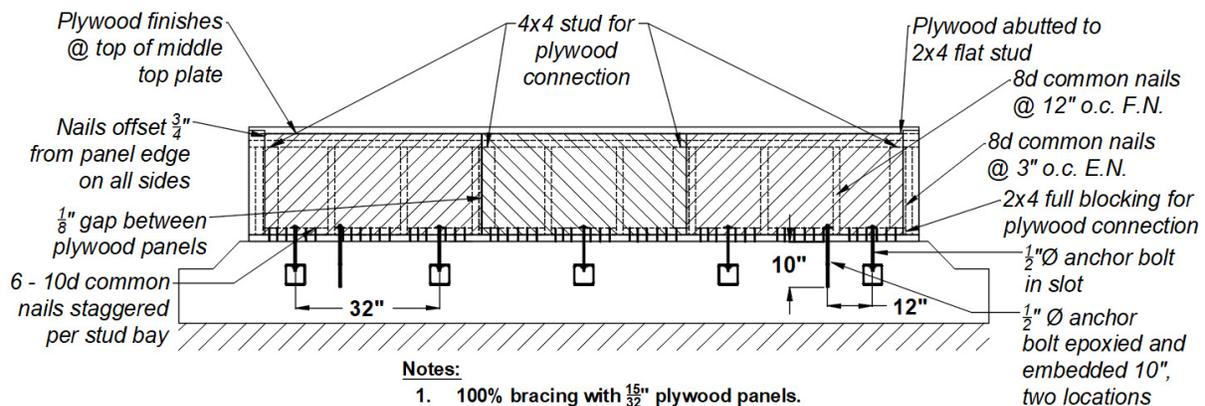
**Elevation**  
**Retrofit Framing Details (Interior Face)**  
**2' Tall Cripple Wall**  
**7 Anchor Bolt Configuration**

**Figure 2.17** Diagram of *FEMA P-1100* retrofit [2018] (as applied to Specimen A-19).

Small-component Specimen A-19 also included seismic retrofit of the cripple wall. The retrofit was installed on a test specimen with top boundary condition B and bottom boundary condition c. The retrofit was design in accordance with the finalized *FEMA P-1100* prescriptive retrofit provisions [FEMA 2018] for houses with a weight classification of “heavy” construction. The retrofit involved fully sheathing the interior face of the cripple wall with 15/32-in. plywood. Prior to sheathing, 2 × 4 blocking was attached to the sill plate with 6-10d common nails per stud bay. Full sections of blocking were used so that the anchor bolts were seated on the blocking. Additional 2 × 4 studs were toe-nailed in with 2-8d common nails top and bottom at each end of the wall, and two 4 × 4 studs were toe-nailed in with 2-8d common nails top and bottom in the interior of the cripple wall at each interior third.

The addition of studs and blocking plates were used to allow the plywood panels to be nailed to the cripple wall. Details of the framing are shown in Figure 2.17. The interior of the framing before the application of plywood can be seen in Figure 2.18(a), (b), and (c). The plywood was placed in three 4-ft sections, fully sheathing the interior face of the wall. Panels were attached with 8d common nails at 3 in. on center along the edges and 12 in. on center along the field. A 1/8-in. gap was provided between panels to allow for expansion, and the nails were placed 3/4 in. from the panel edge to prevent nails from tearing through the panel edges. Details of the plywood panel attachment for Specimen A-5 can be seen in Figure 2.19. For the 12-ft section of wall tested, five 1/2-in.-diameter anchor bolts were used. In addition, *FEMA P-1100* requires an extra 1/2-in.-diameter anchor bolt at each end of the cripple wall. Five anchor bolts were installed in the pre-existing anchor bolt sleeves on the foundation, spaced at 32 in. on center, and the additional two anchor bolts were embedded 10 in. into the foundation and epoxied with Simpson Strong-Tie SET-XP, 12 in. inward from the outer two most anchor bolts; see Figure 2.17. Photographs of Specimen A-20 are provided in Figure 2.20.

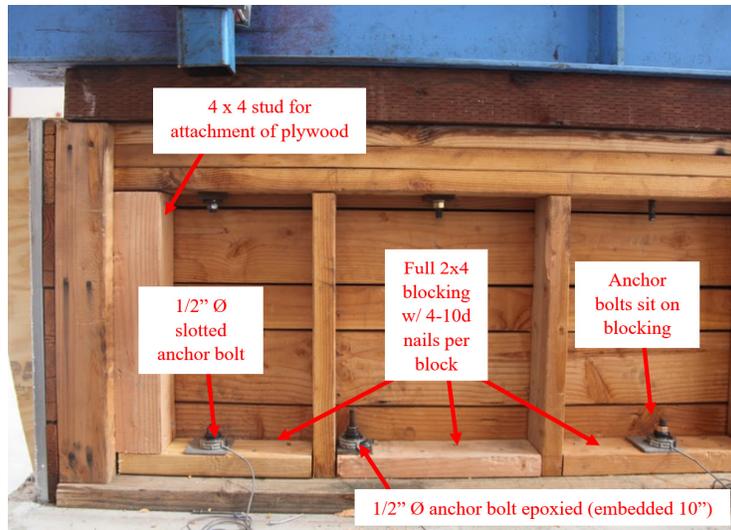
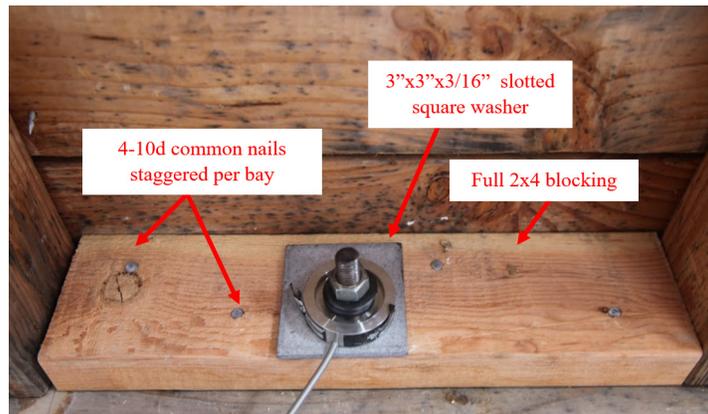
**Figure 2.18 Specimen A-19 anchor bolt retrofit: (a) framing face corner retrofit detail; (b) view of stud bay; and (c) view of added 4 × 4 stud attachment.**

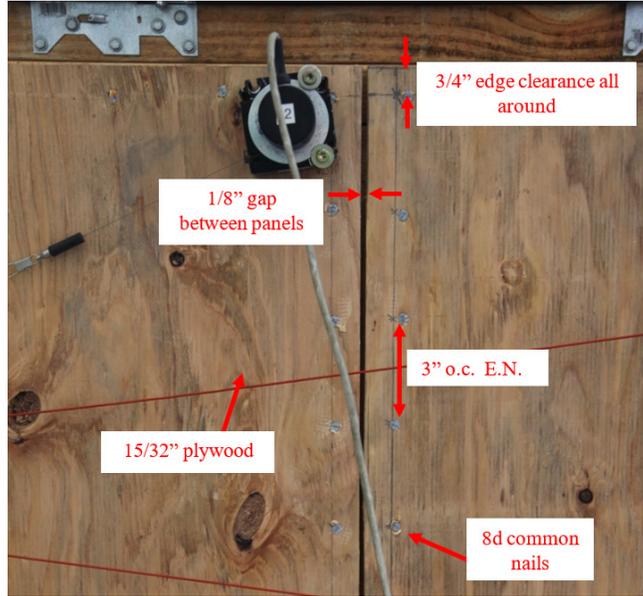
**Figure 2.19 Specimen A-19 retrofit plywood sheathing.**

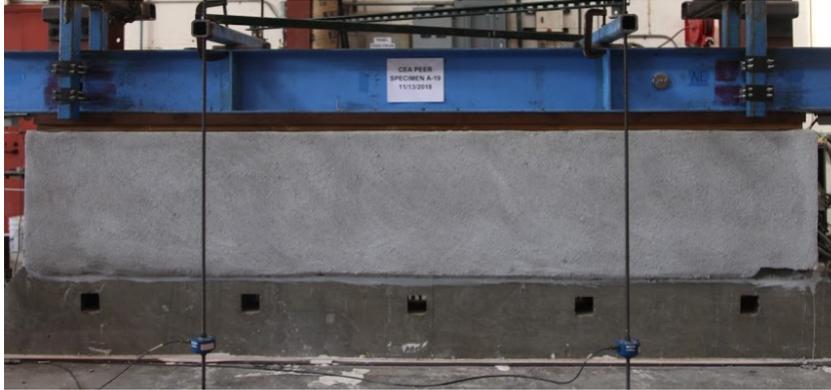
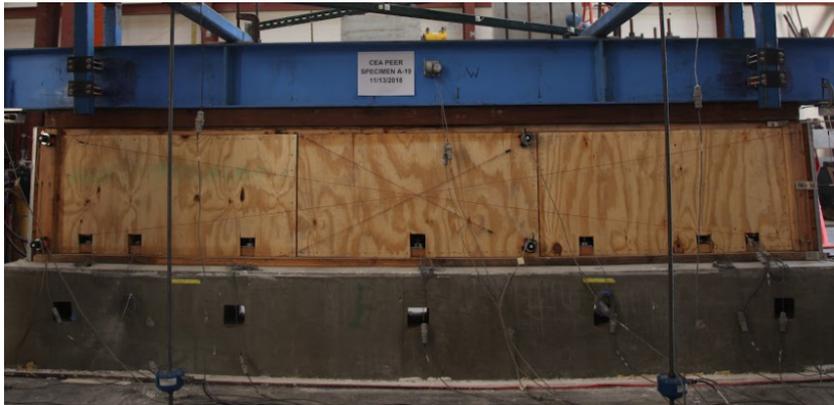
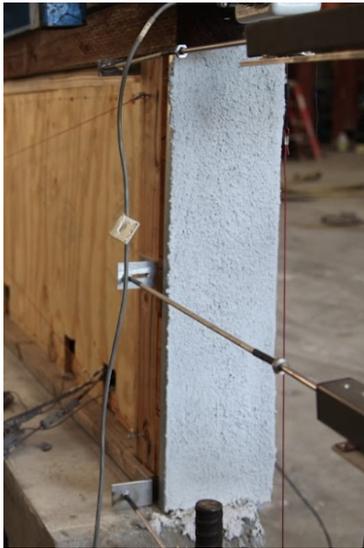
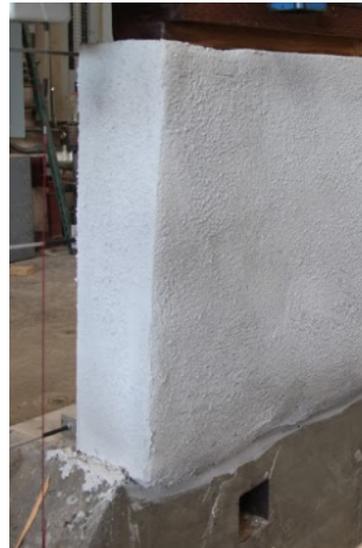
**Figure 2.20** Retrofitted Specimen A-19 pre-test photographs with top boundary condition B and bottom boundary condition c: (a) exterior elevation; (b) interior elevation; (c) south exterior corner; and (d) south interior corner.

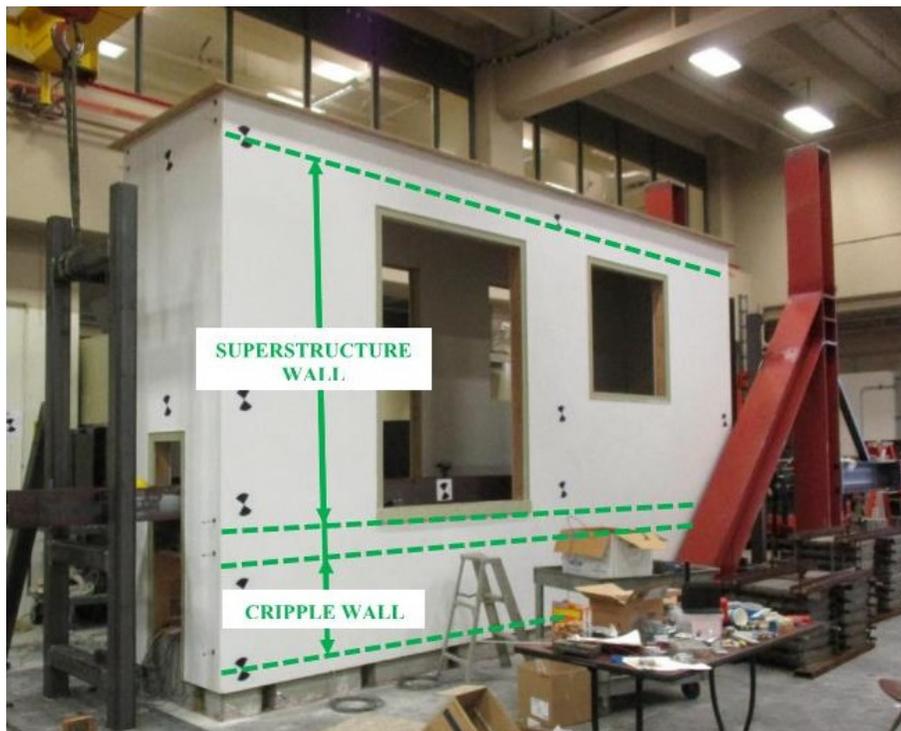
Figure 2.21 Overview of large-component Specimen AL-1.

a floor diaphragm, an 8-ft-tall superstructure, and a roof diaphragm. Figure 2.22 shows Specimen AL-1; the configuration for Specimen AL-2 was identical except that the cripple wall was retrofitted according to the *FEMA-1100* guidelines. Loading was applied parallel to the 20-ft-long walls.

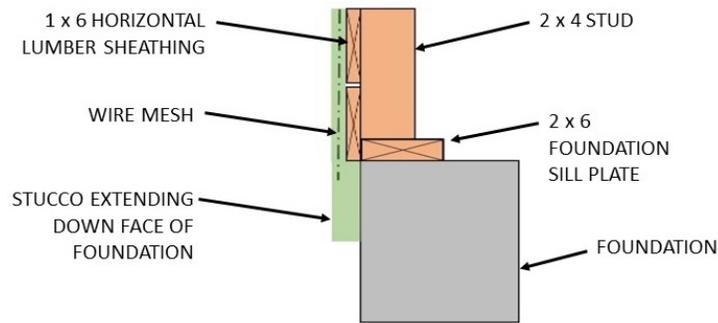
**Figure 2.22 Bottom of stucco detail for Specimens AL-1 and AL-2.**

This configuration allowed continuity of the stucco exterior finish around the corners, continuity of the stucco from the cripple wall into the superstructure above, and continuity of the stucco down the face of the foundation (a common detail in older stucco clad houses). Figure 2.9 illustrates extension of the stucco down the face of the foundation, which matches bottom boundary condition d from the small-component testing. The stucco used was representative of 1940s-era construction, including the application of three coats of stucco over a 1-1/2-in. 17-gauge wire mesh fastened with #11  $\times$  1-1/2-in. furring nails with 1/4-in. wads. Like the small-component specimens, the stucco in Specimens AL-1 and AL-2 was applied over 1  $\times$  6 horizontal lumber sheathing. The interior of the superstructure for both large-component specimens was finished with 1/2-in. gypsum wallboard.

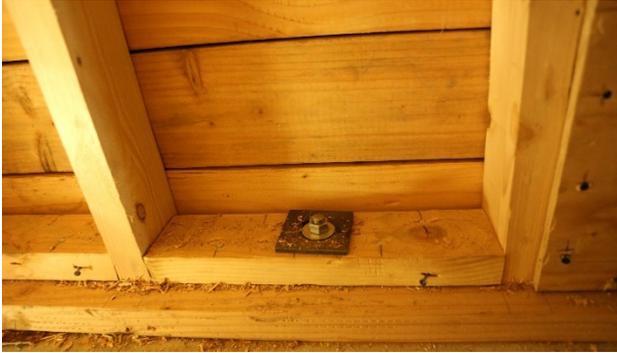
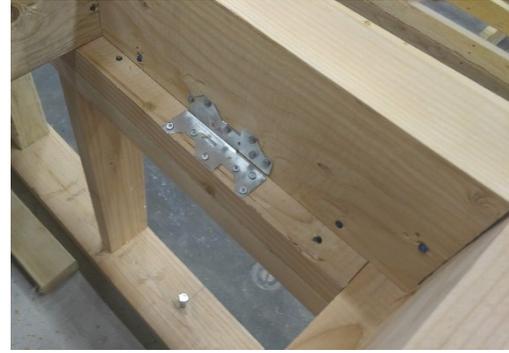
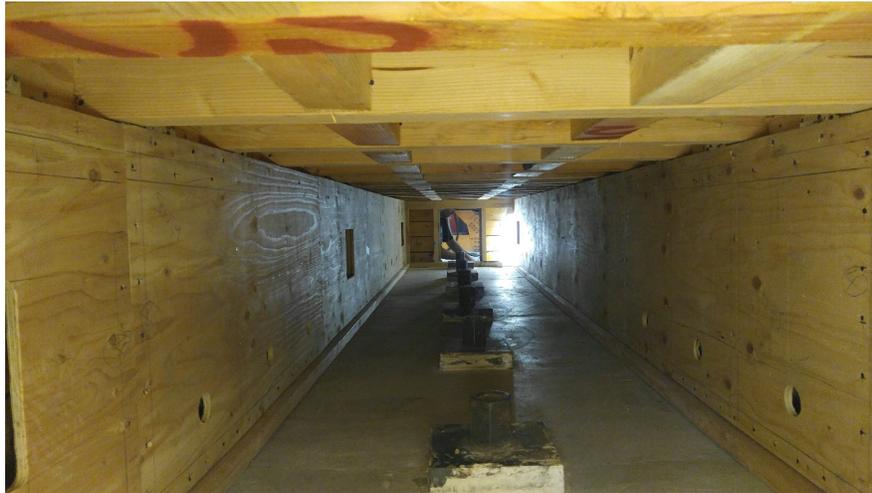
**Figure 2.23** Overview of large-component seismic retrofit elements: (a) view of stud bay with retrofit anchor bolt and steel plate washer (Specimen AL-2); (b) view of A-35 clip at cripple wall top plate; and (c) view of crawlspace and retrofit plywood.

Large-component Specimen AL-2 was intended to represent an existing 1940s-era house with seismic retrofit of the cripple walls and anchorage. The retrofit was designed in accordance with the prescriptive vulnerability-based provisions of *FEMA P-1100*, Volume 1 [FEMA 2018]. The retrofit included increasing the number of anchor bolts from four to ten on each 20-ft wall. The ten anchor bolts include eight that are intended to provide shear and an additional anchor bolt at each end of each wall, intended to provide supplemental uplift capacity. The retrofit also included 19 ft of 15/32-in. plywood sheathing applied on the interior face (crawl space face) of each 20-ft wall, nailed with 8-penny common nails at 3 in. on center. Finally, the retrofit included fourteen A-35 shear clips on each wall, providing shear transfer between the cripple wall top plates and the floor diaphragm above. The retrofit was installed in accordance with *FEMA P-1100*. Figure 2.23 shows the installed retrofit elements.

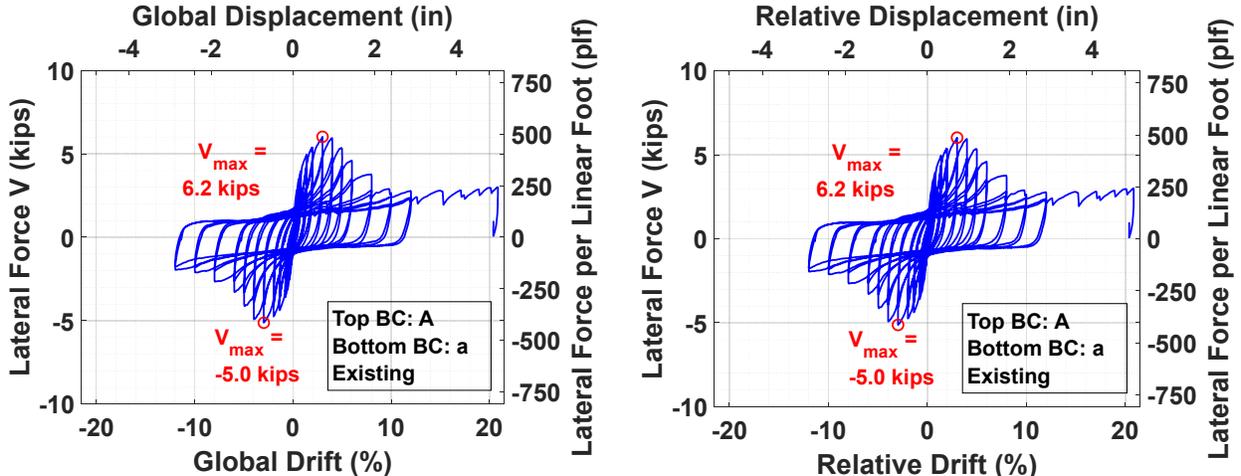
Figure 3.1 Specimen A-1 load-displacement plots showing global drift (left) and relative drift (right).

The load-deflection response of the small-component tests is provided in Figures 3.1 through 3.7. Figures 3.1 through 3.5 illustrate the response of unretrofitted small-component test specimens. Figures 3.6 and 3.7 illustrate the response of retrofitted small-component test specimens.

The load-deflection responses of the five unretrofitted specimens varied considerably and provide a large range in expected performance of the stucco over horizontal sheathing finish. Specimen A-1 had the lowest lateral strength in push directions of loading of the five specimens considered. This cripple wall contained no stucco return around the corners; this stucco return was shown to have a large effect on the strength capacity of the cripple wall. The cripple wall that best matched the boundary conditions of Specimen AL-1 was Specimen A-20. With both specimens, all finish materials (stucco and horizontal lumber sheathing) were orientated outboard of the foundation and were able to freely rotate as the specimen displaced. The lateral strength of Specimen A-20 was 22% higher than Specimen A-1. The lateral strength of A-20 was 22% less than that of Specimen A-2. Specimens A-1, A-2, and A-3 all orientated the stucco outboard of the foundation, with the sheathing bearing on the top of the foundation. Of the unretrofitted specimens, A-4 had the largest lateral strength. The lateral strength of Specimen A-4 was 57% higher than Specimen A-20. With Specimen A-4, all of the finish materials were bearing on the foundation.

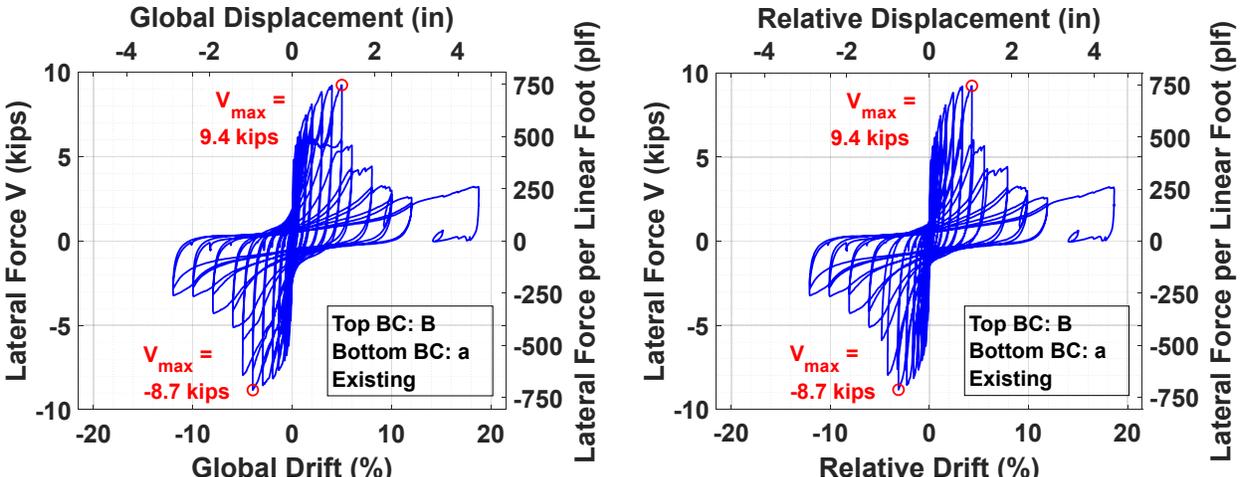
Figure 3.2 Specimen A-2 load-displacement plots showing global drift (left) and relative drift (right).

The orientation of the finish materials relative to the foundation significantly affected the lateral strength of the specimens. By inhibiting the in-plane rotation of the finish materials due to the bearing of the materials on the foundation, the cripple walls gained strength. In addition, the drift capacity of the specimens was also significantly affected by the orientation of the finish materials. The drift capacity increased when more materials were bearing on the foundation. This is due to the imposed displacement being taken on by the sheathing fasteners more than the stucco furring nails. After reaching strength, the specimens with the stucco outboard of the foundation had large drops in strength in subsequent drift cycles; see Figure 3.2, 3.3, and 3.5.

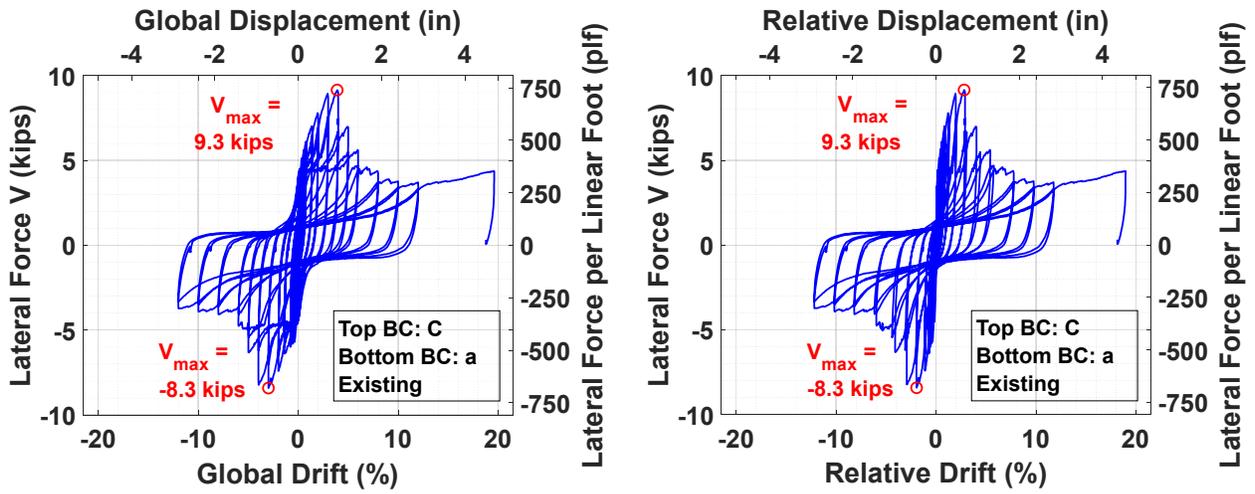
Figure 3.3 Specimen A-3 load-displacement plots showing global drift (left) and relative drift (right).

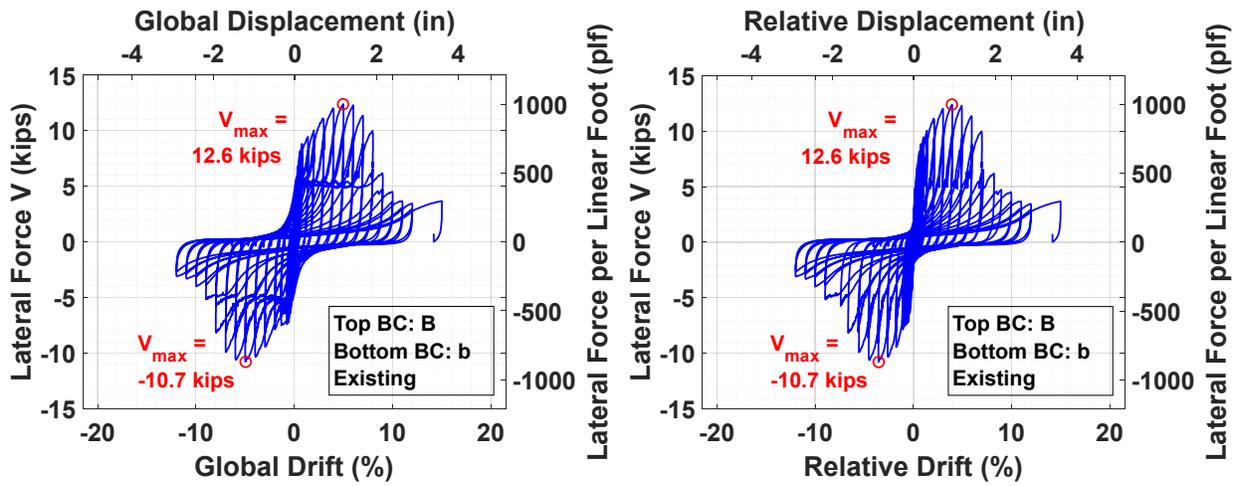
Figure 3.4 Specimen A-4 load-displacement plots showing global drift (left) and relative drift (right).
