# PACIFIC EARTHQUAKE ENGINEERING RESEARCH CENTER

## **Comparison of the Response of Small- and Large-Component Cripple Wall Specimens Tested under Simulated Seismic Loading**

**A Report for the “Quantifying the Performance of  
Retrofit of Cripple Walls and Sill Anchorage in Single-  
Family Wood-Frame Buildings” Project**

PEER Report 2020/21

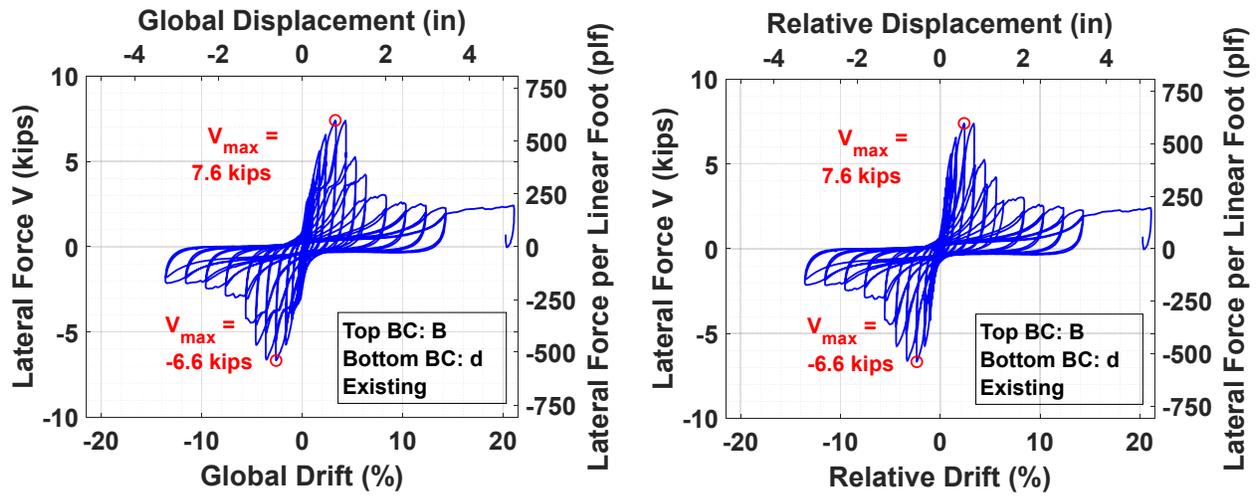
Figure 3.5 Specimen A-20 load-displacement plots showing global drift (left) and relative drift (right).

The orientation of the finish materials relative to the foundation significantly affected the lateral strength of the specimens. By inhibiting the in-plane rotation of the finish materials due to the bearing of the materials on the foundation, the cripple walls gained strength. In addition, the drift capacity of the specimens was also significantly affected by the orientation of the finish materials. The drift capacity increased when more materials were bearing on the foundation. This is due to the imposed displacement being taken on by the sheathing fasteners more than the stucco furring nails. After reaching strength, the specimens with the stucco outboard of the foundation had large drops in strength in subsequent drift cycles; see Figure 3.2, 3.3, and 3.5.

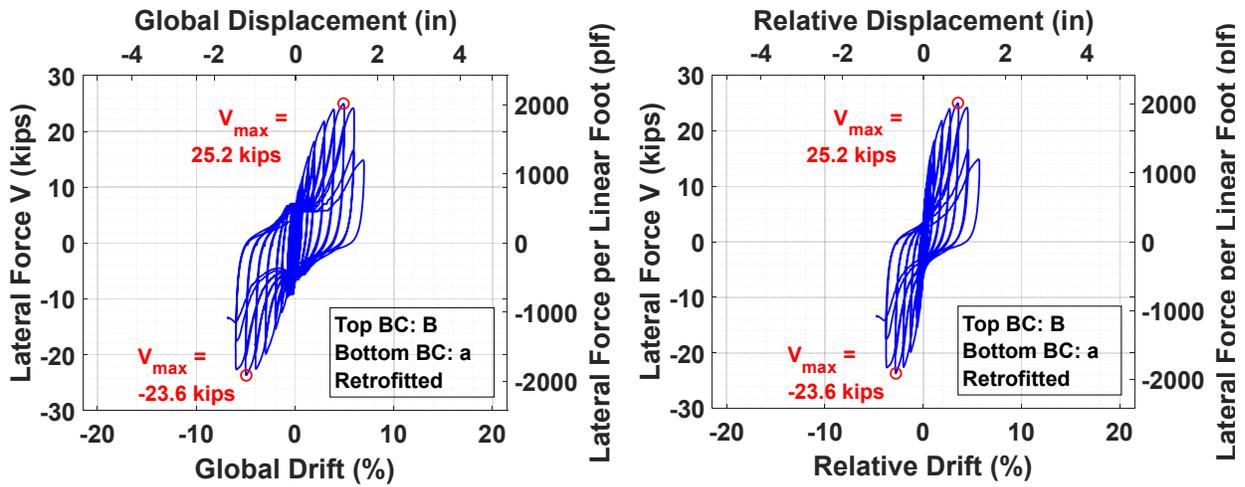
Figure 3.6 Specimen A-5 load-displacement plots showing global drift (left) and relative drift (right).

The most dramatic differences between the global and relative drifts can be seen in Figures 3.6 and 3.7 for retrofitted Specimens A-5 and A-19. In both cases, about one-third of the displacement at peak capacity came from slip observed at the interface between the foundation sill plate and the foundation. Further discussion of this can be found in Chapter 4.

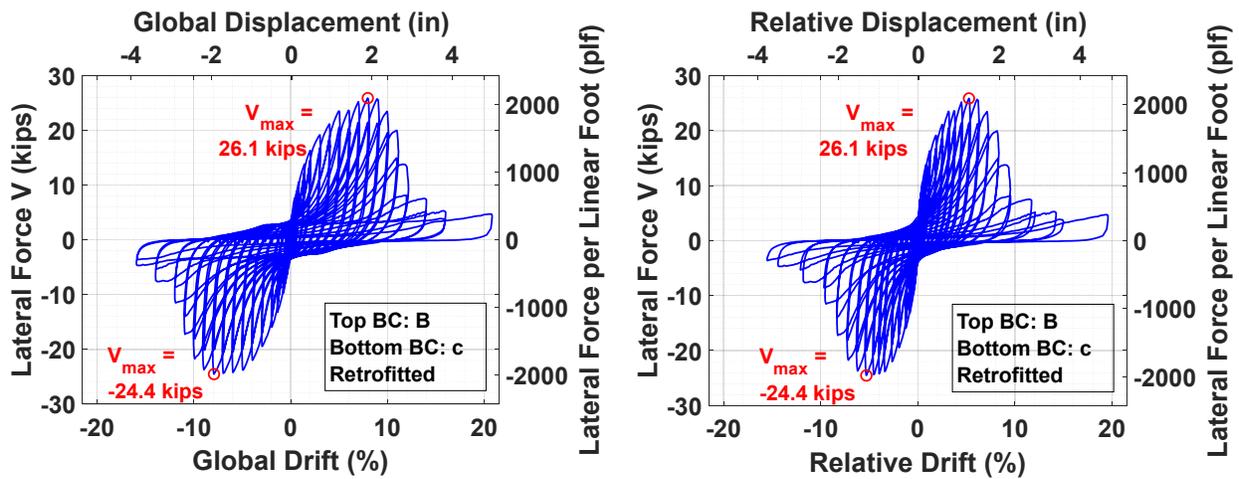
Figure 3.7 Specimen A-19 load-displacement plots showing global drift (left) and relative drift (right).

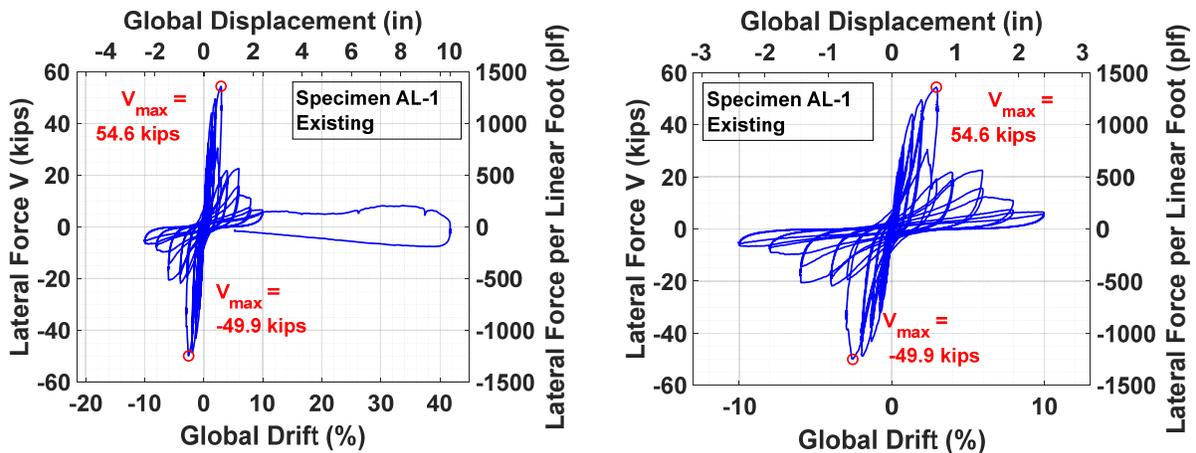
Figure 3.8 Specimen AL-1 hysteresis curves.

The load-deflection behavior of the large-component tests is provided in Figures 3.8 and 3.9. Two plots are provided for each specimen. One includes both the hysteresis loops and the end monotonic push. The second provides an enlarged view of the hysteresis loops. Because no measurable slip occurred between the foundation sill plate and the foundation in the large-component tests, the global and relative drift do not need to be differentiated.

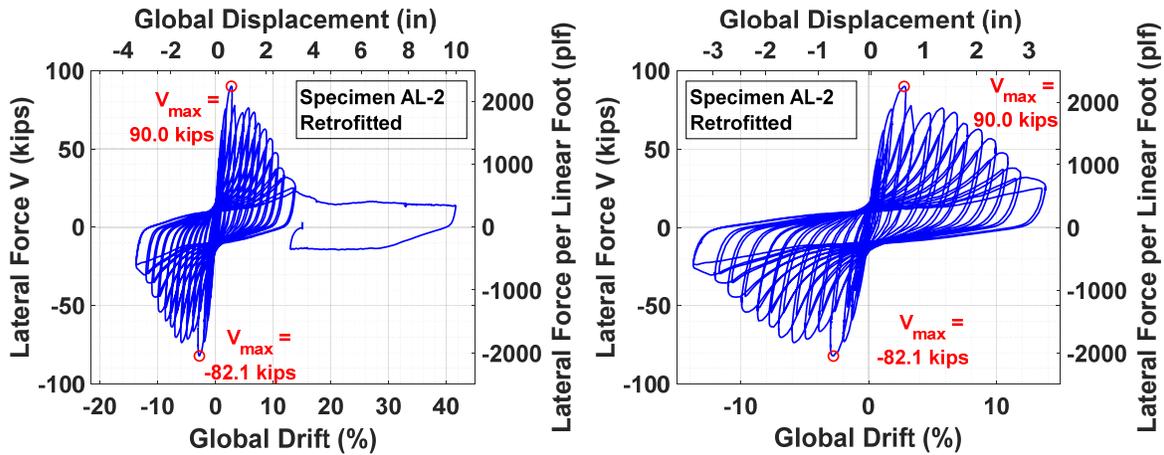
Figure 3.9 Specimen AL-2 hysteresis curves.

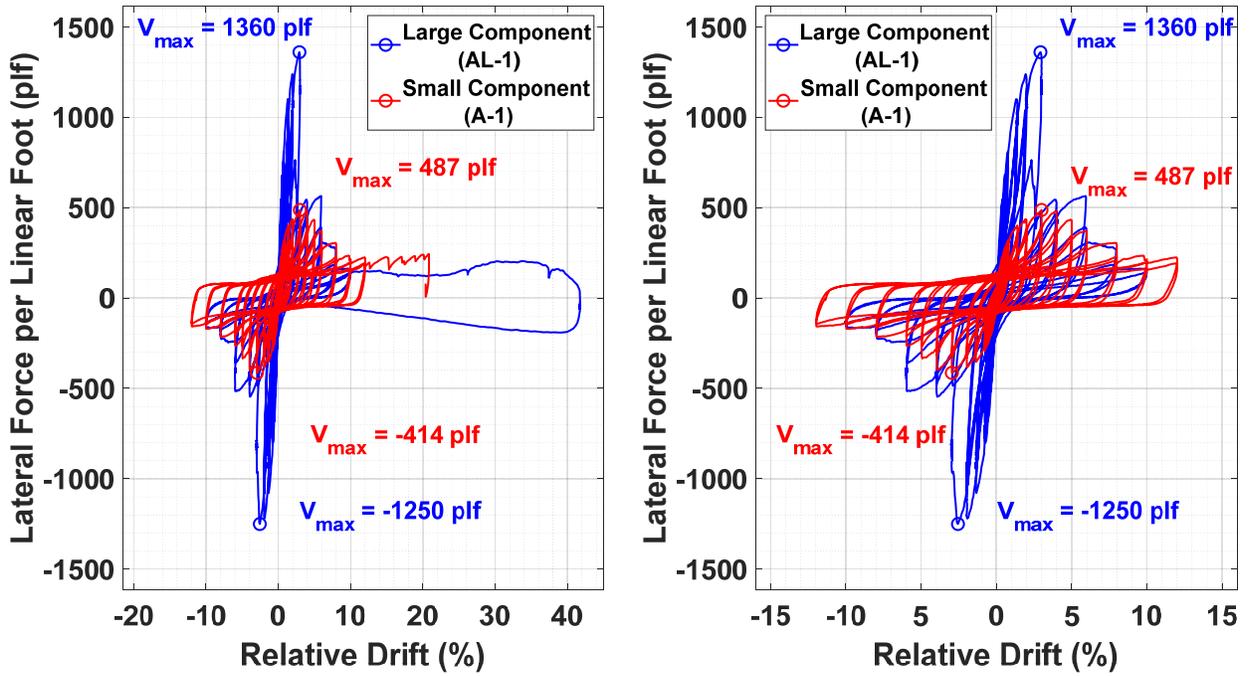
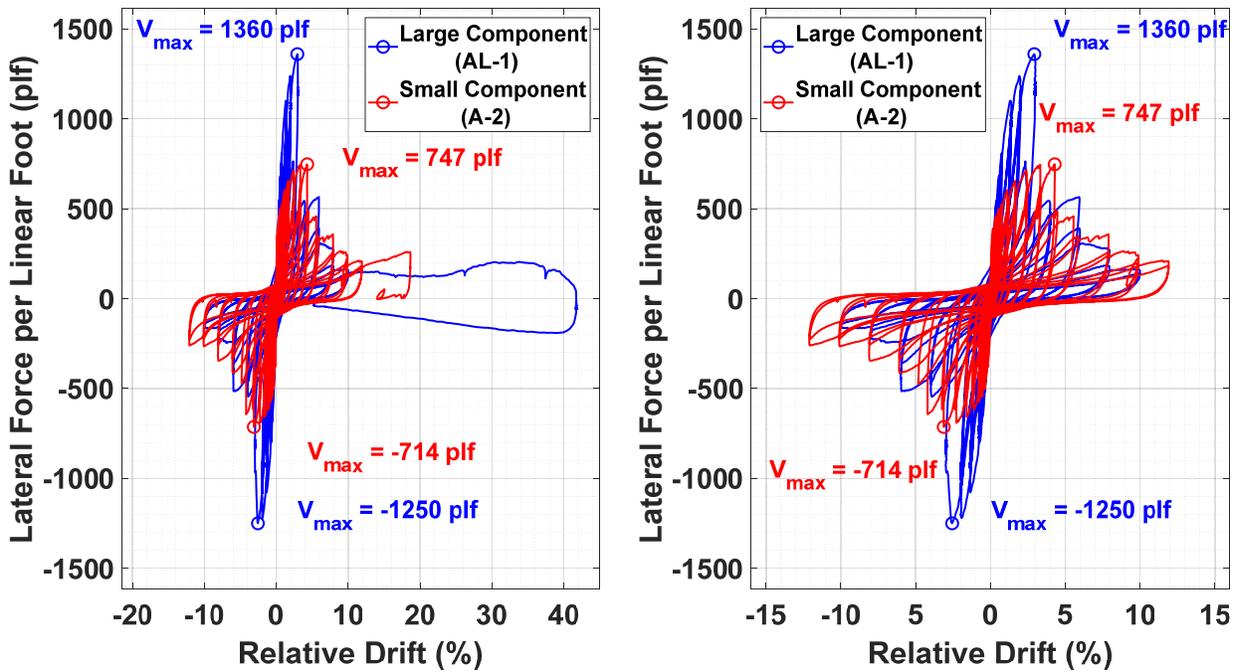
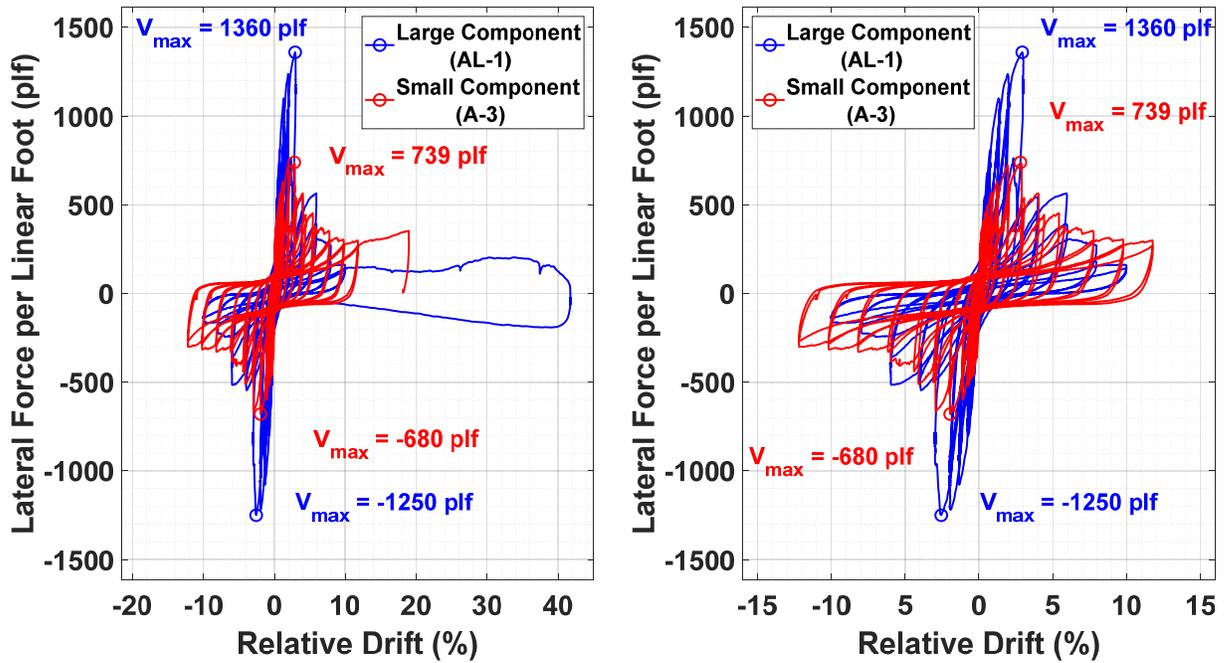
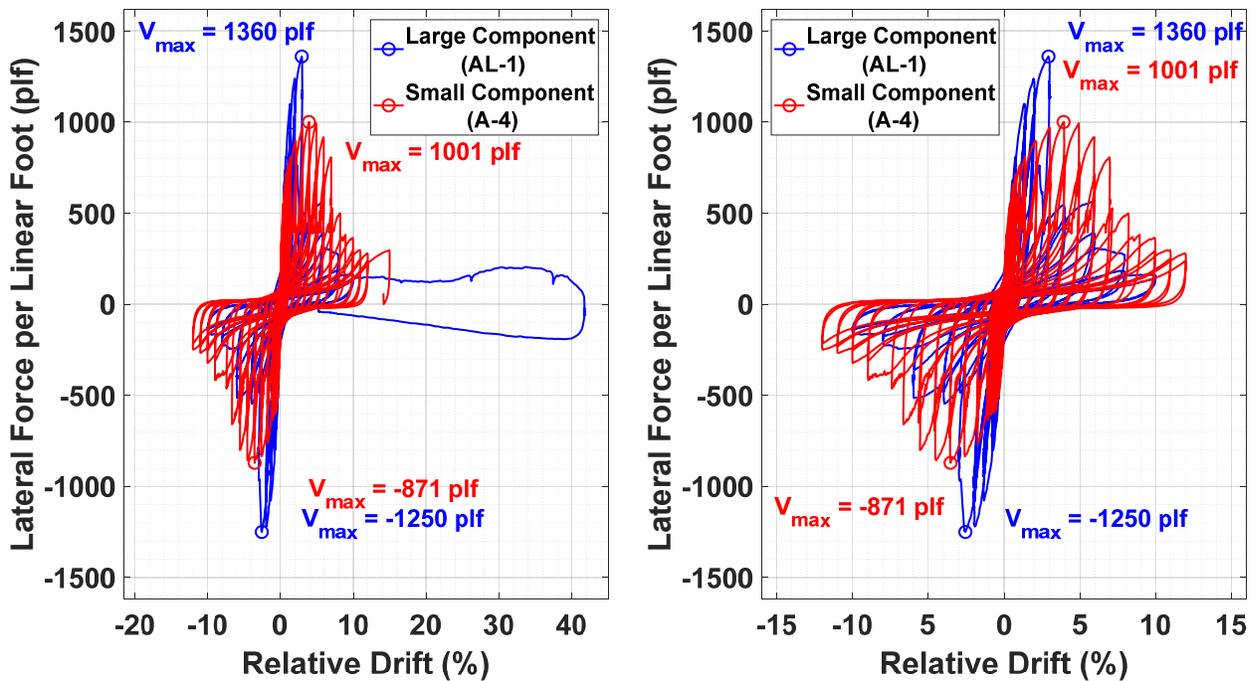
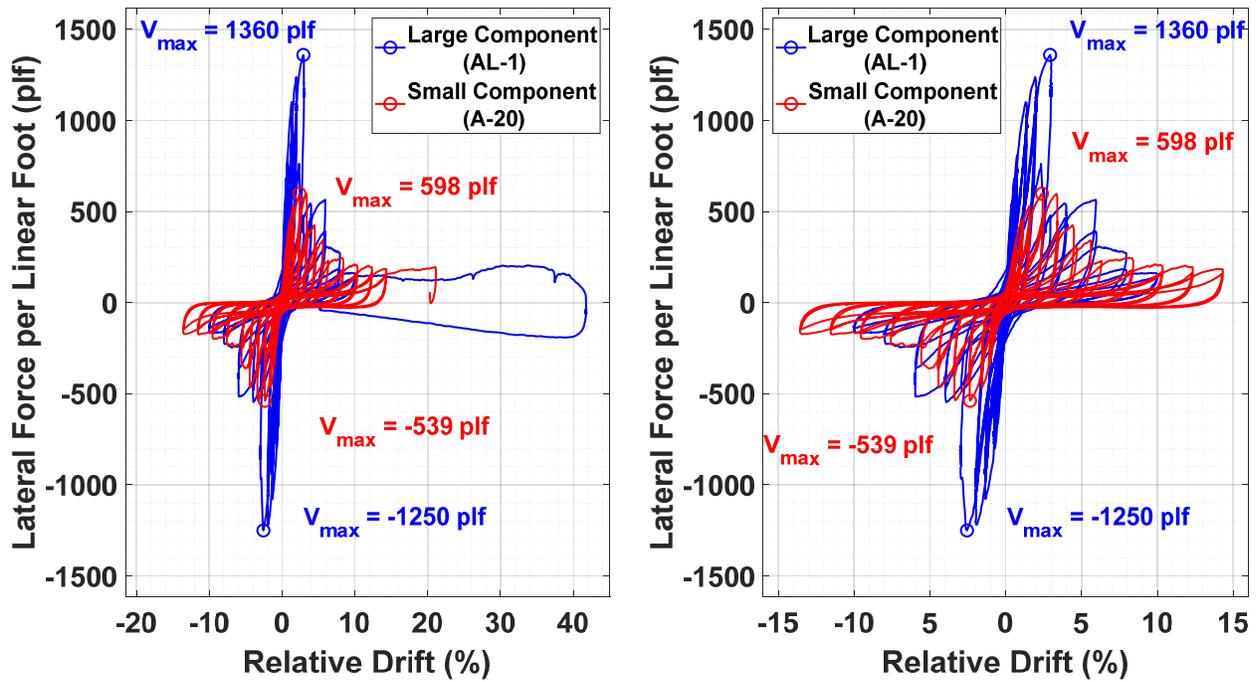
Figure 3.10 Comparison of lateral force versus *relative drift* for large-component Specimen AL-1 and small-component Specimen A-1.

Figure 3.11 Comparison of lateral force versus *relative drift* for large-component Specimen AL-1 and small-component Specimen A-2.

Figure 3.12 Comparison of lateral force versus *relative drift* for large-component Specimen AL-1 and small-component Specimen A-3.

Figure 3.13 Comparison of lateral force versus *relative drift* for large-component Specimen AL-1 and small-component Specimen A-4.

Figure 3.14 Comparison of lateral force versus *relative drift* for large-component Specimen AL-1 and small-component Specimen A-20.

The comparison of response of the small- and large-component test specimens can best be seen with overlays of the load-deflection plots. Figures 3.10 through 3.14 show the overlays of small-component Specimens A-1 through A-4 and A-20 relative to large-component specimen Specimen AL-1. These are shown only for the relative displacement (as discussed in Section 3.1) because this most directly reflects the displacement demands imposed on the cripple wall itself. The overlaid hysteresis plots are shown with the monotonic push included and the monotonic push excluded to allow comparison of the cyclic loading portion of the response.

For Specimens A-1, A-2, A-3 and A-20, the character of the post-peak response is generally similar to Specimen AL-1, even though there is significant variation in the peak capacity. For Specimen A-4, the character of the load-deflection response is markedly different and more in line with the response of the retrofitted specimens. The drop in capacity over many loading cycles tended to be more limited. This will be discussed below.

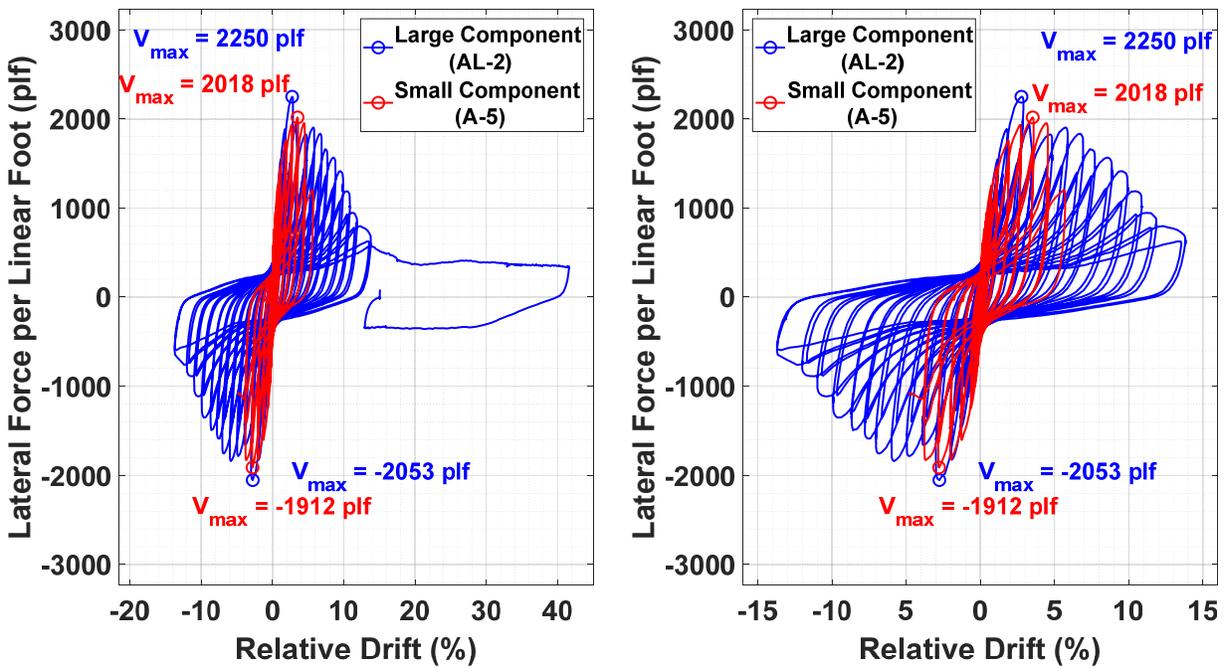
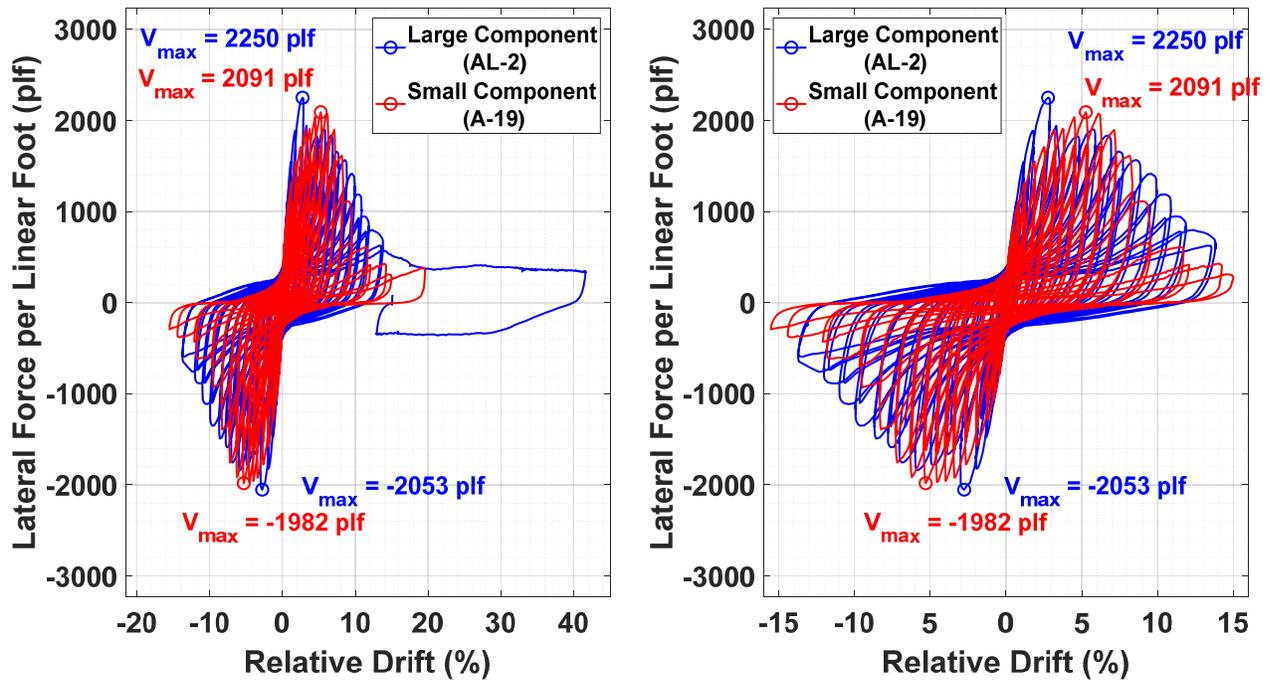
Figure 3.15 Comparison of lateral force versus *relative drift* for large-component Specimen AL-2 and small-component Specimen A-5.

Figure 3.16 Comparison of lateral force versus *relative* drift for large-component Specimen AL-2 and small-component Specimen A-19.

Figures 3.15 and 3.16 show the overlays of small-component Specimens A-5 and A-19 relative to large-component Specimen AL-2. These are shown only for the relative displacement (as discussed in Section 3.1) because this most directly reflects the displacement demands imposed on the cripple wall itself. The overlaid hysteresis plots are shown with the monotonic push included and the monotonic push excluded to allow comparison of the cyclic loading portion of the response. Both Specimens A-5 and A-19 provide a good match to the lateral strength of Specimen AL-2, although the displacements at lateral strength vary. For Specimen A-5, a significant drop in lateral strength occurred just after reaching peak capacity, after which testing stopped. Both Specimens A-19 and AL-2 had a very slow drop in post-peak lateral strength, allowing the testing to extend to very large drift ratios.

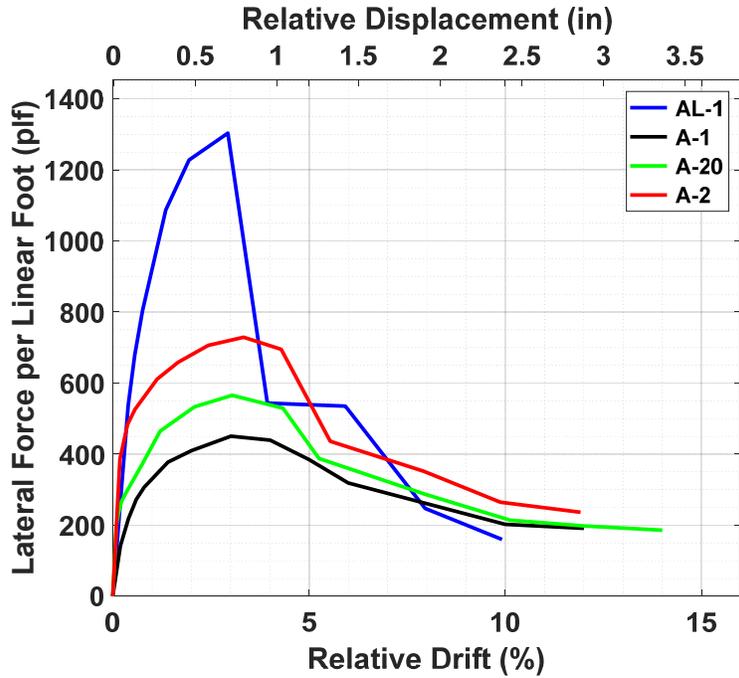
Figure 3.17 Envelope of lateral force–*relative* lateral displacement hysteresis for existing specimens. (average of push and pull directions presented)

The overlaying of envelope curves provides a convenient way to compare the post-peak behavior of multiple test specimens. Figure 3.17 compiles envelope curves for unretrofitted test specimens. To allow direct comparison, the force axis reflects unit loads in pounds per linear foot of cripple wall. This is accomplished by dividing the small-component forces by 12 ft, and the large-component forces by 40 ft. The figures use the relative displacement, rather than global displacement, and drift ratios from the UC San Diego tests, since sliding of the small-component specimens was appreciable for certain specimens.

As shown in Figure 3.17, Specimens A-2, A-20, and AL-1 experienced a notable post-peak drop in lateral force. In contrast, Specimen A-1 had a lower lateral strength but did not exhibit the same type of post-peak drop in lateral force. While the lateral strengths varied widely, the general character of the post-peak lateral force for 6% drift (1.5 in.) and higher is relatively similar. All specimens retained 15–20% of lateral strength to drift ratios of between 20 and 40% in the final monotonic pushes. The slope of the post-peak drop in lateral force is one of the important parameters in numerical modeling. For the group of curves shown in Figure 3.17, Specimen AL-1 is noted to have both a more significant drop immediately post-lateral strength and a more rapid drop in post-peak capacity.

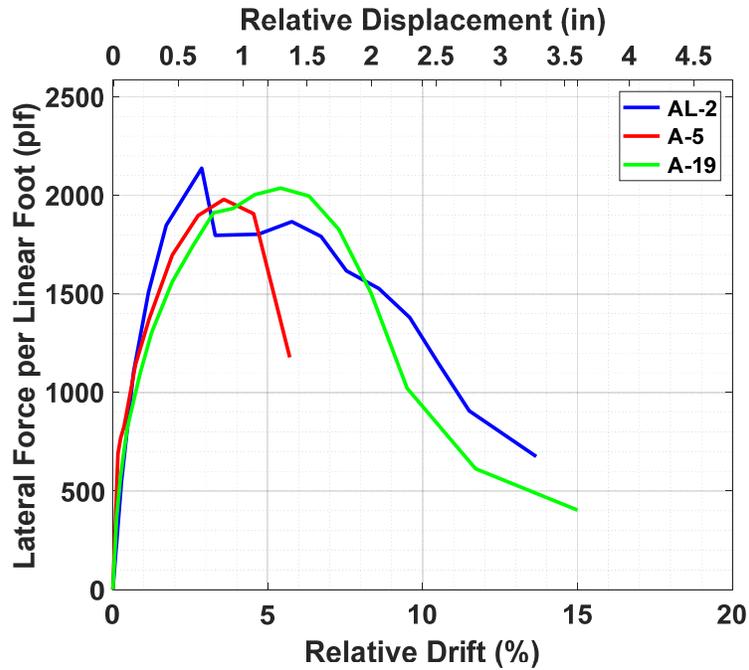
Figure 3.18 Envelope of lateral force–*relative* lateral displacement hysteresis for retrofitted specimens. (average of push and pull directions presented)

Figure 3.18 compiles envelope curves for test specimens with retrofit, again reflecting unit loads in pounds per linear foot of cripple wall. This figure shows that although the three specimens have very similar lateral strengths, the lateral strengths occur at widely varying drift ratios. While Specimen AL-2 experienced a limited drop in lateral force following lateral strength, Specimens A-5 and A-19 did not experience this drop. The overall character of the envelope curves following lateral strength are also widely varying, with Specimen A-5 showing a rapid drop-off, Specimen A-19 showing a more moderate drop-off, and Specimen AL-2 showing the most moderate drop-off. The variability of drift ratios at peak capacity and rates of drop-off shown for these three specimens create challenges for numerical modeling studies.

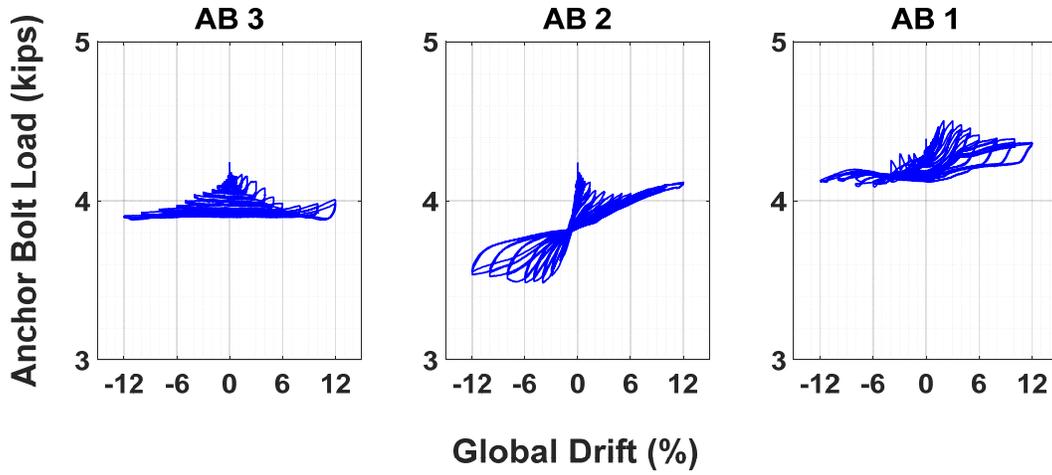
Figure 4.1

Specimen A-1 anchor bolt loads.

Anchor bolt uplift forces were measured in all of the test specimens. Anchor bolt forces for the unretrofitted small-component specimens are shown in Figures 4.1 through 4.5. Anchor bolt forces for unretrofitted large-component Specimen AL-1 are shown in Figure 4.6. All of the anchor bolts were given a nominal level of preload prior to start of testing. The data in Figures 4.1 through 4.6 reflects the change in anchor bolt tension force over the duration of testing. For simplicity, the discussion that follows refers to these as anchor bolt forces, but they are more precisely recognized as the *change* in anchor bolt forces. It should be noted that there was a range in initial tension for anchor bolts in the small-component tests. Specimens A-1 and A-4 had anchor bolts initially tensioned between 4000 and 5000 lbs. The anchor bolts for Specimens A-2 and A-3 were initially tensioned around 1000 lbs. For all other small- and large-component tests, the anchor bolts were tensioned to around 200 pounds prior to testing.

Among the group of unretrofitted specimens, Specimen A-4 had by far the highest anchor bolt tension forces, with an estimated maximum of 9850 lbs. This anchor bolt force suggests that the mechanisms occurring in the anchorage for this particular specimen are very different compared to the other test specimens. All of the finish materials in Specimen A-4 were seated on the foundation, thus restricting movement due to the bearing of the finish materials. When the cripple wall displaced, the finish materials could only uplift when they rotated. In effect, this produced large increases in the anchor bolt loads throughout the test. The tension in the outermost anchor bolts for Specimen A-4 increased as much as 5000 lbs, while all the other unretrofitted small-component specimens experienced increases less than 1000 lbs. It should be noted that Specimen A-4 was the strongest of the unretrofitted small-component specimens tested, and the tension developed in the anchor bolts increased with increasing specimen strength. The weakest cripple wall tested, Specimen A-1, only experienced a 100 lbs increase in anchor bolt tension throughout the entire test.

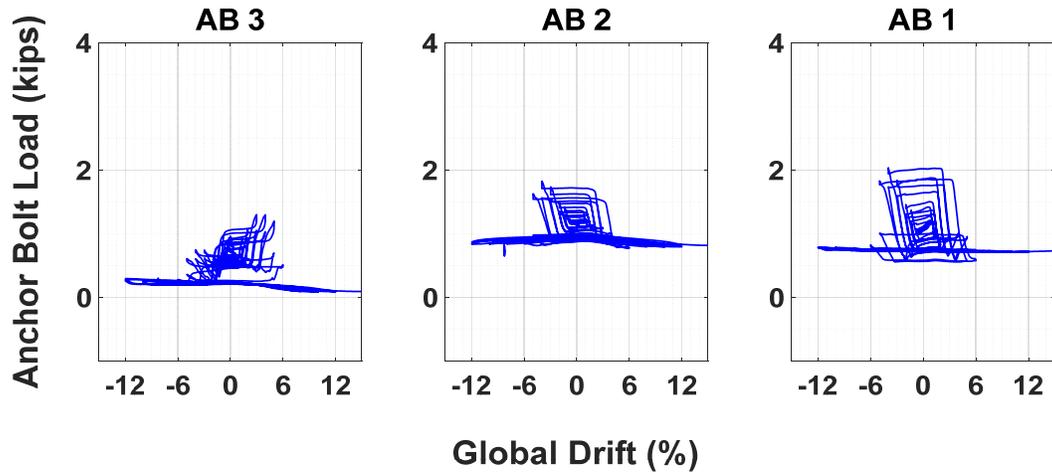
Figure 4.2

Specimen A-2 anchor bolt loads.

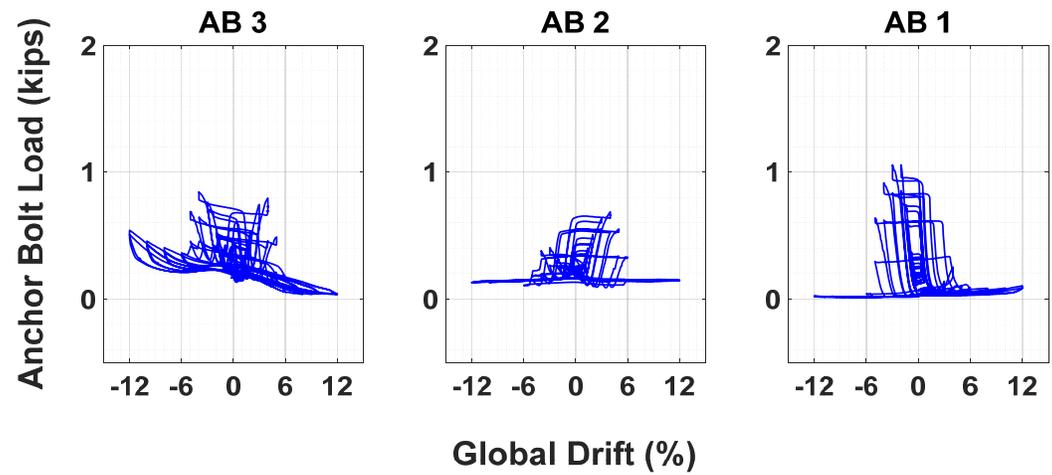
Figure 4.3

Specimen A-3 anchor bolt loads.

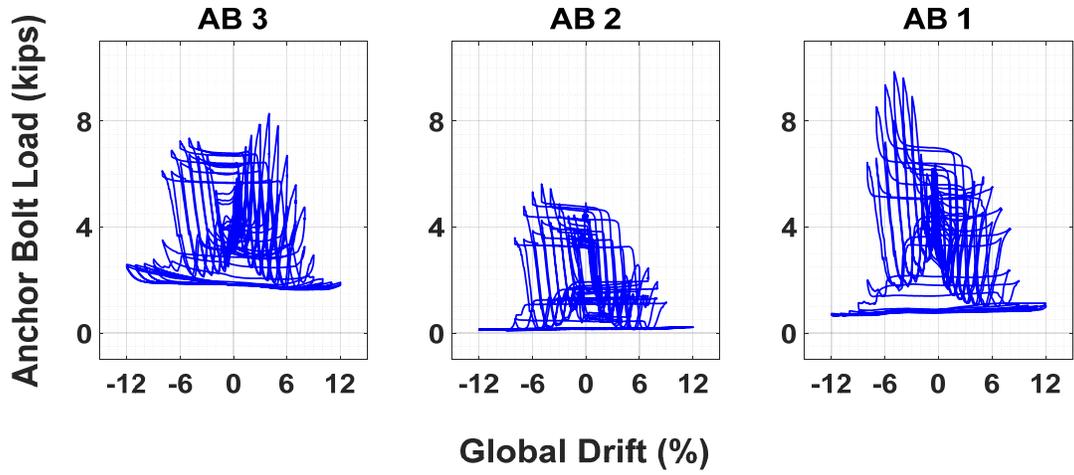
Figure 4.4 Specimen A-4 anchor bolt loads.

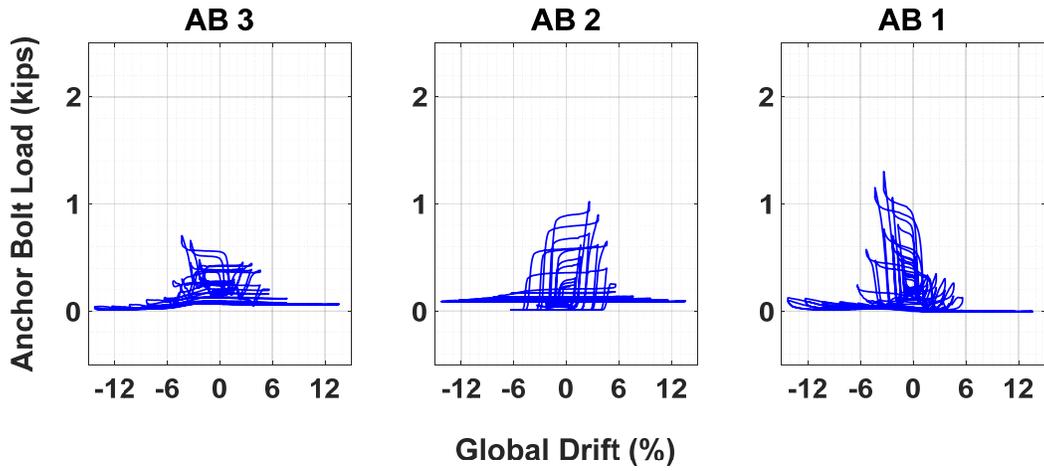
Figure 4.5 Specimen A-20 anchor bolt loads.

The maximum increases in anchor bolt forces for the balance of the small-component test specimens ranged between 500 and 1100 lbs. This can be compared to the unretrofitted large-component test specimen, which had a maximum anchor bolt tension force of approximately 400 lbs. A comparison between Specimen A-20 and the other unretrofitted small-component tests (with the exception of Specimen A-4) showed that the sheathing bearing on the foundation or outboard of the foundation had little affect on the tension developed in the anchor bolts. With the exception of Specimen A-4, all of the anchor bolt changes in force can be categorized as low to moderate. In general, the small-component specimen maximum anchor bolt forces are larger than they are for the large-component specimen.

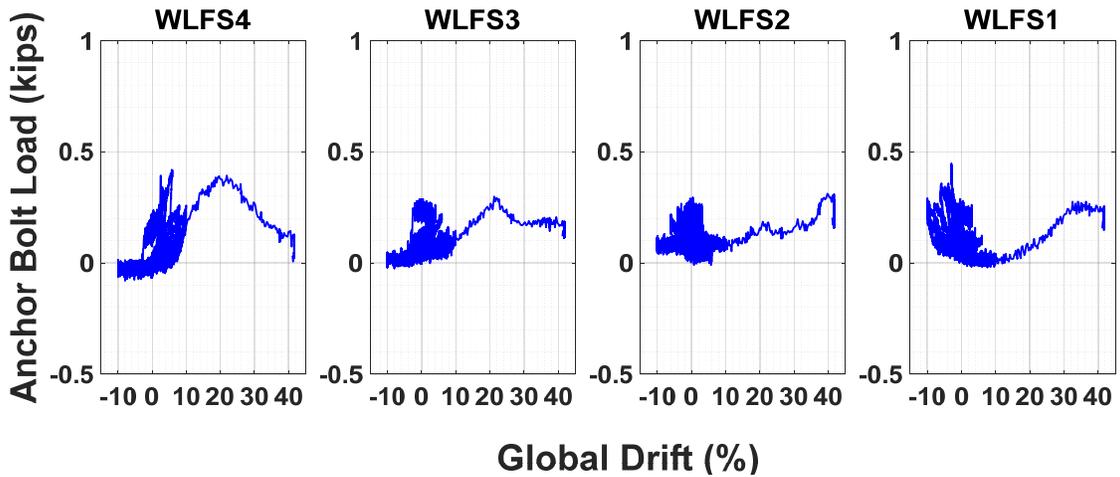
Figure 4.6 Specimen AL-1 anchor bolt loads.

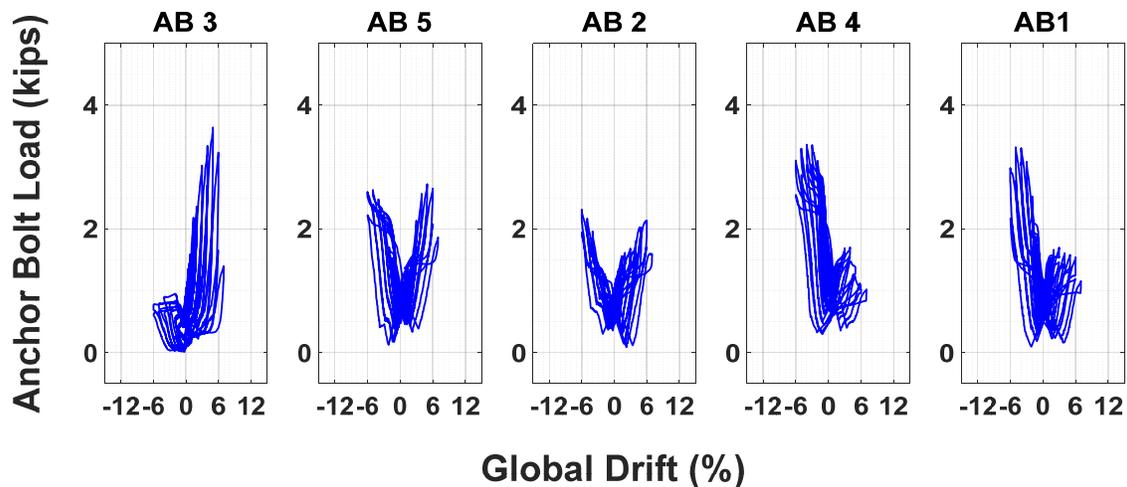
Figure 4.7 Specimen A-5 anchor bolt loads.

Anchor bolt forces for the retrofitted small-component specimens are shown in Figures 4.7 and 4.8. Anchor bolt forces for retrofitted large-component Specimen AL-2 are shown in Figure 4.9. Again, this data reflects the change in anchor bolt force over the duration of the test.

The retrofitted small-component test specimen maximum anchor bolt tension forces are estimated to be 3800 lbs for Specimen A-5 and 4600 lbs for Specimen A-19. This can be compared to the retrofitted large-component test specimen with a maximum anchor bolt tension force of approximately 1200 lbs. The range in maximum anchor bolt tension for the retrofitted small-component tests were similar to each other. Increases in anchor bolt tension ranged from 900 to 4400 lbs for both specimens. The small-component specimen maximum anchor bolt forces are again larger compared to the large-component specimen. The differences in anchor bolts tensions were partially due to the lower level of uplift restraint of the plywood on the small-component specimens. As the plywood uplifts, the uplift forces were transferred through the blocking into the sill plate, increasing the tension in the anchor bolts.

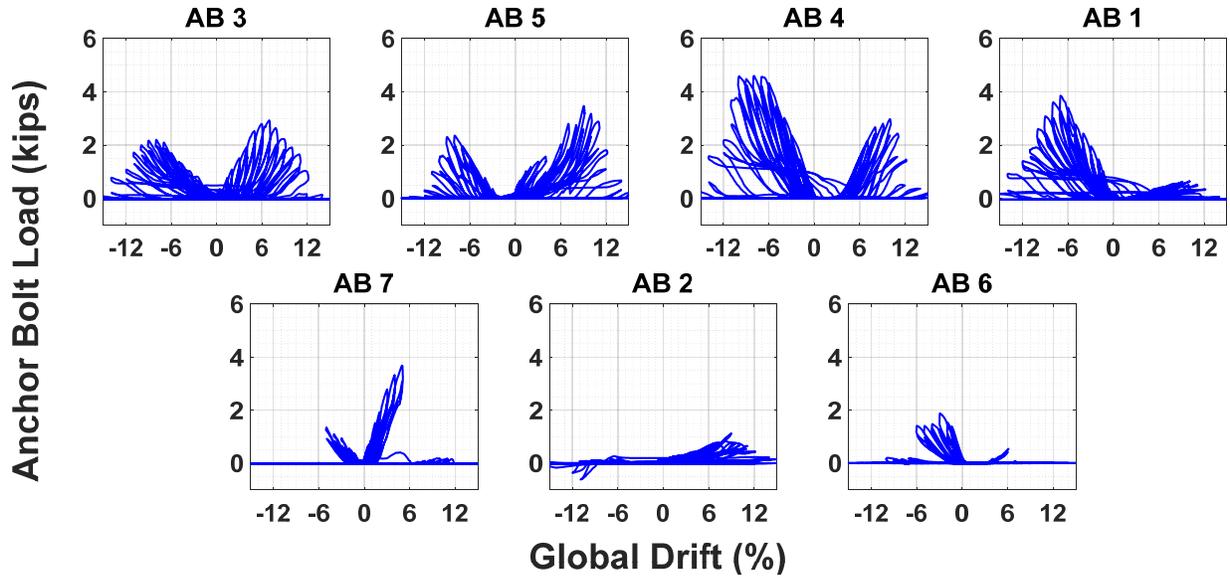
Figure 4.8 Specimen A-19 anchor bolt loads.

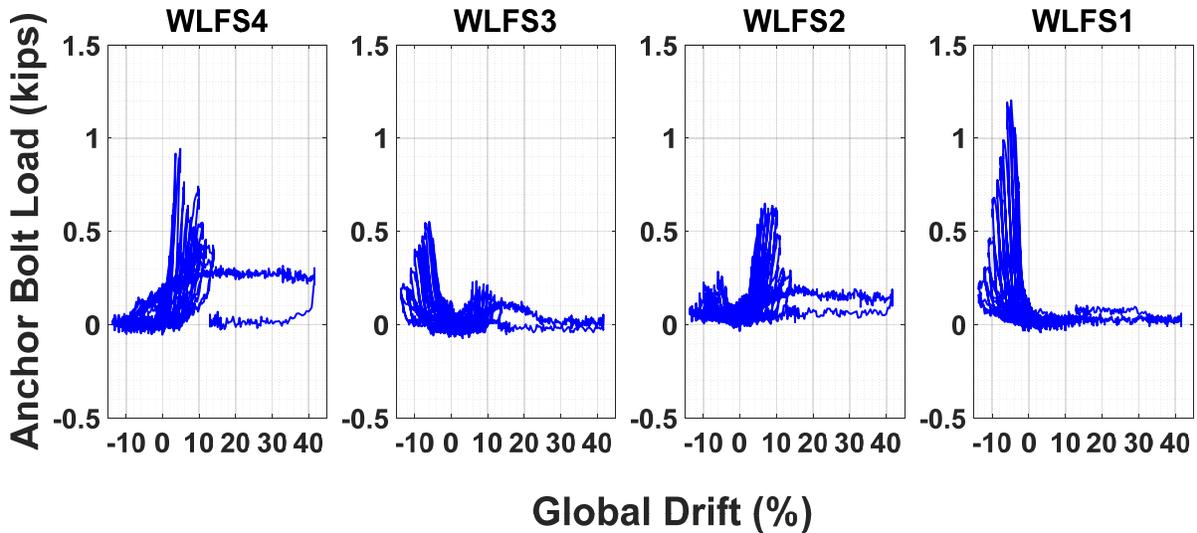
Figure 4.9 Specimen AL-2 anchor bolt loads.

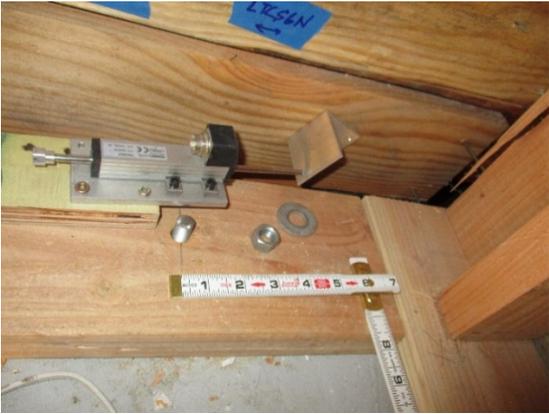
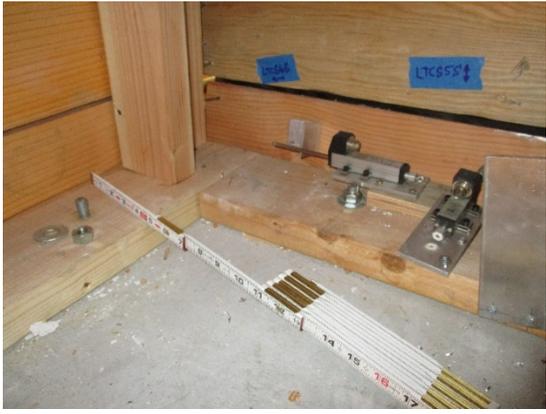
**Figure 4.10** Specimen AL-1 anchor bolts with nuts and washers removed following completion of testing.

As noted previously, there was negligible uplift between the foundation and foundation sill plate during the testing of unretrofitted large-component Specimen AL-1. There was a maximum horizontal slip between the foundation and foundation sill plate of 0.04 in. Following completion of testing, portions of the finish materials were selectively removed to allow detailed observations of the conditions underlying the materials and any hidden damage. Full details can be found in Appendix D of the large-component test report [Cobeen et al. 2020]. The nuts and cut washers were removed from a number of the anchor bolts to allow detailed observation of the anchor bolt and surrounding foundation sill plate. There was no apparent indication of slip, crushing of wood, or other similar behavior in any of the locations examined. The sill plate wood was observed to be slightly smoother under the cut washer, indicating very limited wood crushing. It is not clear if this is a result of the testing or the initial tensioning of the bolts; see Figure 4.10.

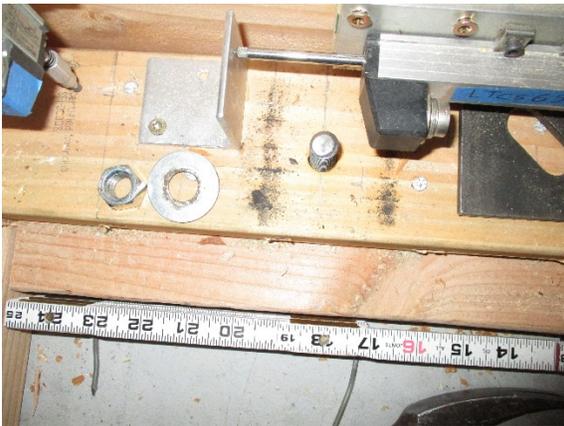
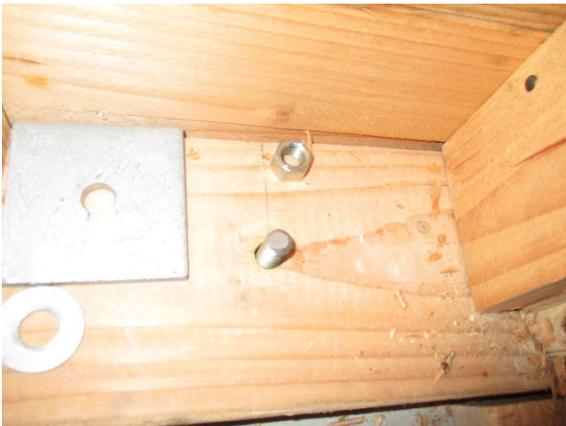
**Figure 4.11** Specimen AL-2 anchor bolts with nuts and washers removed following completion of testing.

During the testing of retrofitted large-component Specimen AL-2, as previously noted there was negligible uplift between the foundation and foundation sill plate, with a maximum horizontal slip between the foundation and foundation sill plate of 0.12 in. Following testing, the nuts and cut washers were removed from a number of the anchor bolts to allow detailed observation of the anchor bolt and the 2 × 4 blocks connected to the foundation sill plate and foundation using anchor bolts; see Figure 4.11. There was no apparent indication of slip, crushing of wood, or other similar behavior in any of the locations examined. The 2 × 4 blocking wood was again observed to be slightly smoother under the cut washer, indicating very limited wood crushing. Splitting of blocking at anchor bolts had been observed in the small-component testing, therefore significant

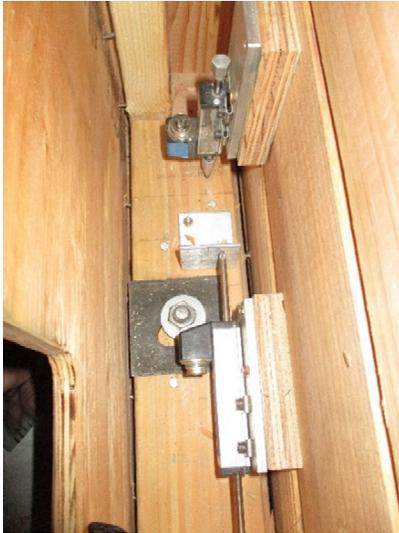
**Figure 4.12 Specimen AL-2 retrofit blocks at end of testing showing no signs of splitting.**

attention was paid to the condition of the blocking at anchor bolts in Specimen AL-2. Where access openings in the plywood sheathing permitted, photos were taken from above looking for splitting of the block that might fracture the top surface. No splitting was observed in the blocks that were accessible; see Figure 4.12.

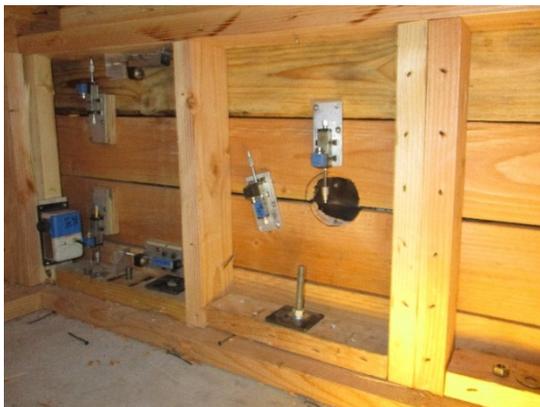
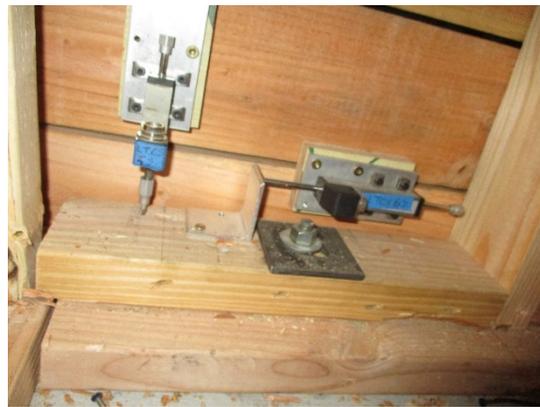
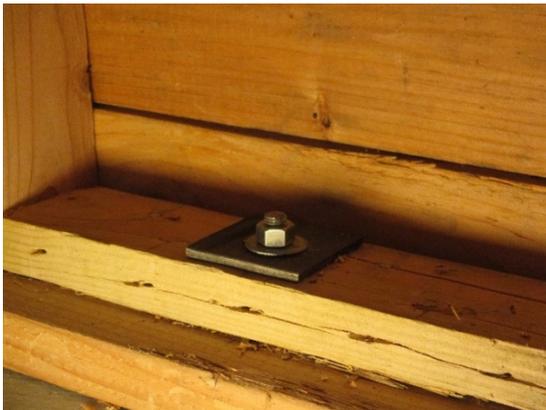
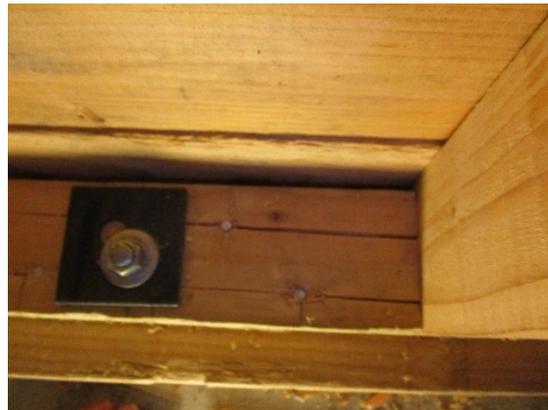
**Figure 4.13 Specimen AL-2 showing the only block that experienced splitting.**

Plywood cripple wall sheathing was removed in selected locations to allow for more complete access to observe splitting of the blocking. Figure 4.13(a) shows an overview of the framing with the plywood removed. Figure 4.13(b) shows a block with no splitting. Figure 4.13 (c) and (d) shows the one block in which splitting had occurred in both the vertical and the top faces of the block. This block was located near the middle of the north wall.

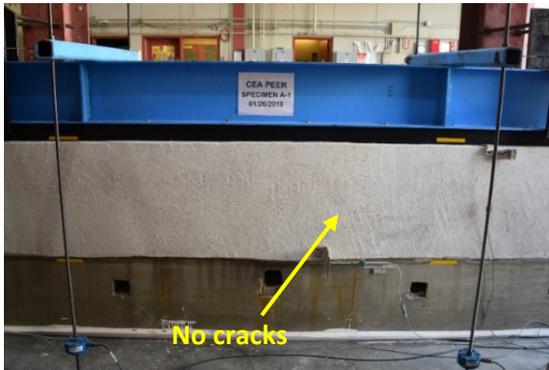
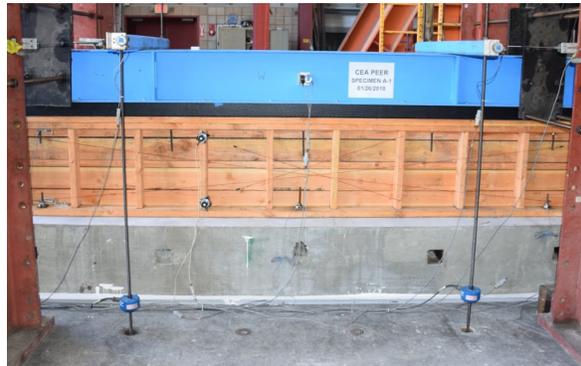
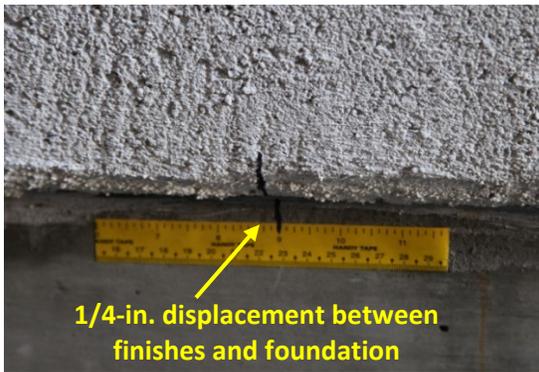
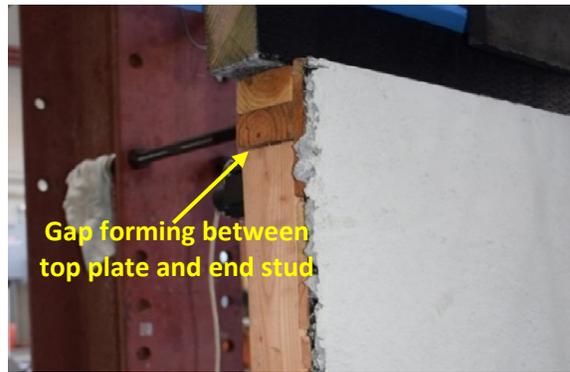
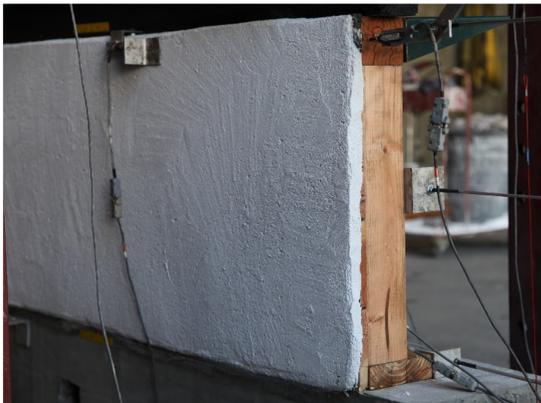
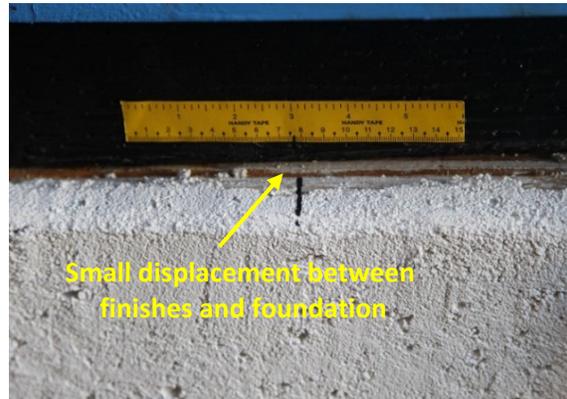
**Figure 5.1 Specimen A-1 damage state of at -1.4% global drift ratio @  $\Delta = -0.336$  in.:**  
 (a) exterior elevation; (b) interior elevation; (c) bottom of exterior wall displacement; (d) south top exterior and corner view; (e) north exterior and corner view; and (f) top of wall displacement.

Figures 5.1(a) to (f) show the damage state of Specimen A-1 at 1.4% drift amplitude. At this low-level amplitude, no cracks had formed on the stucco face. On the interior of the wall, the studs had started to uplift and exhibited slight rotation. This uplift and rotation can be seen in the connection of the studs to the sill plate, and the connection to the top plates. The most noticeable damage characteristics was the 1/4 in. of relative displacement between stucco and foundation face at the base of the cripple wall and the 1/8 in. of relative displacement between the stucco and framing at the top of the cripple wall. Based on visual observations, the lack of cracking on the specimen would indicate minimal to no structural damage to the wall.
