# PACIFIC EARTHQUAKE ENGINEERING RESEARCH CENTER

## **Comparison of the Response of Small- and Large-Component Cripple Wall Specimens Tested under Simulated Seismic Loading**

**A Report for the “Quantifying the Performance of  
Retrofit of Cripple Walls and Sill Anchorage in Single-  
Family Wood-Frame Buildings” Project**

PEER Report 2020/21

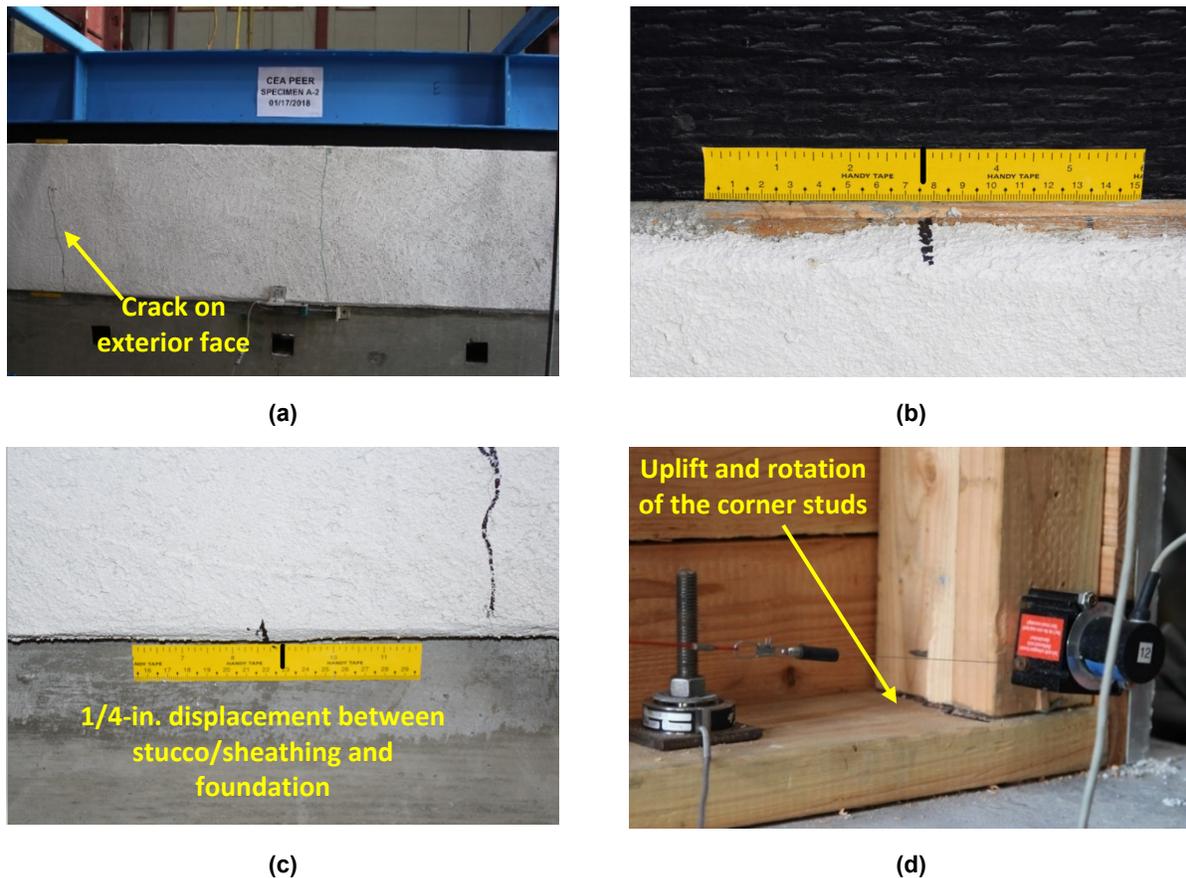
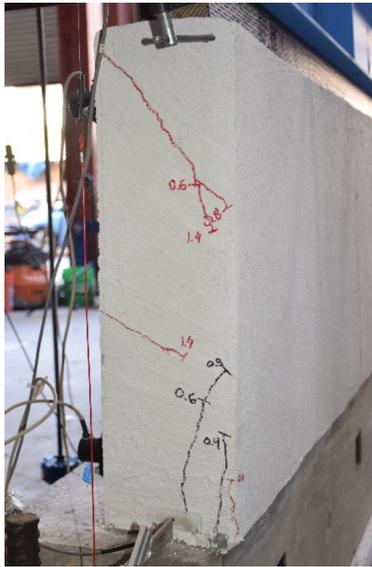
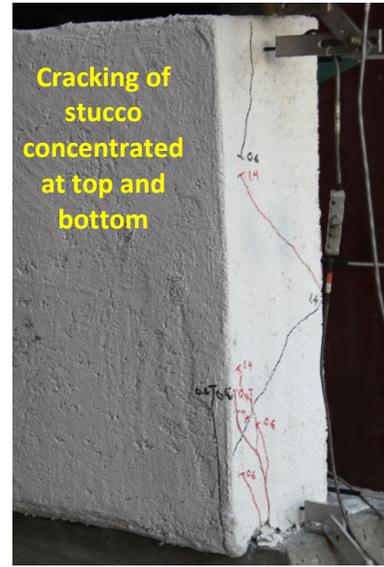
**Figure 5.2** Specimen A-2 damage state of at -1.4% drift @  $\Delta = -0.336$  in.: (a) exterior elevation; (b) top of exterior wall; (c) bottom of exterior wall; (d) bottom corner of south-end interior; (e) north-end exterior corner view; and (f) north-end interior corner view.

Figure 5.2(a) to (f) show the damage state of Specimen A-2 at 1.4% drift ratio amplitude. At this drift ratio level, a new vertical crack started to form at the base of the stucco but had not yet propagated up the entire stucco face. In addition, both the north and south corners of the wall exhibited extensive cracking. Figure 5.2(e) and (f) shows that most of the cracks were concentrated at the bottom close to the corner and ran vertically, but additional cracks had formed on corner faces that propagated diagonally across the face. These cracks began forming at drift ratio amplitudes as low as 0.2% and continued extending at larger drift ratio amplitudes. Figure 5.2(c) shows that the stucco experienced 1/4-in. displacement relative to the foundation. This figure also shows that the stucco had detached from the foundation and a gap was beginning to form between the stucco and the foundation face. This occurred as the furring nails began to detach from the sheathing board and framing members. Like Specimen A-1, the studs had begun to rotate and uplift. At the top of the cripple wall, the displacement between the sheathing and framing was negligible.

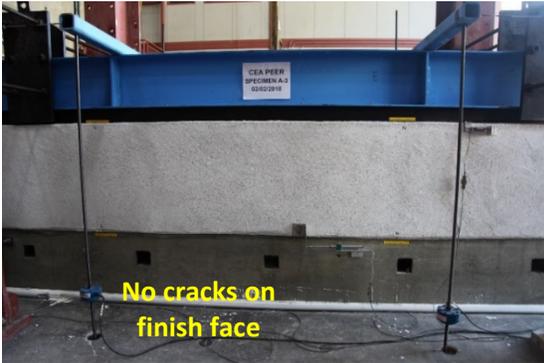
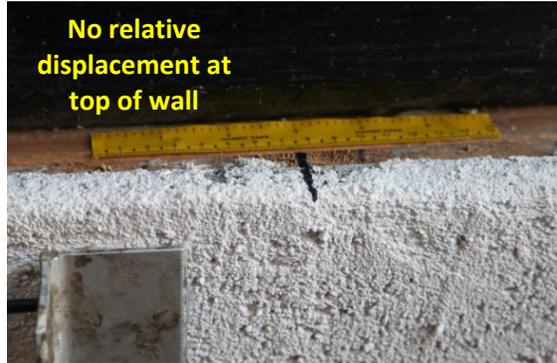
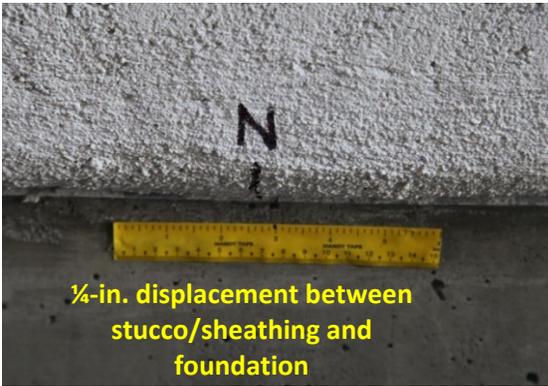
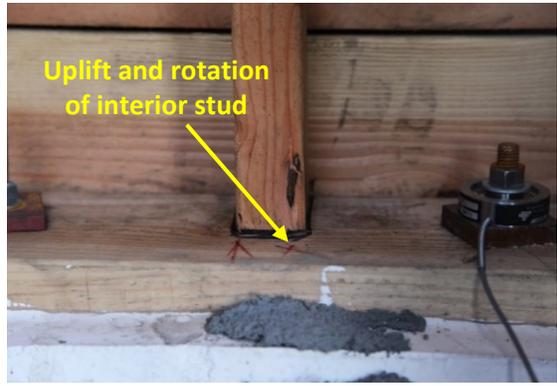
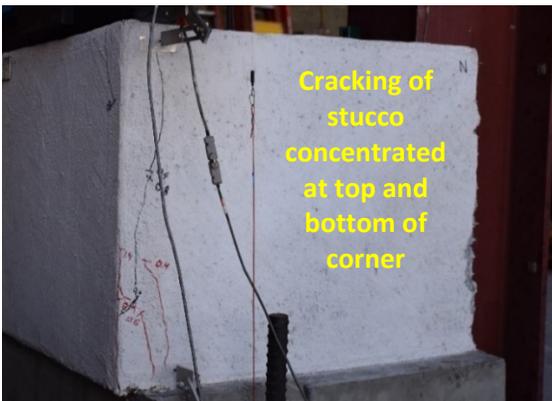
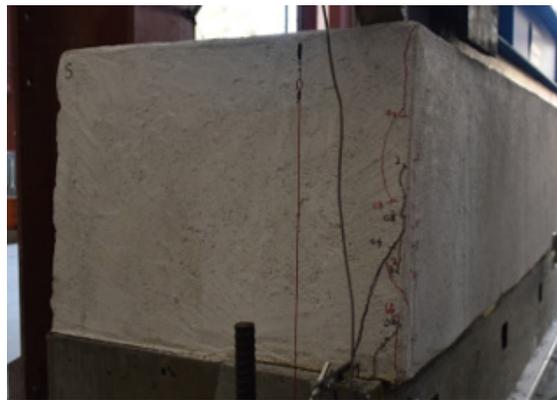
**Figure 5.3** Specimen A-3 damage state at -1.4% drift @  $\Delta = -0.336$  in.: (a) exterior elevation; (b) top of the exterior wall; (c) bottom of exterior wall; (d) bottom of interior wall; (e) north-end of exterior corner; and (f) south-end of exterior corner.

Figure 5.3(a) to (f) show the damage state of Specimen A-3 at 1.4% drift ratio amplitude. At this drift ratio level, no cracks had yet formed on the exterior face of the stucco other than a small crack running diagonally from the top of the cripple wall to the corner on the north, although many cracks began propagating vertically at the corners, as shown in Figures 5.3(e) and (f). Similar to the previous specimen, these cracks started at the 0.2% drift ratio amplitude and continued to extend in subsequent cycles of increased drift ratio amplitude. It is notable that no cracks appeared on the face of either return wall. Figure 5.3(c) shows that the stucco to foundation displacement of 3/8 in., which is higher than the previous test; the displacement of the sheathing relative to the framing did not occur, unlike the previous test. The continued reduction of relative displacement between the sheathing and framing was attributed to the presence of extended corners (end return walls), which offered additional resistance, as evidenced by the 50% reduction in displacement. Figure 5.3(d) shows significant uplift and slight rotation in the studs of the return walls.

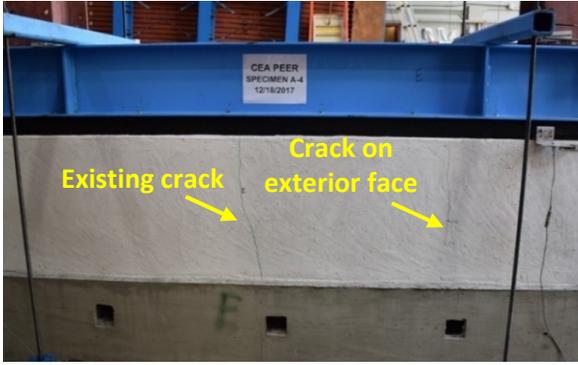
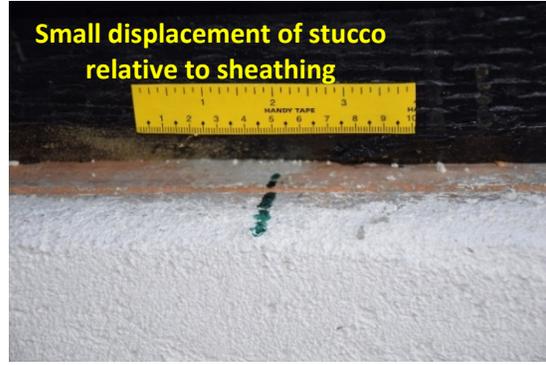
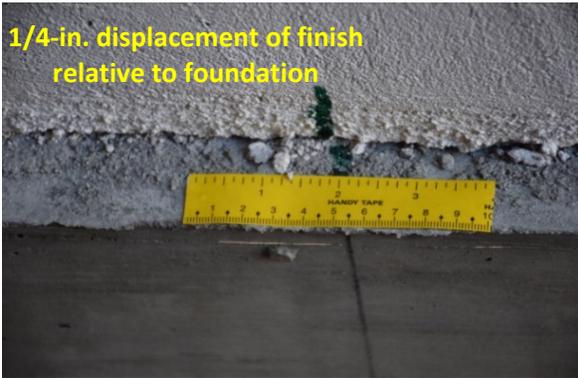
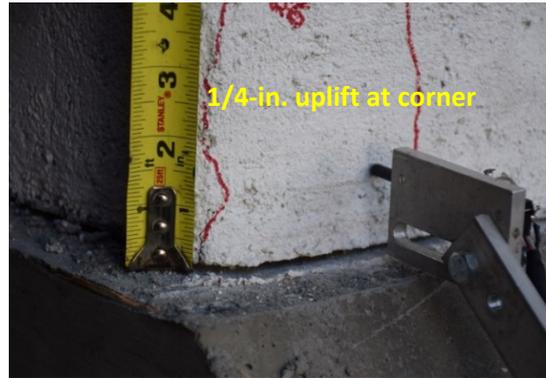
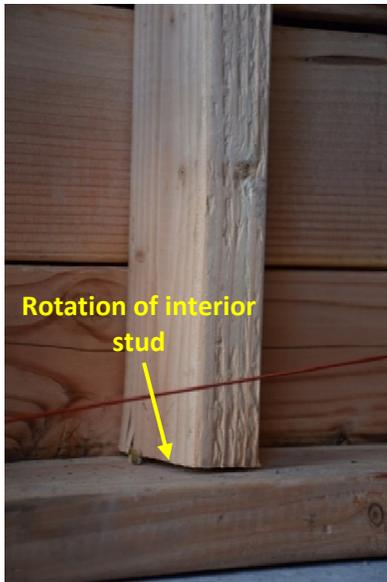
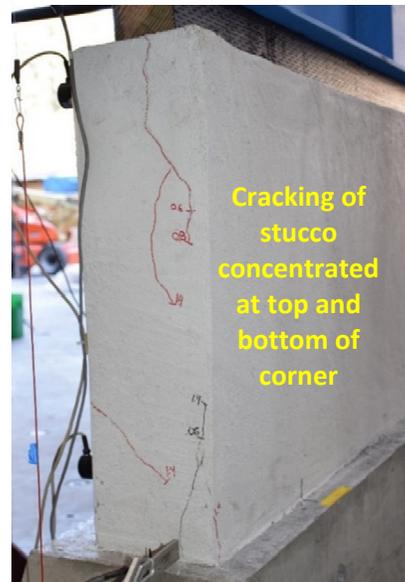
**Figure 5.4** Specimen A-4 damage state of at -1.4% drift @  $\Delta = -0.336$  in.: (a) exterior elevation; (b) top of exterior wall; (c) bottom of exterior wall; (d) bottom of north-end exterior corner; (e) bottom of interior wall; and (f) north-end of exterior corner.

Figures 5.4(a) to (f) show the damage of Specimen A-4 at 1.4% drift ratio amplitude. At this drift ratio level, cracks had started to propagate vertically on the exterior face of the stucco; see Figure 5.4(a). As with the two previous specimens, significant cracking occurred, concentrated around the corners of the wall. Specimen A-4 varied slightly though, showing more cracks on the corner faces, both vertical and diagonal, compared to the previous two cripple walls. Even at this low drift ratio amplitude, 1/8 in. of uplift occurred at the end of cripple wall; see Figure 5.4(d). Across the entire wall, the seal between the stucco and foundation broke, and a gap had started to form at the base of the wall. On the interior, uplift of the studs occurred but no visible rotation of the studs. This is due to the entire wall bearing on the foundation and resisting movement more evenly than the cripple walls, which had no bearing resistance from the stucco due to the stucco being outboard of the foundation. As with all previously tested specimens, a 1/4-in. displacement between the stucco and the foundation occurred at the base of the wall. Unlike the previous specimens, the relative displacement at the top of the cripple wall was minimal. Figure 5.4(b) shows insignificant displacement—typically less than 1/8 in—between the sheathing and framing, but this was the first instance that showed displacement between the stucco finish and the horizontal sheathing. Again, this is due to the stucco finish bearing on the foundation. As the cripple wall displaces, the bearing causes the furring nails to rotate and pull away from the sheathing boards, leading to a relative displacement between the stucco and sheathing.

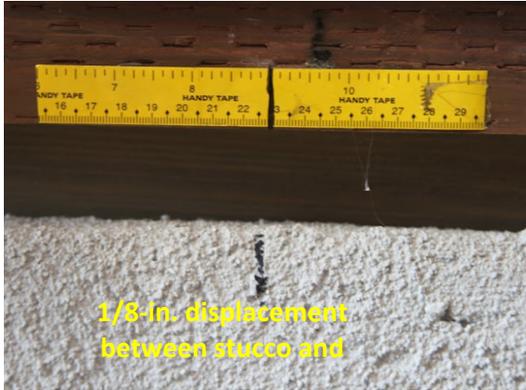
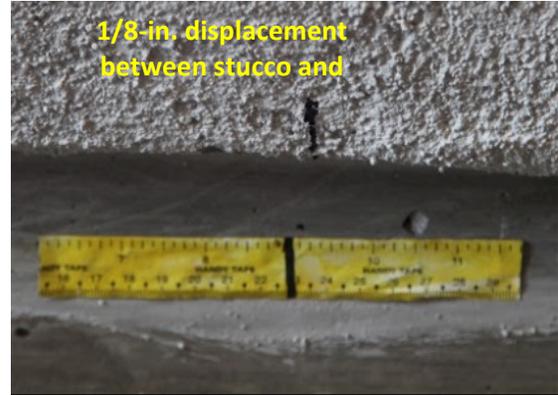
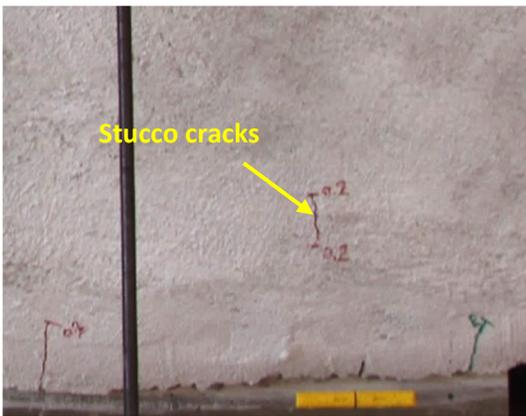
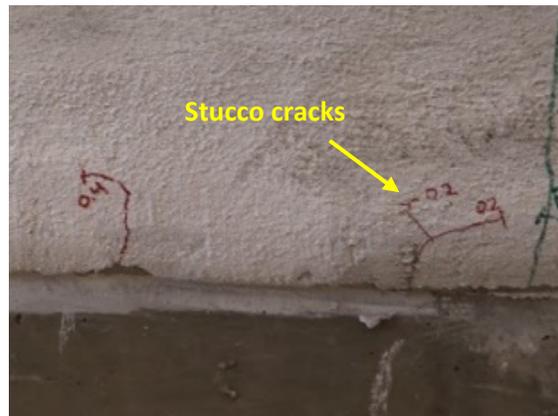
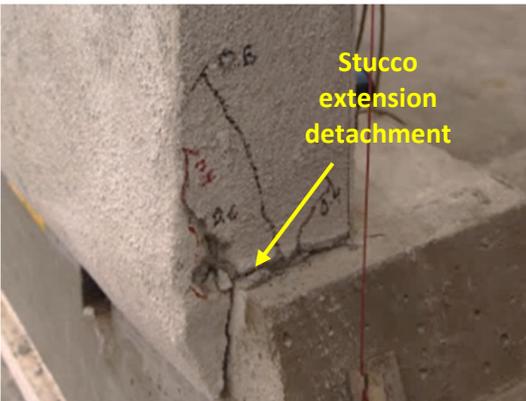
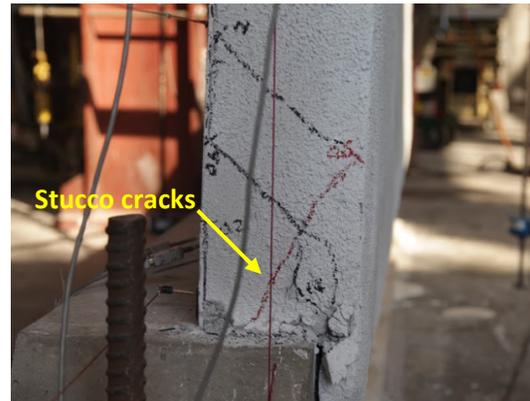
**Figure 5.5** Specimen A-19 damage state of at -1.4% drift ratio @  $\Delta = -0.336$  in.: (a) top of south-end exterior of wall; (b) bottom of south-end exterior of wall; (c) bottom of south-end interior corner of wall; (d) bottom interior of wall (south panel); (e) middle exterior of wall; and (f) bottom of north-end exterior corner of wall.

Specimen A-20 was an existing 2-ft-tall cripple wall with stucco over horizontal sheathing exterior finish and bottom boundary condition d. Figure 5.5 shows the state of the cripple wall at -1.4% (-0.336 in.). A 1/8-in. displacement between the finish materials and the framing [Figure 5.5(a)] and a 1/4-in. displacement between the finish materials and the foundation [Figure 5.5(b)] occurred. These displacements are consistent with the existing, stucco over diagonal sheathing finished Specimen (A-15). Small cracks formed at various locations along the bottom of the face of the cripple wall; see Figure 5.5(c) and (d). At this point, the stucco extension had fully detached from the footing; see Figure 5.5(e) and (f). The same cracking pattern that occurred at the bottom of the corners with the previous specimens also occurred with this specimen.

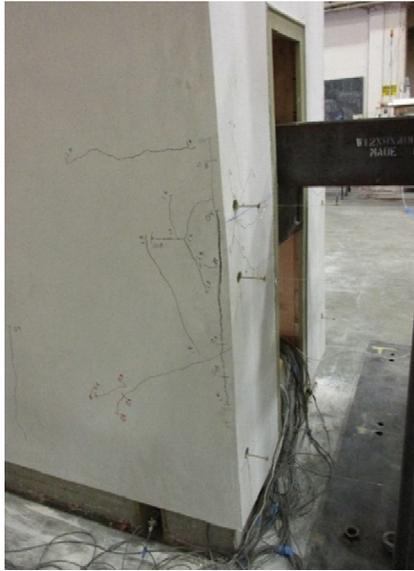
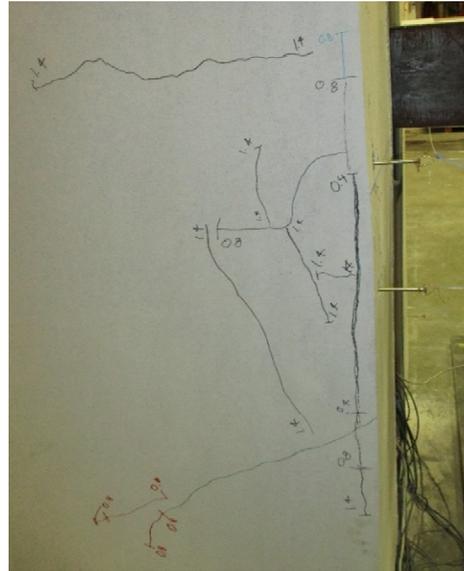
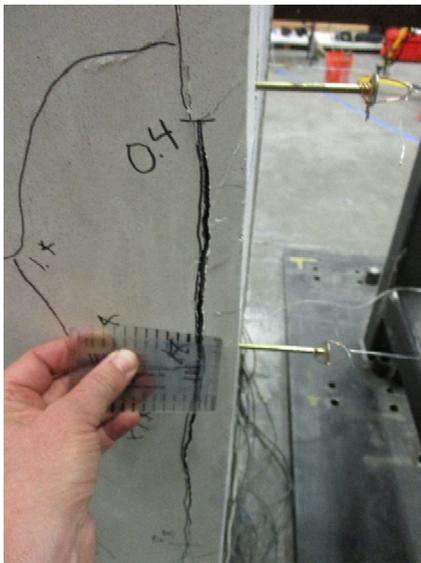
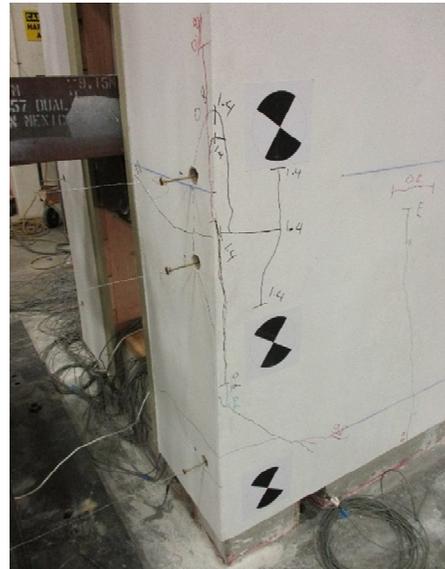
**Figure 5.6 Specimen AL-1 damage state of at 1.4% drift ratio: (a) bottom of northwest corner; (b) middle of northwest corner; (c) northwest corner detail; and (d) bottom of southwest corner.**

Figure 5.6 shows the damage state of Specimen AL-1 at a drift ratio of 1.4%. Stucco cracking initiated in the east and west end walls and corners at the framed floor level. At a drift ratio of 1.4%, stucco cracking at the end walls and corners had spread and began to open. While cracking in much of the north and south walls was very limited, cracking was extensive near the corners at the ends of the north and south walls. Maximum crack widths ranged from 0.075 to 0.125 in. Slight offsets in gypsum wallboard panel edges were noted on interior of the superstructure. There was no observable movement of the stucco relative to the framing and sheathing at the floor. At this drift level, the bond between the stucco and the foundation was still intact, with no measurable relative displacement occurring.

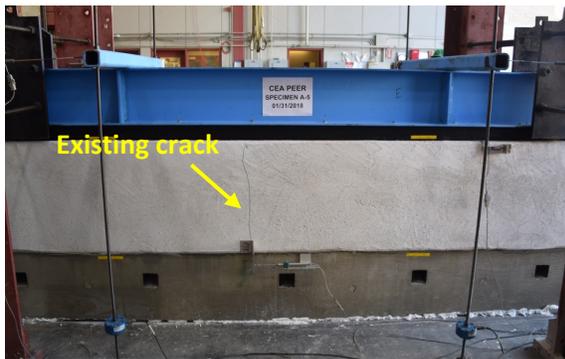
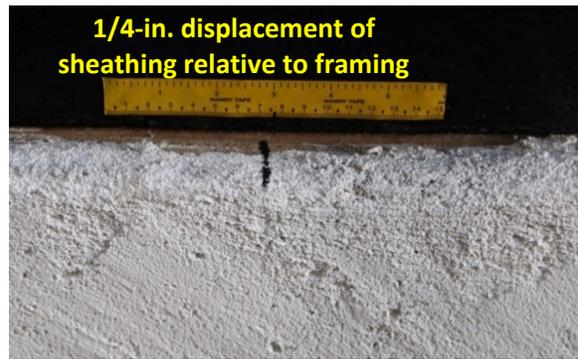
**Figure 5.7** Specimen A-5 damage state at +1.4% drift @  $\Delta = +0.336$  in.: (a) exterior elevation; (b) top of exterior wall; (c) bottom of exterior wall; (d) plywood panel joint; (e) close-up of top of the south-end interior wall; and (f) north-end exterior corner.

Figures 5.7(a) to (f) show the damage state of Specimen A-5 at 1.4% drift ratio amplitude. At this drift ratio, no additional cracks had formed on the face of stucco. There was a large reduction in the amount of cracking at the corners of the cripple wall as compared with Specimens A-2 through A-4, as shown in Figure 5.7(f). This could be due to much of the work resisting displacement being done by the retrofit instead of the corners. As with Specimen A-2, there was a 1/4-in. displacement between the stucco and the foundation as well as disconnect between the stucco and the foundation at the base of the cripple wall. At the top of the cripple wall, a 3/16-in. displacement between the sheathing and framing formed, which is the largest of any of the previous tests. This is due to the framing members being significantly stiffened by the attachment of the plywood panels on the interior face. On the interior face, small displacements between the plywood panels had started to form as the plywood panels began to rotate. The 1/8-in. gap between abutting plywood panels remained; therefore, the wood structural panels had yet to bear on each other. Figure 5.7(e) shows that some of the nails were slightly overdriven and had started to begin pulling through the plywood. For the other nails attaching the plywood to framing, minimal rotation or pulling through was visible at this drift ratio level.

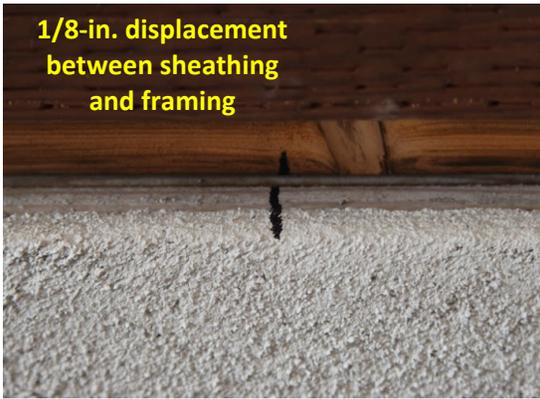
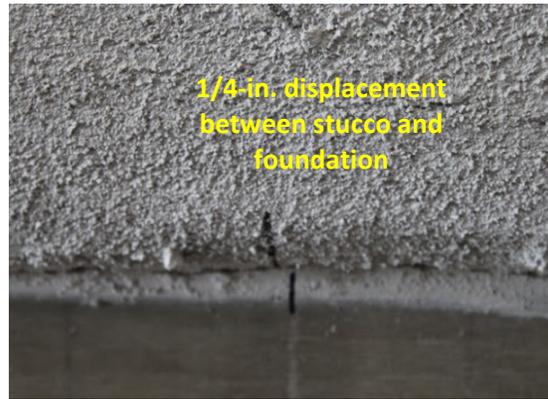
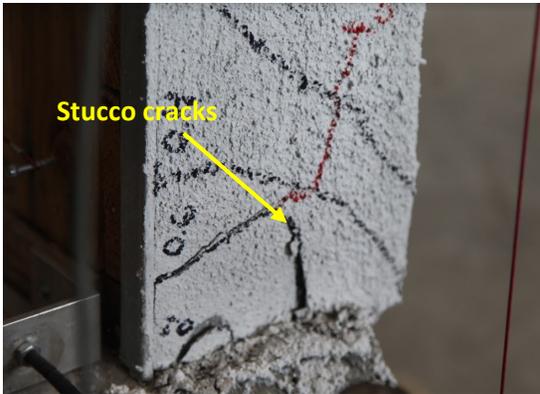
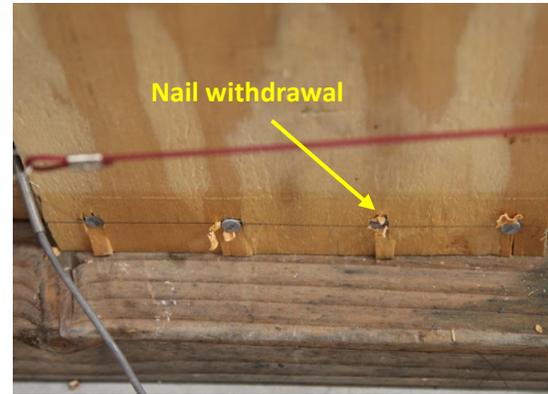
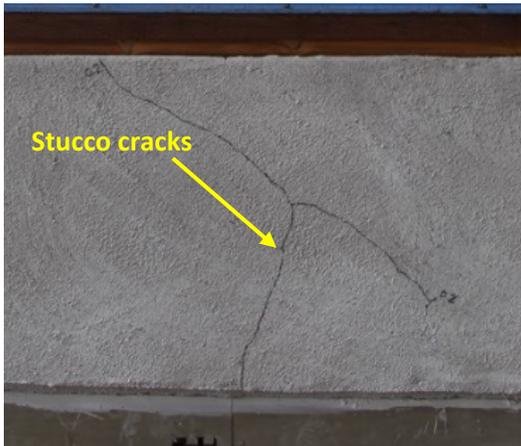
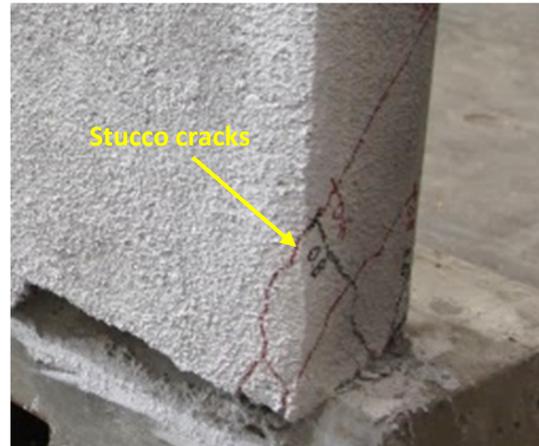
**Figure 5.8** Specimen A-19 damage state at -1.4% drift ratio @  $\Delta = -0.336$  in.: (a) top of south-end exterior of wall; (b) bottom of south-end exterior of wall; (c) bottom of south-end interior corner of wall; (d) bottom interior of wall (south panel); (e) middle exterior of wall; and (f) bottom of north-end exterior corner of wall.

Figure 5.8 shows the state of the cripple wall at -1.4% drift ratio (-0.336 in.); the sheathing at the top of the cripple wall had been displaced by 1/8 in. relative to the framing [Figure 5.8(a)], and both finish materials had been displaced by 1/4 in. relative to the foundation; see Figure 5.8(b). Cracks had formed in the stucco at the bottom of both corners; see Figure 5.8(c) and (f). With all stucco specimens tested, there was increased cracking concentrated at the bottom of the corners due to the corners bearing on the foundation. Along the face of the specimen, a diagonal and a vertical crack had formed, as shown in Figure 5.8(e). On the interior, the damage to the plywood was the same as what occurred in the previously tested retrofitted specimens. There were small rotations of the panels, withdrawal of the nails at some locations, and rotation of many of the edge nails. Nail withdrawal began to occur at the base of the panels can be seen in Figure 5.8(d).

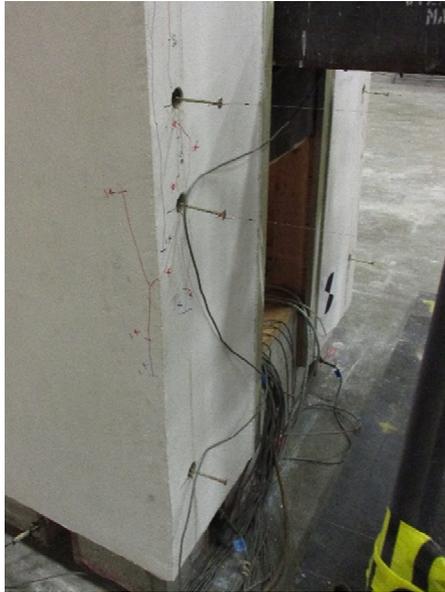
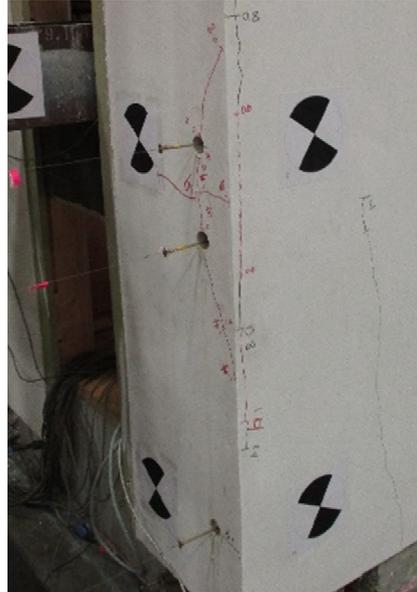
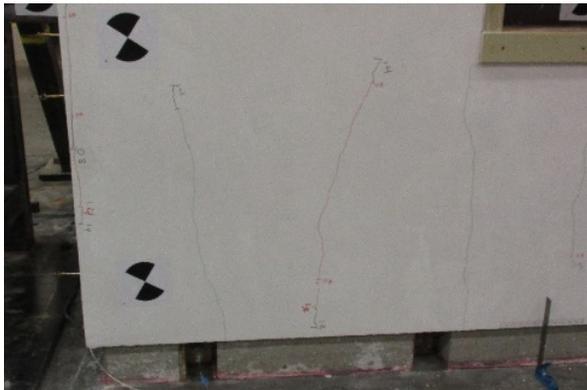
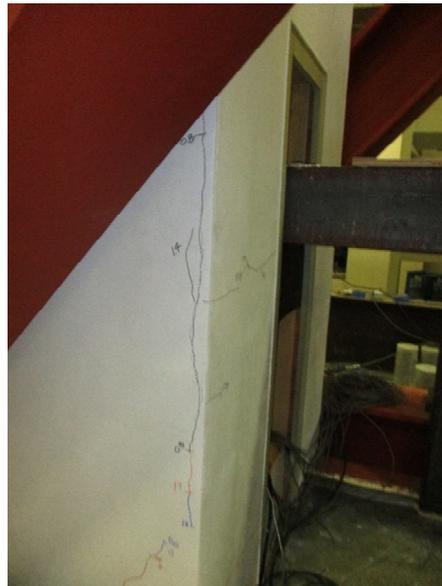
**Figure 5.9** Specimen AL-2 damage state at 1.4% drift ratio: (a) bottom of northwest corner; (b) bottom of southwest corner; (c) bottom of south-end of wall; and (d) middle of southeast corner.

Figure 5.9 shows the damage state of Specimen AL-2 at a drift ratio of 1.4%. Cracking was first observed at the west and east end walls near the framed floor level at 0.8% drift. At 1.4% drift the cracking at the end walls and corners was observed to spread up and down from the floor level. At the north and south walls modest spreading and new hairline cracks were observed in the field of the wall. Unlike Specimen AL-1, the cracking that initiated at the specimen corners and extended into the north and south walls was much more limited. Like Specimen AL-1, at this drift ratio the bond between the stucco and foundation was still intact, with no measurable relative movement.

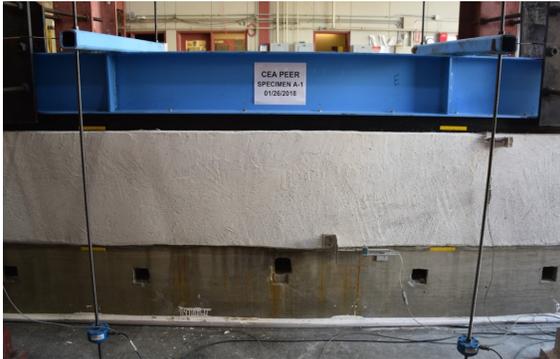
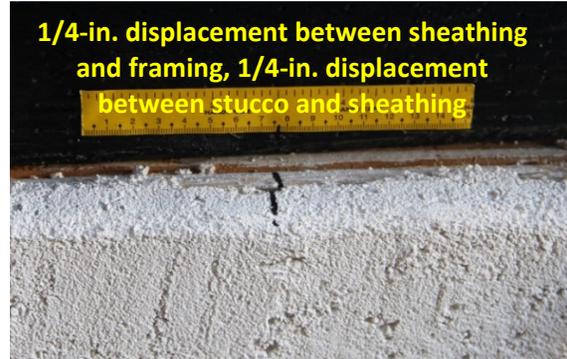
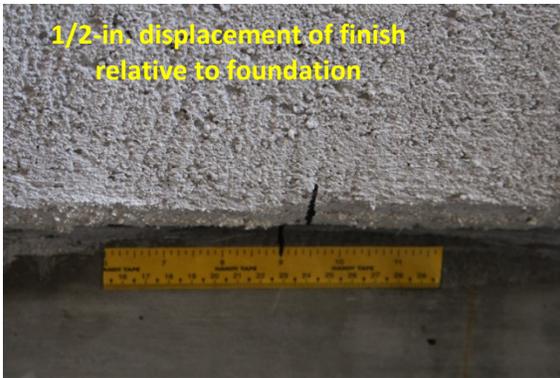
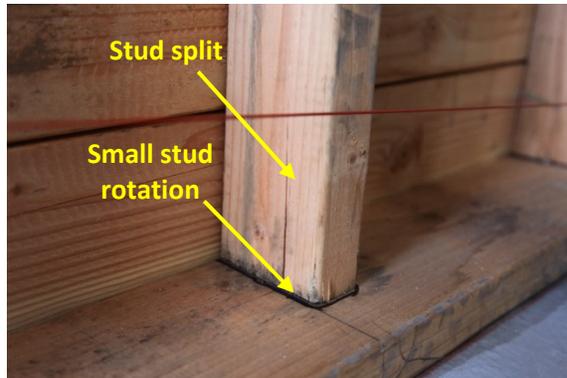
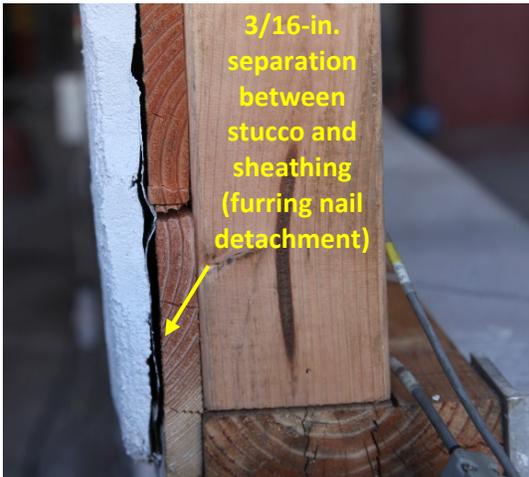
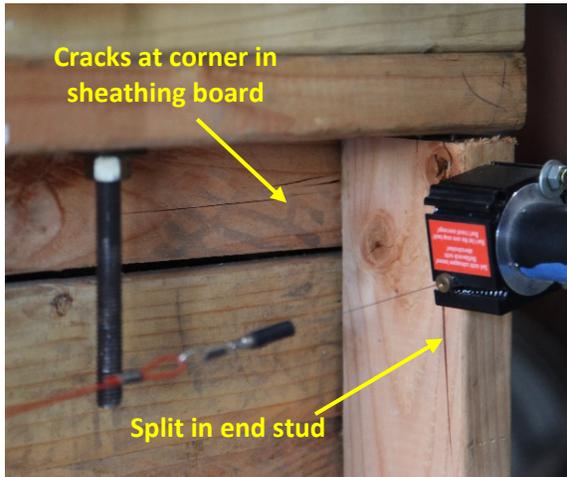
**Figure 5.10** Specimen A-1 damage state of at lateral strength @ +3% drift,  $\Delta = +0.72$  in.: (a) exterior elevation; (b) top of the exterior wall; (c) bottom of exterior wall; (d) close-up of stud; (e) north-end corner of wall; and (f) close-up of top of south-end interior corner.

Figures 5.10(a) to (f) show the damage state of Specimen A-1 at lateral strength, which occurred at 3% global and relative drift ratio in both the push and pull loading directions. Due to its lower capacity, Specimen A-1 did not experience any sill displacement relative to the foundation. At strength, there were still no visible cracks on the face of the stucco. Figure 5.10(e) shows a 3/16-in. separation between the stucco and sheathing. This occurred as the furring nails detached from the framing and started to work their way out of the sheathing (nail withdrawal), or the furring nails have detached from the stucco (nail head pullout). Both conditions can occur, and their occurrence is dependent on how well the furring nails were fastened to the wire lath and how well they were fastened to the sheathing. Whichever condition has the least capacity determines what mechanism will occur first. It should be noted that only 1/8 in. of the 1-1/2-in furring nails would be driven into the framing because the nails were furred out 1/4 in. and penetrated through the 7/8-in.-thick horizontal sheathing.

The displacement between the base of the stucco and the foundation increased to 1/2 in., and a gap between the stucco and foundation face became more pronounced. Figure 5.10(f) shows that at the top of the cripple wall, a 1/4-in. relative displacement between the stucco finish and the sheathing developed as well as a 1/4-in. relative displacement between the sheathing and framing. In addition, a small gap opened up between the sheathing and framing, indicating that the small amount of embedment that the furring nails had into the framing was now gone. On the interior of the cripple walls, the uplift of the studs was more pronounced, while the rotation of the studs was similar to that at the service-level drift ratio. Some of the studs began splitting at both the connection to the sill plate and top plate. Lastly, cracks had begun to form on the ends of the sheathing boards, concentrated near the location that the boards are nailed to the studs.

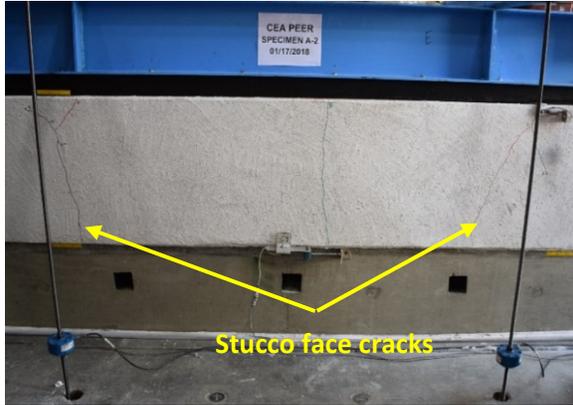
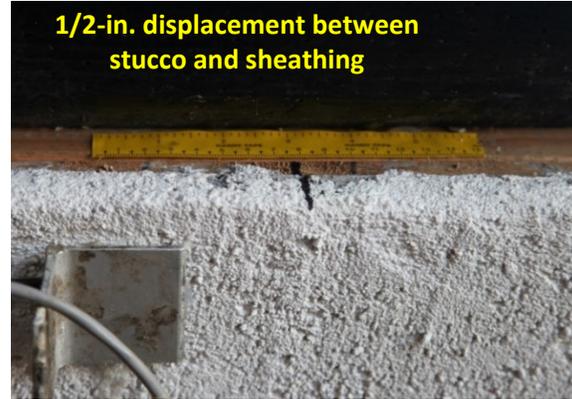
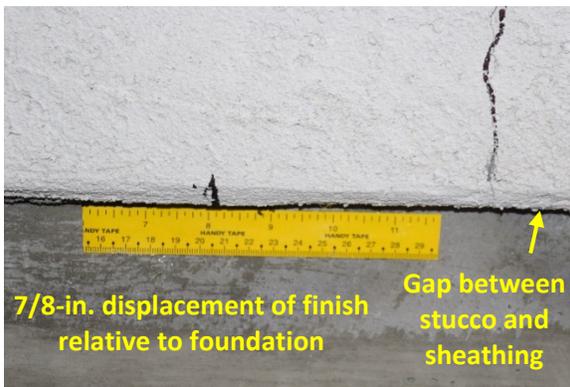
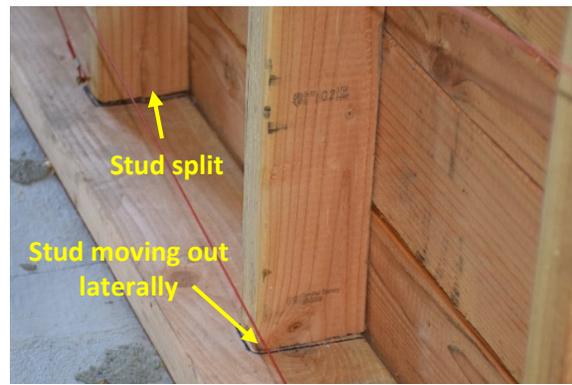
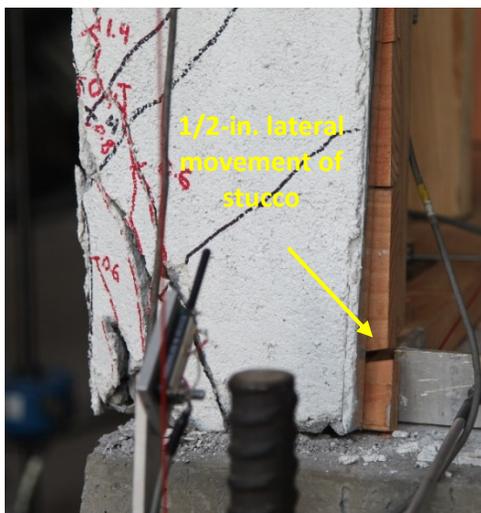
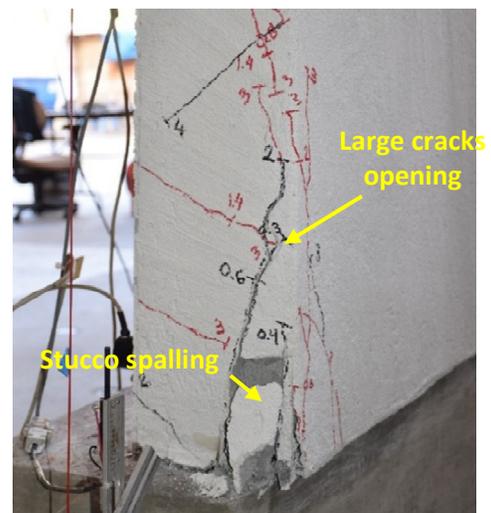
**Figure 5.11** Specimen A-2 damage state at lateral strength @ -4% drift,  $\Delta = -0.96$  in.: (a) exterior elevation; (b) top of exterior wall; (c) bottom of exterior wall; (d) close-up of studs; (e) close-up of north-end corner; and (f) close-up of bottom south-end exterior corner.

Figure 5.11(a) to (f) show the damage state of Specimen A-2 at lateral strength. The lateral strength occurred at 5% global drift ratio in the push loading direction and 4% in the pull loading direction. The corresponding relative drift ratio was 4.3% in the push direction and 3.1% in the pull direction. At lateral strength, additional vertical cracks began propagating along the face of the stucco. The formation of a 1/2-in. gap occurred at the base of the stucco, which is evident from Figures 5.11(c) and (e). At this point, the stucco had detached from most of the furring nails at the base, but in some cases, the furring nails remained attached to the stucco and had withdrawn significantly from the sheathing. The former being the more common occurrence. This same gap was not evident at the top of the cripple wall because of the increased pullout resistance due to the significantly denser furring nail arrangement on the upper top plates. The displacement of the stucco at the base and the foundation has increased to 7/8 in., while the only apparent relative displacement at the top of the cripple wall was a 1/4-in. displacement between the stucco and sheathing, as shown in Figure 5.11(d). This is due to the rotation of the furring nails at the top of the wall. At the exterior corners, major cracking ran in all directions and was heavily concentrated at the corner edge; see Figure 5.11(f). Crushing and spalling of the stucco was extensive at the corner faces due to the heavy bearing of the stucco finish on the foundation. On the interior face, some of the studs had split at the connection to the sill plate. In addition, a slight lateral movement occurred on the studs. This lateral movement can be attributed to the horizontal sheathing and stucco finish moving out laterally due to the nails being pulled out as they rotated back and forward during each cycle.

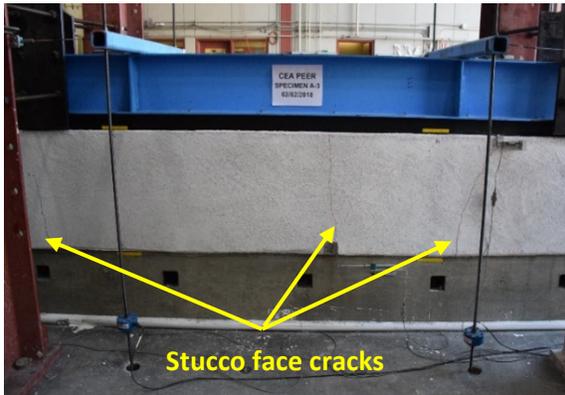
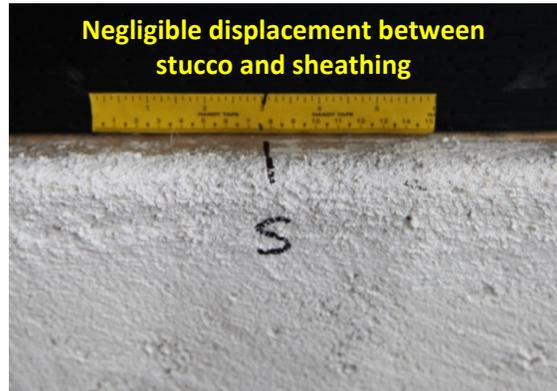
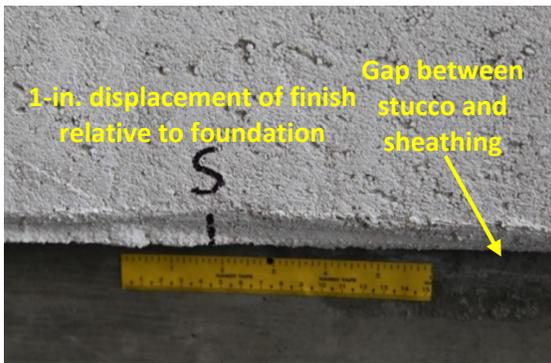
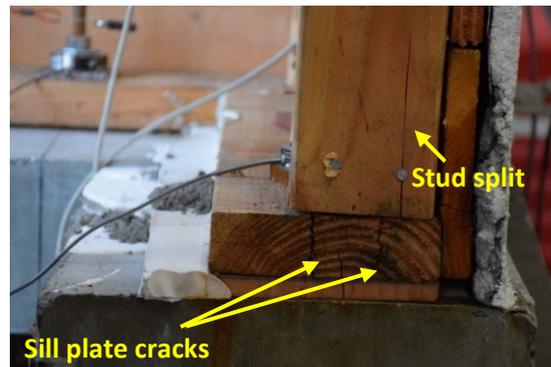
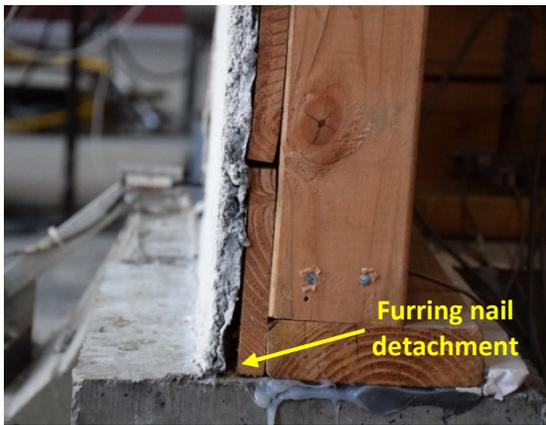
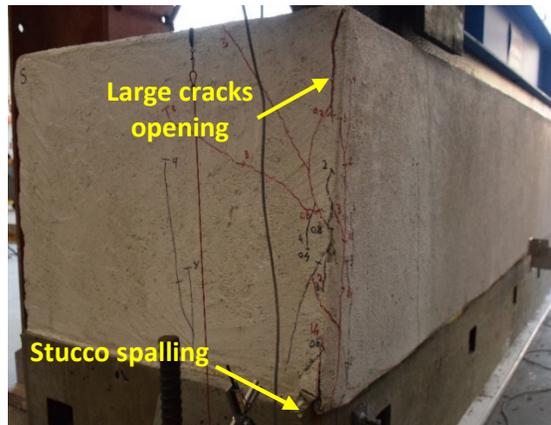
**Figure 5.12** Specimen A-3 damage state of at lateral strength @ +4% drift,  $\Delta = +0.96$  in.: (a) exterior elevation; (b) top of exterior wall (c) bottom of exterior wall; (d) close-up of south-end wall; (e) close-up of north-end corner of wall; and (f) north-end exterior corner.

Figures 5.12(a) to (f) show the damage state of Specimen A-3 at lateral strength. The lateral strength occurred at 4% global drift ratio in the push loading direction and 3% in the pull loading direction. The corresponding relative drift ratio was 2.9% in the push direction and 2.0% in the pull direction. At lateral strength, cracks had propagated vertically along the face of the stucco. As seen in Figure 5.12(c), the displacement between the base of the stucco and the foundation had increased to 1 in., and a large gap had formed between the stucco and the foundation face, evidence that the furring nails had completely detached from the stucco along bottom of the stucco face. This is confirmed by large cracks running vertically from the base of the stucco at the corners. In addition to the vertical cracks at the corners, diagonal cracks were propagating along the face of the return walls. At the top of the cripple wall, the displacement between the sheathing and framing did not expand, and there was no presence of displacement between the stucco and sheathing. This is both due to the dense furring nail arrangement on the upper top plates as well as the extended corner return walls resisting these relative displacements. Figure 5.12(e) shows that a gap formed at the base of the return walls as the furring nails detached from the stucco. On the interior of the wall, more pronounced uplift of the studs occurred. Again, some of the studs had split near the connection to the sill plate; see Figure 5.12(b). This splitting occurred in the South return wall sill plate due to the rocking motion of the return walls during cyclic loading.

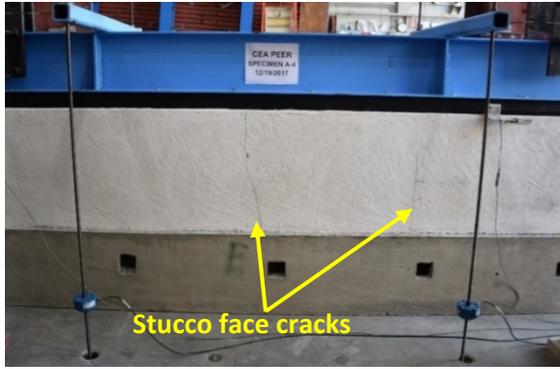
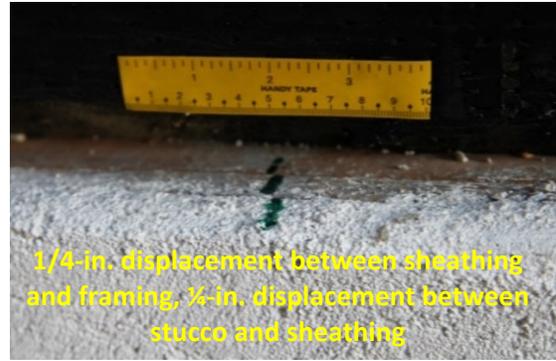
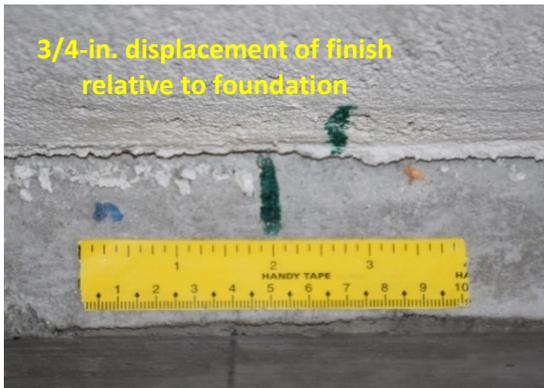
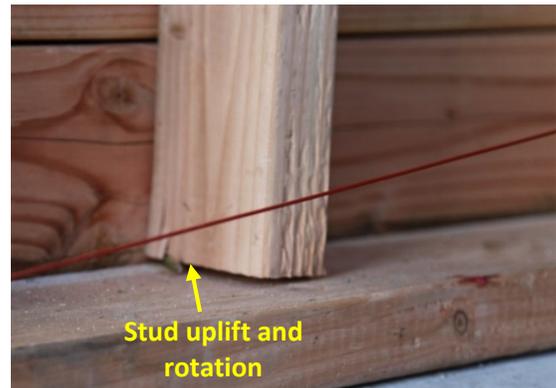
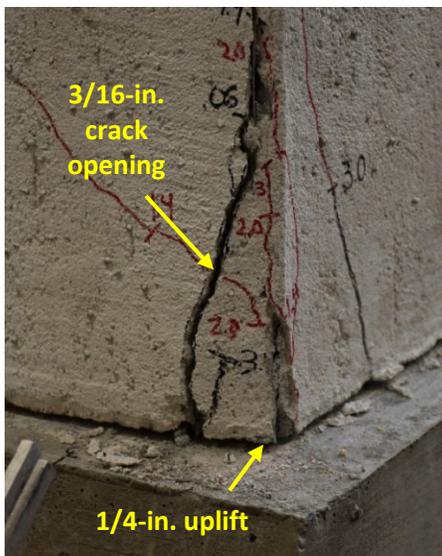
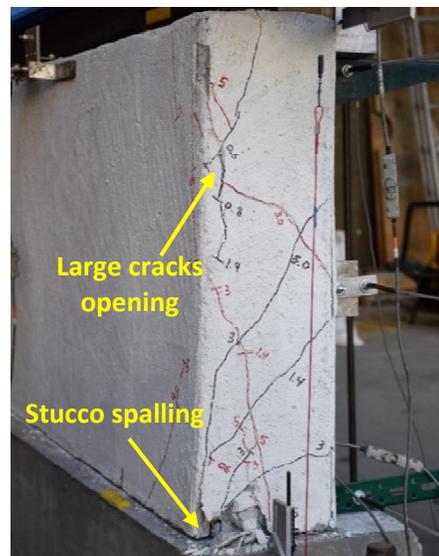
Figure 5.13 Specimen A-4 damage state of at lateral strength @-5% drift,  $\Delta = -1.20$  in.: (a) exterior elevation; (b) top of exterior wall; (c) bottom of exterior wall; (d) close-up of stud; (e) close-up of exterior south-end corner; and (f) north-end exterior corner.

Figure 5.13(a) to (f) show the damage state of Specimen A-4 at lateral strength. The lateral strength occurred at 5% global drift ratio in the push loading direction and 5% in the pull loading direction. The corresponding relative drift ratio was 3.9% in the push direction and 3.5% in the pull direction. At lateral strength, an additional crack in the stucco formed, running from the top of the cripple wall to the base. The displacement between the base of the stucco and the foundation increased to 3/4 in. Figure 5.13(e) shows that large cracks opened up near the bottom at the corner of the wall, indicating that the stucco had moved laterally away from the sheathing, confirmed by the furring nails having become detached from the stucco at the base of the wall. Because the stucco was bearing on the foundation, the rotation was inhibited unlike the previous specimens. This led to an increased capacity of the cripple wall and drift ratio at strength for the cripple wall because the separation between the stucco finish and the sheathing occurs as a lateral movement of the stucco away from the sheathing or an uplift of the stucco. The stucco nails detached primarily from the wire lath in the stucco; however, more commonly compared to the previous tests, the furring nails withdrew from the sheathing boards. At the top of the cripple wall, a 1/4-in. displacement occurred between the stucco and the sheathing, accompanied by a 1/4-in. displacement occurring between the sheathing and framing. Both the nails in the sheathing and the furring nails exhibited significant bending leading to these displacements. As shown in Figure 5.13(f), extensive cracking occurred at the exterior on the corners, extending vertically and diagonally on the corner faces. In addition, significant crushing and spalling of the stucco occurred on the corner faces. On the interior, the uplift of the studs was more pronounced, with was no visible rotation of the studs.

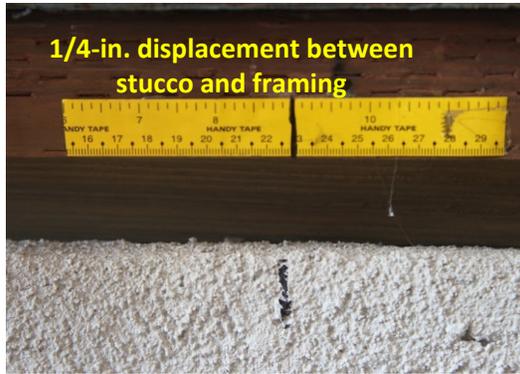
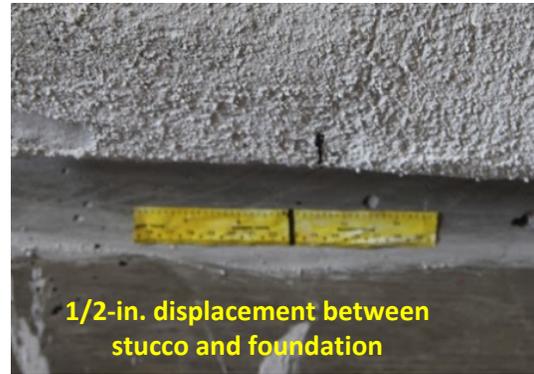
**Figure 5.14** Specimen A-20 damage state of at lateral strength @ +3% drift ratio,  $\Delta = +0.72$  in.: (a) top of north-end exterior of wall; (b) bottom of north-end exterior of wall; (c) bottom of south-end interior corner of wall; (d) middle of south-end interior corner of wall; (e) south-end corner of wall; and (f) bottom of south-end corner of wall.

Figure 5.14 shows the damage state of Specimen A-20 at lateral strength. Lateral strength occurred at 3% global drift ratio in the push loading direction and 3% global drift ratio in the pull loading direction. The relative drift ratio at strength was 2.4% in the push direction and 2.4% in the pull direction. At strength, the stucco had detached from the furring nails at the sill plate and bottom of the studs, a common occurrence for all wet finished (stucco) cripple walls. This can be seen by the gap that formed between the stucco extension and the footing in Figure 5.14(f). At the top of the cripple wall, the stucco and sheathing had displaced 1/4 in. relative to the framing, and at the bottom, a 1/2-in. displacement of the finish material and the foundation occurred; see Figure 5.14(a) and (b). Many of the sheathing board at the corners split due to the bearing of the finish materials at the corners on the foundation; see Figure 5.14(c). The stucco detached from the sheathing nails as well but remained attached to the furring nails; see Figure 5.14(d). For most specimens, the furring nails would stay attached to the sheathing/framing, but due to the cracks in the sheathing boards, there was less resistance to the furring nails withdrawing from the sheathing/framing.

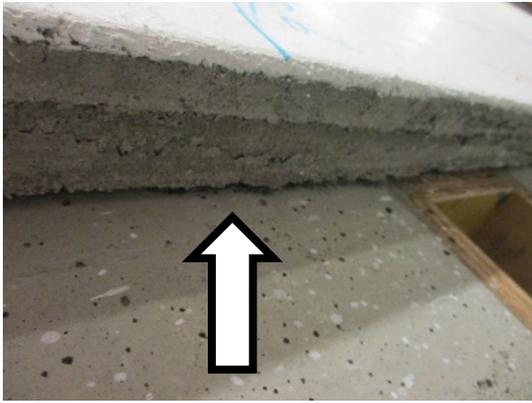
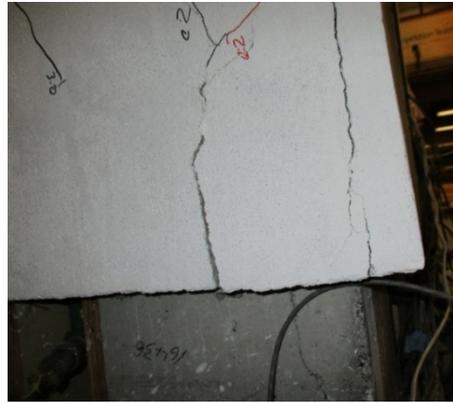
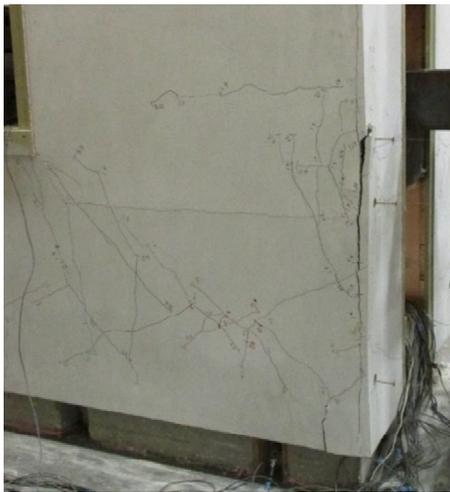
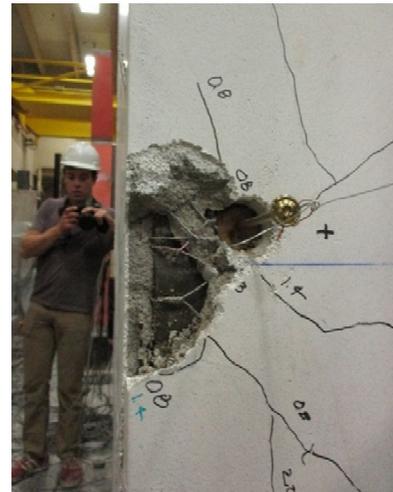
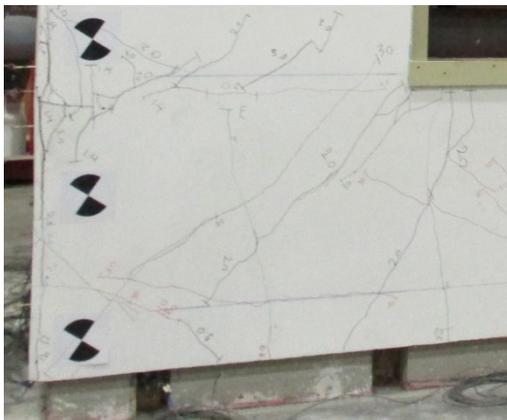
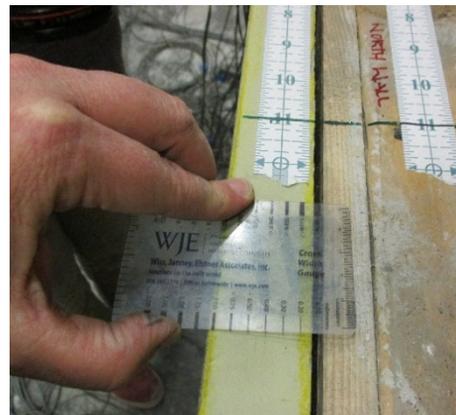
**Figure 5.15 Specimen AL-1 damage state of at lateral strength @ 3% drift ratio,  $\Delta = +0.72$  in.: (a) gap between stucco and foundation; (b) cracking and flaring of stucco; (c) bottom of northwest corner; (d) stucco spall at floor line; (e) bottom of south-west end of wall; and (f) separation of stucco and lumber sheathing.**

Figure 5.15 shows the damage state of Specimen AL-2 at lateral strength. As Specimen AL-1 reached lateral strength at approximately 3% drift, the end-wall stucco continued to deteriorate and pushed off of the framing, leading to the damage patterns seen in Figure 5.15(b) and (c). On the north and south walls, the stucco had developed an extensive network of cracks, but they remained near hairline; see Figure 5.15(e). A 1/8-in. out-of-plane gap opened between the stucco and sheathing at the floor line; see Figure 5.15(f). Following popping noises, visible out-of-plane gaps opened up between the stucco and the concrete foundation; see Figure 5.15(a). This is understood to have been the stucco debonding from the foundation. The gaps were estimated to be 1/16 in. wide. During selective demolition following testing, it was observed that all of the furring nail heads at the foundation sill plate has been pulled out of the stucco. This head pull-out is believed to have occurred at the same time as the stucco debonded from the foundation.
