# PACIFIC EARTHQUAKE ENGINEERING RESEARCH CENTER

## **Comparison of the Response of Small- and Large-Component Cripple Wall Specimens Tested under Simulated Seismic Loading**

**A Report for the “Quantifying the Performance of  
Retrofit of Cripple Walls and Sill Anchorage in Single-  
Family Wood-Frame Buildings” Project**

PEER Report 2020/21

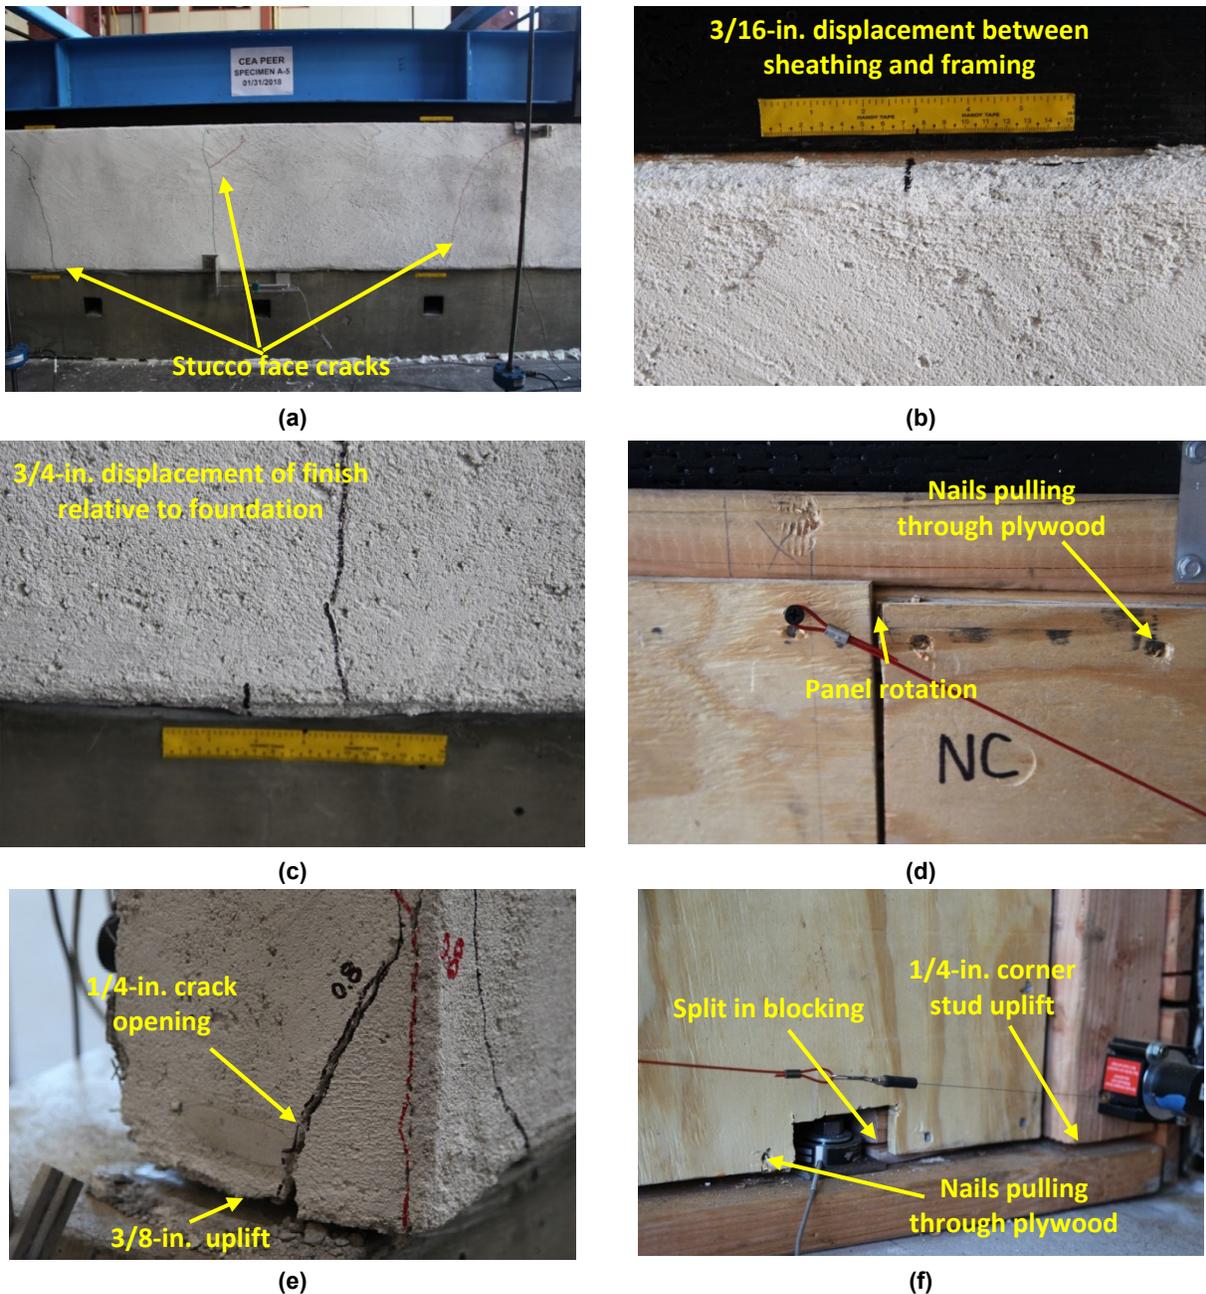
**Figure 5.16** Specimen A-5 damage state of at lateral strength @ +5% drift,  $\Delta = +1.20$  in.: (a) exterior elevation; (b) top of exterior wall; (c) bottom of exterior wall; (d) close-up of plywood panel joint; (e) close-up of south-end exterior corner; (f) bottom of south-end interior wall corner.

Figure 5.16(a) to (f) show the damage state of Specimen A-5 at lateral strength. The lateral strength occurred at 5% global drift ratio in the push loading direction and 5% in the pull loading direction. The corresponding relative drift ratio was 3.6% in the push direction and 2.8% in the pull direction. At strength, multiple cracks had propagated vertically from across the entire face of the stucco. The displacement between the stucco base and the foundation had increased to almost 5/8 in., which is around half of total displacement imposed on the wall. Again, this correlates to a complete detachment of stucco from the sheathing at the base of the wall. Most of this detachment came in the form of the furring nails detaching from the wire lath in the stucco. As shown in Figure 5.16(e), significant uplift (3/8 in.) occurred at the ends of the cripple walls, which can be attributed to the strength of the plywood panels causing the sill plate to bend.

At the top of the cripple wall, there was a 3/16-in. relative displacement between the sheathing and the framing, which was due to the increased stiffness of the framing from the plywood attachment resisting displacement. Figure 5.16(f) shows the damage state of the interior at the corner. Evident is uplift of the corner studs, uplift of the sill plate, splitting of the added blocking that the plywood is nailed to, and partial pull-through of the nails attaching the plywood panels to the blocking. In addition, the displacement between the plywood panels was more pronounced as the panel rotations increased. All nails on the plywood panels had begun to either withdraw or pull through. Any nail that was slightly overdriven falls into the latter category, while the other nails fall into both categories. The majority of nails pulling out were located at the base

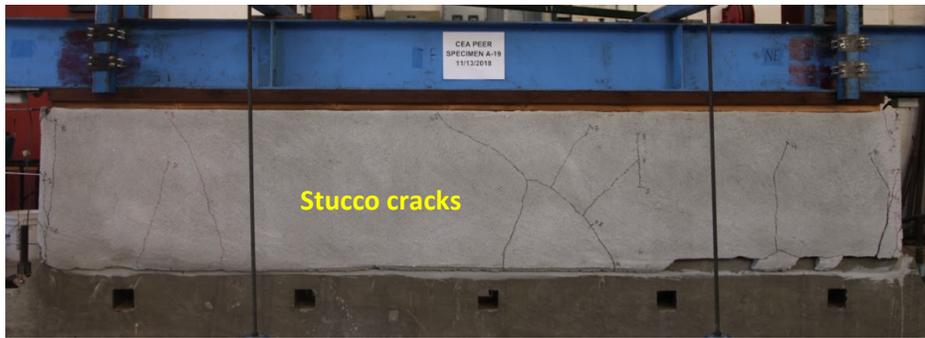
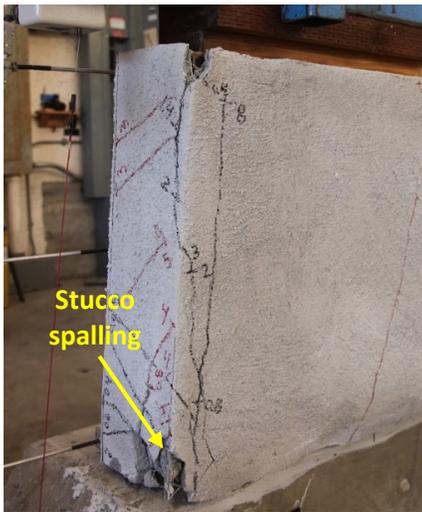
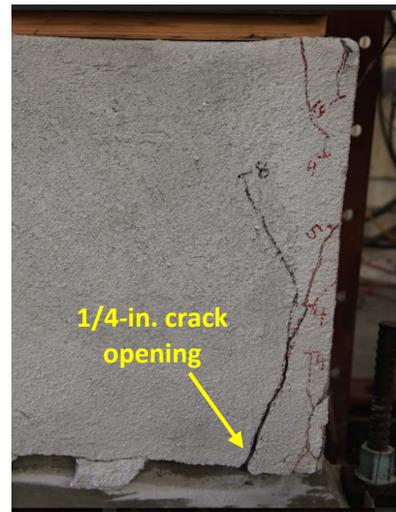
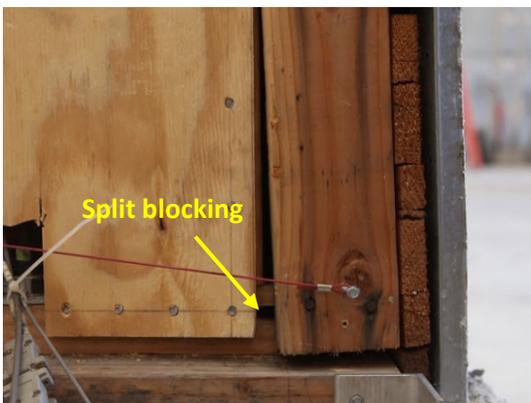
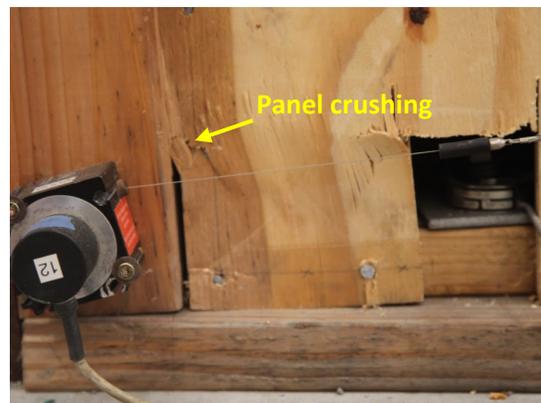
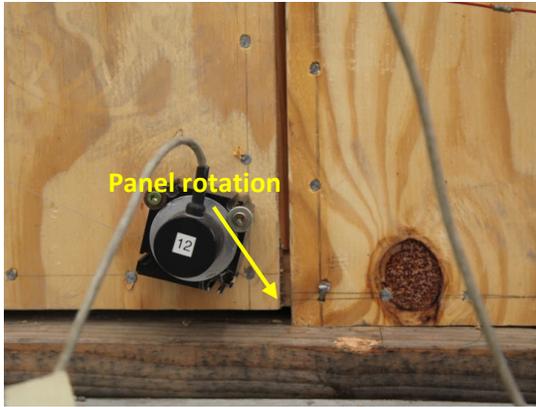
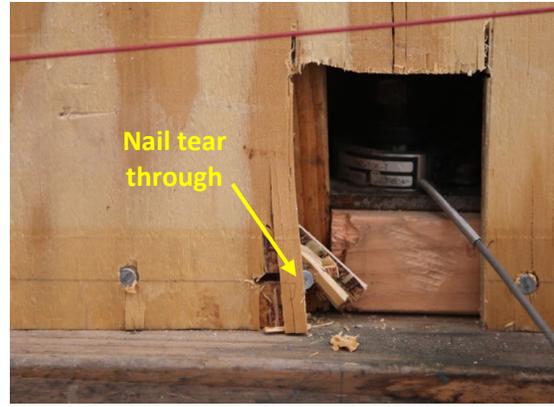
**Figure 5.17** Specimen A-19 damage state of at lateral strength @ +8% drift ratio,  $\Delta = +1.92$  in.: (a) exterior elevation; (b) south-end exterior corner of wall; (c) north-end exterior of wall; (d) bottom interior of wall (south and middle panels); (e) bottom interior of wall (north panel); (f) bottom interior of wall (south and middle panels); and (g) bottom interior of wall (north panel).

Figure 5.17 shows the damage state of Specimen A-19 at lateral strength. Lateral strength occurred at 8% global drift ratio in the push loading direction and 8% global drift ratio in the pull loading direction. The relative drift ratio at strength was 5.3% in the push direction and 5.3% in the pull direction. At strength, multiple cracks had formed in the stucco along the exterior face of the specimen; see Figure 5.17(a). Most of the cracks propagated vertically, and the largest crack openings occurred near both corners of the cripple wall; see Figure 5.17(b) and (c). The crack openings were as large as a 1/4-in. thick, indicating that the stucco had detached from the furring nails at the sill plate and bottom of the studs. On the interior of the cripple wall, 1/2-in. uplift of the plywood and corner studs occurred at the ends of the specimens. The uplift caused splitting of the blocking at the end stud bays; see Figure 5.17(d). The plywood panels were crushed due to their bearing on the flat studs at both ends of the specimen; see Figure 5.17(e). The panels exhibited large rotations; see Figure 5.17(f). Many of the nails showed partial pull through at the bottom and sides of the panels, and some of the nails had torn through the edges near the locations of the anchor bolts; see Figure 5.17(g).

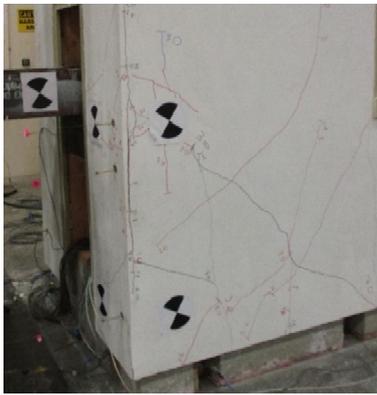
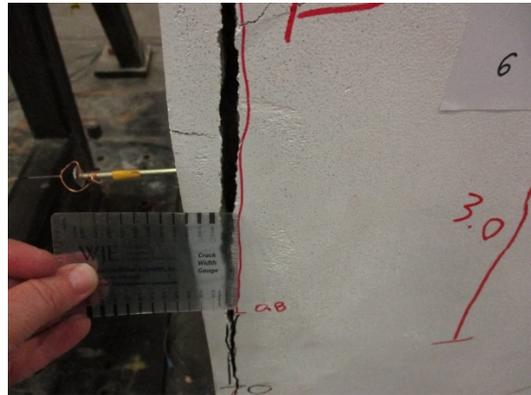
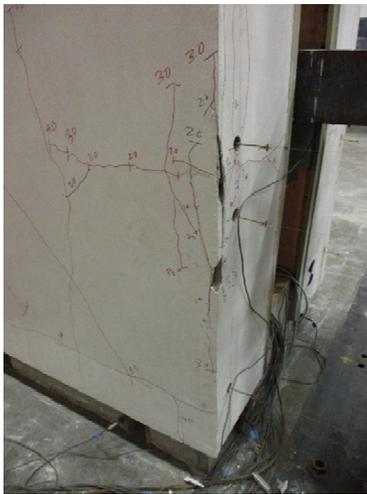
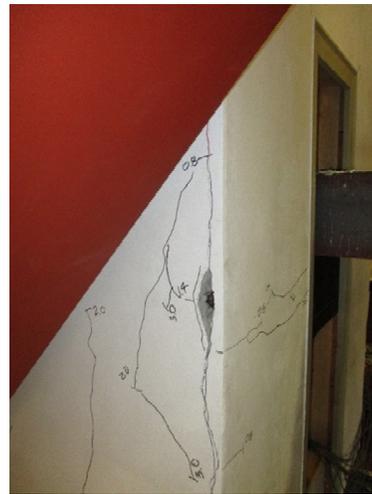
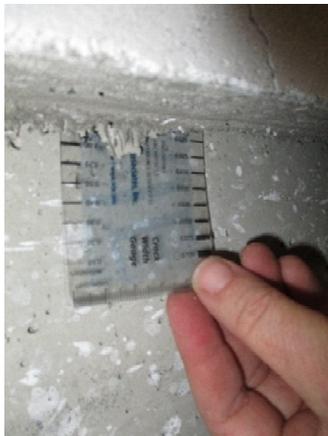
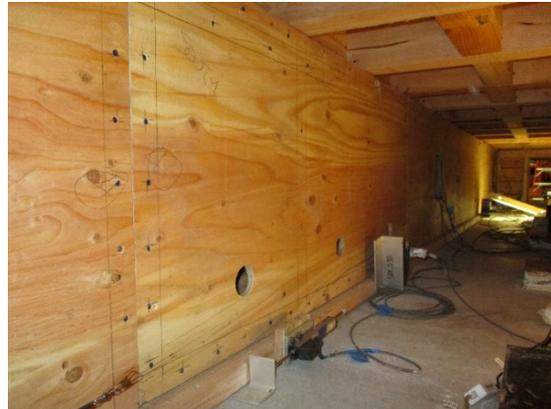
**Figure 5.19 Specimen AL-2 damage state of at lateral strength @ 3% drift ratio,  $\Delta = +0.72$  in.:** (a) bottom of southwest corner; (b) southwest corner detail; (c) bottom of northwest corner; (d) middle of southwest corner; (e) gap between stucco and foundation; and (f) middle of north-end of crawlspace.

Specimen AL-2 reached lateral strength at approximately 3% drift; see Figure 5.18 damage state at this drift level. At the end walls and corners, cracks at the floor line widened to approximately 1/8 in.; see Figure 5.18(a) and (b). The stucco was pushed off of the end walls, and limited small pieces of stucco started falling off at corners; see Figure 5.18(c) and (d). At the north and south walls, popping noises were heard, corresponding to debonding of the stucco from the foundation. A gap of approximately 1/16 in. was measured between the foundation and the stucco; see Figure 5.18(e). Like Specimen AL-1, later selective demolition identified that furring nails at the foundation sill plate had been pulled out of the stucco; it is believed that this occurred at the time the stucco debonded from the foundation. There was no observable damage to the retrofit; see Figure 5.18(f). No uplift of the cripple wall relative to the foundation was observed.

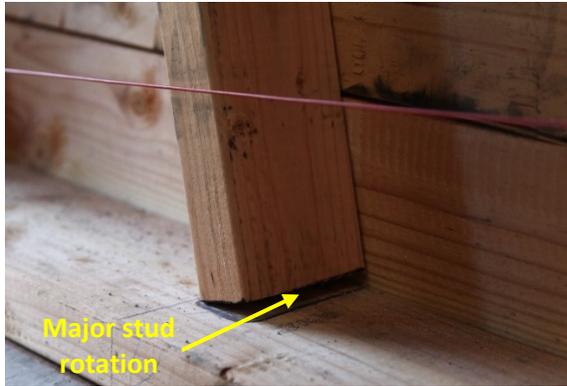
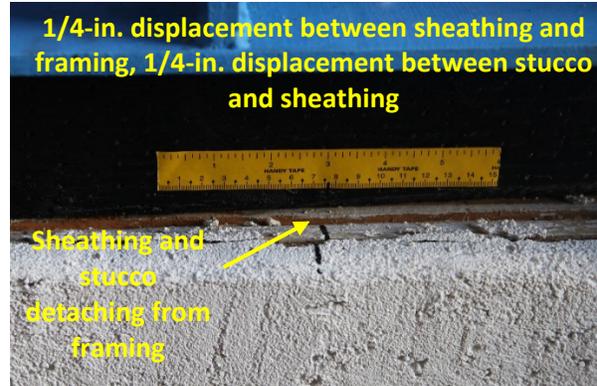
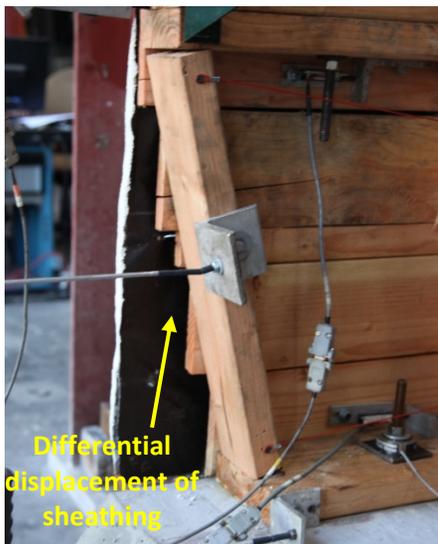
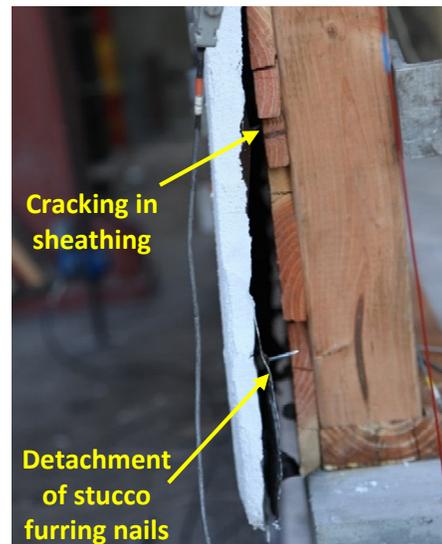
**Figure 5.20** Specimen A-1 damage state at 60% post-peak reduction of lateral strength @ +12% drift,  $\Delta = +2.88$  in.: (a) close-up of studs and sill plate; (b) exterior top of the wall; (c) north-end interior corner; and (d) north-end bottom of corner.

Figure 5.19(a) to (d) shows the damage state of Specimen A-1 at +12% drift ratio. Specimen A-1 never reached an 80% drop in lateral strength. The damage state at 12% correlates closer to a 60% drop in lateral strength. At this stage, the stucco is connected only to the top plate and top row of furring nails on the studs. As shown in Figure 5.19 (c) and (d), almost all of the furring nails remained attached to the sheathing and pulled away from the wire lath in the stucco. At the top of the wall, the displacement between the stucco and sheathing was 1/4 in. and between the sheathing and the framing had grown to 1/4 in. In addition, the gaps occurred at the interface of both the stucco and sheathing as well as sheathing and framing. At this point, the stucco provided negligible lateral resistance. The source of capacity was due to the stacking of (bearing between) the horizontal sheathing boards bearing on the foundation. In Figure 5.20(c), the gaps between all but the top sheathing board had closed. Cracks formed on the corners of the sheathing boards where the nails were located. Figure 5.20 shows photographs of the cripple wall in its residual state at the end of testing after a +5.0 in. (+20% drift ratio) monotonic push. There was a residual displacement of +4.90 in. (+20.4% drift ratio) once the load was removed.

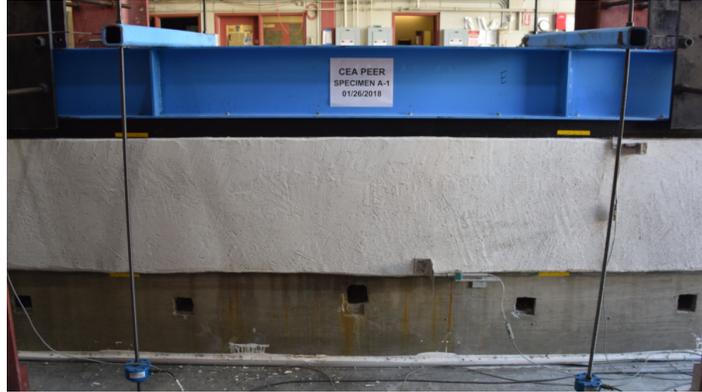
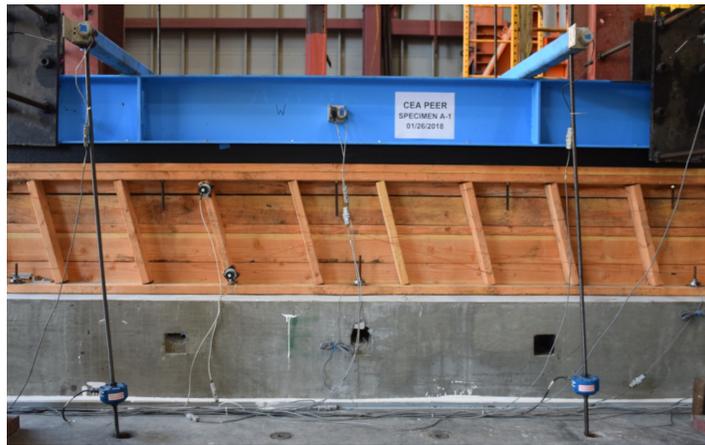
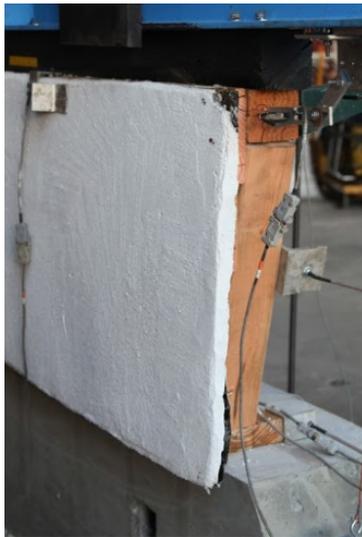
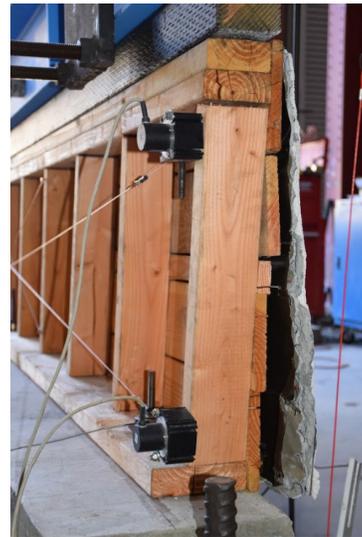
**Figure 5.21 Specimen A-1 post-test photographs (lateral load = 0 kips, residual displacement = +4.90 in. @ +20.4% drift): (a) exterior elevation of cripple wall; (b) interior elevation of cripple wall; (c) north-end exterior corner view; and (d) south-end interior corner view.**

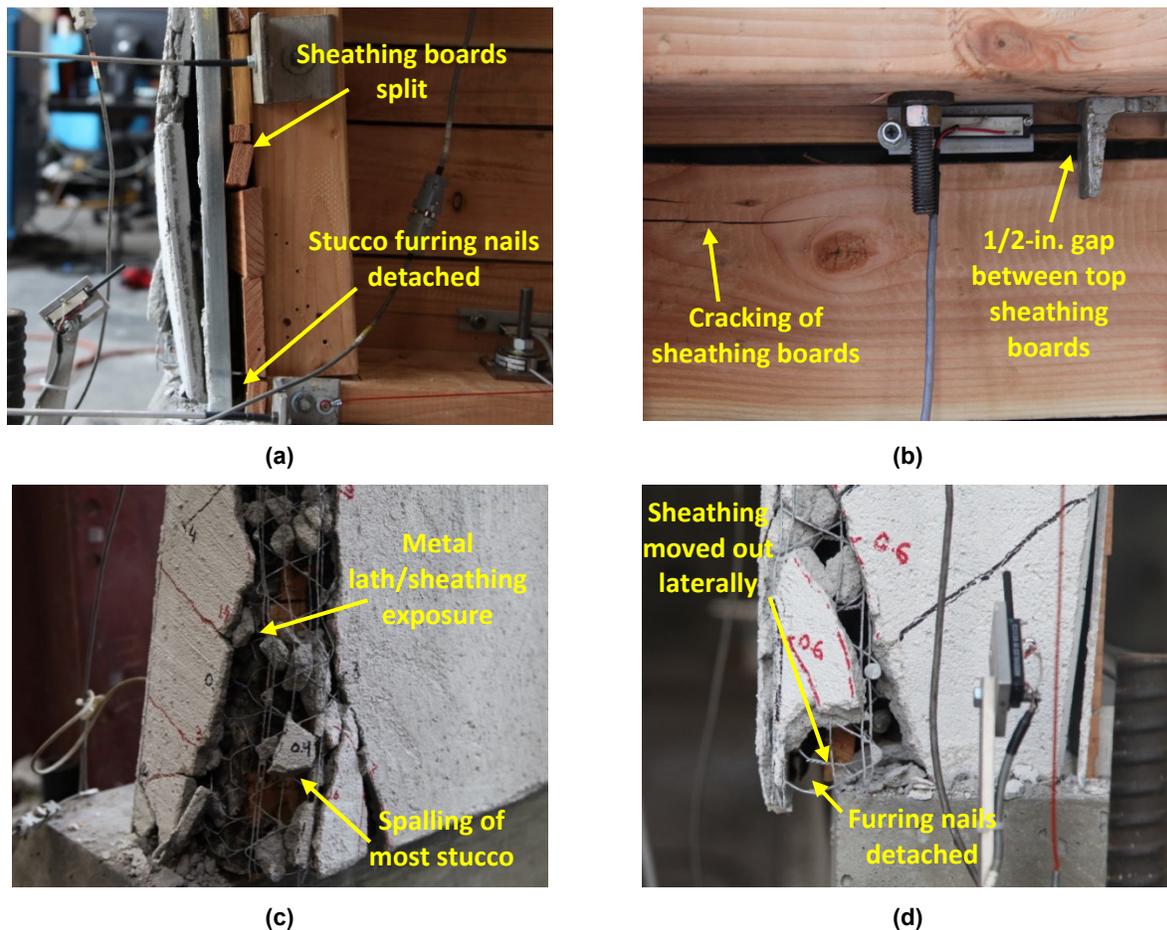
**Figure 5.22** Specimen A-2 damage state of at 70% post-peak reduction of lateral strength @ +12% drift,  $\Delta = +2.88$  in.: (a) north-end of interior corner bottom; (b) close-up of top of interior wall; (c) south-end of exterior bottom corner; and (d) north-end of bottom corner.

Figure 5.21(a) to (d) shows the damage state of Specimen A-2 at +12% drift ratio. Specimen A-2 never reached an 80% drop in lateral strength. The damage state at 12% correlates closer to a 70% drop in lateral strength. The stucco completely detached over the majority of the wall. The only attachment was at the dense furring nail arrangement at top. Figure 5.21(d) shows extensive movement of the stucco away from the sheathing at the base as well as around a 1/4 in. of movement of the sheathing board away from the framing. Much of the stucco had spalled off of the corners, coming off in large chunks. Sheathing boards on the corners had mostly split. A 3/8-in. gap had formed between the top two sheathing boards, which was due to the top sheathing board being fastened to the top plates while the other sheathing boards were attached to the studs. The capacity of the wall is attributed again the sheathing boards stacking (bearing) on each other and bearing on the foundation. Figure 5.22 shows photographs of the cripple wall in its residual state at the end of testing, after a +4.50 in. (+18.8% drift ratio) monotonic push. There was a residual displacement of +3.45 in. (+14.4% drift ratio) once the load was removed.

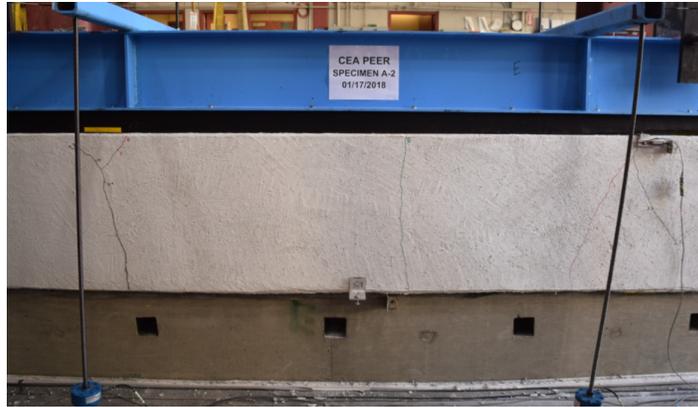
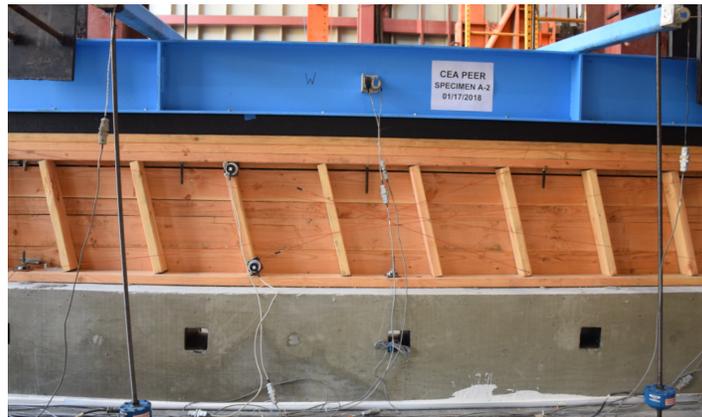
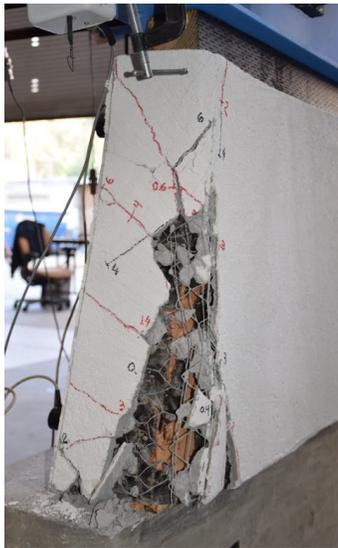
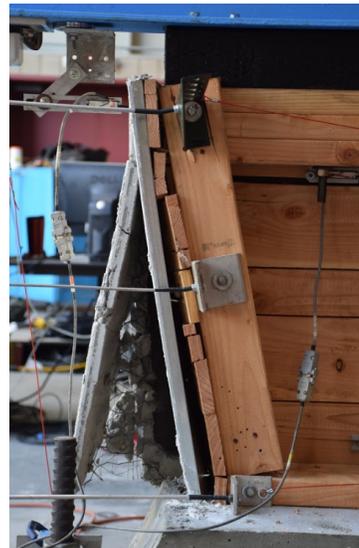
**Figure 5.23** Specimen A-2 post-test photographs (lateral load = 0 kips, residual displacement = +3.45 in @ +14.4% drift): (a) exterior elevation of cripple wall; (b) interior elevation of cripple wall; (c) south-end exterior corner view; (d) north-end interior view.

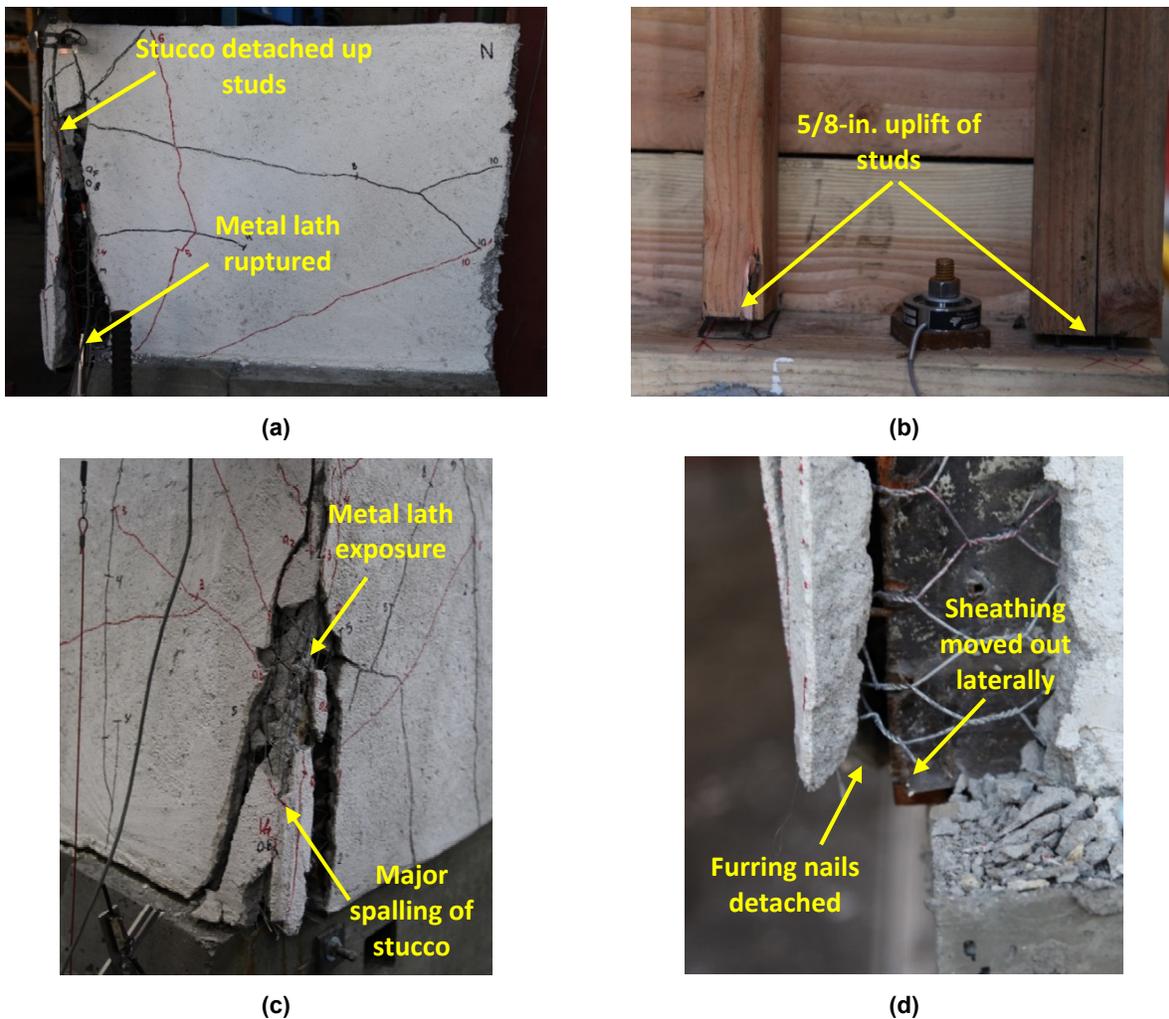
**Figure 5.24** Specimen A-3 damage state at 60% post-peak reduction of lateral strength @ -12% drift,  $\Delta = -2.88$  in.: (a) exterior view of north-end return wall; (b) interior of bottom of south-end return wall; (c) bottom of south-end exterior corner; (d) bottom of north-end corner.

Figure 5.23(a) to (d) shows the damage state of Specimen A-3 at -12% drift ratio. Specimen A-3 never reached an 80% drop in lateral strength. The damage state at 12% correlates closer to a 60% drop in lateral strength. Extensive horizontal cracks had propagated across the return walls; a massive gap between the return wall and stucco face is clearly visible. Again, the only attachment of the stucco on the face remained at the top plates. The face stucco acted as a rigid body, providing little lateral resistance. Like Specimen A-2, the sheathing boards stacked (bore) on each other, providing the majority of the remaining strength in the wall. This stacking caused the sheathing nails to pull away from the framing, which is evident in Figure 5.23(d). Significant rotation of the studs on the return walls occurred; see Figure 5.23(b). Figure 5.24 shows the cripple wall in its residual state at the end of testing, after a +5.0 in. (+20.8% drift ratio) monotonic push. There was a residual displacement of +4.51 in. (+18.8% drift ratio) once the load was removed.

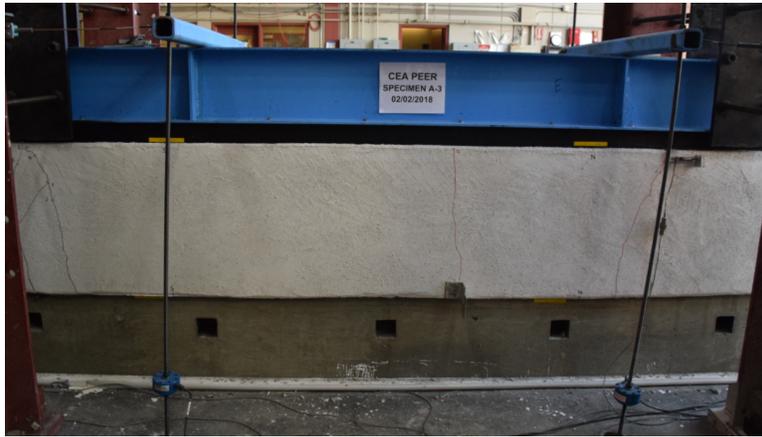
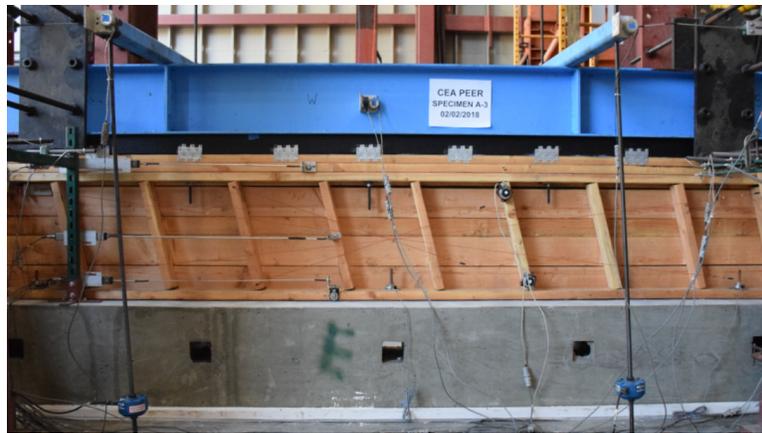
**Figure 5.25** Specimen A-3 damage state at 80% post-peak reduction of lateral strength @-12% drift,  $\Delta = -2.88$  in.: (a) exterior elevation (b) bottom of north-end interior corner; (c) north-end exterior corner; and (d) top-down view of exterior.

Figure 5.25(a) to (d) shows the damage state of Specimen A-4 at -12% drift ratio. Specimen A-4 achieved an 80% loss of strength before the monotonic push was implemented. Unlike the previous three specimens, the stucco detached from both the bottom and top of the wall; see Figure 5.25(c) and (d). At this point, the stucco provided almost no lateral resistance. The stucco completely detached at the corners and many of the sheathing boards split; see Figure 5.25(b). Like the previous three tests, the majority of the lateral resistance can be attributed to the bearing of the sheathing boards on the foundation. Figure 5.26 shows photographs of the cripple wall in its residual state at the end of testing, after a +4.70 in. (+19.6% drift ratio) monotonic push. There was a residual displacement of +3.43 in. (+14.3% drift ratio) once the load was removed.

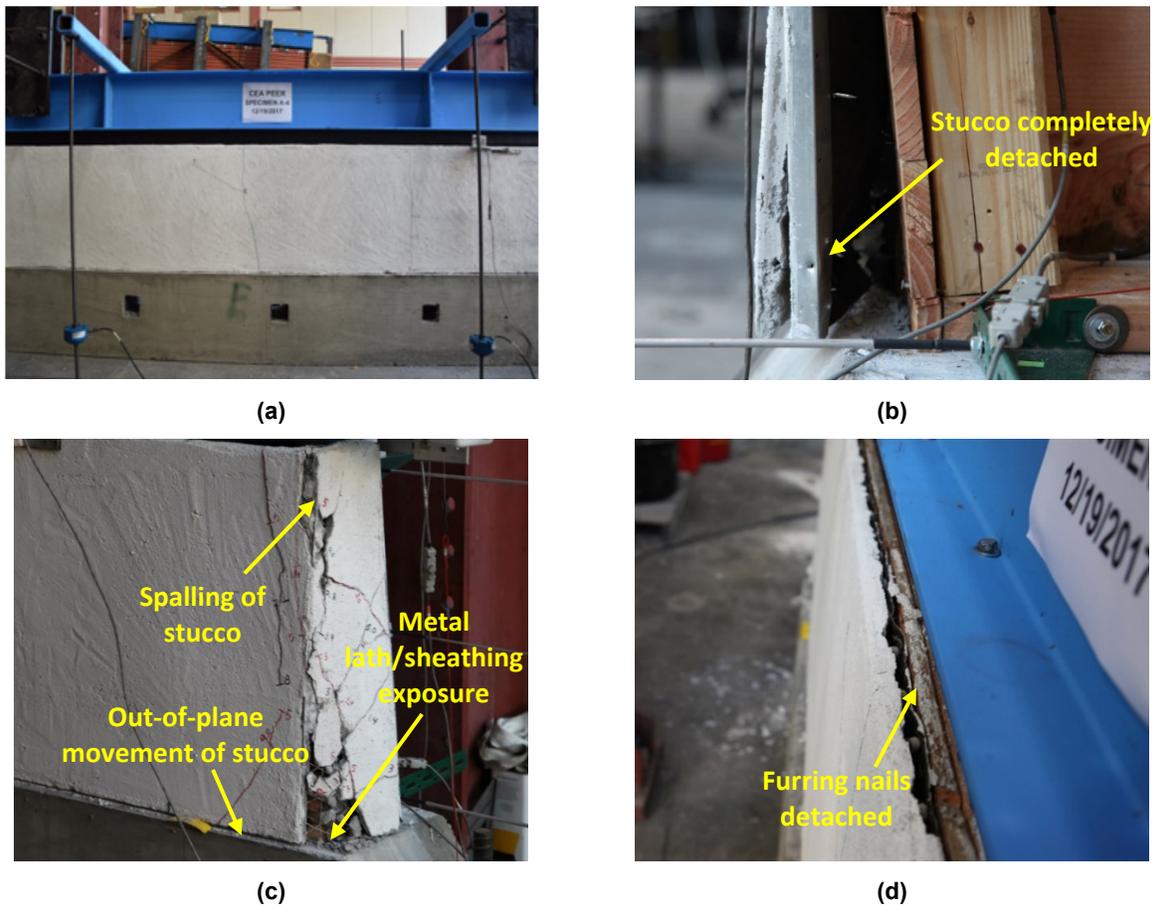
Figure 5.26 Specimen A-4 damage state at 80% post-peak reduction of lateral strength @ -12% drift,  $\Delta = -2.88$  in.: (a) exterior elevation; (b) bottom of north-end interior corner; (c) north-end exterior corner; and (d) bottom of north-end corner.

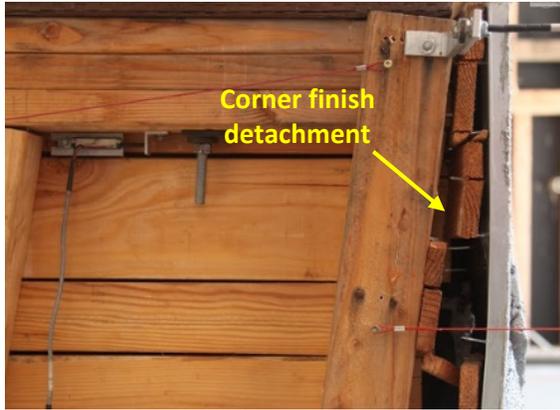
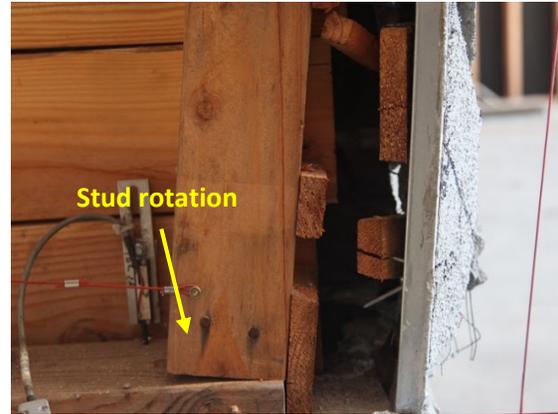
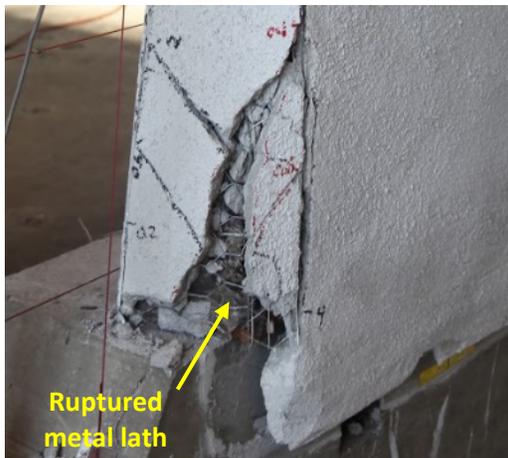
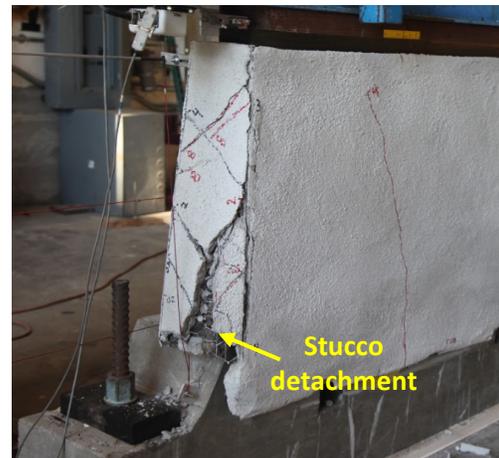
**Figure 5.28** Specimen A-20 damage state at 20% residual lateral strength at -14% drift ratio @  $\Delta = -3.36$  in. unless otherwise noted: (a) top of south-end interior of wall at +14% drift; (b) bottom of south-end interior of wall at +14% drift; (c) bottom of south-end exterior corner of wall; and (d) south-end exterior corner of wall.

The loss of strength was primarily due to the detachment of the stucco from most of the cripple wall as the horizontal sheathing boards do not provide a large amount of lateral resistance relative to the contribution from the stucco. Figure 5.28 shows the residual state of the specimen is shown after a monotonic push to +5.0 in. (+20.8% drift ratio). The residual displacement was +4.81 in. (+20.0% drift ratio). Along the exterior face, no additional vertical cracks propagated post-strength, but the cracks at the edges had opened significantly; see Figure 5.28(a) and (c). At this point, the only remaining attachment of the stucco to the framing was at the top plates, while the stucco was nearly fully detached at the corners; see Figure 5.28(d). Along the interior of the cripple wall, there was little visible damage to both the framing and the sheathing boards; see Figure 5.28(b).

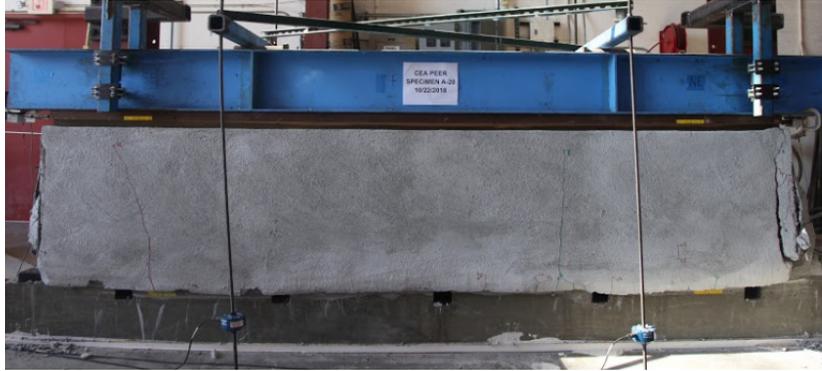
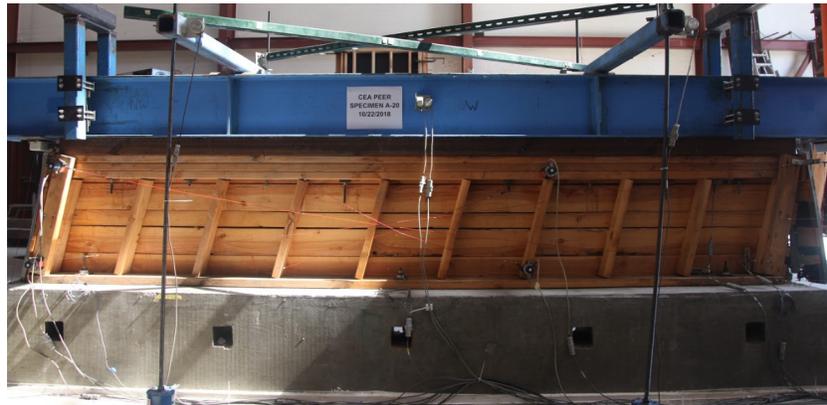
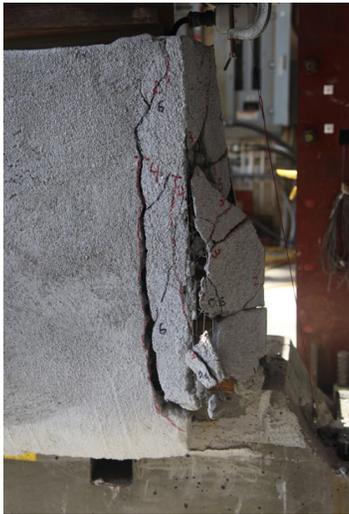
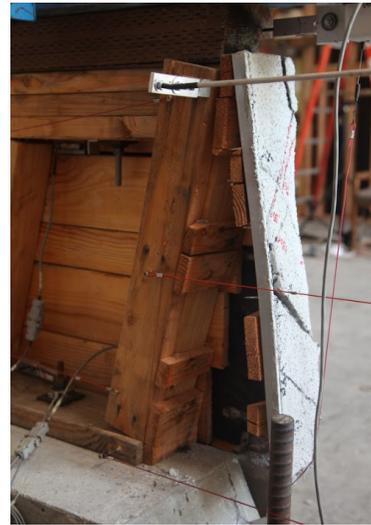
**Figure 5.29** Specimen A-20 post-test photographs at lateral load = 0 kips, residual displacement = +4.81 in. (+20.0% drift ratio) after monotonic push to +5.0 in. (+20.8% drift ratio): (a) exterior elevation; (b) interior elevation; (c) north-end exterior corner of wall view; and (d) south-end interior corner of wall view.

Specimen AL-1 dropped to approximately 20% of the lateral strength at a drift ratio of between 6 and 7%; see damage state in Figure 5.29. At the end wall and corners, the stucco continued to deteriorate and be pushed off of end wall sheathing and framing. Gaps of up to approximately 1/2 in. were observed between stucco and sheathing at the end walls and corners. At the north and south walls for 4% drift and above, only very limited spreading or additional cracks were observed. At the end walls, the stucco cracked open at corners, exposing the wood sheathing below.

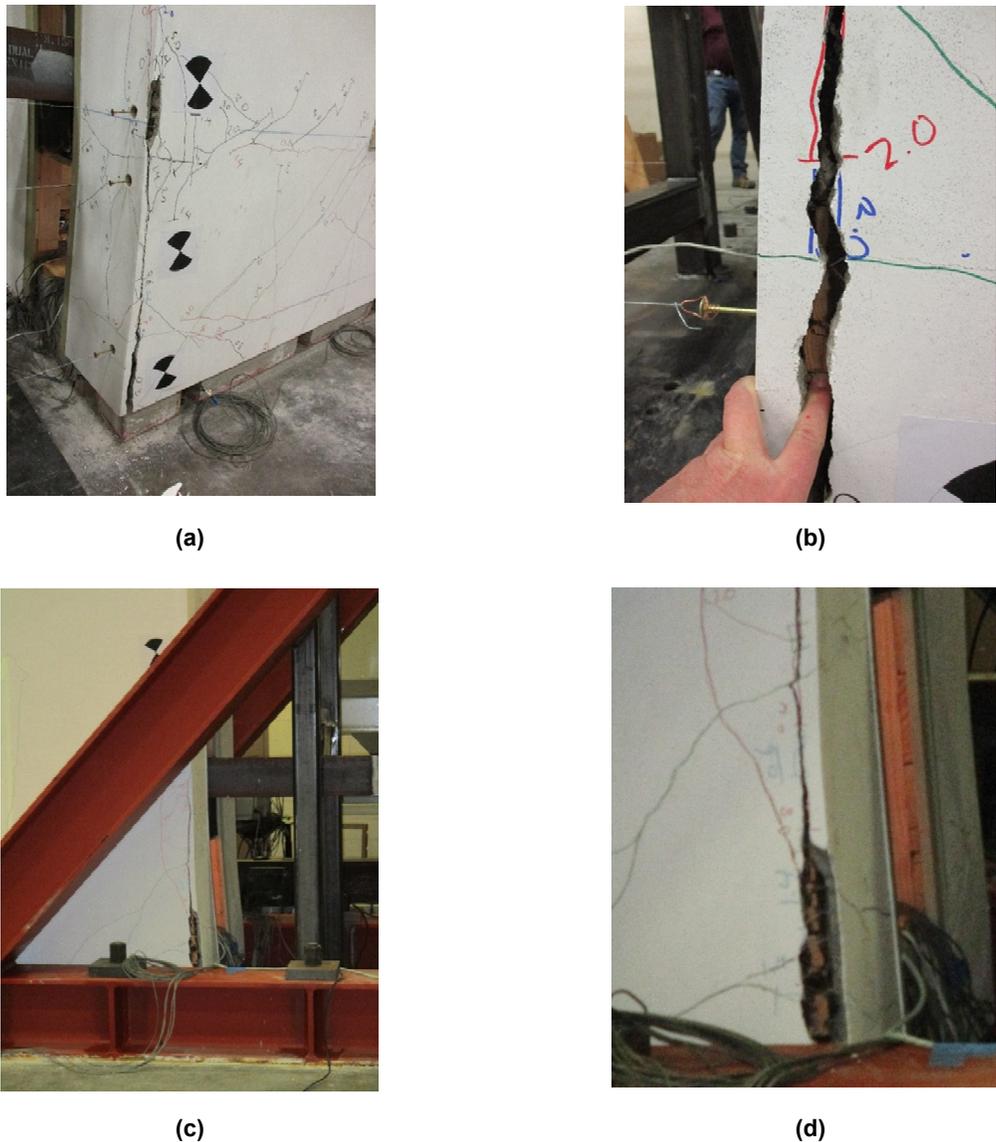
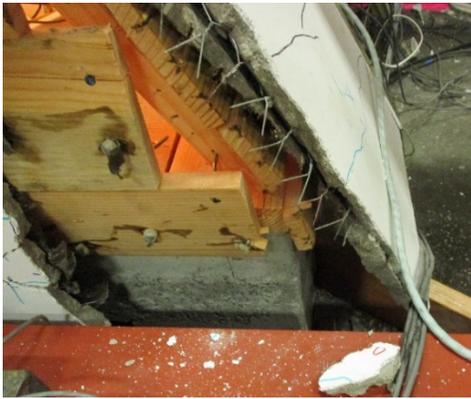
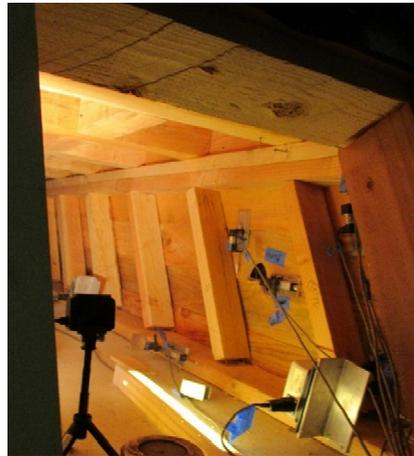
**Figure 5.30** Specimen AL-1 photographs after cyclic testing to 6 to 8% drift ratio: (a) bottom of southwest corner; (b) southwest corner detail; (c) bottom of northeast corner; and (d) bottom of southeast corner detail.

Figure 5.30 shows the damage state of Specimen AL-1 at the end of the final monotonic push. The final monotonic push took the 24-in.-tall cripple wall to a 10-in. (40%) drift. The already separated stucco was pushed away at the east end and sucked under the cripple wall at the west end. Horizontal sliding of the lumber sheathing was clearly visible, with the sheathing nails being fully withdrawn from lower sheathing boards towards the end of the monotonic push. Even with the sheathing board nails being withdrawn, the overlying stucco tended to hold the lumber sheathing boards in place.

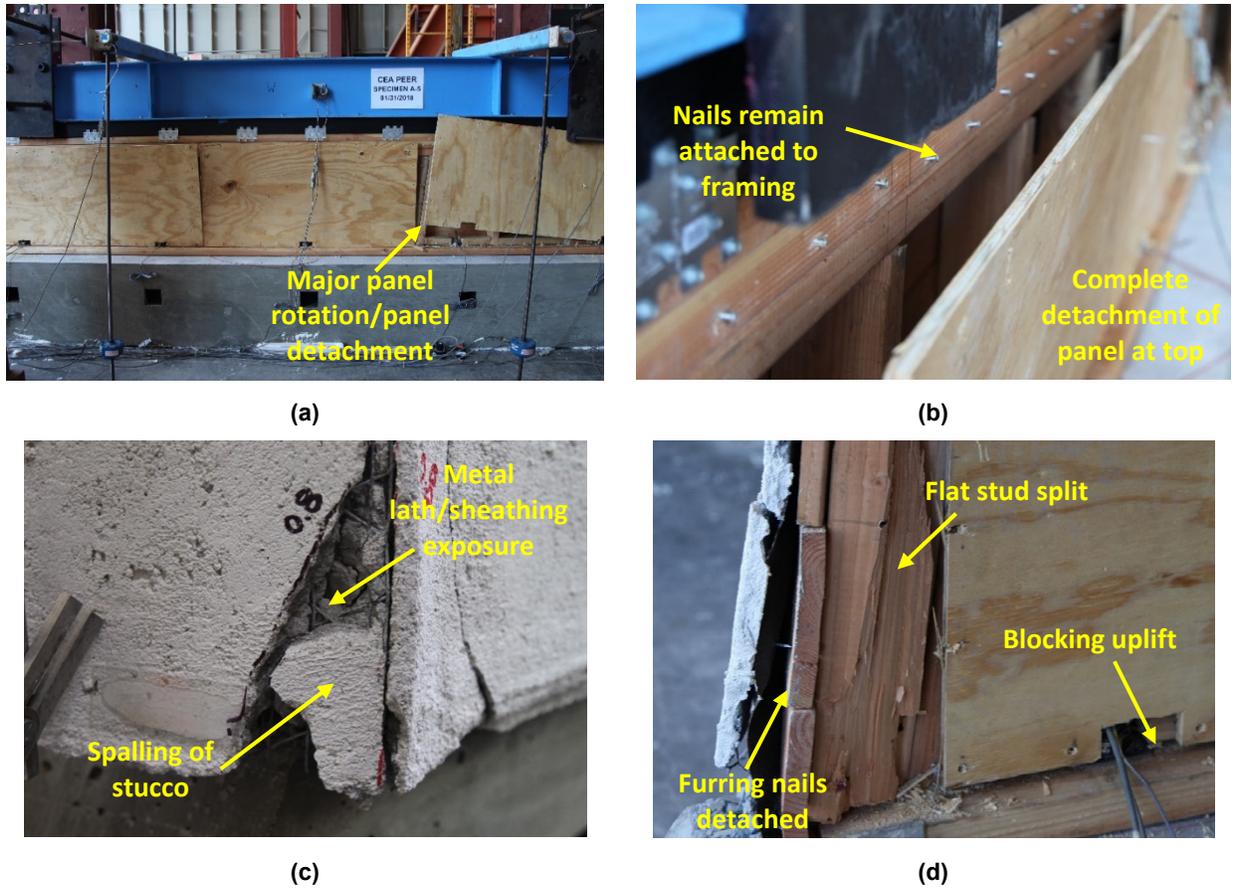
**Figure 5.32** Specimen A-5 damage state at 80% post-peak reduction of lateral strength @ -11% drift,  $\Delta = -2.64$  in.: (a) interior elevation; (b) top-down view of interior; (c) close-up of exterior south-end corner; and (d) close-up of interior north-end corner.

A-2. Figure 5.32 shows photographs of the cripple wall in its residual state at the end of testing, after the end of the 11% drift ratio cycle group. After the wall was unloaded at -11% drift ratio (-2.64 in.), a residual displacement of -1.74 in. (-7.3% drift ratio) remained.

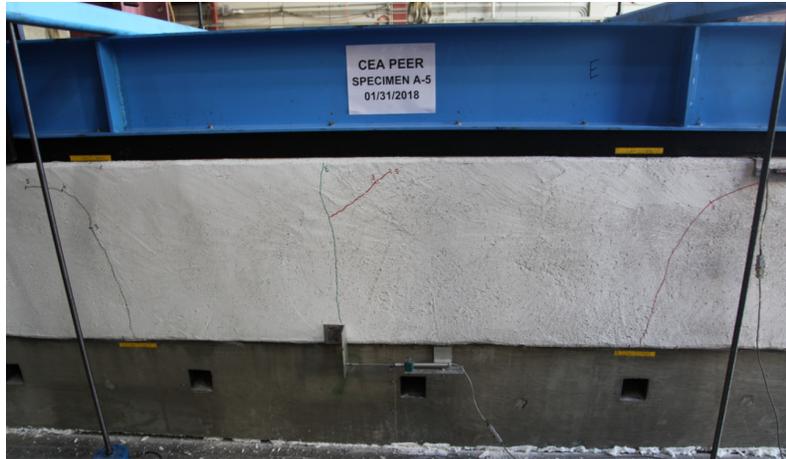
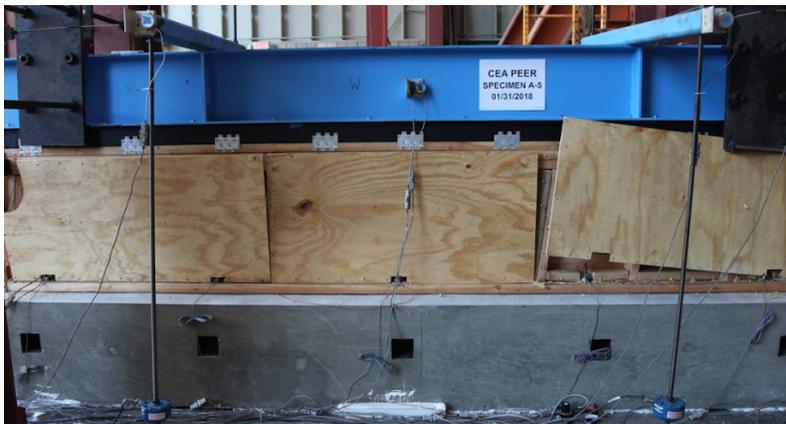
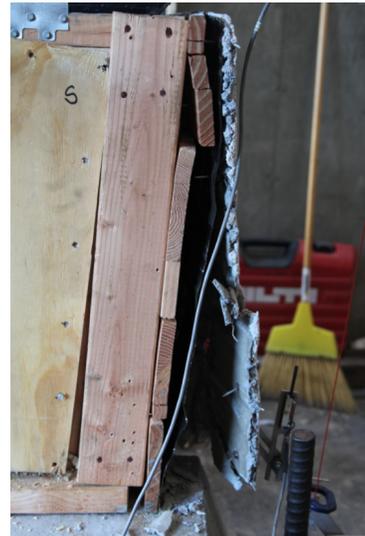
**Figure 5.33** Specimen A-5 post-test photographs at lateral load = 0 kips and residual displacement = -1.74 in. @ -7.3% drift: (a) exterior elevation of cripple wall; (b) interior elevation of cripple wall; (c) north-end exterior corner view; and (d) south-end interior corner view.

Figure 5.33 shows the state of Specimen A-10 at -12% global drift ratio, corresponding to an 80% drop in lateral strength. The stucco finish had detached from most of the furring nails on the studs and remained only attached to the furring nails at the top plates and the tops of the studs, a response similar to that of all wet finished (stucco) specimens. This is indicated by the large cracks in the stucco at the corners; see Figure 5.33(d). Along the interior, the plywood panels had rotated heavily and were detached from the framing at many locations; see Figure 5.33(a) and (c). Most of the nails at the bottom of panels failed either through edge tear-out or head pull-through; see Figure 5.33(b). At the corners, most of the sheathing boards had split. Many of the sheathing boards also detached from the framing when the stucco had fully detached from the framing, as seen in Figure 5.33(a).

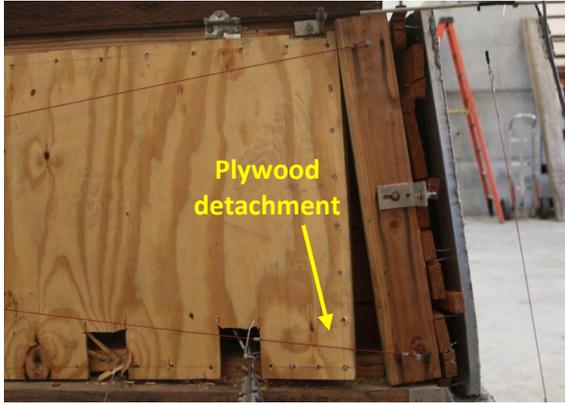
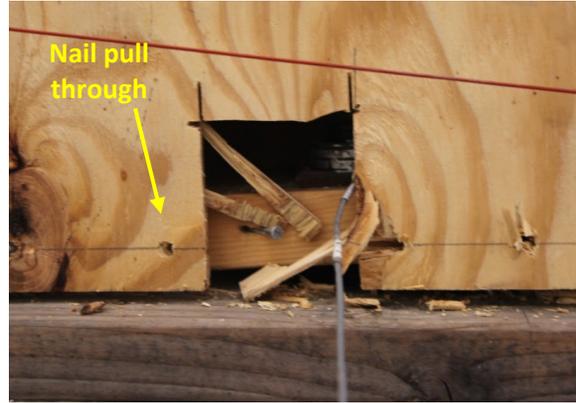
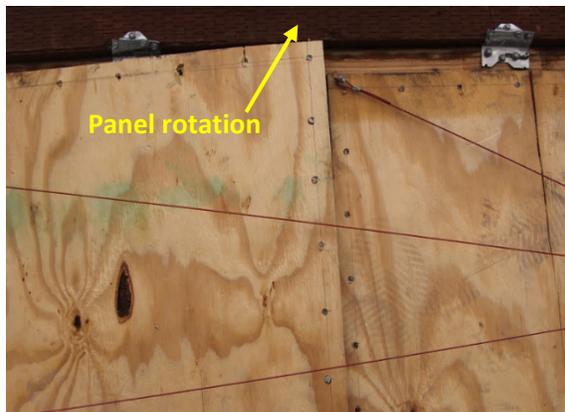
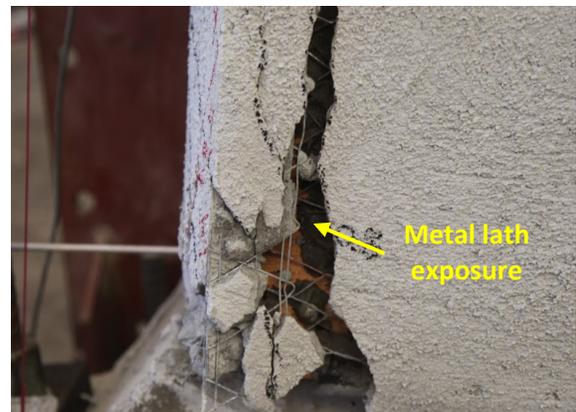
**Figure 5.34** Specimen A-19 damage state at 20% residual lateral strength @ -11% drift,  $\Delta = -2.64$  in.: (a) interior elevation; (b) top-down view of interior; (c) close-up of exterior south-end corner; and (d) close-up of interior north-end corner.

In Figure 5.34, the residual state of the specimen is shown after a monotonic push to +5.0 in. (+20.8% drift ratio) for a residual displacement of +4.26 in. (+17.8% drift ratio). Along the exterior face, no additional vertical cracks propagated post-strength, but the cracks at the edges had opened significantly; see Figure 5.34(a) and (c). The metal lath at the north corner had ruptured from the bottom of the wall all the way to the bottom of the top plates. The only remaining attachment of the plywood panels was at the top of the cripple walls. The north panel had nearly completely detached; see Figure 5.34(b). In addition, the plywood panels had crushed against the flat end studs. The blocking remained relatively intact.
