# PACIFIC EARTHQUAKE ENGINEERING RESEARCH CENTER

## **Comparison of the Response of Small- and Large-Component Cripple Wall Specimens Tested under Simulated Seismic Loading**

**A Report for the “Quantifying the Performance of  
Retrofit of Cripple Walls and Sill Anchorage in Single-  
Family Wood-Frame Buildings” Project**

PEER Report 2020/21

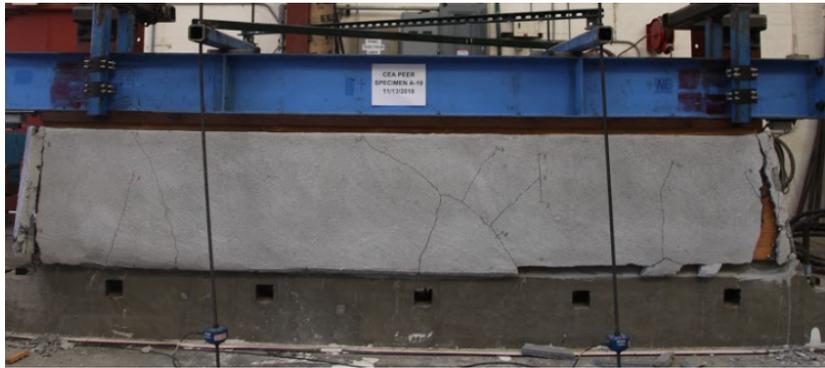
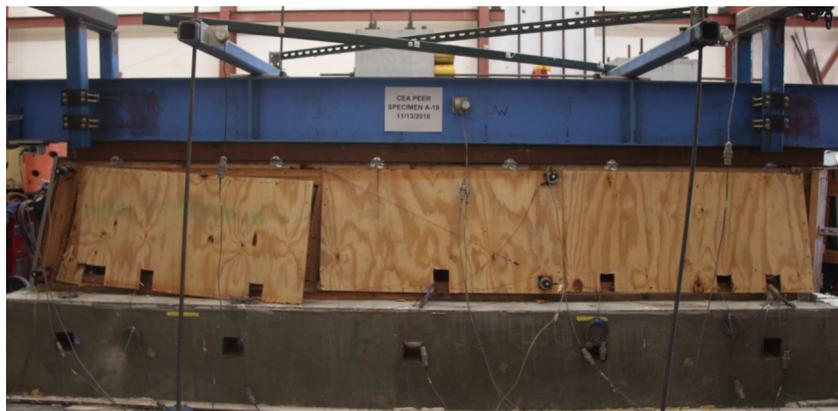
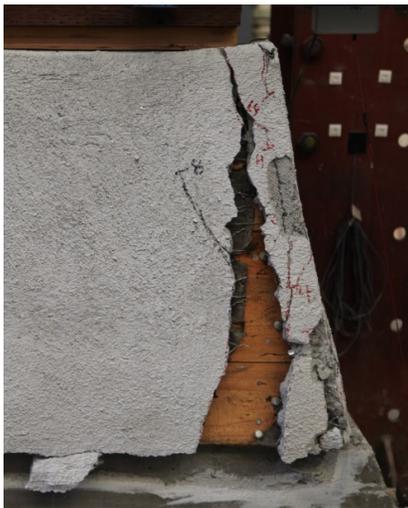
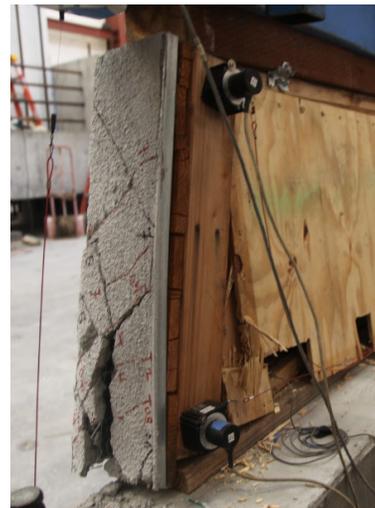
**Figure 5.35** Specimen A-19 post-test photographs at lateral load = 0 kips and residual displacement = +4.26 in. (+17.8% drift ratio) after monotonic push to +5.0 in. (+20.8% drift ratio): (a) exterior elevation; (b) interior elevation; (c) north-end exterior of wall view; and (d) north-end interior corner of wall view.

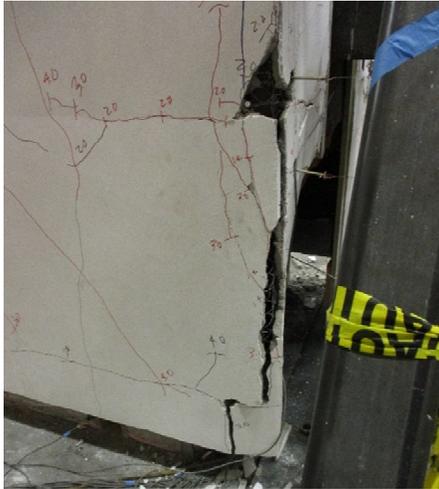
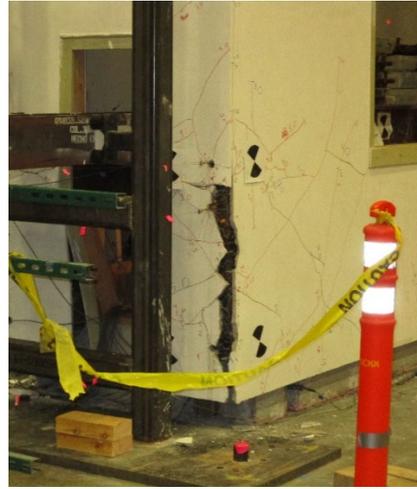
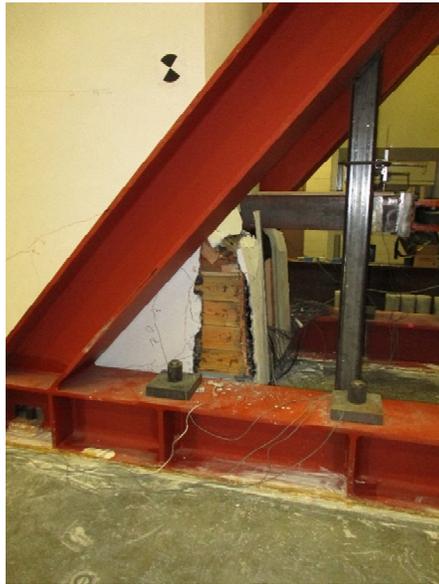
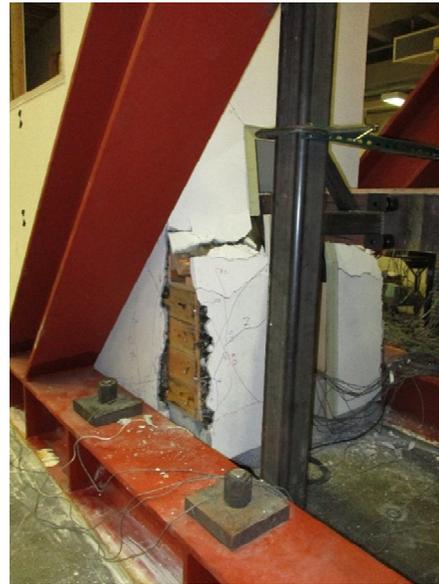
**Figure 5.36** Specimen AL-2 during the final monotonic push to 40% drift ratio: (a) bottom of northwest corner; (b) bottom of southwest corner; (c) east-end of wall; and (d) northeast-end of wall.

In the final monotonic push, the diaphragm and upper top plate were pushed off from the lower top plate and cripple walls. The cripple walls remained at a very low drift, while the majority of the actuator displacement was taken up in diaphragm sliding.

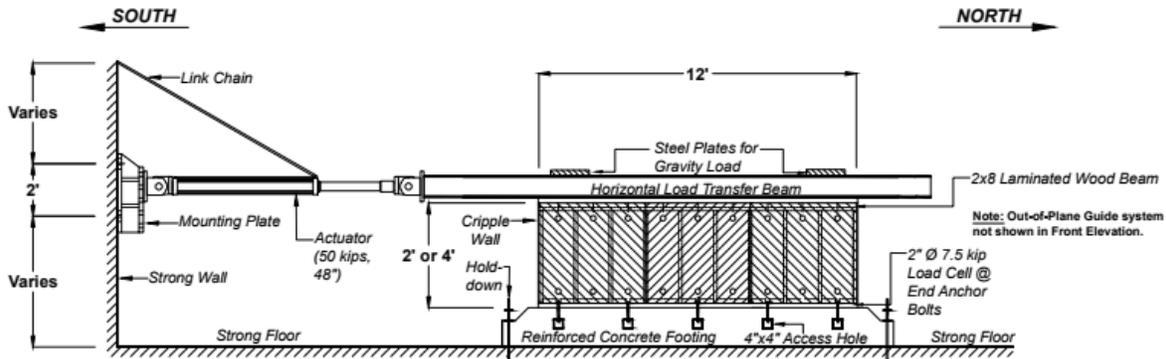
Figure A.1 Group A small-component test setup (2 ft and 4 ft CW) is proposed to be similar to that used in CUREE testing by Chai et al. [2002].

**Tests:** Twenty-eight tests with varying materials, condition, year of construction, and load path connections (consistent with year of construction); see Table A.1 and Figures A.1 and A.2. It is noted that the setup adopted in the UC Davis cripple wall test program [Chai et al. 2002] is proposed with modified edge conditions for specimens finished in stucco to capture the additional restraint anticipated at the floor and end-wall boundaries.

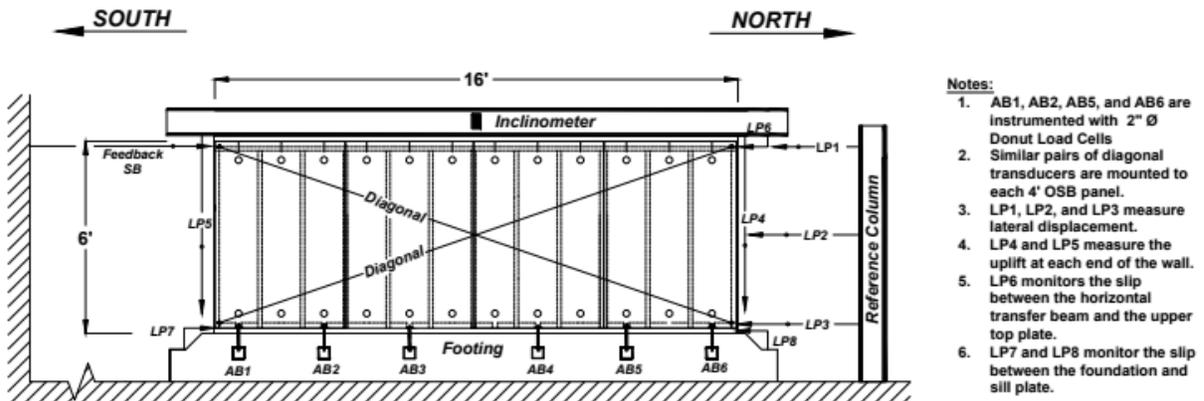
Figure A.2 Group A small-component instrumentation setup (6 ft CW) is proposed to be similar to that used in CUREE testing by Chai et al. [2002].

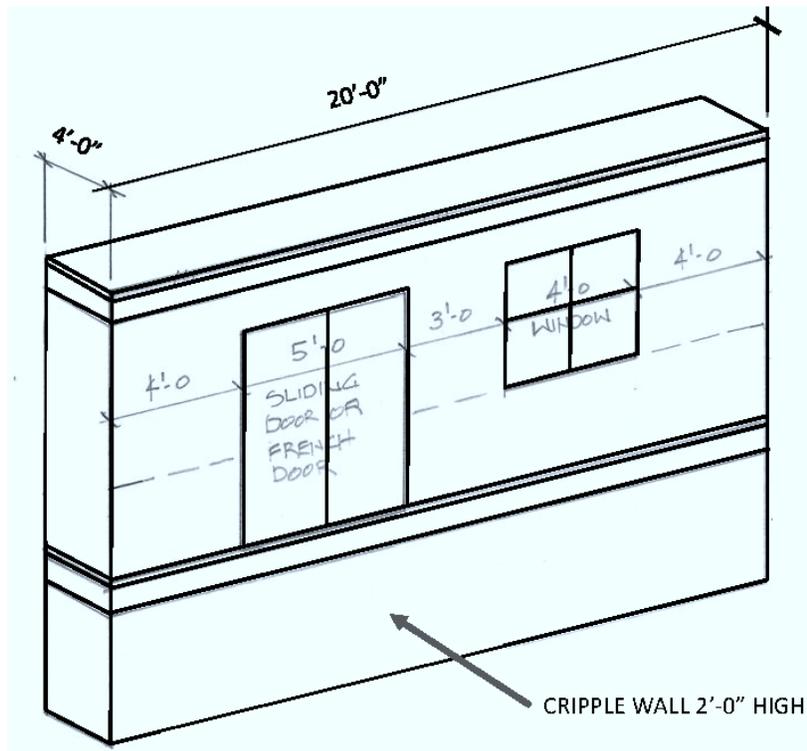
**Figure A.3** Group A large-component test setup is proposed to be similar to that used in CUREE-CEA testing by Arnold et al. [2003] i.e., *CUREE EDA-03* and *CUREE EDA-07*.

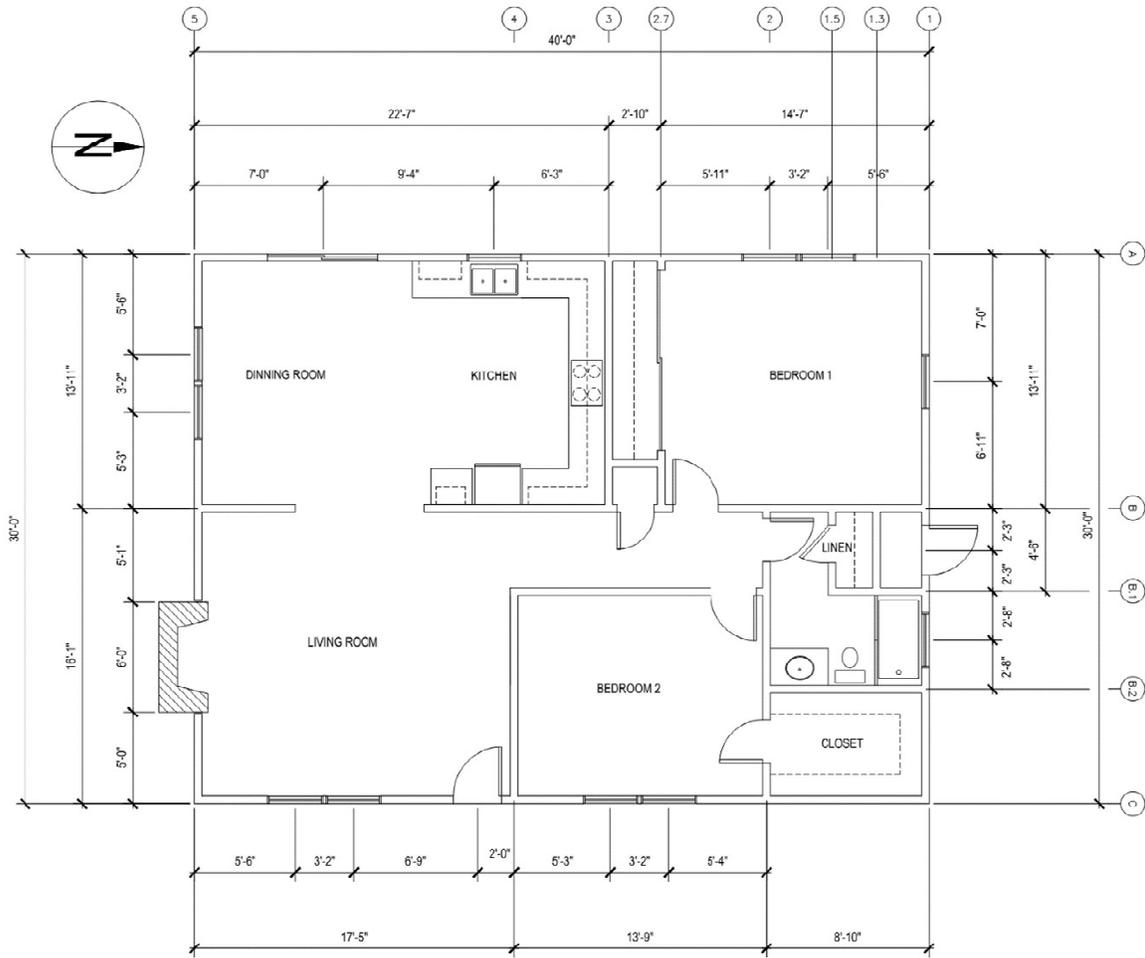
**Figure B.1 PEER-CEA Project Earthquake Damage Workshop Case Study Building 1 and Case Study Building 2 plan [Vail et al. 2020]**

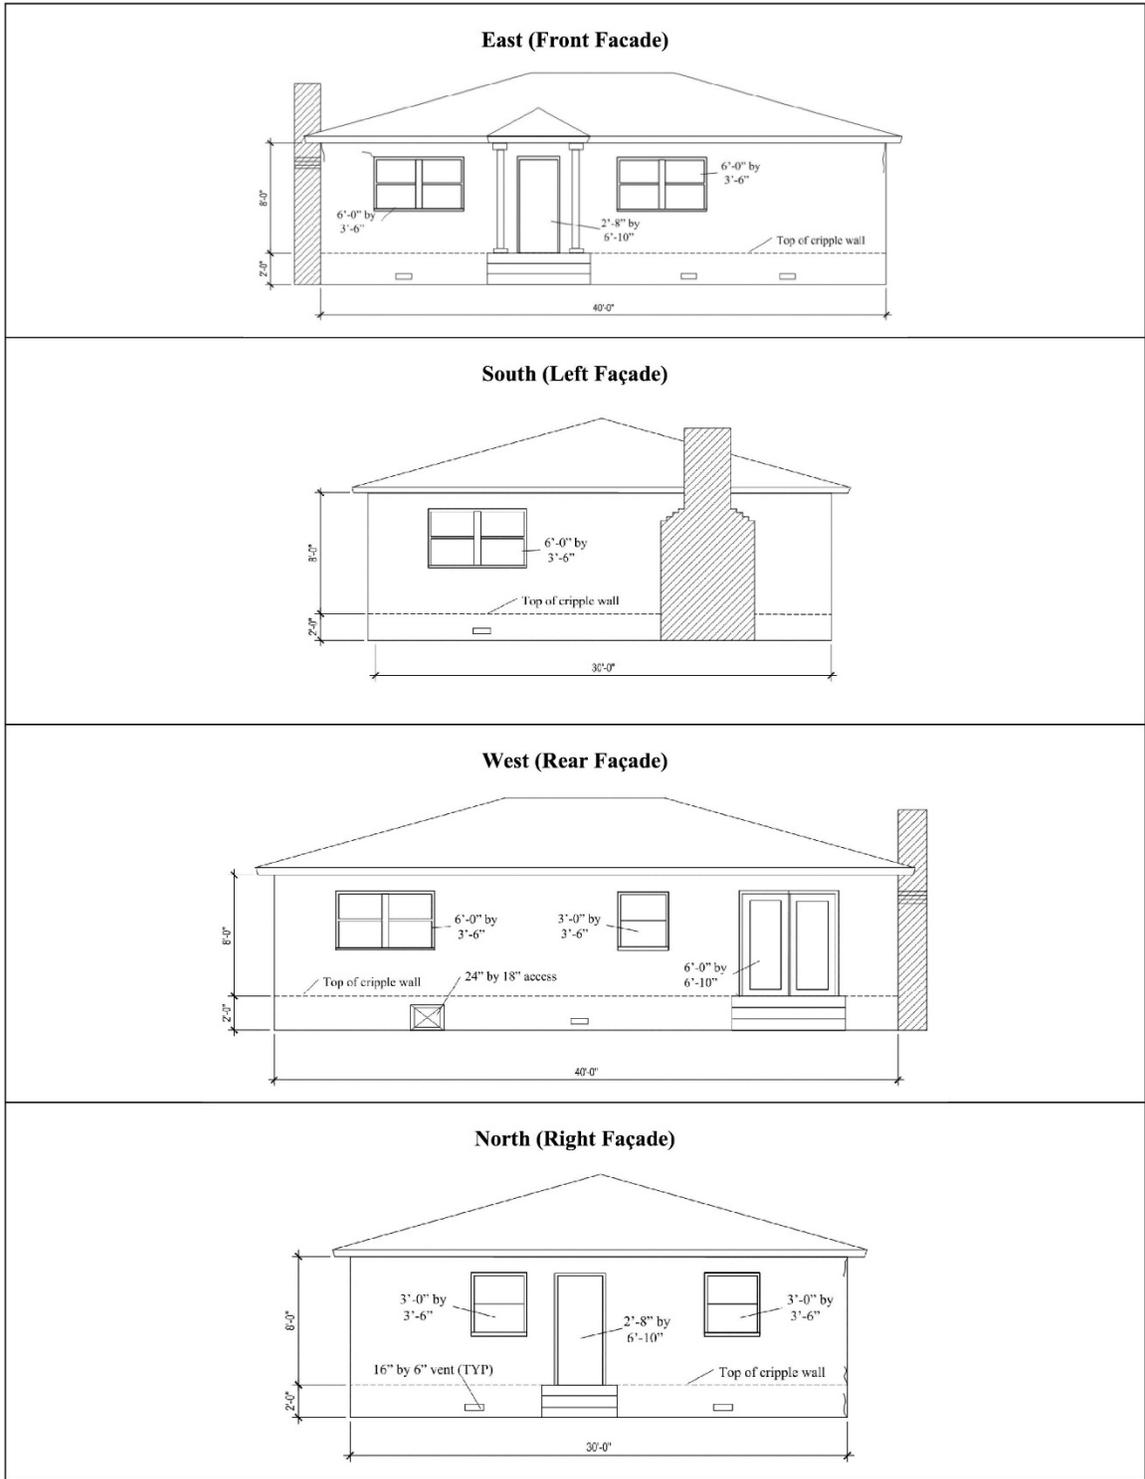
**Figure B.2 PEER-CEA Project Earthquake Damage Workshop Case Study Building 1 exterior elevations [Vail et al. 2020]**

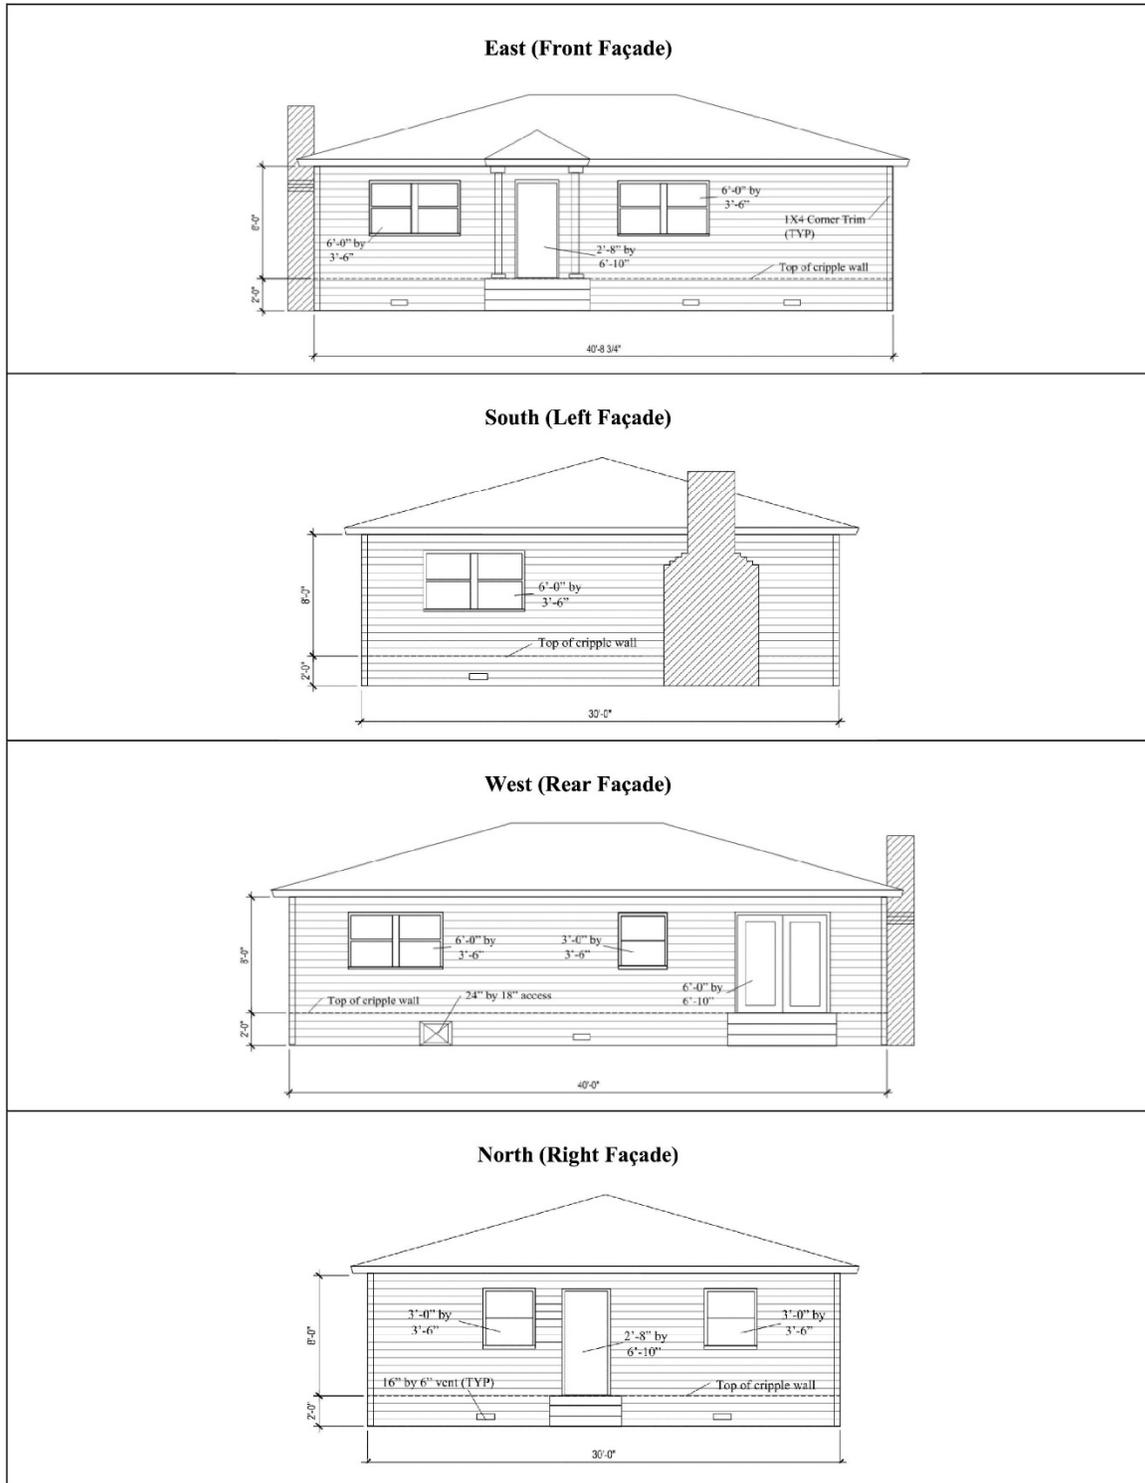
**Figure B.3 PEER-CEA Project Earthquake Damage Workshop Case Study Building 2 exterior elevations [Vail et al. 2020].**
