Cripple Wall Small-Component Test Program: Wet Specimens I

**A Report for the “Quantifying the Performance of
Retrofit of Cripple Walls and Sill Anchorage in Single-
Family Wood-Frame Buildings” Project**

PEER Report 2020/16

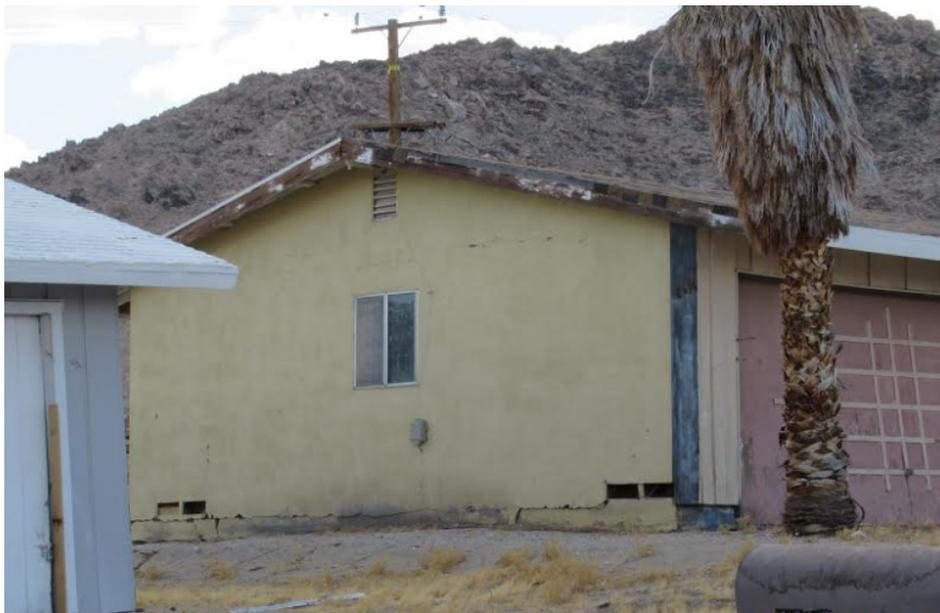
Figure 1.4 Partial foundation anchorage failure at the cripple wall of a stucco house in Trona, California (image courtesy of Cobeen [2019]), 2019 Ridgecrest earthquake, Ridgecrest, California.

Figure 1.4 shows a foundation anchorage failure as a result of the 2019 Ridgecrest earthquake [Cobeen 2019]. In this case, the shaking caused sliding between the house and the foundation. In addition to the foundation anchorage failure at the cripple wall, the superstructure shows large cracks extending up the face of the stucco on the front of the house (note that these may not be as visible in the photograph at the present print scale). Besides these cracks and the foundation anchorage failure, the house appears to be relatively undamaged.

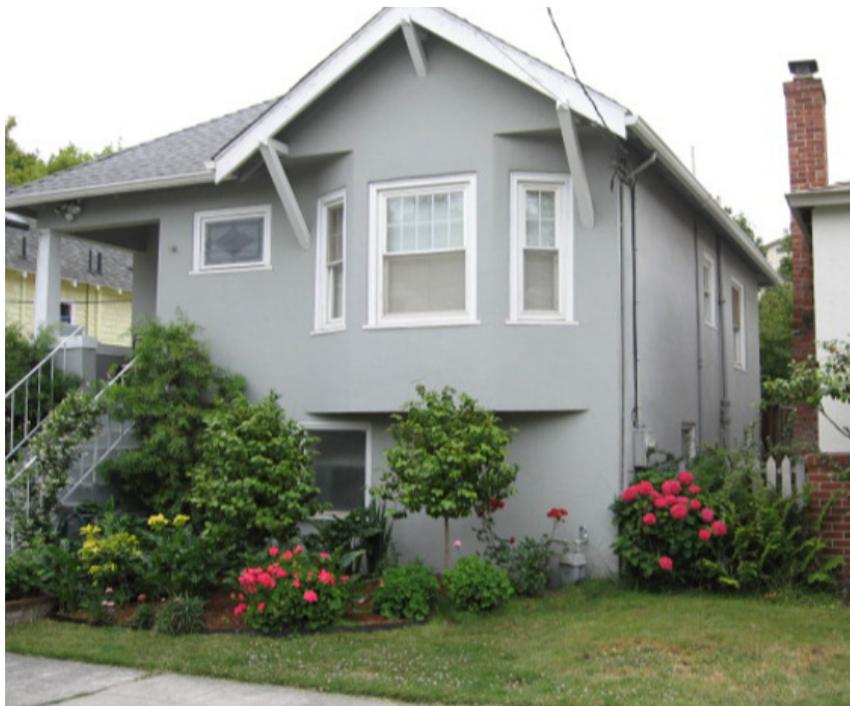
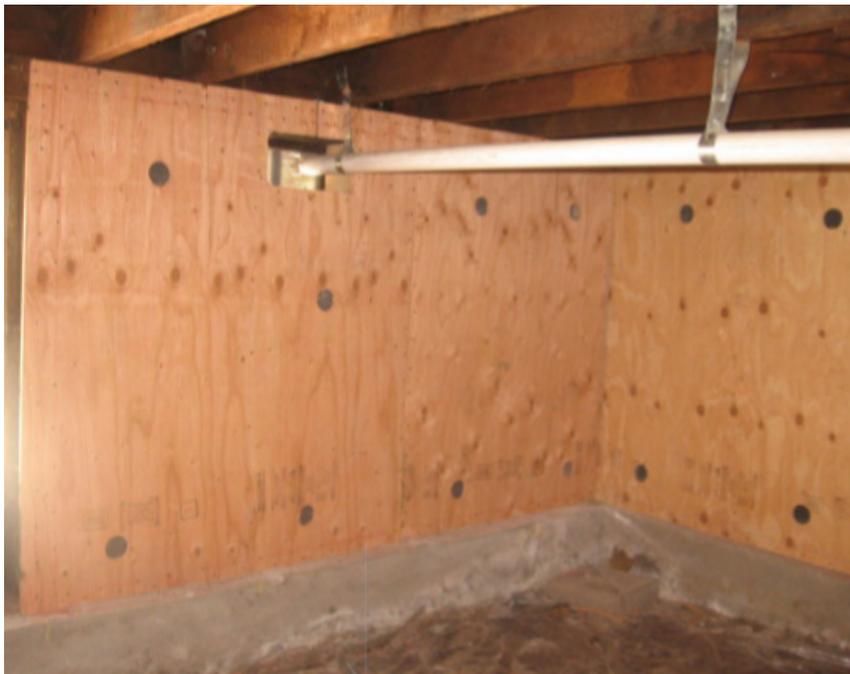
Figure 1.5 A 1920s one-story home in Alameda, California, with 6-ft-tall cripple walls finished with stucco over horizontal sheathing: (a) view of the front of the house; and (b) plywood panels providing lateral bracing on the interior of the cripple wall [photos courtesy of Anderson-Niswander [2015)].

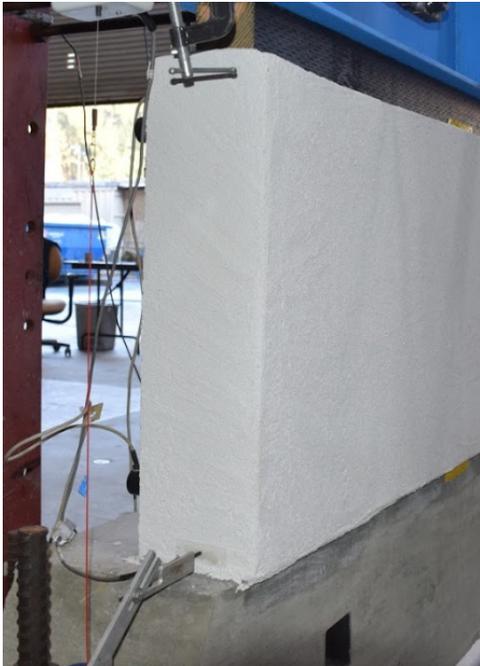
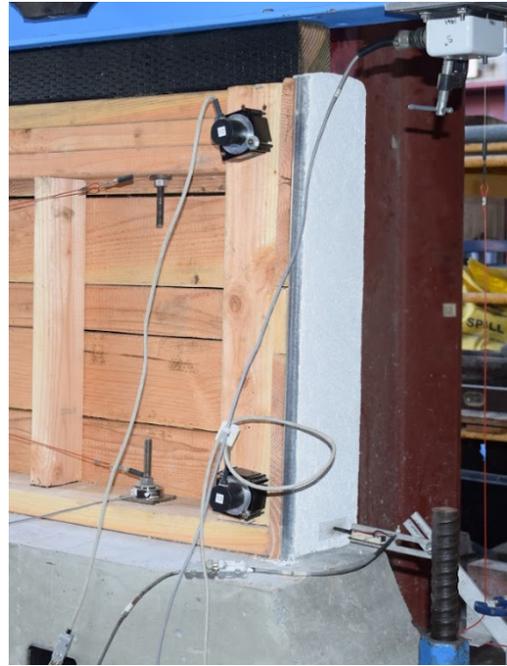
Figure 3.10 Specimen A-2 isometric corner views showing top boundary condition B details: (a) south exterior corner; and (b) south interior corner.

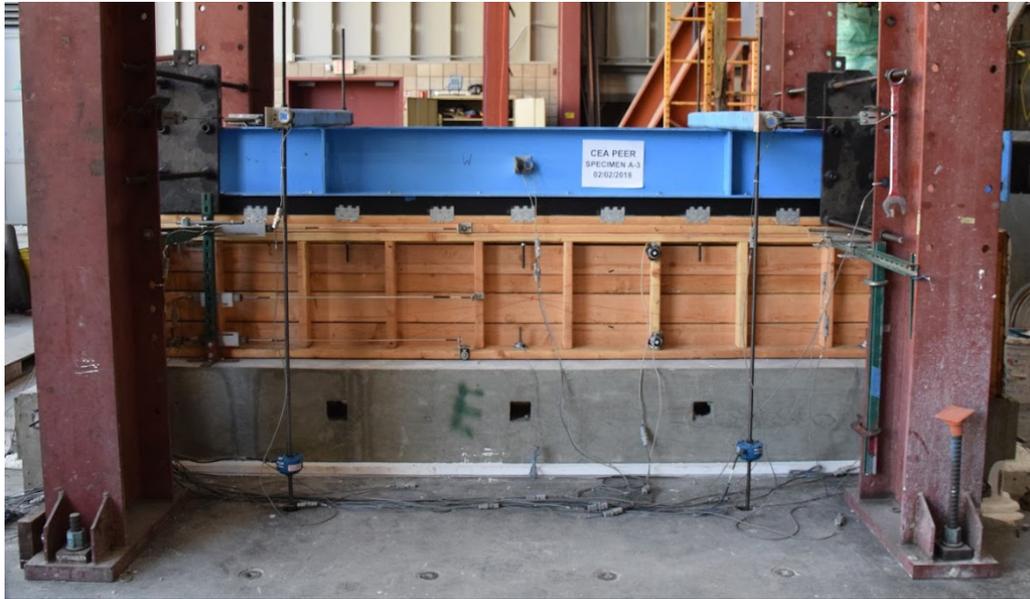
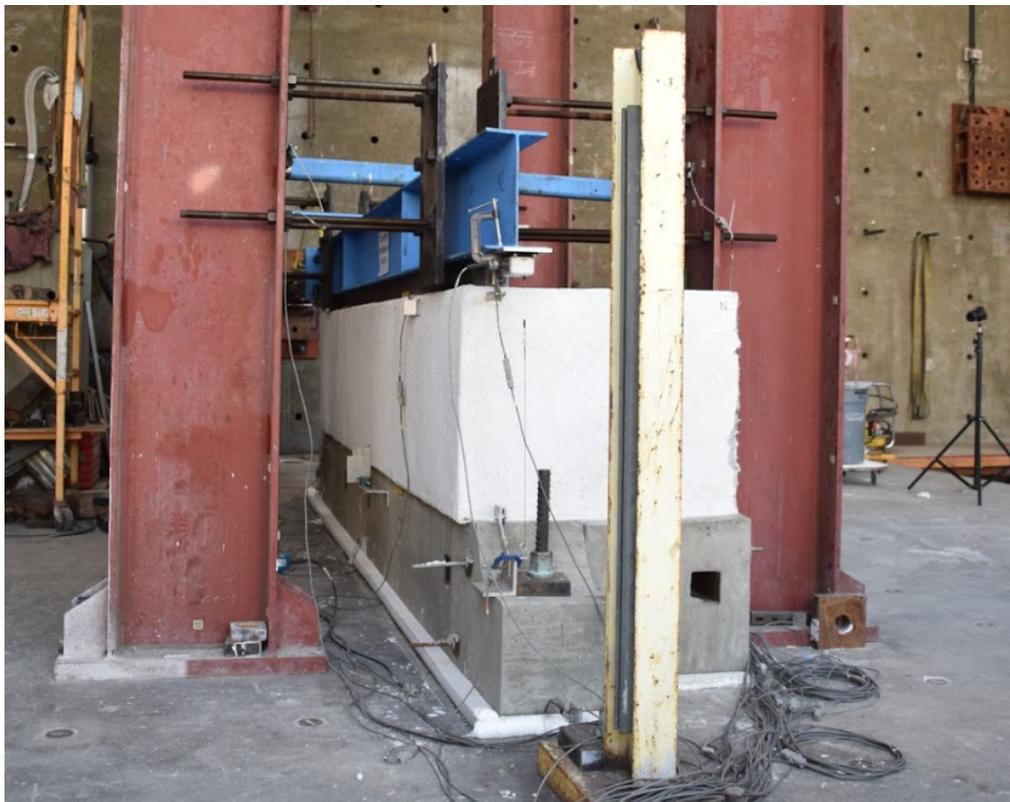
Figure 3.12 Specimen A-3 showing top boundary condition C details: (a) interior elevation; and (b) isometric view of north exterior corner.

Top boundary condition C contained the same detailing at the top of the wall and stucco and sheathing attachment details as top boundary condition B; however, this boundary condition incorporated a return wall at each end, effectively resulting in a C-shaped wall specimen. The purpose of the return wall was to determine if the detailed end conditions adopted in top boundary condition B sufficiently contributed to the response of the wall considering the presence of a return wall. The return walls were 2 ft long on both ends of the specimen. The first stud bay was 16 in. on center, and the second was 8 in. on center. The return wall corners were framed with two 2 × 4 studs; the return wall was tied down with two anchor bolts, one within each stud bay; see Figure 3.11 for details of the corner construction. Figure 3.12 provides photographs of this boundary condition. Only one specimen was constructed with top boundary condition C.

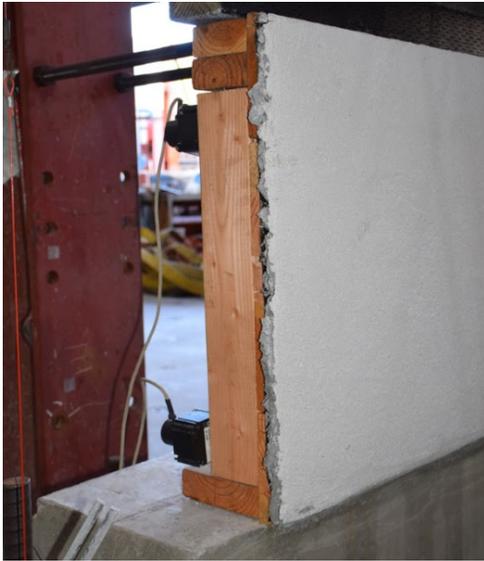
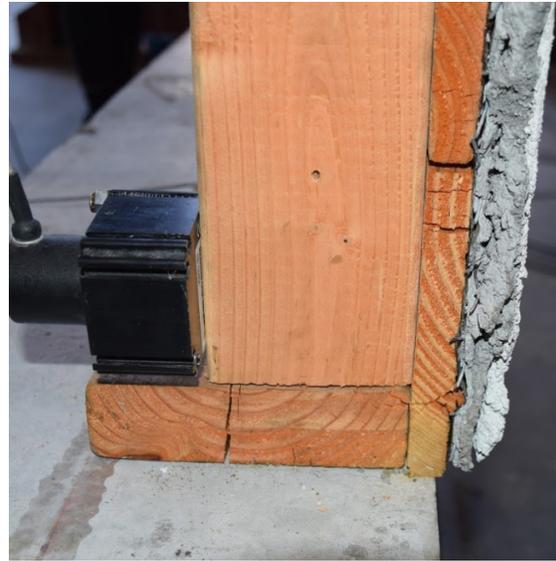
Figure 3.14 Specimen A-1 showing bottom boundary condition details: (a) south exterior corner; and (b) south corner bottom.

Bottom boundary condition “a” pertains to instances when there is a combined exterior finish. This boundary condition orientated the cripple wall so that the siding or stucco overhung the face of the footing while the sheathing (if present) remained bearing on the foundation; see Figure 3.13. Typically, houses in California containing sheathing behind siding have both the siding and sheathing overhanging the footing, allowing them both to rotate freely as the cripple wall deforms; but there are a significant number of houses that only have the siding or stucco overhanging with the sheathing material remaining bearing on the foundation. This is attributed to the difficulty in construction of applying stucco from the cripple wall to the base of the footing when overhanging sheathing boards produce a 3/4-in. to 7/8-in. gap between the face of the footing and the face of the sheathing; see Figure 3.14.

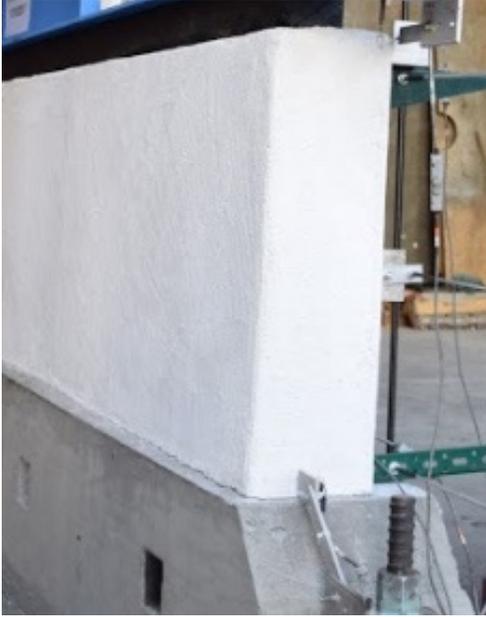
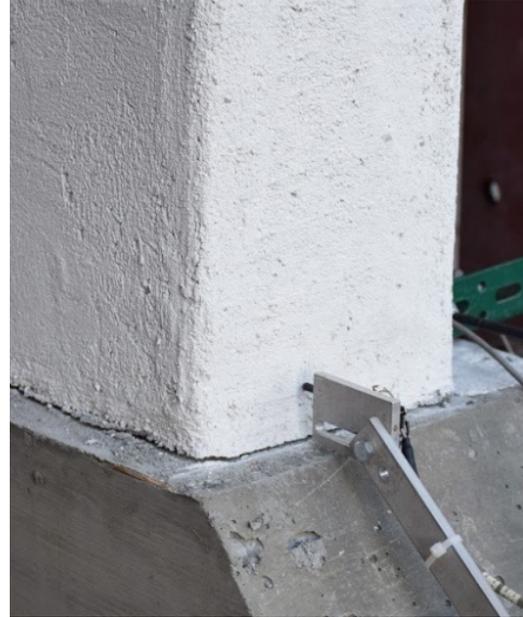
Figure 3.16 Specimen A-4 showing bottom boundary condition “b” details: (a) north exterior corner; and (b) north exterior corner bottom.

Bottom boundary condition “b” also pertained to combined exterior finishes. This configuration had both the siding or stucco and sheathing material bearing on the top of the foundation, where the bottom nailing of the sheathing was attached to the middle of the sill plate (if a sill plate exists). In the case of a wet set sill plate, the bottom nail of the sheathing was attached to the stud instead of the sill plate due to the lack of member depth available to attach to the sill plate. In the case of either wet set sill or typical sill on foundation, the furring nails were nailed to the sill plate. Details of bottom boundary condition “b” can be seen in Figure 3.15 for both the wet set sill plate and the typical sill plate. While this is not the most common condition in California houses, it still occurs in older dwellings. Moreover, the bearing of the stucco on the concrete inhibits the stucco from rotating freely as the cripple wall deforms, producing a significantly different response than the boundary condition, where the exterior finishes overhang the face of the foundation and can freely rotate as the cripple wall deforms. Figure 3.16 shows this boundary condition with a typical sill plate, and Figure 3.17 shows photographs of the same bottom boundary condition with a wet set sill plate.

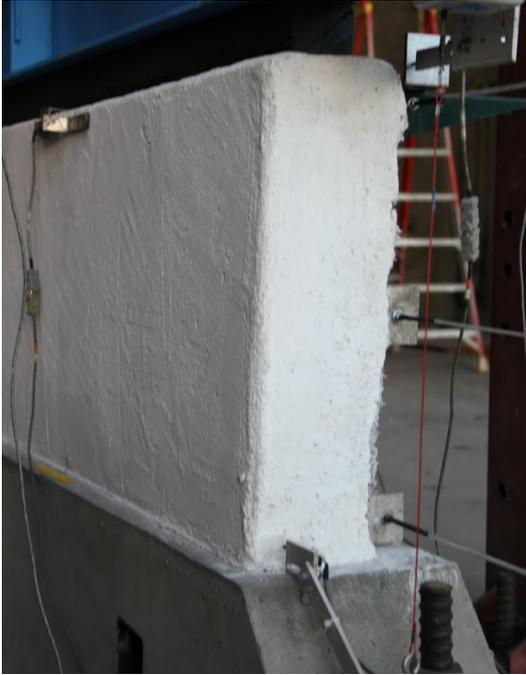
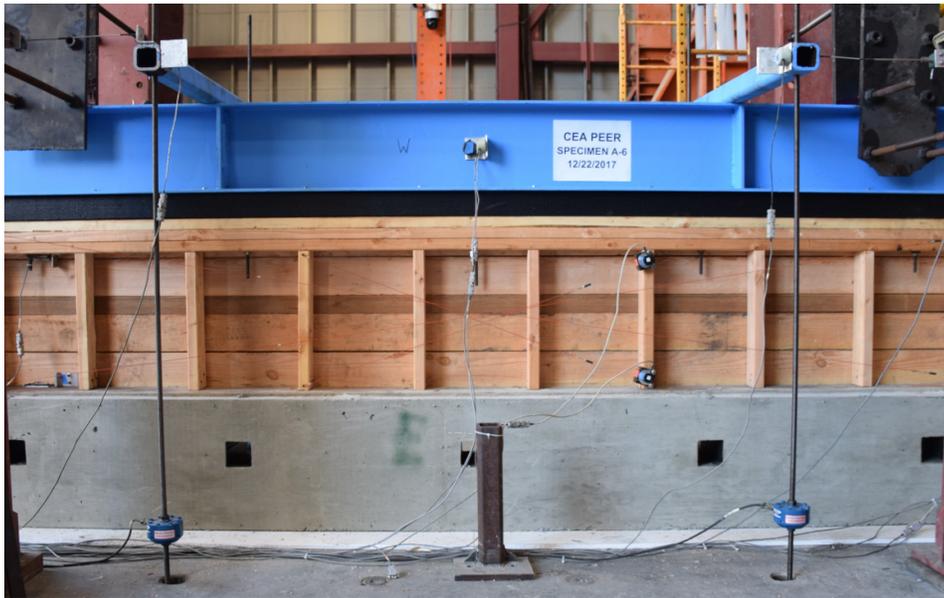
Figure 3.17 Specimen A-6 showing corner details for bottom boundary condition “b” with a wet set sill plate: (a) north exterior corner; (b) south interior corner; and (c) interior face.

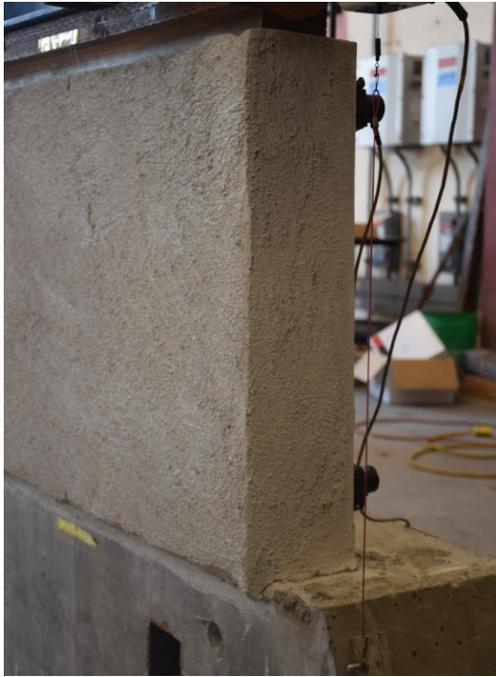
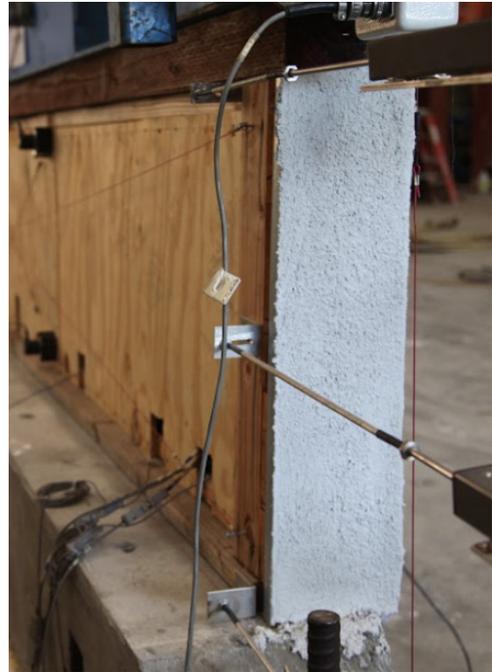
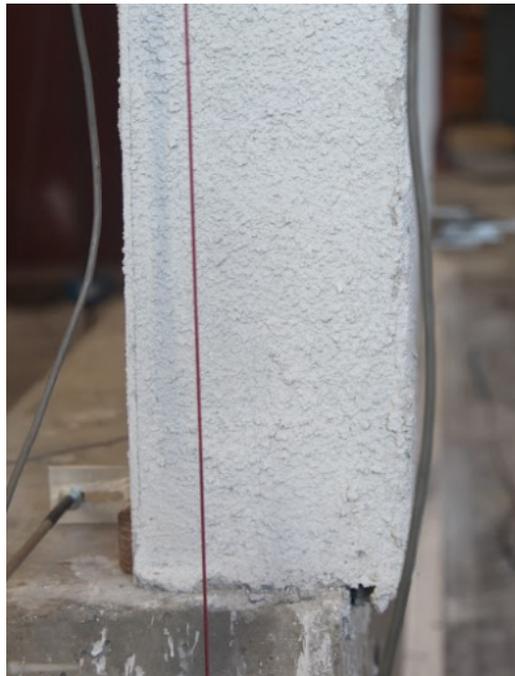
Figure 3.19 Corner views showing bottom boundary condition “c” detail: (a) south corner exterior; (b) south interior corner; and (c) north corner bottom.

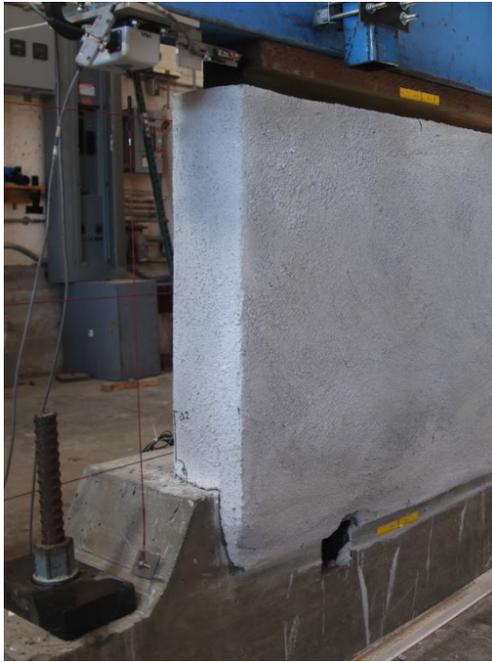
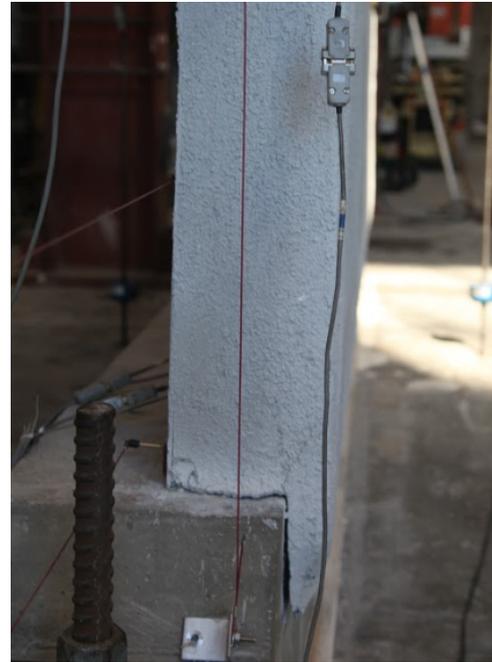
Figure 3.21 Specimen A-2 showing corner views with bottom boundary condition “d”:
(a) south exterior corner; and (b) bottom of south corner.

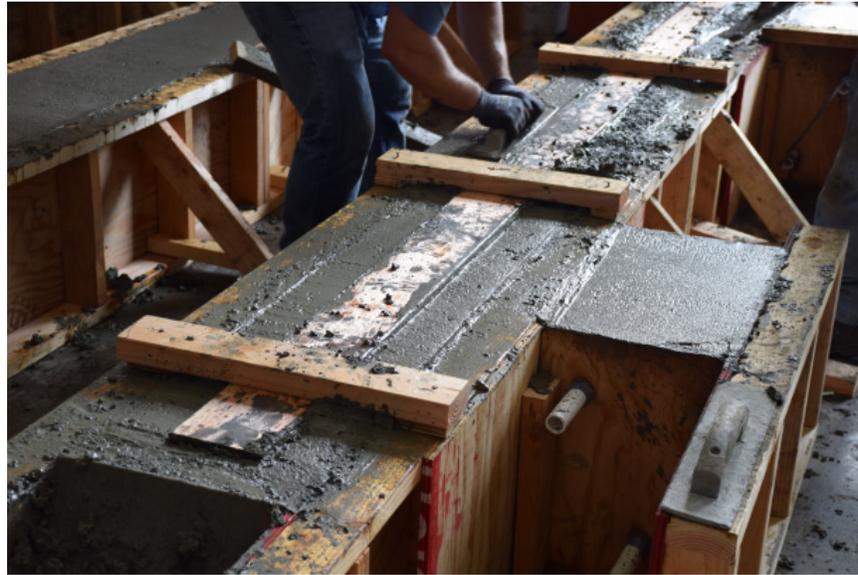
Figure 3.22 Specimen A-6 sill plate being wet set into the footing.

Although not as common as a traditional sill plate placed atop a foundation and tied down with anchor bolts, wet set sill plates have a statistically significant presence in California homes, especially in older construction. No information is available on the performance of wet set sill plates. Traditionally, wet set sill plates are 2 × 4 or 2 × 6 wood sill plates placed or set-in foundations when it is being poured; see Figure 3.22. The sill is usually prepared prior to the pour with a series of nails, potentially offering additional load transfer. In these tests, the wet set sill used was construction-grade redwood 2 × 6 with 2–30d nails driven through the sill at 24 in. center-to-center spacing along the board length. The nailed side was set in the wet foundation to offer additional resistance to movement of the sill plate. Details of the wet set sill and the construction procedure in shown in Figure 3.23. A view of the wet set sill plate used in Specimen A-6 is shown in Figure 3.24.

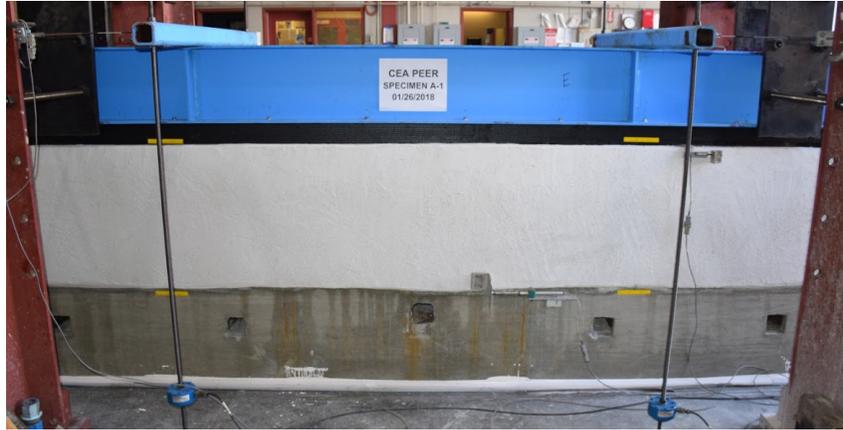
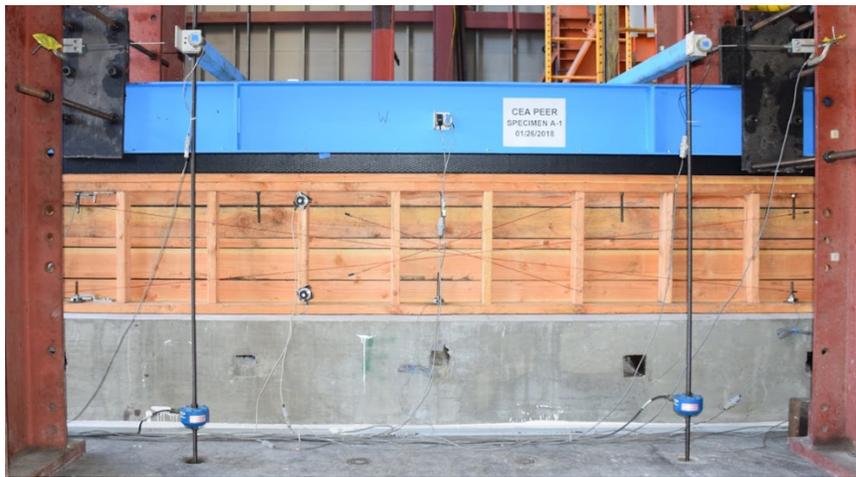
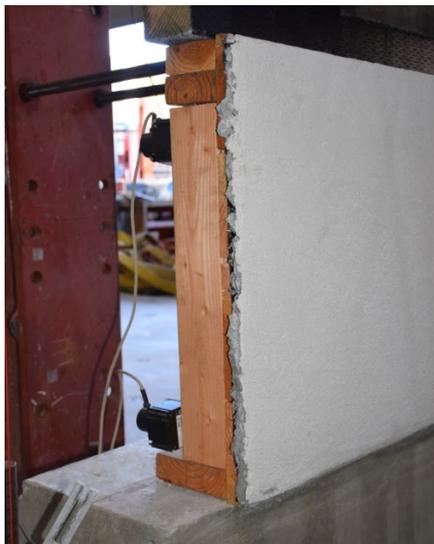
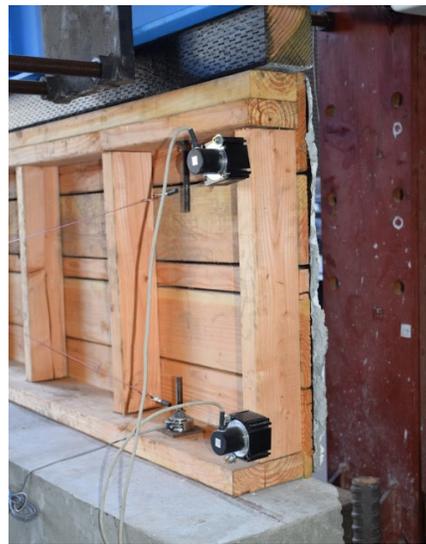
Figure 4.1 Specimen A-1 pre-test photographs for top boundary condition A and bottom boundary condition "a": (a) exterior elevation; (b) interior elevation; (c) south exterior corner; and (d) south interior corner.

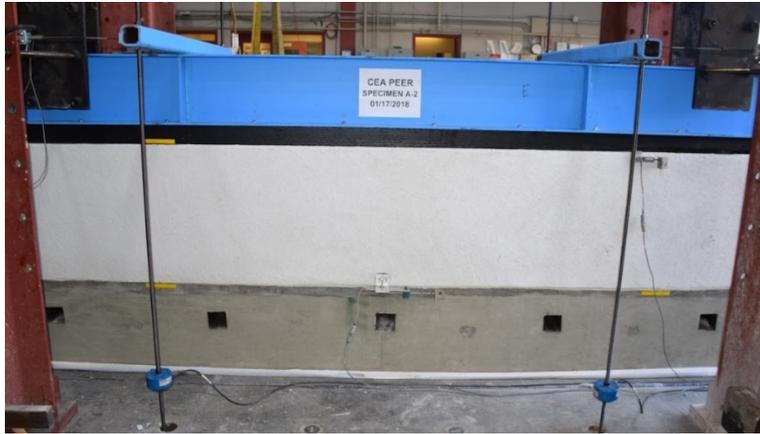
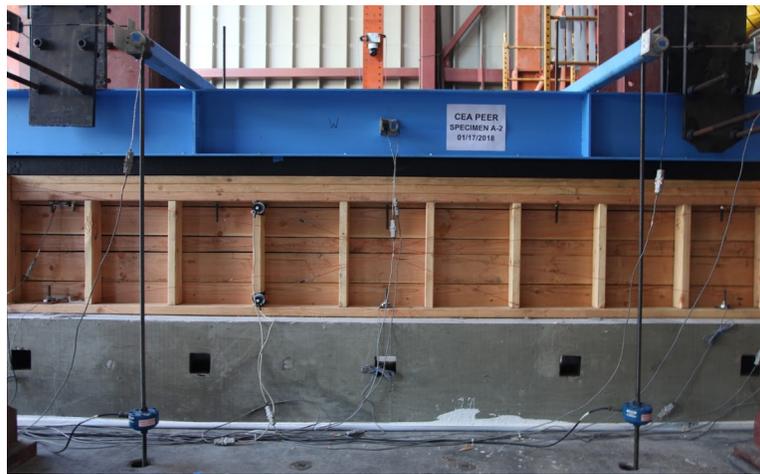
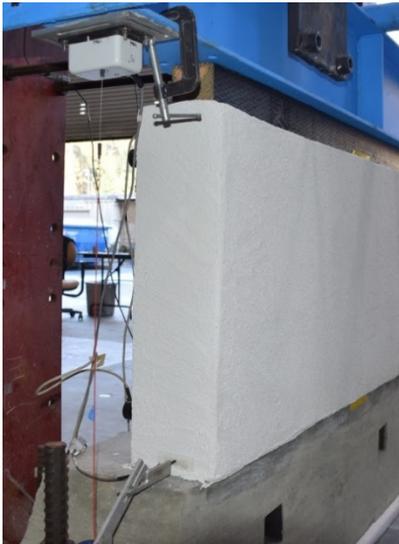
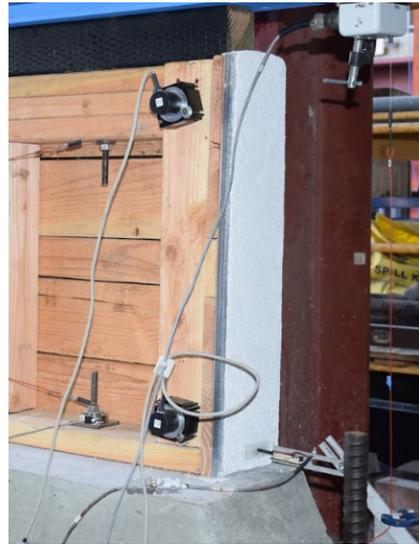
Figure 4.4 Specimen A-2 pre-test photographs, top boundary condition B and bottom boundary condition "a": (a) exterior elevation; (b) interior elevation; (c) south exterior corner; and (d) south interior corner.

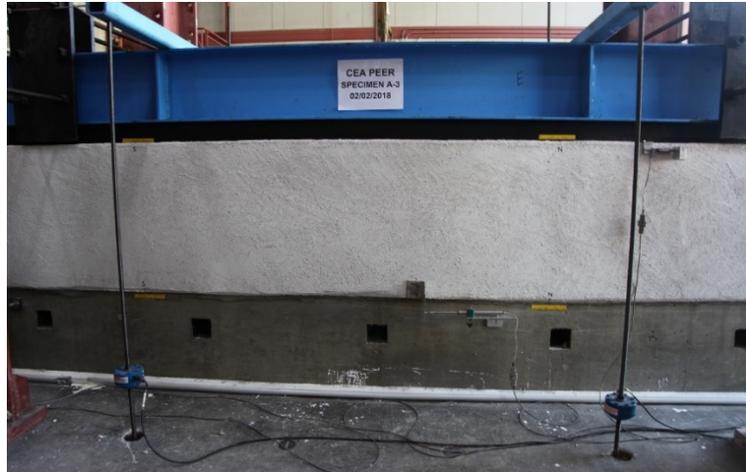
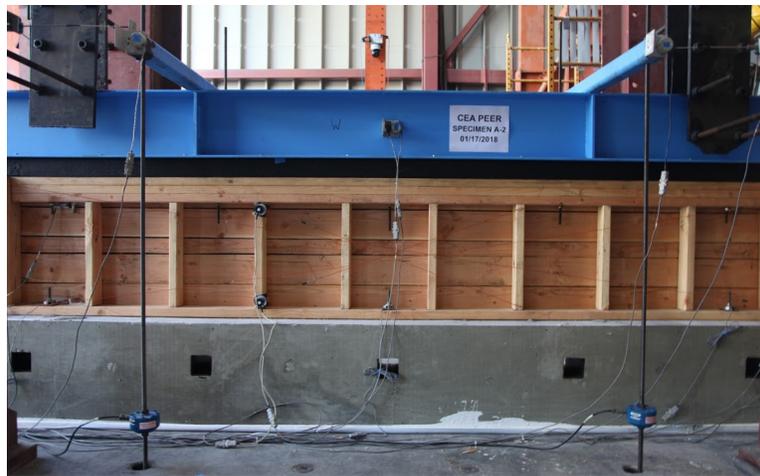
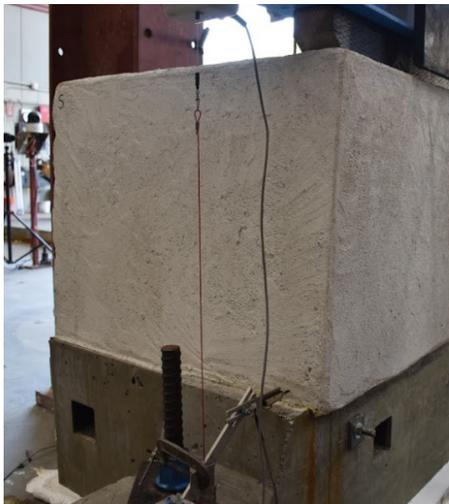
Figure 4.7 Specimen A-3 pre-test photographs, top boundary condition C and bottom boundary condition "a": (a) exterior elevation; (b) interior elevation; (c) south exterior corner; and (d) south interior corner.

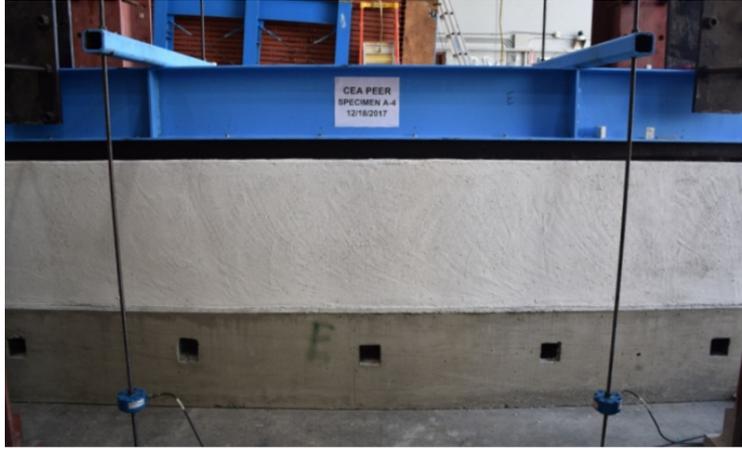
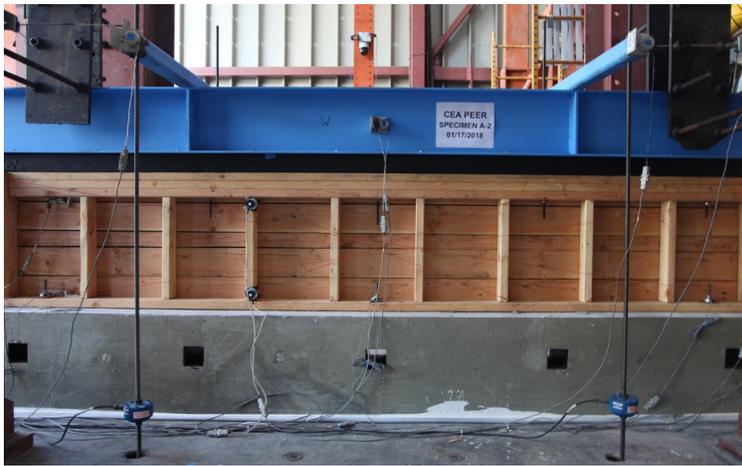
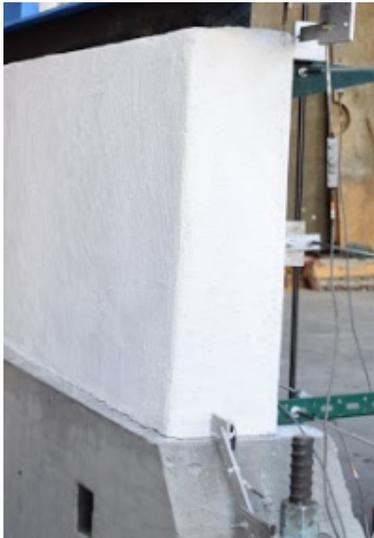
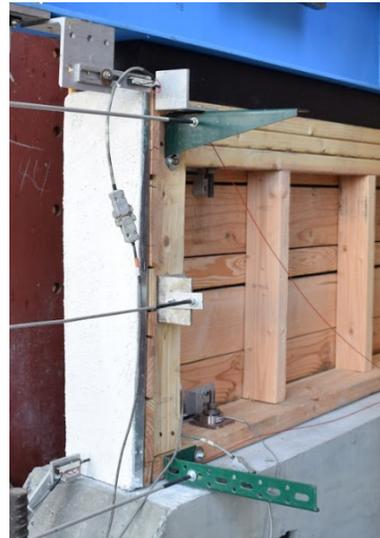
Figure 4.10 Specimen A-4 pre-test photographs, top boundary condition B\ and bottom boundary condition "b": (a) exterior elevation; (b) interior elevation; (c) north exterior corner; and (d) north interior corner.

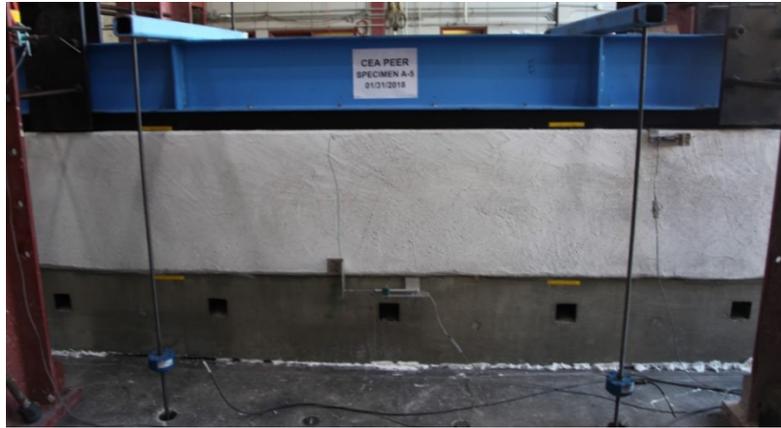
Figure 4.13 Specimen A-5 (retrofitted) pre-test photographs, top boundary condition B and bottom boundary condition "a": (a) exterior elevation; (b) interior elevation; (c) north exterior corner; and (d) south interior corner.

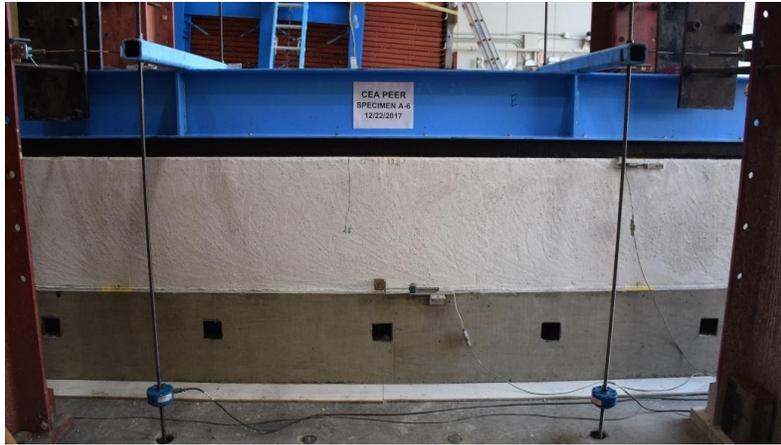
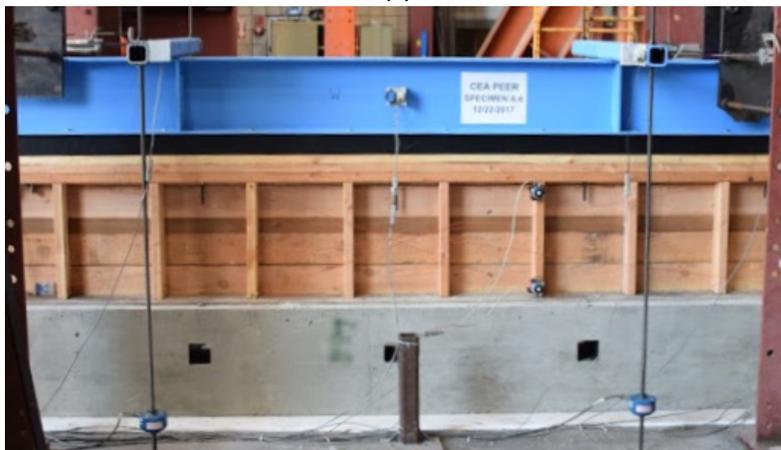
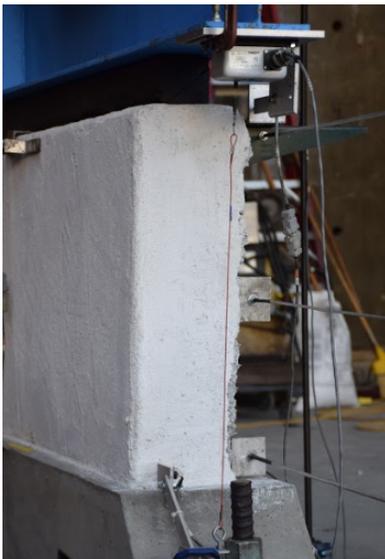
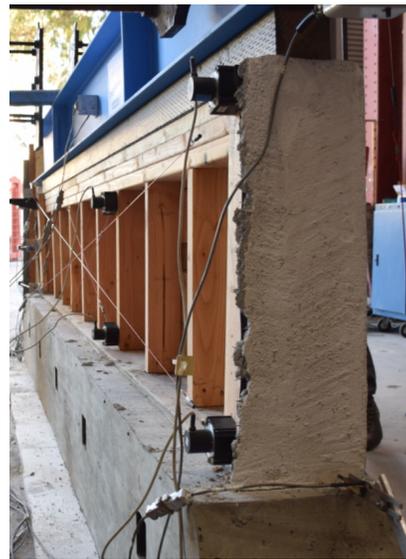
Figure 4.16 Specimen A-6 (wet sill plate) pre-test photographs, top boundary condition B and bottom boundary condition "b": (a) exterior elevation; (b) interior elevation; (c) north exterior corner; (d) and south interior corner.

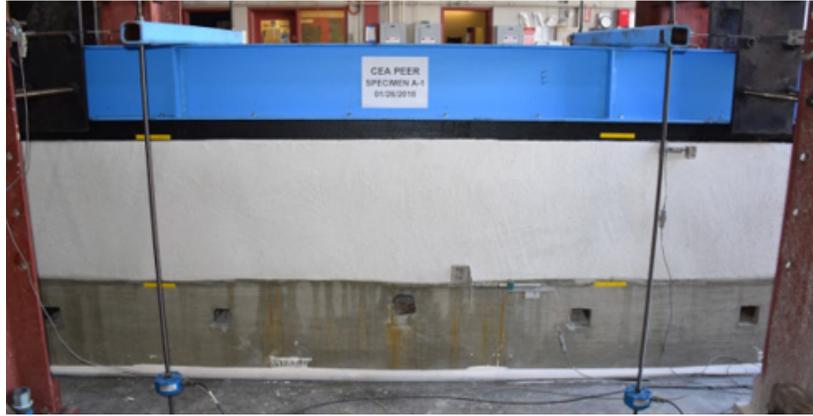
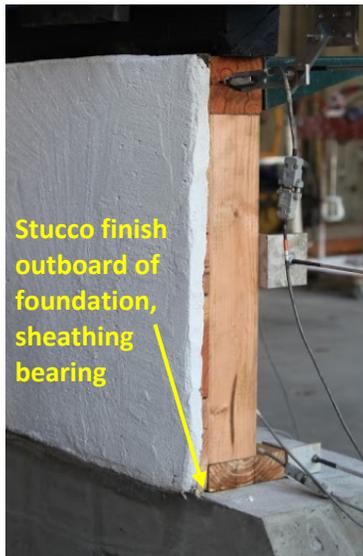
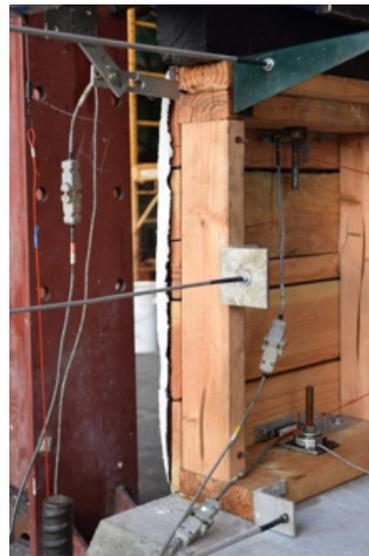
Figure 5.1 Specimen A-1 pre-test photographs with top boundary condition A and bottom boundary condition "a": (a) exterior elevation; (b) interior elevation; (c) exterior north-end corner view; and (d) interior north-end corner view.

Figure 5.1 shows the initial state of Specimen A-1 constructed without any end-wall continuity, i.e., no additional continuity of finish was incorporated. There were no built-up corners compared to the other five cripple walls tested in Phase 1. In addition, this cripple wall contained the most widely spaced furring nails at the cripple wall top plate of any of the other specimens. The framing and stucco attachment details of Specimen A-1 match those of cripple walls tested in the UC Davis testing program within the CUREE Caltech-Woodframe Project [Chai et al. 2002]. Figure 5.1(a)

shows the exterior face of the cripple wall, while Figure 5.1(b) shows the interior face of the cripple wall. Views of the corners are shown in Figure 5.1(c) and (d).

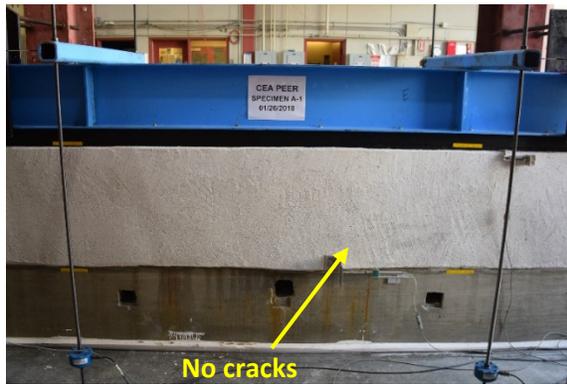
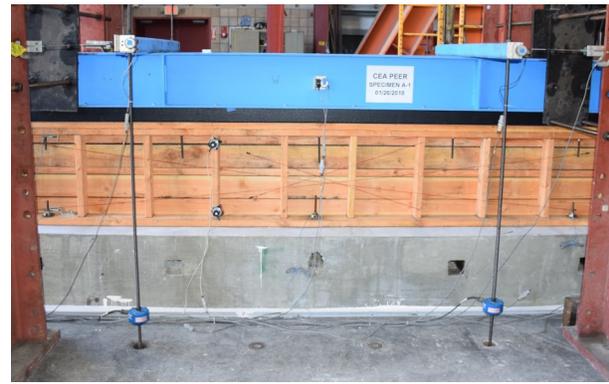
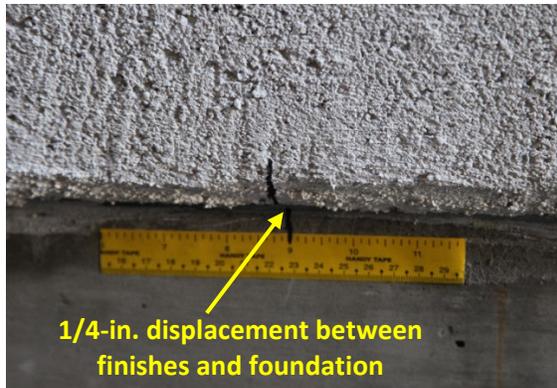
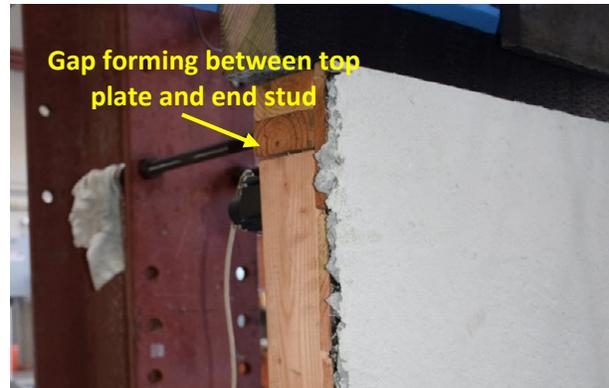
Figure 5.2 Specimen A-1 damage state at -1.4% drift @ $\Delta = -0.336$ in.: (a) exterior elevation; (b) interior elevation; (c) bottom of exterior wall displacement; (d) south top exterior and corner view; (e) north exterior and corner view; and (f) top of wall displacement.

Figure 5.2(a) to (f) show the damage state of Specimen A-1 at 1.4% drift amplitude. At this low-level amplitude, no cracks had yet formed on the stucco face. On the interior of the wall, the studs began to uplift and exhibit slight rotation. This uplift and rotation can be seen in the connection of the studs to the sill plate as well as the connection to the top plates. The most noticeable damage characteristics are as follows: the 1/4 in. of relative slip between stucco and foundation face at the base of the cripple wall and the 1/8 in. of relative slip between the stucco and framing at the top of the cripple wall. From an exterior view, the lack of cracking on the specimen would indicate that at this point there was minimal-to-no structural damage to the wall.

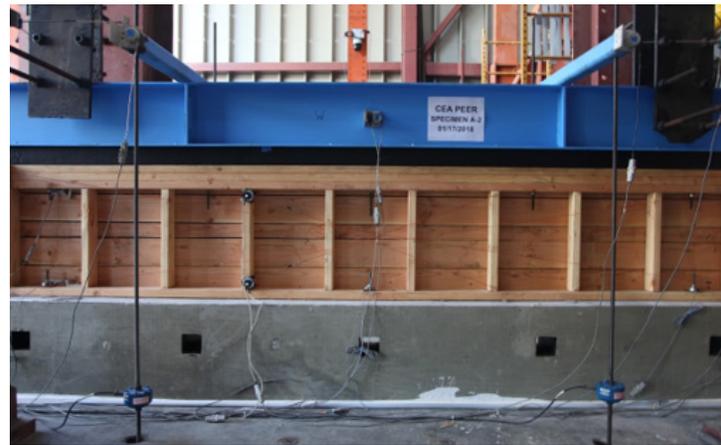
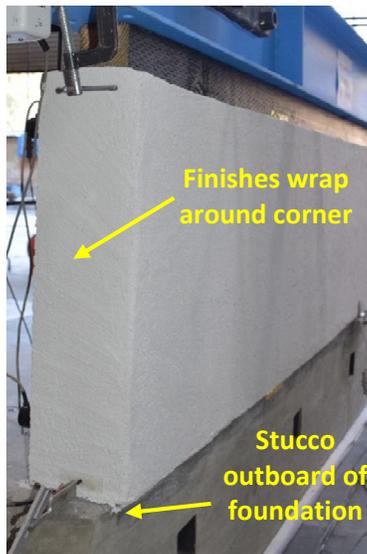
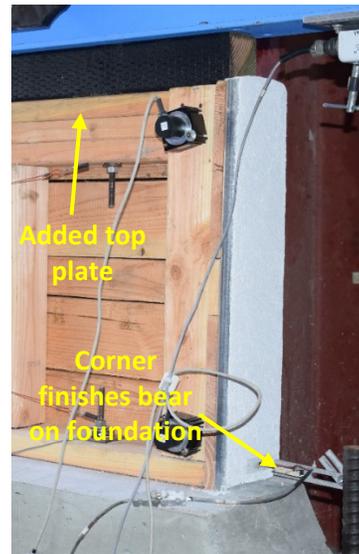
Figure 5.3 Specimen A-2 pre-test photographs with existing top boundary condition B, bottom boundary condition "a": (a) exterior elevation of cripple wall; (b) interior elevation of cripple wall; (c) north-end exterior and corner view; and (d) north-end interior and corner view.

Figure 5.3 shows the initial state of Specimen A-2 prior to testing. The primary difference between Specimen A-1 versus Specimen A-2 is the change in the boundary conditions. Specimen A-2 utilized an extra top plate to allow for two rows of a denser furring nail arrangement. This provides the extra 1-1/2 in. of wall height compared with Specimen A-1, which contained only a double top plate. In addition, Specimen A-2 incorporated built-up corners, featuring two 2 × 4 corner studs and a 2 × 4 flat stud. In addition, the finishes wrapped 6 in. around the corner; see Figure 5.3(c). The stucco finish was outboard of the foundation, while the face of the horizontal sheathing boards was flush with the foundation face. Specimen A-2 had top boundary condition B and bottom boundary condition “c”; see Figure 5.3(a); note that a crack had already formed on the face of the stucco prior to testing.

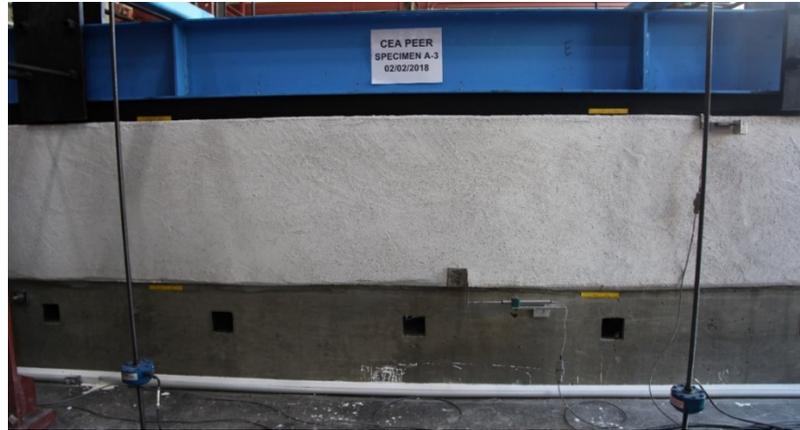
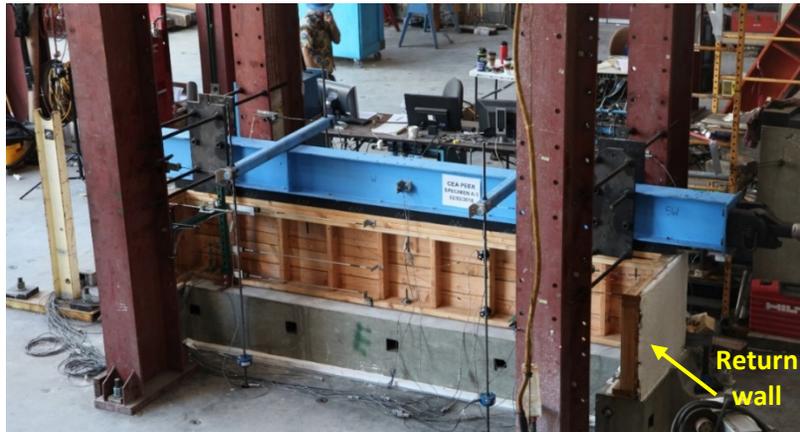
Figure 5.5 Specimen A-3 pre-test photographs with existing top boundary condition C and bottom boundary condition "a": (a) exterior elevation of cripple wall; (b) isometric view of interior cripple wall; and (c) isometric view of south-end return wall.

The photographs in Figure 5.5 show the initial state of Specimen A-3 prior to testing. Specimen A-3 has a C-shape configuration, which extended the corner finishes from 6 in. for Specimen A-2 to 30 in for Specimen A-3. The triple top plate and furring nail arrangement remained the same as in the previous test. The stucco on the exterior face is outboard of the foundation, while the sheathing boards bear on the foundation. For the return walls, both the stucco and sheathing boards bear on the foundation; see Figure 5.5(c). Two anchor bolts were added to each return wall section.

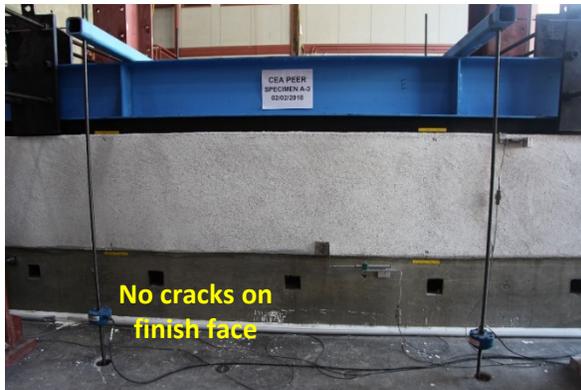
Figure 5.6 Specimen A-3 damage state at -1.4% drift @ $\Delta = -0.336$ in.: (a) exterior elevation; (b) top of the exterior wall; (c) bottom of exterior wall; (d) bottom of interior wall; (e) north-end of exterior corner; and (f) south-end of exterior corner.

Figure 5.6(a) to (f) show the damage state of Specimen A-3 at 1.4% drift amplitude. At this drift level, no cracks had yet formed on the exterior face of the stucco besides a small crack running diagonally from the top of the cripple wall to the corner on the north. Many cracks started propagating vertically at the corners; see Figure 5.6(d) and (e). Similar to the previous specimen, these cracks started at the 0.2% drift amplitude and continued to extend in subsequent cycles of increased drift amplitude. Note: no cracks appeared on the face of either return walls. Figure 5.6(c) shows that stucco-to-foundation slip of 3/8 in. occurred, which is higher than the previous test; however, unlike the previous test, the slip of the sheathing relative to the framing did not occur. The continued reduction of relative displacement between the sheathing and framing is attributed to the presence of extended corners (end return walls), which offered additional resistance. This is demonstrated by the 50% reduction in slip. The return walls showed significant uplift and slight rotation in the studs; see Figure 5.6(d).

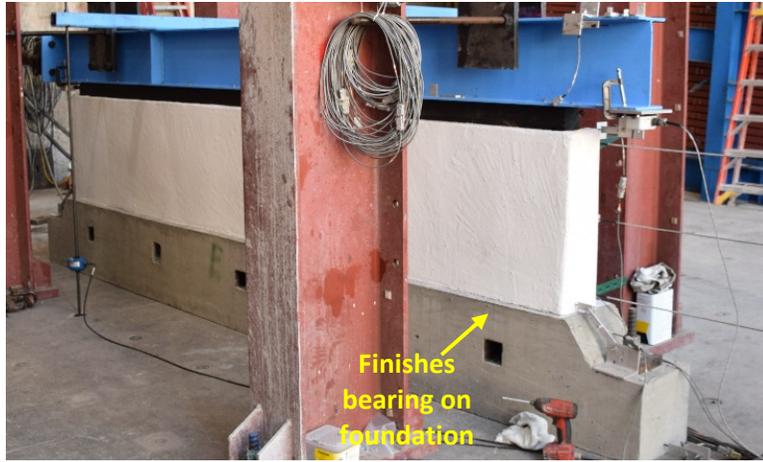
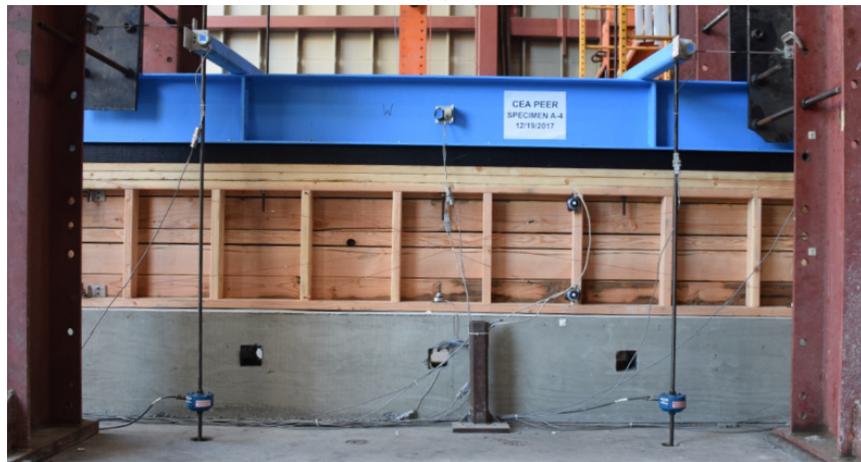
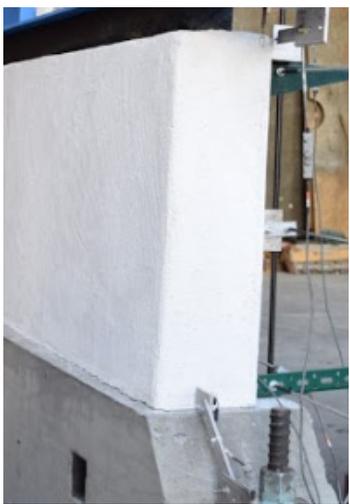
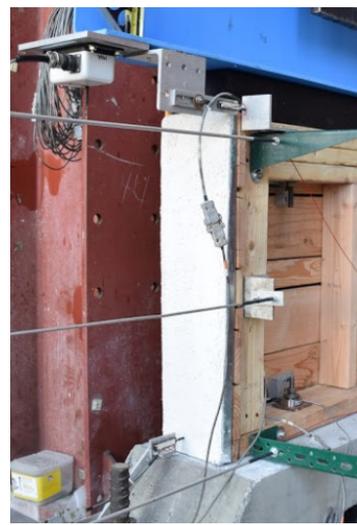
Figure 5.7 Specimen A-4 pre-test photographs with existing top boundary condition C and bottom boundary condition “b”: (a) isometric view of cripple wall exterior face; (b) interior elevation of cripple wall; (c) north-end exterior corner view; and (d) north-end interior corner view.

Photographs in Figure 5.7 show the initial state of Specimen A-4 prior to testing. Specimen A-4 has the same construction details as Specimen A-2; however, the location of the cripple wall is centered on the middle of the foundation. Denoted as bottom boundary condition “b”, both the stucco finish and the horizontal sheathing boards bore down on the foundation. While this condition is not as common in the California housing stock where the stucco finish runs outboard of the foundation, the bearing of the stucco was expected to cause significant differences in the response and visual damage of the cripple wall.
