Cripple Wall Small-Component Test Program: Wet Specimens I

**A Report for the “Quantifying the Performance of
Retrofit of Cripple Walls and Sill Anchorage in Single-
Family Wood-Frame Buildings” Project**

PEER Report 2020/16

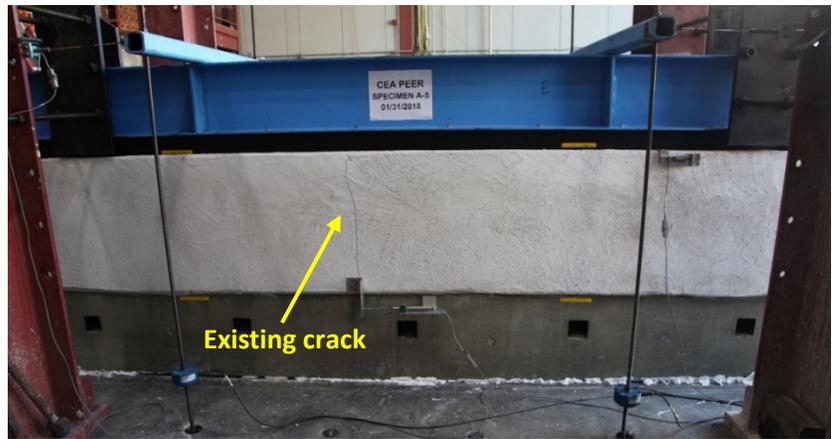
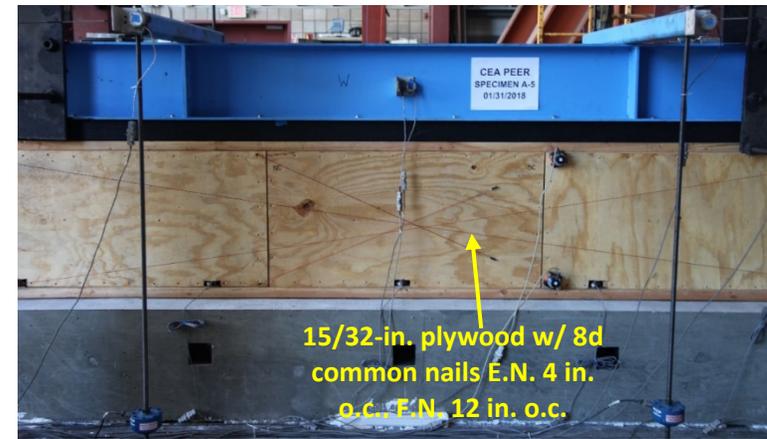
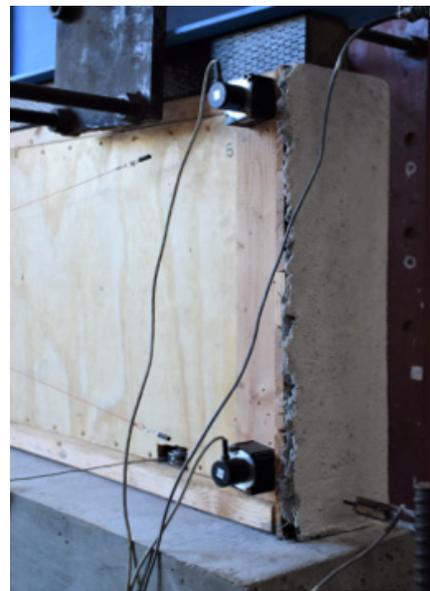
Figure 5.9 Specimen A-5 (retrofitted) pre-test photographs with top boundary condition B and bottom boundary condition "a": (a) exterior elevation; (b) interior elevation; (c) exterior north-end corner view; (d) interior north-end corner view; and (e) close-up of plywood nailing at top of wall.

Photographs in Figure 5.9 show the initial state of Specimen A-5 prior to testing. Specimen A-5 has the same boundary conditions as the Specimen A-2 but was retrofitted. The retrofit consisted of 100% bracing of 15/32-in. plywood panels. Each panel was 4 ft long and ran from the sill plate to the top of the middle top plate. As described in Chapter 3, additional studs and blocking were placed on the interior of the cripple wall to allow for connection of the plywood panels. The plywood was connected with 8d common hot-dipped galvanized nails at 4 in. on center over the edge and 12 in. on center over the field. In addition, two anchor bolts were added to decrease the spacing from the typical 64 in. on center, as is with the previous cripple walls, to 32 in. on center. The retrofit detail conforms to the ATC-110 design guidelines. As shown in Figure 5.9(a), a vertical crack had formed along the face of the stucco prior to testing, and that ~one-fourth of the nails were slightly overdriven between 1/16 and 1/8 in.; see Figure 5.9(e).

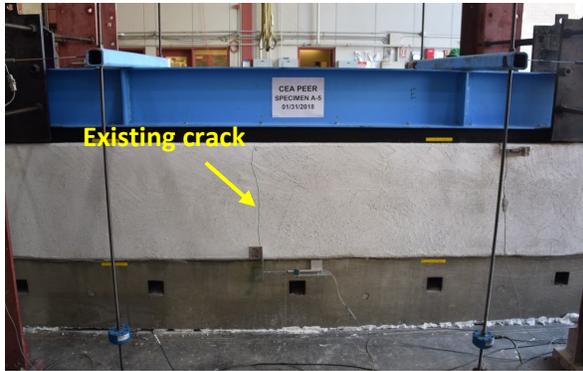
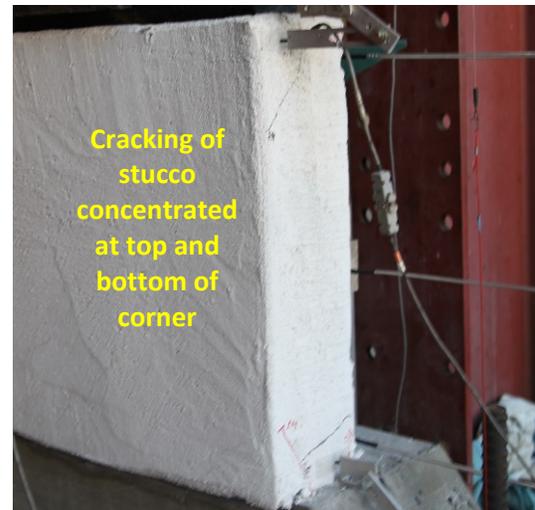
Figure 5.10 Specimen A-5 damage state at +1.4% drift @ $\Delta = +0.336$ in.: (a) exterior elevation; (b) top of exterior wall; (c) bottom of exterior wall; (d) plywood panel joint; (e) close-up of top of the south-end interior wall; and (f) north-end exterior corner.

Figure 5.10(a) to (f) shows the damage state of Specimen A-5 at 1.4% drift amplitude. At this drift level, no additional cracks formed on the face of stucco. There was a large reduction in the amount of cracking at the corners of the cripple wall compared to Specimens A-2 through A-4; see Figure 5.10(f). This could be because much of the work resisting displacement was due to the retrofit strategy instead of the finish materials bearing on the foundation at both ends of the specimen, as was the case with Specimen A-2. As with Specimen A-2, there was a 1/4-in. slip between the stucco and the foundation, as well as disconnect between the stucco and the foundation at the base of the cripple wall. At the top of the cripple wall, a 3/16-in. displacement between the sheathing and framing formed, which is the largest seen in any of the previous tests. This is due to the framing members being significantly stiffened by the attachment of the plywood panels on the interior face. On the interior face, small slips between the plywood panels had started to form as the plywood panels began to rotate. The 1/8-in. gap between abutting plywood panels remained; therefore, the wood structural panels had not yet begun to bear down on each other. Figure 5.10(e) shows that some of the nails were slightly overdriven and had started to pull through the plywood. For the other nails that attached the plywood to framing, minimal rotation or pulling through was visible at this drift level.

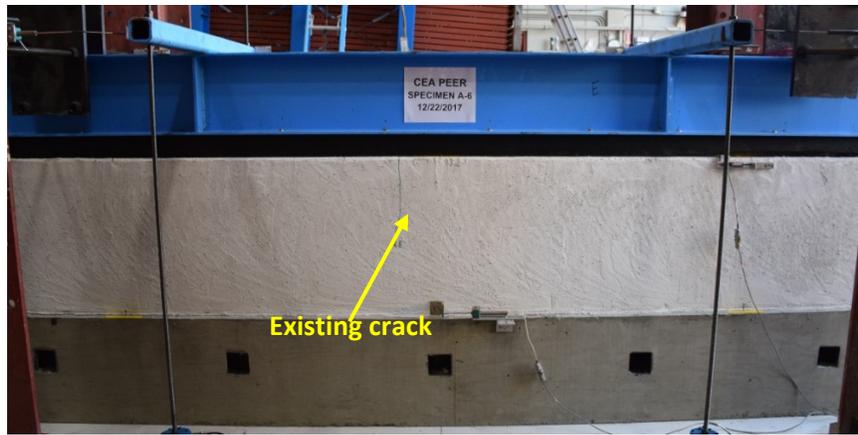
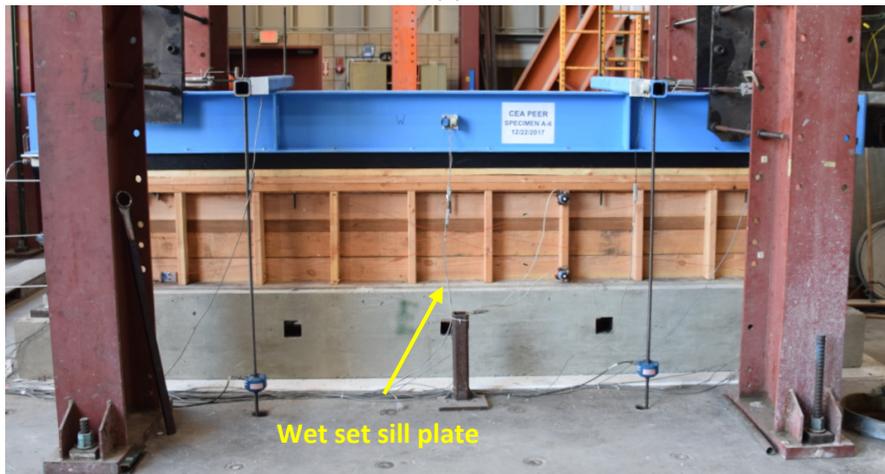
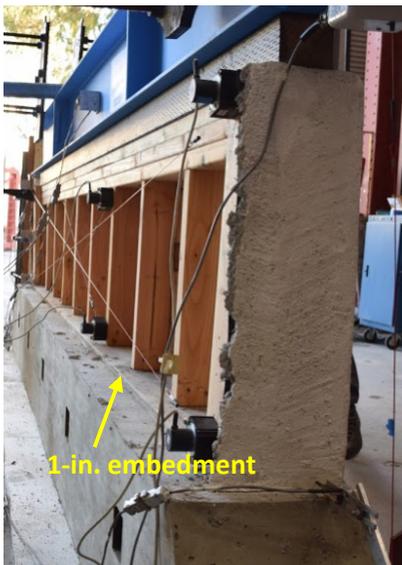
Figure 5.11 Specimen A-6 (wet set sill plate) pre-test photographs with top boundary condition B and bottom boundary condition "b": (a) exterior elevation; (b) interior elevation; (c) interior south-end corner view; and (d) interior north-end corner view.

The photographs in Figure 5.11 show the initial state of Specimen A-6 prior to testing, which has the same boundary conditions as Specimen A-4 but with the addition of a wet set sill plate. The wet set sill plate is a nominal 2 × 6, construction-grade redwood member, which is different from the #2 Douglas Fir sill plates used in all other cripple walls. As described in Chapter 3, the wet set sill plate was embedded 1 in. into the center of the foundation when the foundation was being cast; see Figure 5.11(c). Because of this embedment, there remained only 1/2 in. of sill plate to attach the furring nails into, whereas the furring nails would typically be driven into the center of the 1-1/2 in. sill plates as was done with other specimens. All finish material bore down on the top of the foundation.

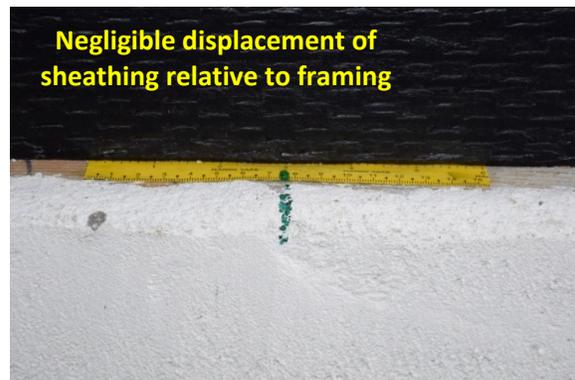
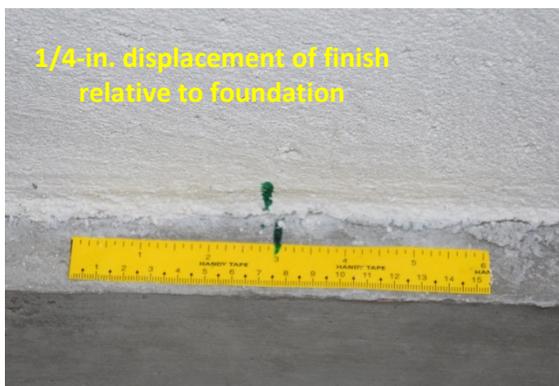
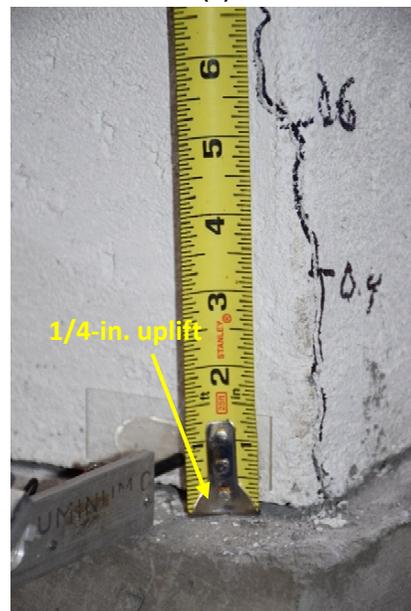
Figure 5.12 Specimen A-6 damage state at -1.4% drift ($\Delta = -0.336$ in.): (a) exterior elevation; (b) top of exterior wall; (c) bottom of exterior wall; (d) close-up of stud; (e) south-end exterior corner; and (f) close-up of south-end exterior corner.

Figure 5.12(a) to (f) show the damage state of Specimen A-5 at 1.4% drift amplitude. At this drift level, extensive cracking had begun to form on the face of the stucco. These cracks started as early as 0.4% drift and continued to propagate vertically along the face of the stucco. These cracks began both at the top and the bottom of the cripple wall but eventually would run vertically across the entire cripple wall face as drift amplitudes increased. As was found for Specimen A-4, a 1/4-in. slip occurred between the base of the stucco and the foundation; unlike Specimen A-4, there was less slip between the sheathing and the stucco and no slip between the stucco finish and the sheathing.

The increased presence of surface stucco cracks and lack of displacement between the stucco and sheathing are due to the inability for the wet set sill plate to slip. At this drift amplitude, the sill plate of Specimen A-4 had displaced 1/10 in. relative to its foundation. With a wet set sill, an appreciable resistance to sliding is created, thus the imposed lateral displacements propagated in the form of more extensive cracking on the stucco face. Figure 5.12(e) and (f) show that single vertical cracks had formed at the bottom corners of the cripple wall. The reduction in corner cracks between this Specimens A-4 and A-6 is again due to the lack of sill slip. As with Specimen A-4, the stucco finish bearing condition caused an 1/8-in. uplift on the corner of the wall and separated the connection between the base of the stucco and top of the foundation.

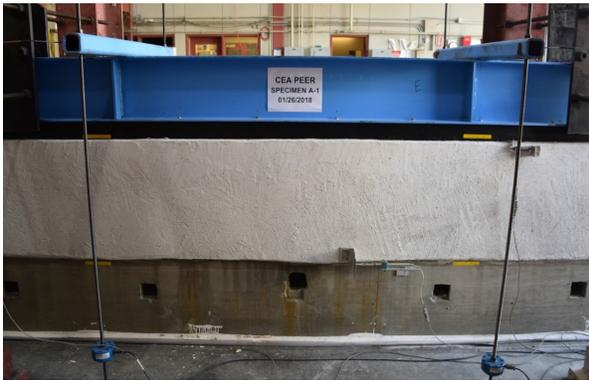
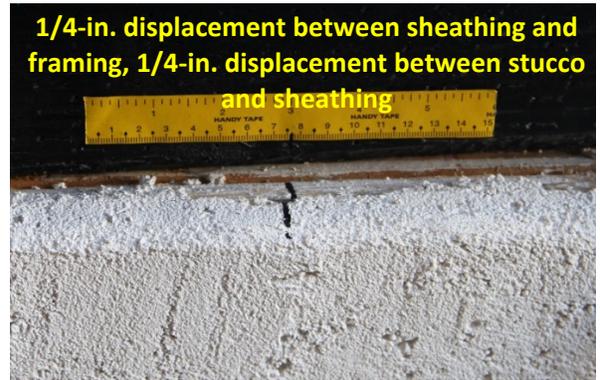
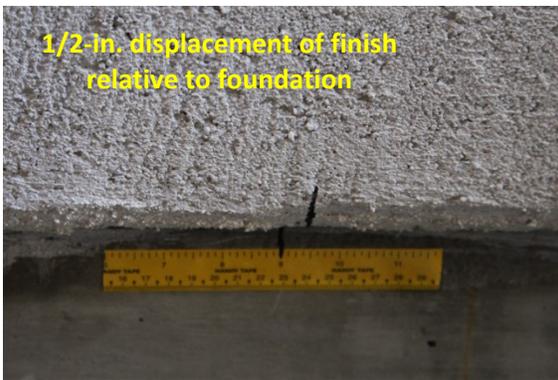
Figure 5.13 Specimen A-1 damage state at lateral strength @ +3% drift, $\Delta = +0.72$ in.: (a) exterior elevation; (b) top of the exterior wall; (c) bottom of exterior wall; (d) close-up of stud; (e) north-end corner of wall; and (f) close-up of top of south-end interior corner.

Figure 5.13(a) to (f) show the damage state of Specimen A-1 at lateral strength, which occurred at 3% global and relative drift in both the push and pull directions. Due to its lower capacity, Specimen A-1 did not experience any sill slip relative to the foundation. At strength, there were still no visible cracks on the face of the stucco. Figure 5.13(e) shows a 3/16-in. separation between the stucco and sheathing. This occurred as the furring nails (a) began to detach from the framing and work their way out of the sheathing (nail withdrawal) and/or (b) the furring nails had detached from the stucco (nail head pullout). Nail withdrawal or nail head pullout is dependent on how well the furring nails were fastened to the metal reinforcement mesh and how well they were fastened to the sheathing. Whichever condition has the least capacity will occur first. Note: only 1/8 in. of the 1-1/2-in. furring nails would be driven into the framing; the nails are furred out 1/4 in. and penetrate through the 7/8 in.-thick horizontal sheathing. The slip between the base of the stucco and the foundation increased to 1/2 in., and a gap between the stucco and foundation face became more pronounced. Figure 5.13(f) shows that at the top of the cripple wall there was a 1/4-in. relative displacement between the stucco finish and the sheathing, as well as a 1/4-in. relative displacement between the sheathing and framing. In addition, a small gap opened up between the sheathing and framing, indicating that the small amount of embedment of the furring nails into the framing was gone. On the interior of the cripple walls, the uplift of the studs was more pronounced, while the rotation of the studs was similar to that experienced at the service-level drift. Some of the studs began splitting at both the connection to the sill plate and top plate. Lastly, cracks had begun to form on the ends of the sheathing boards and were concentrated near the location where the boards were nailed to the studs.

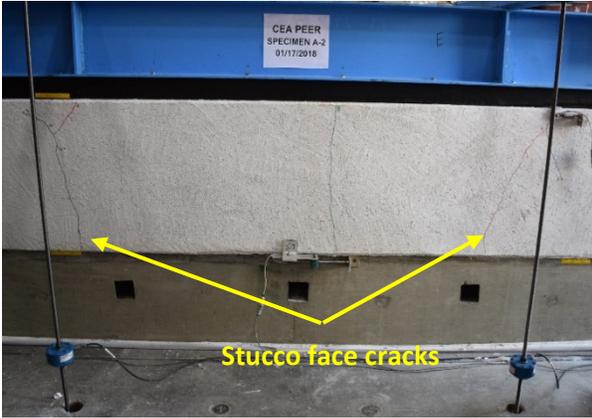
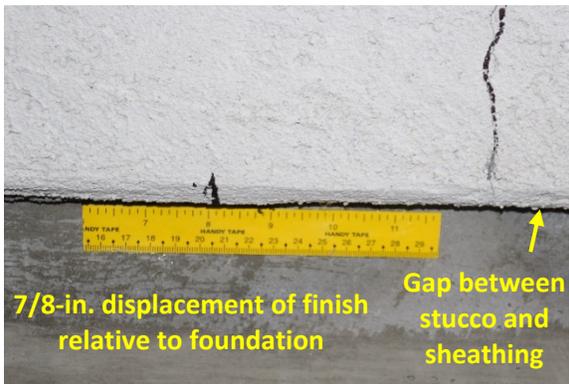
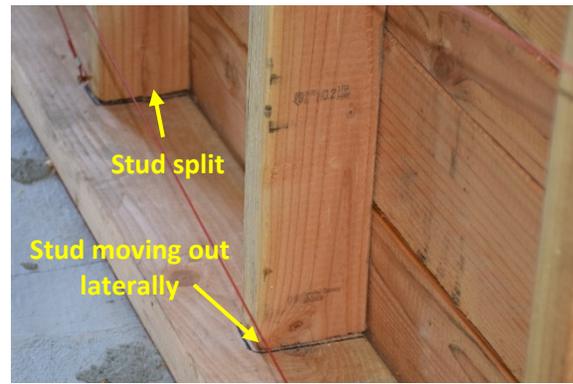
Figure 5.14 Specimen A-2 damage state at lateral strength @-4% drift, $\Delta = -0.96$ in.: (a) exterior elevation; (b) top of exterior wall; (c) bottom of exterior wall; (d) close-up of studs; (e) close-up of north-end corner; and (f) close-up of bottom south-end exterior corner.

Figure 5.14(a) to (f) show the damage state of Specimen A-2 at lateral strength. The lateral strength occurred at 5% global drift in the push loading direction and 4% in the pull loading direction. The subsequent relative drift was 4.3% in the push direction and 3.1% in the pull direction. At peak strength, additional vertical cracks began propagating along the face of the stucco. The formation of a 1/2-in. gap formed at the base of the stucco; see Figure 3.14(c) and (e). At this point, although the stucco had detached from the furring nails at the base, in some cases the furring nails remained attached to the stucco, but as expected they had pulled out significantly from the sheathing. This same gap is not evident at the top of the cripple wall because of the increased pullout resistance due to the significantly denser furring nail arrangement on the upper top plates. The displacement of the stucco at the base and the foundation increased to 7/8 in., while the only apparent relative displacement at the top of the cripple wall was 1/4-in. displacement between the stucco and sheathing; see Figure 5.14(d). This is due to the rotation of the furring nails at the top of the wall. At the exterior corners, major cracking ran in all directions and was heavily concentrated at the corner edge. Crushing and spalling of the stucco was extensive at the corner faces due to the heavy bearing sown of the stucco finish on the foundation. On the interior face, some of the studs split at the connection to the sill plate. In addition, a slight lateral movement occurred on the studs. This lateral movement can be attributed to the horizontal sheathing and stucco finish moving out laterally. The cause of this lateral movement is due to the nails being pulled out as they rotate back and forward during each cycle.

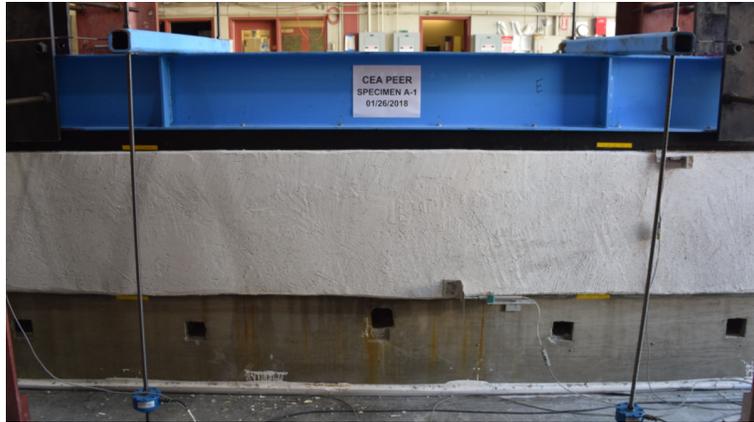
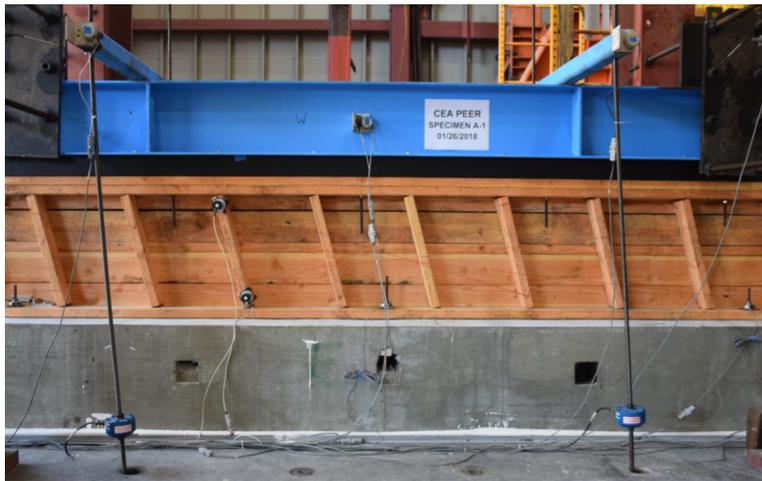
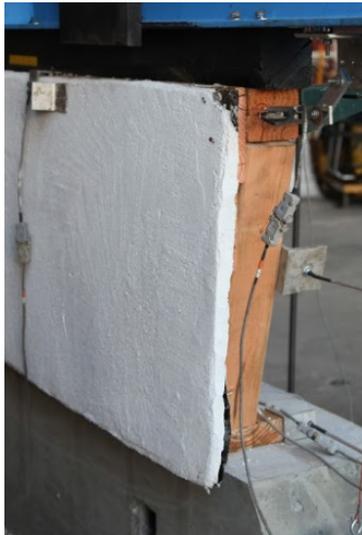
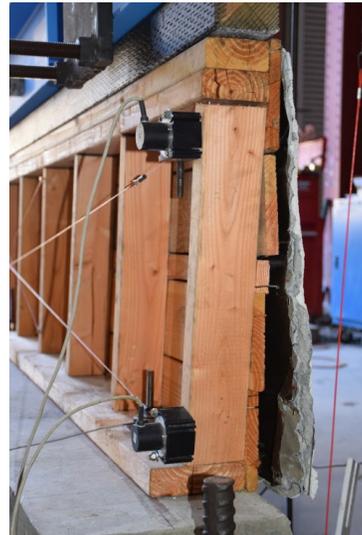
Figure 5.20 Specimen A-1 post-test photographs at lateral load = 0 kips, residual displacement = +4.90 in. @ +20.4% drift: (a) exterior elevation of cripple wall; (b) interior elevation of cripple wall; (c) north-end exterior corner view: and (d) south-end interior corner view.

Figure 5.19(a) to (d) shows the damage state of Specimen A-1 at +12% drift. The damage state at 12% correlates closer to a 60% drop in peak strength as opposed to an 80% drop in lateral strength. At this stage, the stucco was only connected to the top plate and top row of furring nails on the studs. From Figure 5.19(c) and (d), it is evident that almost all of the furring nails remained attached to the sheathing and pulled away the metal reinforcement in the stucco. The displacement between the stucco and sheathing at the top of the cripple wall was 1/4 in., and a 1/4-in. displacement between the sheathing and the framing occurred as well. In addition, pronounced gaps occurred at the interface of the stucco and sheathing, as well as sheathing and framing. At this point, the stucco provided negligible lateral resistance. The source of capacity was due to the stacking of the horizontal sheathing boards bearing on the foundation. As shown in Figure 5.19(c), the gaps between all but the top sheathing board had closed. Cracks formed on the corners of the sheathing boards where the nails were located. Figure 5.20 shows the cripple wall in its residual state at the end of testing after a 5.0-in. monotonic push. There was a residual displacement of 4.90 in. once the load was removed.

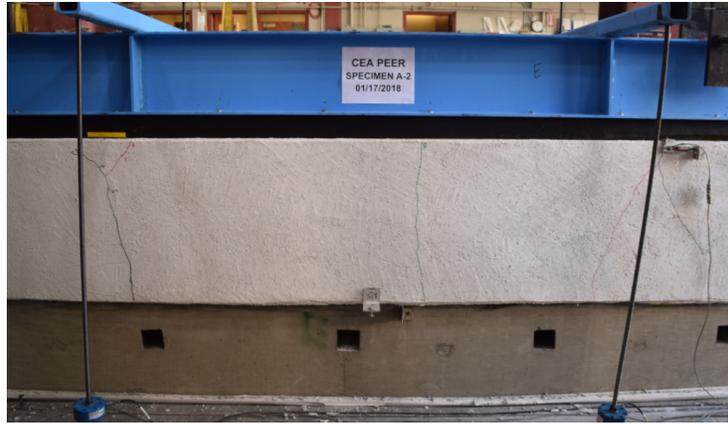
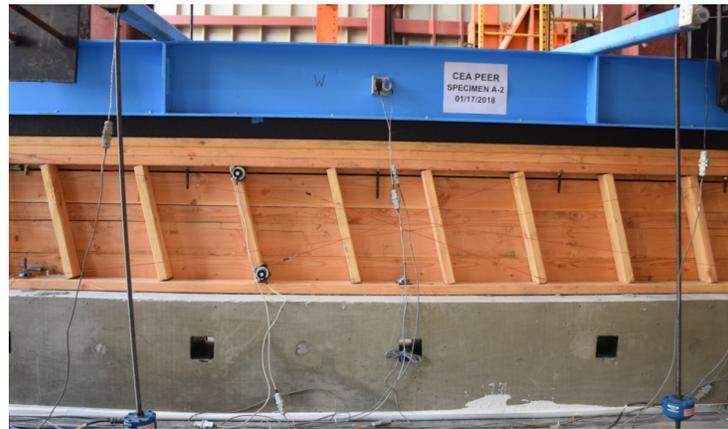
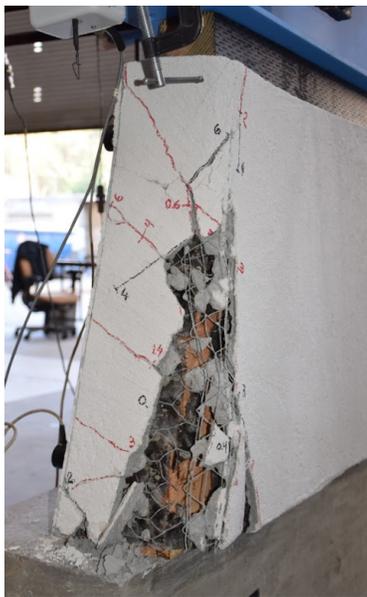
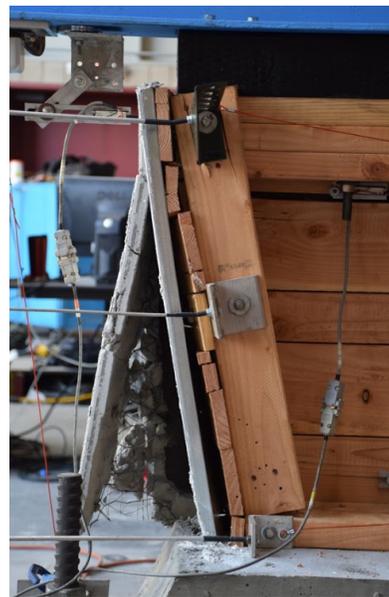
Figure 5.22 Specimen A-2 post-test photographs at lateral load = 0 kips, residual displacement = +3.45 in @ +14.4% drift: (a) exterior elevation of cripple wall; (b) interior elevation of cripple wall; (c) south-end exterior corner view; and (d) north-end interior view.

Figure 5.21(a) to (d) shows the damage state of Specimen A-2 at +12% drift. Specimen A-2 never exhibited an 80% drop in lateral strength. The damage state at 12% correlates closer to a 70% drop in peak strength. The stucco detached completely over the majority of the wall. The only attachment was at the dense furring nail arrangement at top. Figure 5.21(d) shows extensive movement of the stucco away from the sheathing at the base, as well as around a 1/4 in. of movement of the sheathing board away from the framing. Much of the stucco had spalled off of the corners, coming off in large chunks. Most of the sheathing boards on the corners split. A 3/8-in. gap formed between the top two sheathing boards, which was due to the top sheathing board being fastened to the top plates, while the other sheathing boards were attached to the studs. Like the other specimens, the capacity of the wall is attributed the sheathing boards stacking on each other and bearing on the foundation. Figure 5.22 shows the cripple wall in its residual state at the end of testing after a 4.5-in. monotonic push. There was a residual displacement of 3.45 in. once the load was removed.

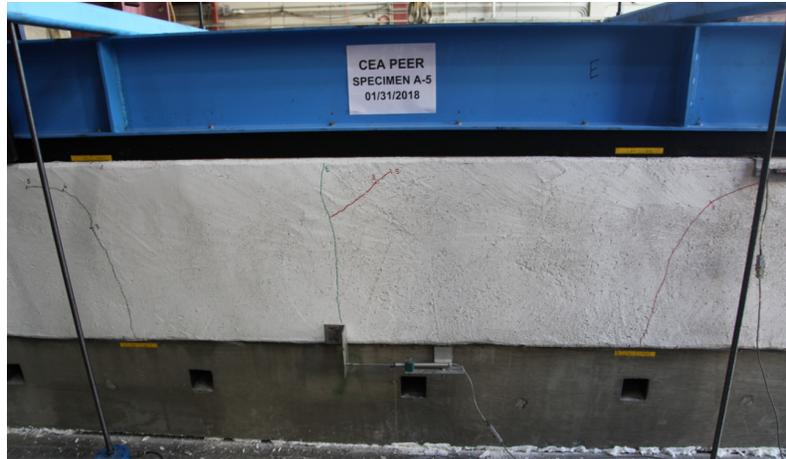
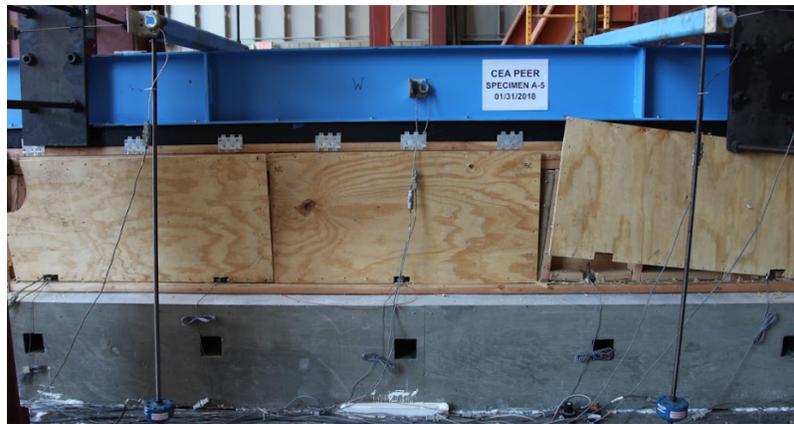
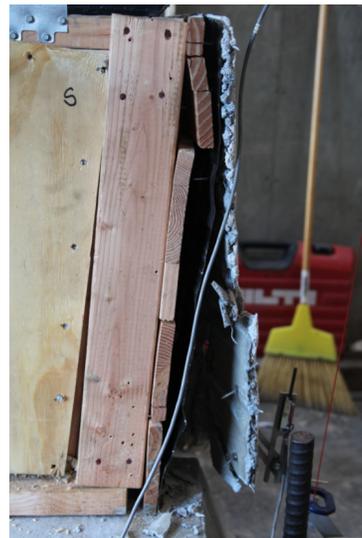
Figure 5.28 Specimen A-5 post-test photographs at lateral load = 0 kips, residual displacement = -1.74 in. @ -7.3% drift: (a) exterior elevation of cripple wall; (b) interior elevation of cripple wall; (c) north-end exterior corner view; and (d) south-end interior corner view.

Figure 5.27(a) to (d) shows the damage state of Specimen A-5 at -11% drift. The data for this test stopped being accurately recorded at 7% drift amplitude due to the loss of the control displacement potentiometer; however, higher amplitudes were imposed to obtain a visual of the damage state of the failed wall. All plywood panels almost completely detached (only two to three nails remained attached) on the top, bottom, and one side, providing no lateral resistance. The south-end plywood panel remained attached by only two nails; see Figure 5.27(a). Most of the nails at the top had ripped through or pulled through the plywood. At the bottom of the plywood panels, many of the nails pulled out of the block, and much of the blocking was either uplifted out of the sill plate or split where the plywood was nailed. The corner flat studs split due to the abutment of the plywood. The damage to the stucco had the same characteristics as Specimen A-2, the existing condition replica. Figure 5.28 shows the cripple wall in its residual state at the end of testing after the end of the 11% drift cycle group. After the wall was unloaded at -11% drift (-2.64 in.), a residual displacement of -1.74 in. remained.

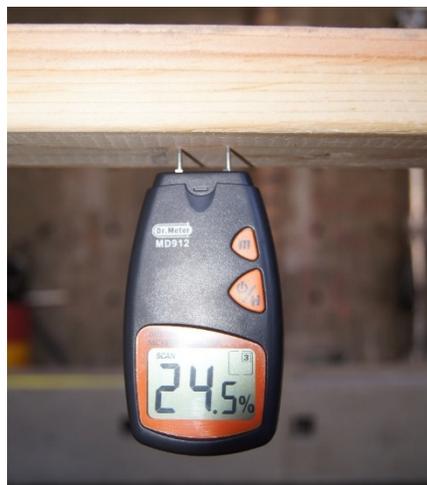
Figure A.1 MD912 digital moisture content reader in use.

For all cripple walls constructed, the moisture content of the wood was recorded. The moisture content was measured using an Dr. Meter MD912 digital moisture meter, which is a pin meter with a resolution of 0.5% and accuracy of +/- 0.5%. A picture of the moisture content reader used for the project can be seen in Figure A.5. Understanding the moisture content of wood is important as drier wood has higher strength properties than fresh or moist wood. For all cripple walls, the moisture content was from 4–12% immediately prior to testing. The moisture content was considerably higher when the lumber was first purchased but dried out significantly before testing, especially after the application of the stucco finish. The moisture content was read on five various places on a piece of lumber—top, bottom, middle, and sides—and then repeated on four additional pieces of the same type of lumber. The results were recorded and are displayed in Table A.3 along with the date of recording and averages for each type of lumber.
