Quantifying the Performance of Retrofit of Cripple Walls and Sill Anchorage in Single Family Wood-Framed Buildings

WORKING GROUP 4 – EXPERIMENTAL TESTING:

SMALL COMPONENT TESTING INTRODUCTION

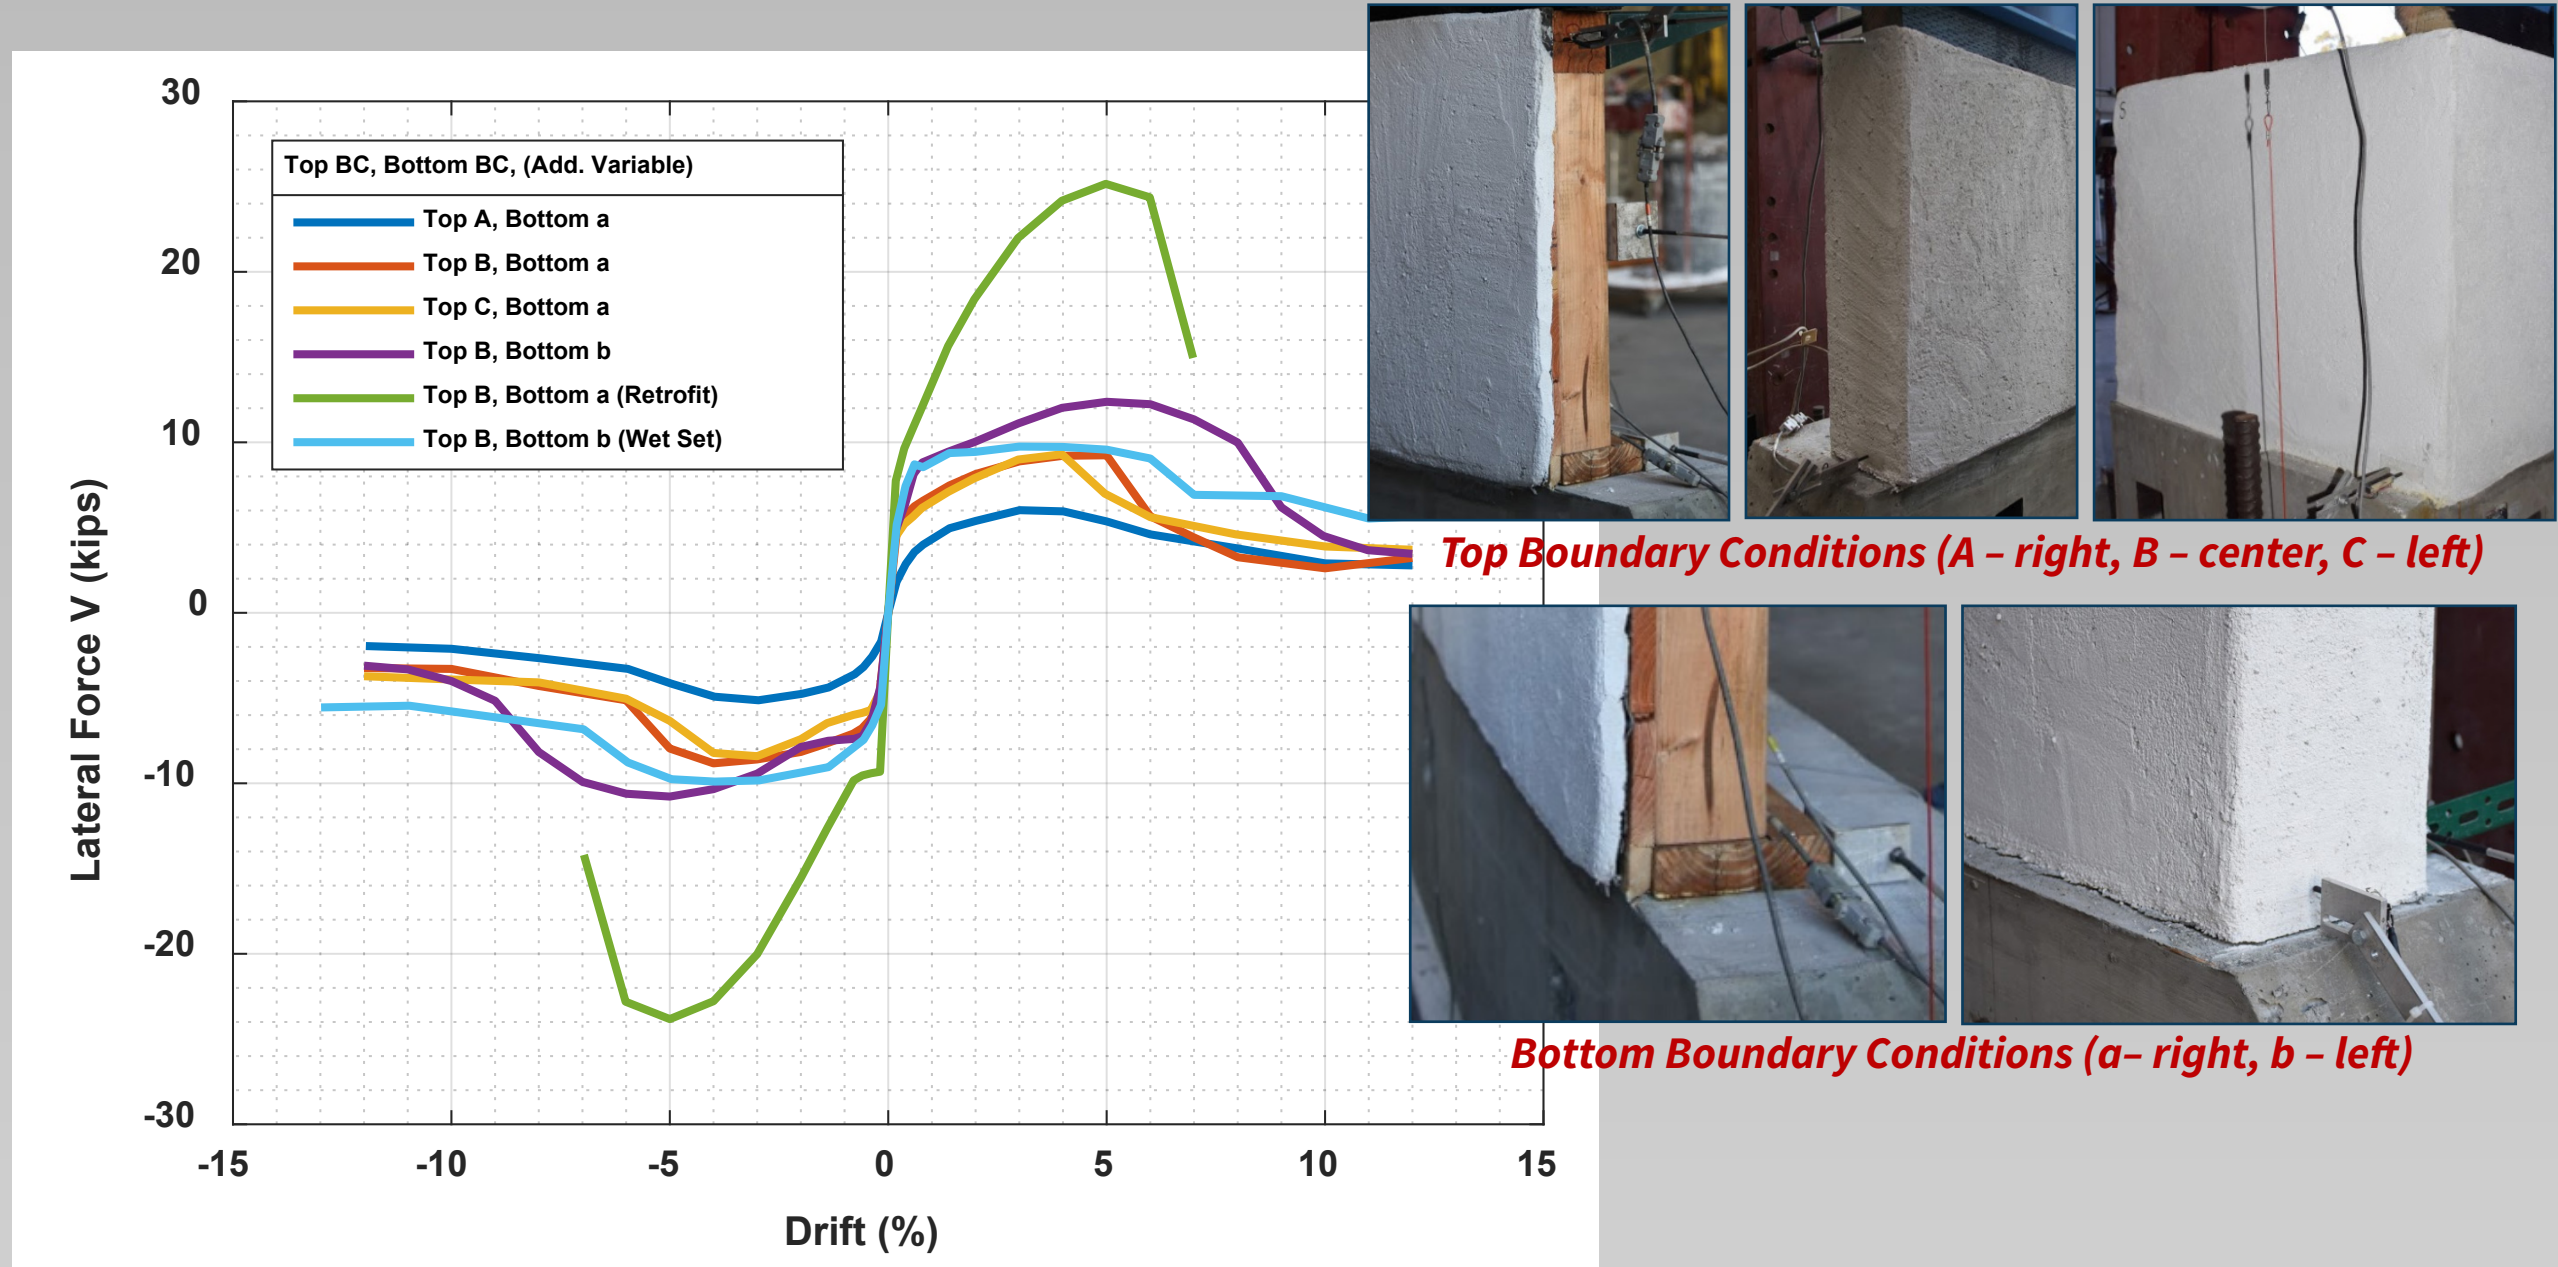
SMALL COMPONENT TESTING - PHASE 1

This figure illustrates load-deflection behavior for five two-foot tall cripple walls without retrofit and one with retrofit. The original bracing material for all was stucco applied over horizontal lumber sheathing. The five tests without retrofit use varying boundary conditions at the top, bottom and sides of the specimen to explore the influence of these conditions. The cripple wall with retrofit is seen to have a significantly higher peak capacity.

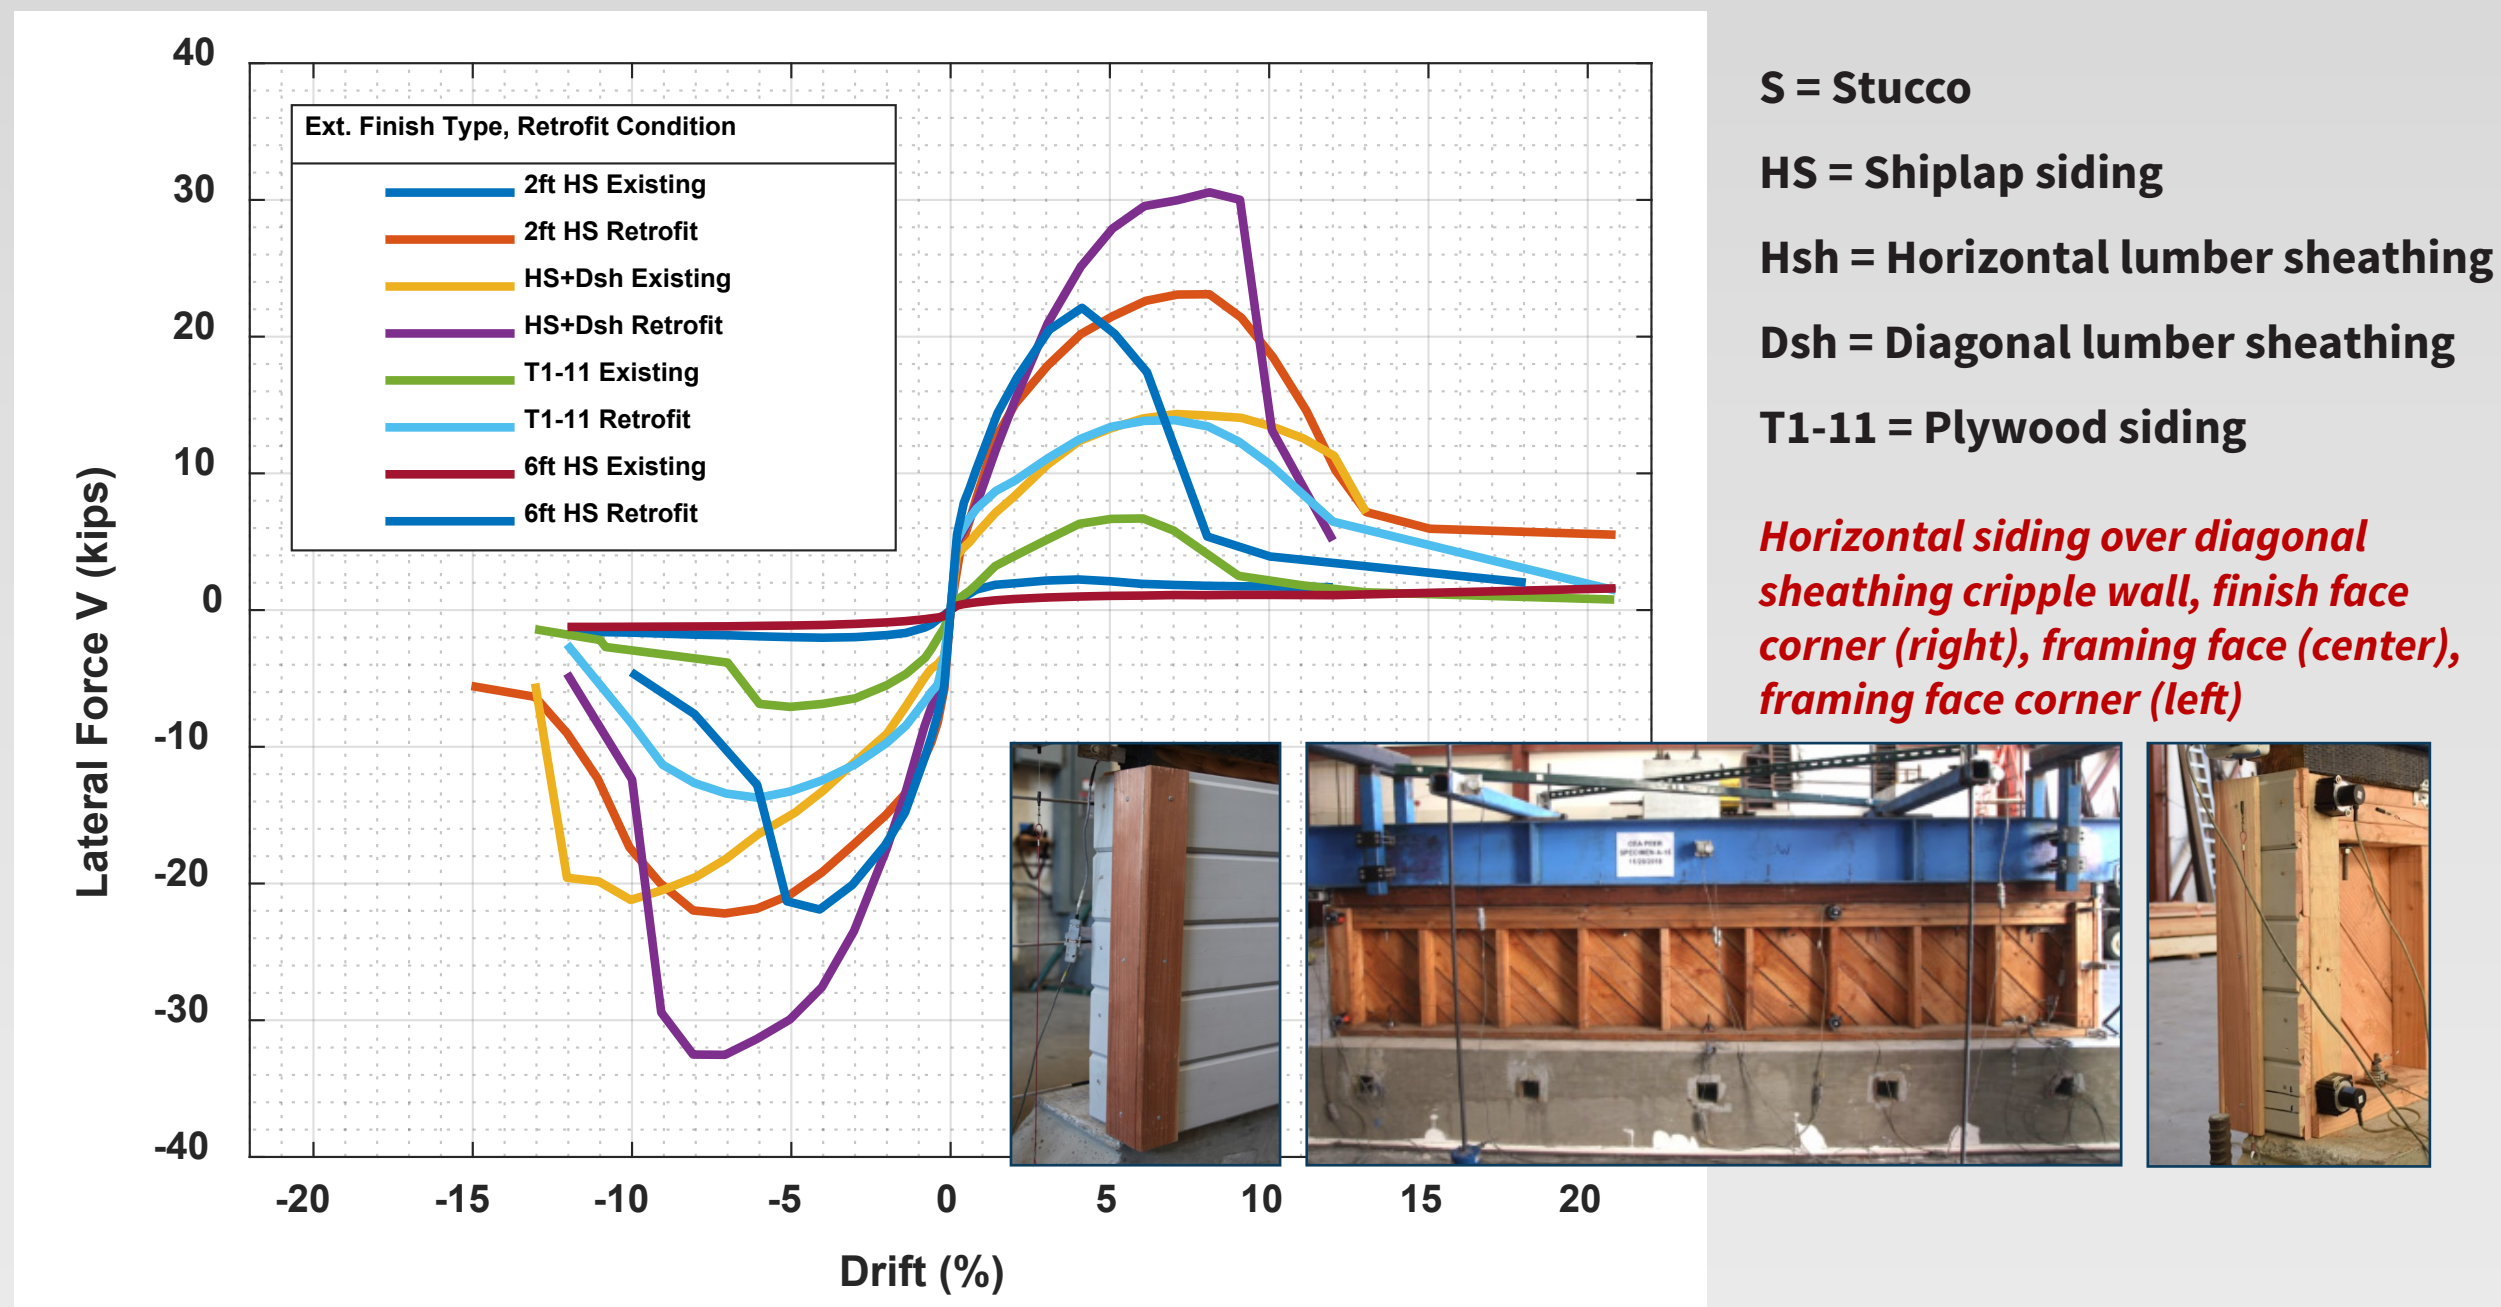
SMALL COMPONENT TESTING - PHASE 2

This figure illustrates load-deflection behavior of cripple walls both with and without retrofit, and having varying original bracing materials and heights. When considered as a group there is a significant overlap between walls with and without retrofit (the highest capacity shown is for a wall without retrofit). This illustrates the complexity of information, and the importance of this information to the Working Group 5 analytical studies.

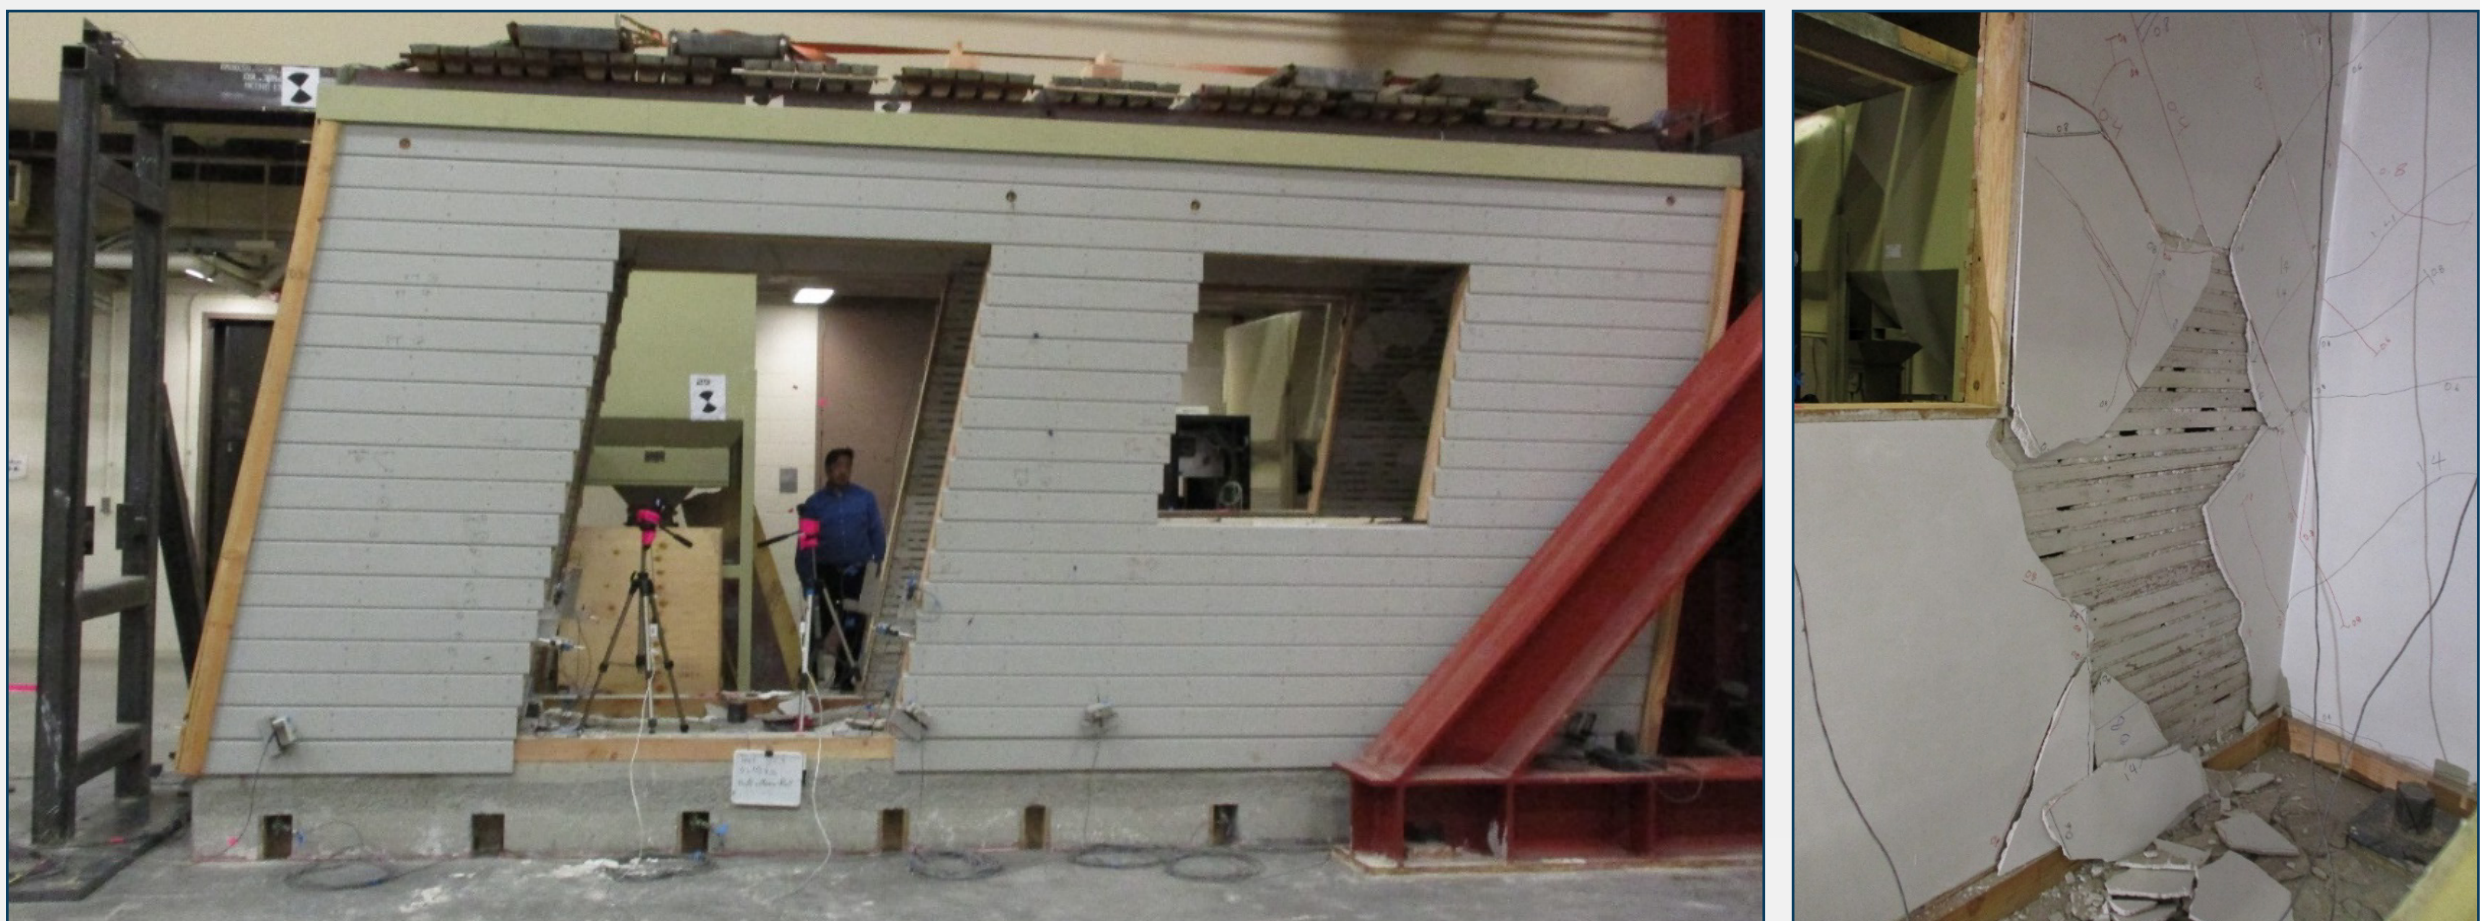
LARGE COMPONENT TESTING - OCCUPIED STORIES

The testing of an occupied story with plaster on wood lath interior and shiplap exterior siding identified the plaster to contribute significantly to the peak capacity, but also to sustain significant damage at small deflections, leading to a drop in capacity. The remaining capacity continued to large deflections, and is thought to be due to the shiplap siding with some remaining strength contribution from the plaster.

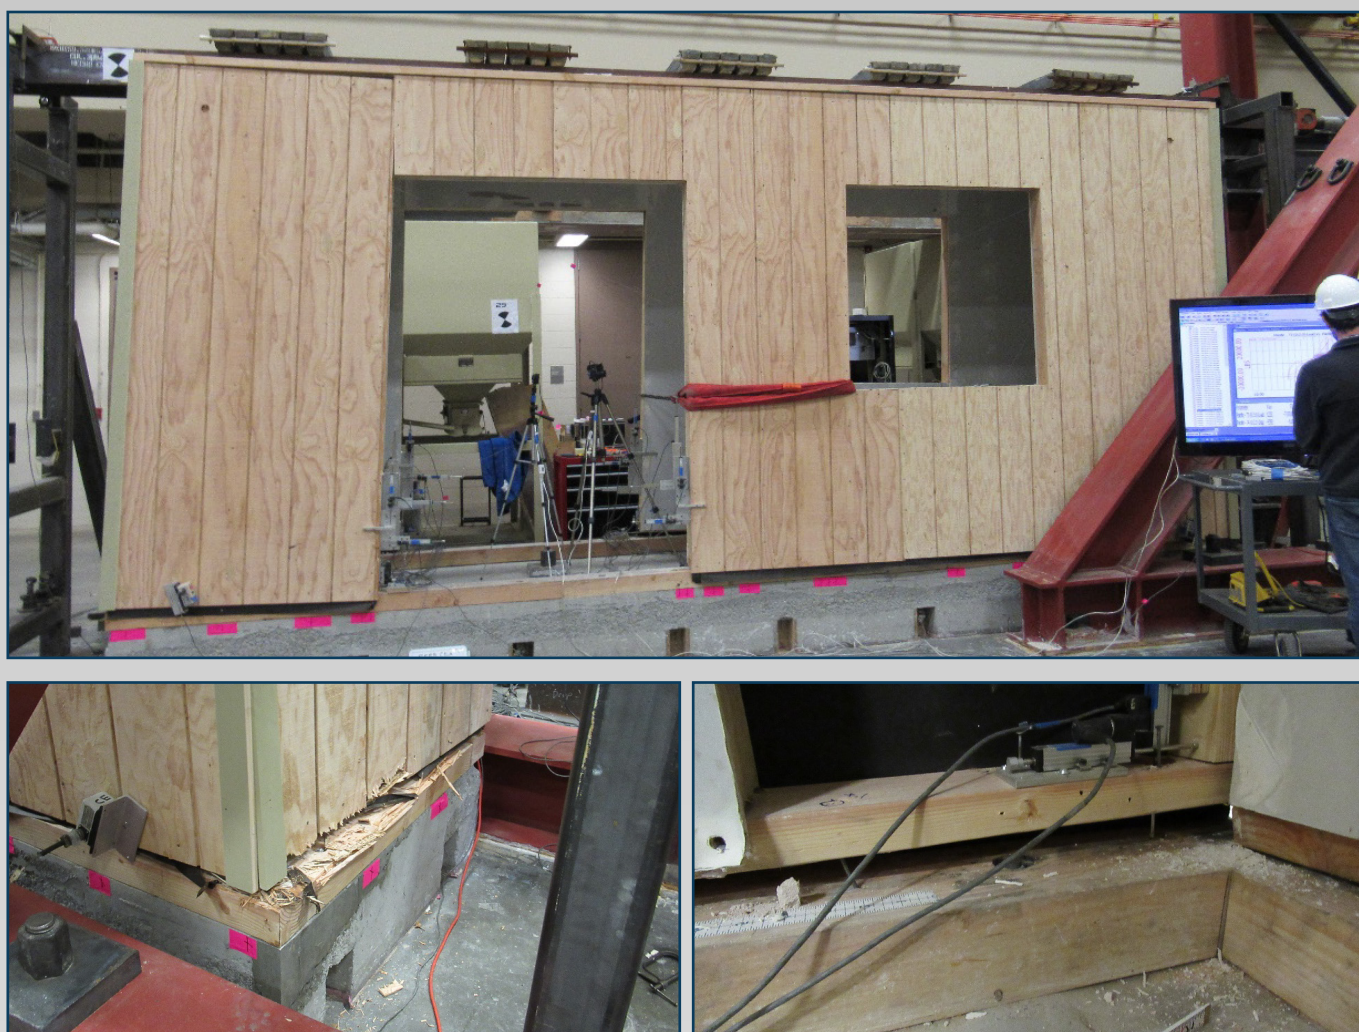
LARGE COMPONENT TESTING - OCCUPIED STORIES

The testing of an occupied story with gypboard interior and plywood panel siding (T1-11) exterior identified the combination of materials to be a good contributor to strength and stiffness. Due to the low weight of the structure and superimposed load, the structure started to experience uplift from overturning forces, which eventually led to the withdrawal of nails to the sill plate, and resulted in failure in sliding, serving as a reminder of this behavior.

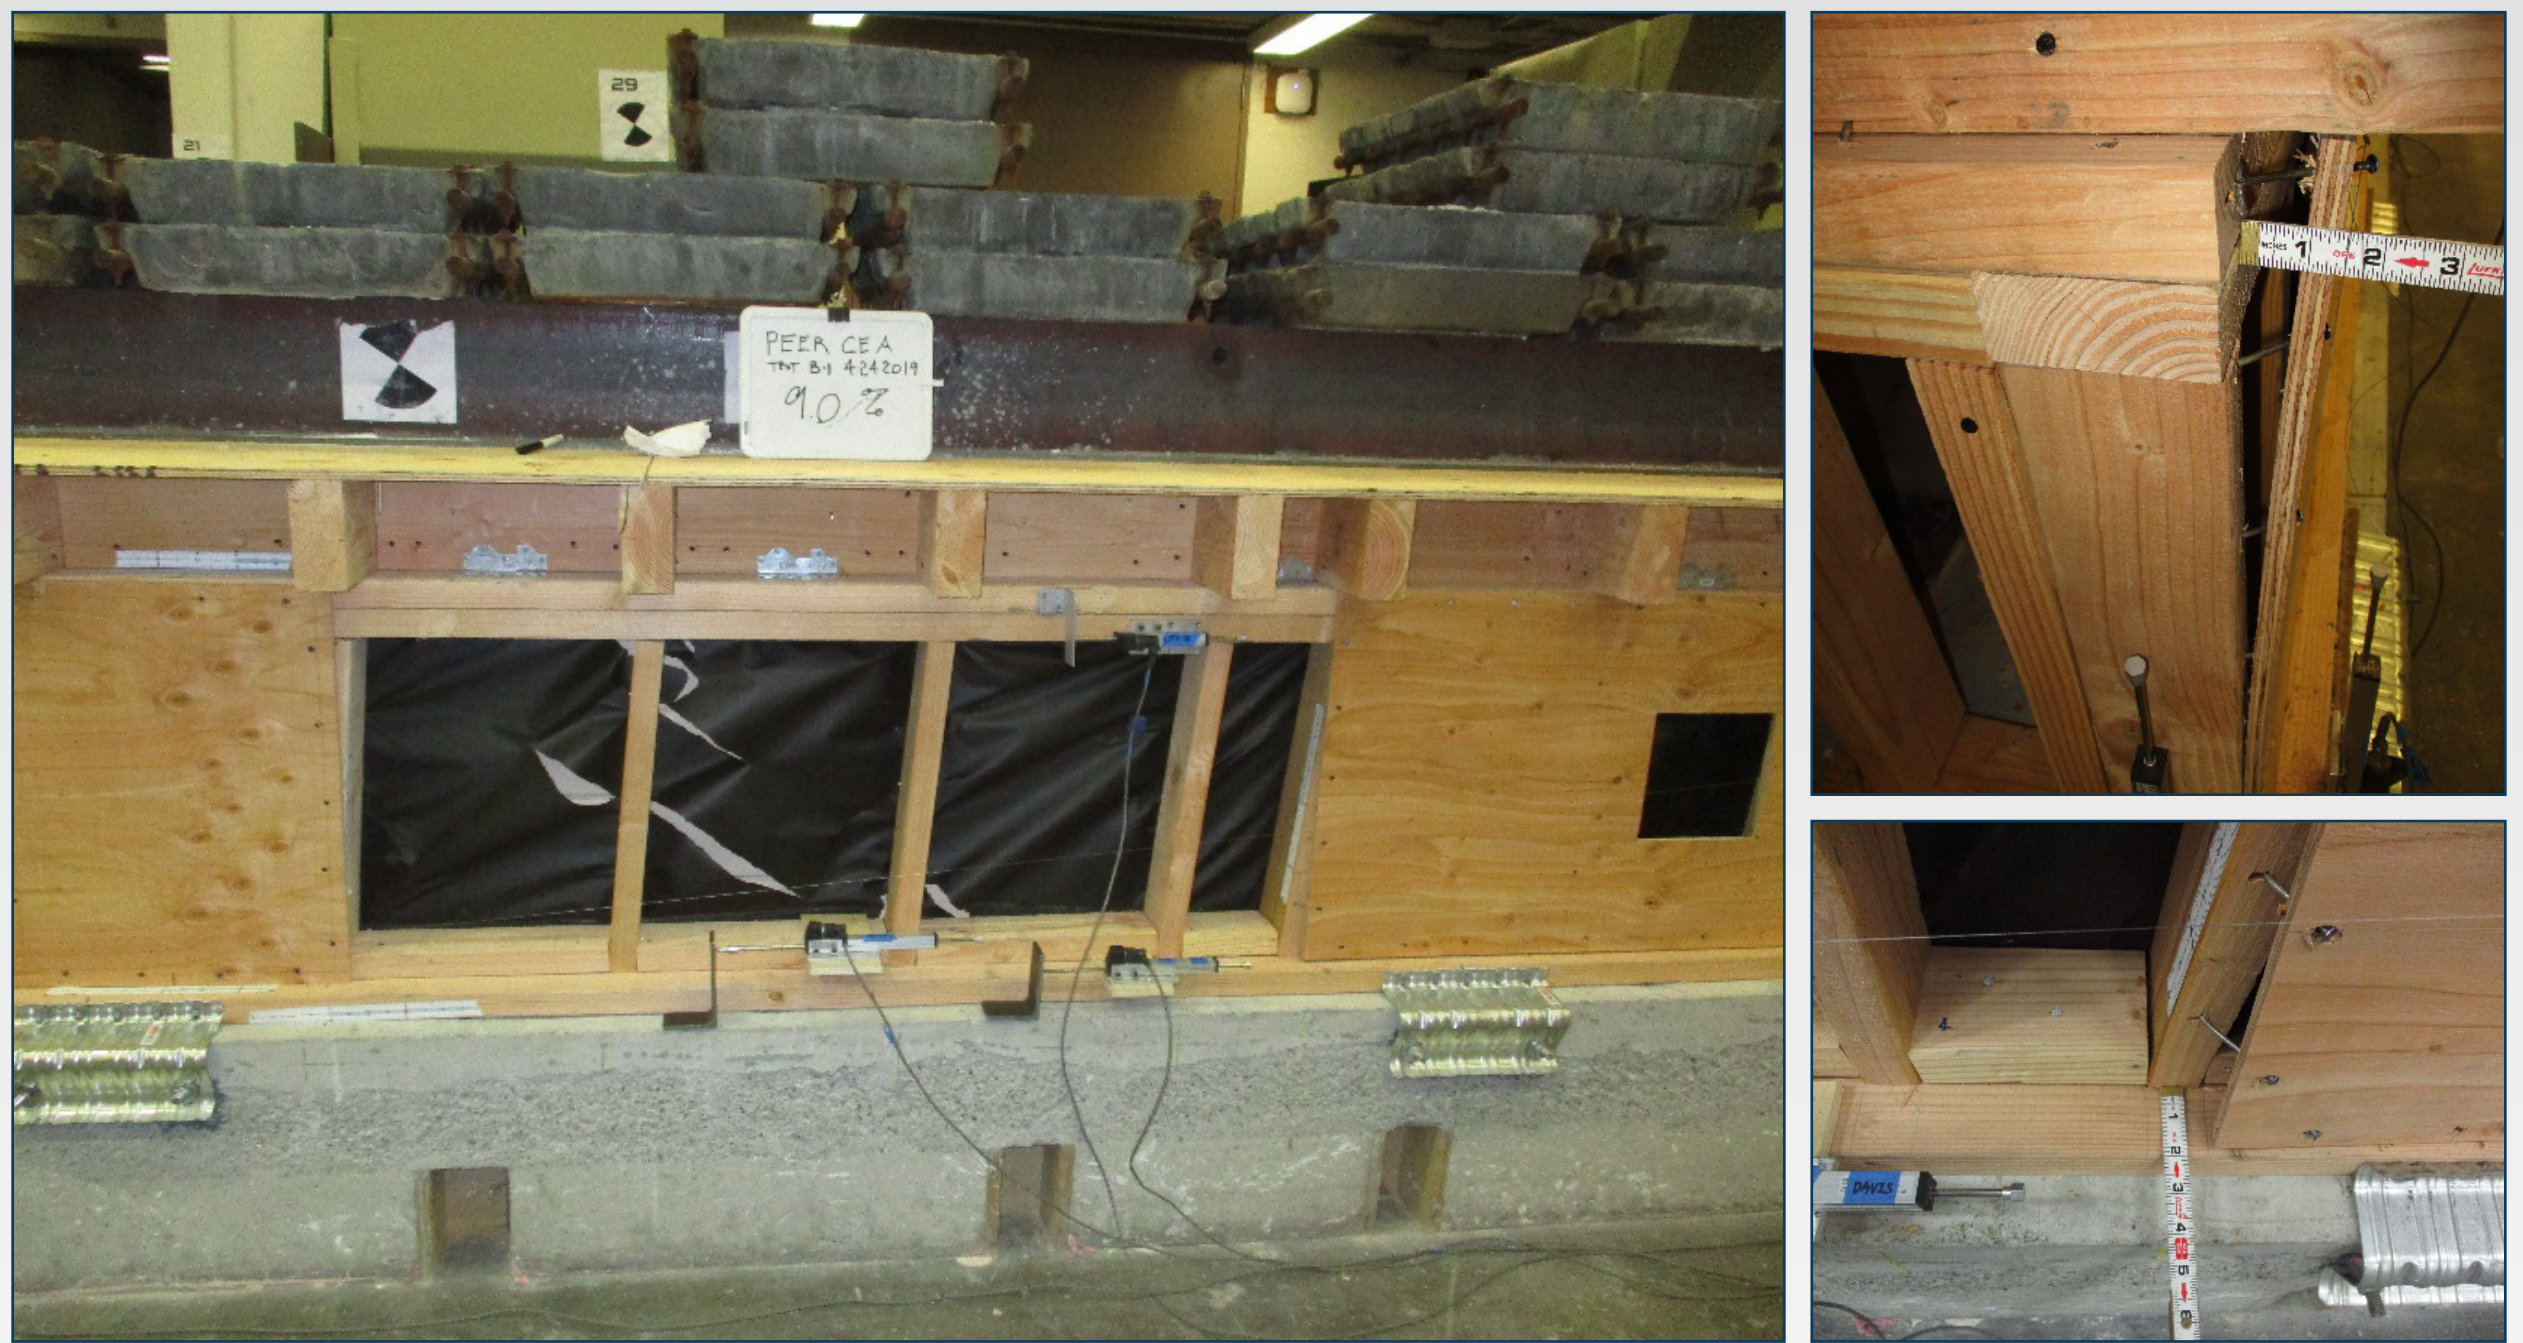
LARGE COMPONENT TESTING - LOAD PATH CONNECTIONS

The testing of a cripple wall with shiplap siding and cripple wall retrofit (designed in accordance with FEMA P-1100 prescriptive retrofit provisions) illustrated that load-path connection selected in accordance with this FEMA P-1100 Guideline were capable of developing the full capacity of the siding and retrofit plywood without signs of deterioration to these connections.
