Bracing Berkeley

A Guide to Seismic Safety on the UC Berkeley Campus

PEER 2006/01
Pacific Earthquake Engineering Research Center
College of Engineering
University of California, Berkeley
January 2006

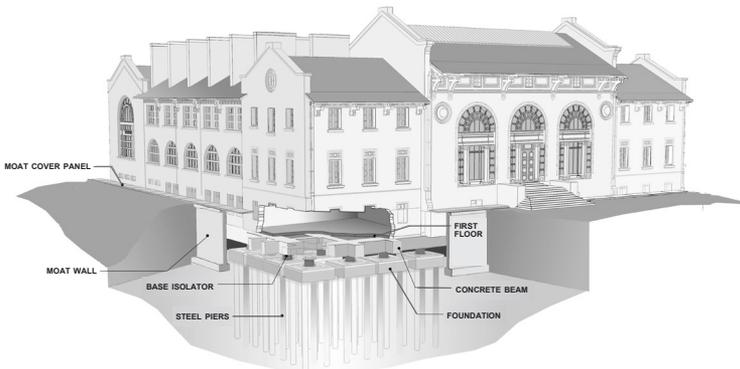
PREVIOUS PAGE:
Hearst Memorial Mining Building
after retrofit.
BELOW:
Rendering showing base-isolation
and foundation system.

The Hearst Memorial Mining Building's base-isolation system consists of 134 steel and rubber-laminated composite columns, called "base isolators," which can move 28 inches in any horizon-

tal direction, allowing the building to safely ride out earthquakes. The technology was pioneered by UC Berkeley Engineering faculty more than twenty years previously. Base isolators are made with elastomeric bearings that decouple the building from the horizontal components of the ground motion by interposing structural elements with low horizontal stiffness between the structure and the foundation. This layer gives the structure a fundamental period that is much higher than that of a fixed-base foundation system. The type of isolators used for HMMB are called “multilayered laminated rubber bearings,” with steel-reinforcing layers as the vertical load-carrying component of the system. Because of the reinforcing steel plates, these bearings are very stiff in the vertical direction, but are flexible in the horizontal direction. Easy to manufacture, these bearings have no moving parts and are very resistant to environmental degradation.

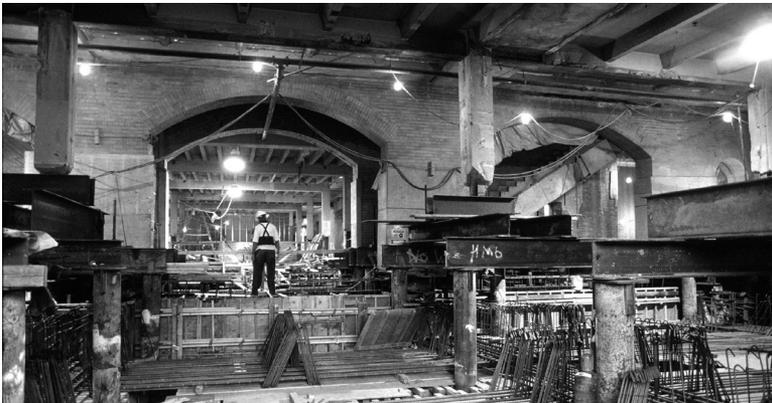
LEFT:
Section of Hearst Mining Memorial
Building.
BELOW:
Installation of base isolators.

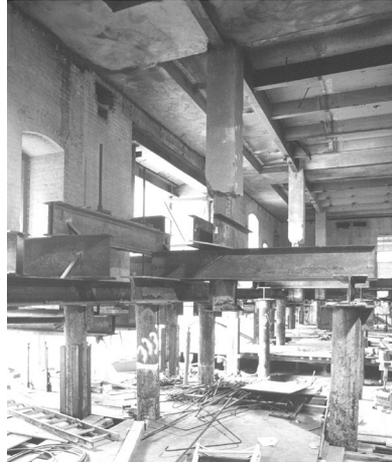
RIGHT:
Detail of installation of base isolators

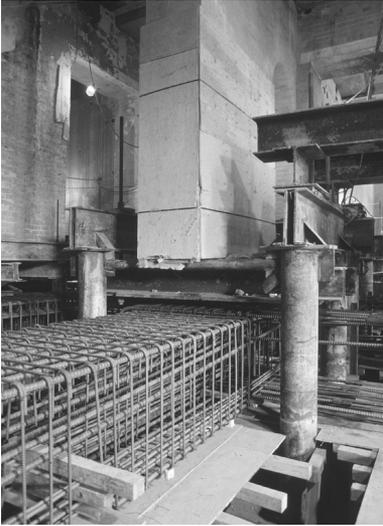
LEFT:
Detail of installation of base isolators.

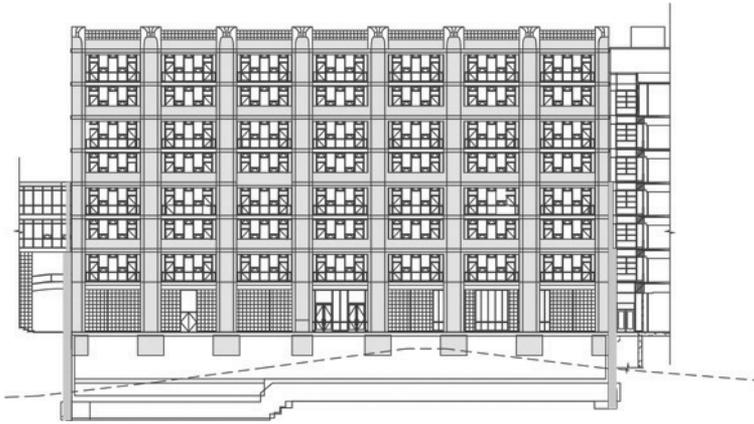
ABOVE:
Elevation showing placement of box
columns.

These concrete box columns along with the floor diaphragms connecting them provided the lateral force resistance in the longitudinal direction. Short shear walls at the stair and elevator cores also provided longitudinal shear strength. Lateral force resistance in a transverse direction was supplied by large concrete shear walls capping the east and west ends of the building, aided by the walls around the elevator core. Gravity loads were shared by the perimeter box columns, the elevator and stair cores, and twelve steel columns in the interior of the building.

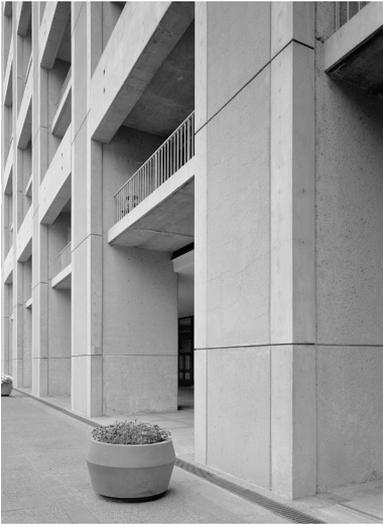
LEFT:
Detail of box columns.

The architects and engineers worked together to find a retrofit solution that would not block light into the lab spaces. Rather than introducing a new structural system into the building, the selected strategy strengthened the building's existing system. This scheme essentially consisted of adding more reinforced concrete to the existing columns, beams, and walls at the building's exterior. At the longitudinal

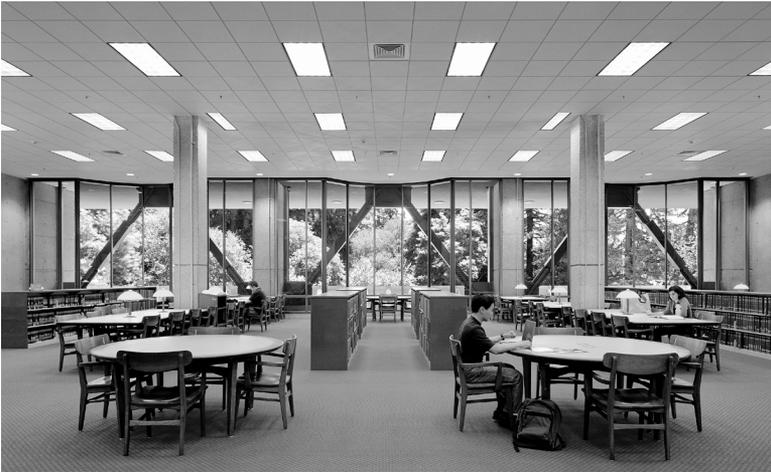
ABOVE:
Interior view of unbonded braces.

tion to anti-seismic technology. Unbonded braces work in a simple and elegant manner. In a traditional steel cross-brace, lateral forces are resisted axially by each cross-member. An applied lateral force will stretch one cross-member in tension and shorten the other in compression. Unbonded braces are made of steel (which is strong in tension) and concrete (which is strong in compression), enabling the braces to exhibit nearly identical properties in both tension and compression. In addition to the braces, new concrete shear walls providing lateral support were added to the two lowest stories, and on the east, west, and south sides a portion of the shear walls extended up to the roof. The walls around the stair cores were strengthened and reinforcement was added to the column-to-slab connections, mitigating the threat of punching shear by the columns. The connections between the precast panel hangers and the roof and floor slabs were strengthened as was the mezzanine level of the library.

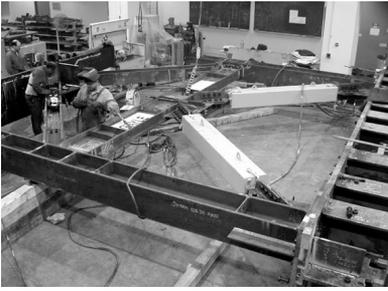
LEFT:
Lab testing of unbonded braces.
BELOW:
View of unbonded braces.

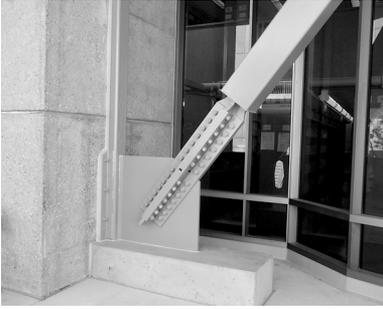
LEFT:
Detail of unbonded brace.

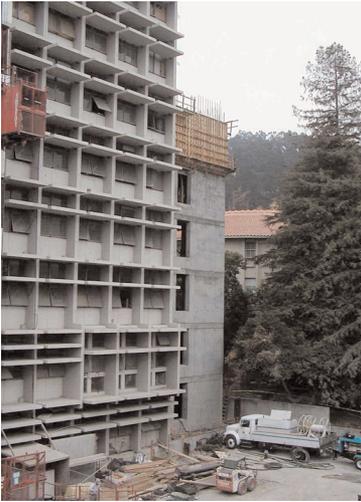
ABOVE:
View of west tube under construction.

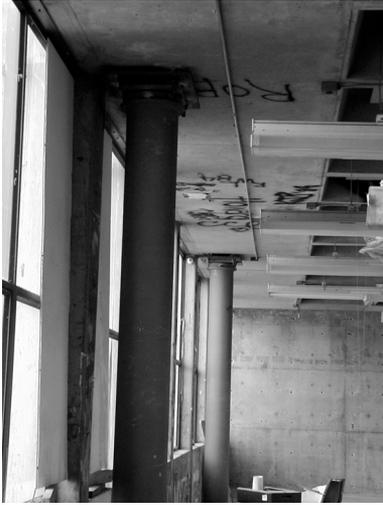
ABOVE:
New interior steel columns in the tower.
BELOW:
Reinforcing bars in new drag struts.

complete an in-depth analysis of Wurster Hall in 1997. In his analysis, Hirsch found that the ten-story tower had little bracing in the east-west direction, and that the tower's existing shear walls were discontinuous, likely resulting in collapse of the tower during a major seismic event. Additionally, Wurster Hall's U-shaped plan with deep reentrant corners suggested the potential for high lateral stresses at the intersection of the north and south legs. Due to sectional asymmetry, the ten-story north tower would experience a different acceleration period compared with the four-story south end of the building. In order to strengthen the building, Hirsch proposed adding precast steel-braced frames inside the facade of the existing structure.

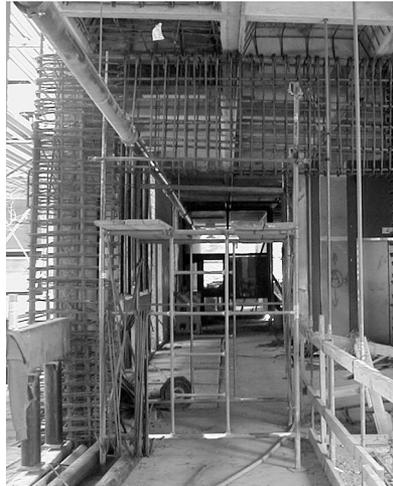
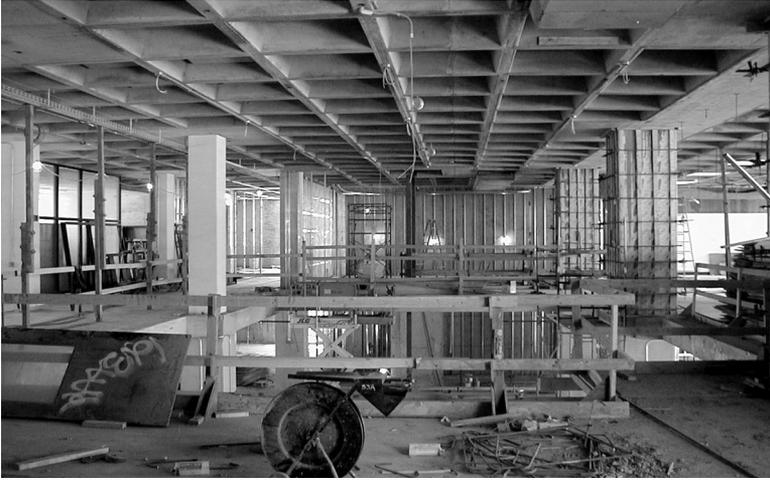
ABOVE:
Rebar laid out for foundation.
RIGHT:
Construction of new shear wall.

or steel bracing, and constructing external buttresses. The project committee selected a design that involved adding two tube-like structures on the east and west sides of the tower. These tubes would brace the tower and provide lateral support. Unlike a number of the other proposals, the tube scheme proposal allowed for extra program space on all of the studio floors. The scheme also included adding new shear walls and foundations to help resist lateral forces, thereby minimizing potential displacement of the tower. Collector beams in the diaphragm were designed to tie the new tube shear walls together with the existing structure. New foundations supported by drilled piers 60 feet deep were added under the tubes. To strengthen the fin columns, a series of steel columns were added on the interior of the facade to transfer the vertical loads. Interior columns were fiber-wrapped to increase strength.

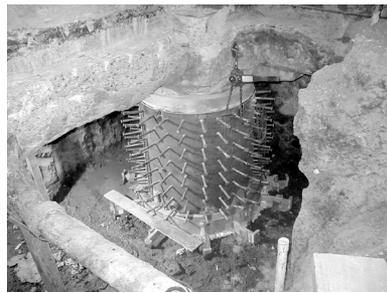
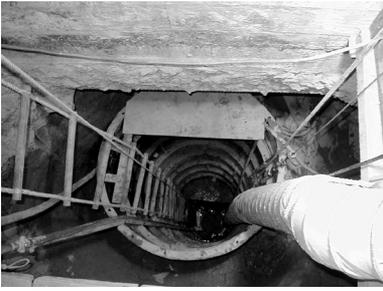
ABOVE:
Library during construction.
RIGHT:
View of pier connection jacket.

LEFT:
View of hand-dug pier below lobby.

Several issues came up during construction that necessitated making changes to the selected scheme. Before pouring the foundations for the new tubes, holes for the new piers had to be drilled below the existing lobby and on the exterior of the east tower facade. Large drills were used for the exterior piers; however, height constraints under the lobby precluded the use of drilling equipment. Hand-digging these holes was the only option. Although the new piers were originally designed with a two-foot diameter, this dimension did not allow sufficient space to enable digging by hand. The piers were resized to a four-foot diameter, which increased their strength and allowed the engineers to reduce the number of piers in the lobby. While the exterior machine-drilled holes took only a day each, the hand-dug holes under the lobby took two months to complete.

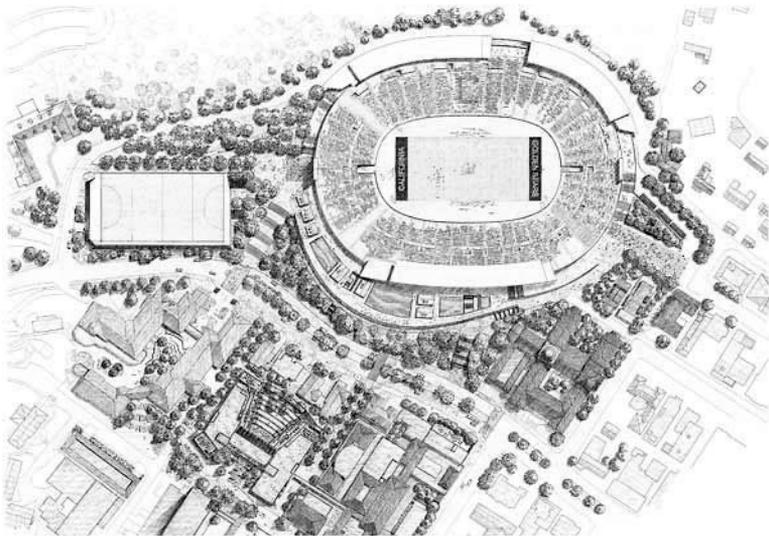
The site proved difficult for several reasons. The Hayward fault runs along the major axis of the final design, and the drainage from the steeply sloping Strawberry Creek basin had to be conveyed under the playing field through a four-foot diameter 1,450-foot-long concrete culvert. Alluvium soil, the Strawberry Creek floodplain, and fill also complicated the foundation. To address these difficulties, the east side was composed of a reinforced concrete structure resting on slab-on-grade construction that followed the slope of the existing hillside with cuts ranging from rock to soft earth. The west side was supported partly on fill and partly by a suspended concrete frame resting on columns that extend far below the surface to a creek bed. Hundreds of square pillars, 20 x 24 feet supported the field, while a continuous concrete foundation wall followed the curving west facade. The west side was divided into three seismically isolated segments that are separated by expansion joints. Seating was fastened to a concrete slab, beam and girder system that was in turn supported on con-

crete columns. The exterior walls were reinforced concrete with concrete walls running longitudinally, connecting the east and west sides.

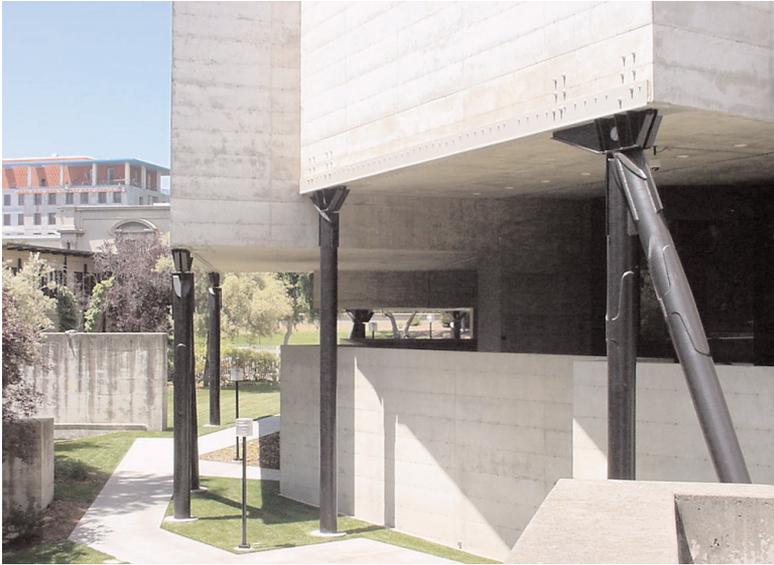
ABOVE:
Berkeley Art Museum after retrofit
with new steel columns.

The exterior retrofit system is designed to catch the building in the event of an earthquake. If the primary structure fails, the steel columns, which are not otherwise structurally loaded, will take over and keep the building from collapsing. These columns sit below the cantilevered galleries and atop new foundation work that includes a series of 3-foot to 3-foot 6-inch piers embedded to depths of up to 60 feet and capped together at grade. The interior system consists of new steel columns that brace the building in vulnerable areas and carry the loads all the way to the foundation. At the perimeter of the galleries, steel trusses tie the building together across the skylights to create continuous diaphragms. Overall, the strategy is an attempt to protect the building against collapse, but it does not incorporate any lateral interior bracing, tree wall strengthening, or tying together of the discrete gallery wings. Due to these deficiencies, the Pacific Film Archive, which can accommodate a relatively high concentration of people at a given time, chose not to reoccupy the building.

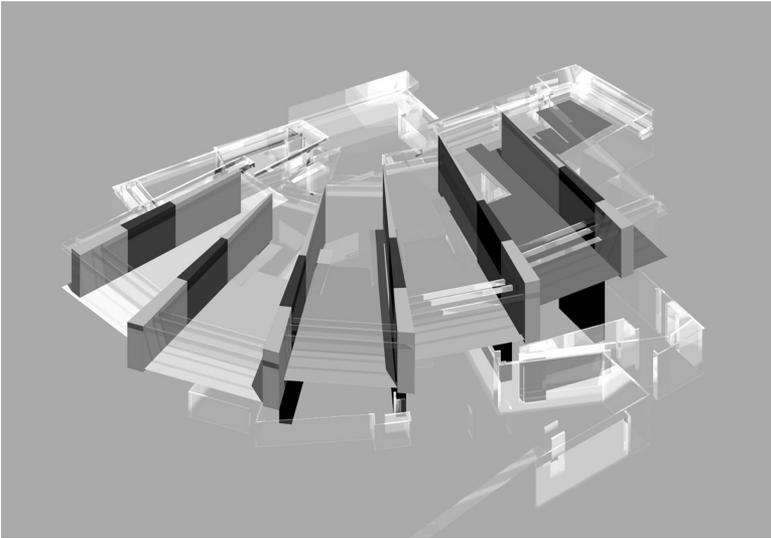
ABOVE:
Isometric drawing showing fan-shaped galleries and shear wall system.

Completed in 1970, Ciampi's bold and innovative reinforced concrete building consists of a three-story fan-shaped plan with a series of stepping galleries radiating from an entrance lobby. The western walls of the lower galleries are glazed, allowing visitors to view the western sculpture gardens. Multiple skylights provide light from above with the largest positioned directly over the entrance lobby. Six "tree walls," freestanding rectangular reinforced concrete walls with

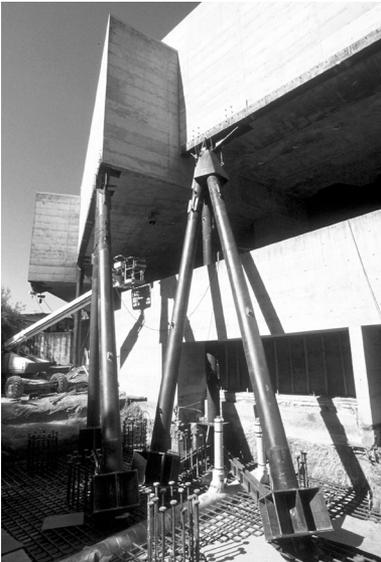
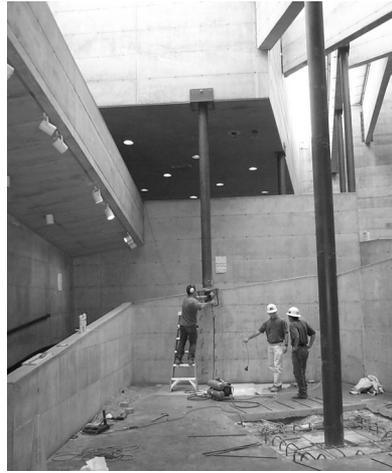
LEFT:
Installation of exterior steel columns.

RIGHT:
Installation of interior steel columns.

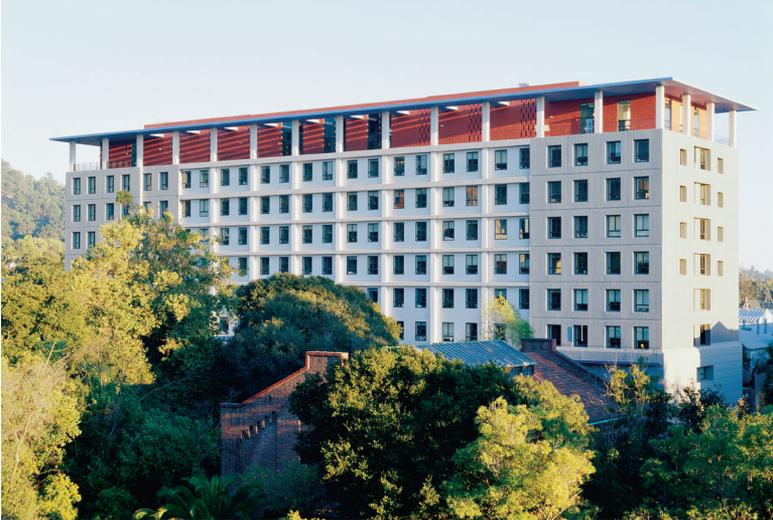
ABOVE:
Barrows Hall after retrofit.
Photo: Liz McBee

The seismic retrofit of Barrows Hall was completed by the architecture firm of Hansen/Murakami/Eshima and the engineering firm of Degenkolb Engineers. Several retrofit schemes were proposed by the design team, including adding buttresses, adding shear walls inside the building, and jacketing both ends of Barrows Hall. After much discussion, the scheme to jacket both ends of the building was selected. The jacketing scheme would increase the strength and stiffness of the building by adding shear walls at the ends of the building. These shear walls would be tied to the building and to the foundation using drag struts (or diaphragm collectors) and boundary reinforcements. The jacketing scheme necessitated removing some windows on the east and west sides.

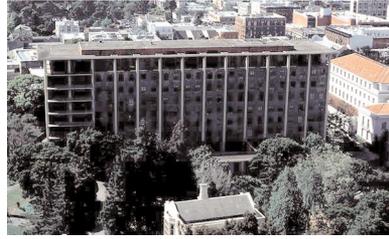
ABOVE:
Barrows Hall before retrofit. Photo by
Steven Brooks.

The architects of Barrows Hall, Aleck L. Wilson and Associates, designed the building according to the aesthetics of the time with "piloti," or columns, popularized by Le Corbusier. The idea was to lessen the mass of the building on its ground floor, giving the impression that the superstructure was floating. The ground floor entrances at the east and west ends of the building were as generous as possible. They opened onto a wide interior corridor which led through the building from the east to the west entrance, and a courtyard to the north. The program called for an upper-story hall and the architects tried to lighten the roof structure above it. They were motivated to make their building as transparent as possible because it was the first high rise on campus and they knew it would obscure the view of the campanile from the south. While the architects succeeded in creating airy circulation spaces and a rooftop auditorium with a deep, continuous balcony and exquisite views, many of the offices and classrooms in the building were cramped and dark. Originally built to house the Business School, today Barrows Hall is the home of multiple departments, faculty, administrative offices, and classrooms.

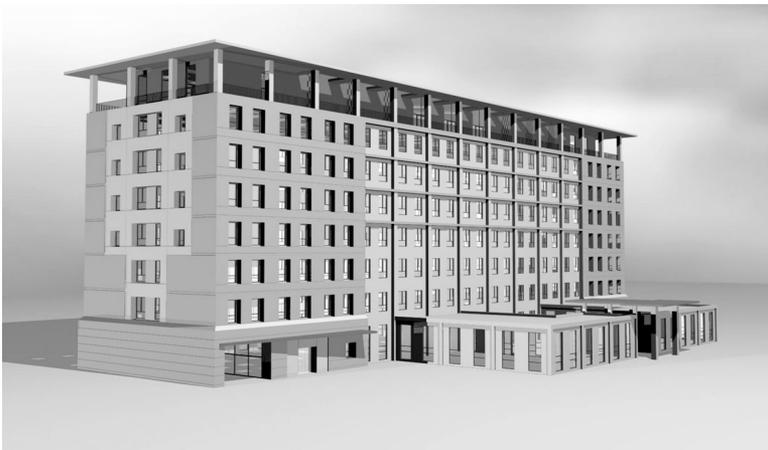
BELOW:

Rendering showing new jacketing scheme on east and west sides of Barrows Hall.

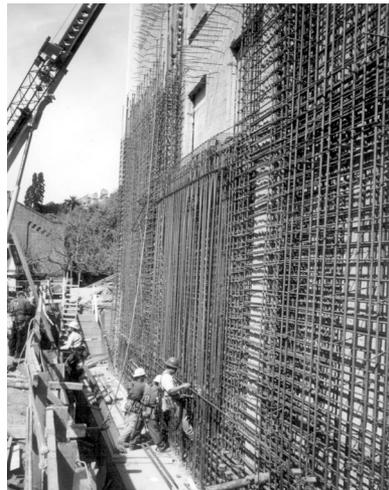
ABOVE AND RIGHT:
View of installation of rebar for new shearwalls.

The retrofit required disruptive construction work, such as chipping and drilling the concrete walls in order to connect the new walls to the original structure. This work was originally scheduled during summer break to avoid disrupting the occupants, but the schedule was difficult to maintain when a number of the original contractors did not fulfill bidding regulations set by the state, thus requiring that the project be rebid. Because construction was delayed, chipping and drilling the concrete took place during the fall semester. Loud construction work was scheduled from 3 p.m.–10 p.m., but limiting noise within these time constraints proved to be quite difficult.

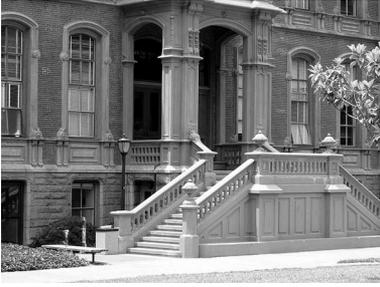
ABOVE:
View of South Hall entrance.

er. Heavy iron girders supported the floors, and strong brickwork and mortar, diagonal sheathing, iron tie bars, anchors, and columns were all used to strengthen the building. The iron rods extended through the building and are visible on the exterior, attached to iron pilasters by decorative bolts. Farquharson intended the iron to provide

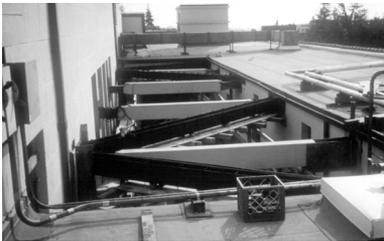
BELOW:

Bracing during construction.

During Step II, the columns were also upgraded and the perimeter walls of the building were tied to the core shear wall system. Three sky trusses were mounted to the new core in Step III. These trusses were designed to collect all the loads from the facade and tie it back to the core. The North Reading Room is listed in the National Register of Historic Places and required strengthening while maintaining its aesthetic integrity. Without removing any skylights or windows, the room's shear walls were strengthened

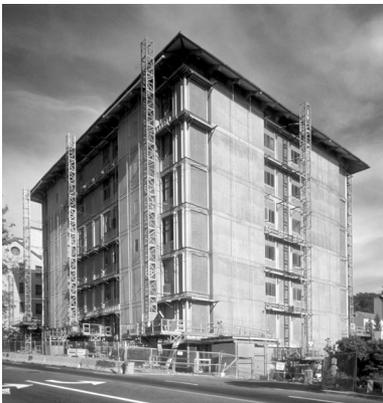
ABOVE:
Barker Hall before retrofit.
LEFT:
Installation of new exterior shear walls.

The engineering firm of Forell/Elsesser was hired to evaluate the existing structure and to propose several possible retrofit schemes. The structural system of Barker Hall consists of shear walls and a reinforced concrete pan joist and column structural system. Individual spread footings bear the weight of the columns, while a continuous spread footing around the perimeter of the building bears the weight of the basement wall. The soil condition is dense and sandy clay, which has a relatively high load-bearing capacity. The core elements that would normally resist lateral force were found to be relatively weak in a number of ways. The precast/pretensioned concrete panel cladding system was found to be not only brittle but insufficient to resist the

lateral load due to the pattern of the window openings, which created a random shear wall system. In addition, the tops and sides of the panels were connected to the perimeter beams and columns by dowels, but the bottoms of the

panels were not connected at all. Shims, instead of dowels, were found between the bottoms of the panels and the beams. Additionally, the perimeter columns did not contain closed ties and the existing frame was found to be inadequate to resist seismic forces.

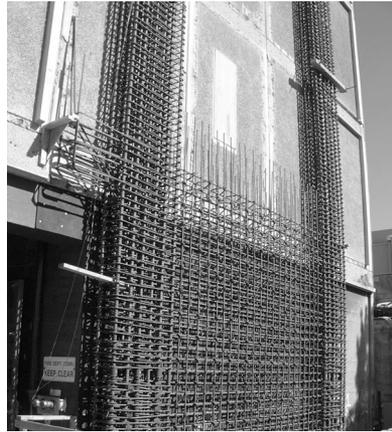
ABOVE:
Rebar for exterior shear walls.
BELOW:
Rebar for foundation.

Forell/Elsesser, and the project architects, Anshen and Allen, drew up the final plan to add eight exterior shear walls (two per side) and collectors, and drilled pier foundations. Later the foundation was changed to a continuous post-tensioned concrete perimeter foundation. The new foundation was constructed 10 feet below the old perimeter foundation. It is a post-tensioned concrete belt beam, 6 feet wide and 11 feet deep. The entire building had to be underpinned because of the close-in construction.

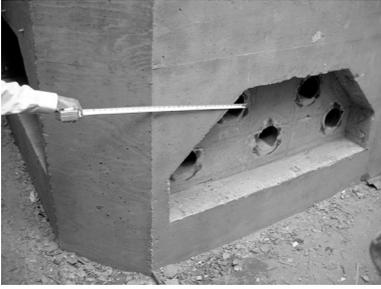
ABOVE:
Detail of construction.

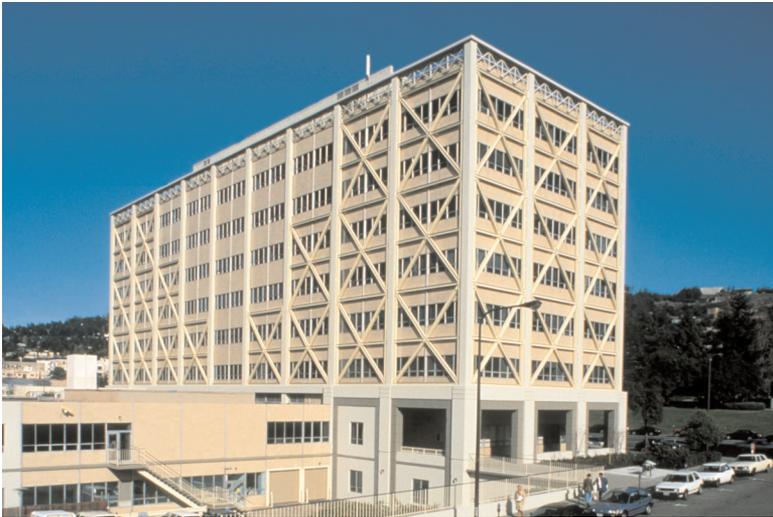
ABOVE:
View of the west and south sides
of University Hall after retrofit.

Located in downtown Berkeley on the corner of Oxford and Addison streets, and buttressing the west end of campus, stands the seven-story tower of University Hall. The prominent exterior steel X-bracing provides a striking testimony of the university's seismic retrofit program. While these structural steel elements may show their purpose, they do not tell of the ten-year process that put them there.

Degenkolb Engineers acted as structural engineers on the 1988 University Hall study and proposed three retrofit schemes to UC Berkeley’s Seismic Review Committee. In the chosen scheme, steel X-frames were added to the exterior of the building, providing clear, visual articulation of the long-awaited seismic improvements. To prevent early column failure, the engineers

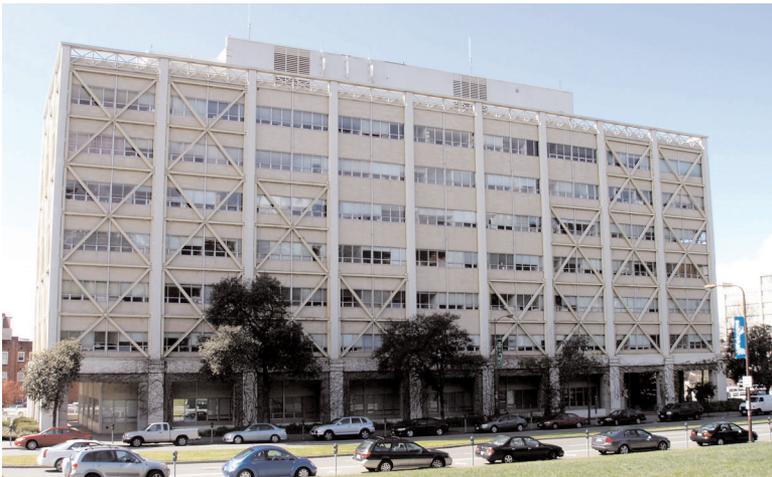
ABOVE:
South entrance to University Hall displays soft story.

Structural engineers found in University Hall an additional seismic deficiency called a “soft story.” Lateral forces acting on a building during an earthquake accumulate as they travel from the top of the structure to the ground. Therefore, the base of the building must provide sufficient resistance to these accumulating loads. If the first story is too weak, it will collapse under the weight of the upper floors—hence the term “soft story.” University Hall suggested this weakness because the first floor is recessed on the south, east, and north sides. The exterior walls of the tower do not extend down to the ground, but stop above the first floor, with columns extending to the ground.

also proposed connecting steel to either side of the concrete columns with epoxy-threaded rods. The scheme also included adding a horizontal truss member to the roof and installing reinforced concrete shear walls to the first floor to prevent soft-story failure.

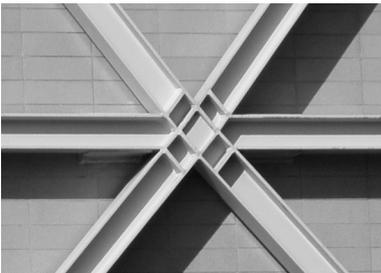
BELOW:
Detail of X-bracing.

Special aesthetic attention was given to the connections of the braced frames, since the connections would be visible on the exterior of the building. Because connections require considerable cutting, drilling, and welding, they frequently end up the messiest looking part of a steel structure. Two critical groups of connections existed in the retrofit system:

the brace intersection where six pieces came together (two beams and four braces) and the column-to-column connections where steel columns connected to concrete columns. At the column-to-column connections, engineers provided steel plates to which fabricators could fillet weld the steel columns on site. These steel plates were connected to the concrete columns by coring across the concrete column and inserting 4- or 5-inch pipes that were then welded to the plates. To make welding as simple as possible, 8-inch wide flange shapes were chosen for all beam, brace, and column sections.
