# **Review of Earthquake Brace and Bolt Program's Photographic Database**

**A Report for the “Quantifying the Performance of Retrofit  
of Cripple Walls and Sill Anchorage in Single-Family  
Wood-Frame Buildings” Project**

**David P. Welch  
Joseph Harijanto  
Gregory G. Deierlein**

Pacific Earthquake Engineering Research Center  
Headquarters at the University of California, Berkeley

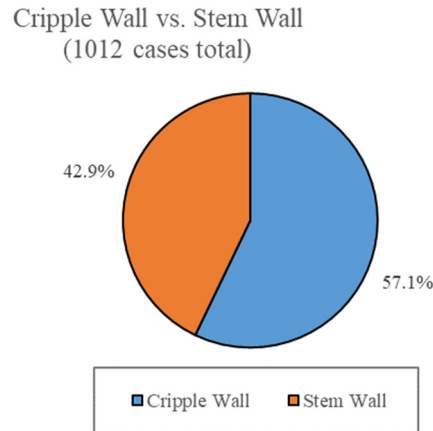
**Figure 2.1** Distribution of observed cripple wall and stem wall dwellings.

The most general classification is made between cripple wall (i.e., those having a raised first floor supported by wood framing on at least two sides of the perimeter) and stem wall houses (i.e., those with first floor framing resting directly on a raised concrete perimeter foundation). The distribution of cripple wall versus stem wall houses is shown in Figure 2.1 with the numerical data provided in Table 2.1. The figure illustrates that the cases documented include comparable numbers of cripple wall (57%) and stem wall (43%) houses, with slightly more cripple wall cases being observed.

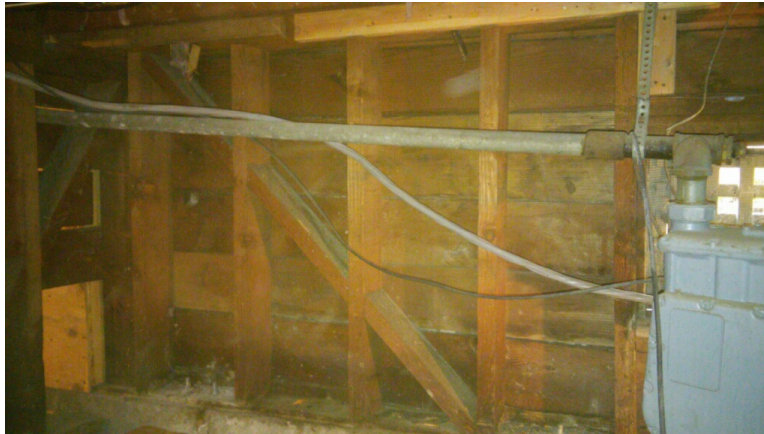
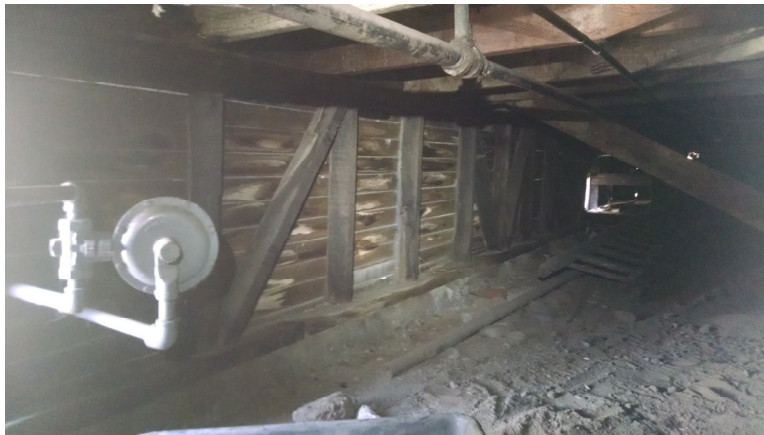
**Figure 2.11** Example photographs of cut-in bracing: (a) cut-in bracing (multiple pieces); and (b) cut-in bracing (single piece).

- Cut-in Bracing (CI) – Diagonal bracing between studs that are installed as individual pieces, commonly fastened to vertical studs by toe-nails. Short cripple walls have single-brace elements, and taller cripple walls have multiple-bracing pieces (see Figure 2.11);

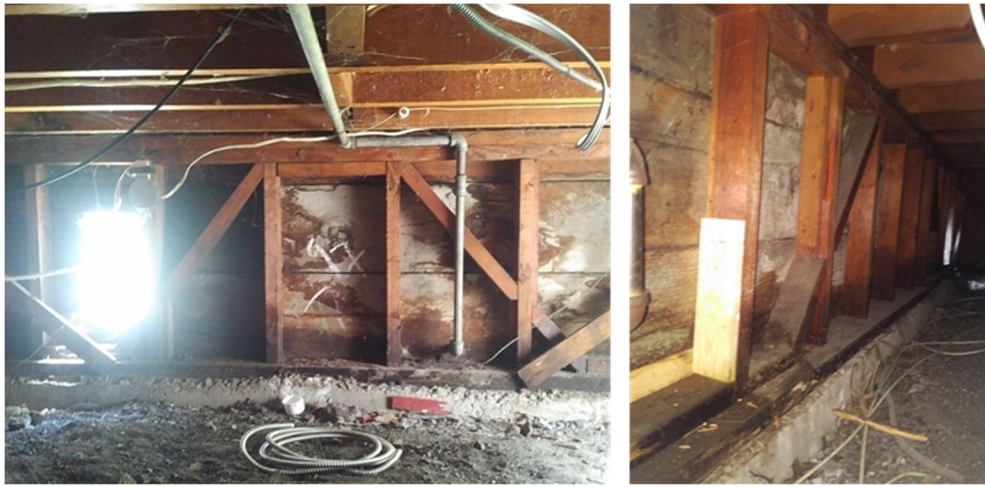
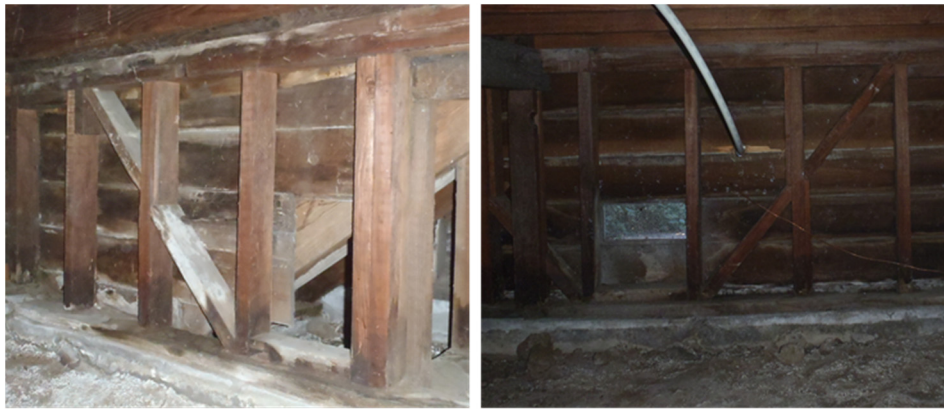
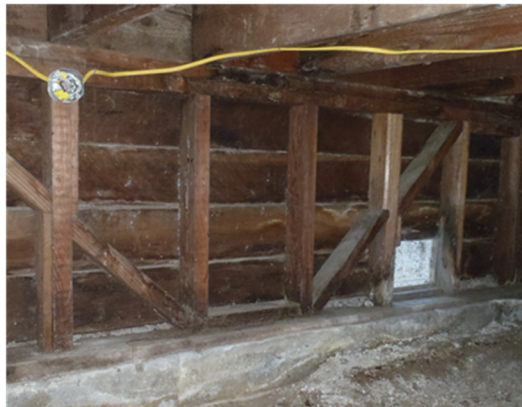
**Figure 2.13** Example photographs of retained block bracing: (a) retained block bracing example dwelling; and (b) retained block bracing example dwelling 2.

- Retained Block Bracing (RBB) – Bracing is “cut-in” between studs and supported in the compression direction by additional blocks face nailed to studs. Additional blocking to support vertical stud connections is commonly placed in stud bays adjacent to braced area (Figure 2.13);

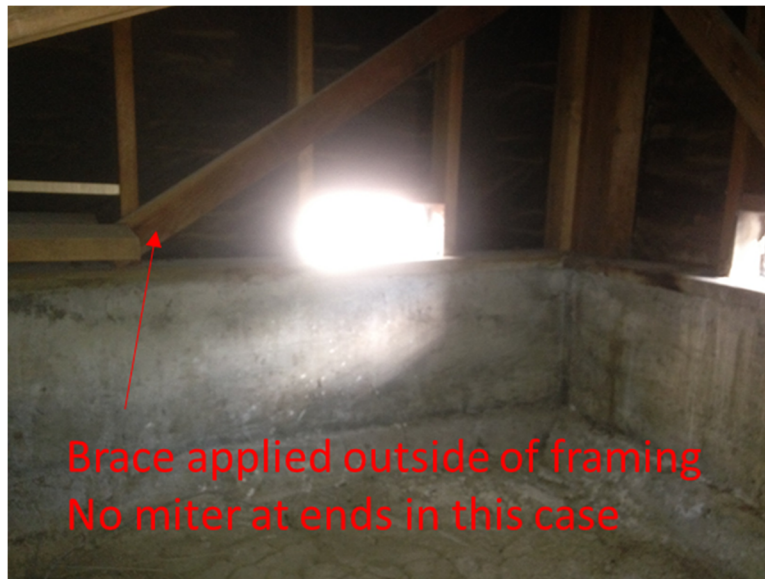
**Figure 2.14** (a) Example photographs of “weak” bracing; and (b) let-in bracing.

- “Weak” Bracing (WB) – Bracing is only face-nailed to the studs. No axial loading of the brace elements possible (the only resistance is provided by face nail connections). Often used as temporary bracing used during construction (Figure 2.14(a); and
