Guidelines, Specifications, and Seismic Performance Characterization of Nonstructural Building Components and Equipment

PEER 2002/05 SEPTEMBER 2001

Final Report

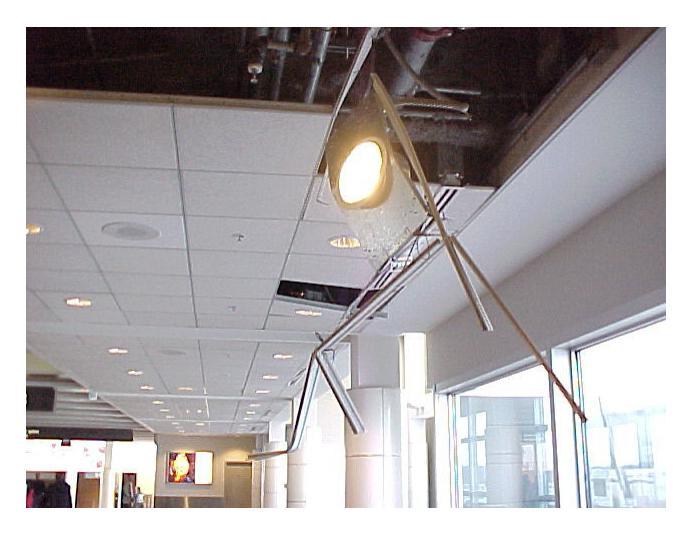
Figure 2.1 Partial Failure of Suspended Ceiling at Sea-Tac Airport (Filiatrault et al. 2001).

One of the most common types of nonstructural component failure observed following the Nisqually earthquake was related to suspended ceiling systems. Examples of partial suspended ceiling failure at Sea-Tac Airport are shown in Figs. 2.1 and 2.2.

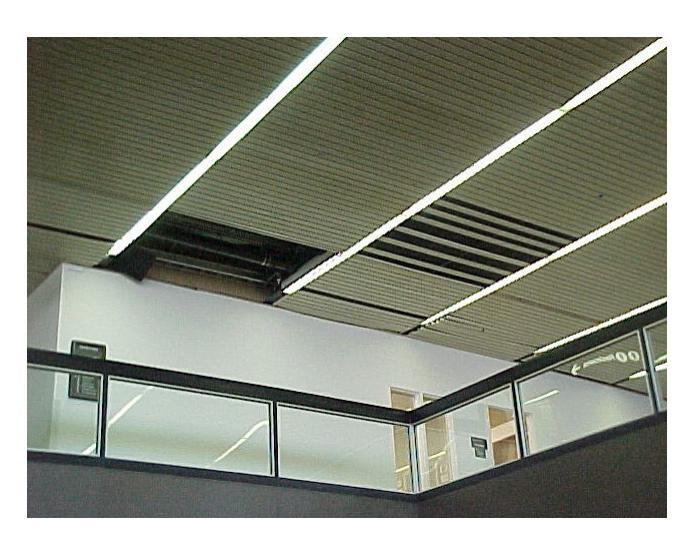
Figure 2.2 Partial Failure of Metal Suspended Ceiling at Sea-Tac Airport (Filiatrault et al. 2001).

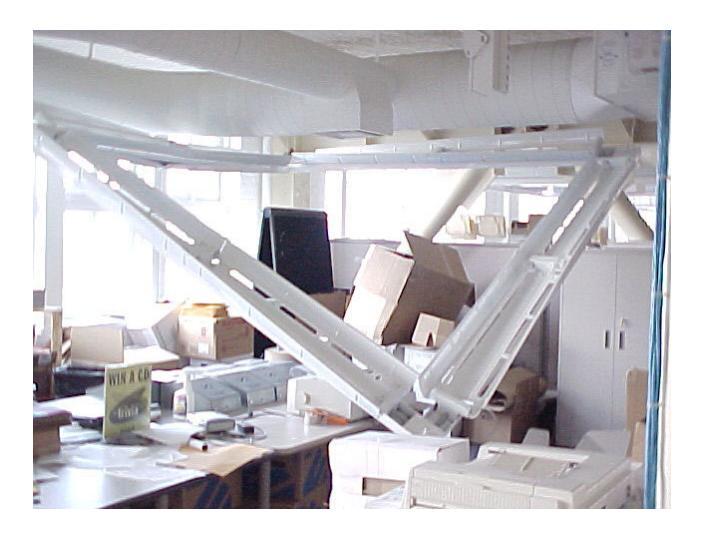
Figure 2.3 Failure of Suspended Lighting Fixtures in Starbucks Headquarters, Seattle (Filiatrault et al. 2001).

One of the buildings that experienced the most damage related to suspended ceiling light fixtures was the Starbucks Headquarters building in downtown Seattle. Although the eccentrically braced steel frames used to seismically upgrade the building performed as intended, the suspended lighting fixtures were unable to accommodate the induced lateral acceleration and caused significant damage, as shown in Fig. 2.3. Fortunately, only minor injuries resulted from the failure of suspended lighting fixtures throughout the building. The building also suffered damage caused by the shifting and tumbling of unanchored furniture items and contents, as shown in Fig. 2.4.

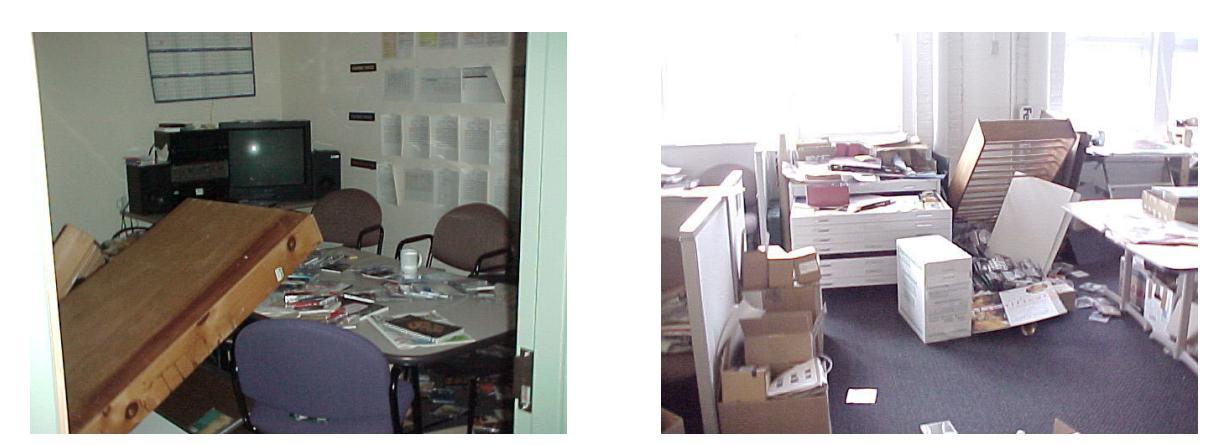
Figure 2.4 Damage Caused by Unanchored Furniture Items and Building Contents in Starbucks Headquarters, Seattle (Filiatrault et al. 2001).

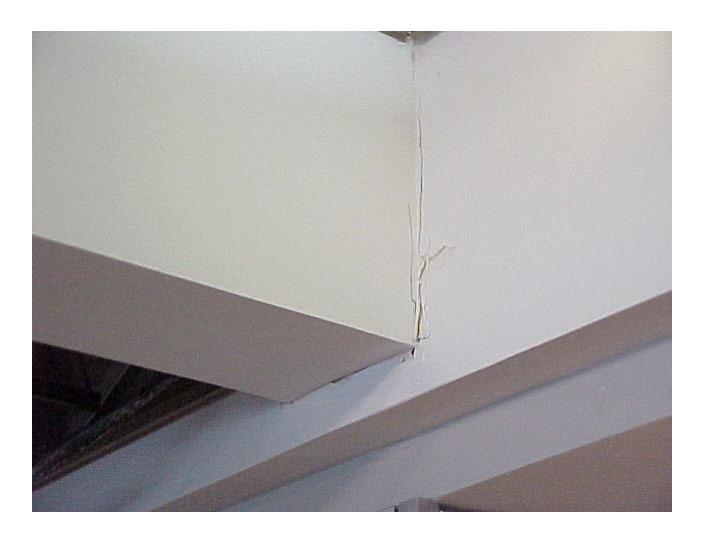
Figure 2.5 Cracking of Drywall Finish in Beam-to-Wall Connection at Sea-Tac Airport (Filiatrault et al. 2001).

Cracking of interior wall finish materials was observed in many buildings following the Nisqually earthquake. In most cases, diagonal cracking occurred at upper corners of doors and window openings and at the intersection of beams and walls, as shown in Fig. 2.5.

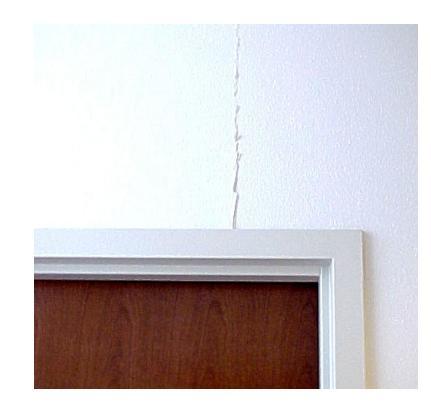
Figure 2.6 Vertical Cracking of Drywall Finish above Door Opening at Kent Regional District Center (Filiatrault et al. 2001).

One interesting observation on the cracking of drywall finish was made at the Kent Regional District Center. Vertical cracking occurred near the upper corner of almost all interior doors of the building. As shown in Fig 2.6, cracks were observed on only one side of each door.

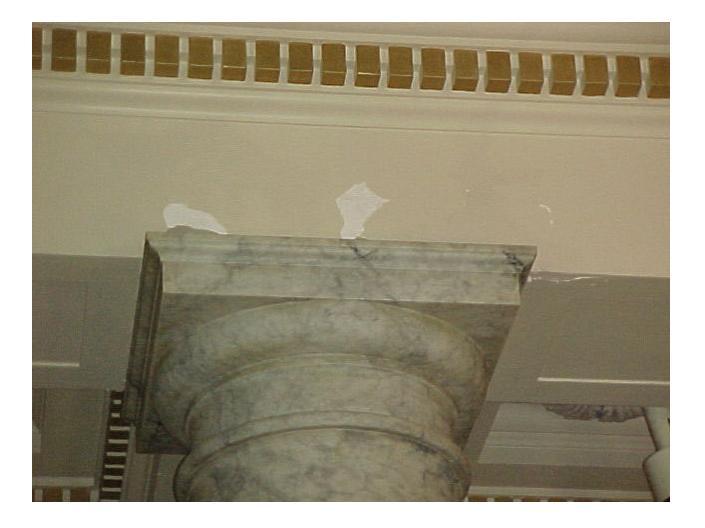
Figure 2.7 Spalling of Plaster in Legislative Building, Olympia (Filiatrault et al. 2001).

Plaster spalled from the walls and ceilings of the Legislative Building in Olympia, as illustrated in Fig. 2.7. This spalling of plaster above the domed rotunda was one of the concerns that contributed to the closing of the Legislative Building after the Nisqually earthquake.

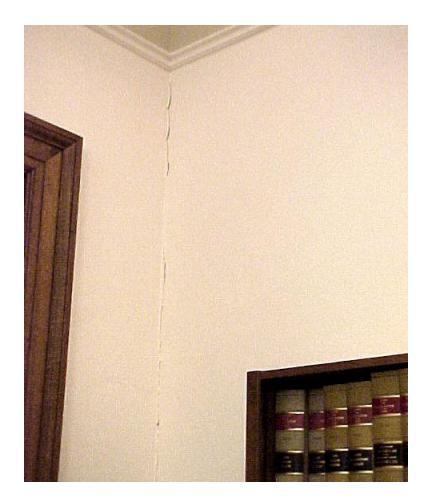
Figure 2.8 Vertical Cracking of Plastered Walls in Supreme Court of Temple of Justice, Olympia (Filiatrault et al. 2001).

Vertical cracking of wall finishes at the corners of perpendicular walls was observed in a number of buildings. Figure 2.8 shows an example of this type of cracking that occurred for the plastered walls of the Supreme Court located in the Temple of Justice Building in Olympia.

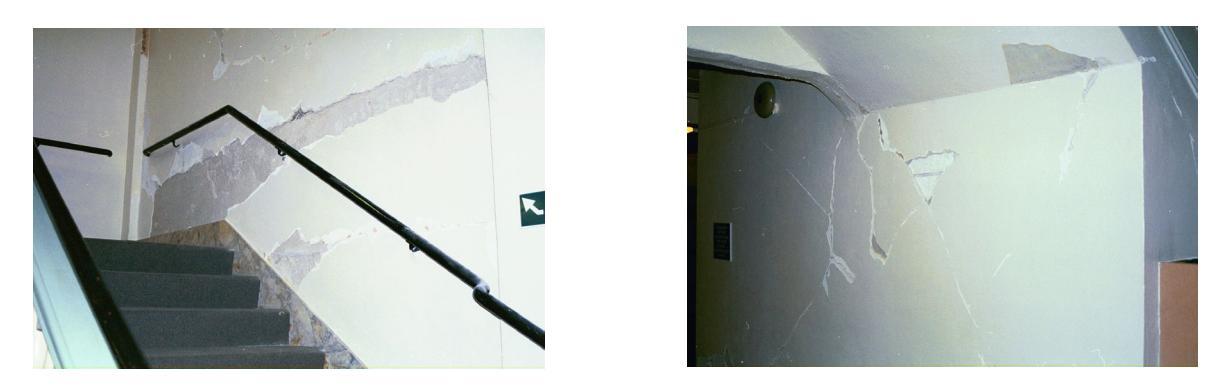
Figure 2.9 Cracking of Plastered Walls in Stairwells of Olympian Apartments, Olympia (Filiatrault et al. 2001).

Substantial cracking of interior wall finish materials was observed in the stairwell of the yellow-tagged Olympian Apartments at 519 Washington Street in Olympia, as shown in Fig. 2.9.

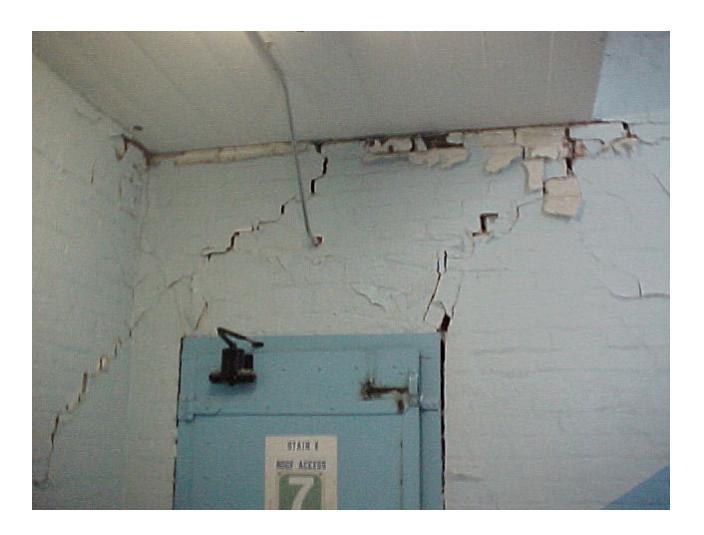
Figure 2.10 Severe Cracking of Masonry Stairwells in Starbucks Headquarters, Seattle (Filiatrault et al. 2001).

Figure 2.10 shows the walls of the original masonry stairwells of the Starbucks Headquarters building in downtown Seattle that suffered severe cracking as a result of the drift level experienced by the building in the east-west direction.

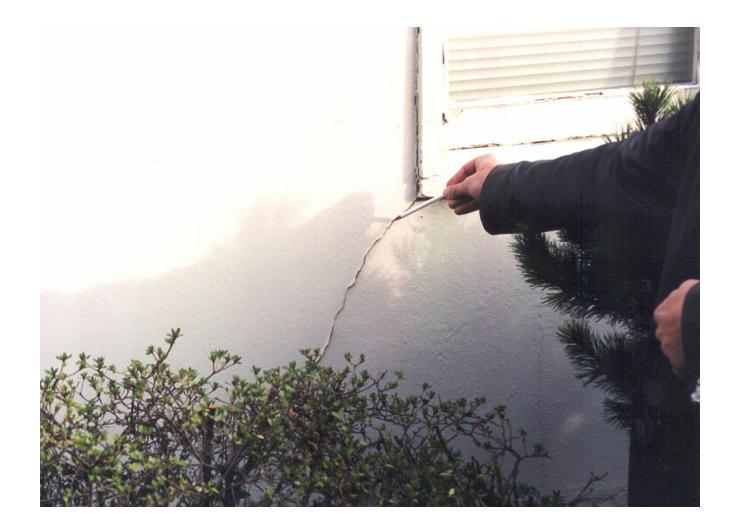
Figure 2.11 Diagonal Cracking of Stucco between Window Openings in Three-Story Apartment Building, Olympia (Filiatrault et al. 2001).

Cracking of exterior wall finish materials was observed in residential wood buildings in Olympia. This cracking was usually diagonal and occurred mainly at the corners of window and door openings, as illustrated in Fig. 2.11 for a three-story apartment building on Columbia Street in Olympia.

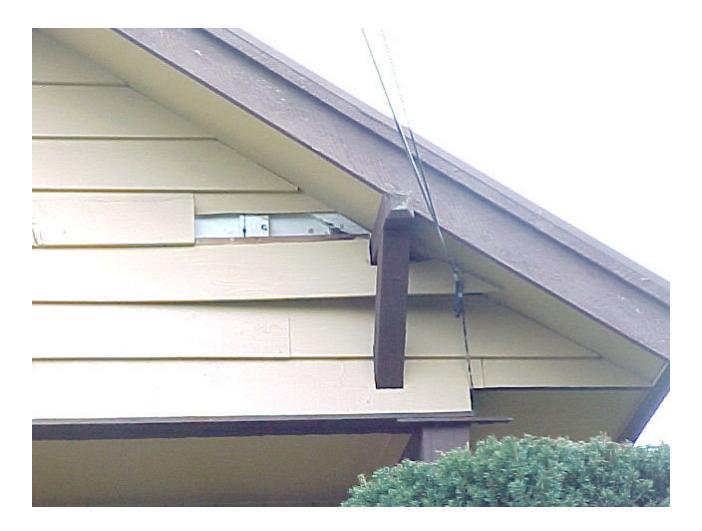
Figure 2.12 Damage to Siding Boards on Wood-Frame House, Olympia (Filiatrault et al. 2001).

In some more recent wood-frame houses, wood siding was also damaged as a result of the shaking. Figure 2.12 shows an example of a two-story wood-frame house on Ninth Avenue in Olympia that lost some straight wood siding during the earthquake. Note that the lateral movement of the house caused some boards to be wedged against the rafters.

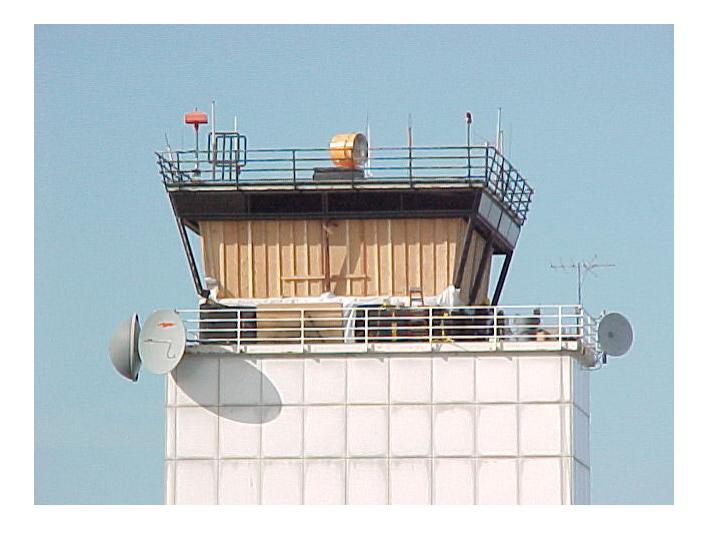
Figure 2.13 Control Tower Shattered Windows Boarded with Plywood at Sea-Tac Airport (Filiatrault et al. 2001).

Shattering of glass windows occurred at several locations. The most dramatic instance of this was the loss of all but one window of the control tower at Sea-Tac airport, as shown in Fig. 2.13. The failures of these windows contributed to the shutdown of the airport for 4 hours following the earthquake because the air-traffic control had to be relocated into a temporary trailer.

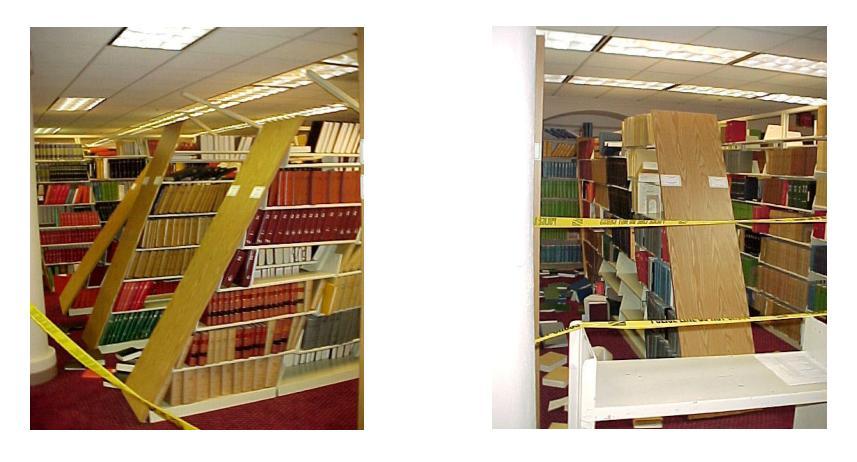
Figure 2.15 Failed Bookshelves in Main Library of Temple of Justice Building, Olympia (Filiatrault et al. 2001).

Another source of damage to nonstructural components during the Nisqually earthquake was the tumbling of building contents. Figure 2.15 shows, for example, the failure of bookshelves that caused some books to fall in the main library of the Temple of Justice Building in Olympia. Figure 2.16 shows a detail of the screwed wood-to-metal connection that failed at the top of one of the leaning bookshelves.

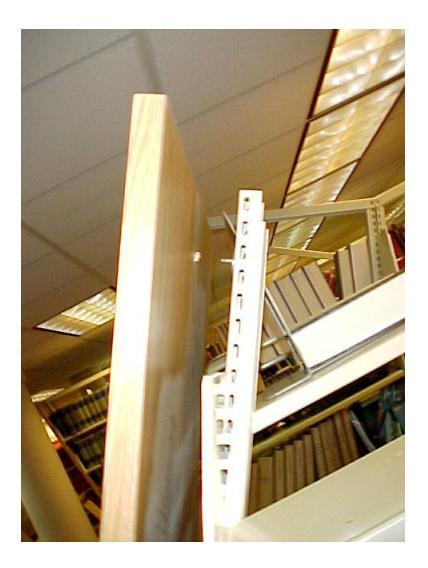
Figure 2.16 Failed Screwed Wood-to-Metal Connection at Top of Leaning Bookshelf in Main Library of Temple of Justice Building, Olympia (Filiatrault et al. 2001). This library contained also sturdier movable compact bookshelves mounted on a floor railing. As shown in Fig. 2.17, these shelves did not suffer any visible damage during the earthquake and seemed to remain functional.

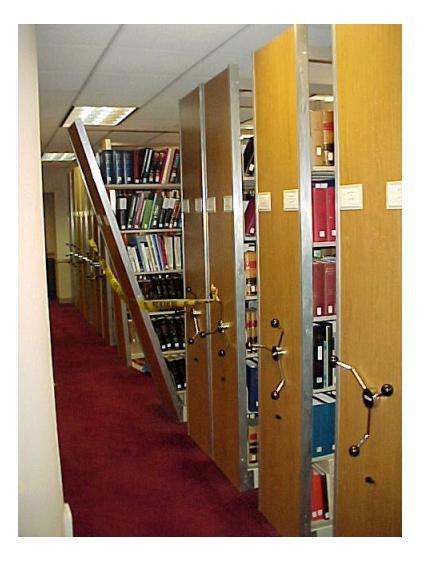
Figure 2.17 Undamaged Movable Compact Bookshelves and Leaning Conventional Bookshelves in Main Library of Temple of Justice Building, Olympia (Filiatrault et al. 2001).

Although the leaning bookshelves in the Temple of Justice Building represented an obvious hazard to occupants following the Nisqually earthquake, only a small number of books fell off the shelves, in contrast with what happened in the Law Library of this building. As shown in Fig. 2.18, the massive wood bookshelves of the Law Library did not collapse. A large number of books, however, were thrown to the floor by the horizontal acceleration induced by the ground motion.

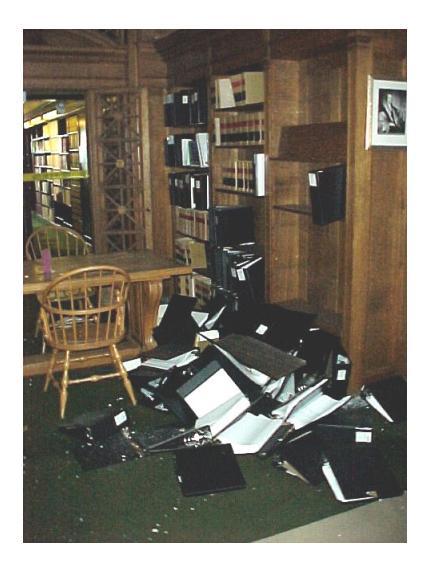
Figure 2.18 Fallen Books from Massive Wooden Shelves in Law Library of Temple of Justice Building, Olympia (Filiatrault et al. 2001).

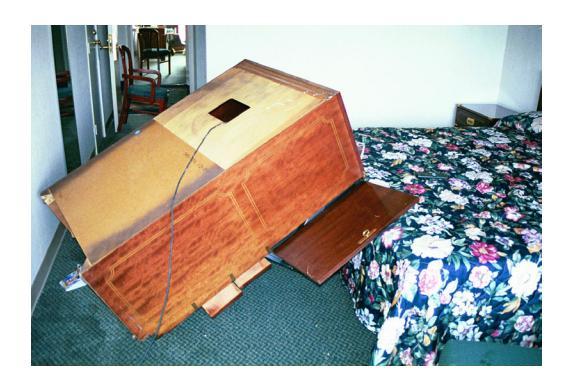
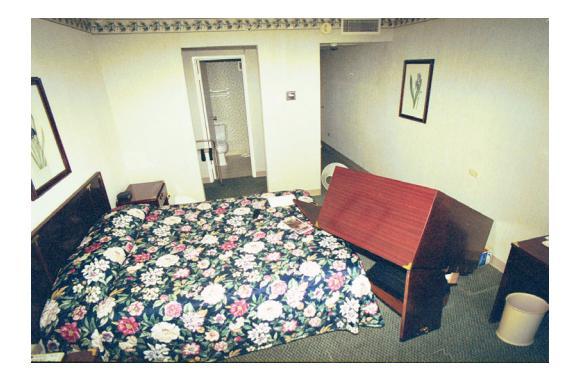
Figure 2.19 Overturned Furniture in Guest Rooms on Eighth Floor of Ramada Inn, Olympia (Filiatrault et al. 2001).

The majority of the furniture in the top three floors of the eight-story Ramada Inn at 621 Capitol Way in Olympia was overturned as a result of the building shaking. Figure 2.19 shows typical examples of the damage to furniture in guest rooms on the eighth floor. In the bottom five floors most of the furniture remained in the upright position. None of the room furniture in the building had been fastened to the walls to prevent overturning.

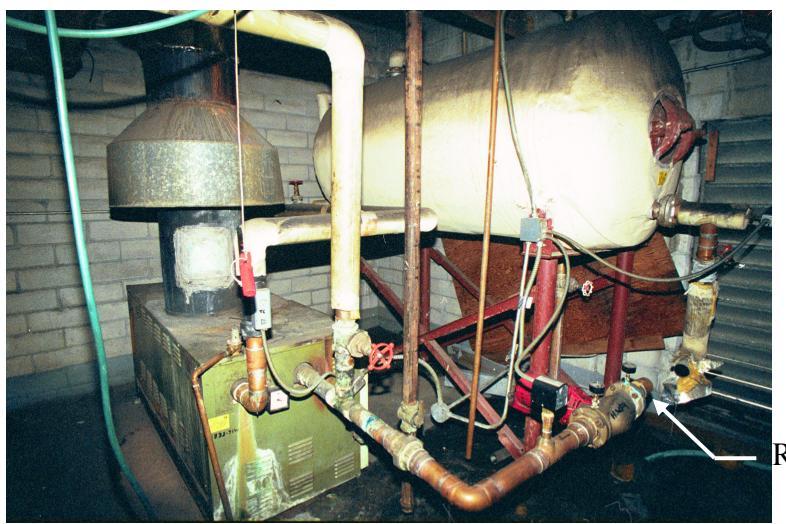
Ruptured Pipe

Figure 2.20 Rupture of Supply Water Line to 3000-Liter Storage Tank in Rooftop Mechanical Room of Ramada Inn, Olympia (Filiatrault et al. 2001).

A 75-mm-diameter water pipe broke in the mechanical room on the roof of the Ramada Inn at 621 Capitol Way in Olympia, causing 3000 liters of water in a storage tank to flood several floors of the building. During the earthquake the unsecured water tank was reported to have shifted about 150 mm along the floor. This, in turn, caused the supply water line to the tank to rupture as shown in Fig. 2.20.

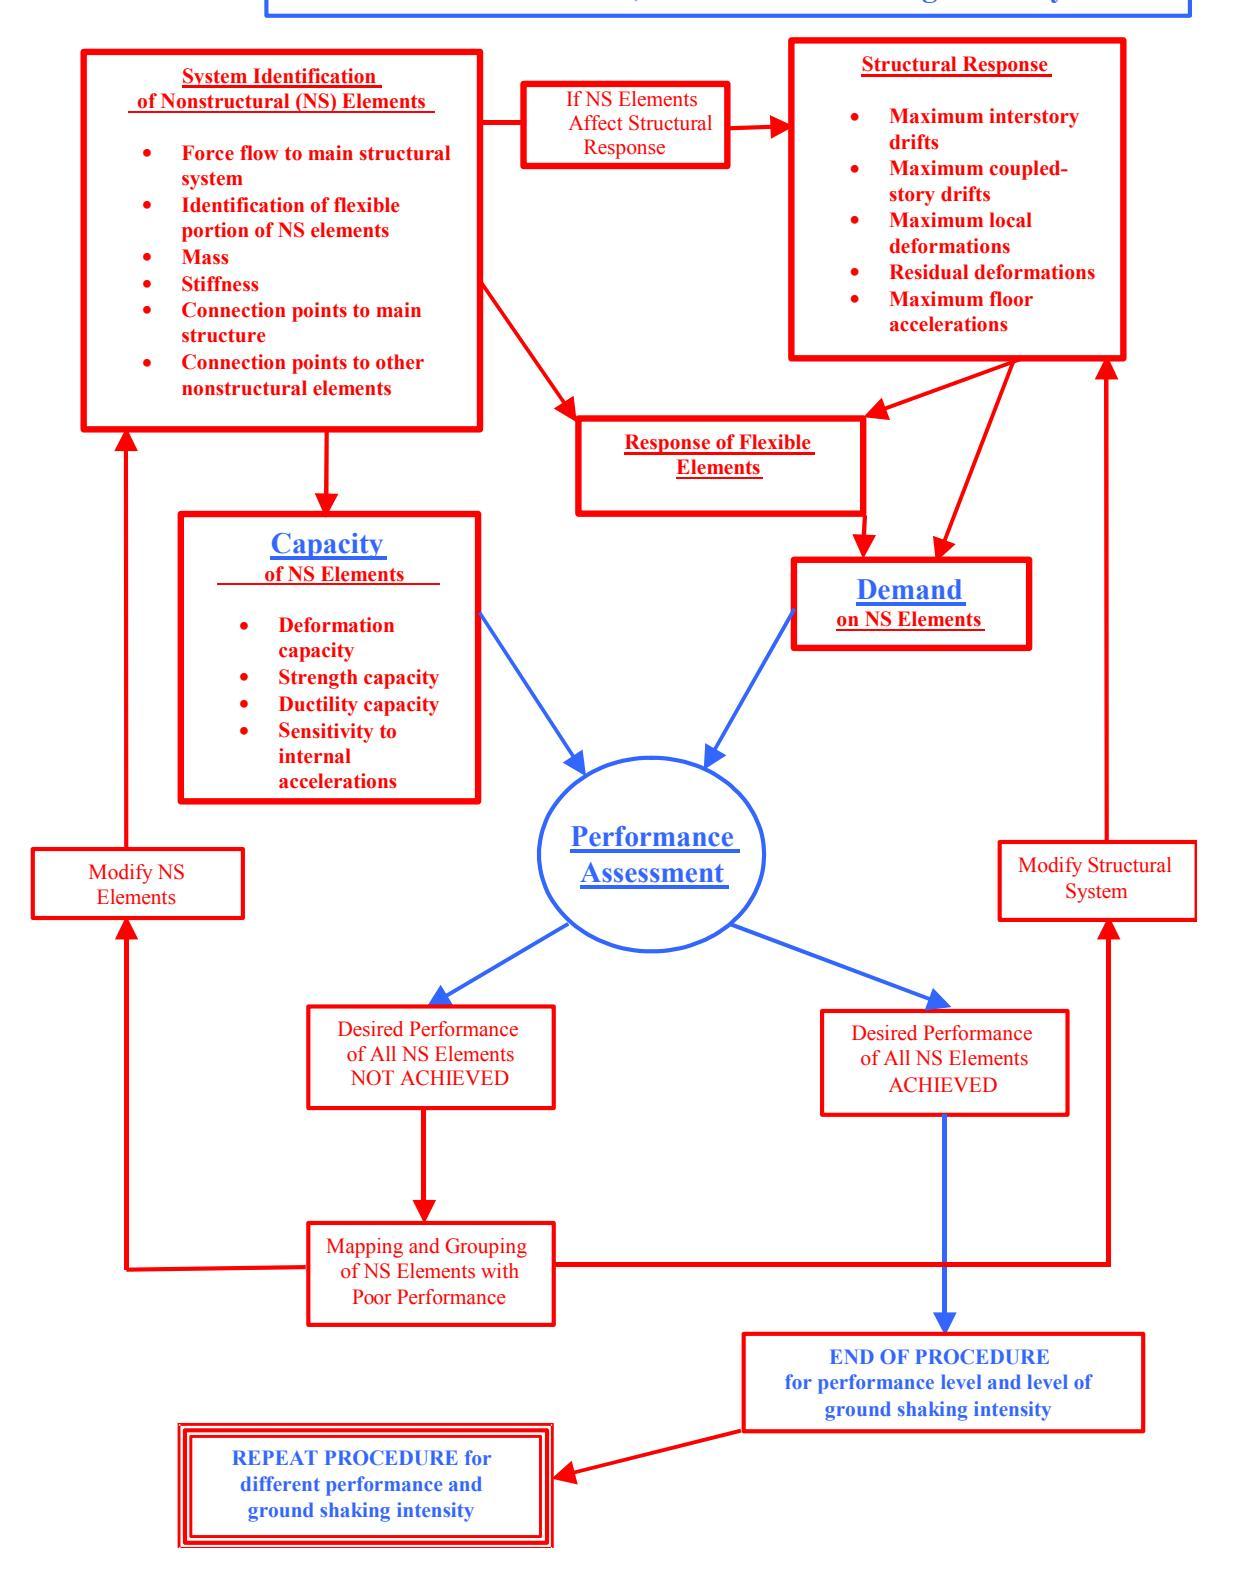
Figure 7.1 Framework for the Seismic Assessment and Design of Nonstructural Elements

Figure 7.1 illustrates a possible comprehensive framework for the seismic assessment and design of nonstructural elements. Once a performance level is set for a given ground motion intensity, the first task in this procedure is to clearly identify all nonstructural elements that are considered in the design process. A clear evaluation of the load path from the center of mass of each nonstructural element to the main structure must be determined, and all the connectors allowing this load path must be identified and characterized. The connection points of each nonstructural element to the main structure and to other nonstructural elements must be identified. This process allows to locate the points where the demand on the nonstructural elements must be evaluated. Among these elements, those affecting the response of the main structural system must be identified and their stiffness, strength and damping characteristics must be included in the structural response of the main system.
