February 6, 2016 (local time)
M_L-6.4 Meinong Earthquake
Kaohsiung City, Taiwan

2016/02/06 – Ver5.0

2016.02.06 Meinong Earthquake

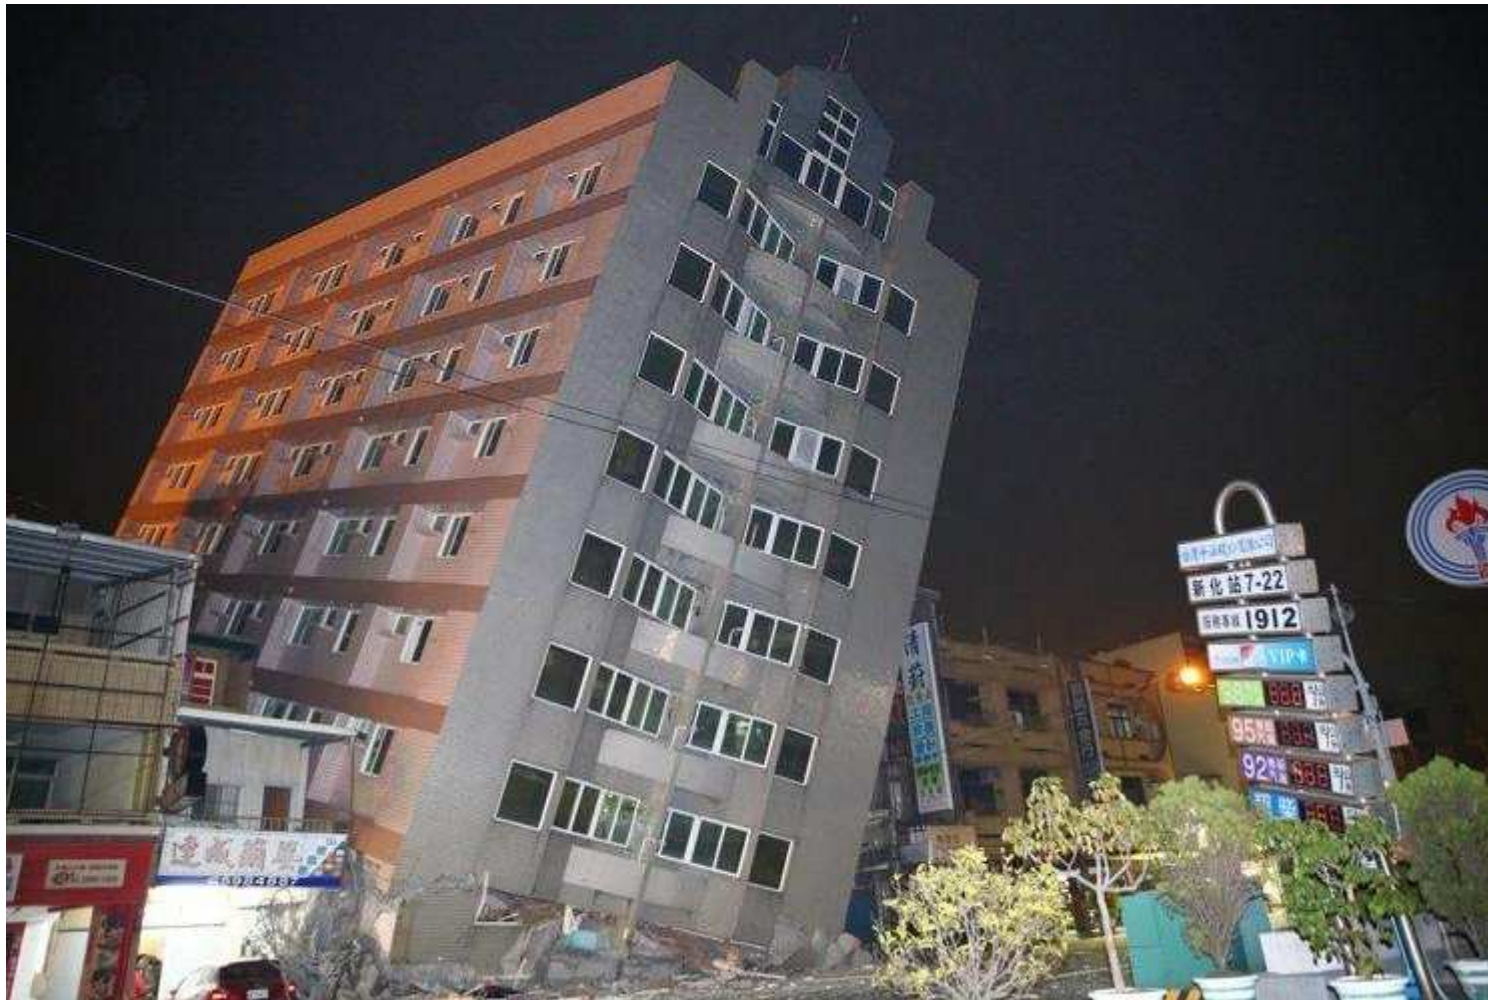
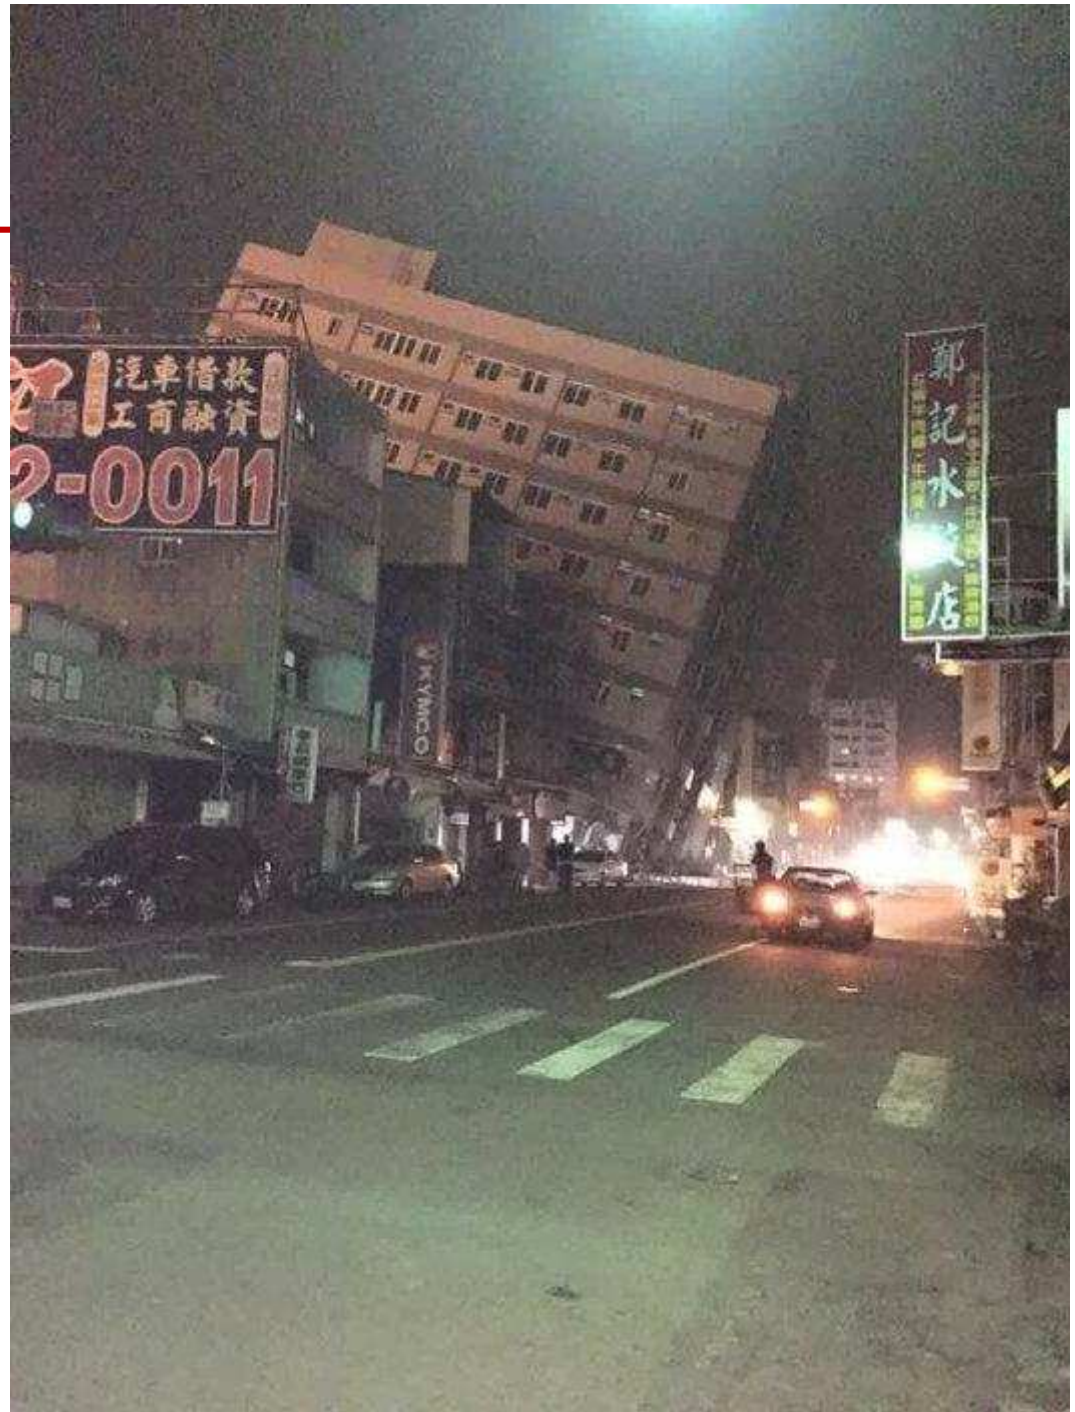
Photographical View of King's Town Bank (京城銀行) after Earthquake

- 586 Zhongshan Rd., Sinhua District, Tainan City
- 10-story

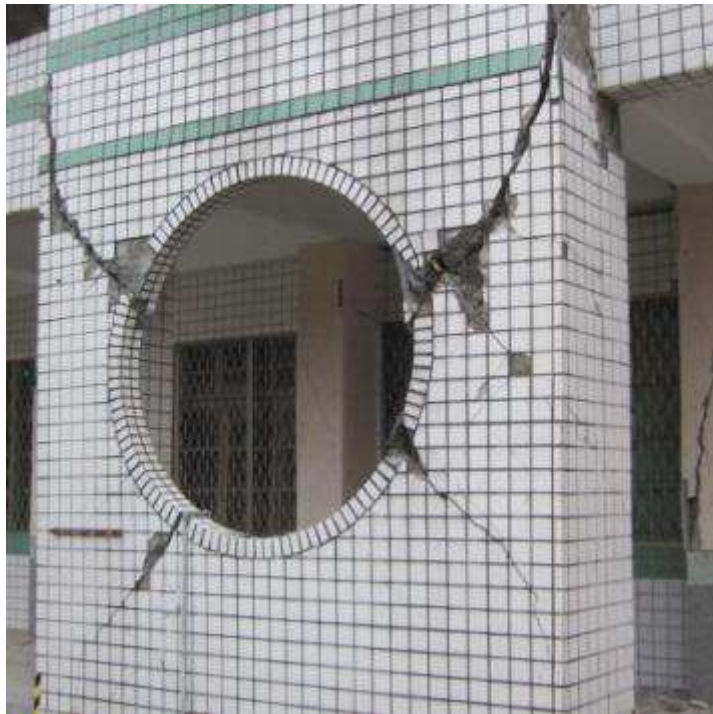
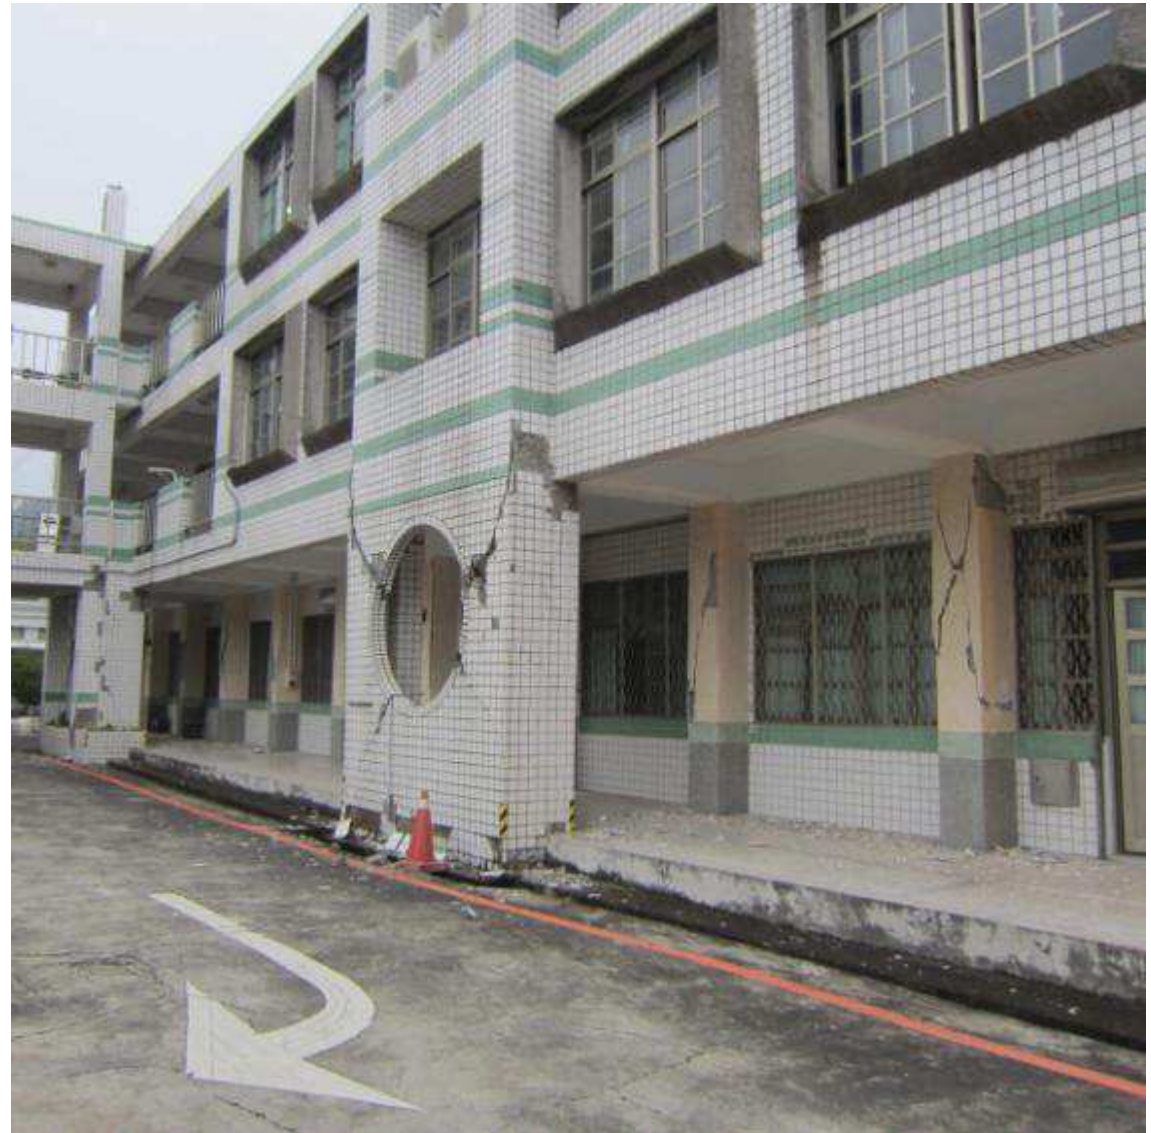
Damage of Junior College Building, Yujing Junior High School (玉井國中)

1. 窗台柱均出現 X 剪力裂縫 (~~B7me~~)

2. 長柱無損 or 撓曲裂縫 (B6)

3. A7, B9 裂縫可見主筋

4. 圓形開孔端時
X 裂縫
平面

5. Y向牆有斜向裂縫 (11 Line) (6 Line) (2 Line)

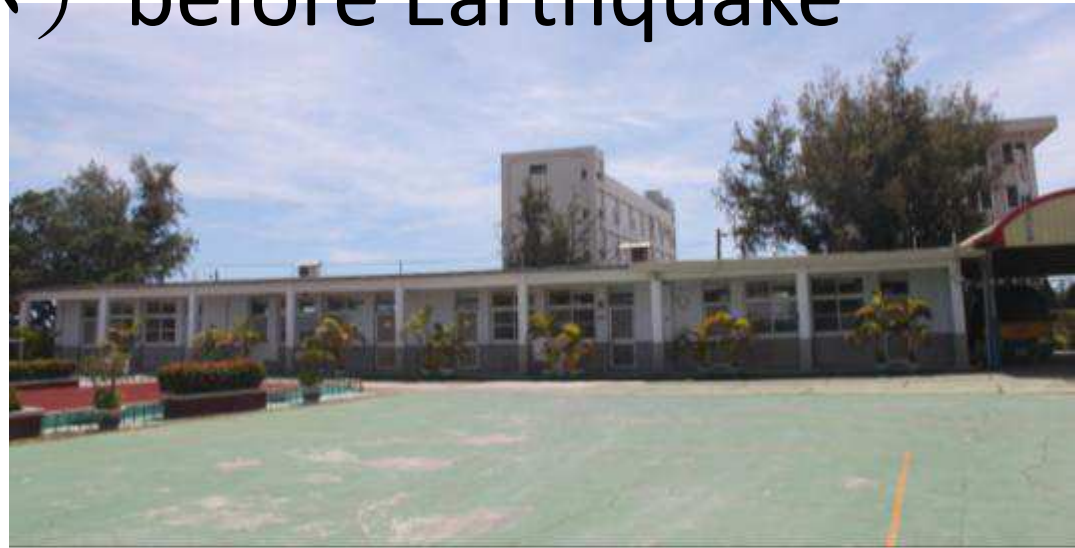
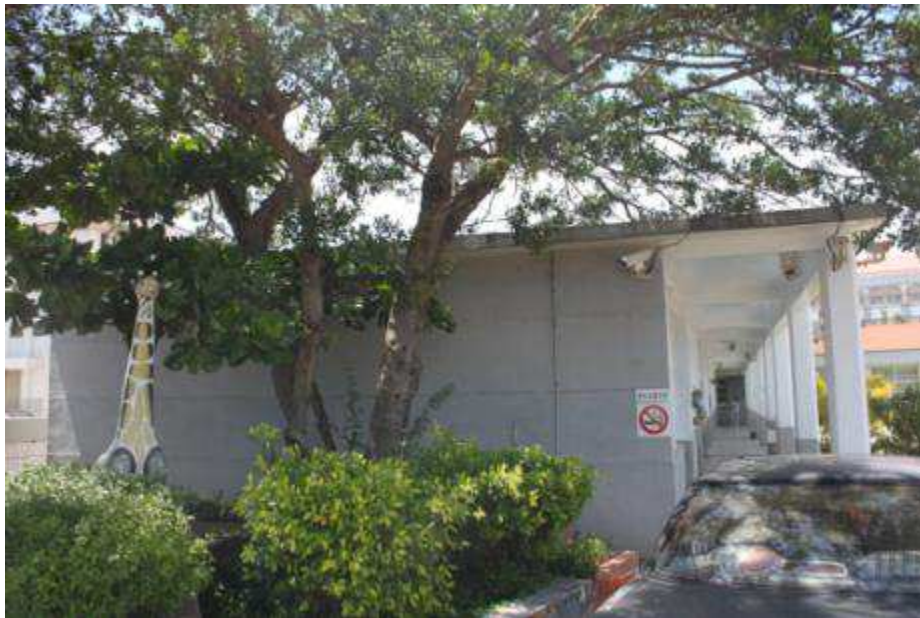
Damage of West Building, Beimen Elementary School (北門國小)

◎ B2、B6 垂直向裂縫

◎ A23梁有見主筋 (推測非此起震造成)
