OBSERVATIONS AFTER 5/12/2008 WENCHUAN EARTHQUAKE BASED ON FIELD RECONNAISSANCE FROM 7/4/2008 TO 7/7/2008

Khalid M. Mosalam, PhD, PE mosalam@ce.berkeley.edu

Nicholas Sitar, PhD, PEng sitar@ce.berkeley.edu

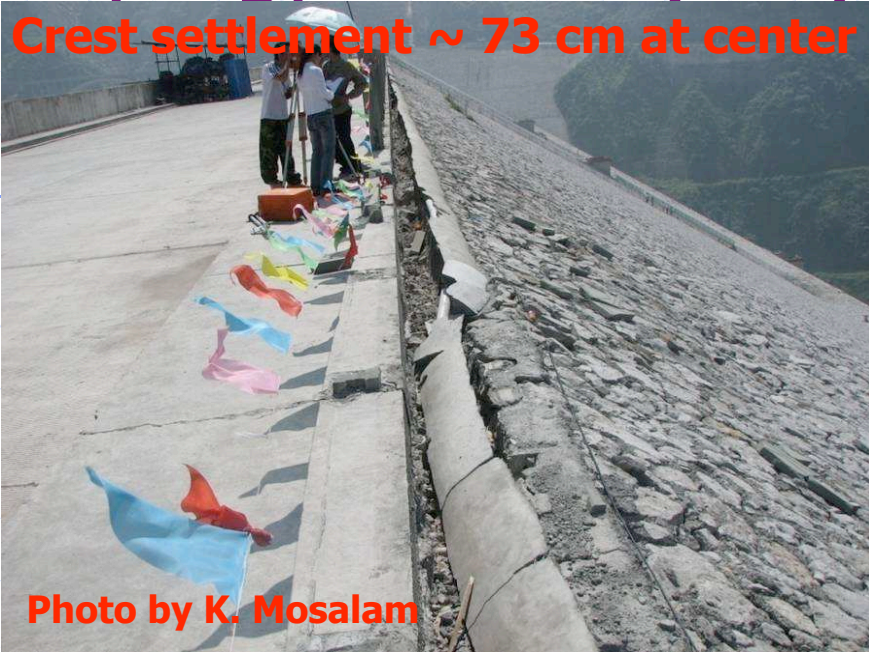
Crest settlement ~ 73 cm at center

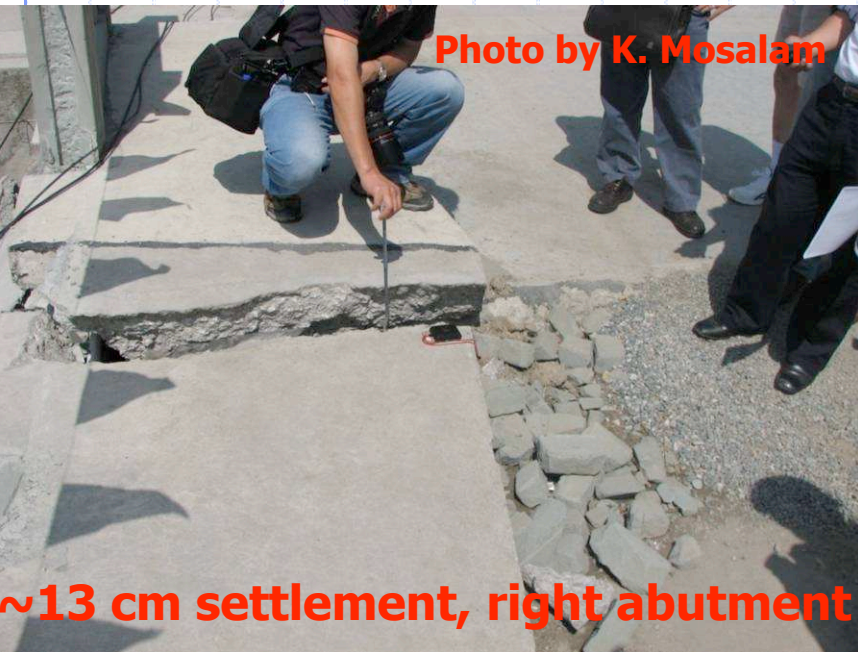
~ 13 cm settlement, right abutment

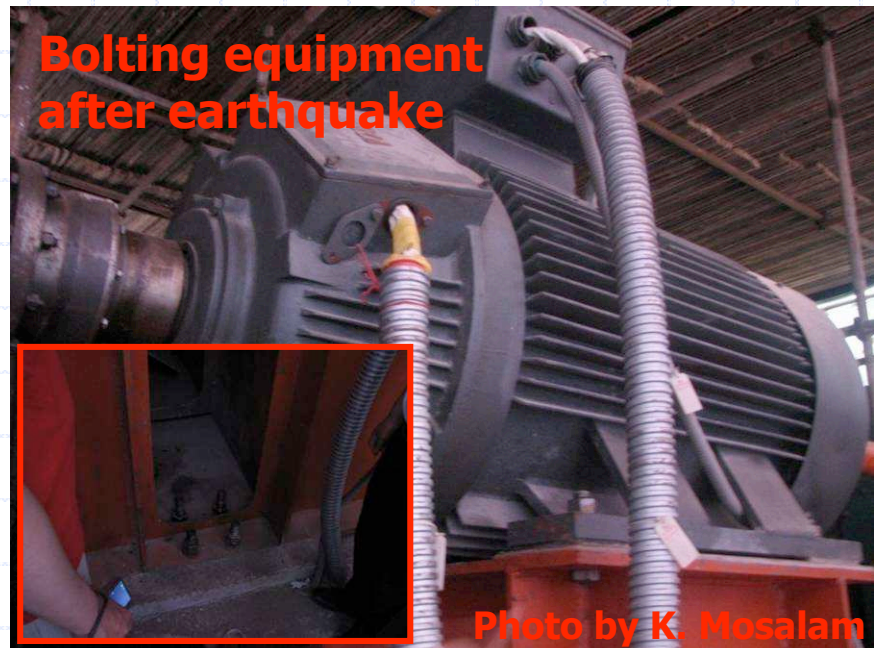
Unbolted gate controllers toppled

Bolting equipment after earthquake

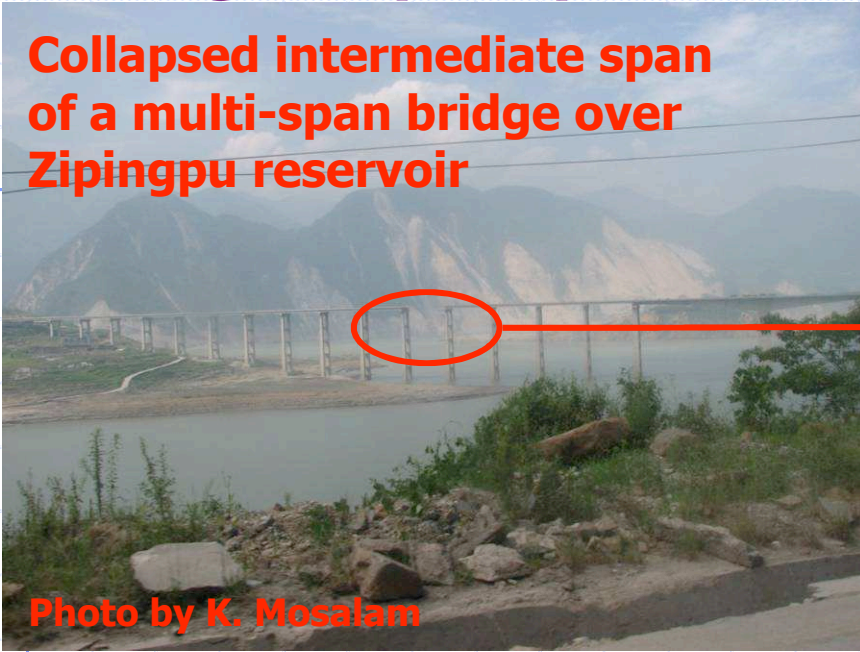
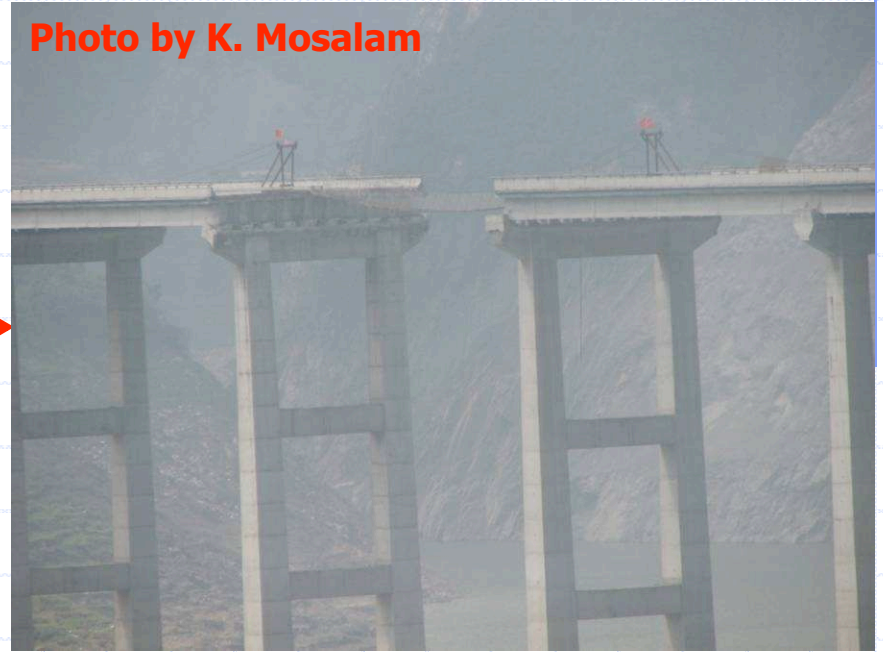
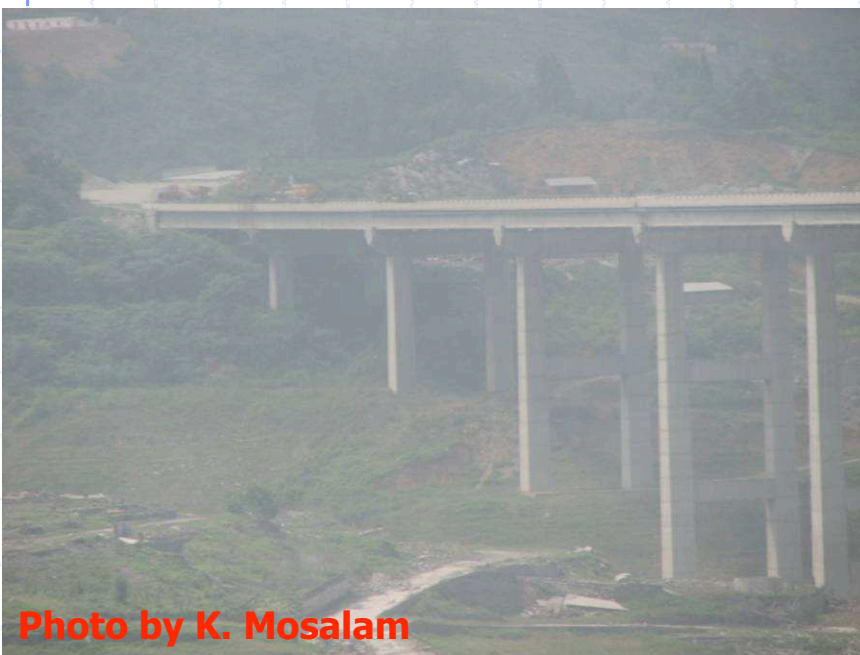
Collapsed intermediate span of a multi-span bridge over Zipingpu reservoir

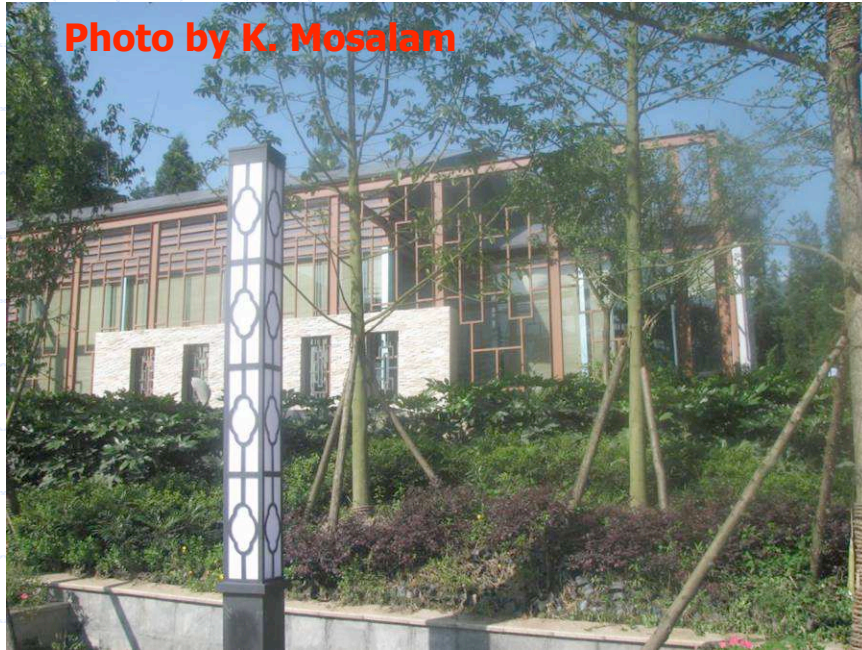
Steel Building

Good performance – within
the fault zone

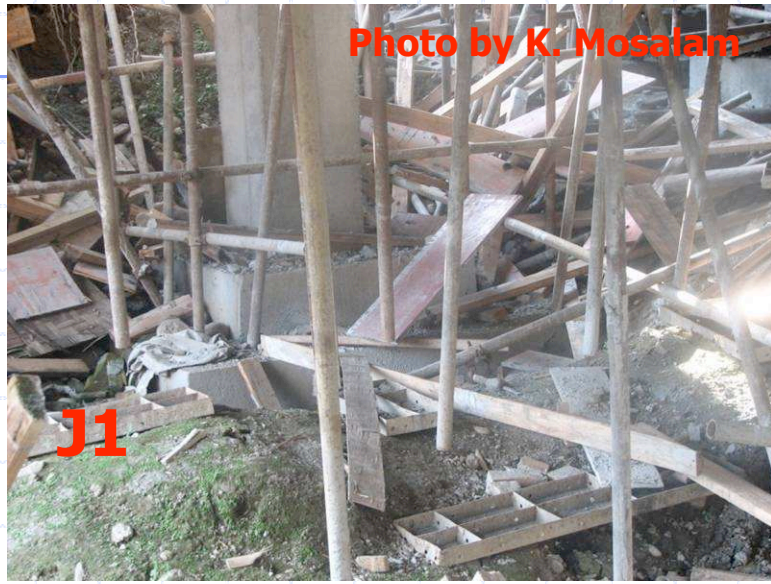
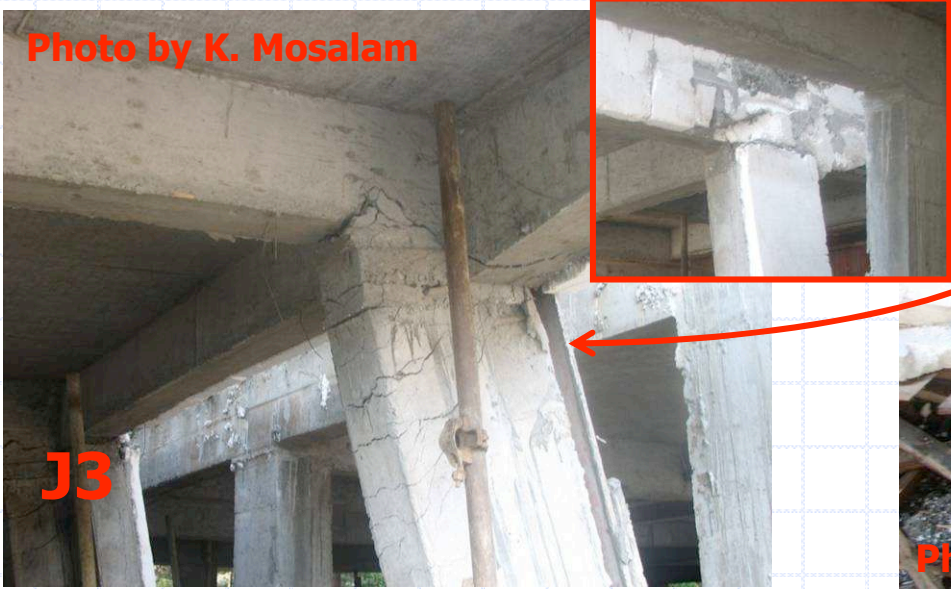
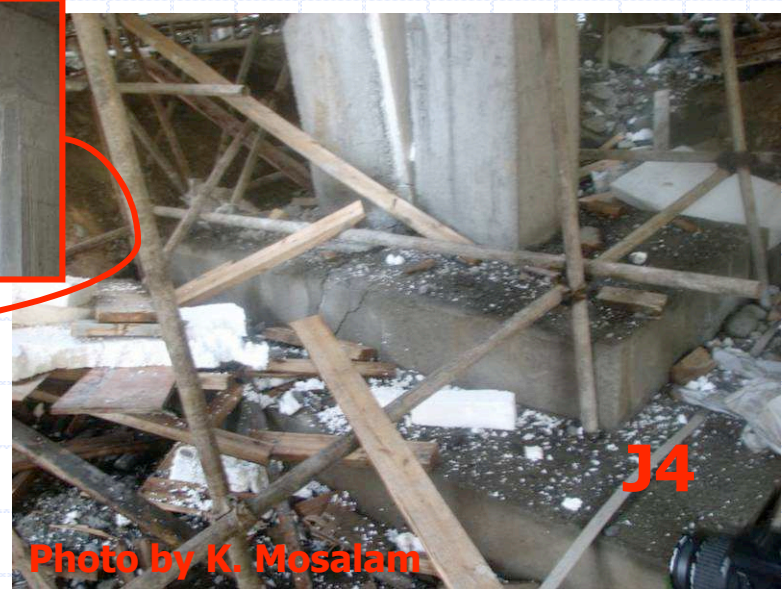
RC Frame Failure Due to Faulting (2/2)

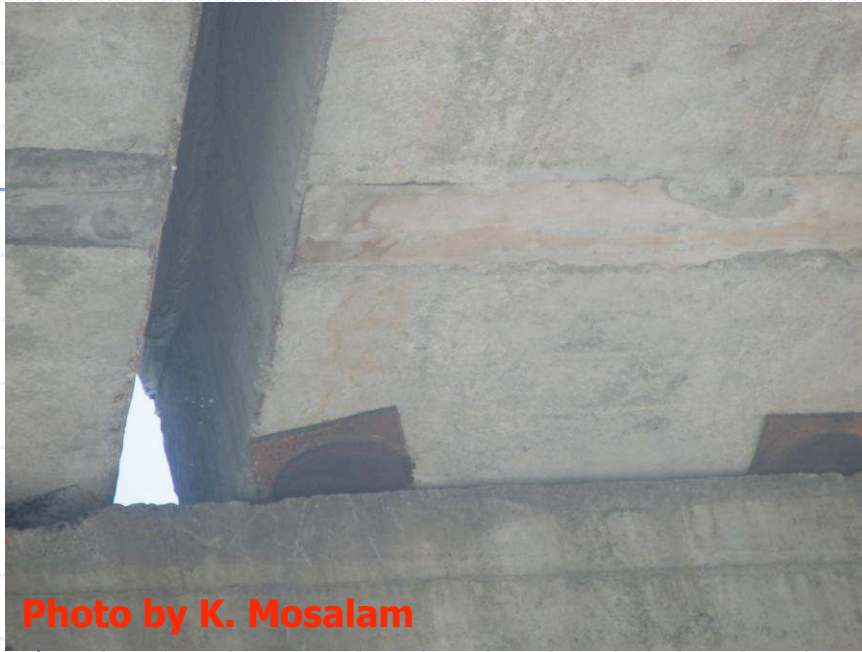
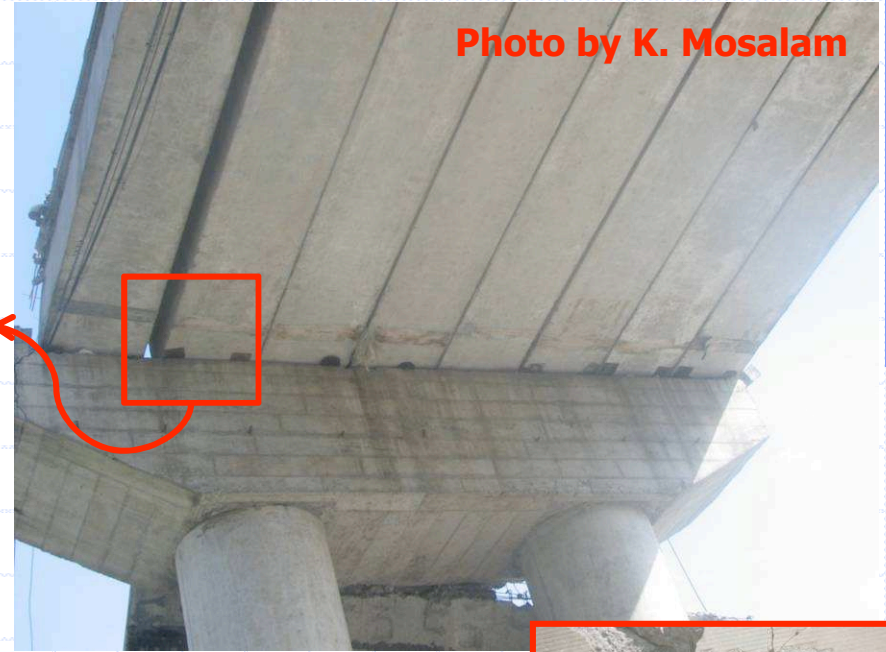
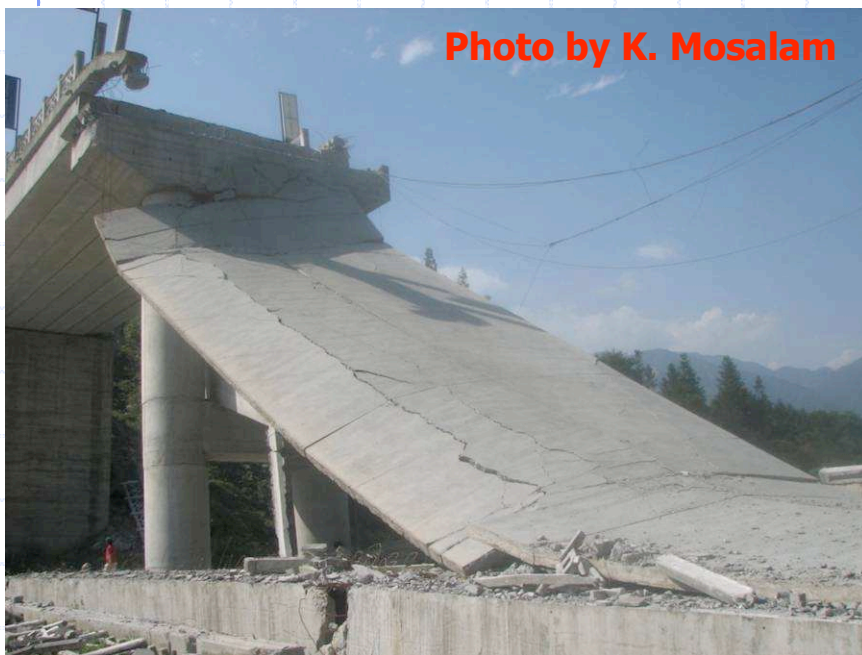
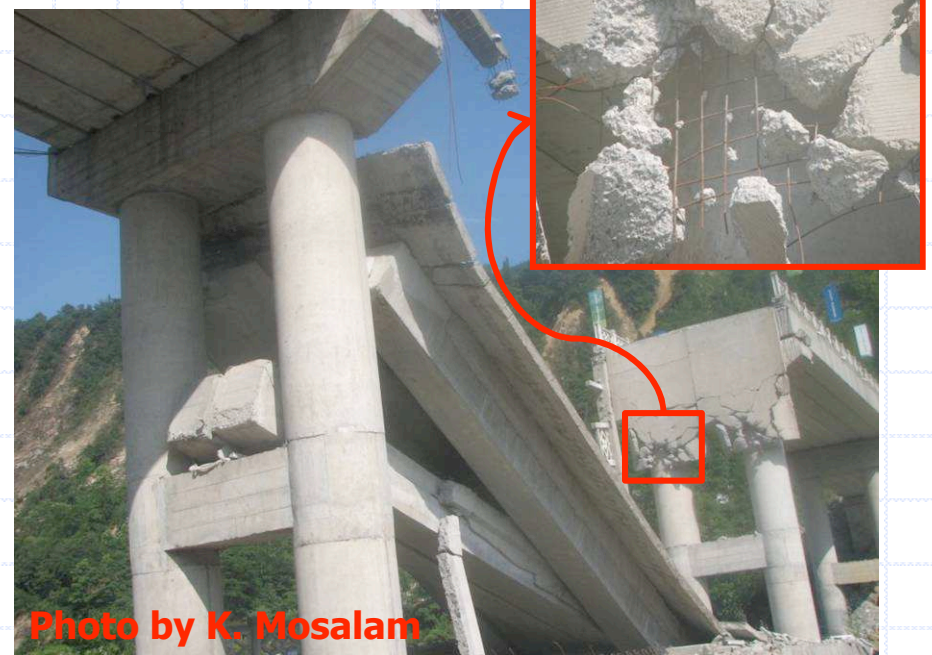
Hongkou Bridge – Faulting Induced Collapse (2/3)

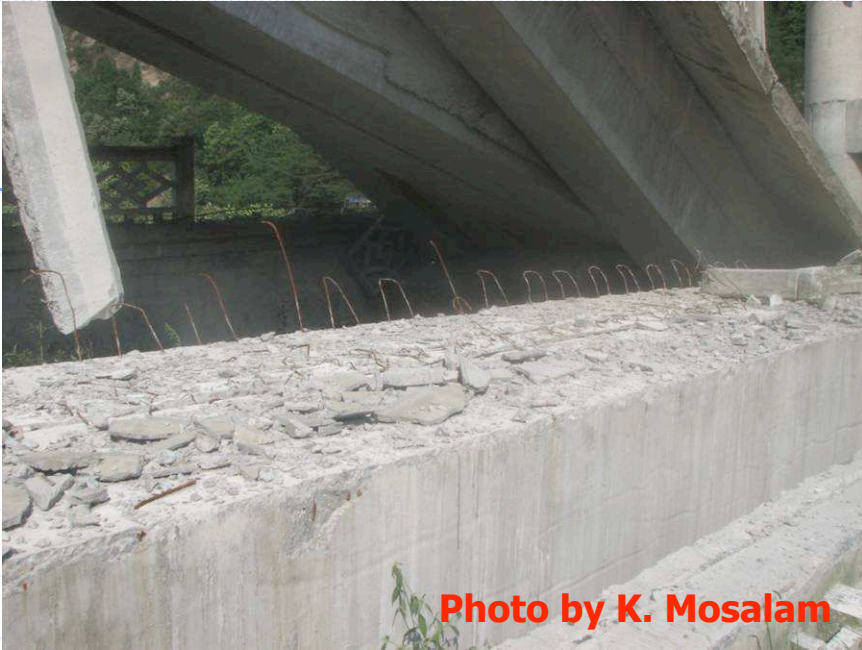
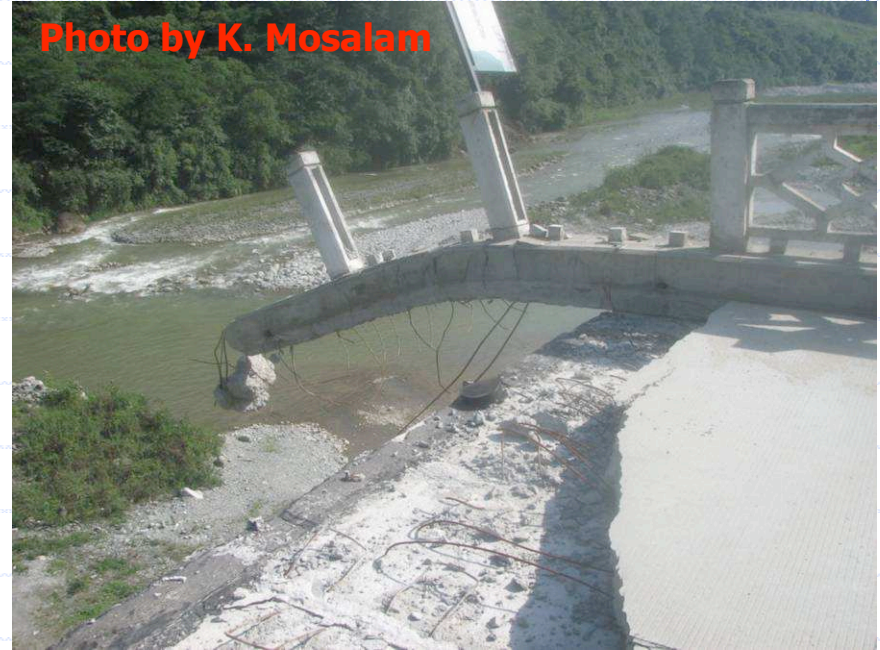
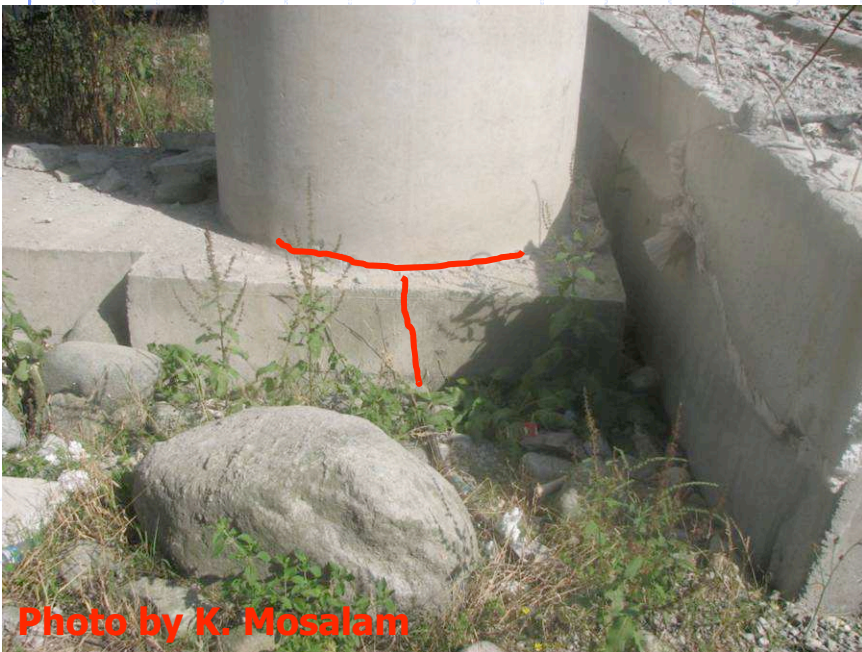
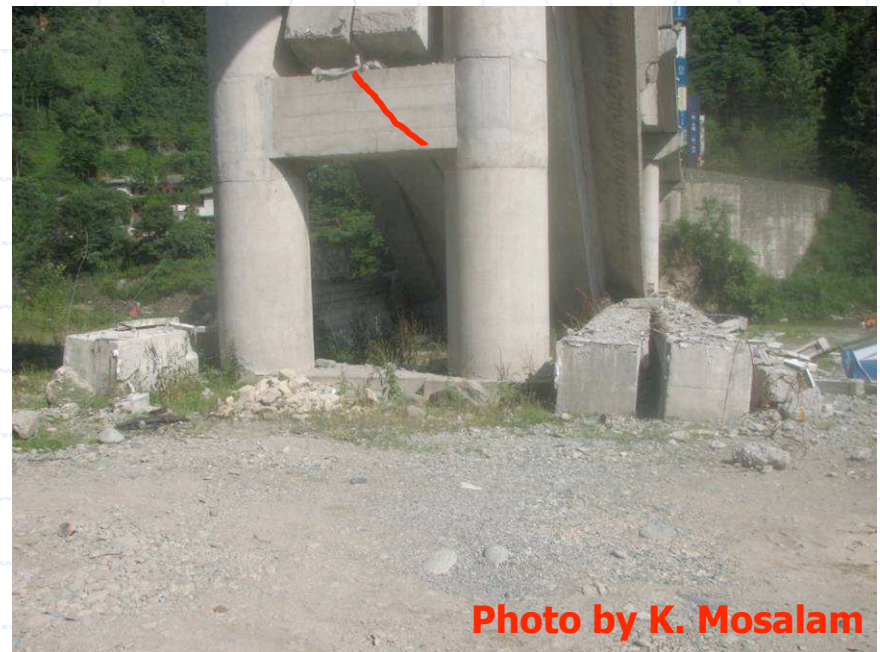
Hongkou Bridge – Faulting Induced Collapse (3/3)

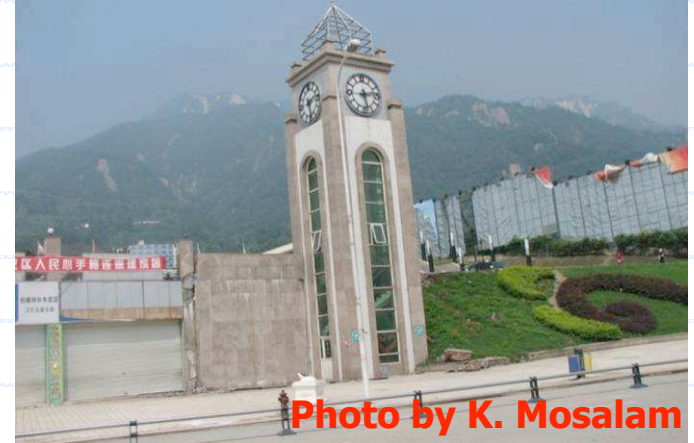
Clock stopped working

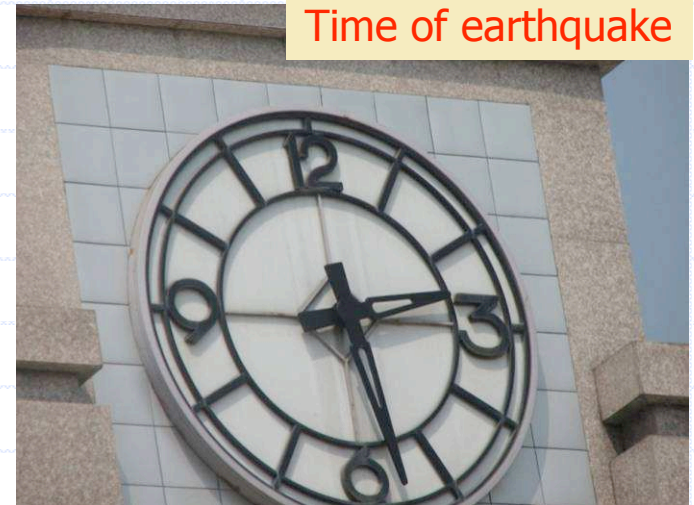
Time of earthquake

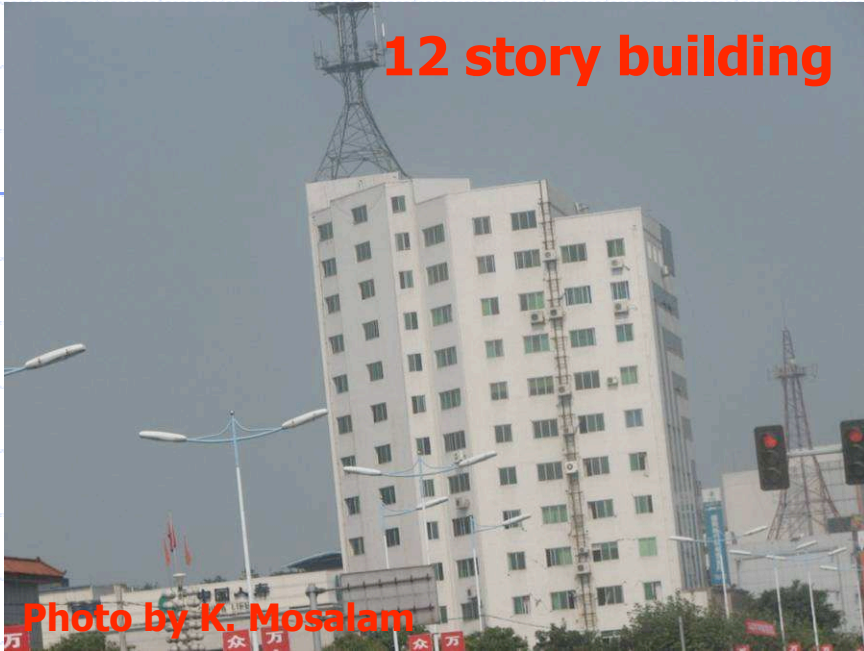
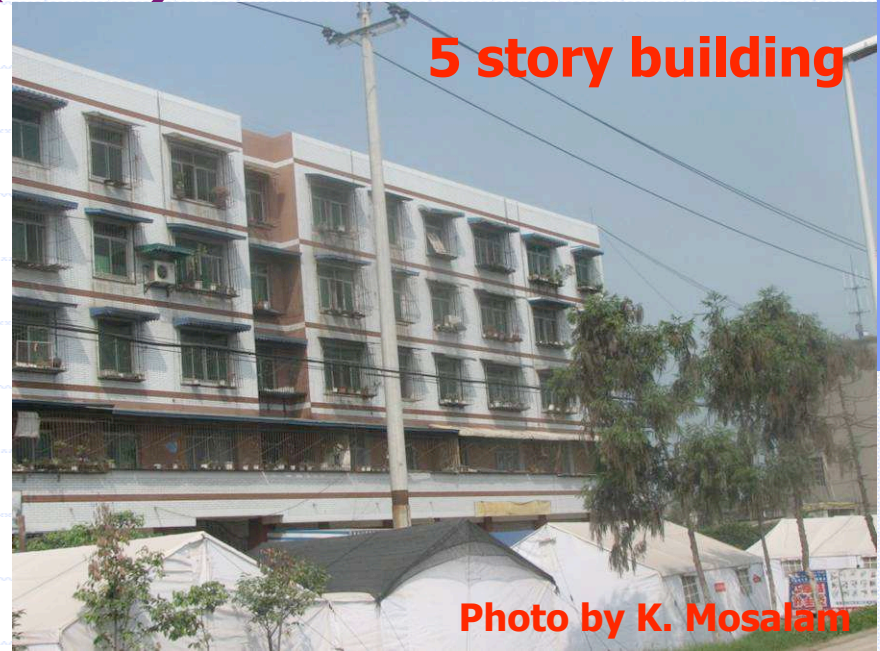
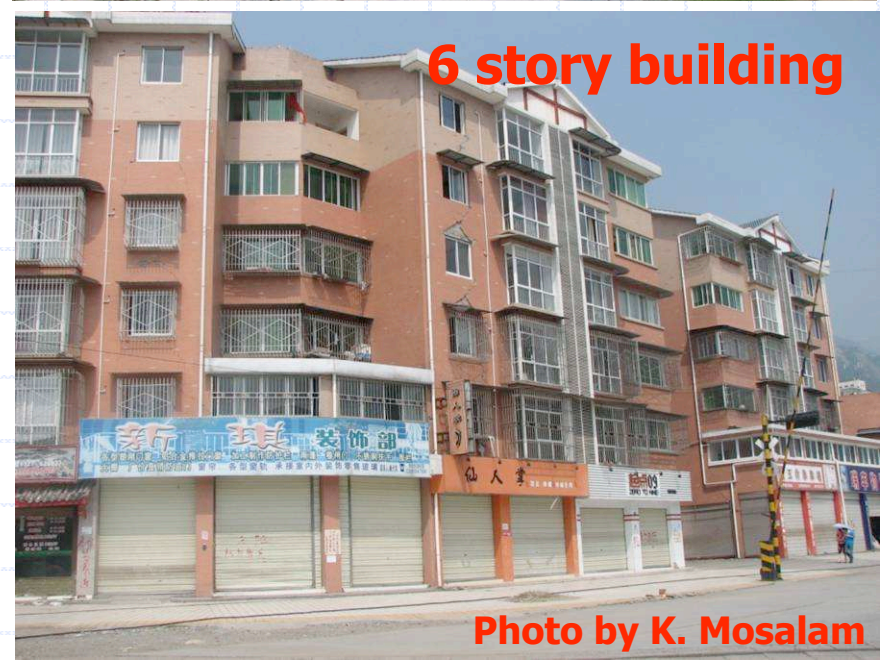
Good Performance (1/2)

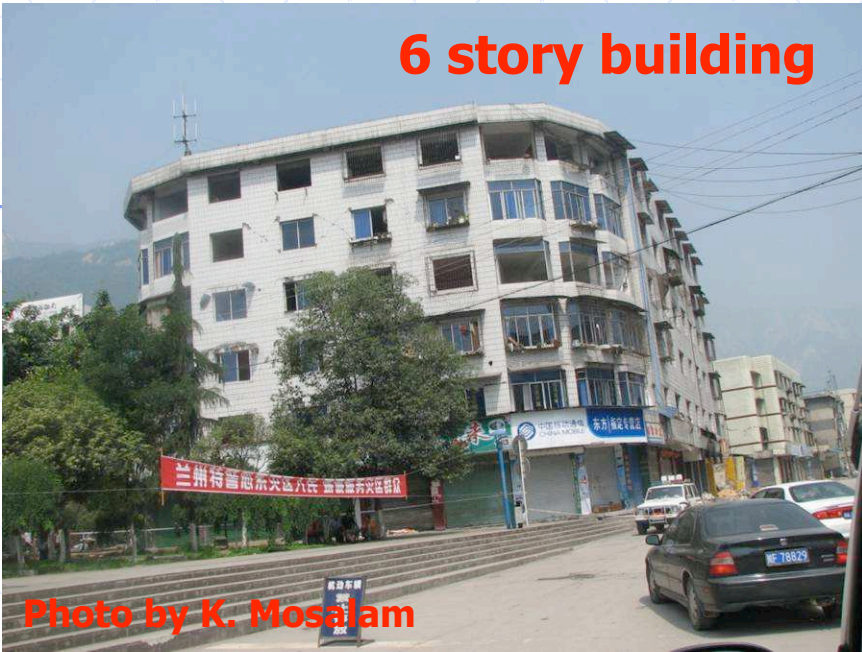
6 story building

Fair Performance

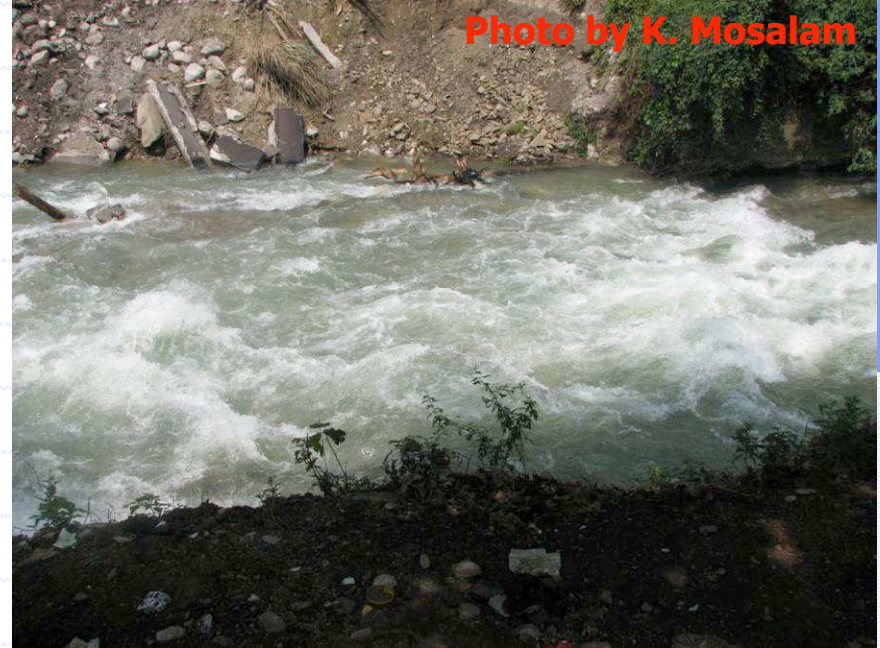
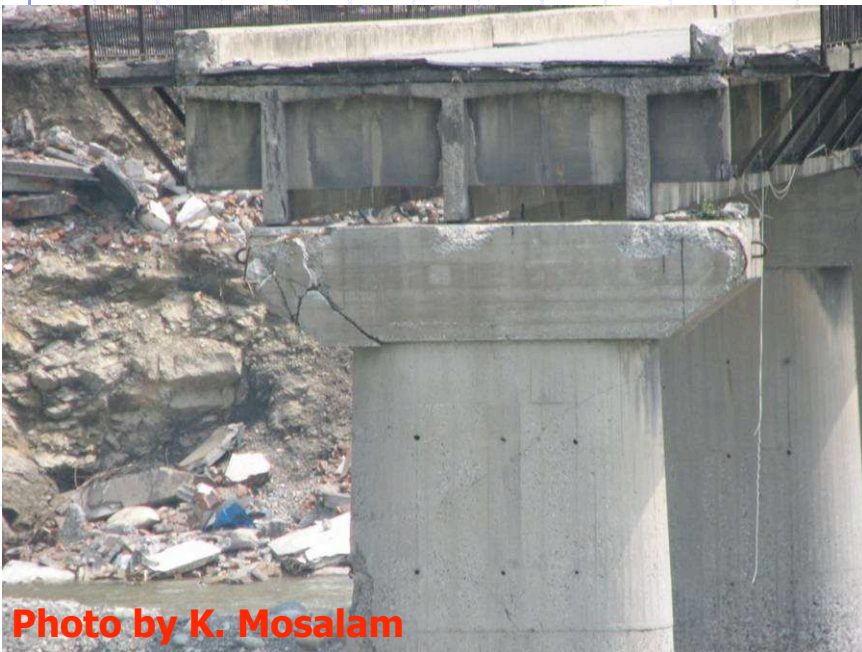
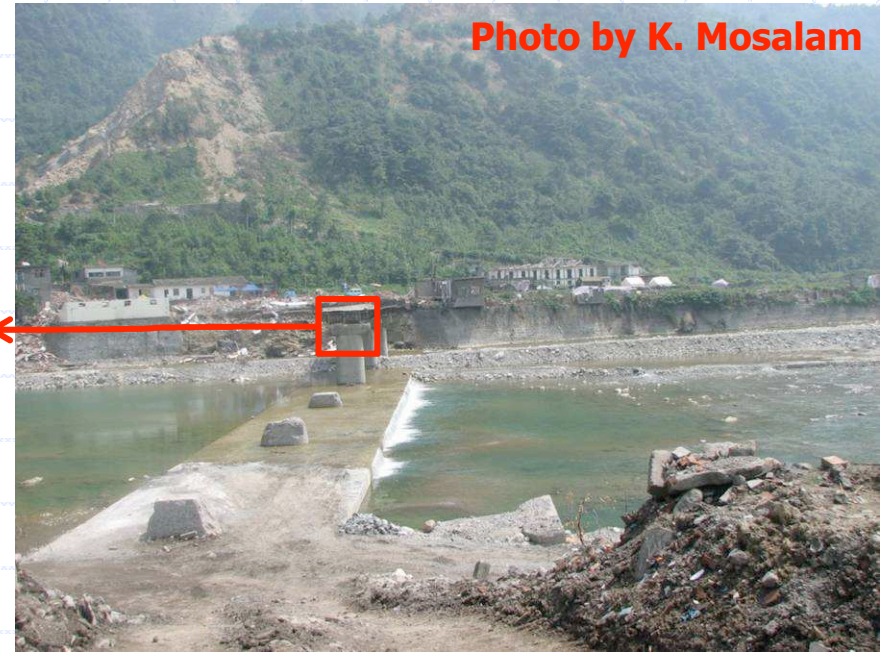
Bridge Collapse and Fault Trace

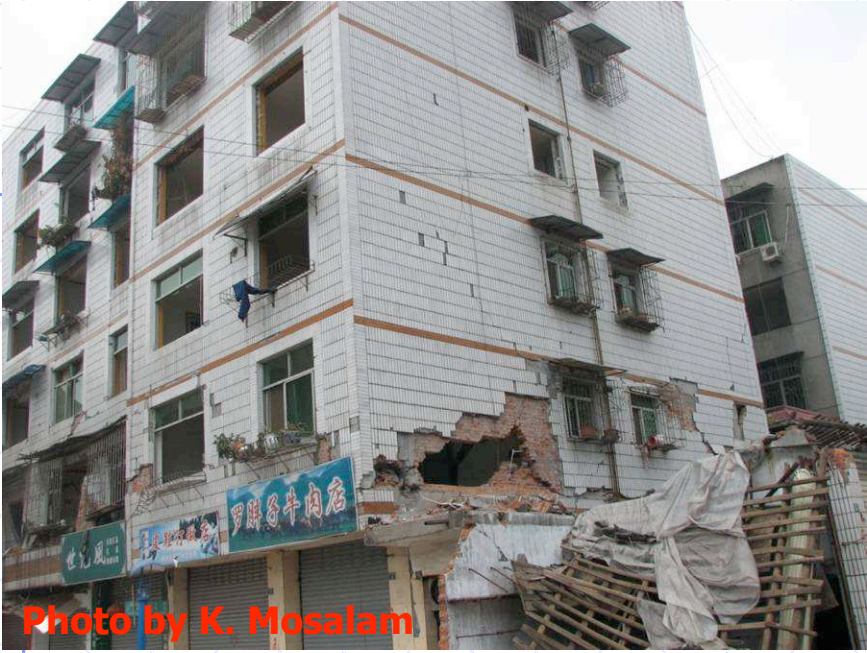
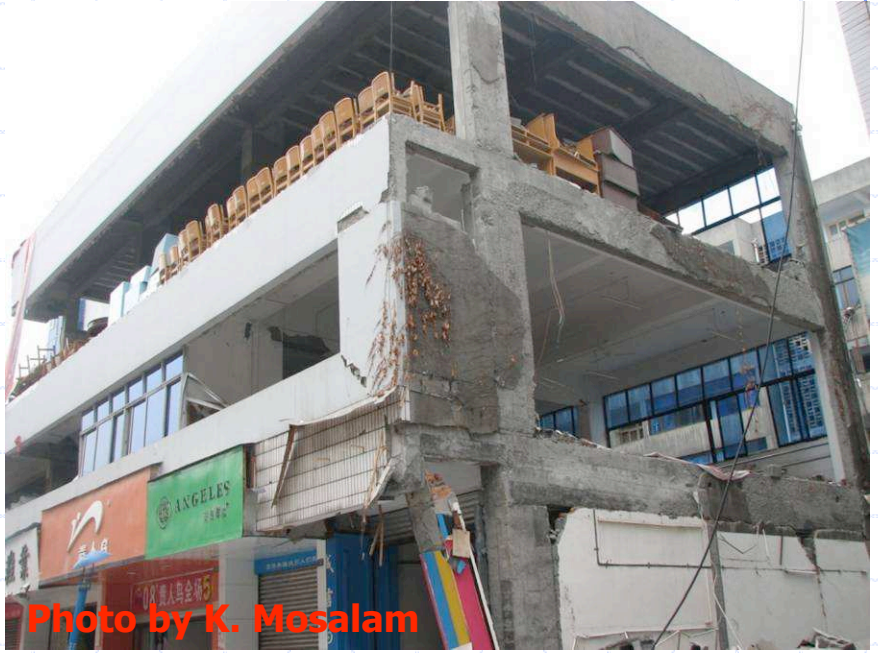
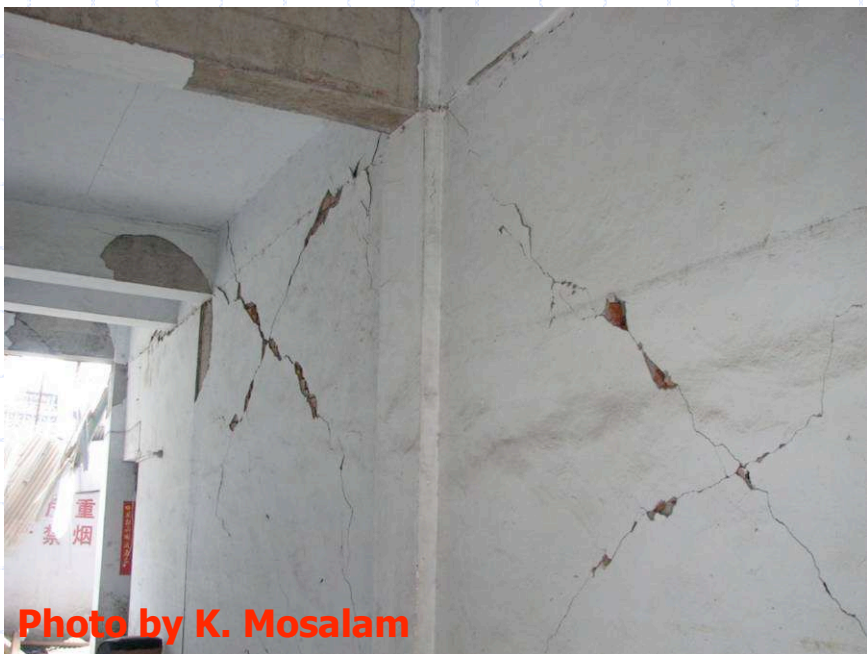
Infill Walls (Poor Performance)

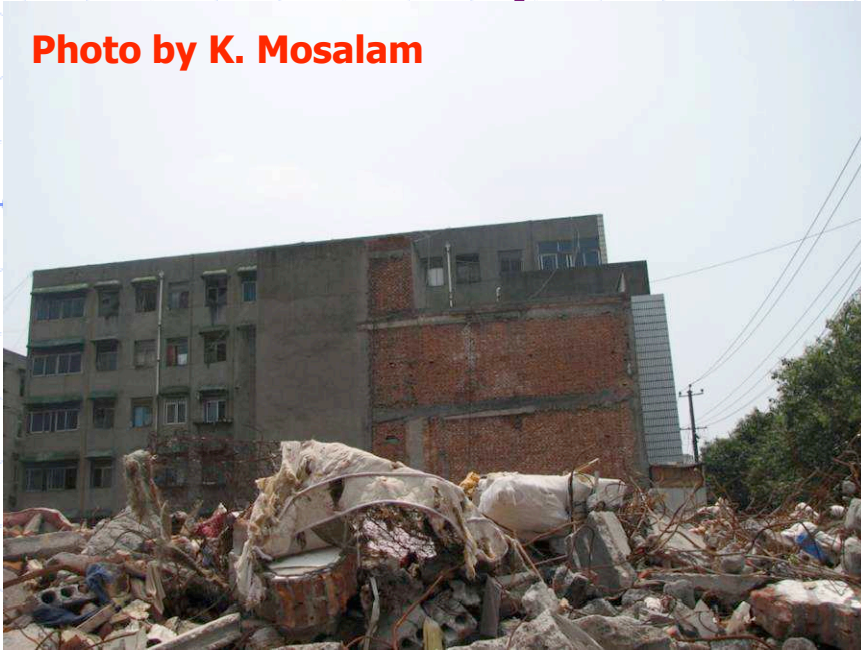
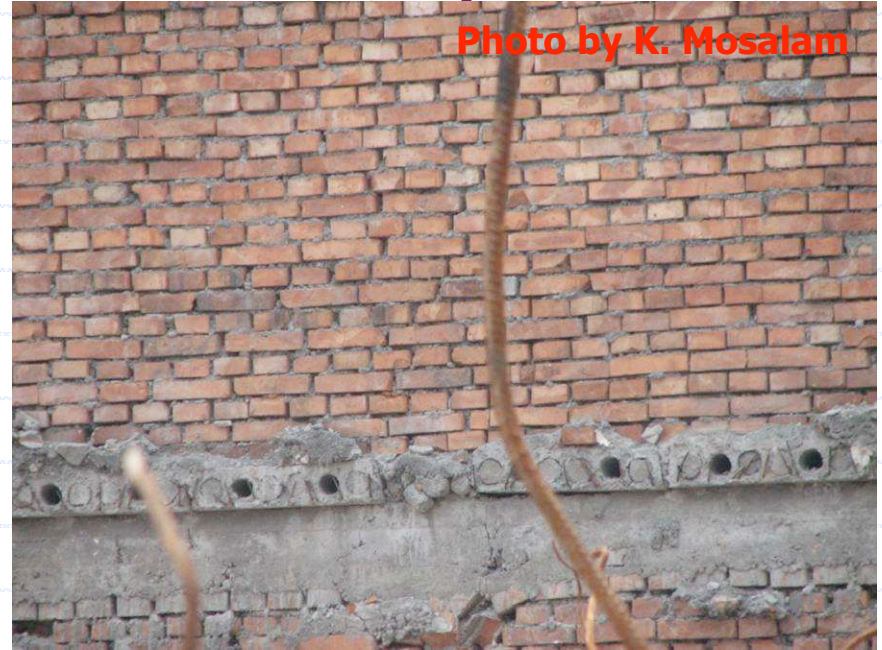
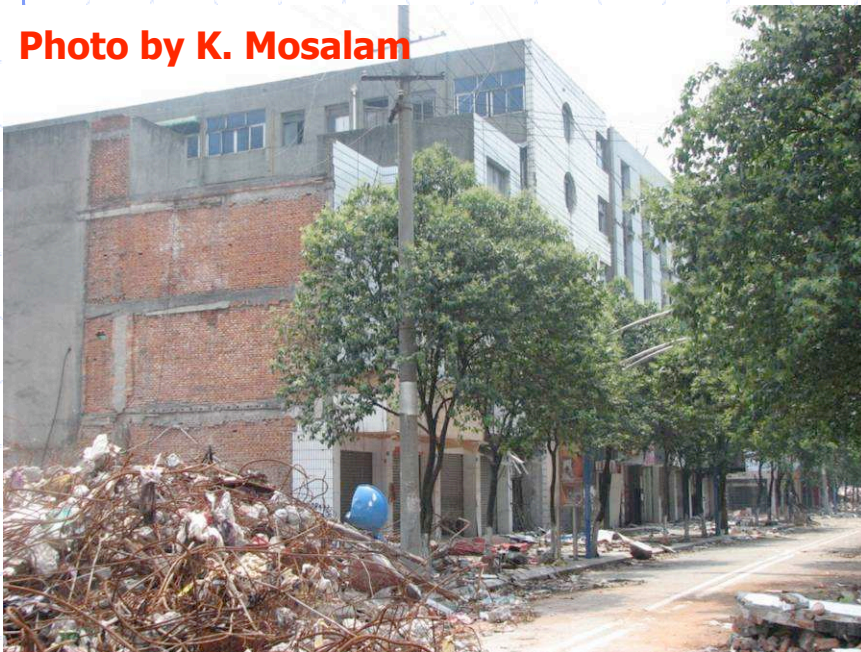
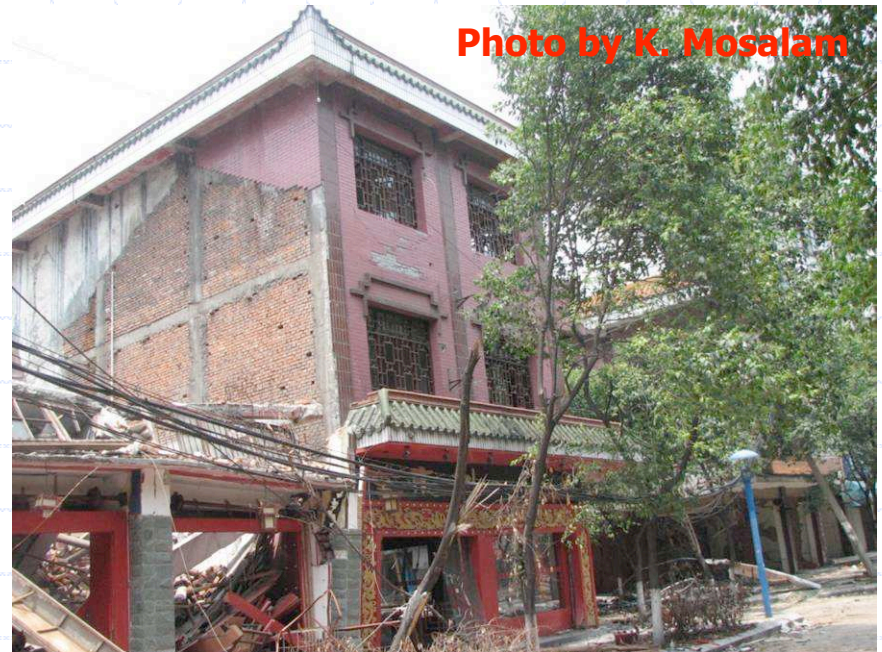
Infill Walls (Good Performance)

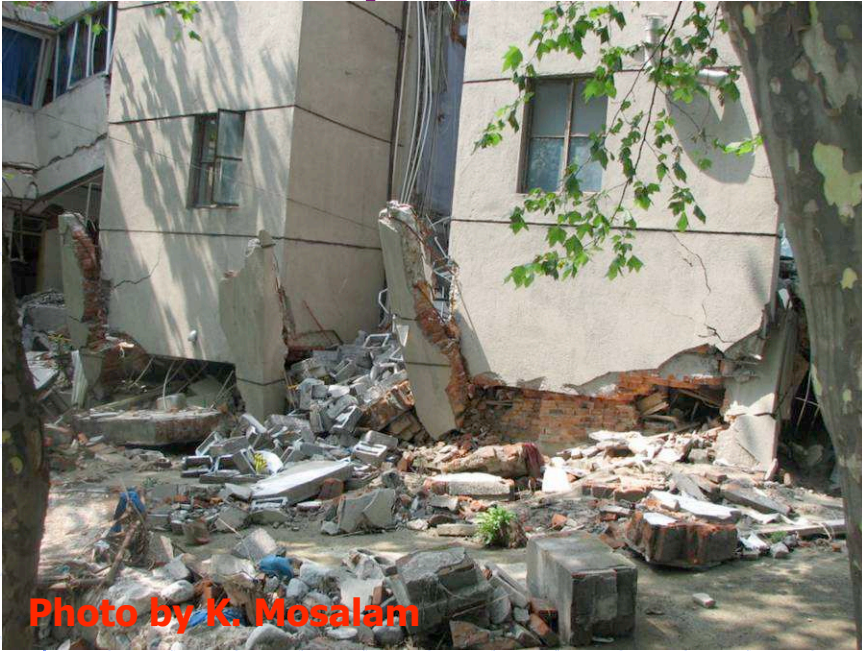
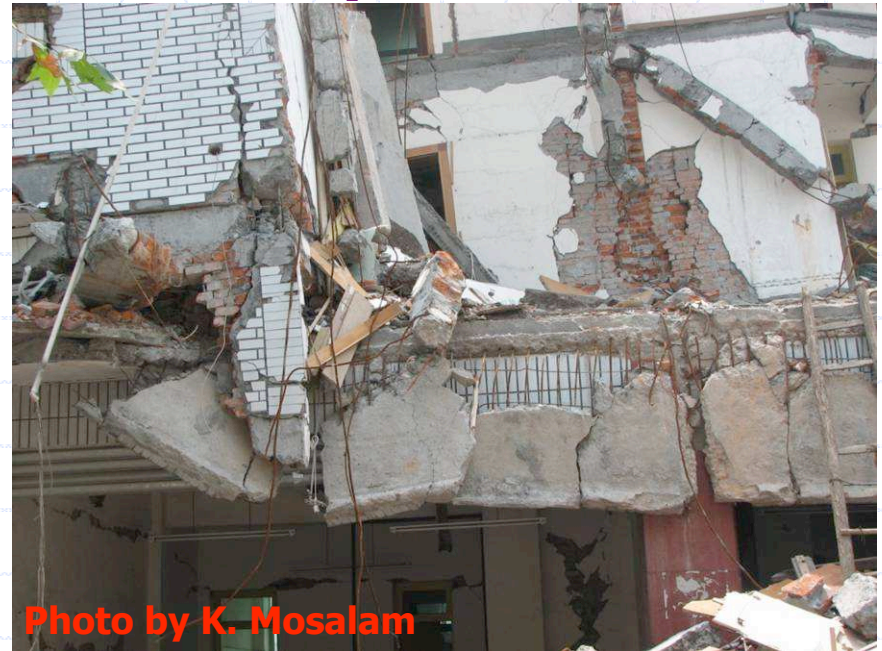
Masonry (Poor Performance)

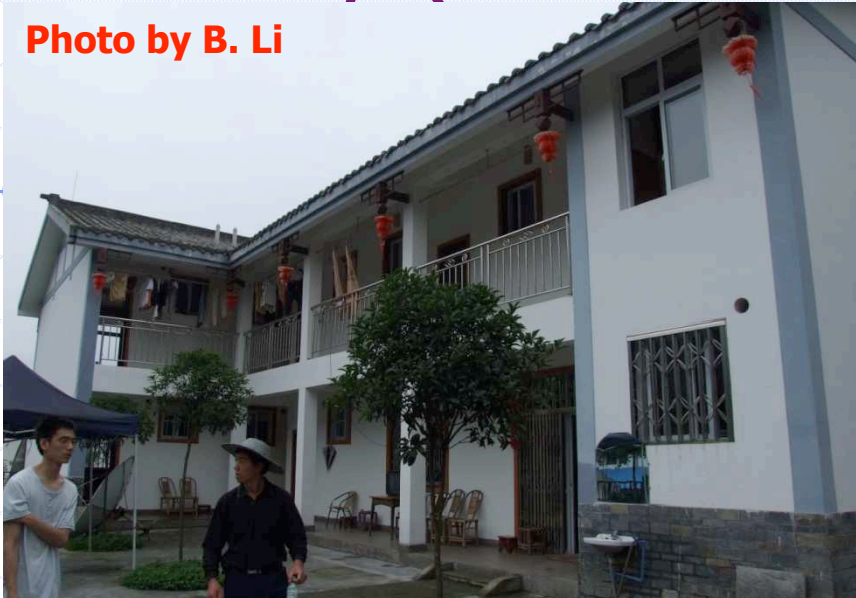
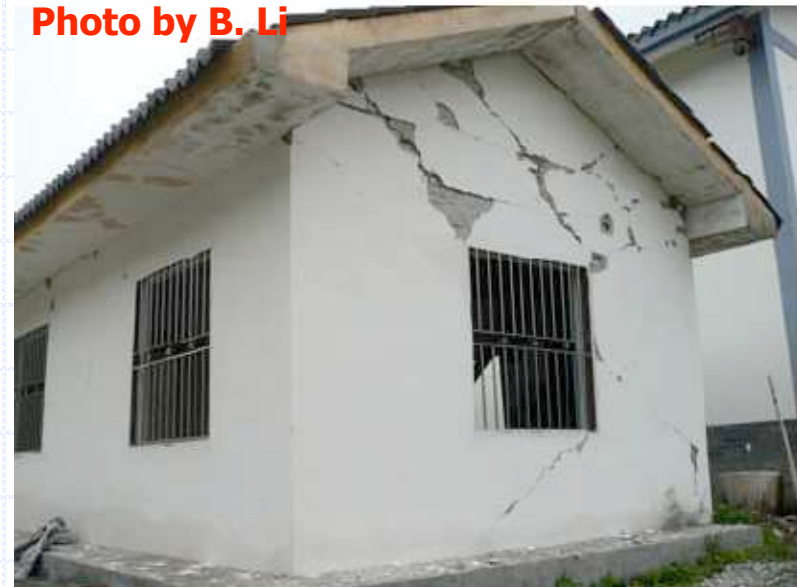
Masonry (Good Performance)

2 story confined masonry residential buildings built in 2006 performed well (Gao Yuan Village)

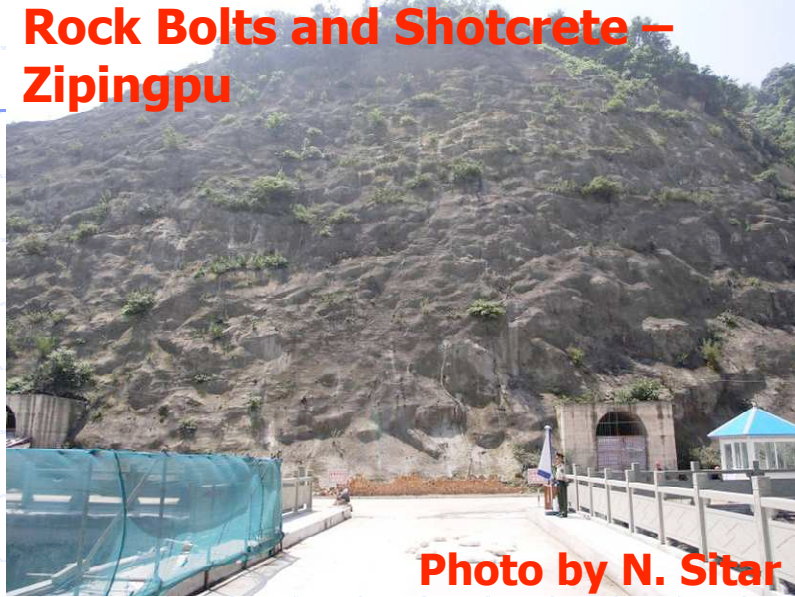
**Rock Bolts and Shotcrete –
Zipingpu**
