# Strong Motion, Damage, and Loss of Wenchuan Earthquake

Zifa Wang

Institute of Engineering Mechanics, China Earthquake Administration

August 18, 2008

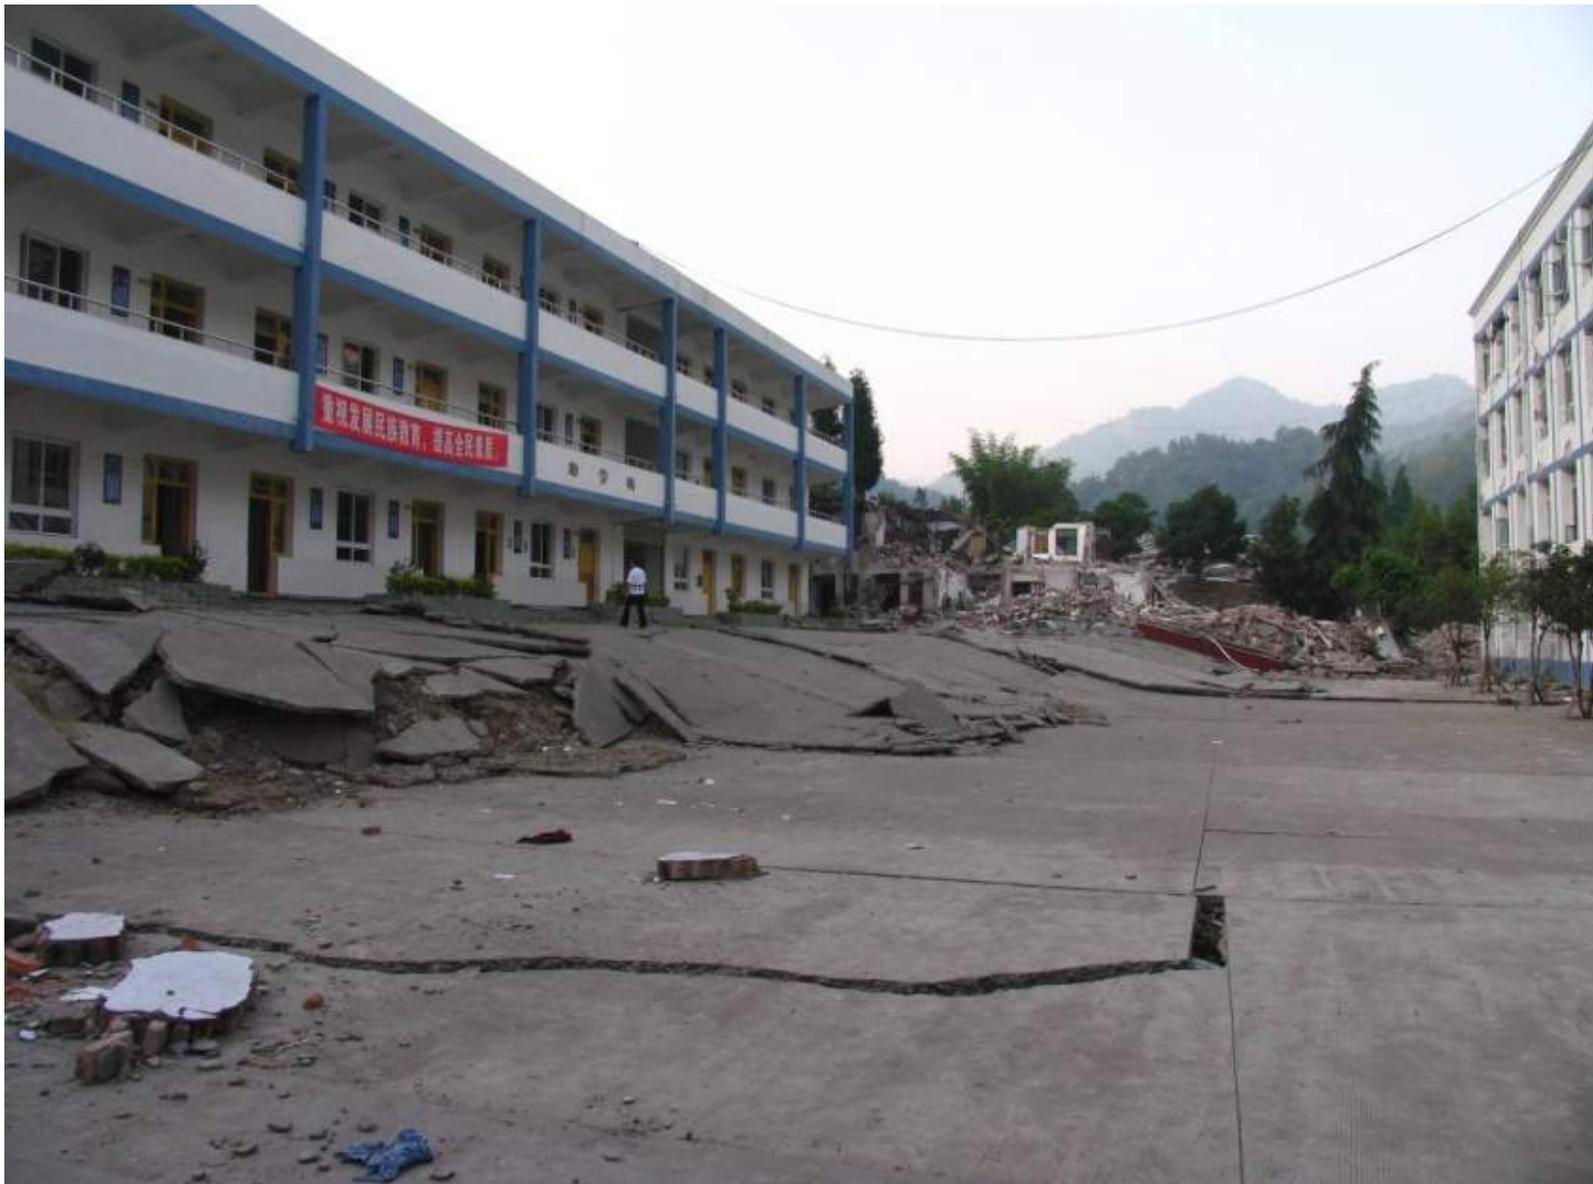
Bailuzhen Middle School in  
Pengzhou
